Expertise

Protocol number: 46153695
Order No. / Reference: 26512589
Inspection date: 25 Jun 2026

Model: Enyaq iV 80

VIN: TMBJC9NY8NF042824

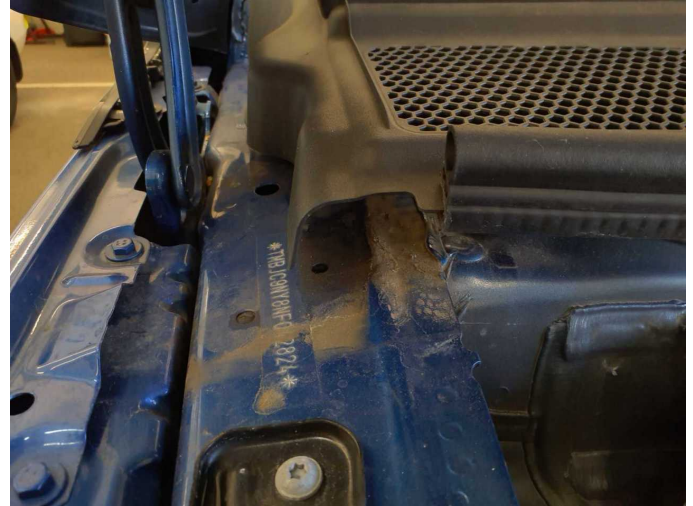
Damage 1: Cab: Insulation lining - Damage caused by marten / rodent - Replace

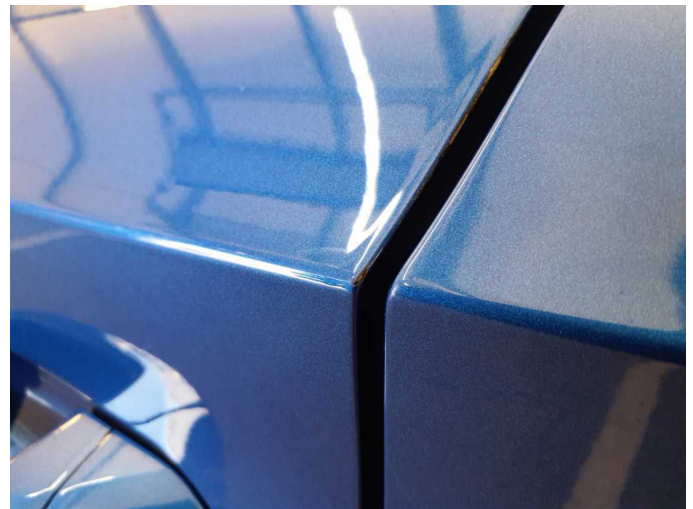
Damage 2: Door - front left side: Door edge - Scratch(es) - Smart repair

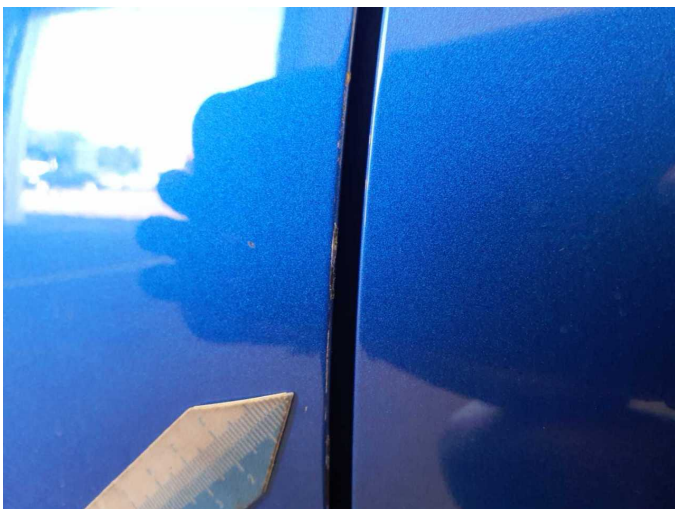
Damage 2: Door - front left side: Door edge - Scratch(es) - Smart repair

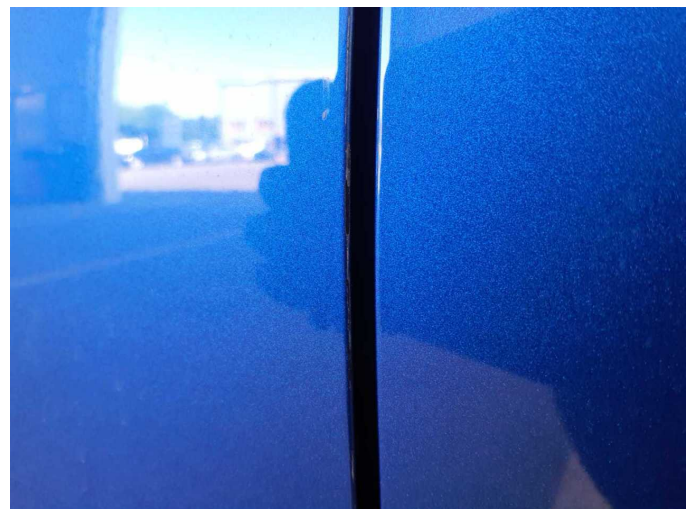
Damage 2: Door - front left side: Door edge - Scratch(es) - Smart repair

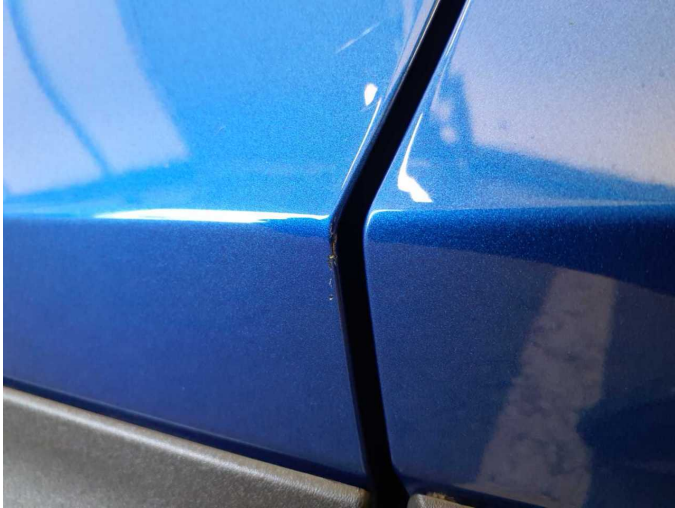
Damage 2: Door - front left side: Door edge - Scratch(es) - Smart repair

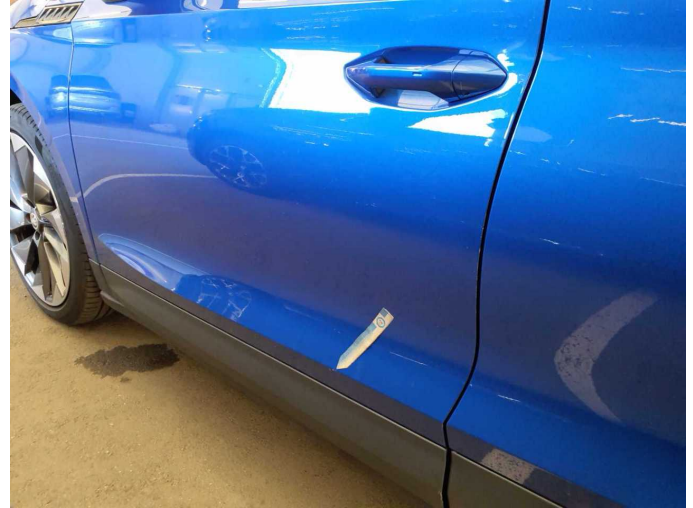
Damage 2: Door - front left side: Door edge - Scratch(es) - Smart repair

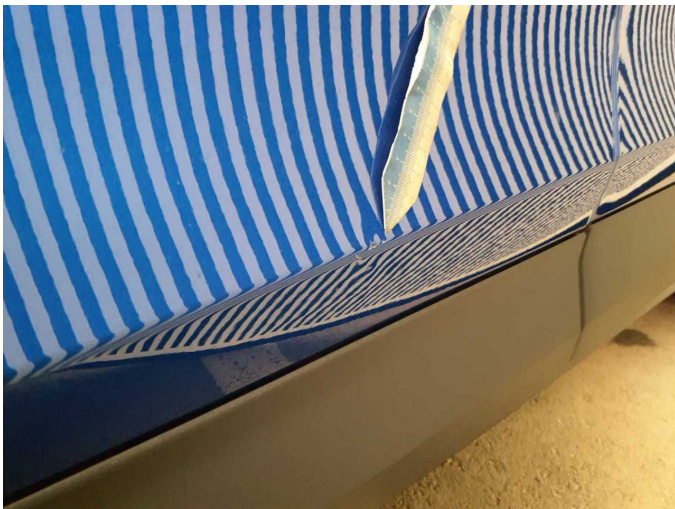
Damage 3: Door - front left side: Door - Dent / paintcoat damage - Smart repair

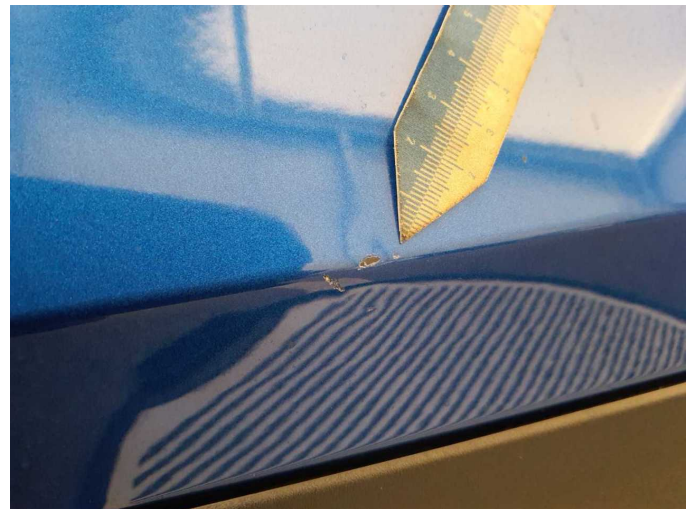
Damage 3: Door - front left side: Door - Dent / paintcoat damage - Smart repair

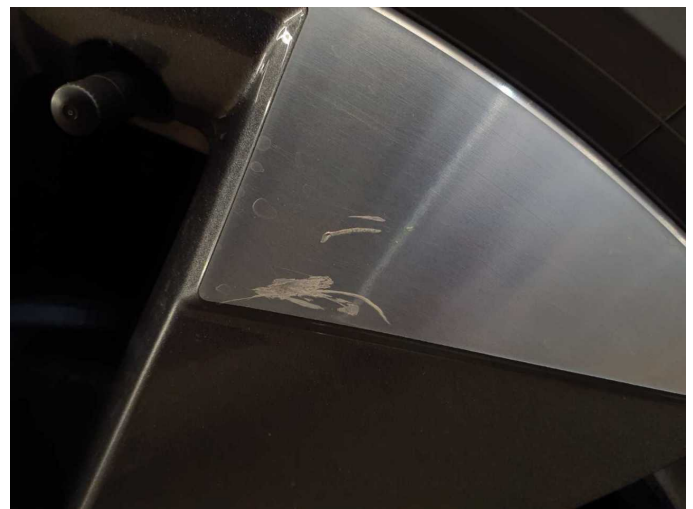
Damage 4: Wheel / tyres: Alloy rim - rear right side - Scratched - Loss in value

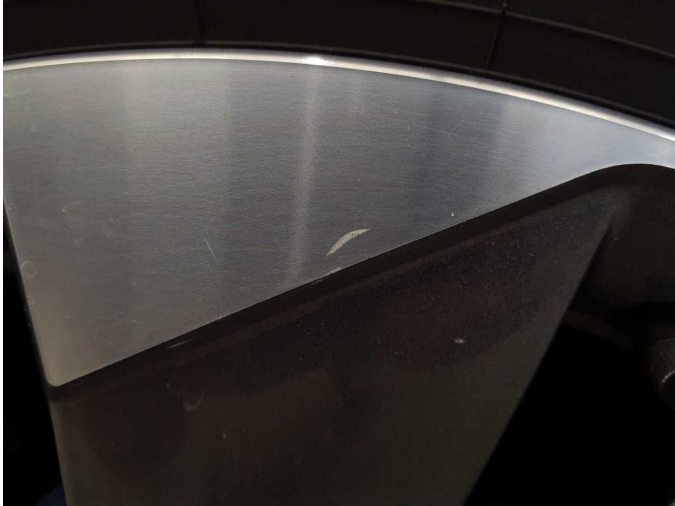
Damage 4: Wheel / tyres: Alloy rim - rear right side - Scratched - Loss in value

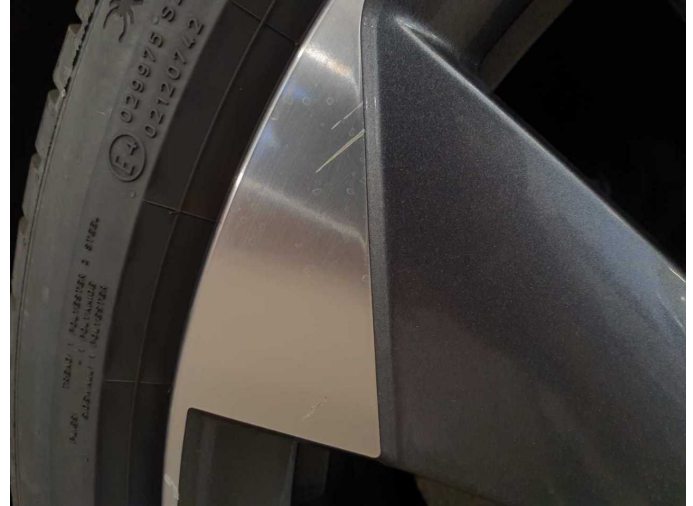
Damage 4: Wheel / tyres: Alloy rim - rear right side - Scratched - Loss in value

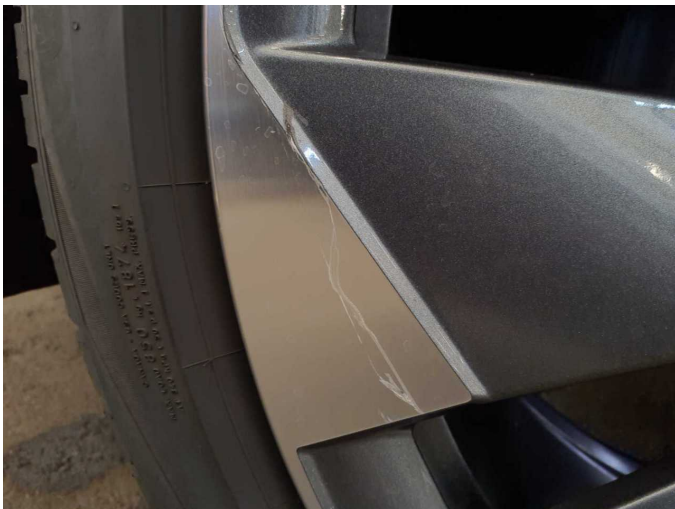
Damage 4: Wheel / tyres: Alloy rim - rear right side - Scratched - Loss in value

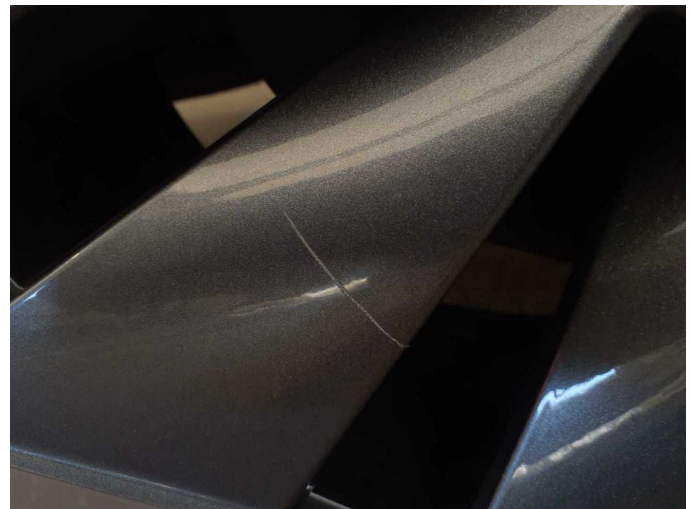
Damage 4: Wheel / tyres: Alloy rim - rear right side - Scratched - Loss in value

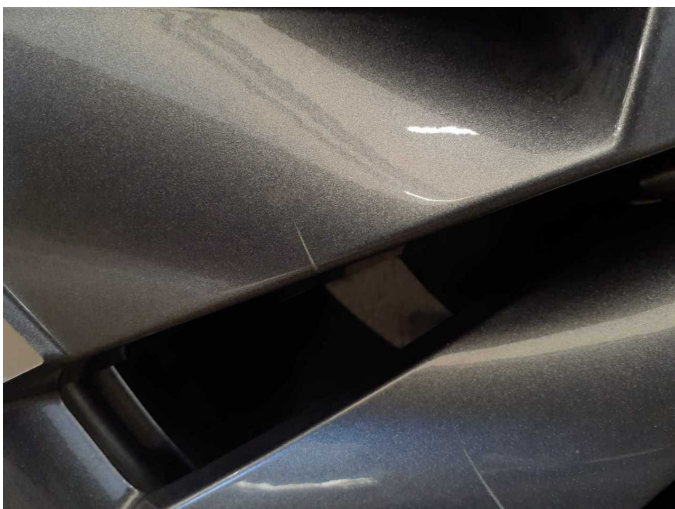
Damage 4: Wheel / tyres: Alloy rim - rear right side - Scratched - Loss in value

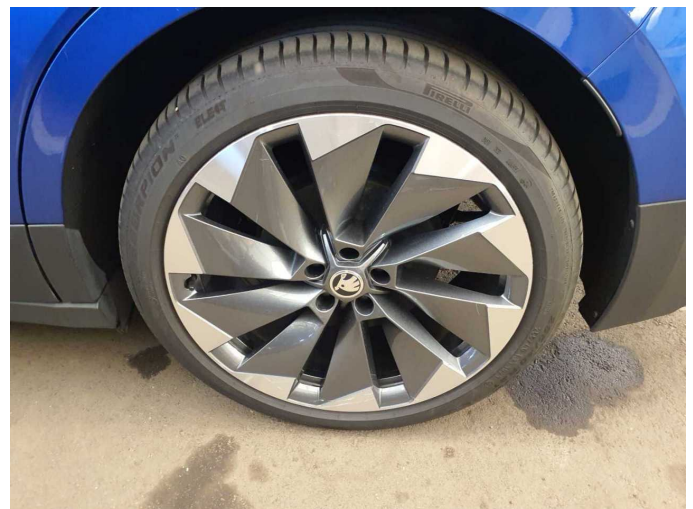
Damage 4: Wheel / tyres: Alloy rim - rear right side - Scratched - Loss in value

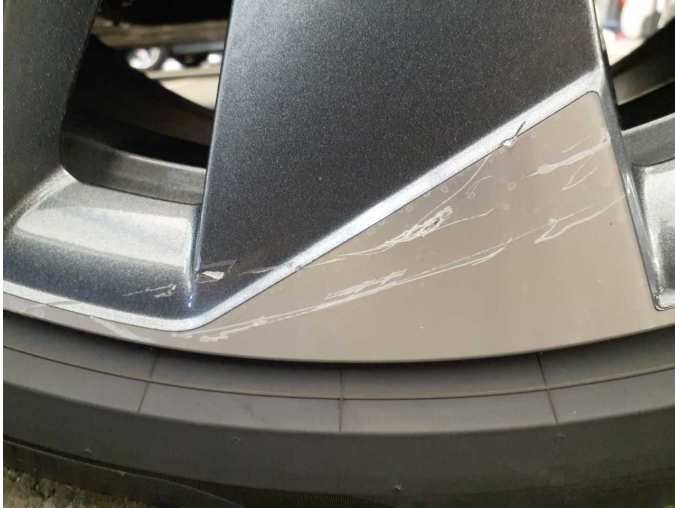
Damage 5: Wheel / tyres: Alloy rim - rear left side - Scratched - Loss in value

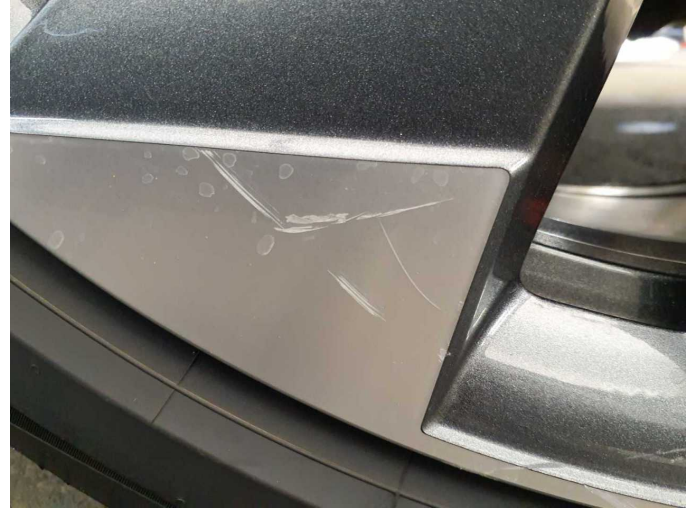
Damage 5: Wheel / tyres: Alloy rim - rear left side - Scratched - Loss in value

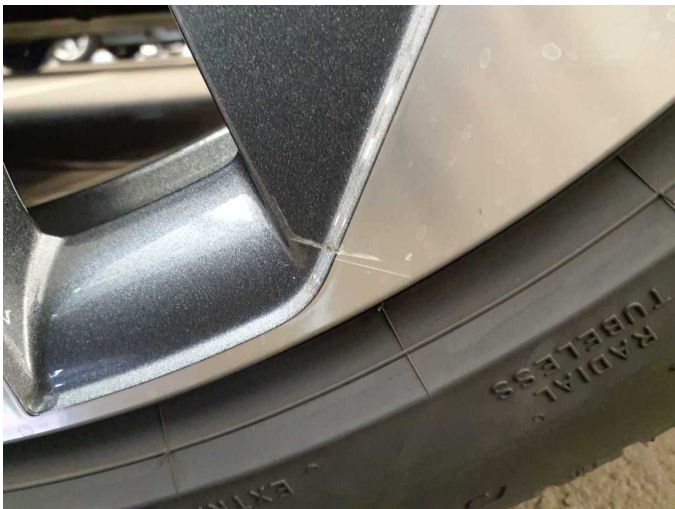
Damage 5: Wheel / tyres: Alloy rim - rear left side - Scratched - Loss in value

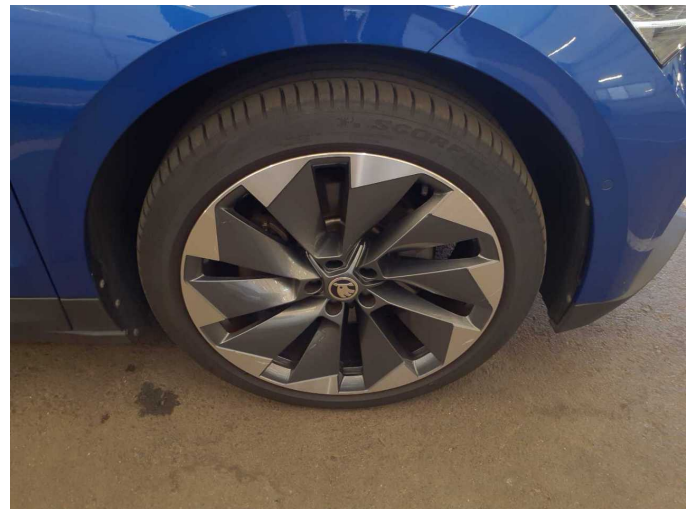
Damage 5: Wheel / tyres: Alloy rim - rear left side - Scratched - Loss in value

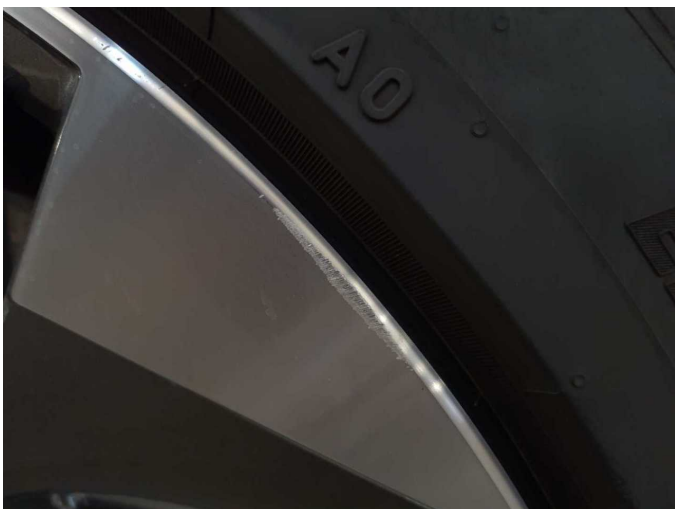
Damage 6: Wheel / tyres: Alloy rim - front right side - Scratched - Loss in value

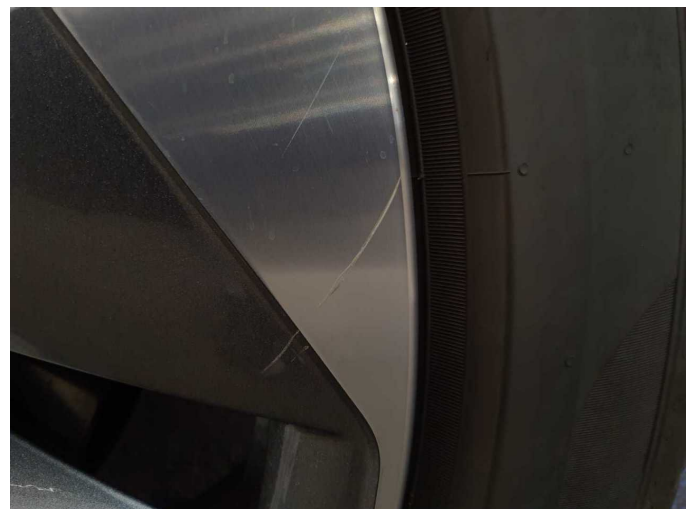
Damage 6: Wheel / tyres: Alloy rim - front right side - Scratched - Loss in value

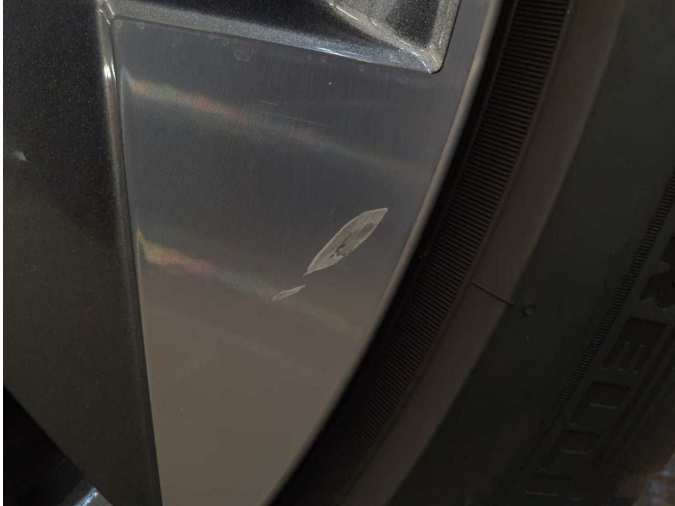
Damage 6: Wheel / tyres: Alloy rim - front right side - Scratched - Loss in value

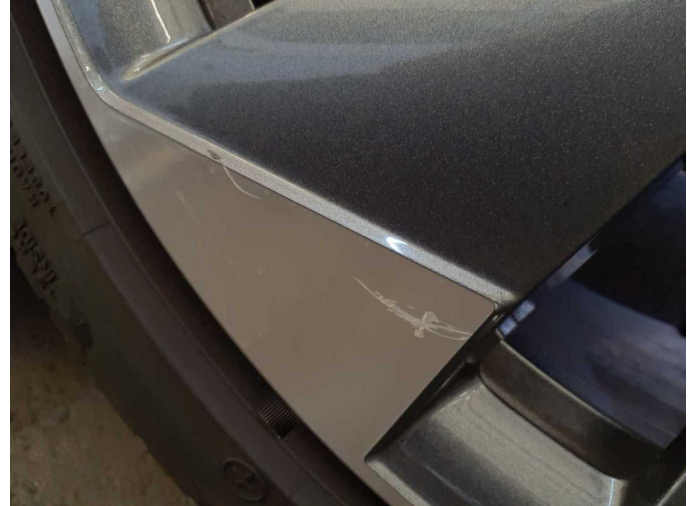
Damage 6: Wheel / tyres: Alloy rim - front right side - Scratched - Loss in value

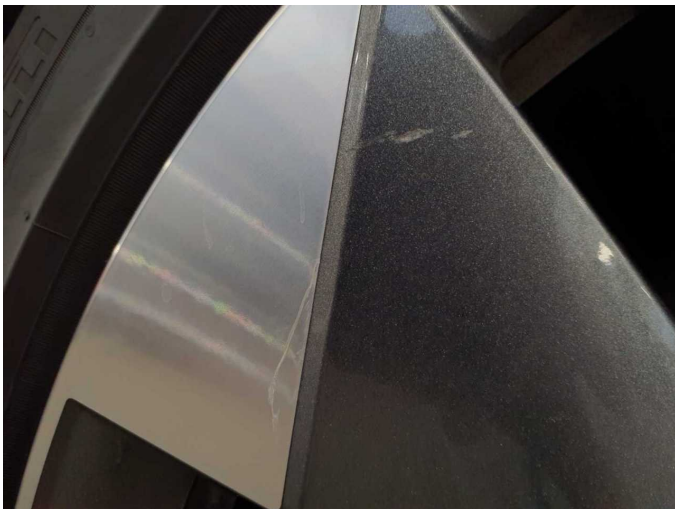
Damage 6: Wheel / tyres: Alloy rim - front right side - Scratched - Loss in value

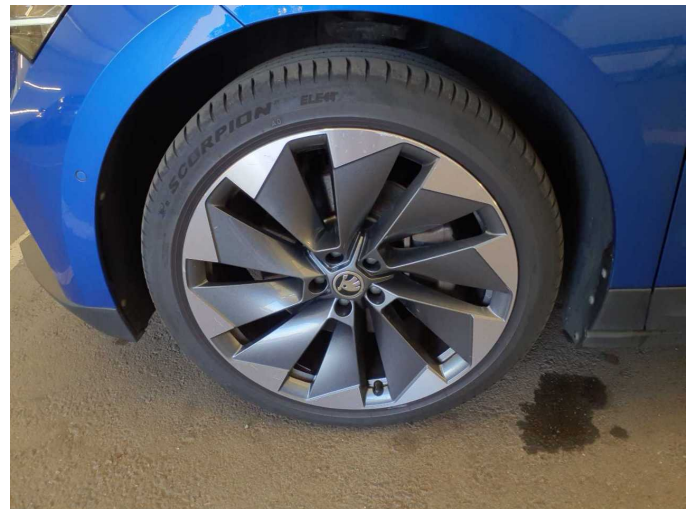
Damage 6: Wheel / tyres: Alloy rim - front right side - Scratched - Loss in value

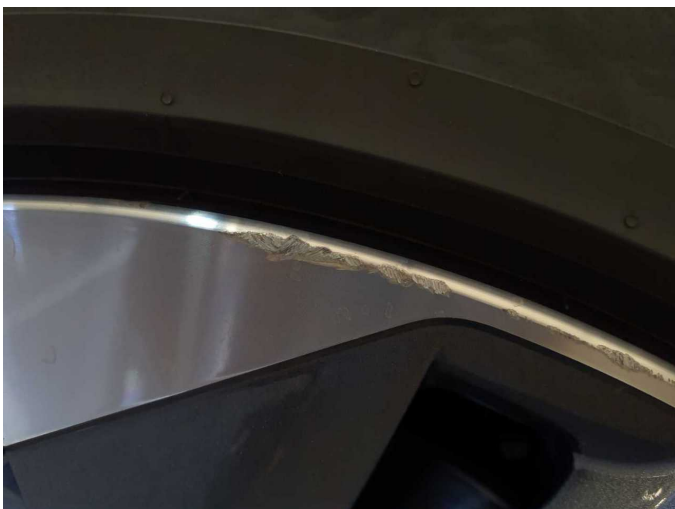
Damage 7: Wheel / tyres: Alloy rim - front left side - Scratched - Replace

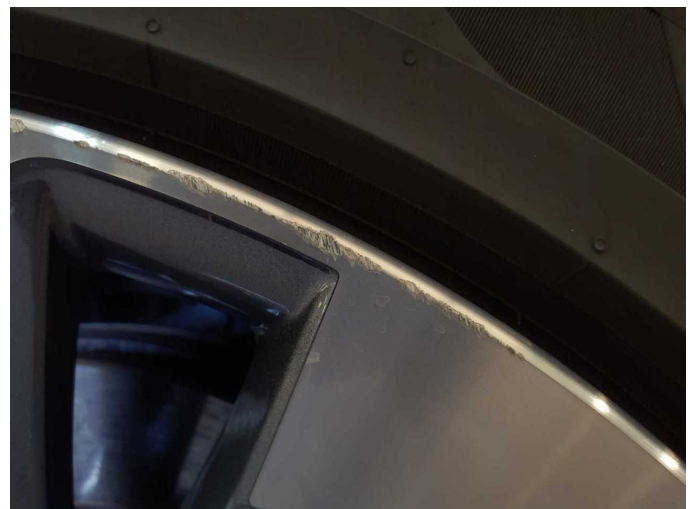
Damage 7: Wheel / tyres: Alloy rim - front left side - Scratched - Replace

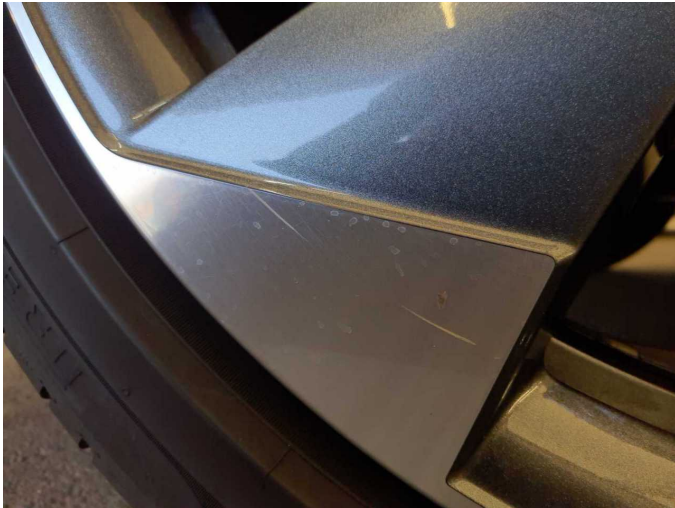
Damage 7: Wheel / tyres: Alloy rim - front left side - Scratched - Replace

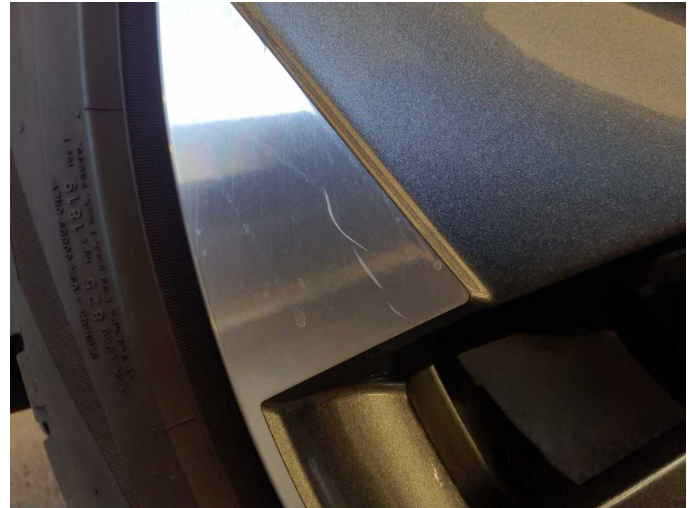
Damage 7: Wheel / tyres: Alloy rim - front left side - Scratched - Replace

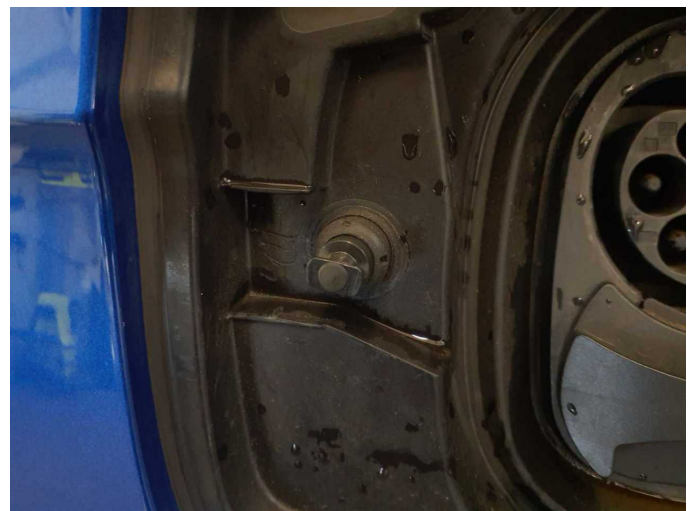
Damage 8: Fuel system: Tank flap (Betätigung + Halterung) - Non-operational - Replace

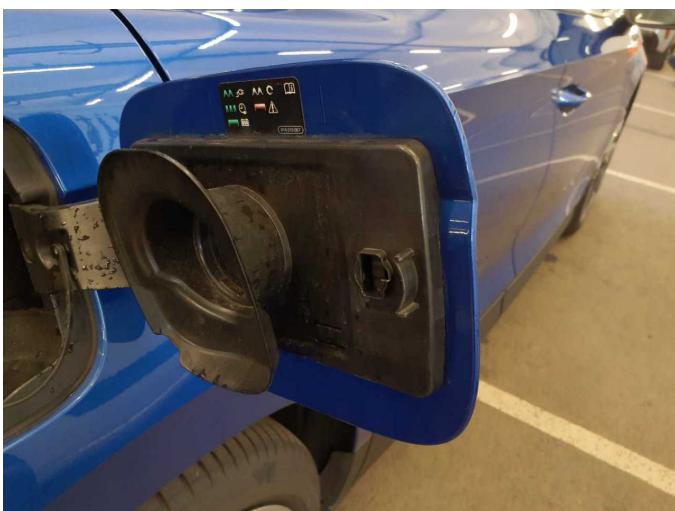
Damage 8: Fuel system: Tank flap (Betätigung + Halterung) - Non-operational - Replace

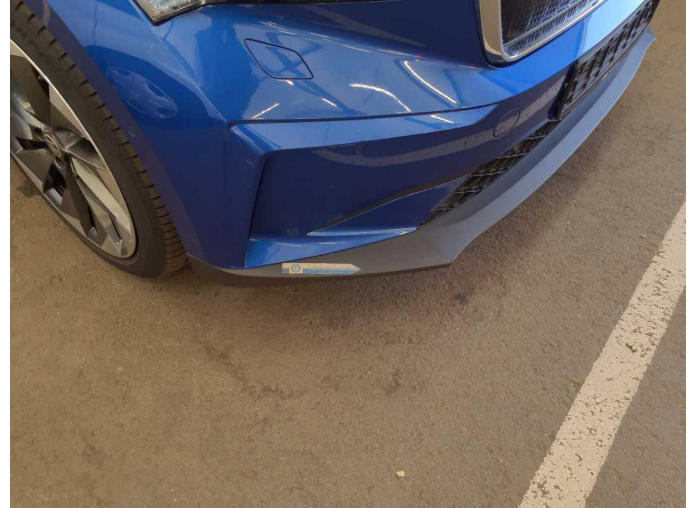
Damage 10: Front bumper: Front bumper (+ Spoiler erneuern) - Deformed - Paint

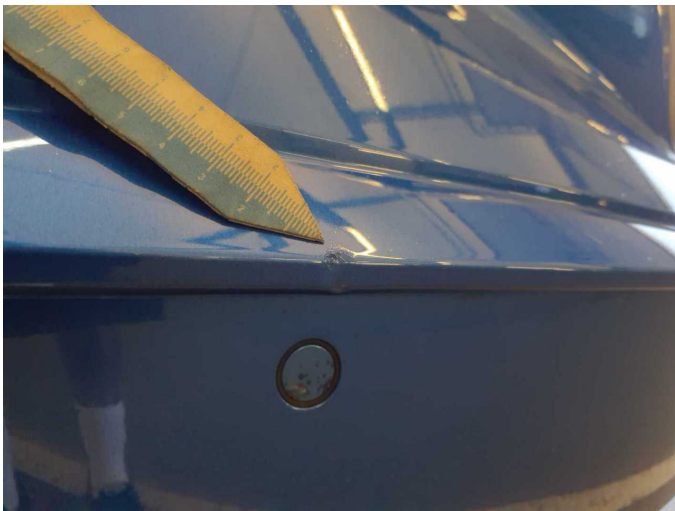
Damage 10: Front bumper: Front bumper (+ Spoiler erneuern) - Deformed - Paint

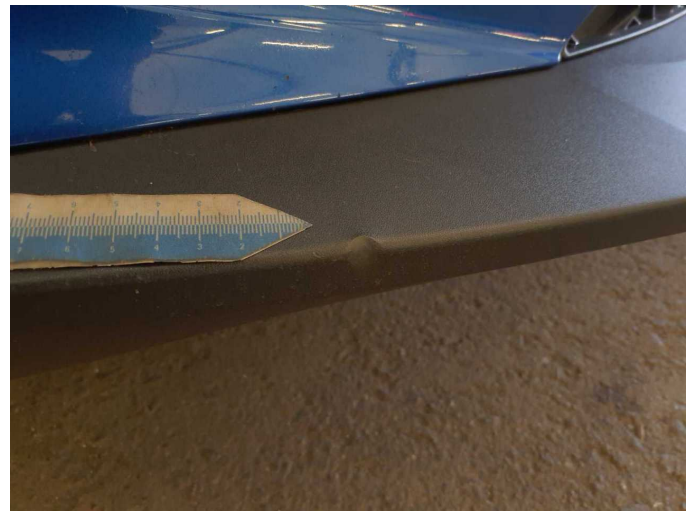
Damage 10: Front bumper: Front bumper (+ Spoiler erneuern) - Deformed - Paint

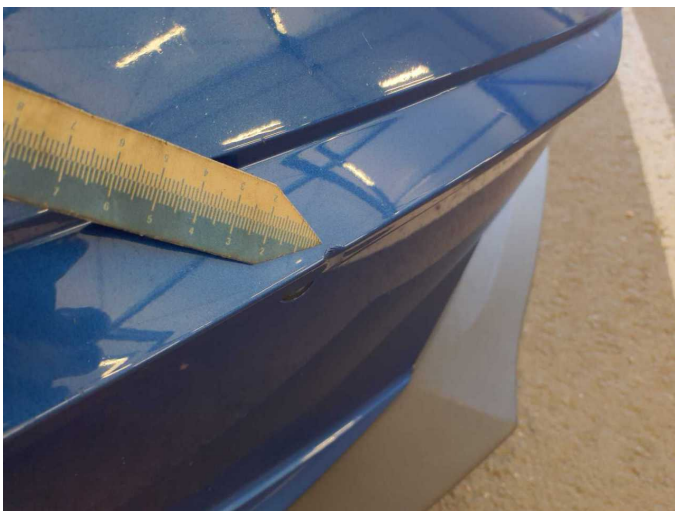
Damage 10: Front bumper: Front bumper (+ Spoiler erneuern) - Deformed - Paint
