Volvo V 90:

Limited Technical Inspection

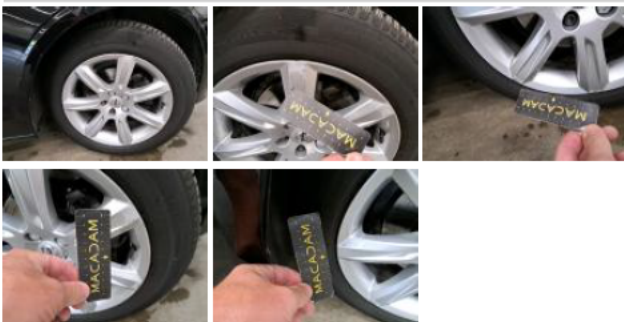
Wing FR, Scratch(es), Acceptable 0,00
