## Expertise

Protocol number: 46237931  
 Order No. / Reference: 26598352  
 Inspection date: 26 Jun 2026

Model: Touran 2.0 TDI SCR DSG Comfortline

VIN: WVGZZZ1TZW016787

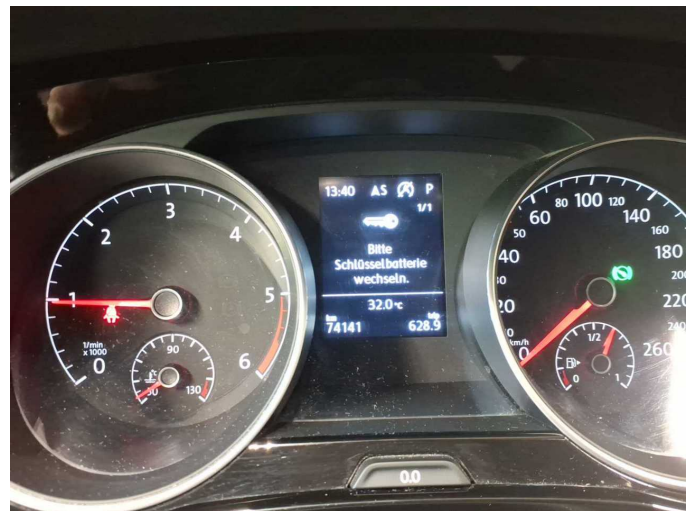
| No. | Component group | Description |
|---|---|--|
| 1 | Equipment | Vehicle key with remote control (Batterie) - Due - Replace |

Damage 1: Equipment: Vehicle key with remote control (Batterie) - Due - Replace

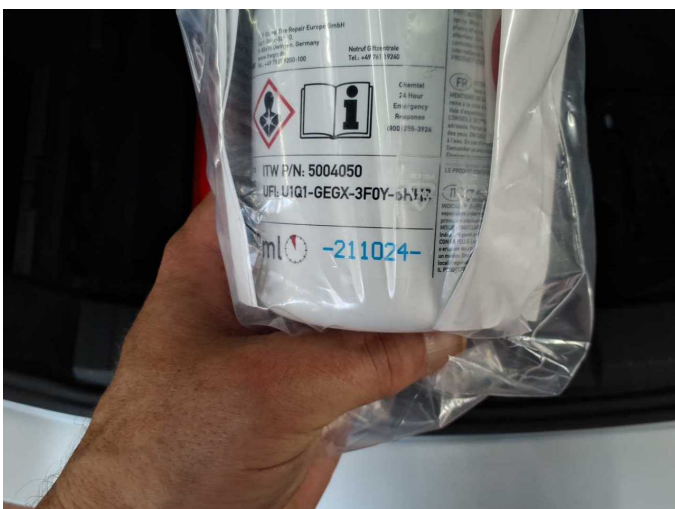
| No. | Component group | Description |
|---|---|--|
| 2 | Equipment | Tirefit filler - Expired - Replace |

Damage 2: Equipment: Tirefit filler - Expired - Replace

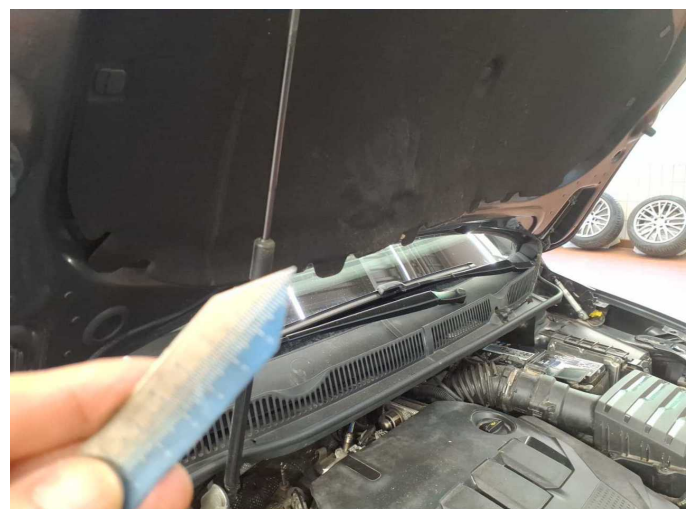
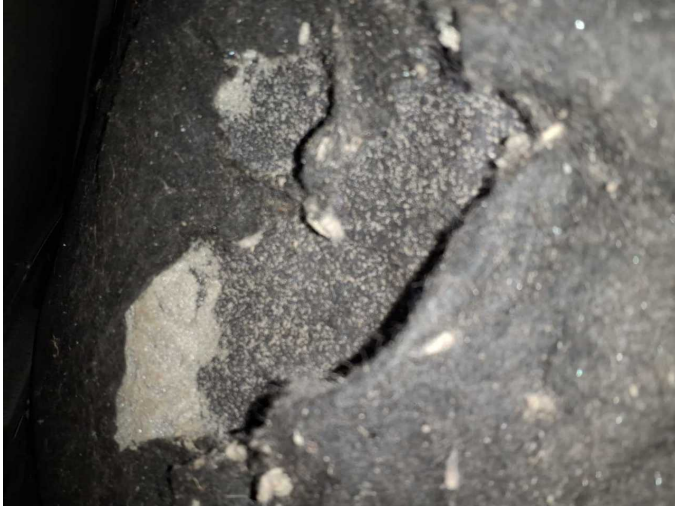
| No. | Component group | Description |
|---|---|--|
| 3 | Bonnet | Insulation lining - Damage caused by marten / rodent - Replace |

Damage 3: Bonnet: Insulation lining - Damage caused by marten / rodent - Replace

**Damage 3:** Bonnet: Insulation lining - Damage caused by marten / rodent - Replace

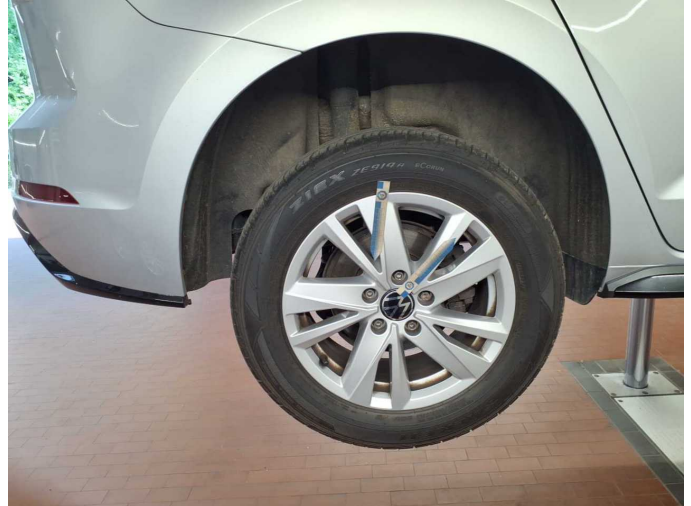
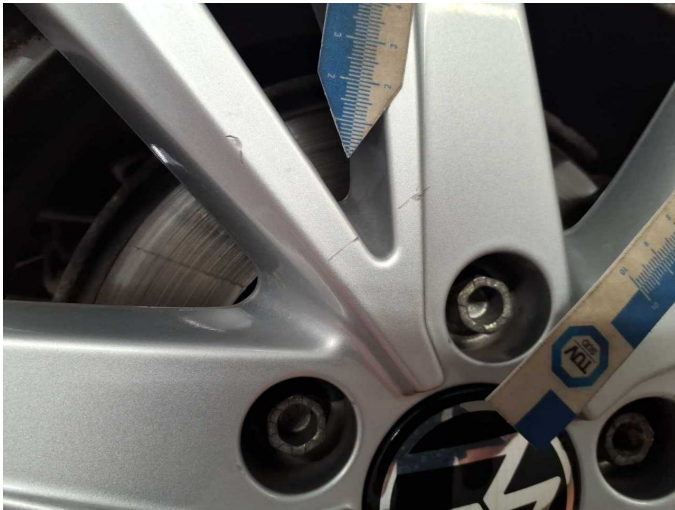
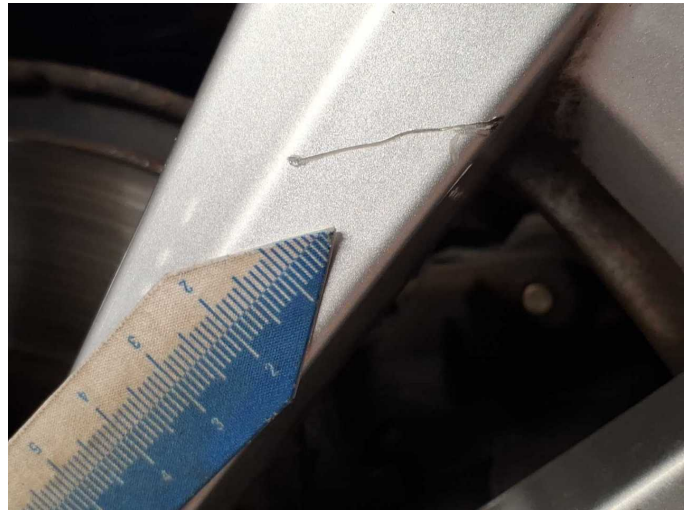
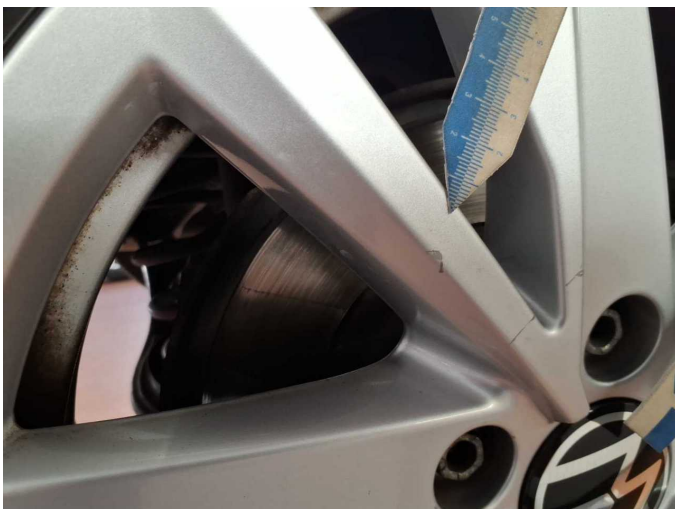
| No. | Component group | Description |
|---|---|--|
| 4 | Wheel / tyres | Alloy rim - rear right side - Scratch(es) - Loss in value |

**Damage 4:** Wheel / tyres: Alloy rim - rear right side - Scratch(es) - Loss in value

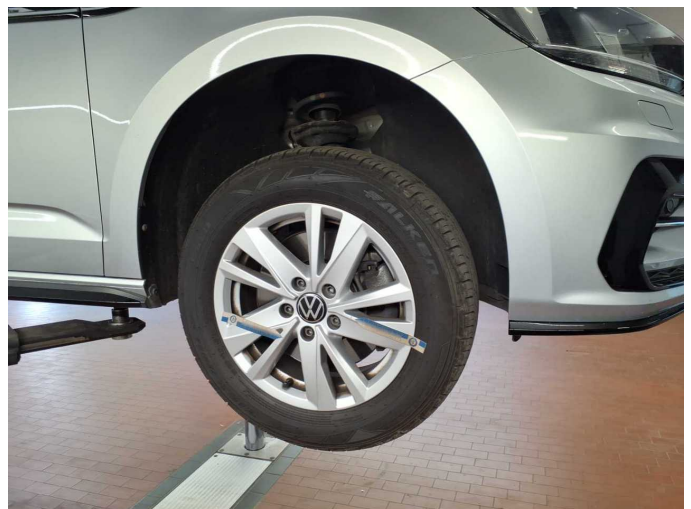
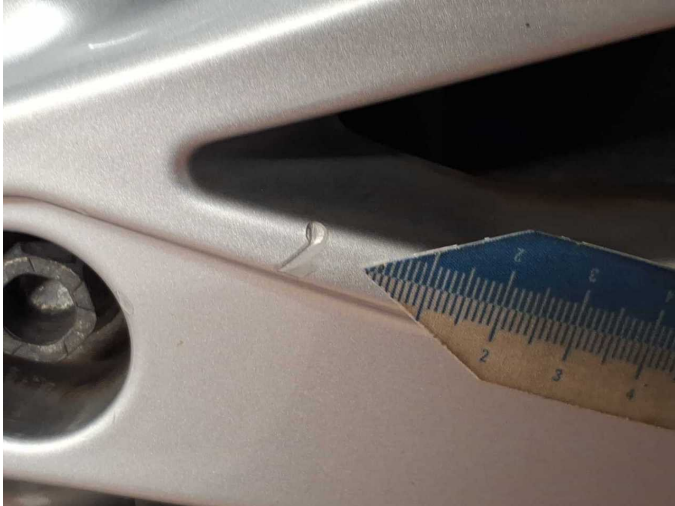
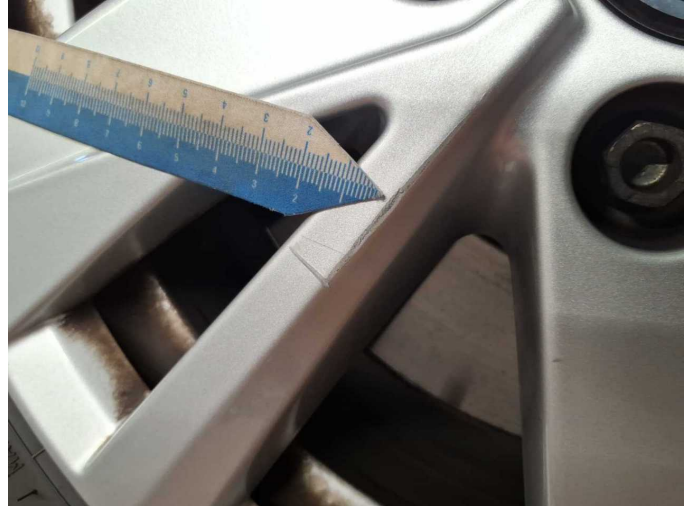
| No. | Component group | Description |
|---|---|--|
| 5 | Wheel / tyres | Alloy rim - front right side - Scratched - Loss in value |

**Damage 5:** Wheel / tyres: Alloy rim - front right side - Scratched - Loss in value

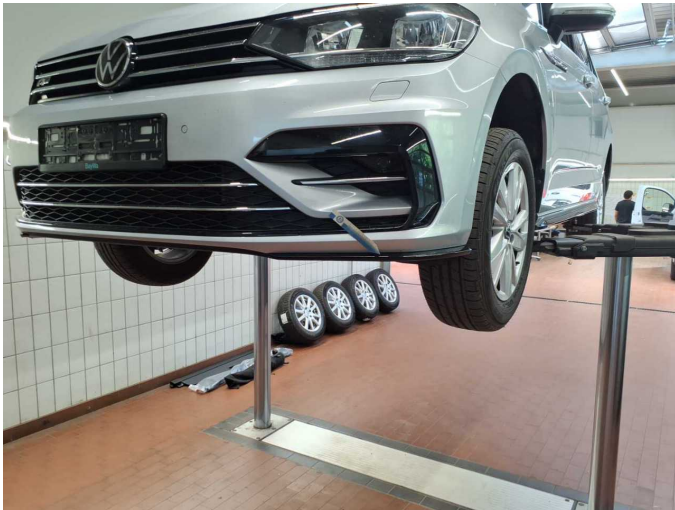
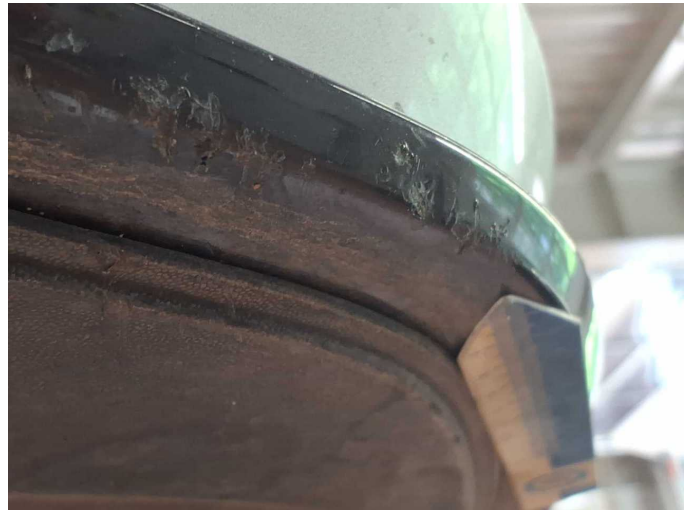
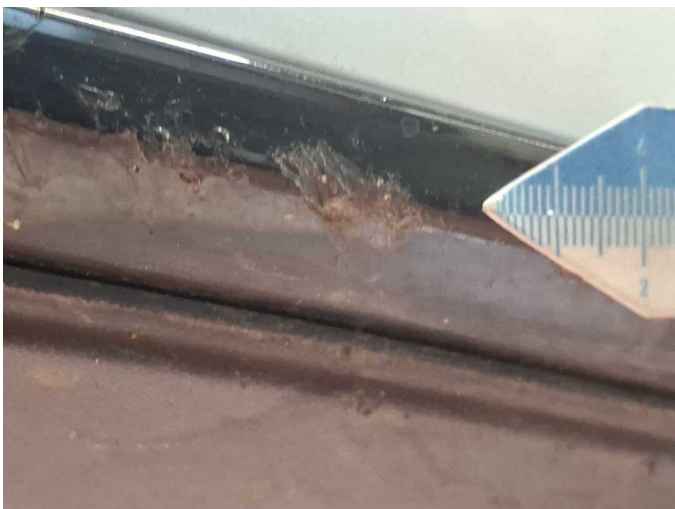
| No. | Component group | Description |
|---|---|--|
| 6 | Front bumper | Spoiler - Scratched - Replace |

**Damage 6:** Front bumper: Spoiler - Scratched - Replace

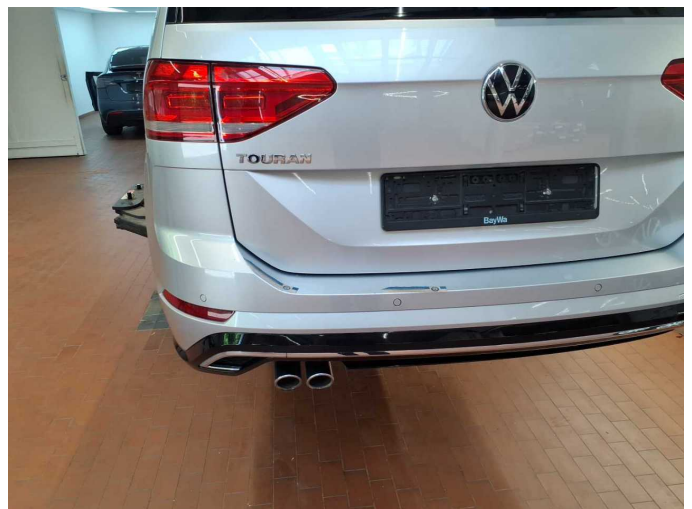
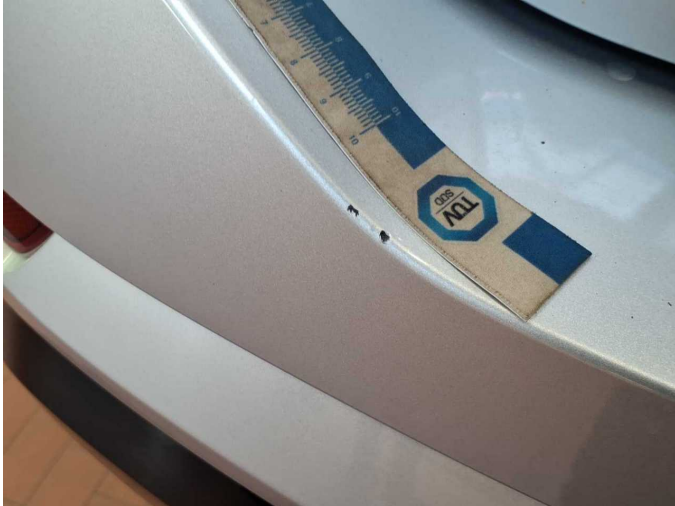
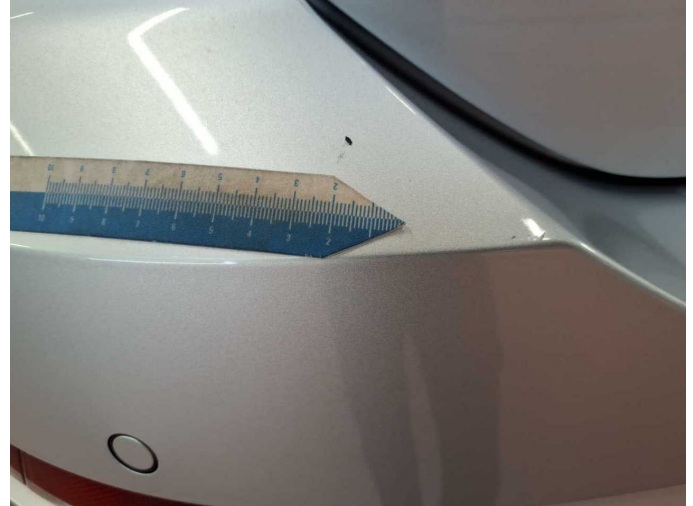
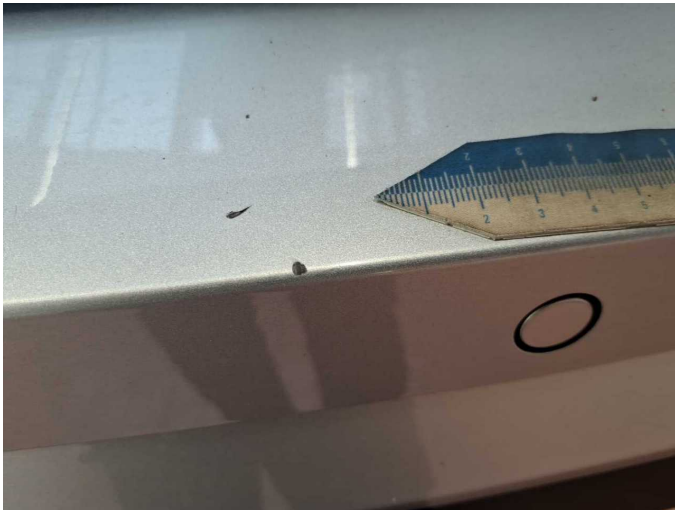
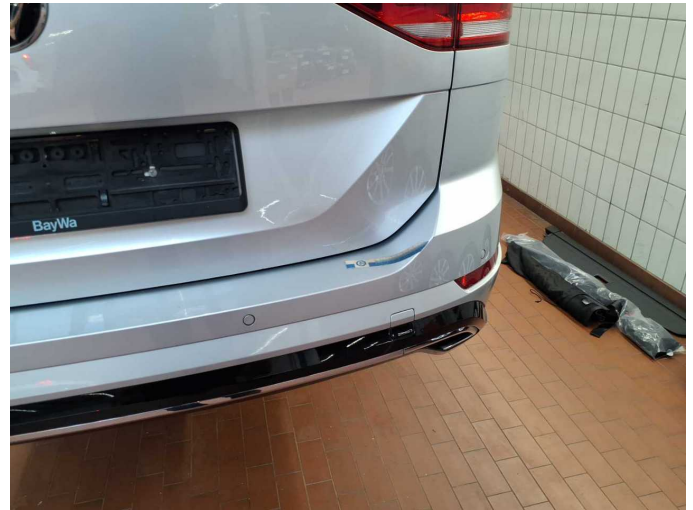
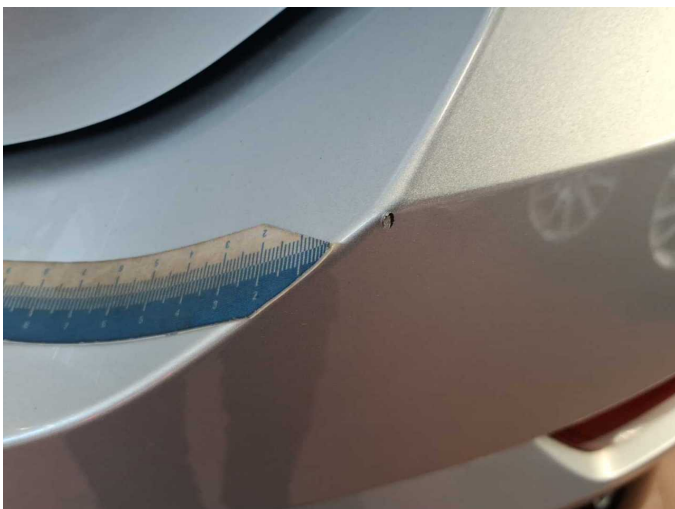
| No. | Component group | Description |
|---|---|--|
| 7 | Rear bumper | Rear bumper - Scratched - Paint |

**Damage 7:** Rear bumper: Rear bumper - Scratched - Paint

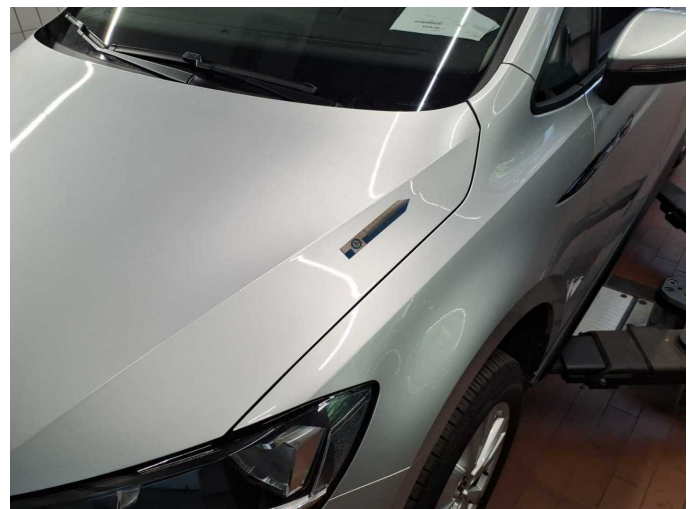
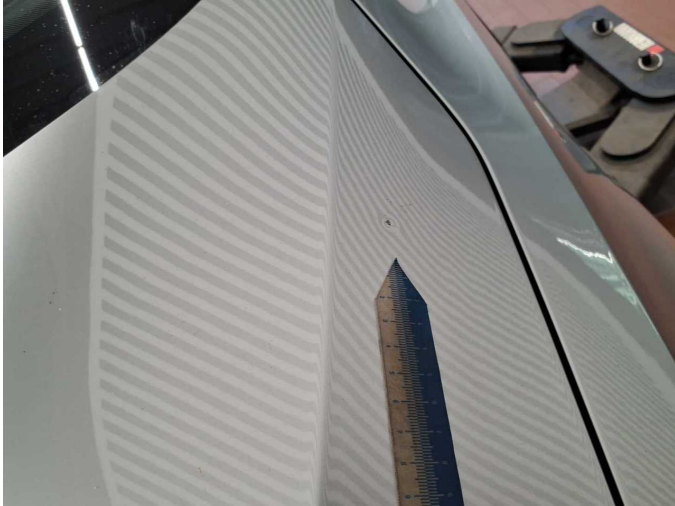
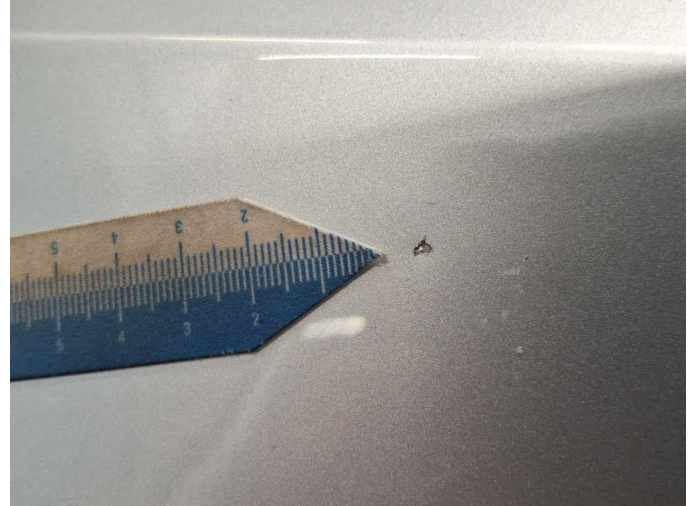
| No. | Component group | Description |
|---|---|--|
| 8 | Bonnet | Bonnet - Dent / paintcoat damage - Paint |

**Damage 8:** Bonnet: Bonnet - Dent / paintcoat damage - Paint

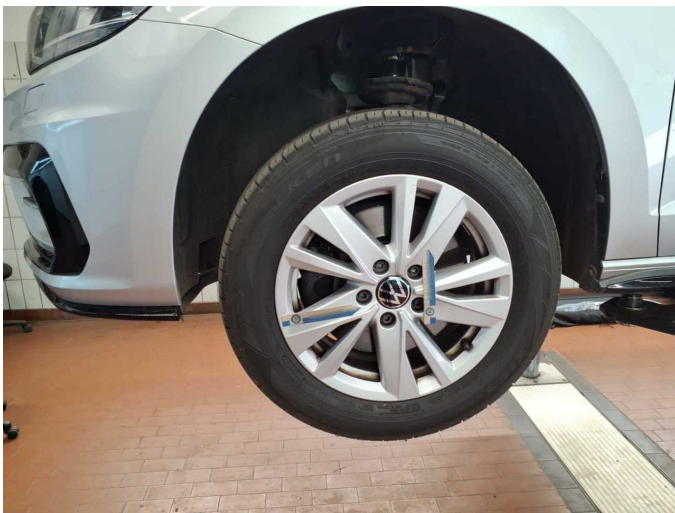
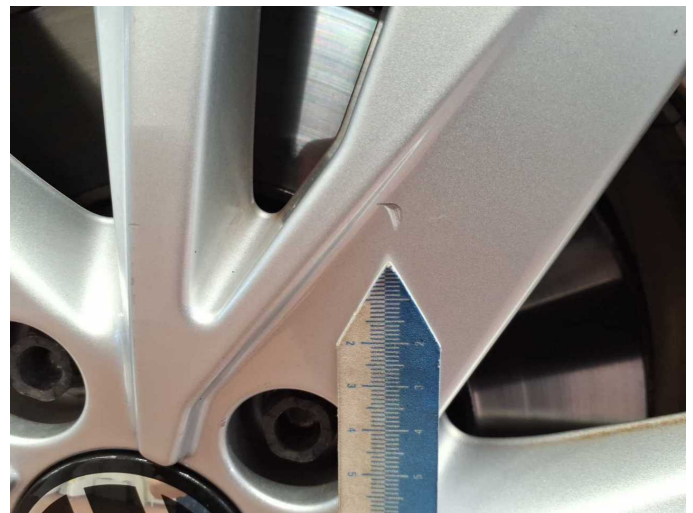
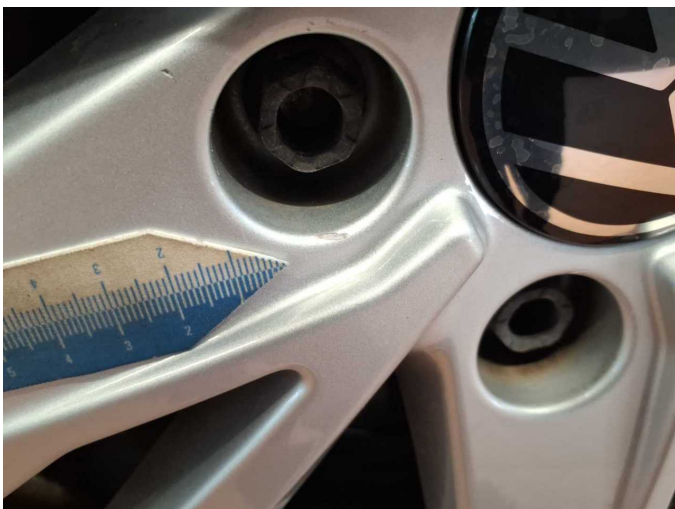
| No. | Component group | Description |
|---|---|--|
| 1 | Wheel / tyres | Alloy rim - front left side - Scratch(es) - No deduction |

**Wear and tear 1:** Wheel / tyres: Alloy rim - front left side - Scratch(es) - No deduction

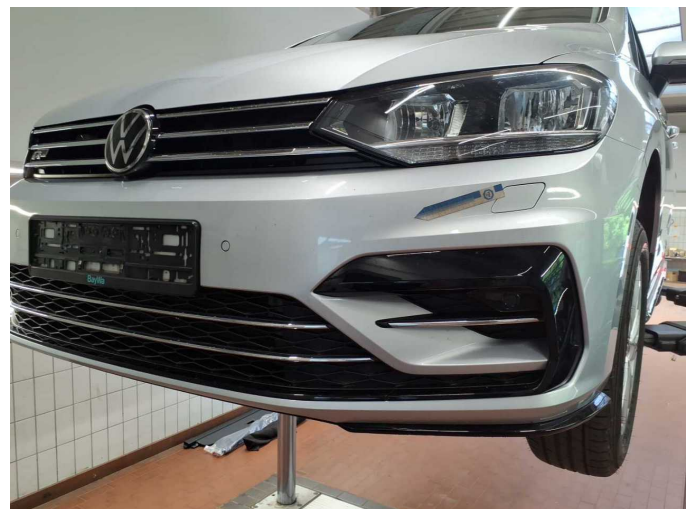
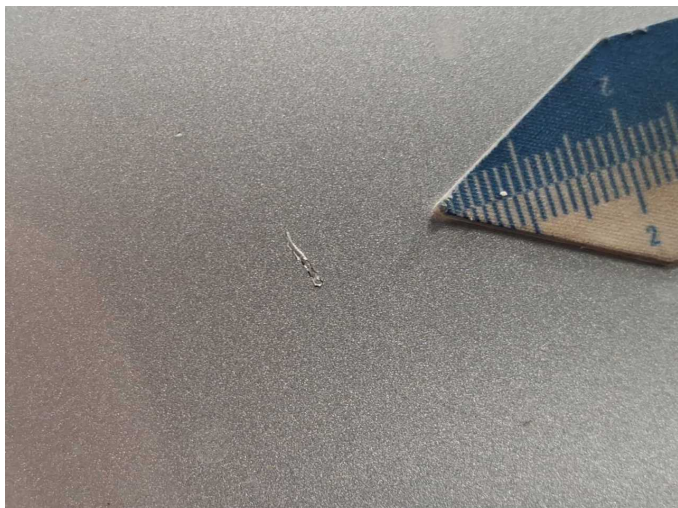
| No. | Component group | Description |
|---|---|--|
| 4 | Front bumper | Front bumper - Scratch(es) - No deduction |

**Wear and tear 4:** Front bumper: Front bumper - Scratch(es) - No deduction
