Expertise

Protocol number: 46014331
Order No. / Reference: 26472432
Inspection date: 18 Jun 2026

Manufacturer: Volvo

Model: V60 T6 AWD Recharge Geartronic RDesign

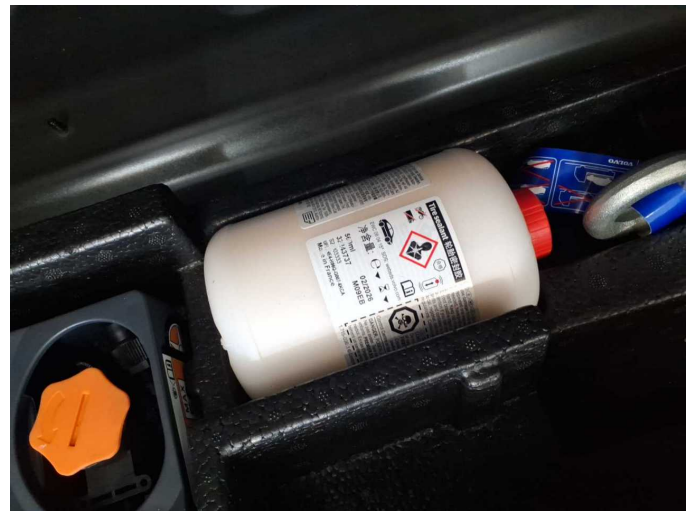
Damage 1: Equipment: Tirefit filler - Expired - Replace

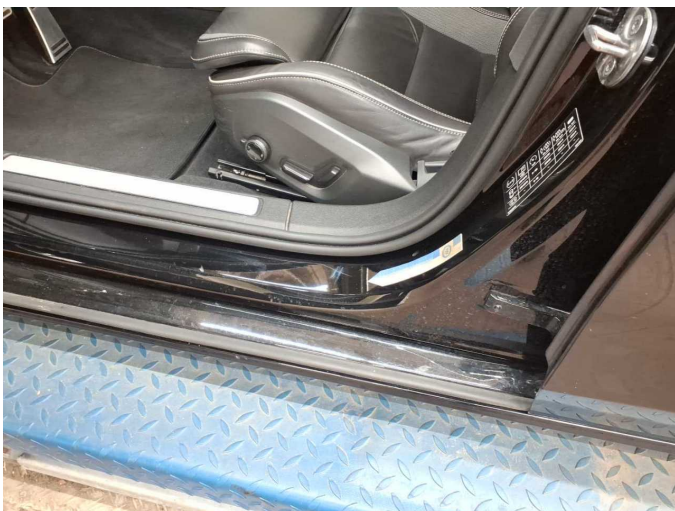
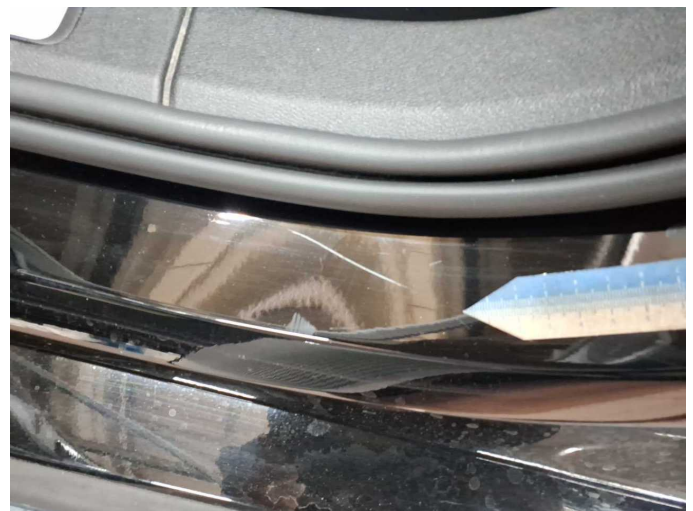
Damage 2: Sill - left side: Sill - Scratch(es) - Smart repair

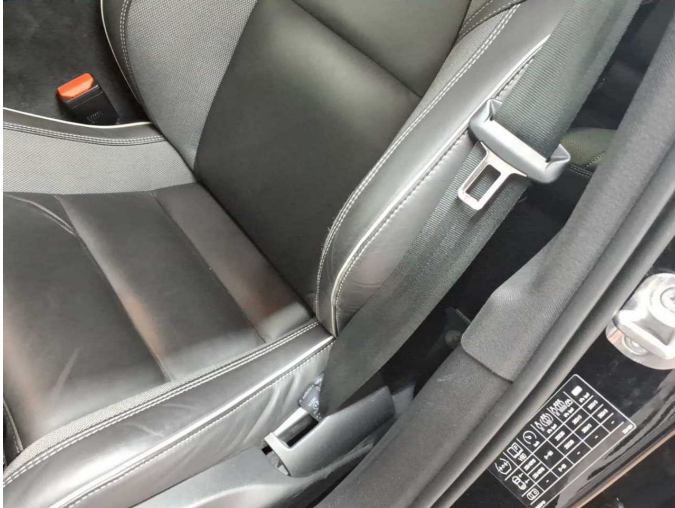
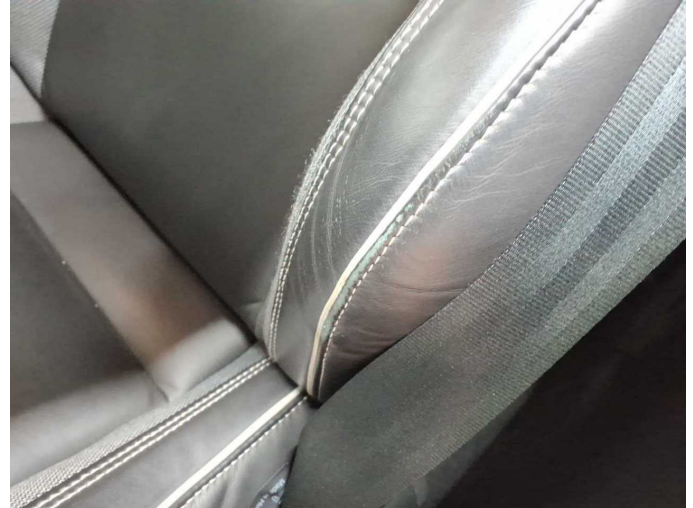
Damage 3: Seat - front: Seat cover - left side - Abrasion - Loss in value

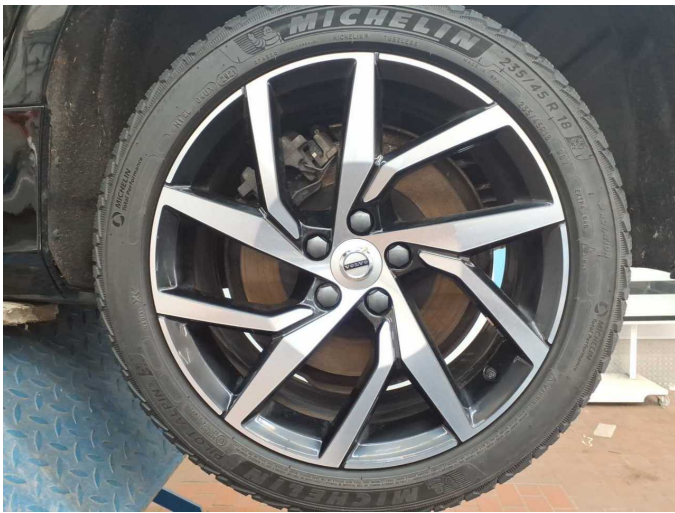
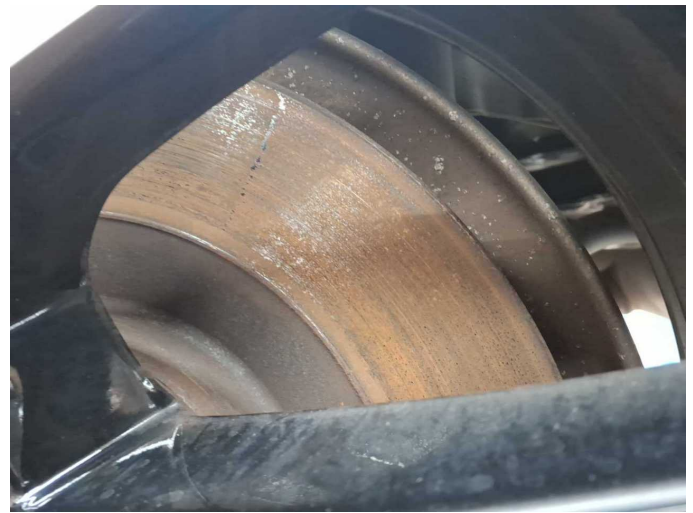
-Bremsen zeigen Korrosion, sollte ein freibremsten nicht möglich sein können Folgekosten entstehen

Damage 4: Braking system: Brake discs and pads - rear (Freibremsen) - Corrosion

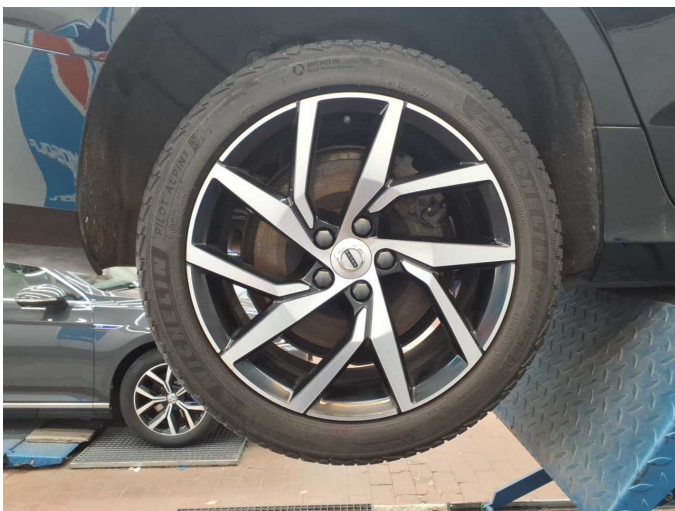
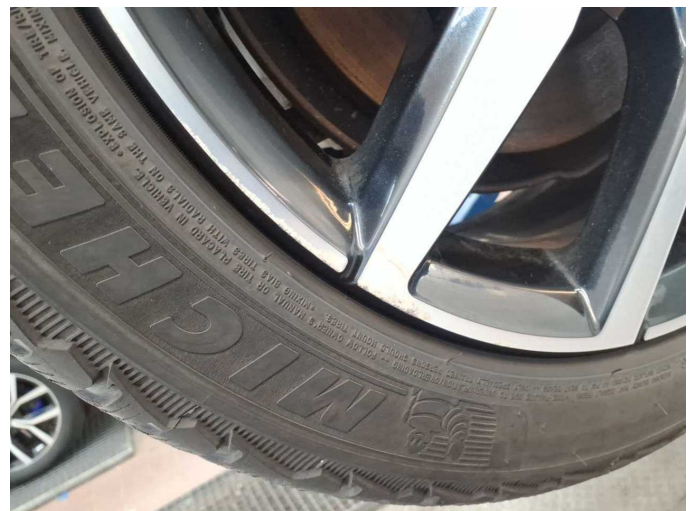
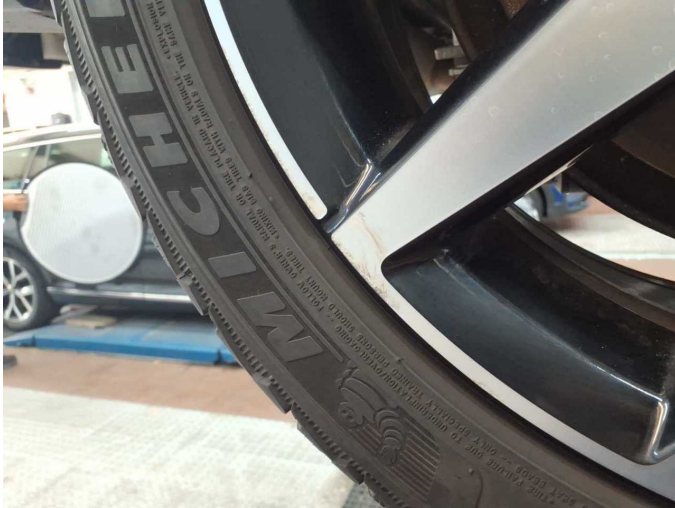
Damage 5: Wheel / tyres: Alloy rim - rear right side - Scratch(es) - Loss in value

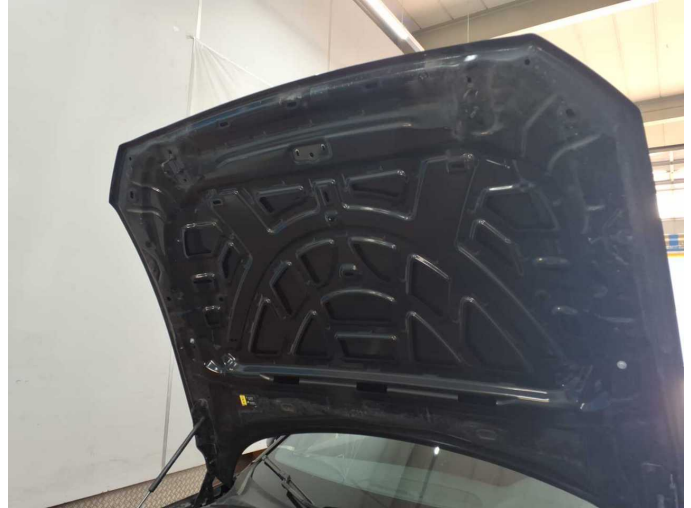
Damage 6: Bonnet: Insulation lining - Missing - Replace

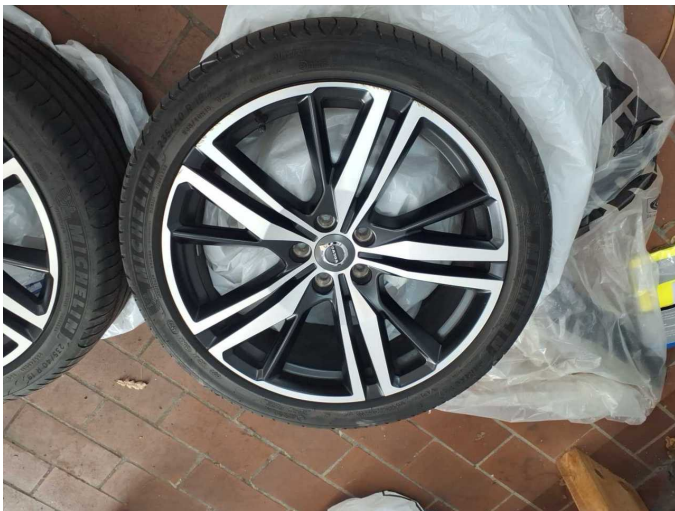
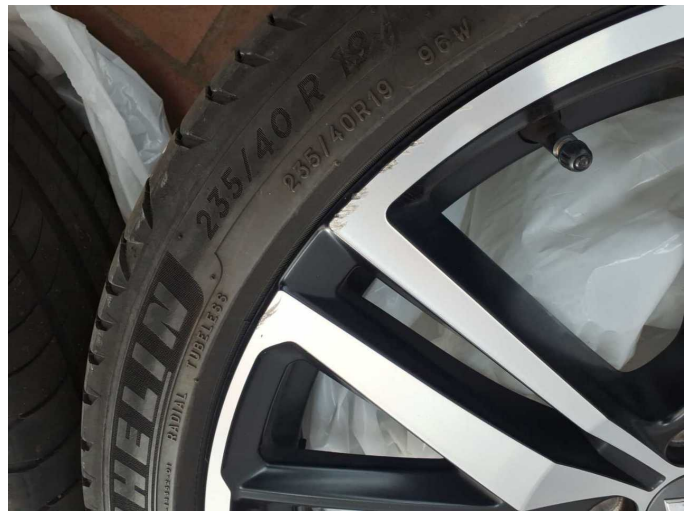
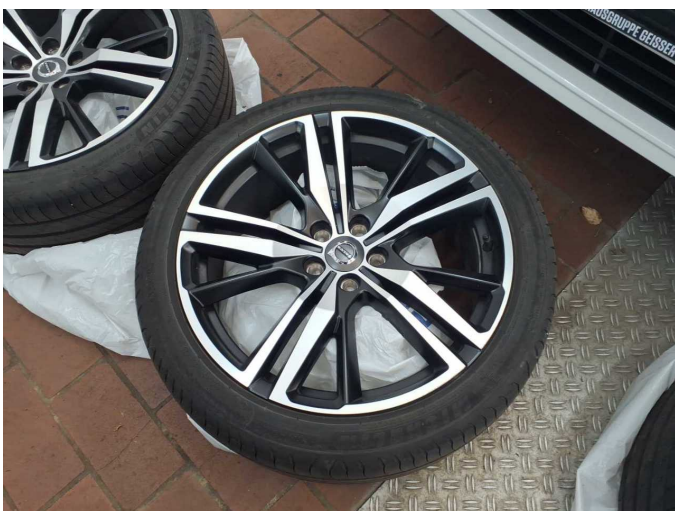
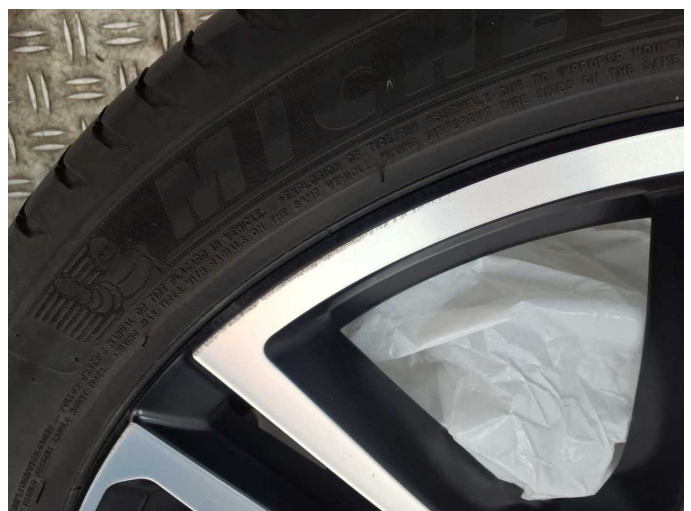
Damage 7: 2nd wheel set: 2 alloy rims - Scratch(es) - Loss in value

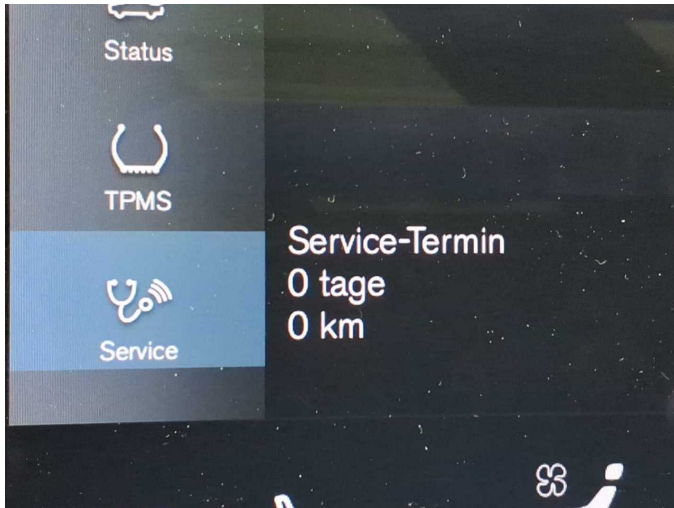
Damage 8: Misc.: Inspection / maintenance - Due - Perform

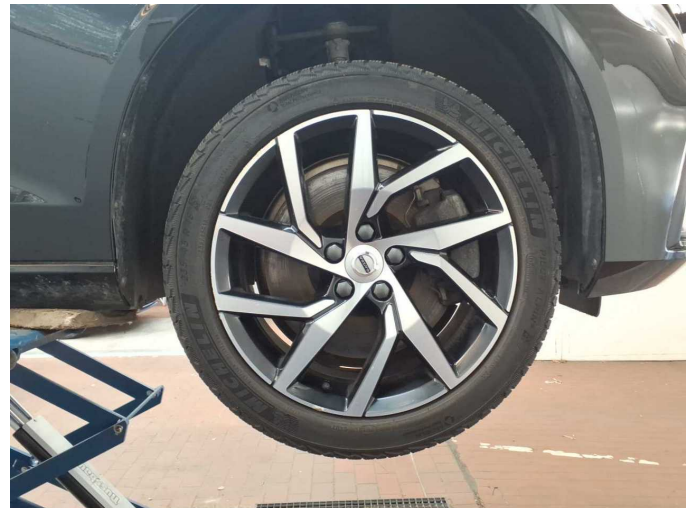
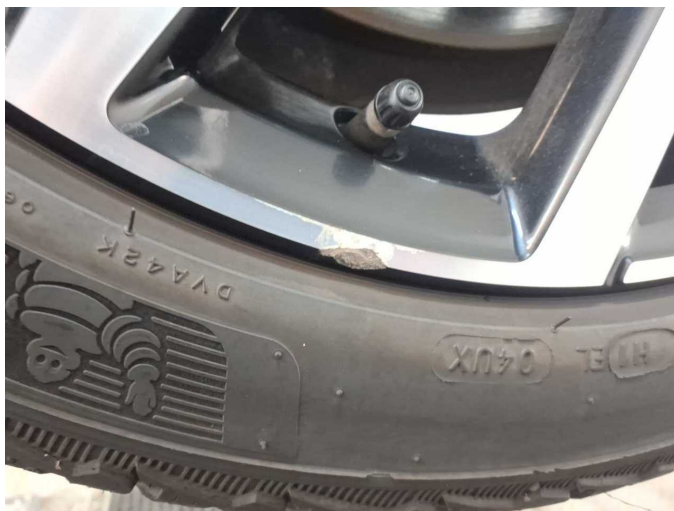
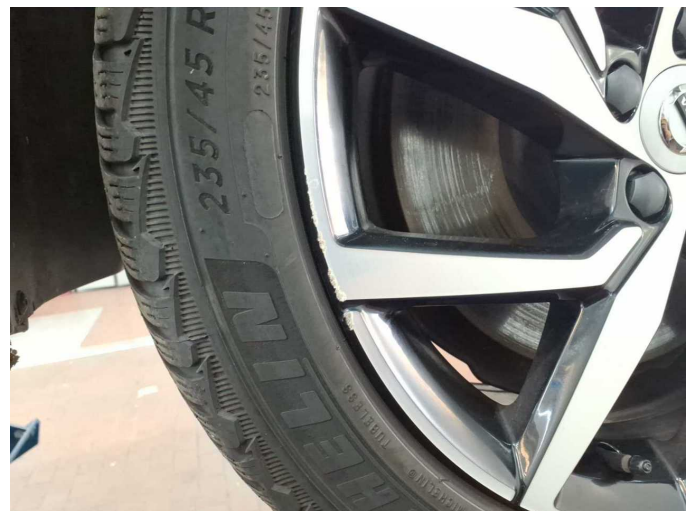
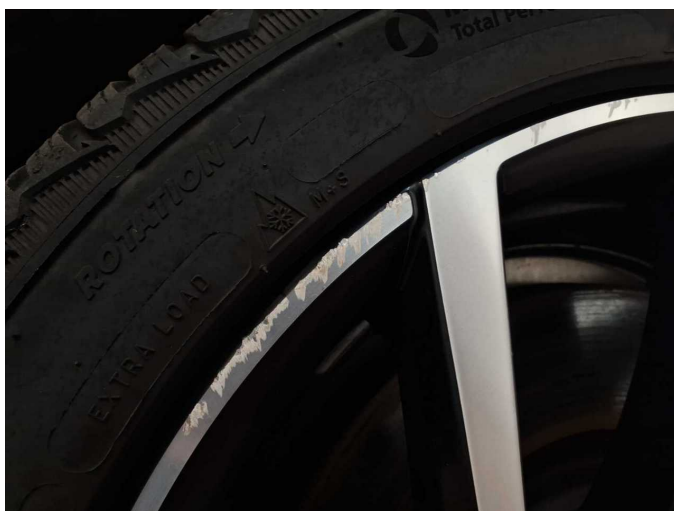
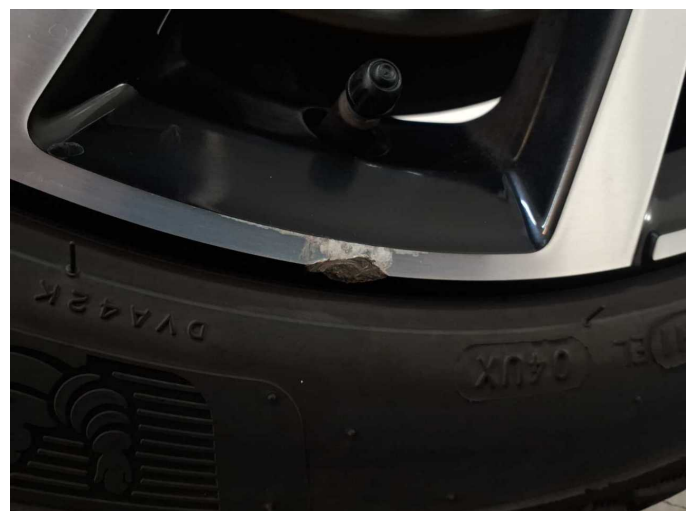
Damage 9: Wheel / tyres: Alloy rim - front right side (Materialabtrag) - Scratched - Replace

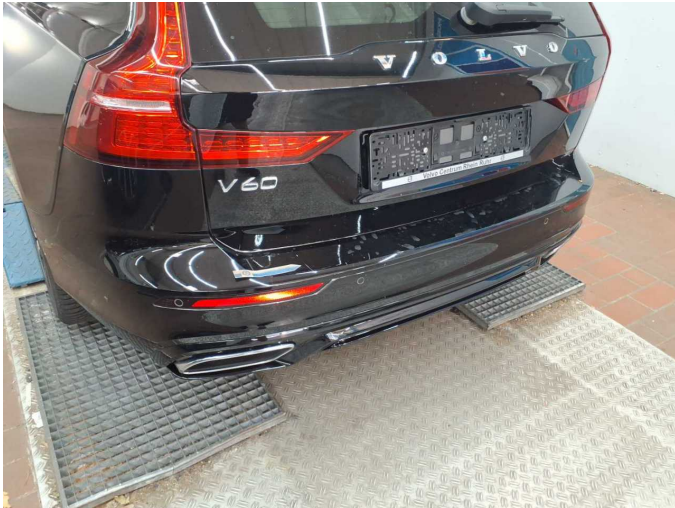
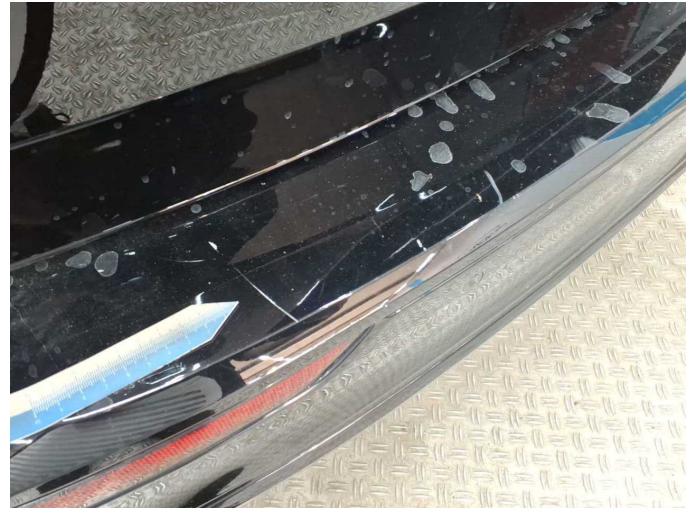
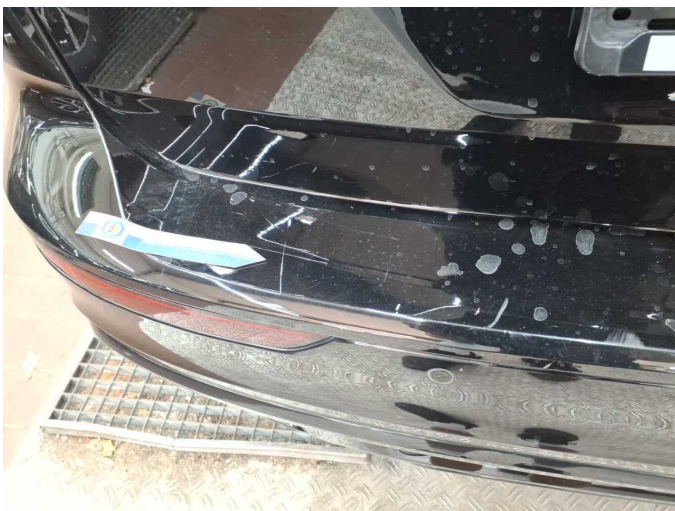
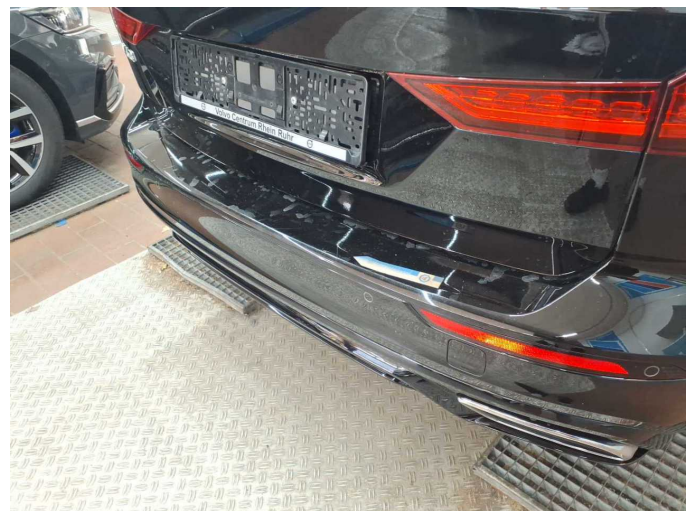
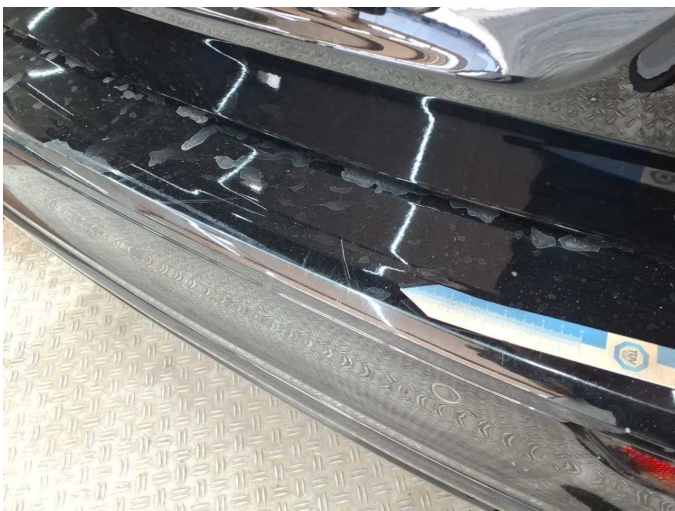
Damage 10: Rear bumper: Rear bumper - Scratch(es) - Paint

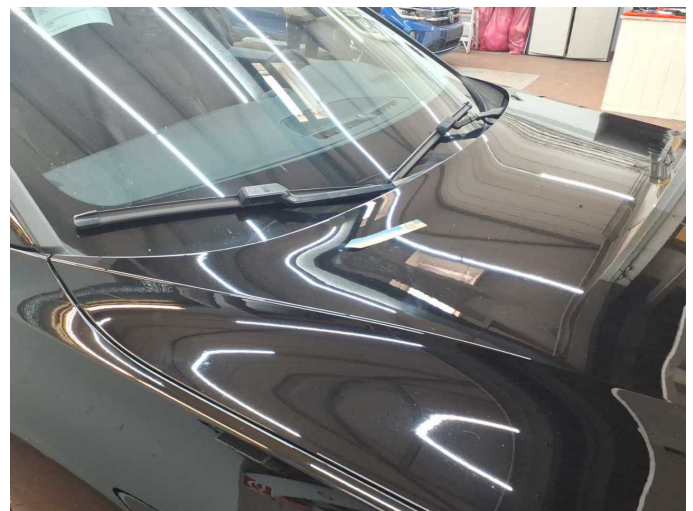
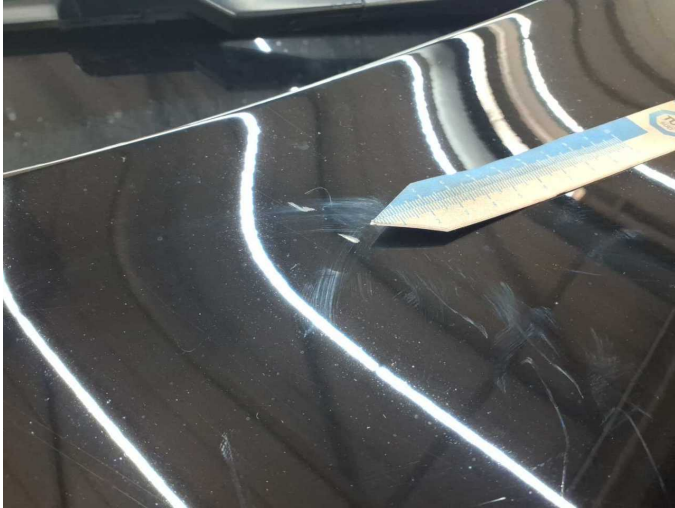
Damage 11: Bonnet: Bonnet - Scratch(es) - Paint

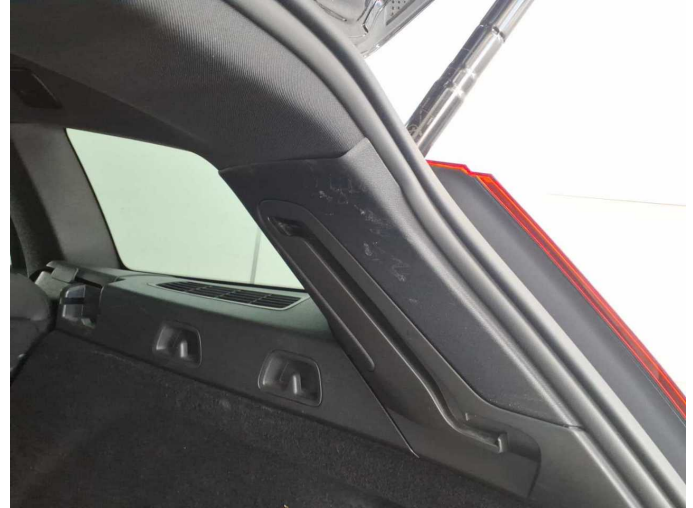
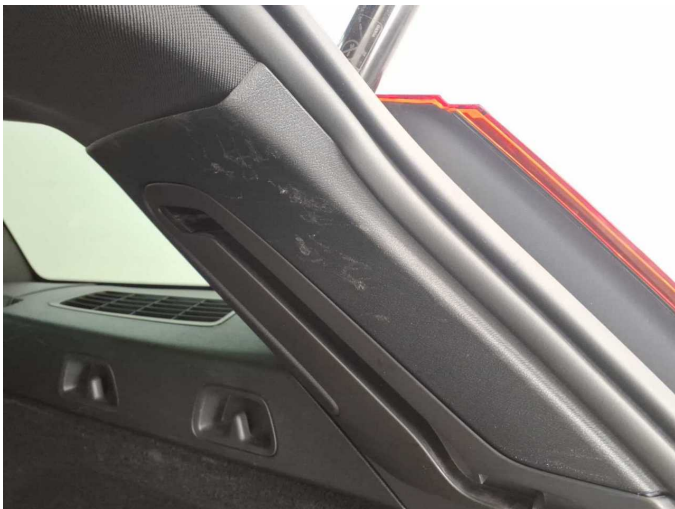
Wear and tear 6: Side panel - rear right side: Interior trim - Scratch(es) - No deduction

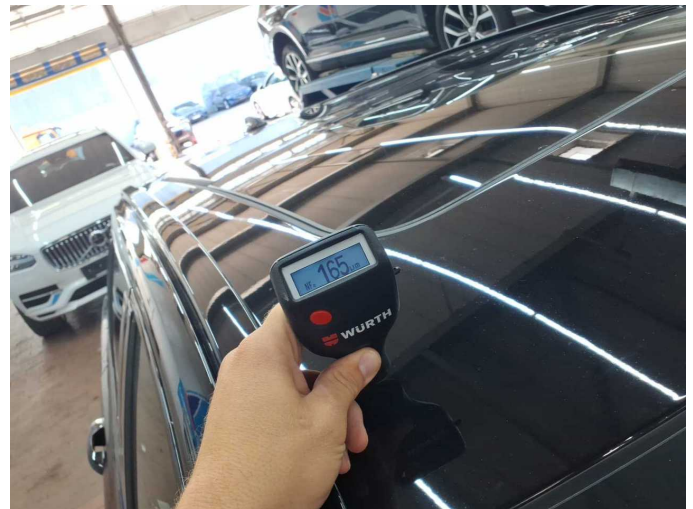
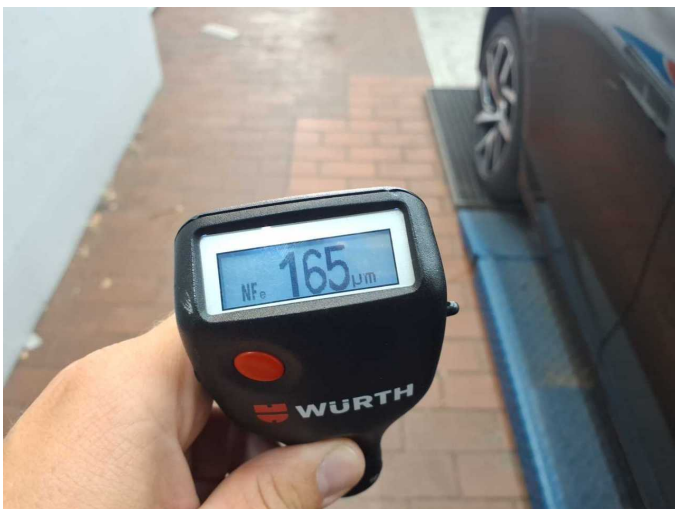
1 Roof, Professionally carried out, Invoice of repair done Non-existent

Roof 165 μm |

Repainting 1: Roof
