Expertise

Protocol number: 46278142
Order No. / Reference: 26485339
Inspection date: 1 Jul 2026

Model: Vito 116 CDI 4MATIC Tourer Extralang HA Aut. PRO

VIN: W1VVLGTZXT4537447

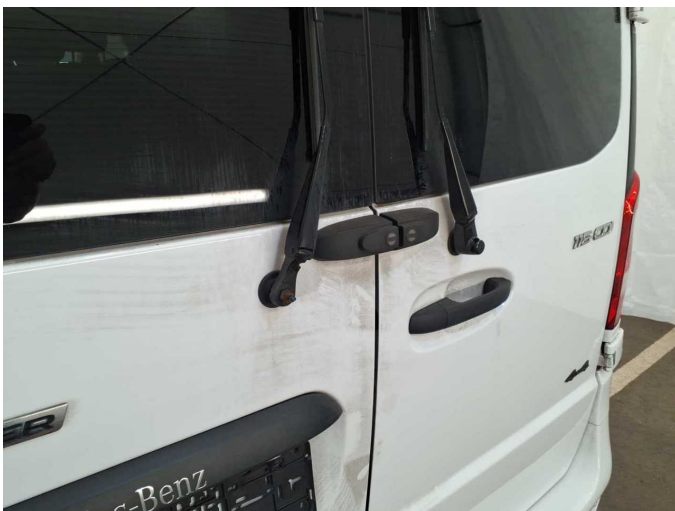
Damage 1: Screen cleaning: Wiper arm - rear (Blende) - Missing - Replace

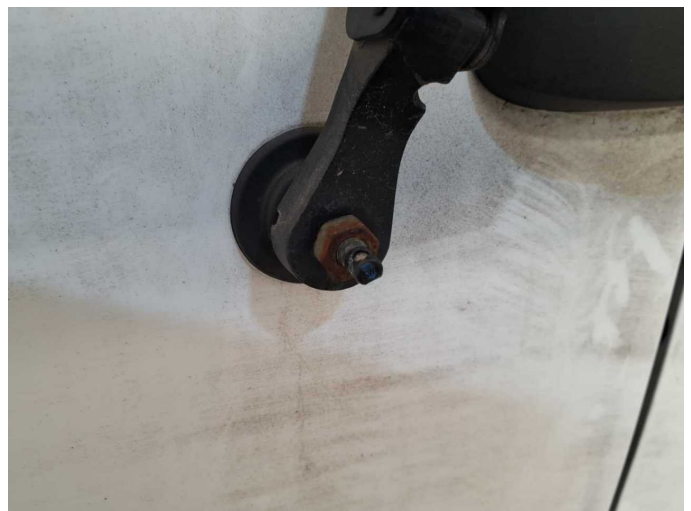
Damage 1: Screen cleaning: Wiper arm - rear (Blende) - Missing - Replace

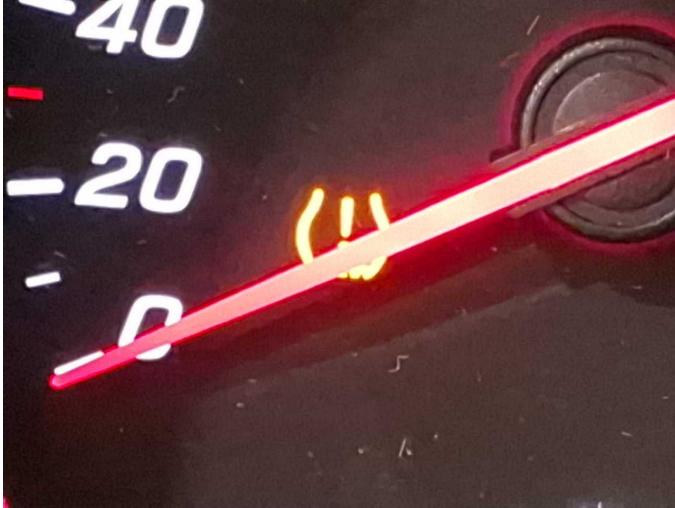
Damage 2: Instrument panel: Indicator light (Reifendruckkontrolle) - on - Perform diagnosis

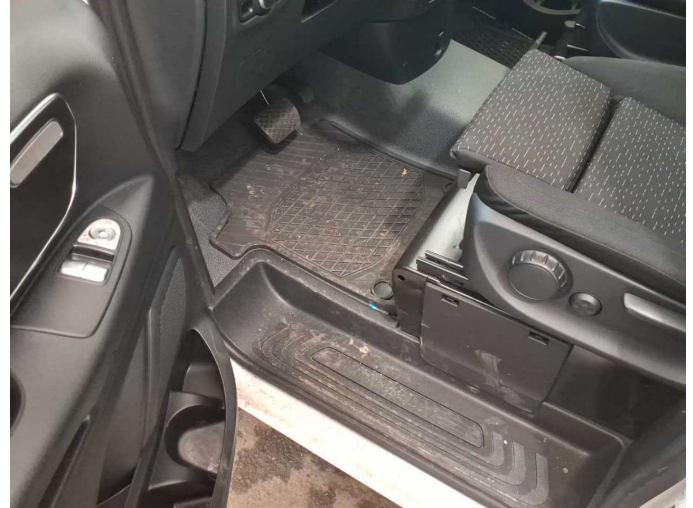
Damage 3: Interior: Interior - Soiled - Clean

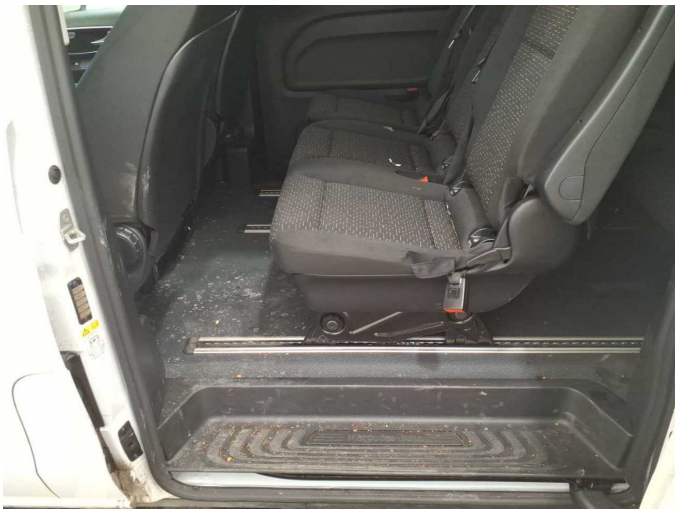
Damage 3: Interior: Interior - Soiled - Clean

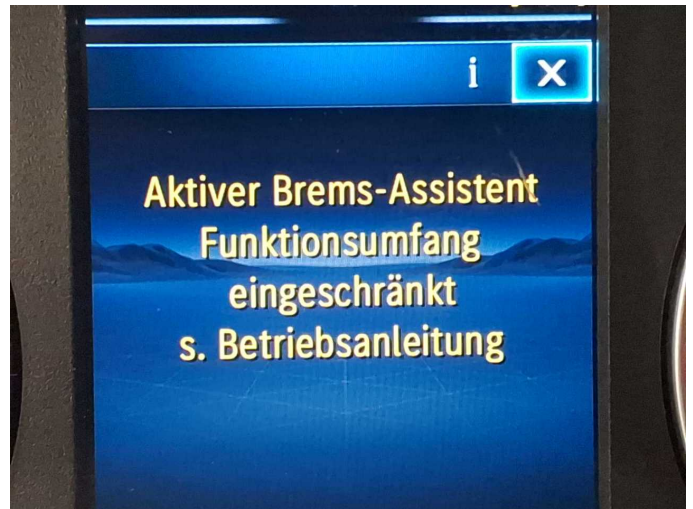
Damage 4: Electronic systems: Electronic systems (Aktiver Bremsassistent) - Specify findings - Perform diagnosis
