Expertise

Protocol number: 44684306
Order No. / Reference: 26138308
Inspection date: 26 Mar 2026

Manufacturer: Skoda

Model: Superb Combi 2.0 TDI DSG Style

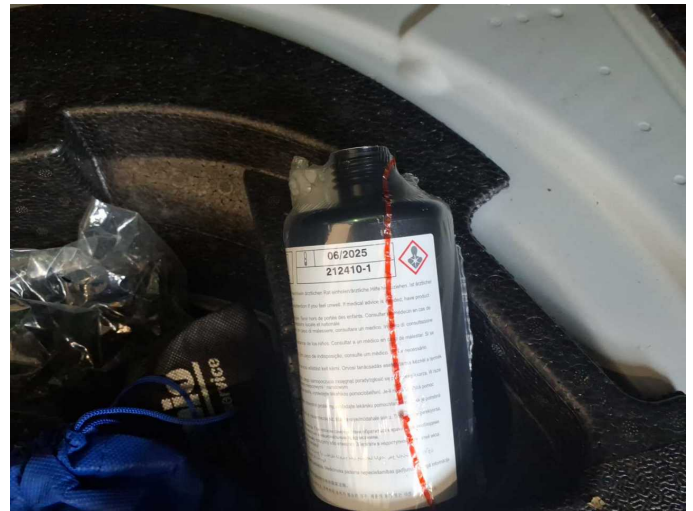
Damage 2: Equipment: Tirefit filler - Expired - Replace

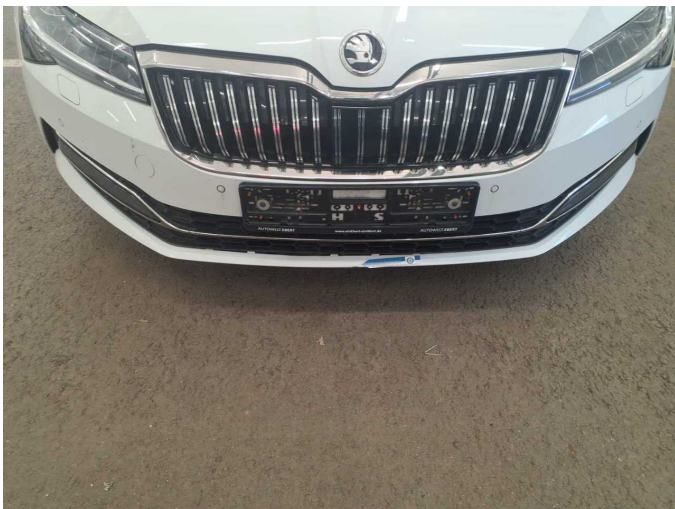
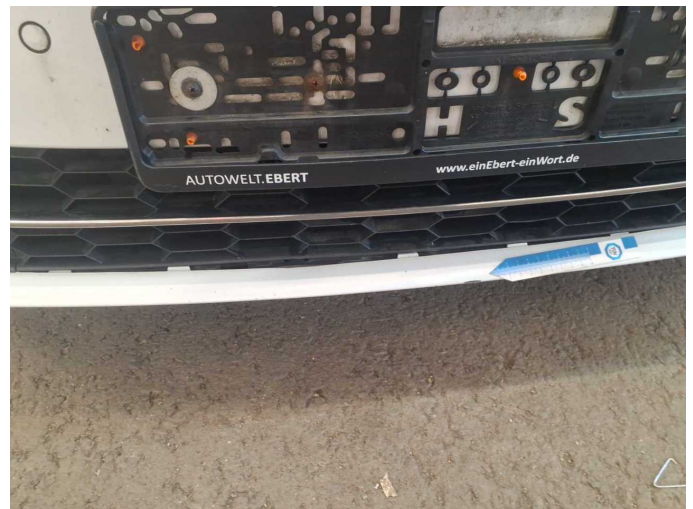
Damage 3: Front bumper: Air-inlet grille - Malposition - Un- / install

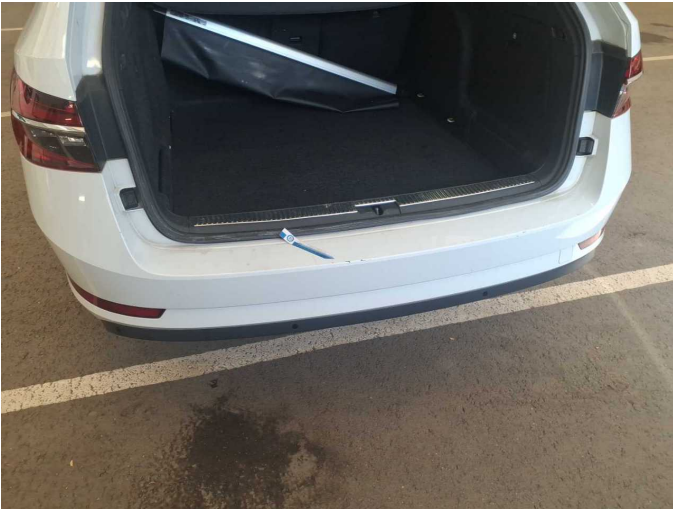
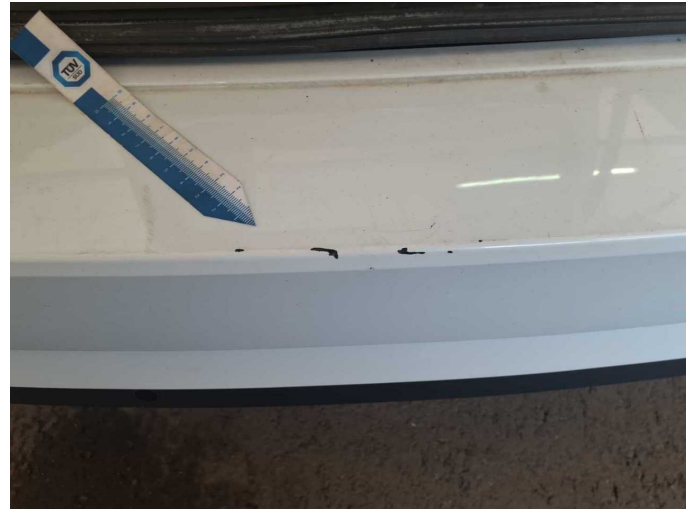
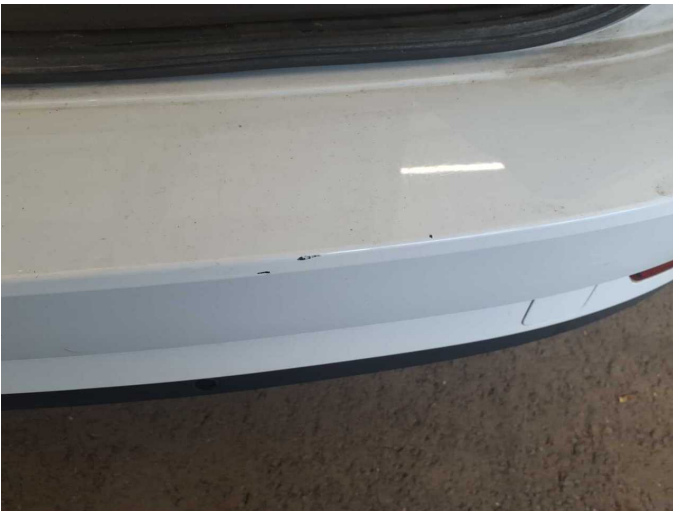
Damage 4: Rear bumper: Rear bumper (Ladekante) - Scratched - Smart repair

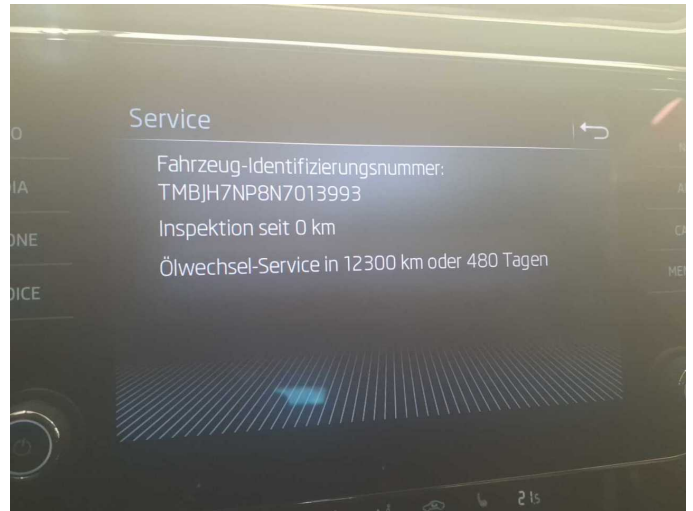
Damage 5: Misc.: Inspection / maintenance (Inspektion) - Due - Perform

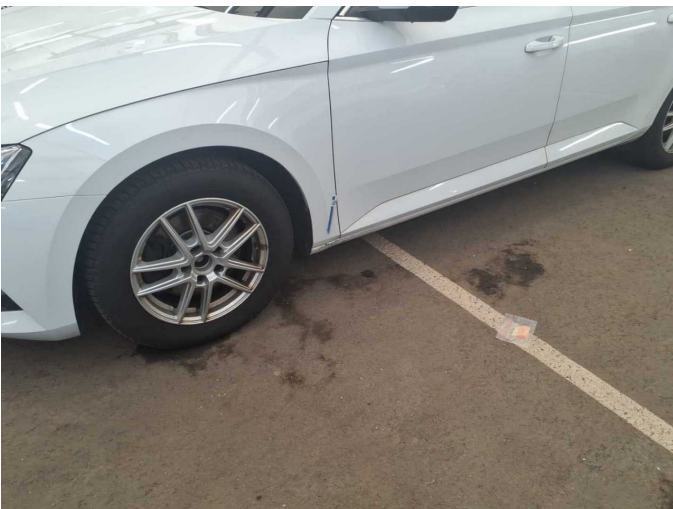
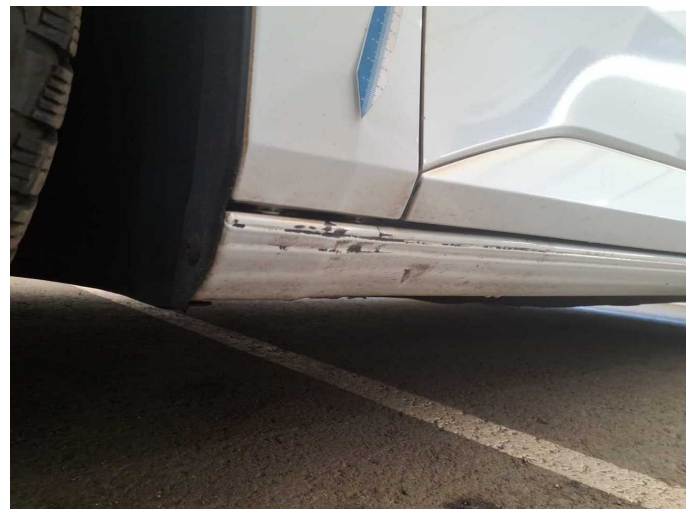
Damage 6: Sill - left side: Sill - Scratched - Repair and paint

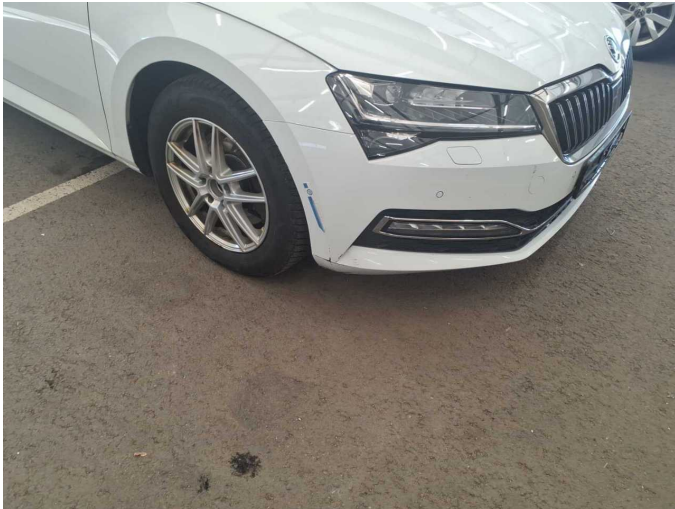
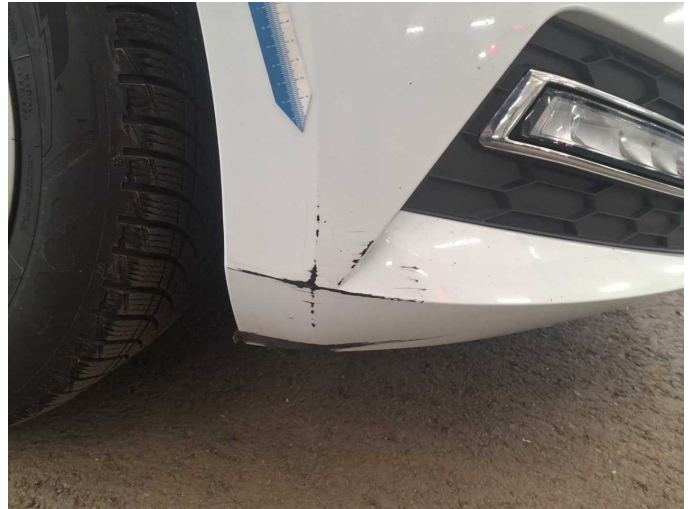
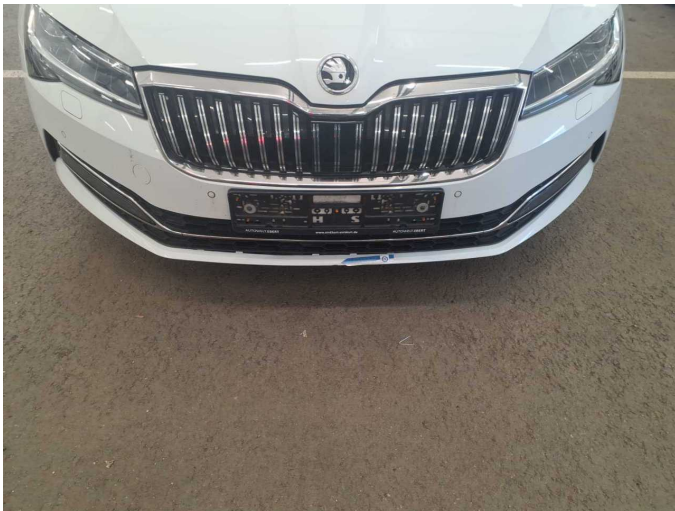
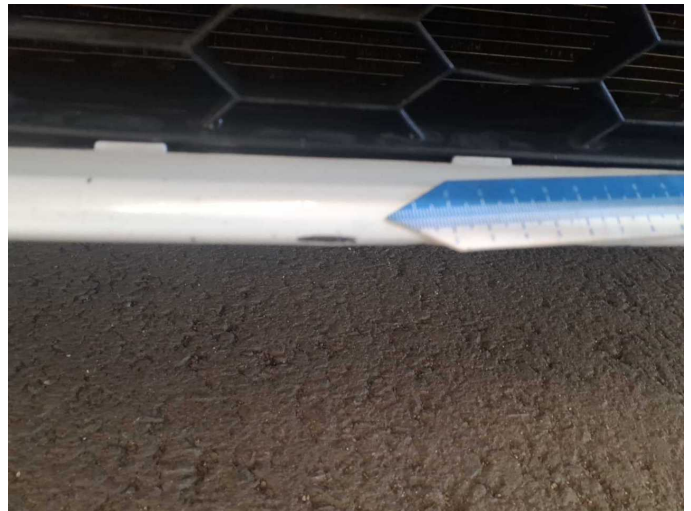
Damage 7: Front bumper: Front bumper - Scratched - Repair and paint
