## Expertise

Protocol number: 45523970  
Order No. / Reference: 26406524  
Inspection date: 20 May 2026

Model: Octavia Combi 2.0 TDI DSG RS

VIN: TMBJK8NX4NY122596

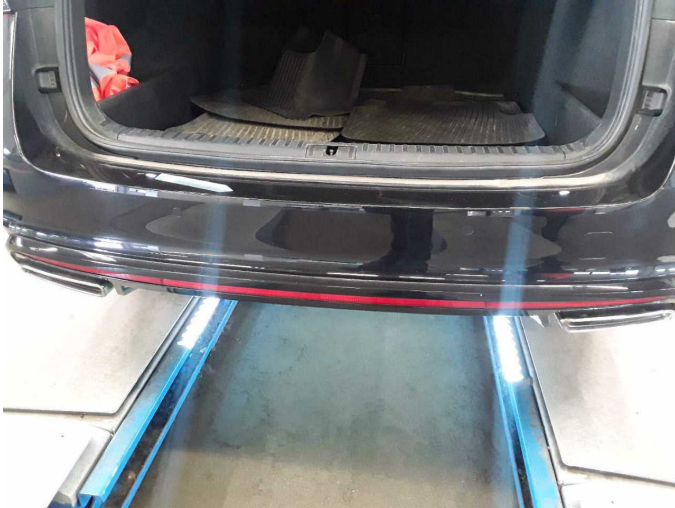
**Damage 1:** Rear bumper: Rear bumper - Scratch(es) - Paint

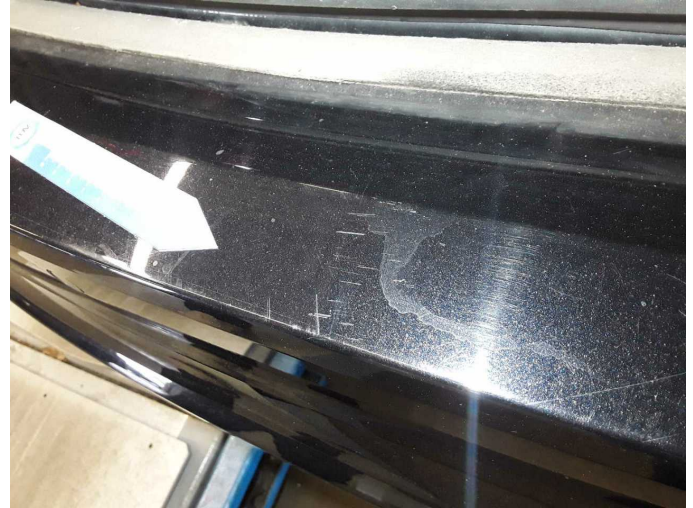
**Damage 1:** Rear bumper: Rear bumper - Scratch(es) - Paint

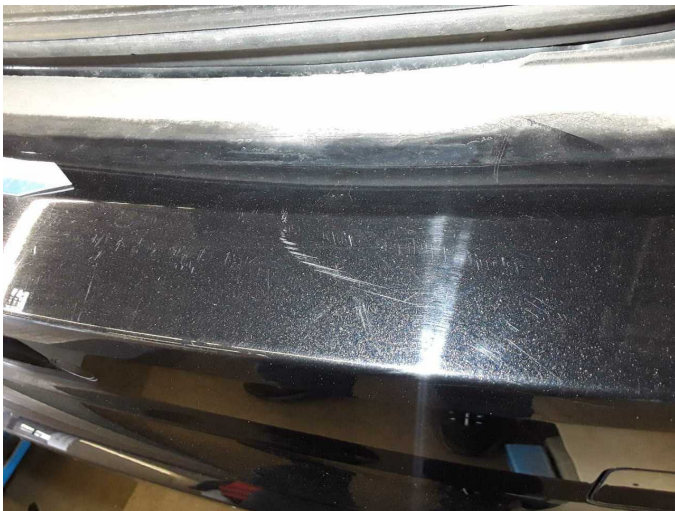
**Damage 1:** Rear bumper: Rear bumper - Scratch(es) - Paint

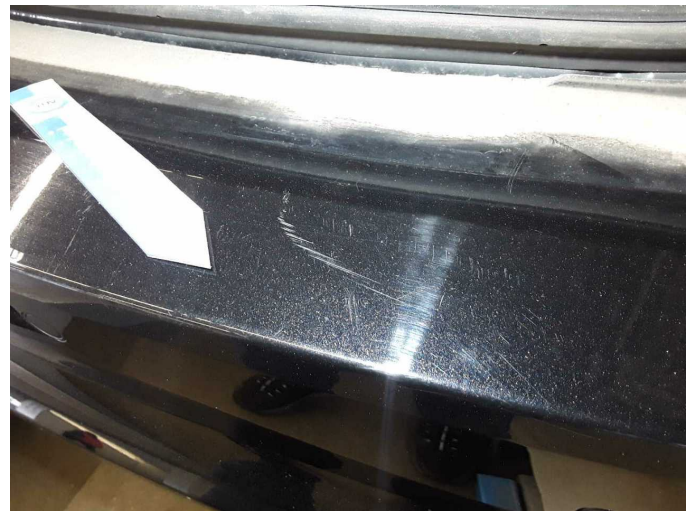
**Damage 1:** Rear bumper: Rear bumper - Scratch(es) - Paint

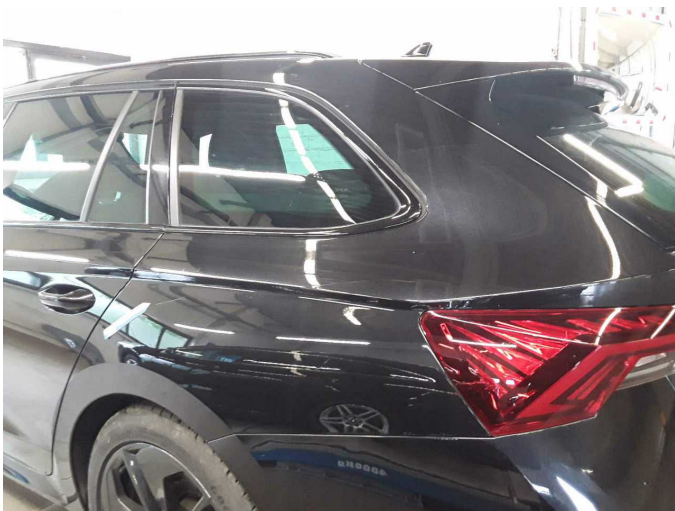
**Damage 2:** Side panel - rear left side: Side panel - Scratch(es) - Paint

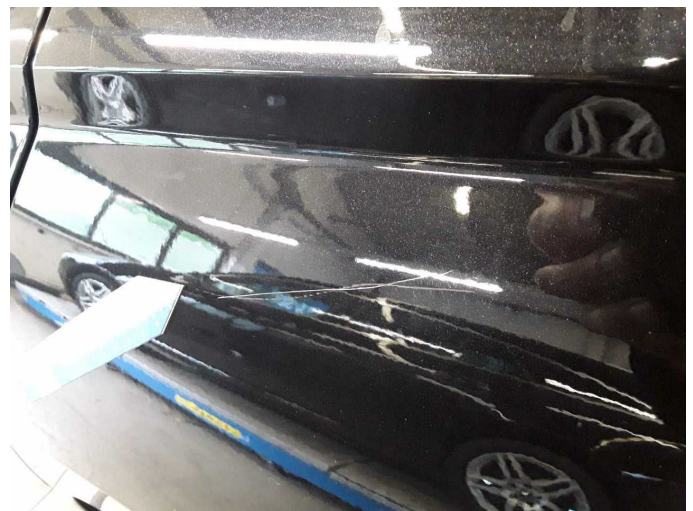
**Damage 2:** Side panel - rear left side: Side panel - Scratch(es) - Paint

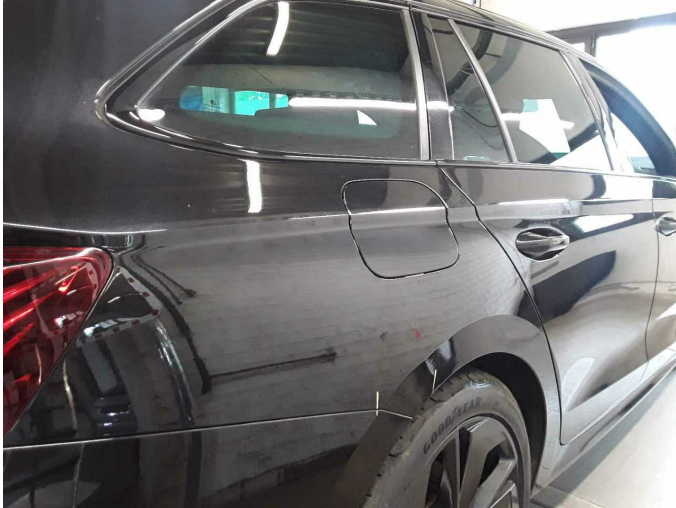
**Damage 3:** Side panel - rear right side: Side panel - Scratch(es) - Paint

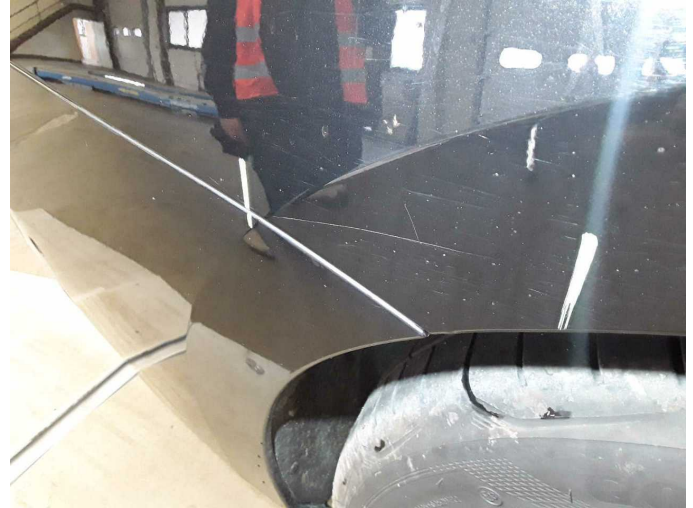
**Damage 3:** Side panel - rear right side: Side panel - Scratch(es) - Paint

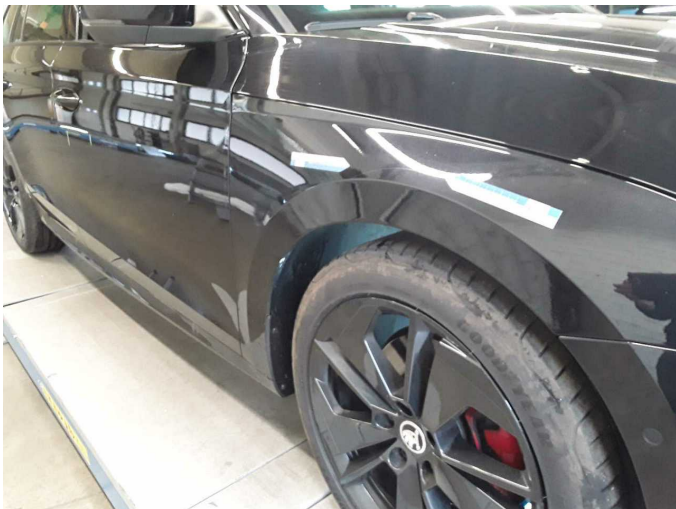
**Damage 4:** Mudguard - right side: Mudguard - right side - Scratch(es) - Paint

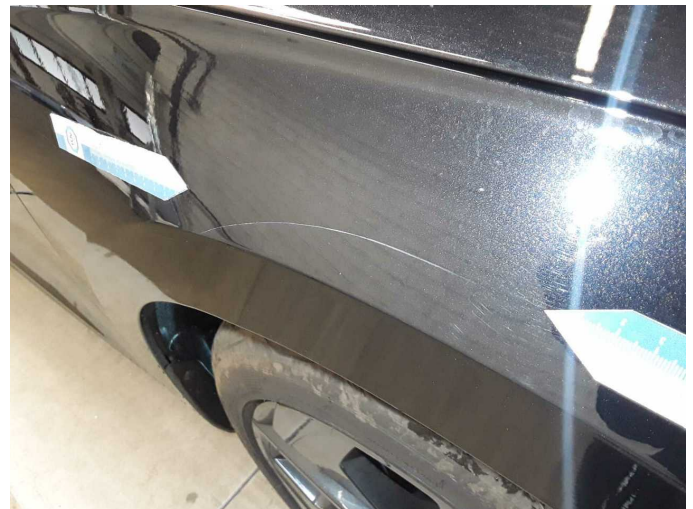
**Damage 4:** Mudguard - right side: Mudguard - right side - Scratch(es) - Paint

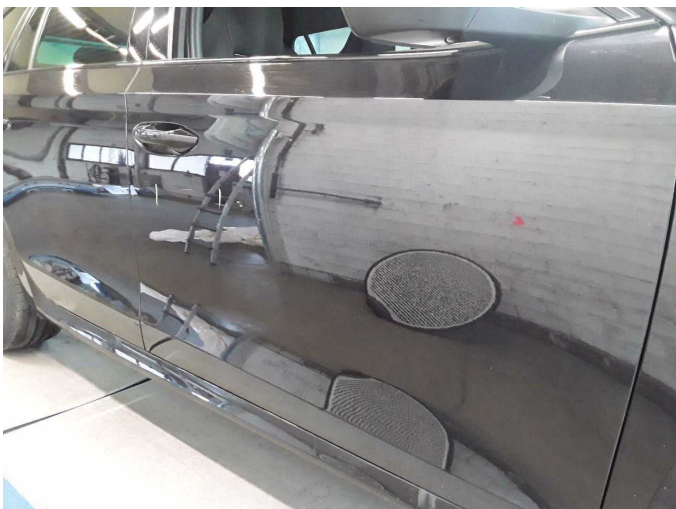
**Damage 5:** Door - front right side: Door - Scratch(es) - Paint

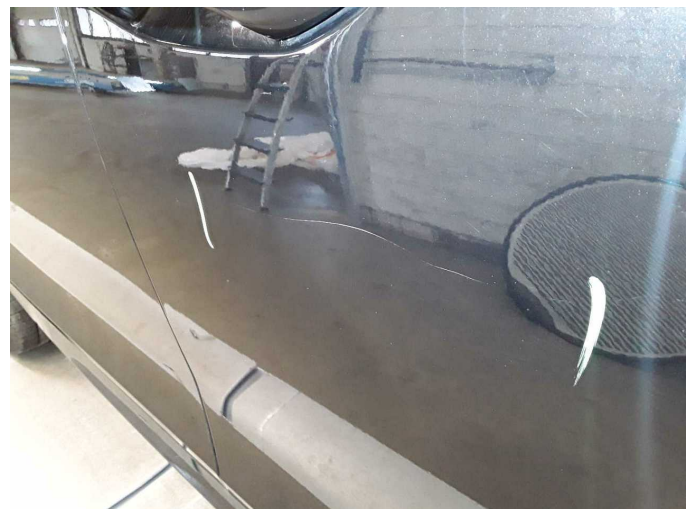
**Damage 5:** Door - front right side: Door - Scratch(es) - Paint

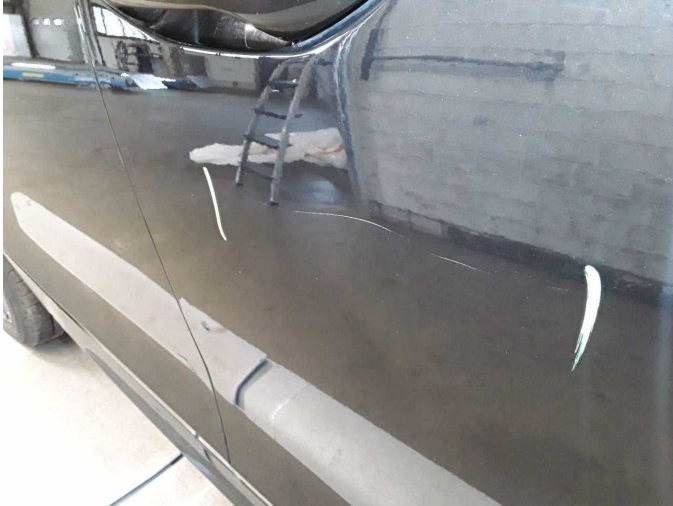
**Damage 5:** Door - front right side: Door - Scratch(es) - Paint

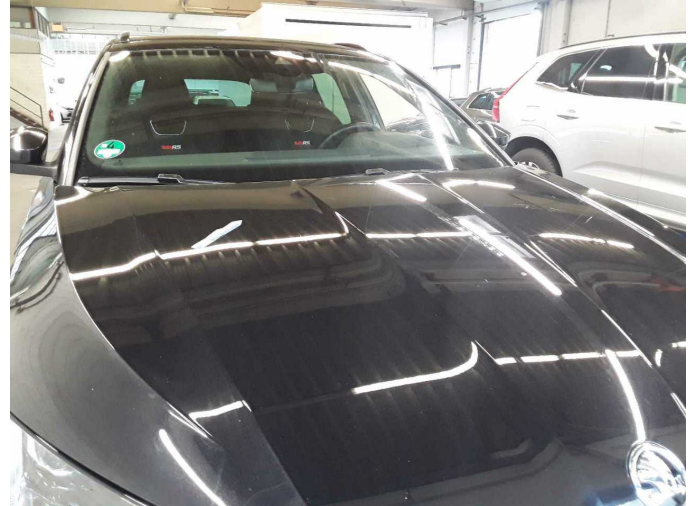
**Damage 6:** Bonnet: Bonnet (Anätzung) - Paint defect - Paint

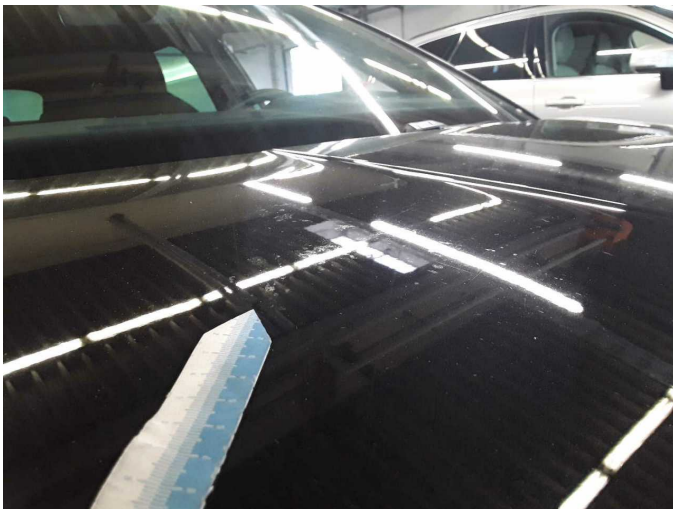
**Damage 6:** Bonnet: Bonnet (Anätzung) - Paint defect - Paint

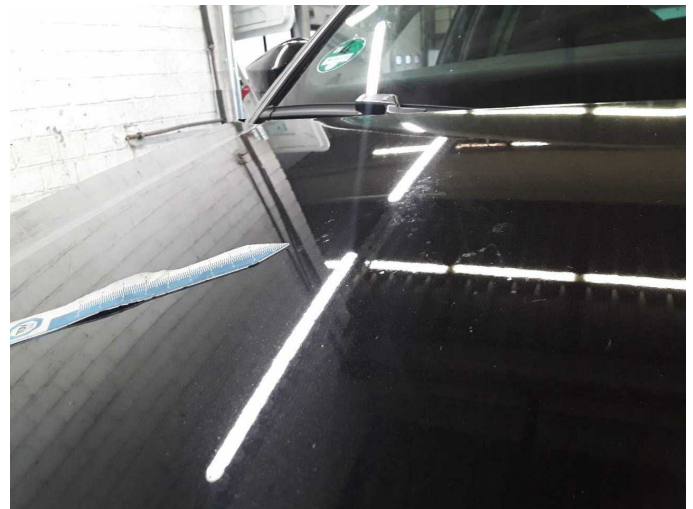
**Damage 6:** Bonnet: Bonnet (Anätzung) - Paint defect - Paint

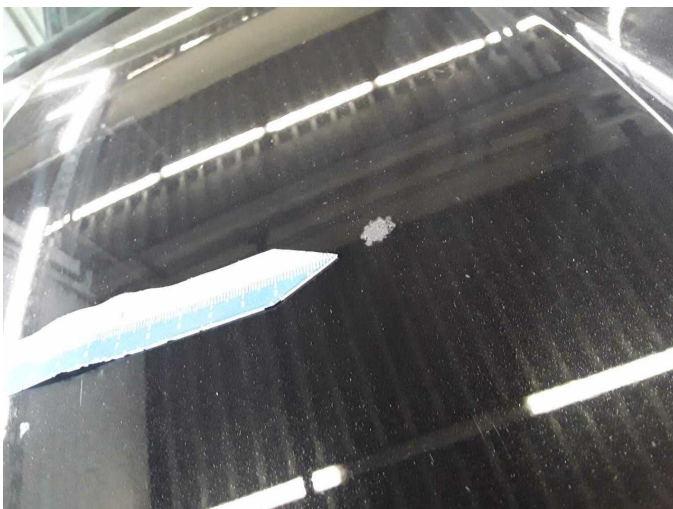
**Damage 6:** Bonnet: Bonnet (Anätzung) - Paint defect - Paint

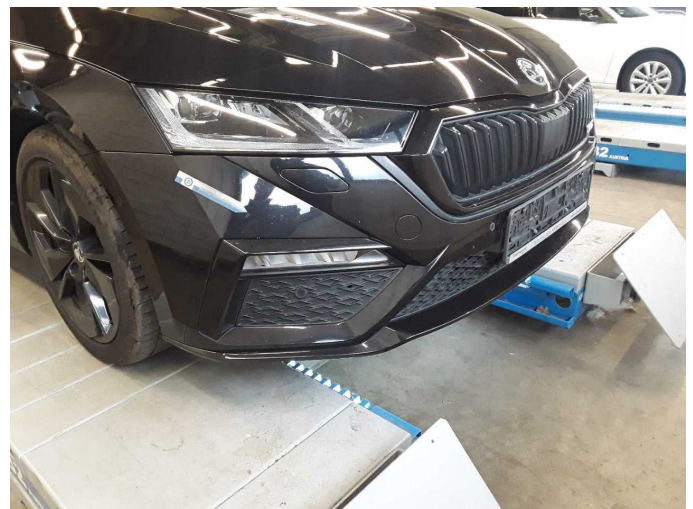
**Wear and tear 1:** Front bumper: Front bumper - Stone chips - No deduction

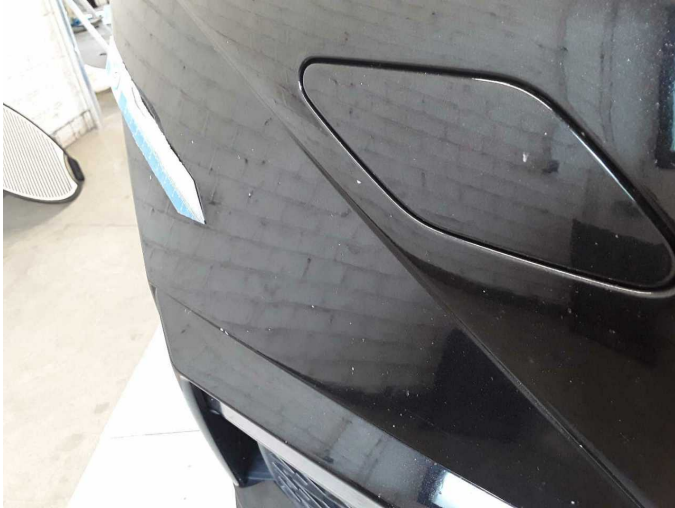
**Wear and tear 1:** Front bumper: Front bumper - Stone chips - No deduction

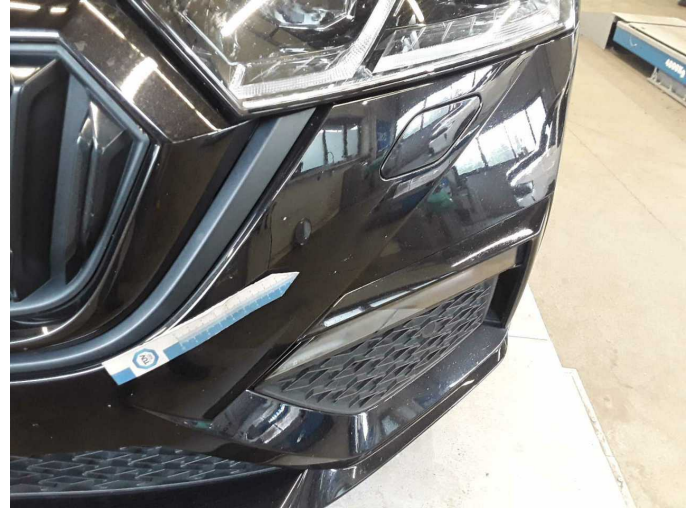
**Wear and tear 1:** Front bumper: Front bumper - Stone chips - No deduction

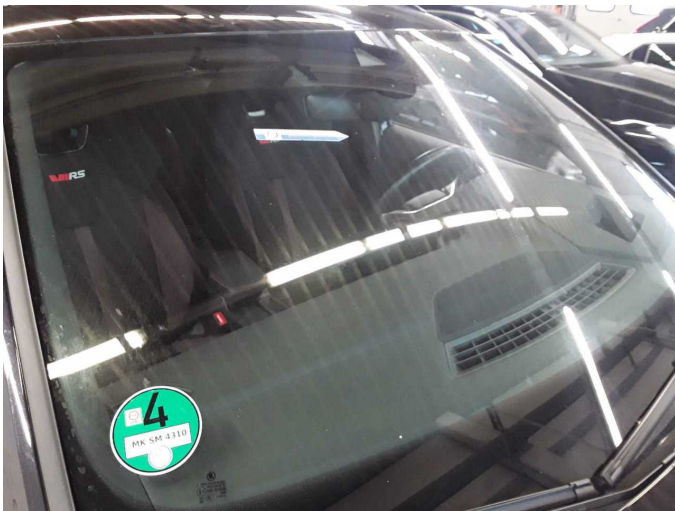
**Wear and tear 2:** Vehicle glazing: Windscreen - Stone chips - No deduction

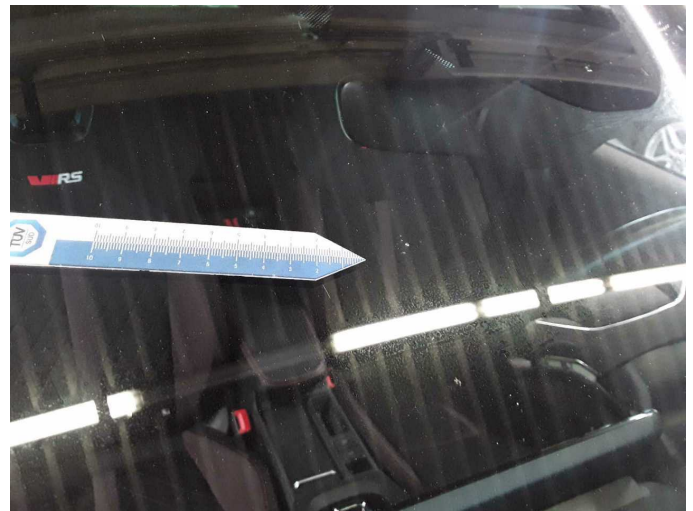
**Wear and tear 2:** Vehicle glazing: Windscreen - Stone chips - No deduction
