Expertise

Protocol number: 46053866
Order No. / Reference: 26511691
Inspection date: 17 Jun 2026

Model: Astra Sports Tourer 1.5 D Automatik Business Elegance

VIN: VXKFCYHZTP1099367

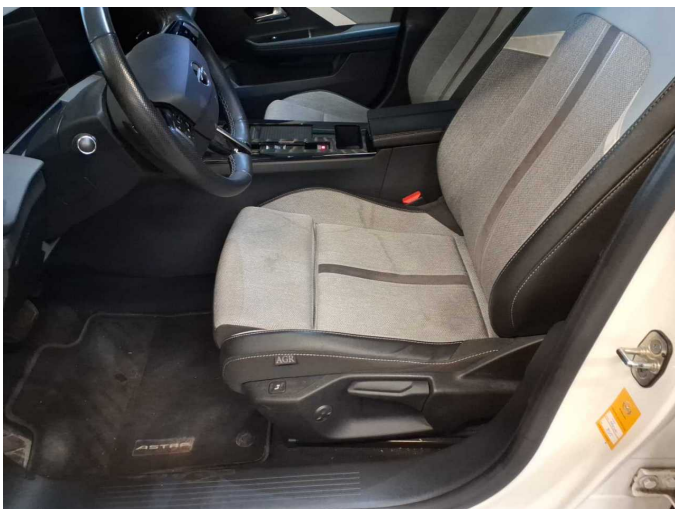
Damage 1: Seat - front: Seat cover - left side (Flecken) - Soiled - Clean

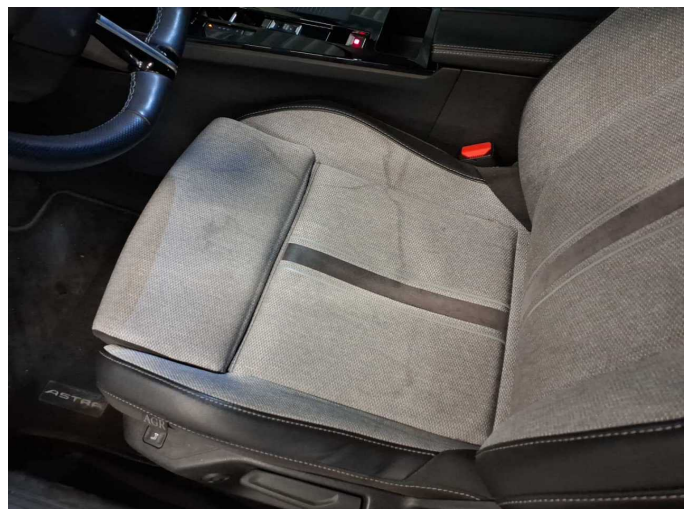
Damage 1: Seat - front: Seat cover - left side (Flecken) - Soiled - Clean

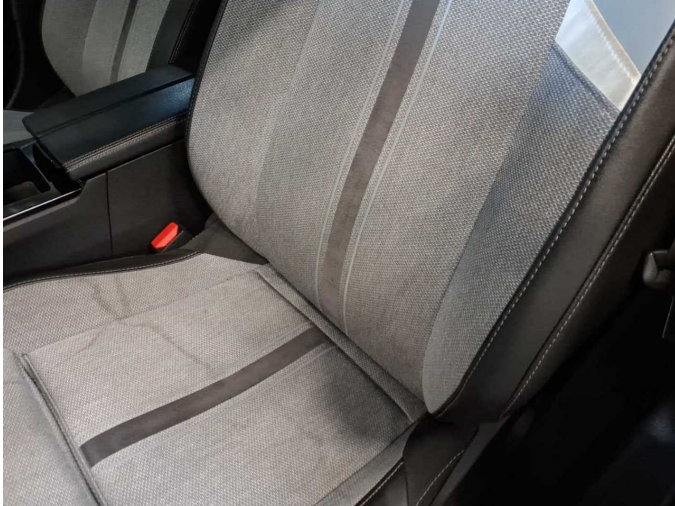
Damage 1: Seat - front: Seat cover - left side (Flecken) - Soiled - Clean

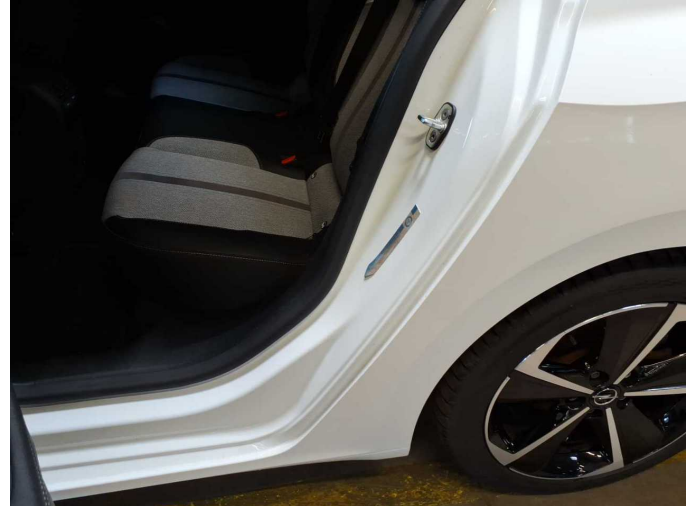
Damage 2: Side panel - rear left side: Sill - dent(s) - Smooth repair work

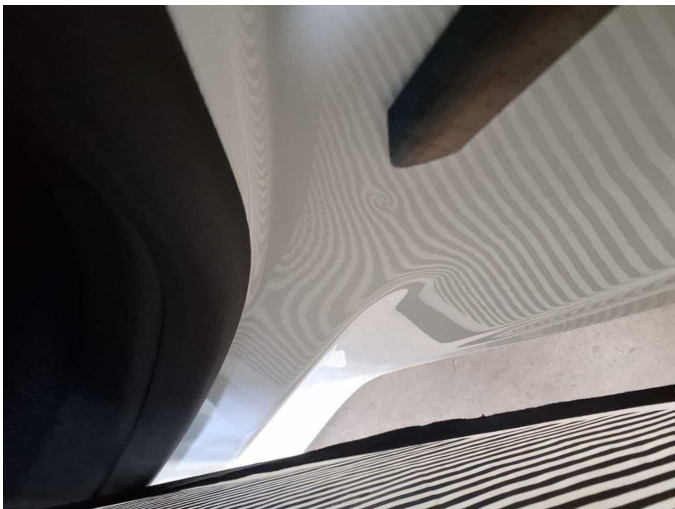
Damage 2: Side panel - rear left side: Sill - dent(s) - Smooth repair work

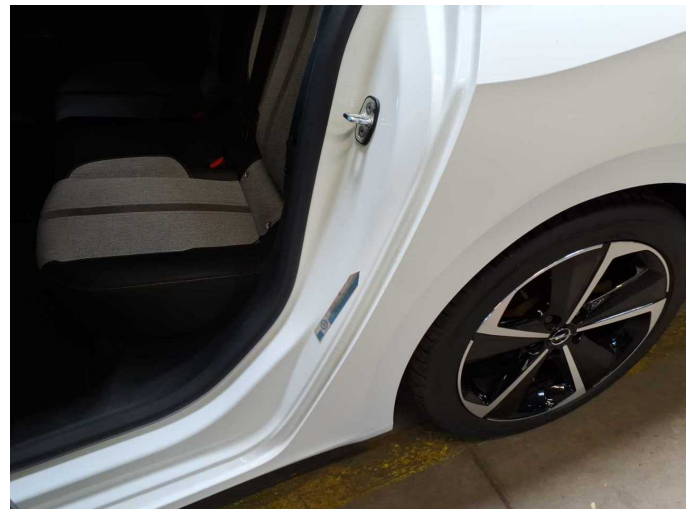
Damage 2: Side panel - rear left side: Sill - dent(s) - Smooth repair work

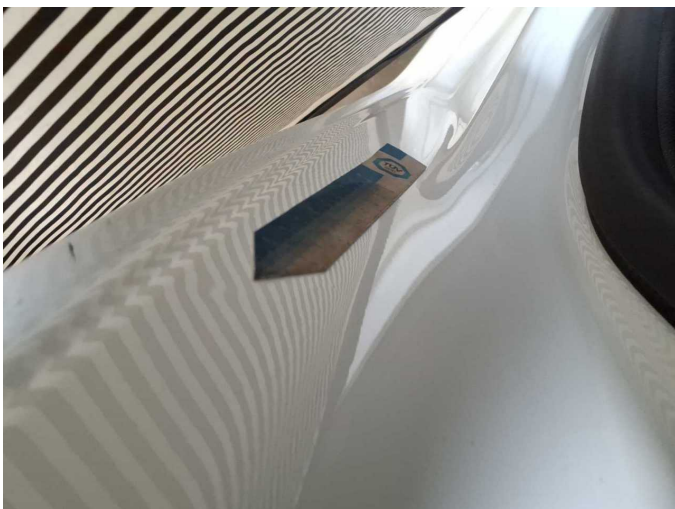
Damage 2: Side panel - rear left side: Sill - dent(s) - Smooth repair work

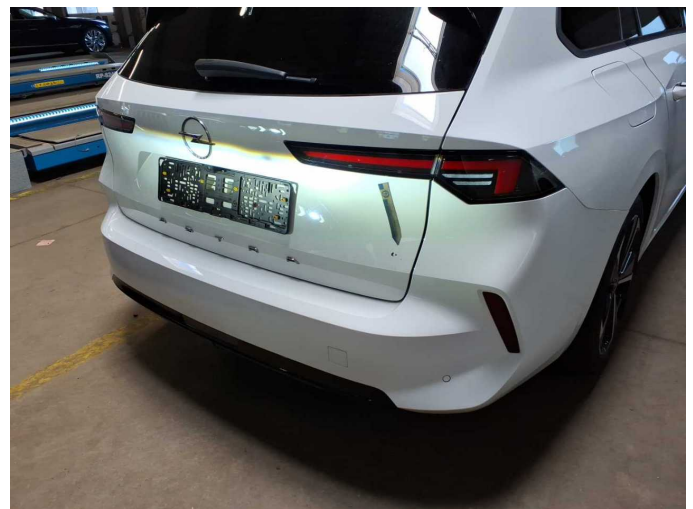
Damage 3: Boot lid / rear door: Boot lid - Scratch(es) - Smart repair

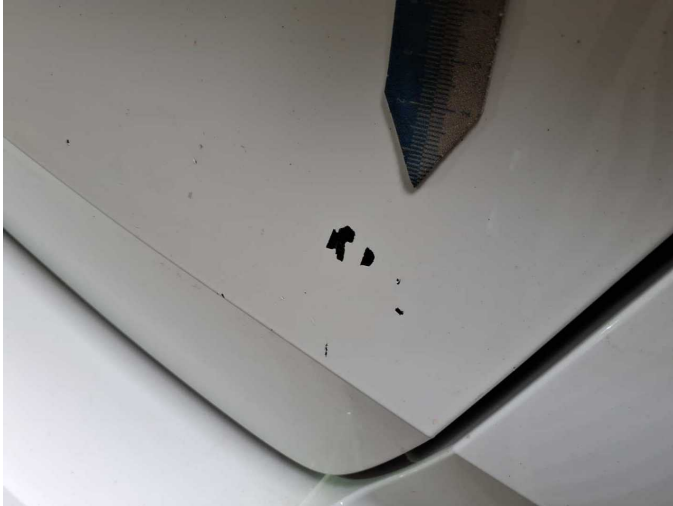
Damage 3: Boot lid / rear door: Boot lid - Scratch(es) - Smart repair

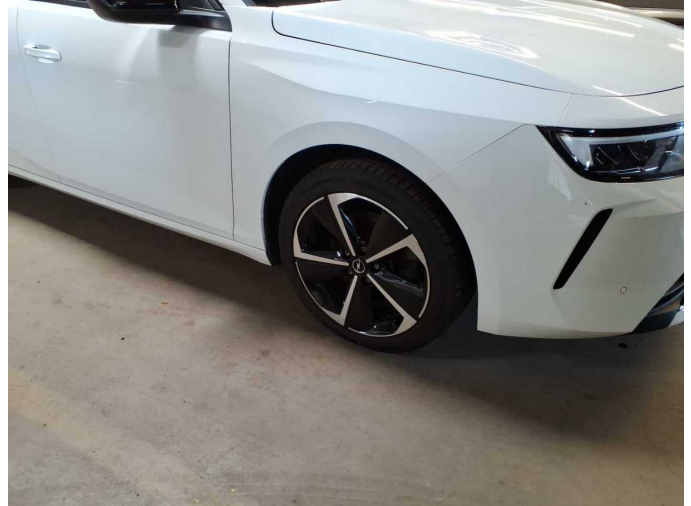
Damage 4: Wheel / tyres: Tyre - front right side - Damaged - Replace

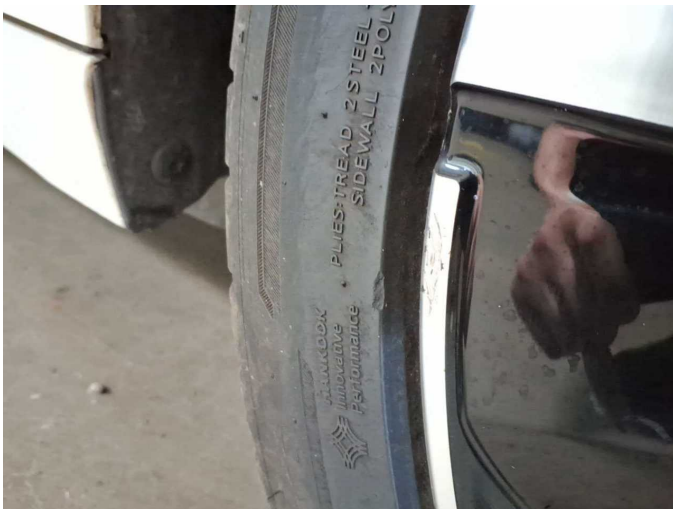
Damage 4: Wheel / tyres: Tyre - front right side - Damaged - Replace

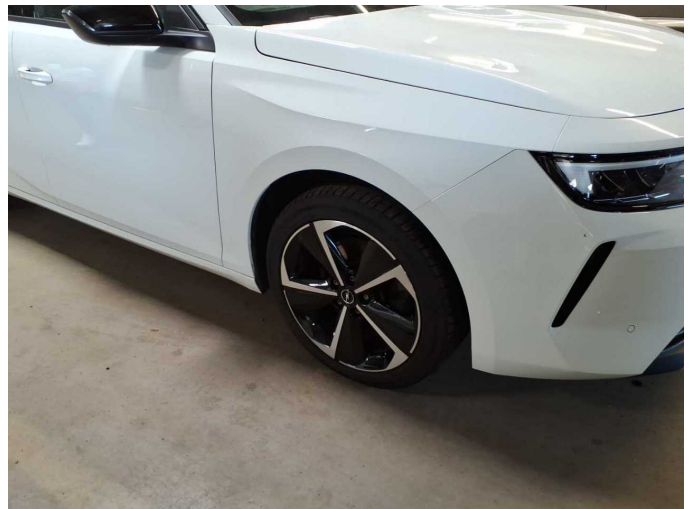
Damage 5: Wheel / tyres: Alloy rim - front right side - Scratch(es) - Loss in value

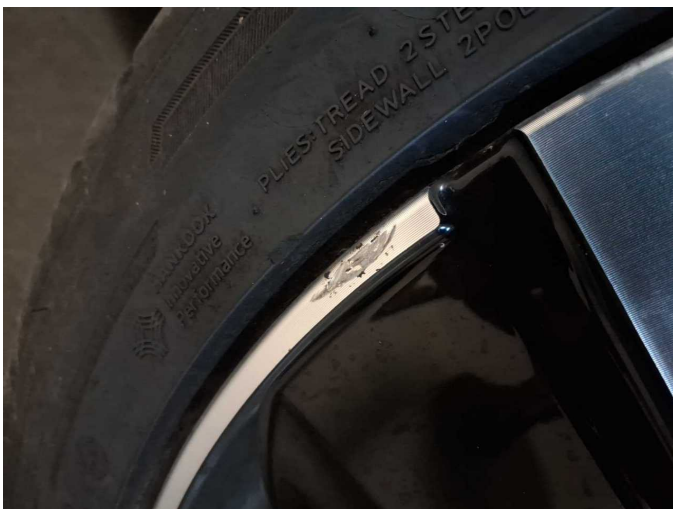
Damage 5: Wheel / tyres: Alloy rim - front right side - Scratch(es) - Loss in value

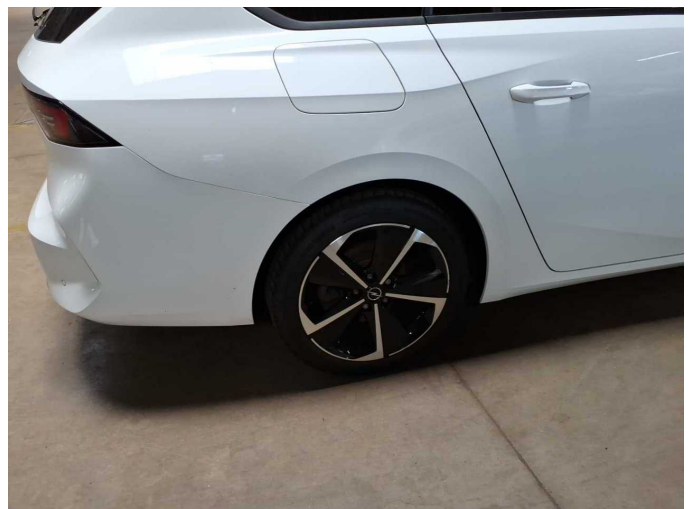
Damage 6: Wheel / tyres: Alloy rim - rear right side - Scratch(es) - Loss in value

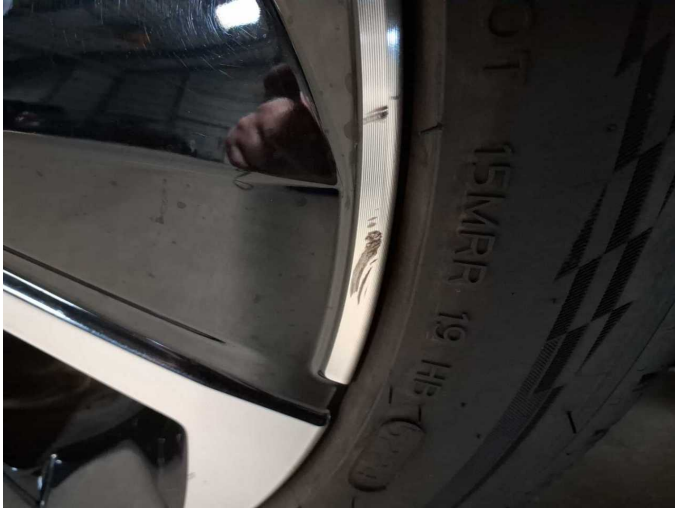
Damage 6: Wheel / tyres: Alloy rim - rear right side - Scratch(es) - Loss in value

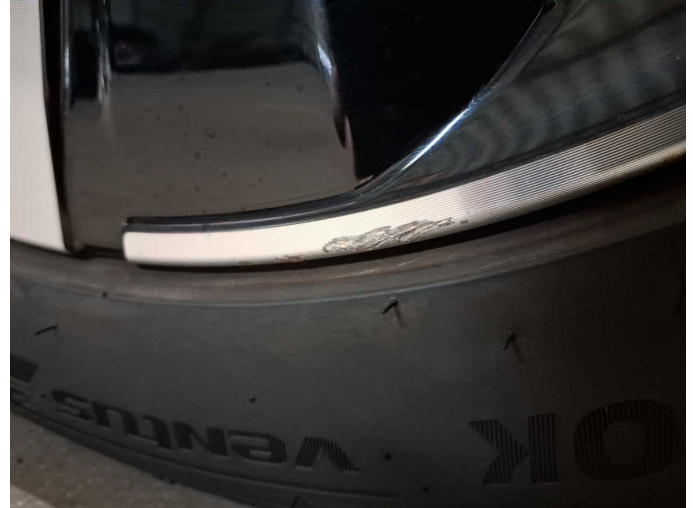
Damage 6: Wheel / tyres: Alloy rim - rear right side - Scratch(es) - Loss in value

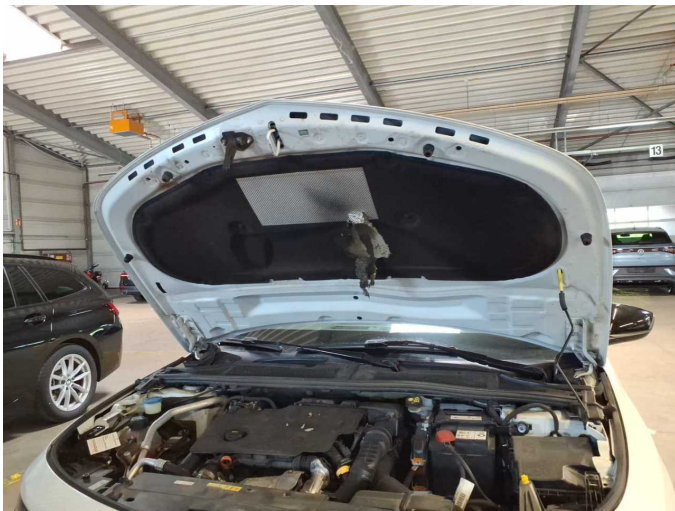
Damage 7: Bonnet: Insulation lining - Damage caused by marten / rodent - Replace

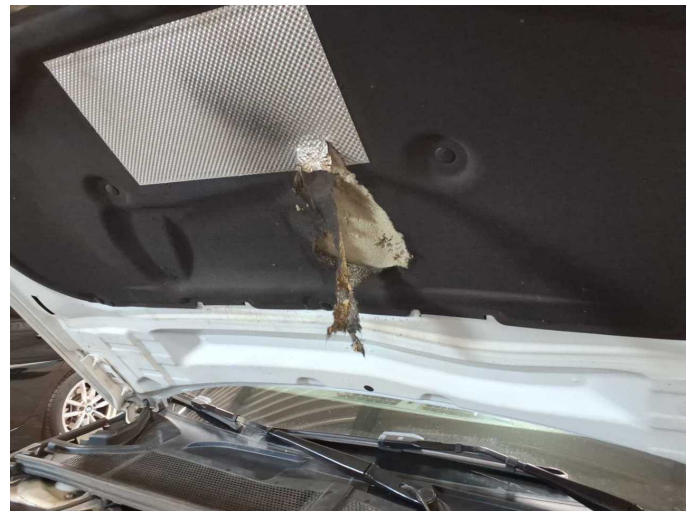
Damage 7: Bonnet: Insulation lining - Damage caused by marten / rodent - Replace

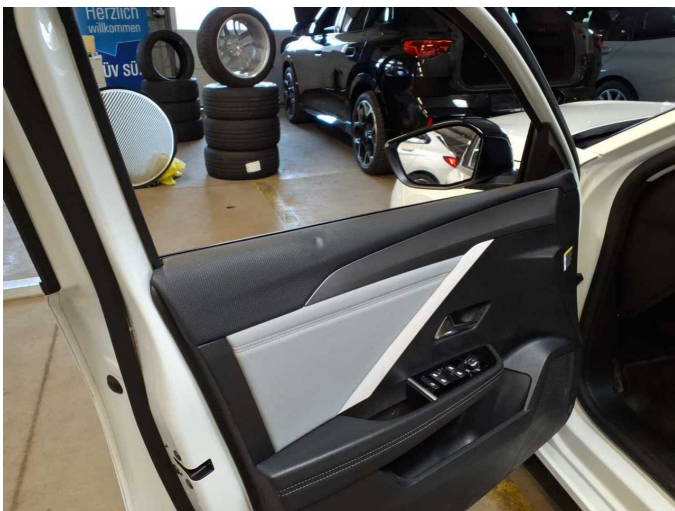
Damage 8: Trim / covers: Door trim - front left side - Deformed - Smart repair

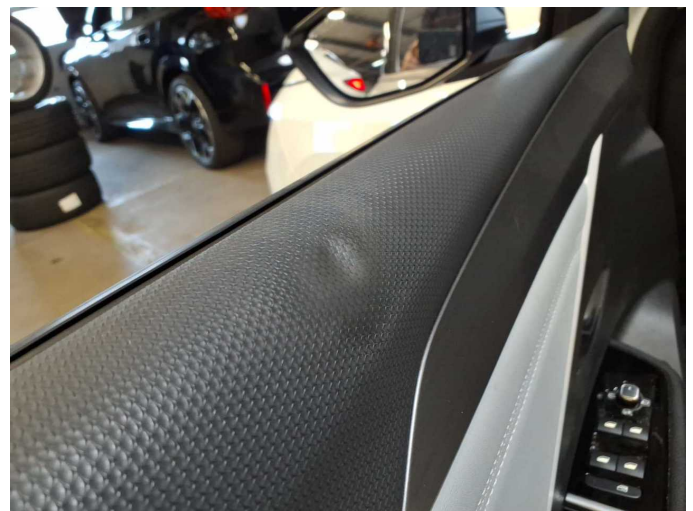
Damage 8: Trim / covers: Door trim - front left side - Deformed - Smart repair

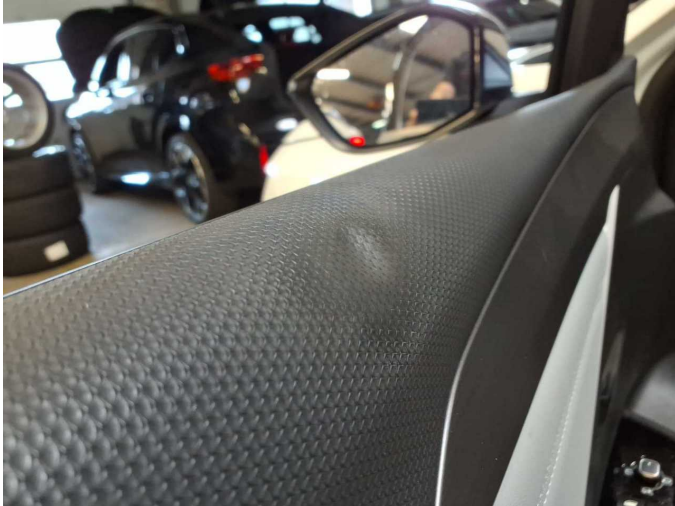
Damage 8: Trim / covers: Door trim - front left side - Deformed - Smart repair

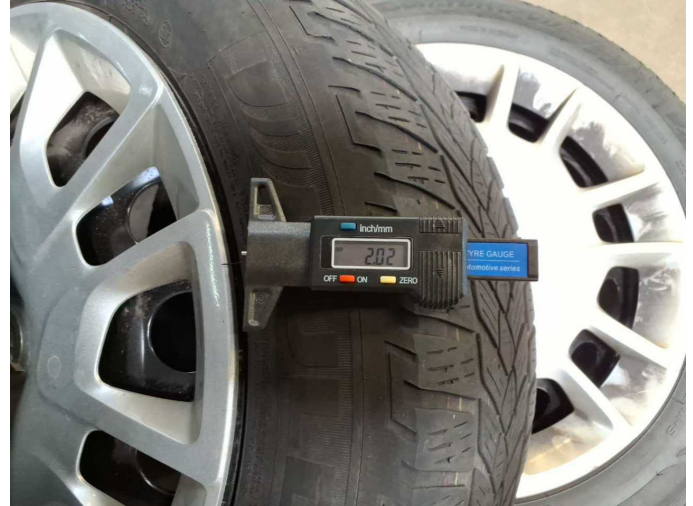
Damage 9: 2nd wheel set: 2nd wheel set (Verschließen, alle unter 3mm.)
- Does not meet the leasing specifications - Replace

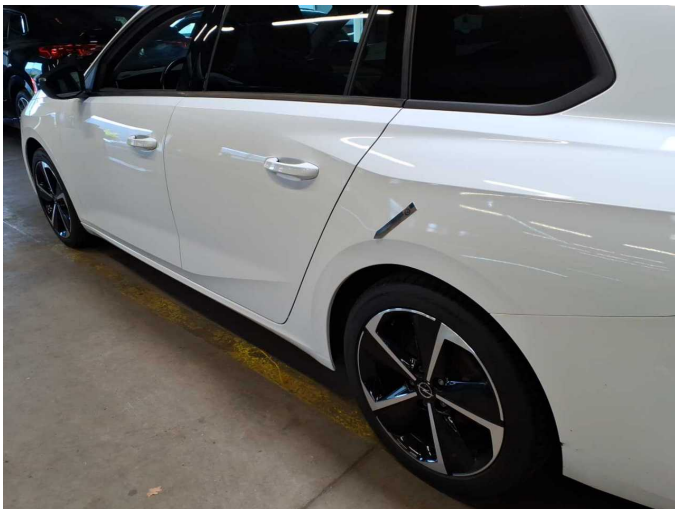
Damage 10: Side panel - rear left side: Side panel - Deformed - Repair and paint

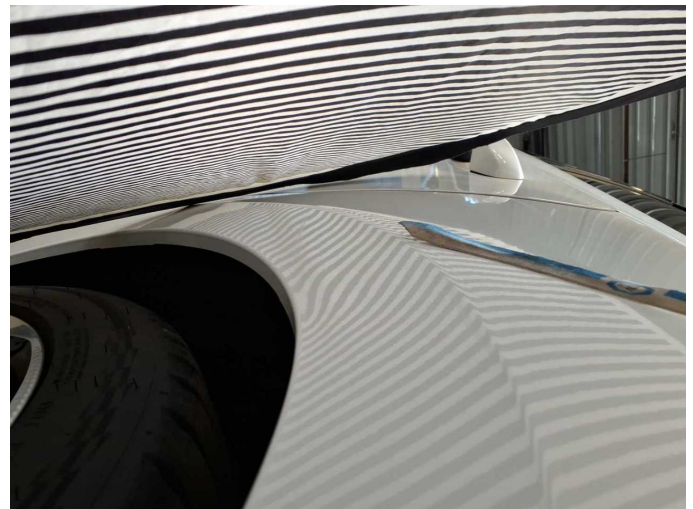
Damage 10: Side panel - rear left side: Side panel - Deformed - Repair and paint

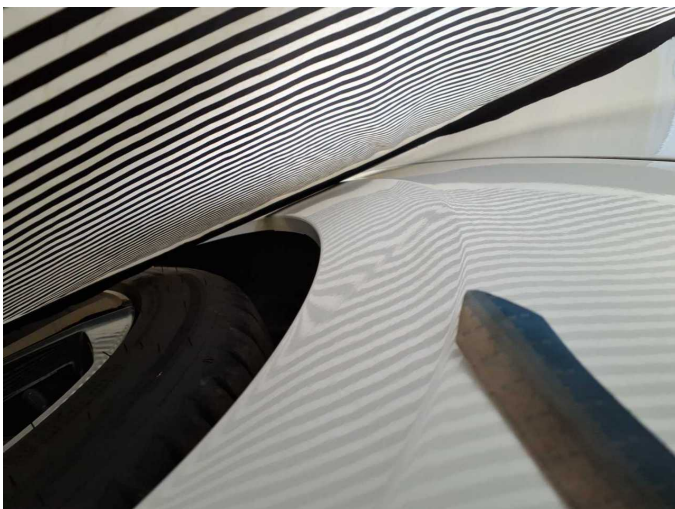
Damage 10: Side panel - rear left side: Side panel - Deformed - Repair and paint

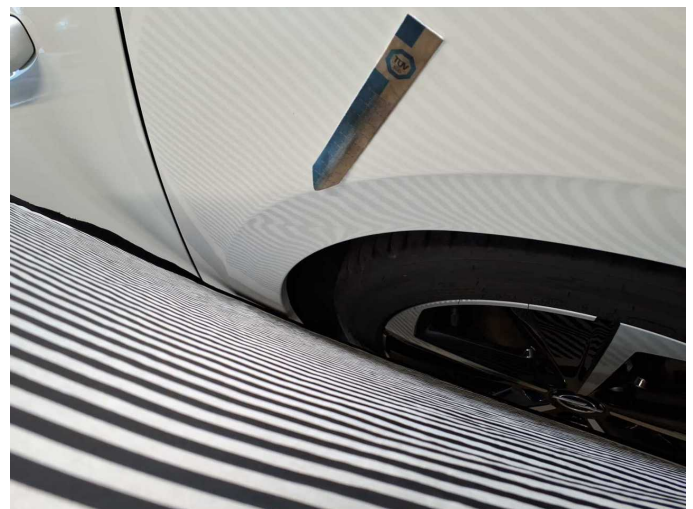
Damage 10: Side panel - rear left side: Side panel - Deformed - Repair and paint

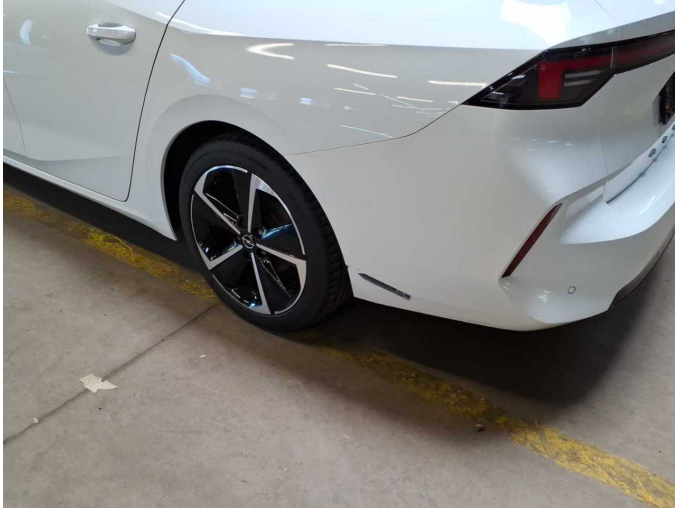
Damage 11: Rear bumper: Rear bumper - Deformed - Repair and paint

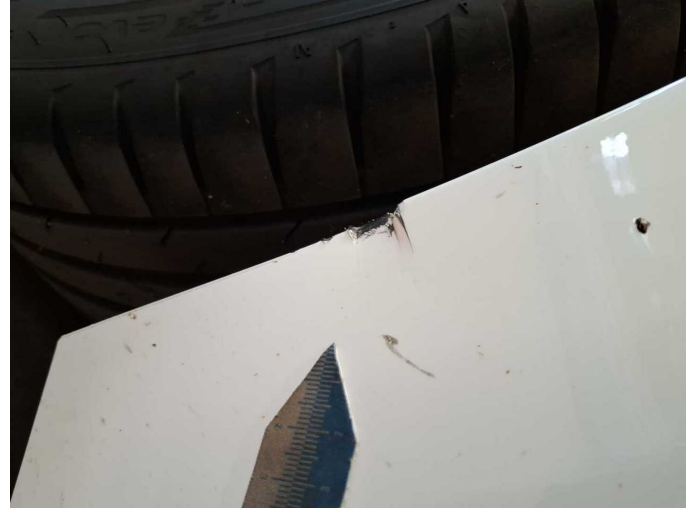
Damage 11: Rear bumper: Rear bumper - Deformed - Repair and paint

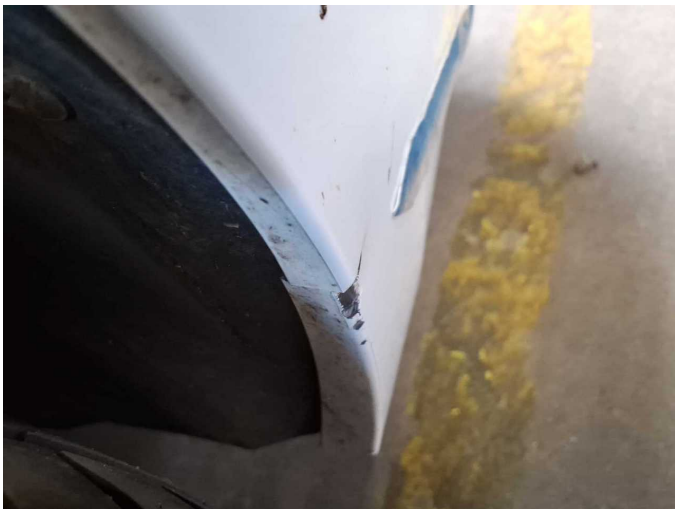
Damage 11: Rear bumper: Rear bumper - Deformed - Repair and paint

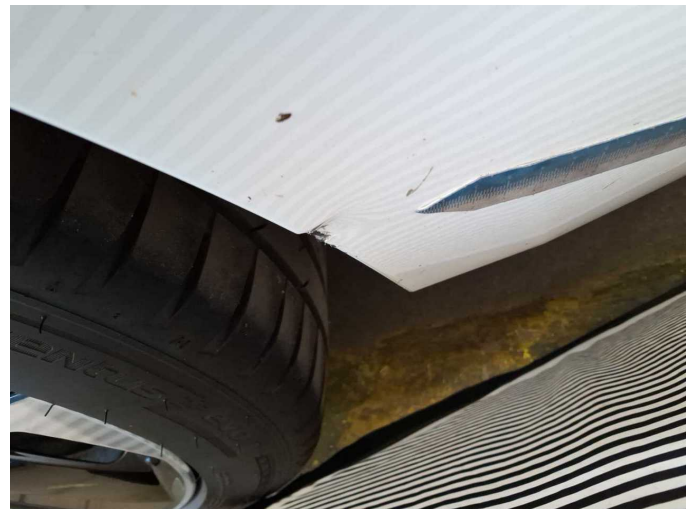
Damage 11: Rear bumper: Rear bumper - Deformed - Repair and paint

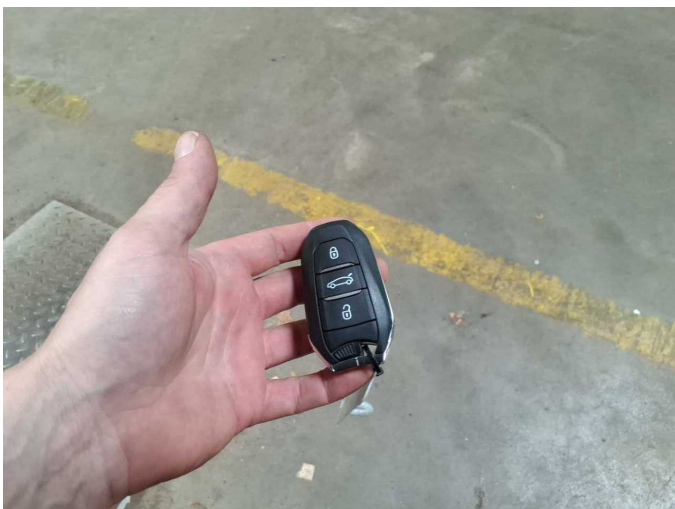
Missing part 1: Equipment: Vehicle key with remote control - Missing - Replace
