Expertise

Protocol number: 47130851  
Order No. / Reference: 26769473  
Inspection date: 18 Aug 2026

| Manufacturer: Ford | Model: Mondeo Turnier 2.0 EcoBlue Aut. Titanium |

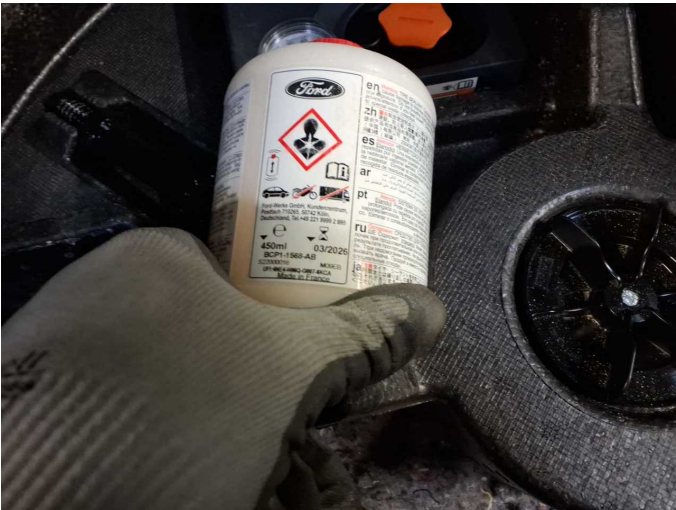
| No. | Component group | Description |
|---|---|---|
| 1 | Equipment | Tirefit filler - Expired - Replace |

Damage 1: Equipment: Tirefit filler - Expired - Replace

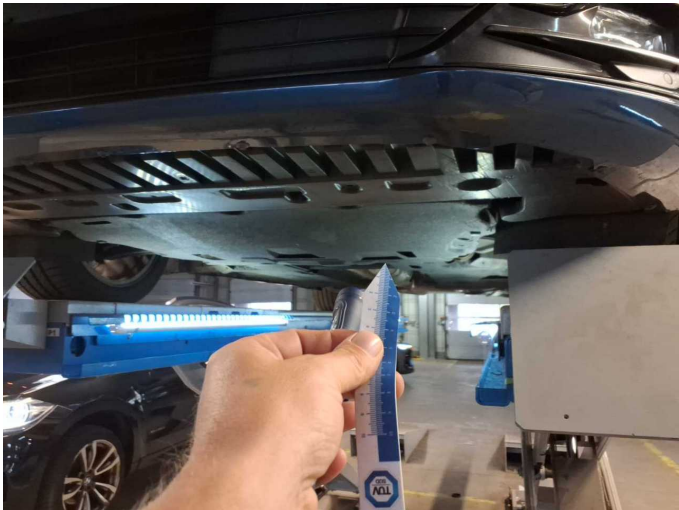
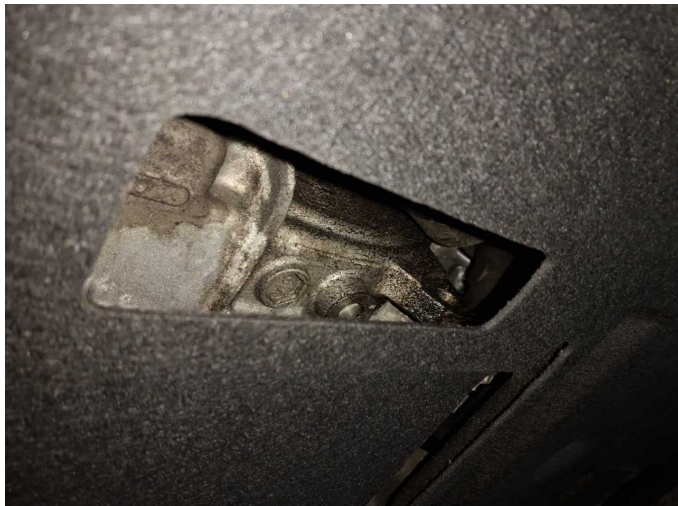
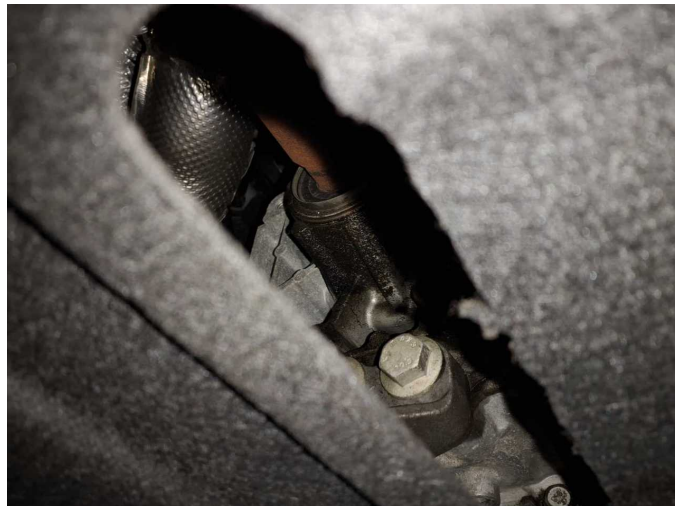
| No. | Component group | Description |
|---|---|---|
| 2 | Gearbox | Gearbox - Leaking - Perform diagnosis |

Damage 2: Gearbox: Gearbox - Leaking - Perform diagnosis

**Damage 2:** Gearbox: Gearbox - Leaking - Perform diagnosis

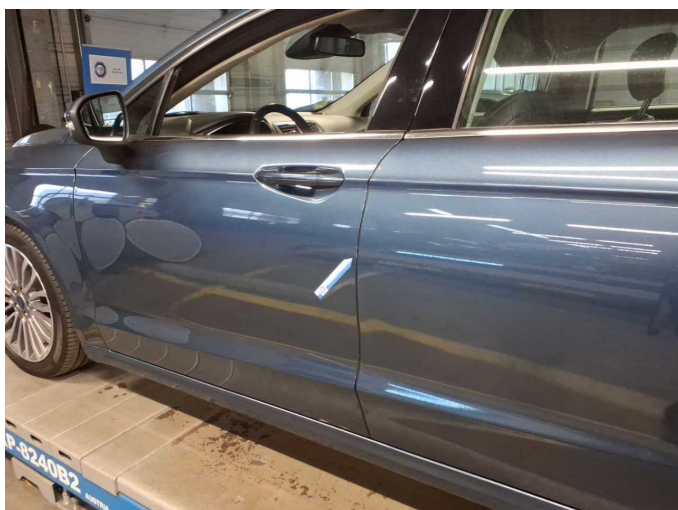
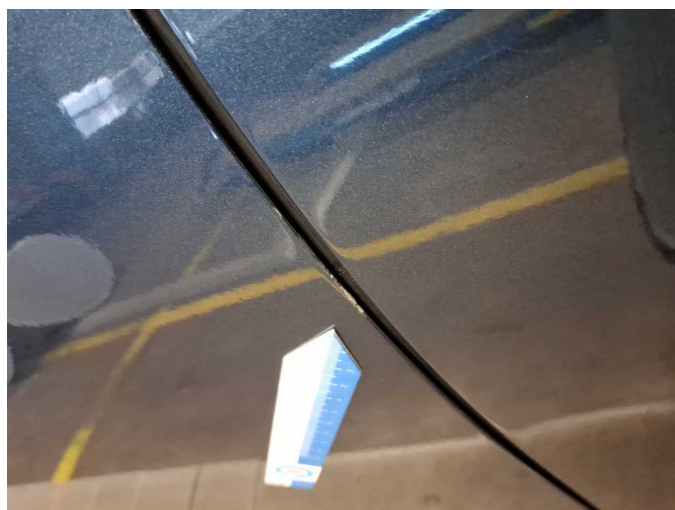
| No. | Component group | Description |
|---|---|---|
| 3 | Door - front left side | Door edge - Scratch(es) - Smart repair |

**Damage 3:** Door - front left side: Door edge - Scratch(es) - Smart repair

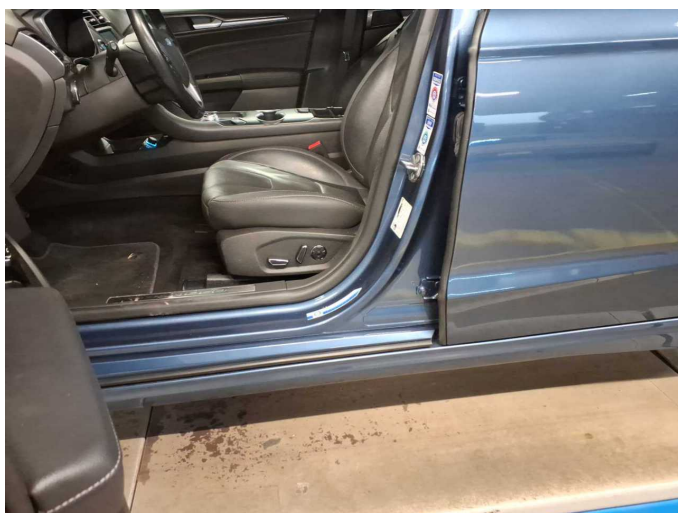
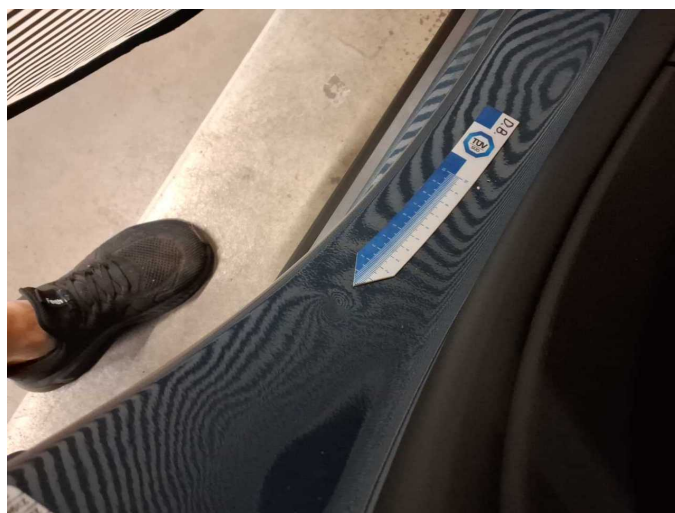
| No. | Component group | Description |
|---|---|---|
| 4 | Sill - left side | Sill - dent(s) - Smooth repair work |

**Damage 4:** Sill - left side: Sill - dent(s) - Smooth repair work

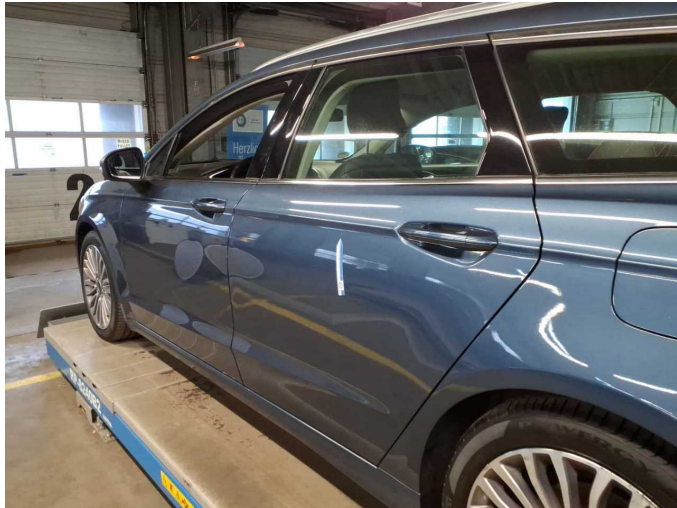
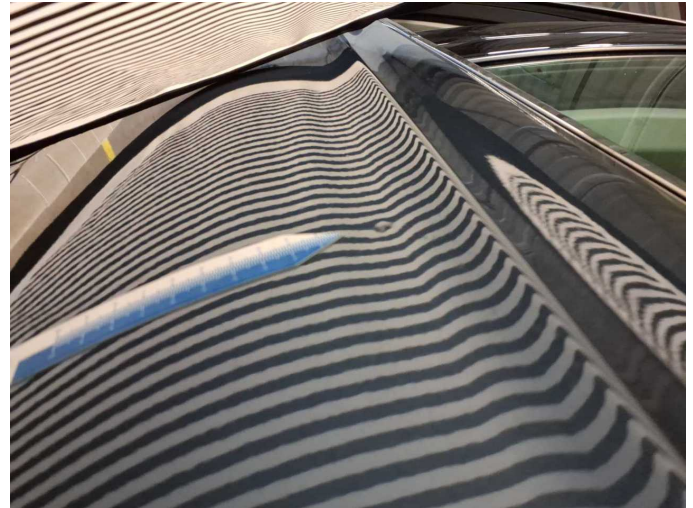
| No. | Component group | Description |
|---|---|---|
| 5 | Door - rear left side | Door - dent(s) - Smooth repair work |

**Damage 5:** Door - rear left side: Door - dent(s) - Smooth repair work

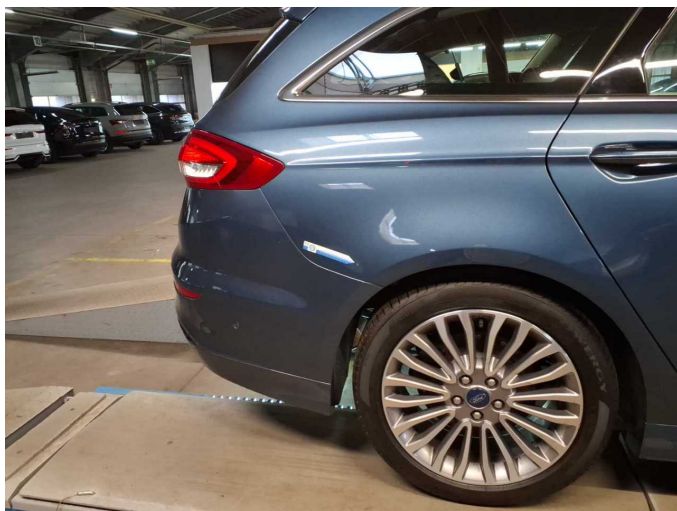
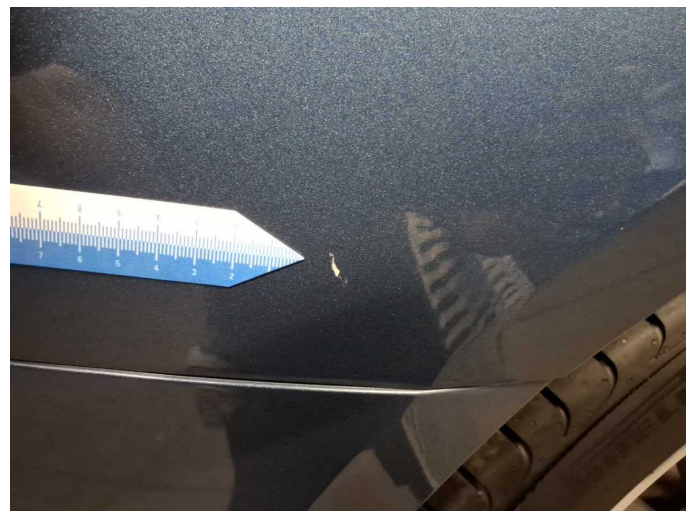
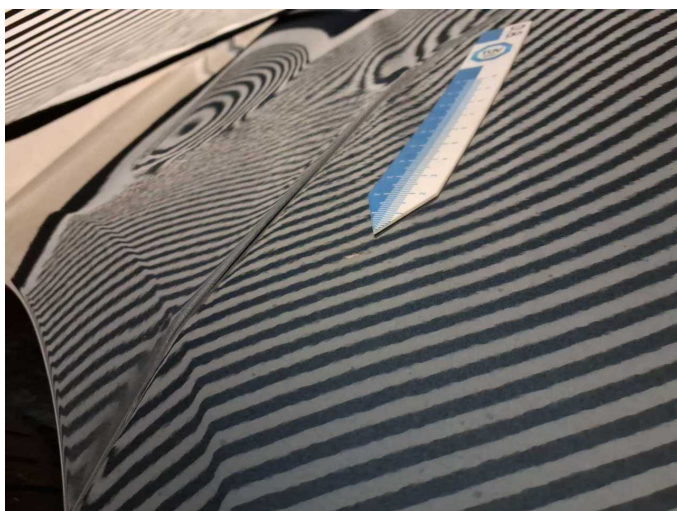
| No. | Component group | Description |
|---|---|---|
| 6 | Side panel - rear right side | Side panel - Scratch(es) - Smart repair |

**Damage 6:** Side panel - rear right side: Side panel - Scratch(es) - Smart repair

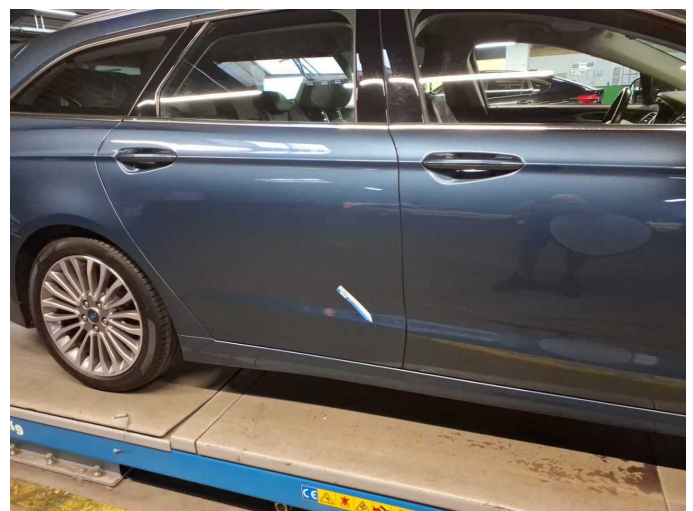
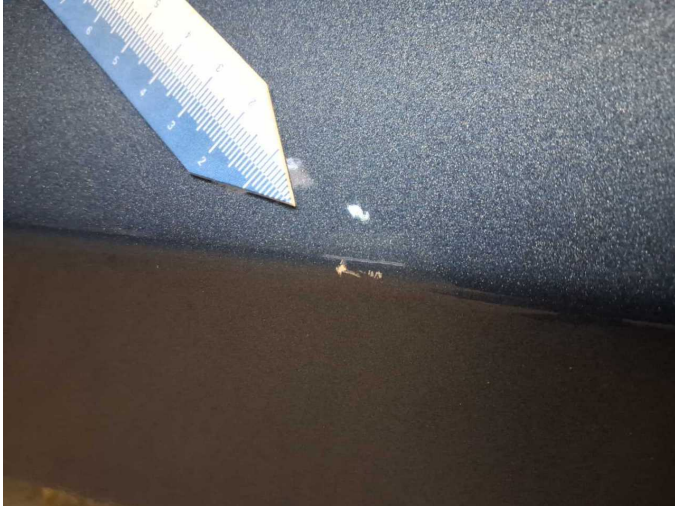
| No. | Component group | Description |
|---|---|---|
| 7 | Door - rear right side | Door - Scratch(es) - Smart repair |

**Damage 7:** Door - rear right side: Door - Scratch(es) - Smart repair

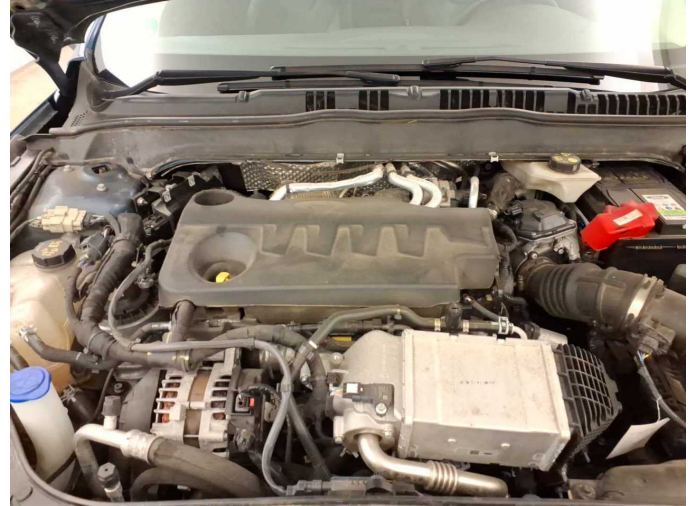
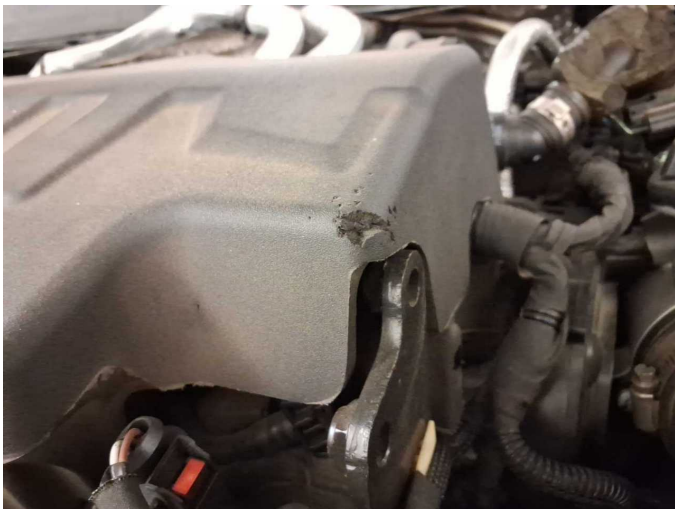
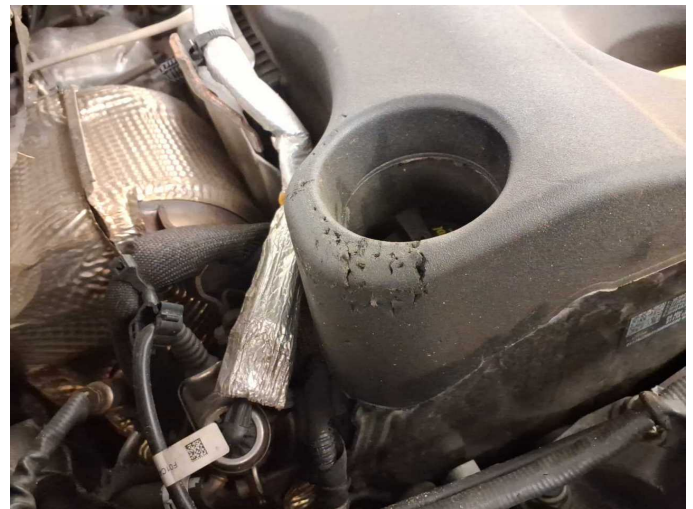
| No. | Component group | Description |
|---|---|---|
| 8 | Engine | Engine cover - Damage caused by marten / rodent - Replace |

**Damage 8:** Engine: Engine cover - Damage caused by marten / rodent - Replace

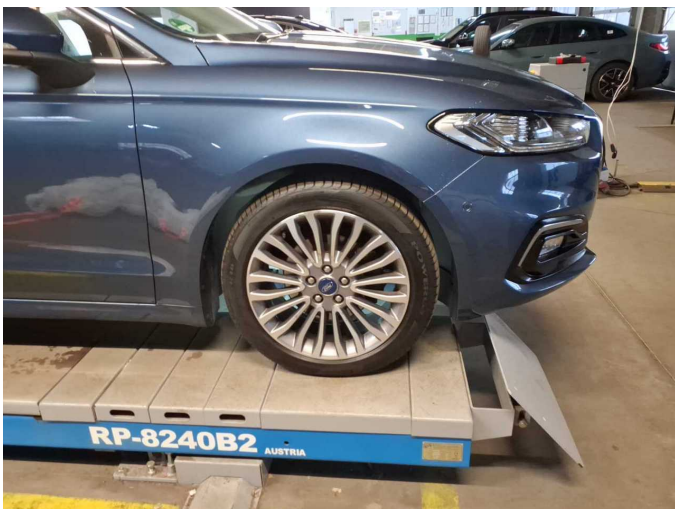
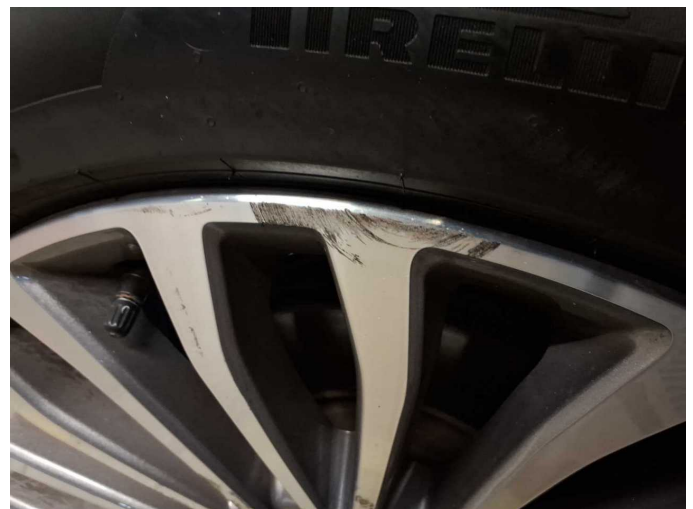
| No. | Component group | Description |
|---|---|---|
| 9 | Wheel / tyres | Alloy rim - front right side - Scratch(es) - Loss in value |

**Damage 9:** Wheel / tyres: Alloy rim - front right side - Scratch(es) - Loss in value

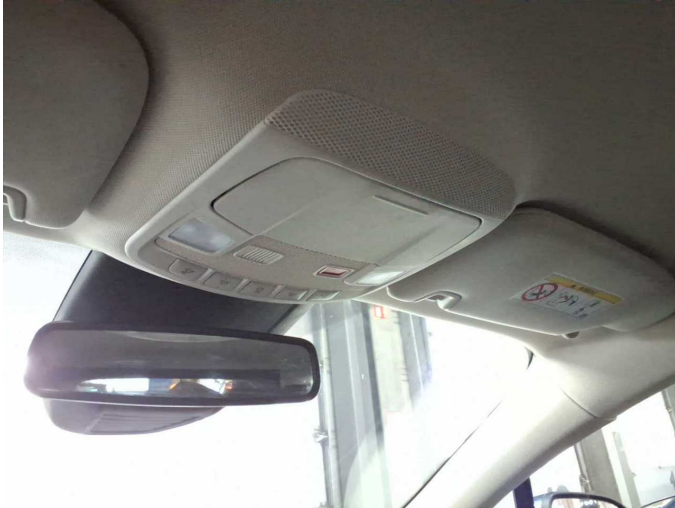
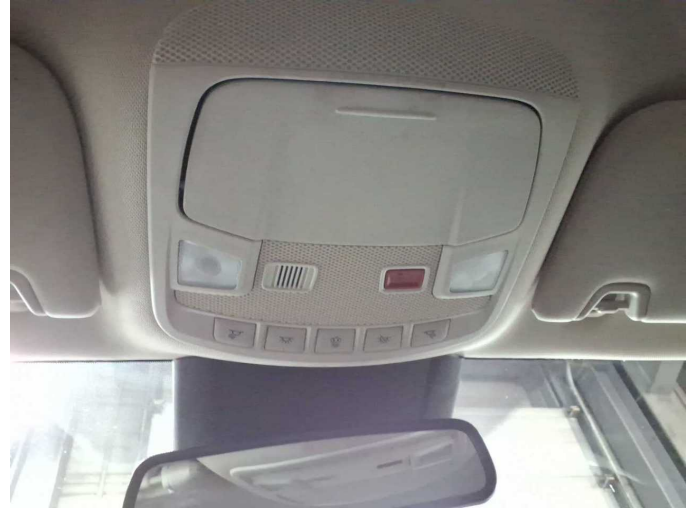
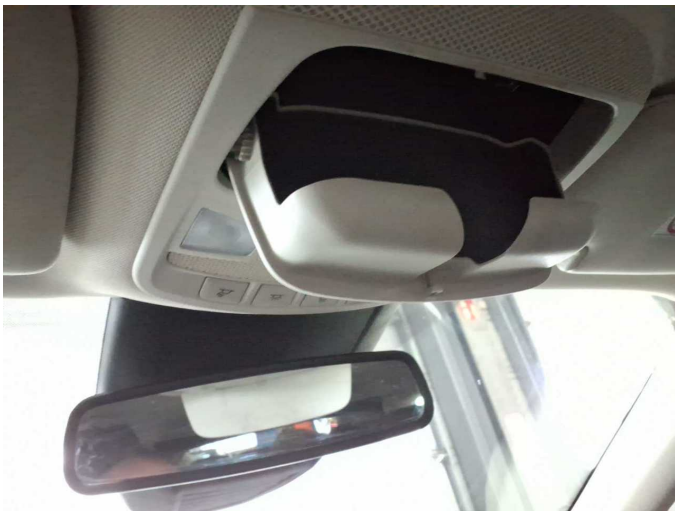
| No. | Component group | Description |
|---|---|---|
| 10 | Equipment | Storage compartment (Brillenfach öffnet/ schließt nicht richtig) - Damaged - Replace |

**Damage 10:** Equipment: Storage compartment (Brillenfach öffnet/schließt nicht richtig) - Damaged - Replace

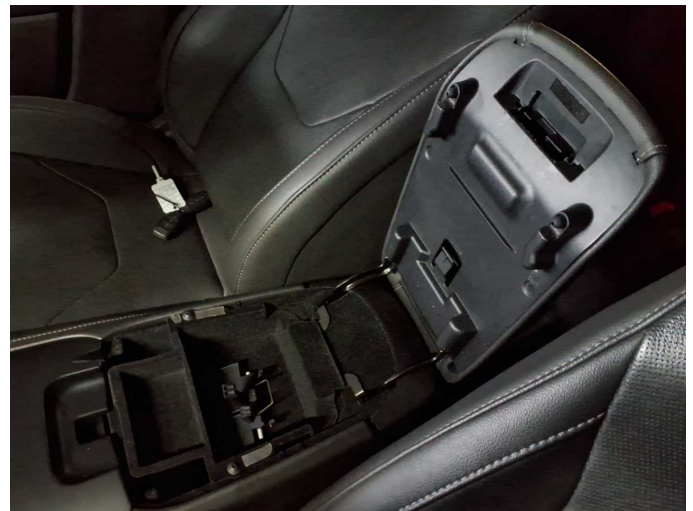
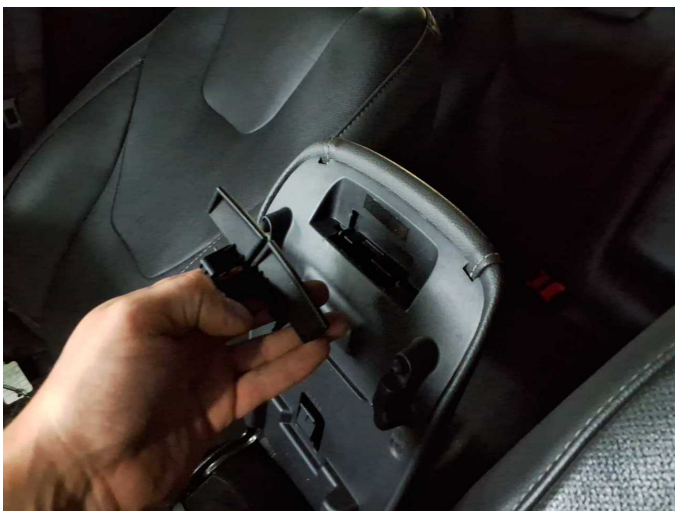
| No. | Component group | Description |
|---|---|---|
| 11 | Seat - front | armrests - Damaged - Replace |

**Damage 11:** Seat - front: armrests - Damaged - Replace

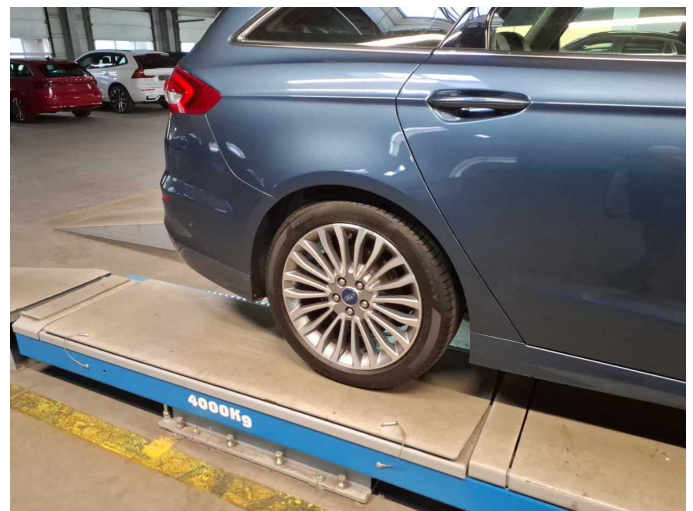
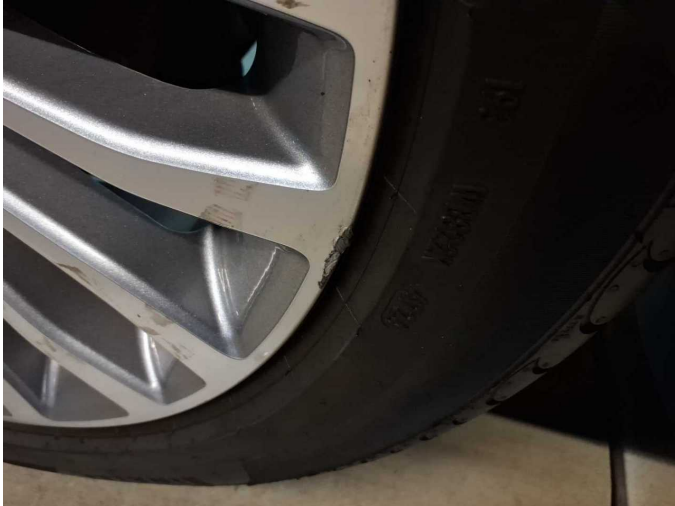
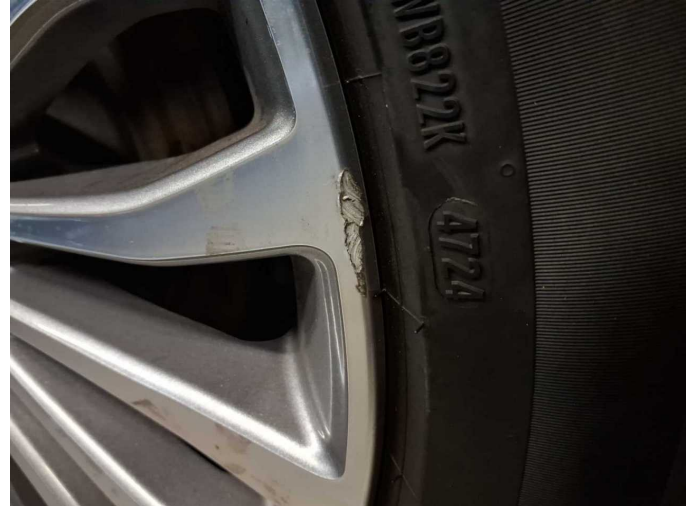
| No. | Component group | Description |
|---|---|---|
| 12 | Wheel / tyres | Alloy rim - rear right side (Materialabtrag) - Scratched - Replace |

**Damage 12:** Wheel / tyres: Alloy rim - rear right side (Materialabtrag) - Scratched - Replace

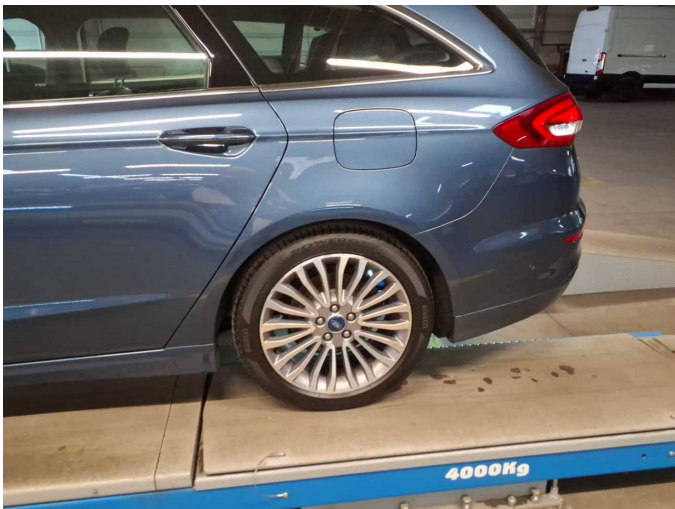
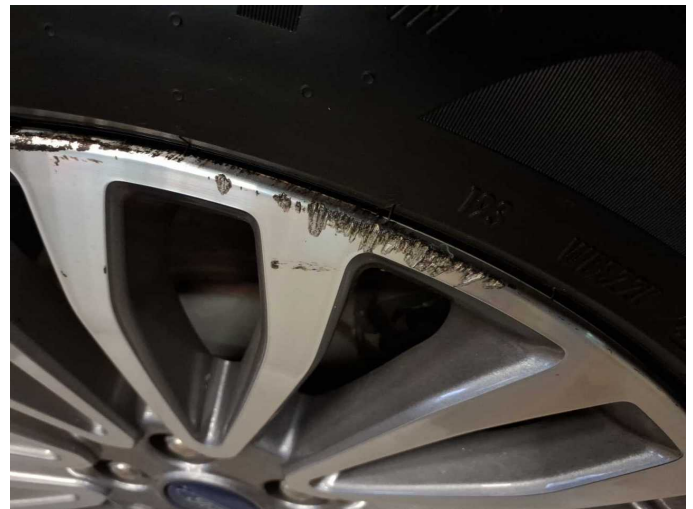
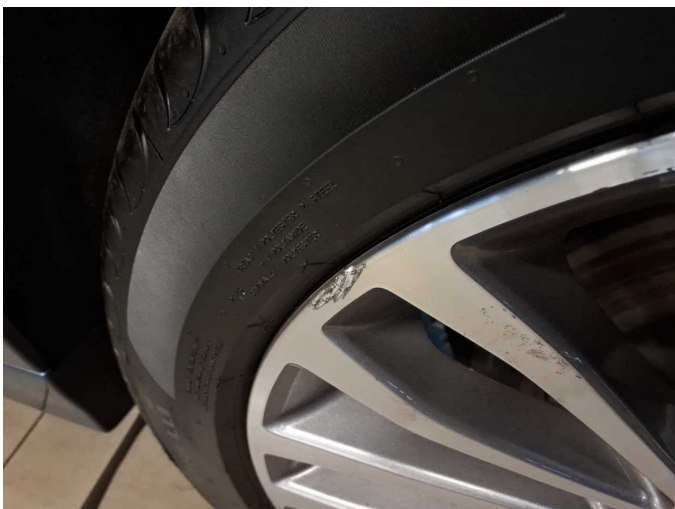
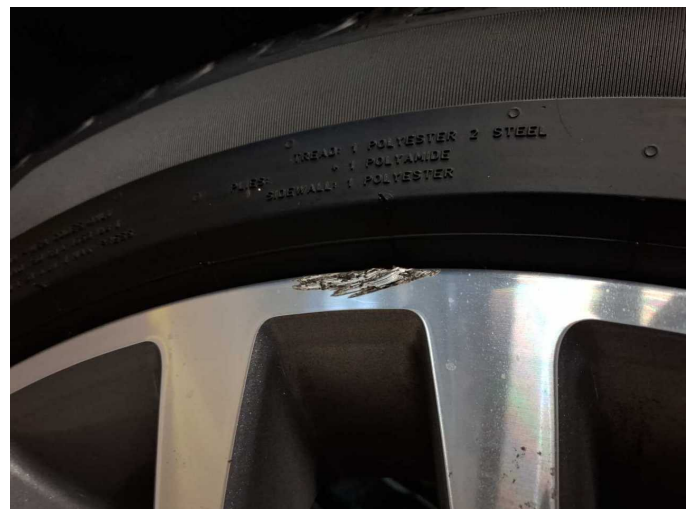
| No. | Component group | Description |
|---|---|---|
| 13 | Wheel / tyres | Alloy rim - rear left side (Materialabtrag) - Scratched - Replace |

**Damage 13:** Wheel / tyres: Alloy rim - rear left side (Materialabtrag) - Scratched - Replace

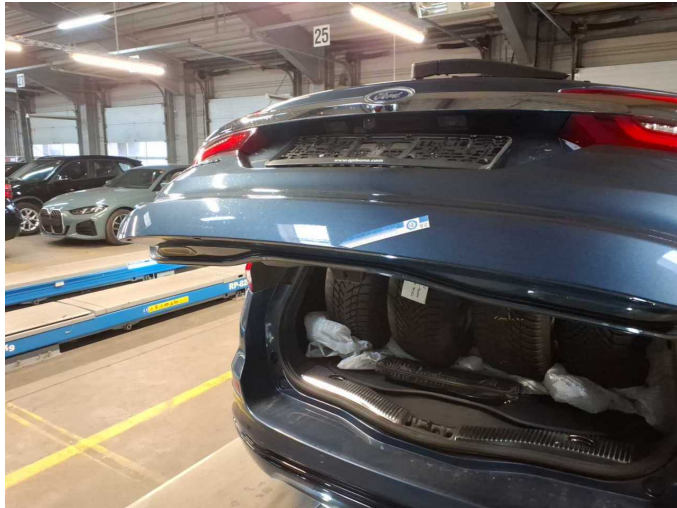
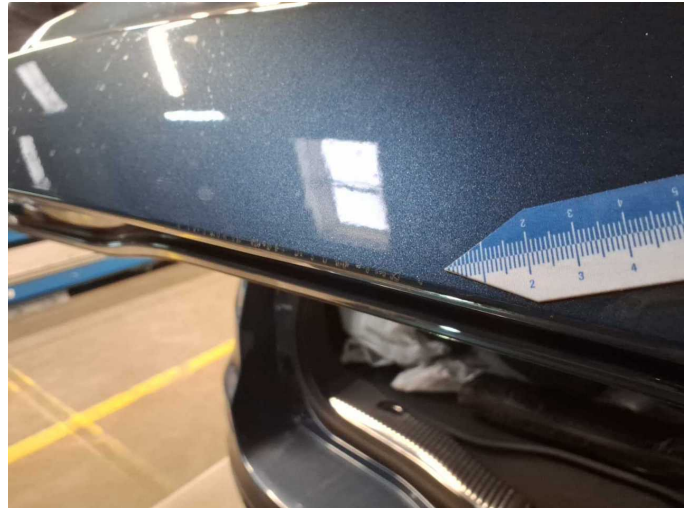
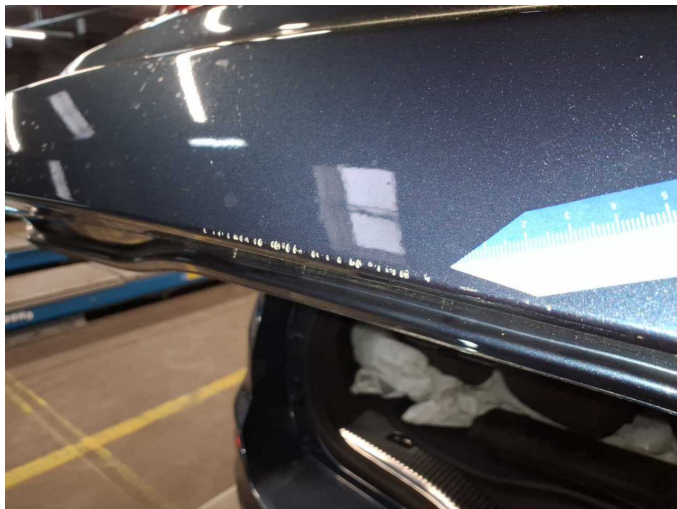
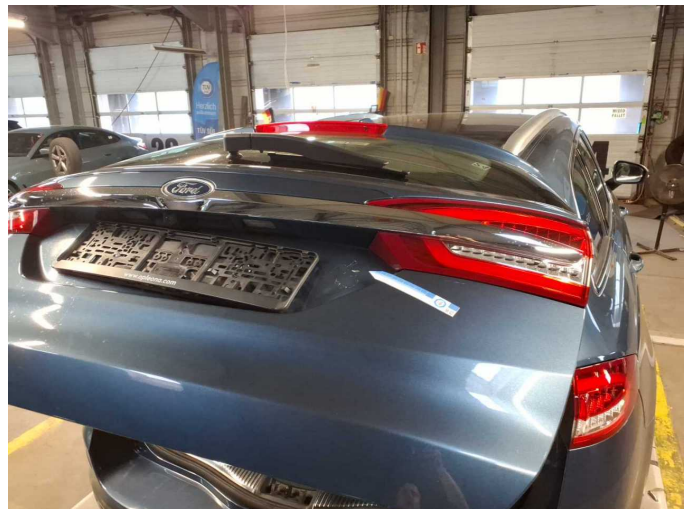
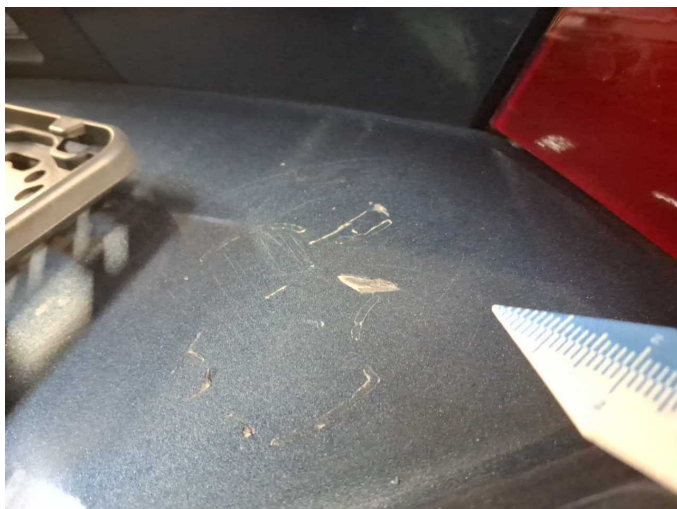
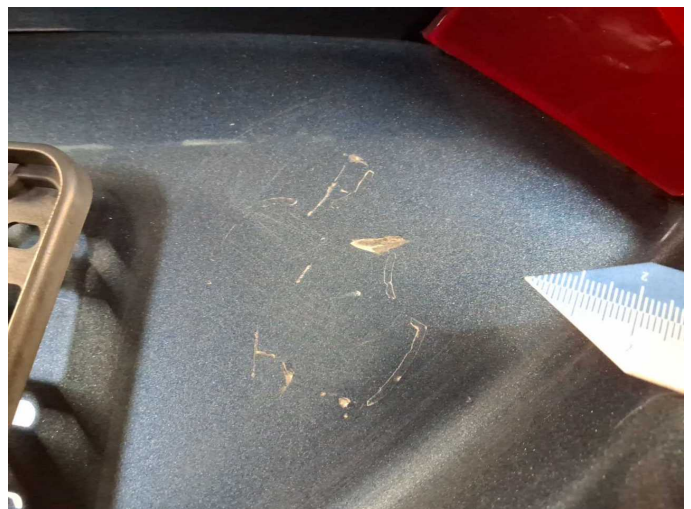
| No. | Component group | Description |
|---|---|---|
| 14 | Boot lid / rear door | Boot lid - Scratched - Repair and paint |

**Damage 14:** Boot lid / rear door: Boot lid - Scratched - Repair and paint

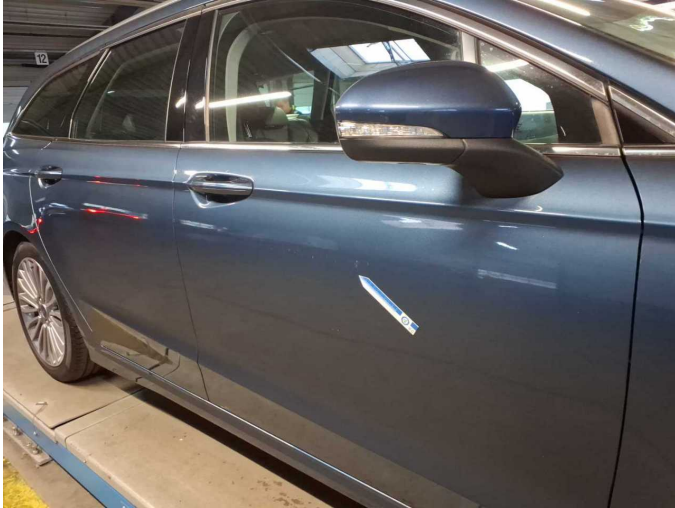
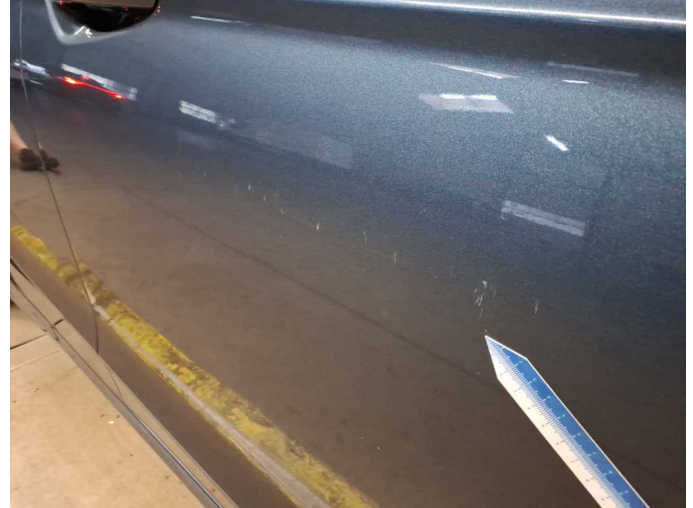
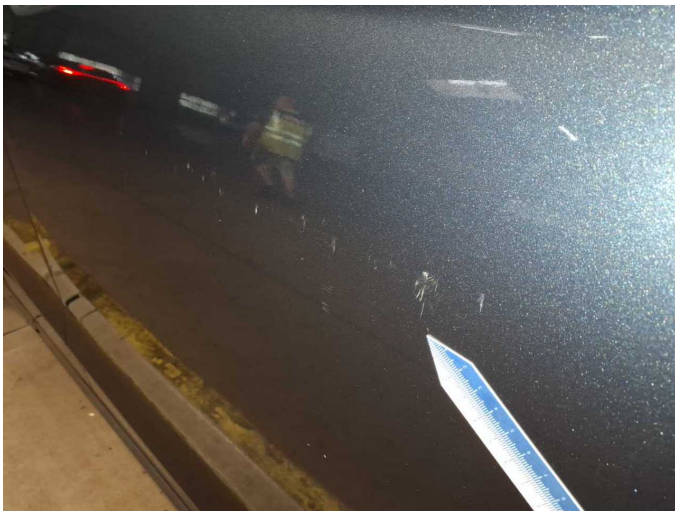
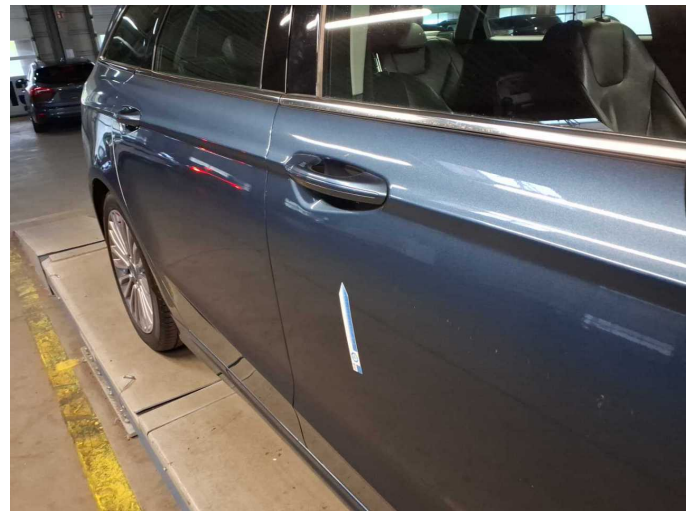
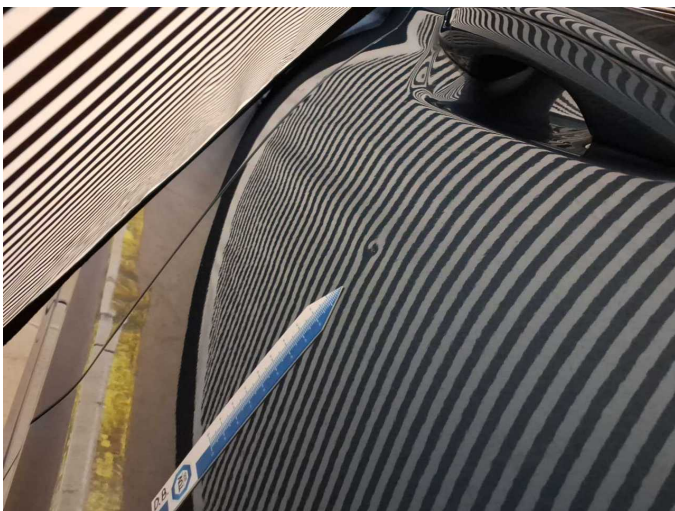
| No. | Component group | Description |
|---|---|---|
| 15 | Door - front right side | Door - Dent / paintcoat damage - Repair and paint |

**Damage 15:** Door - front right side: Door - Dent / paintcoat damage - Repair and paint

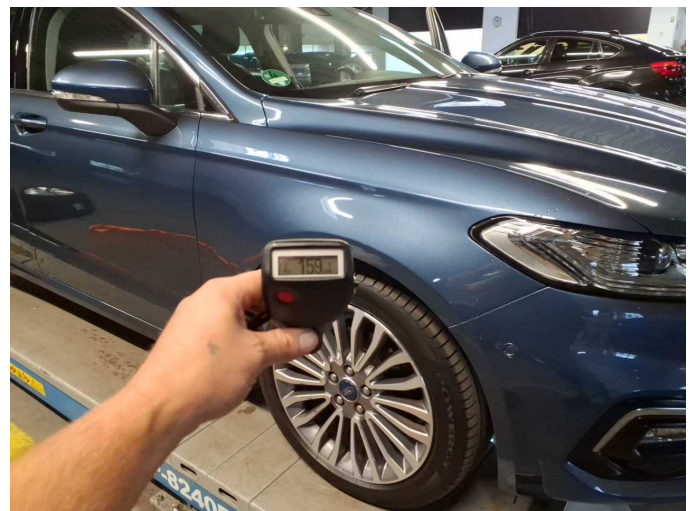
**Repainting 1:** Mudguard - right side

1 Mudguard - right side, Professionally carried out, Invoice of repair done Non-existent

Mudguard - right side 159 µm |
