Expertise

Protocol number: 44485542  
Order number / reference: 26040586  
Inspection date: 16 Mar 2026

Manufacturer: Opel

Model: Grandland 1.2 DI Automatik GS

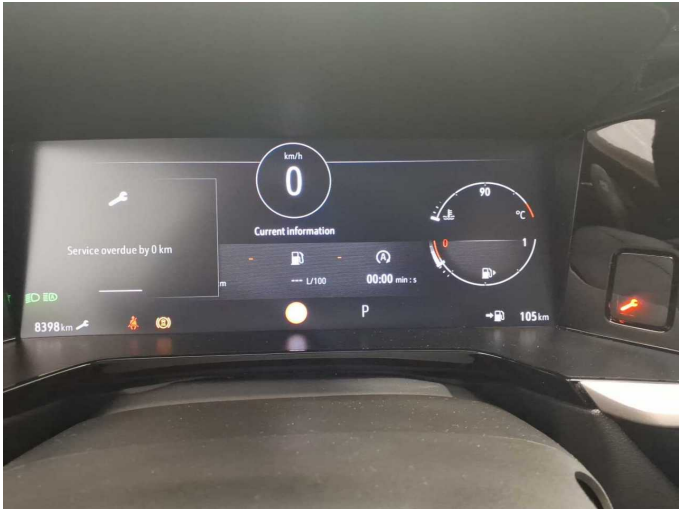
| No. | Component group | Description |
|---|---|---|
| 2 | Misc. | Inspection / maintenance - Due - Perform |

Damage 2: Misc.: Inspection / maintenance - Due - Perform

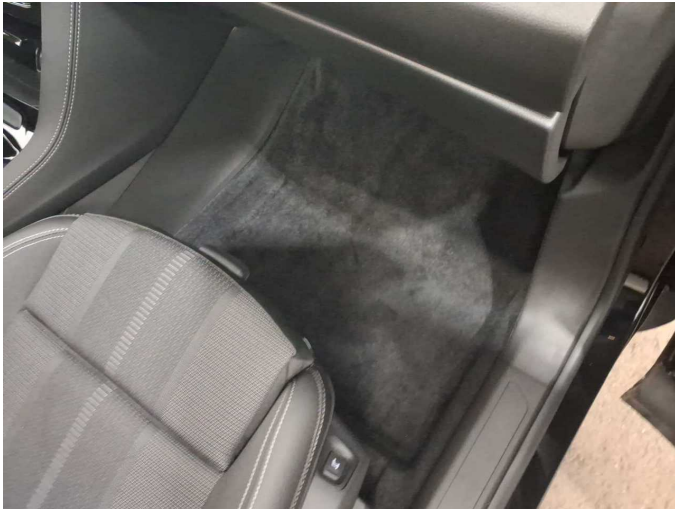
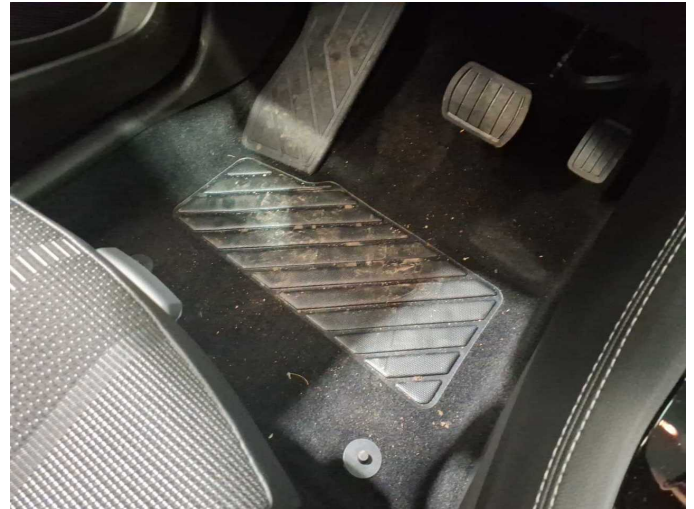
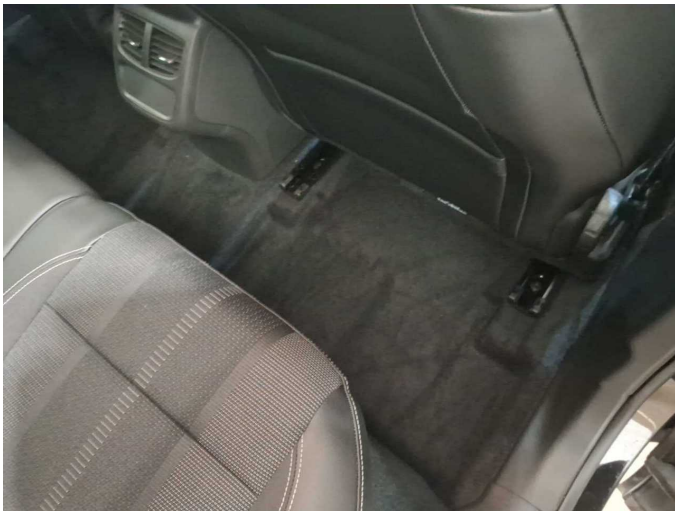
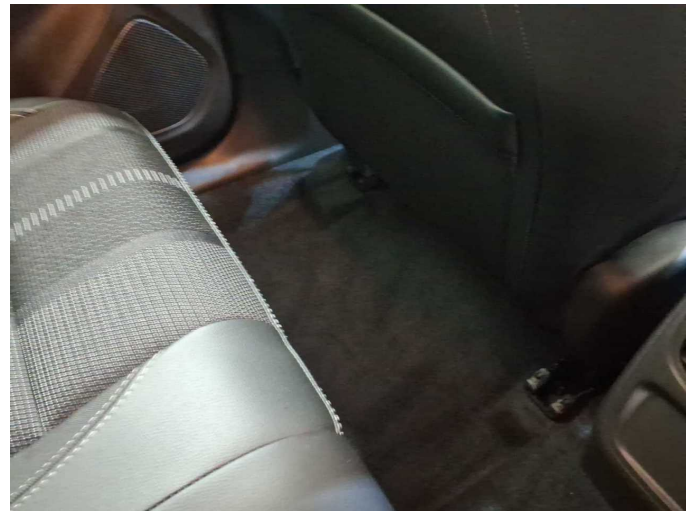
Trim / covers - Floor mats (Komplett)

**Missing part 1:** Trim / covers: Floor mats (Komplett) - Missing - Replace
