Expertise

Protocol number: 46522375  
Order No. / Reference: 26689280  
Inspection date: 13 Jul 2026

| Manufacturer: Opel | Model: Insignia Sports Tourer 1.5 Diesel Automatik Business |
| VIN: W0VZT8ENXN1003531 | |

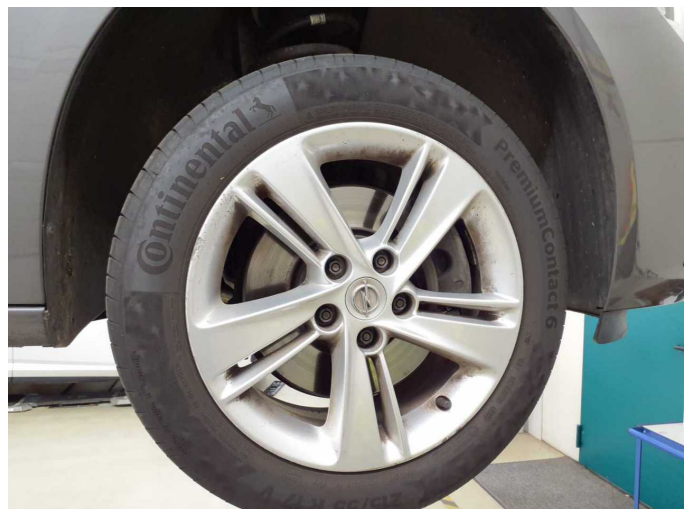
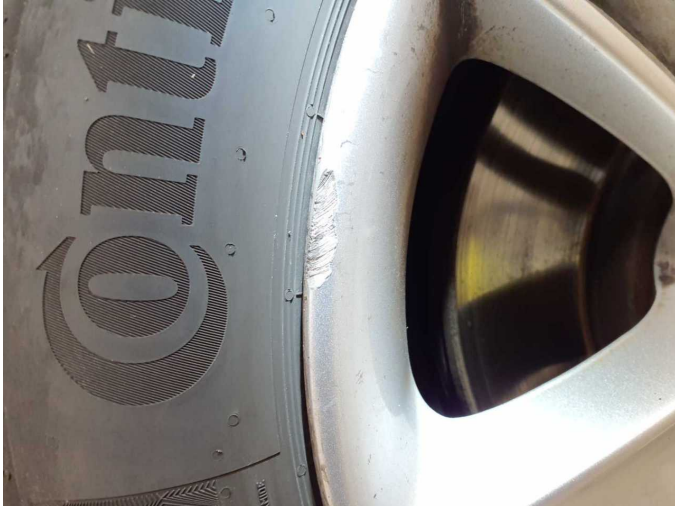
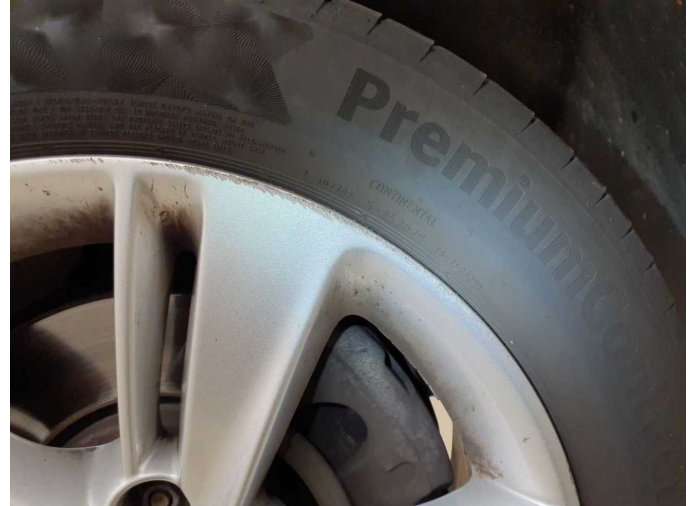
| No. | Component group | Description |
|---|---|---|
| 1 | Wheel / tyres | Alloy rim - front right side - Scratched - Smart repair |

Damage 1: Wheel / tyres: Alloy rim - front right side - Scratched - Smart repair

**Damage 1:** Wheel / tyres: Alloy rim - front right side - Scratched - Smart repair

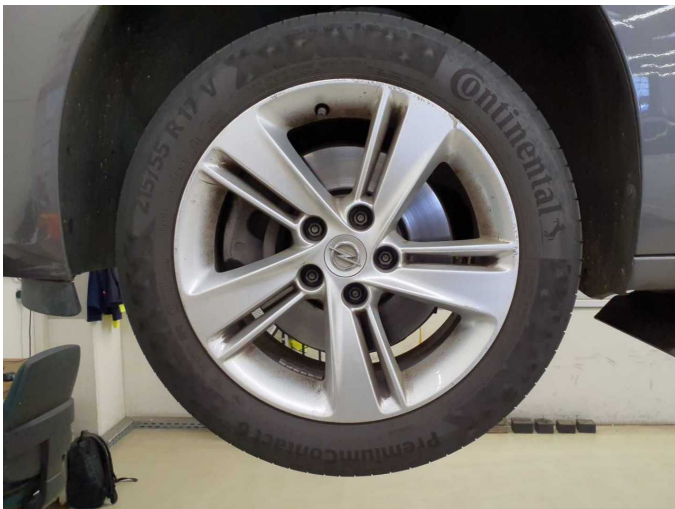
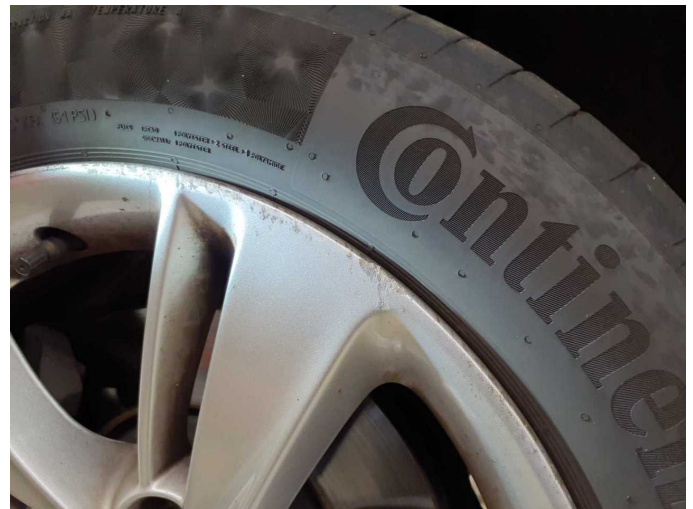
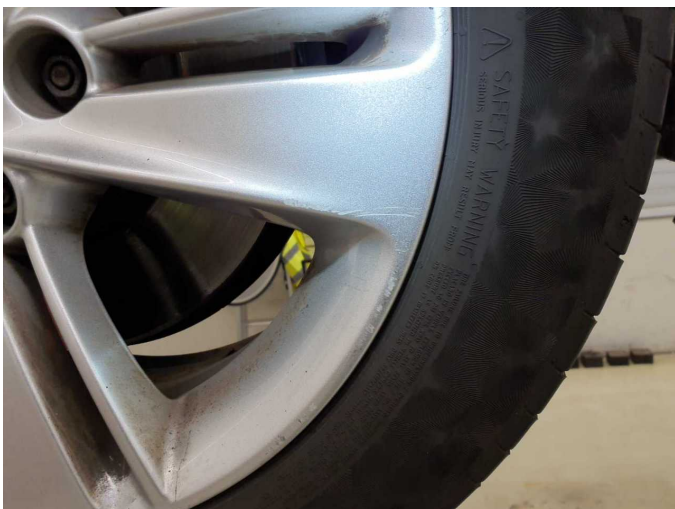
| No. | Component group | Description |
|---|---|---|
| 2 | Wheel / tyres | Alloy rim - front left side - Scratched - Smart repair |

**Damage 2:** Wheel / tyres: Alloy rim - front left side - Scratched - Smart repair

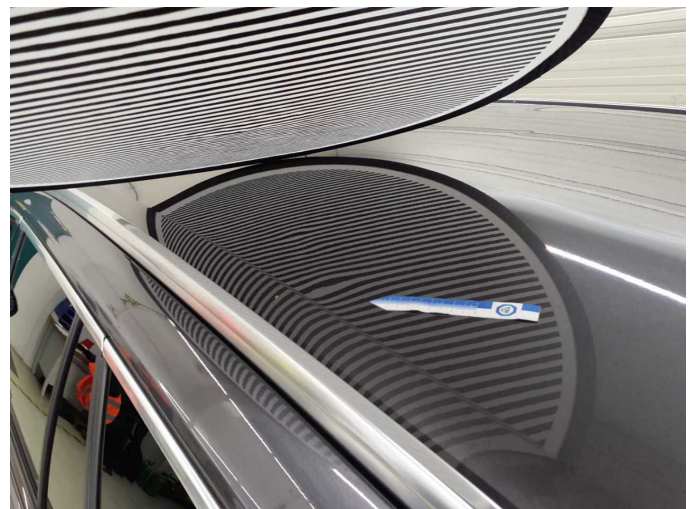
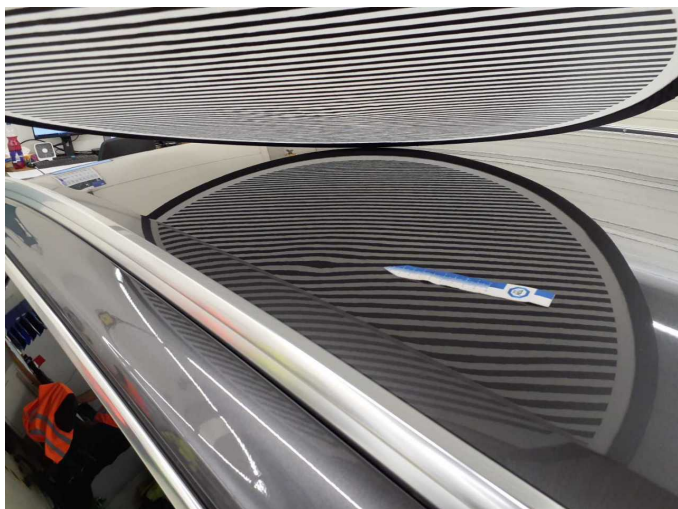
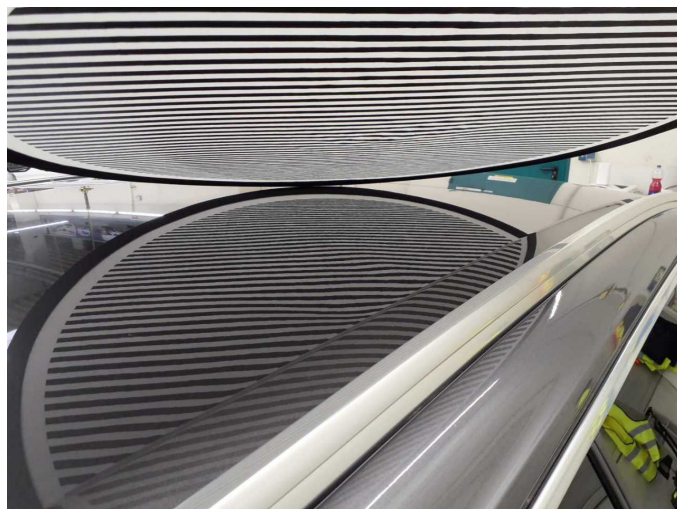
| No. | Component group | Description |
|---|---|---|
| 3 | Roof | Roof - dent(s) - Smart repair |

**Damage 3:** Roof: Roof - dent(s) - Smart repair

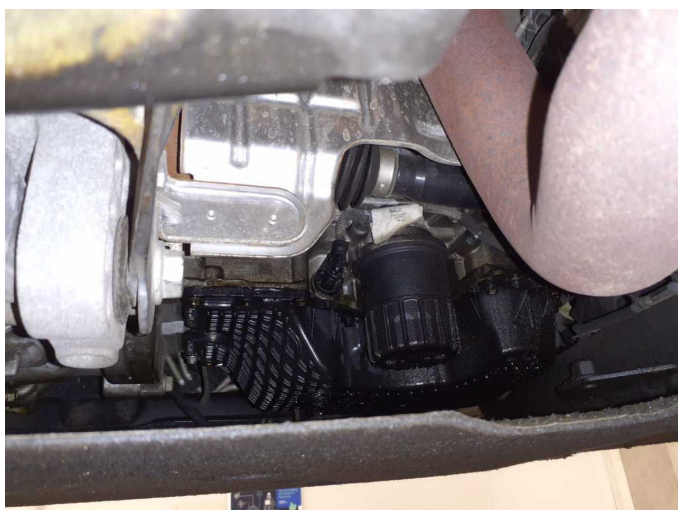
| No. | Component group | Description |
|---|---|---|
| 4 | Engine | Engine - Leaking - Diagnosed and repair if necessary |

**Damage 4:** Engine: Engine - Leaking - Diagnosed and repair if necessary

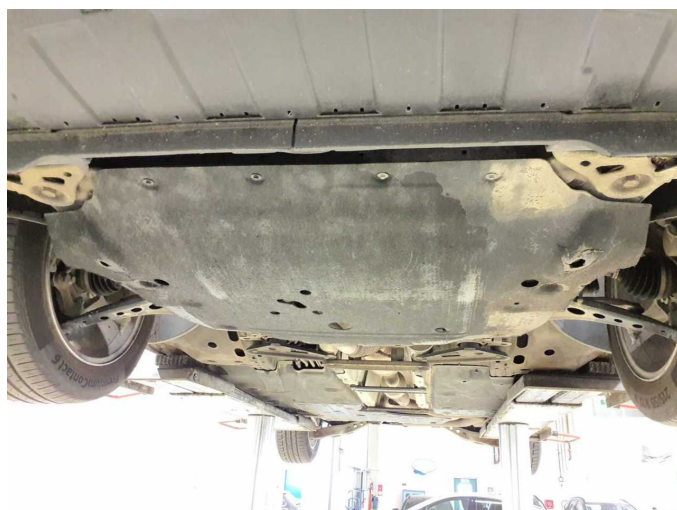
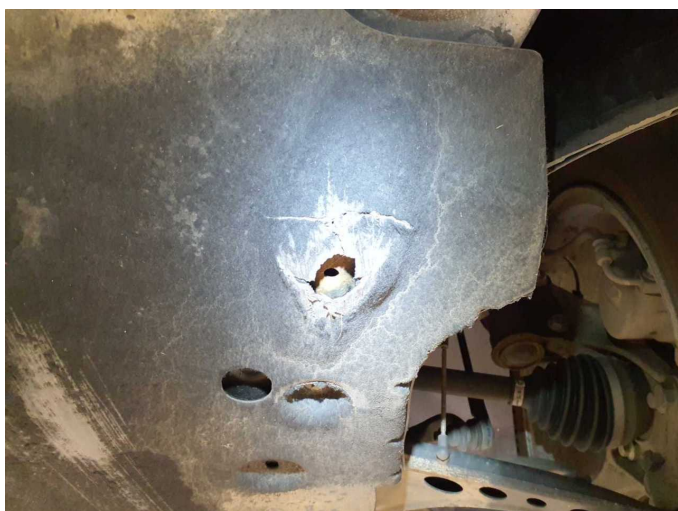
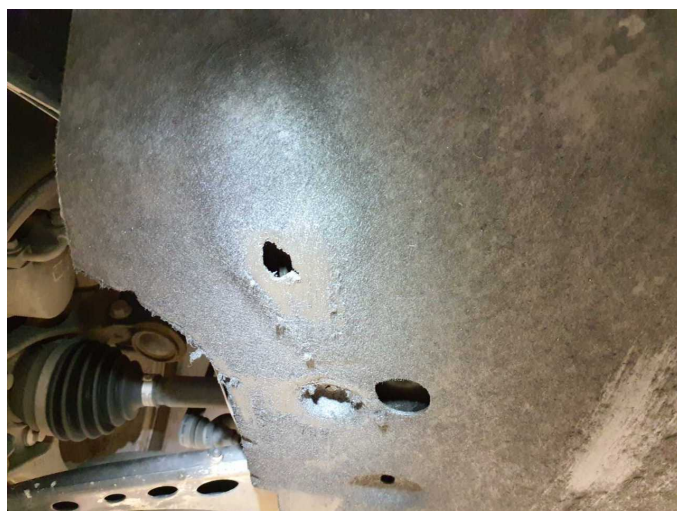
| No. | Component group | Description |
|---|---|---|
| 5 | Body | Underbody panelling (VM) - Broken / torn - Replace |

**Damage 5:** Body: Underbody panelling (VM) - Broken / torn - Replace

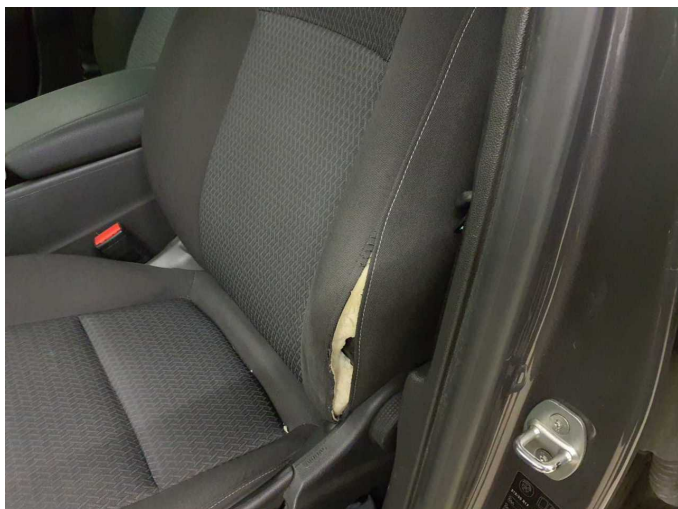
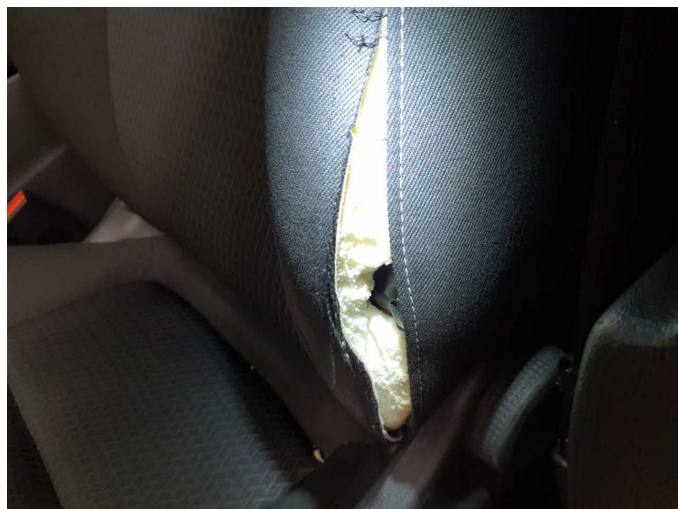
| No. | Component group | Description |
|---|---|---|
| 6 | Seat - front | Backrest cover - left side (Inkl. Polster) - Broken / torn - Replace |

**Damage 6:** Seat - front: Backrest cover - left side (Inkl. Polster) - Broken / torn - Replace

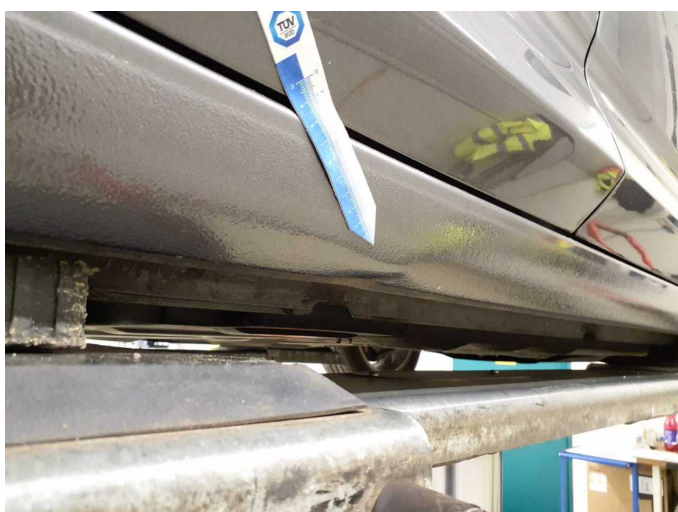
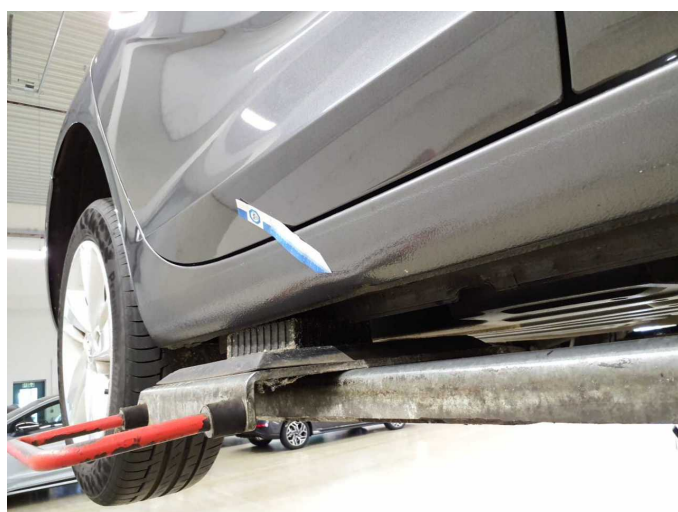
| No. | Component group | Description |
|---|---|---|
| 7 | Sill - right side | Sill - Deformed - Repair and paint |

**Damage 7:** Sill - right side: Sill - Deformed - Repair and paint

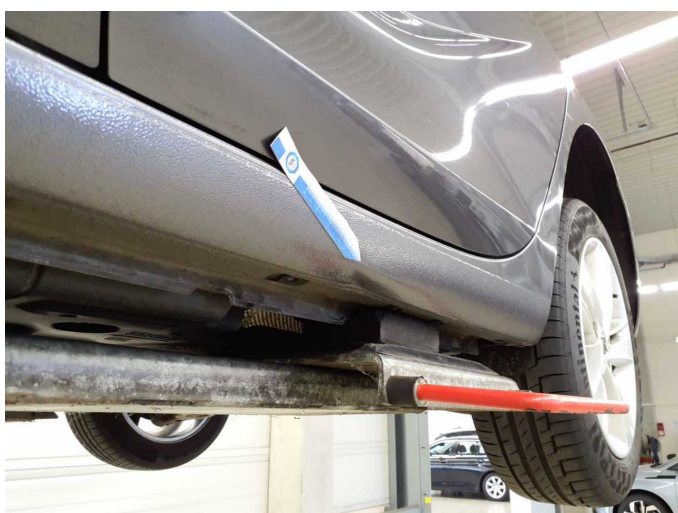
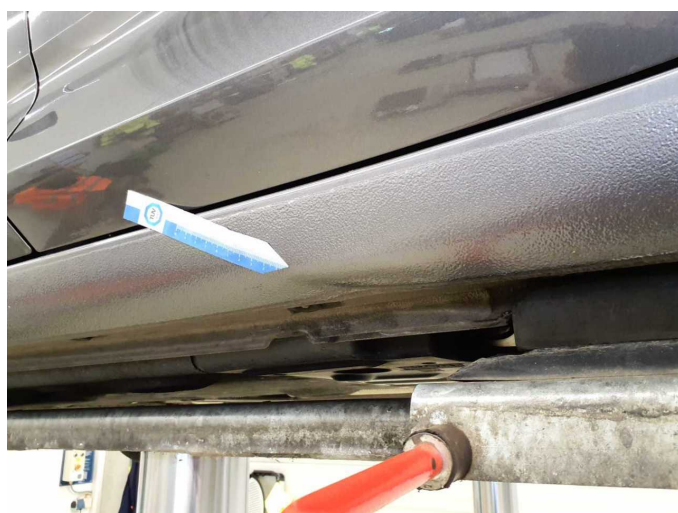
| No. | Component group | Description |
|---|---|---|
| 8 | Sill - left side | Sill - Deformed - Repair and paint |

**Damage 8:** Sill - left side: Sill - Deformed - Repair and paint

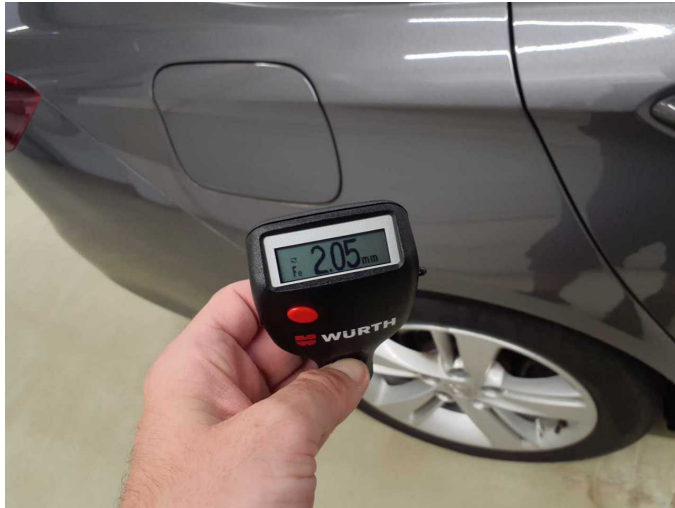
| Side panel - rear right side | 2,050<br>µm | Door - rear right side | 502 µm |

**Side panel - rear right side: 2,050 µm**

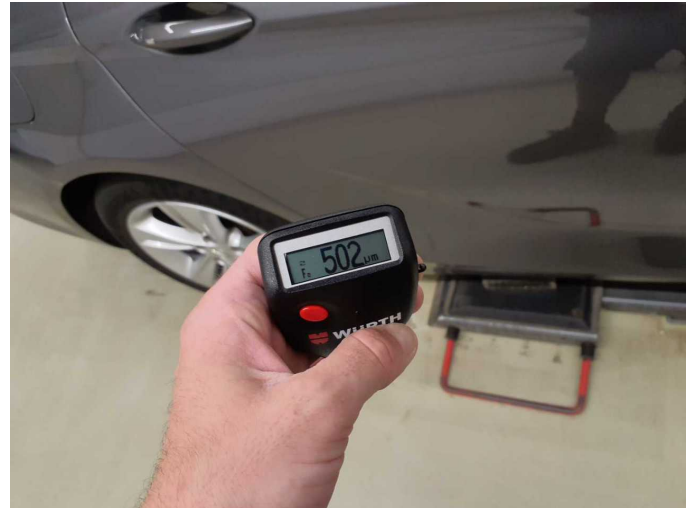
**Door - rear right side: 502 µm**

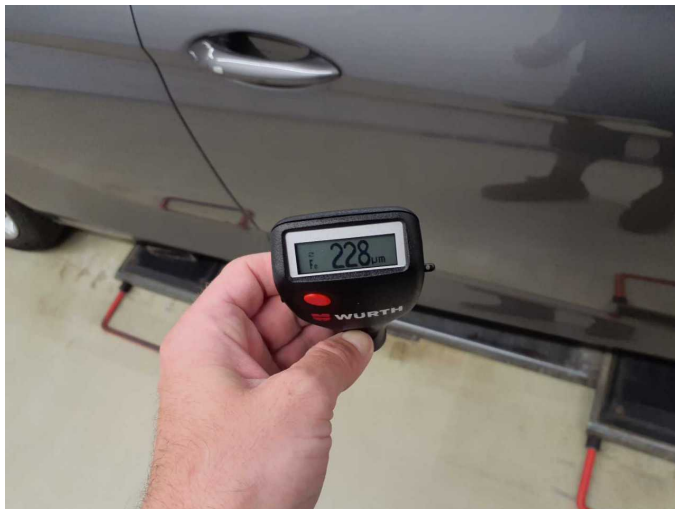
| Door - front right side | 228 µm | | |

**Door - front right side: 228 µm**
