Expertise

Protocol number: 46026933
Order No. / Reference: 26433632
Inspection date: 18 Jun 2026

Manufacturer: Ford

Model: Focus Turnier 2.0 EcoBlue Start-Stopp-System Aut.
COOL&CONNECT

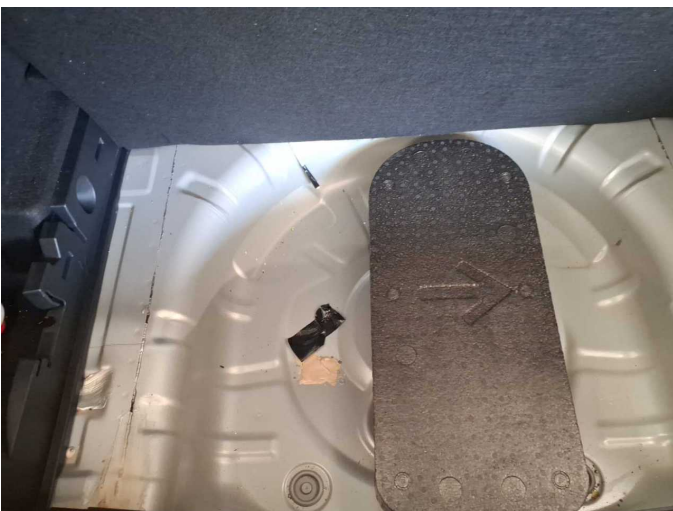
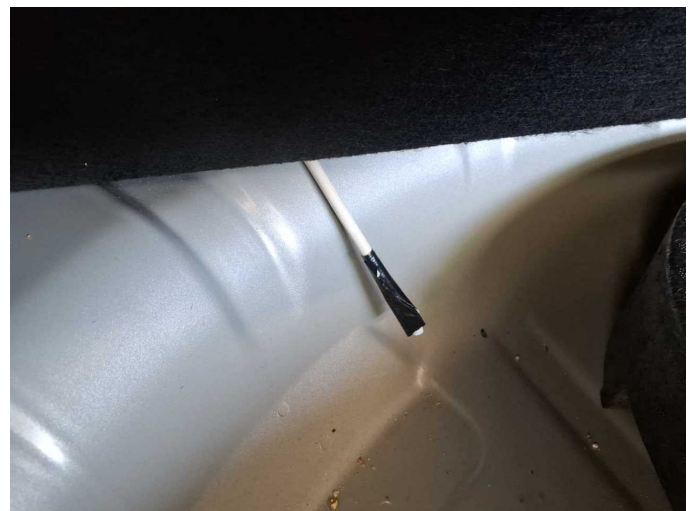
Damage 1: Electrical system: Cable strand (Kabelführung von Frontbereich in Laderaum) - Differs from the original configuration - Un-/install

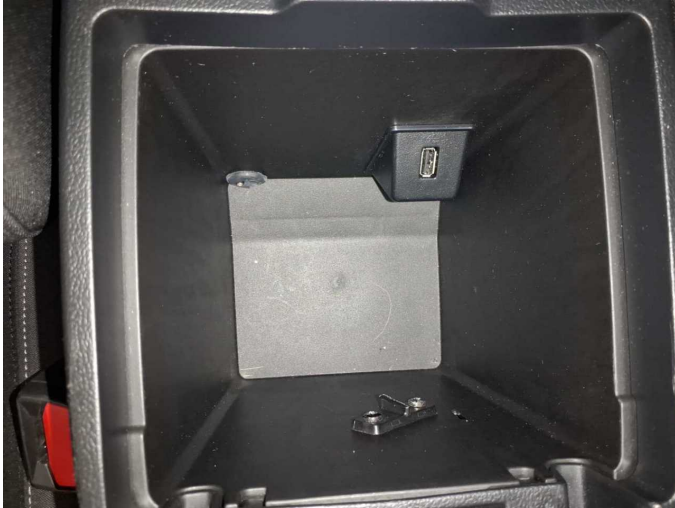
Damage 2: Interior: Arm rest, front (Deckel, Fehlbohrungen) - Differs from the original configuration - Replace

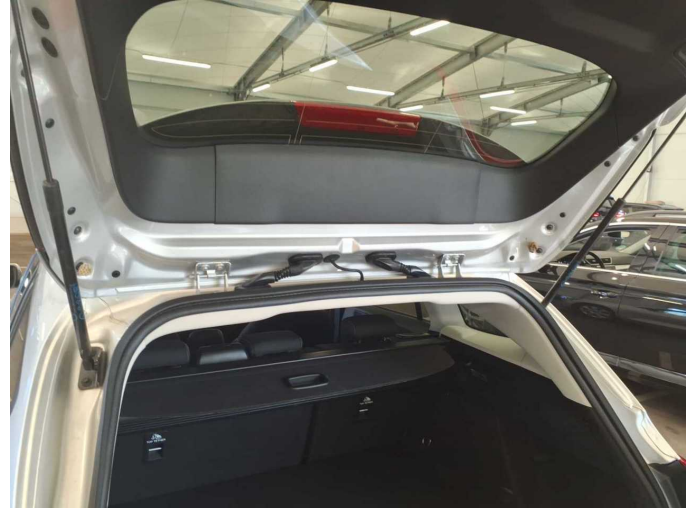
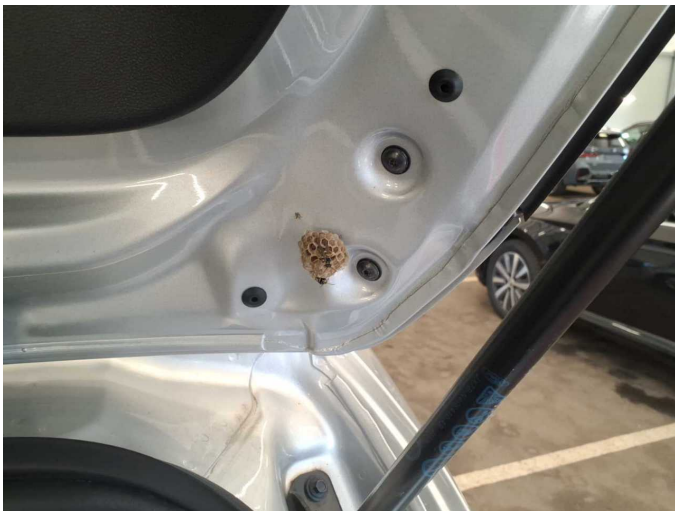
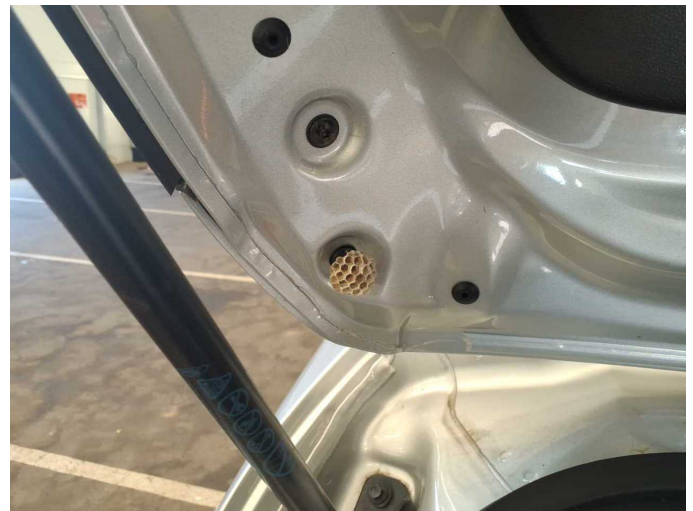
Damage 3: Boot lid / rear door: Boot lid (Wespennest, innenliegend) - Remove

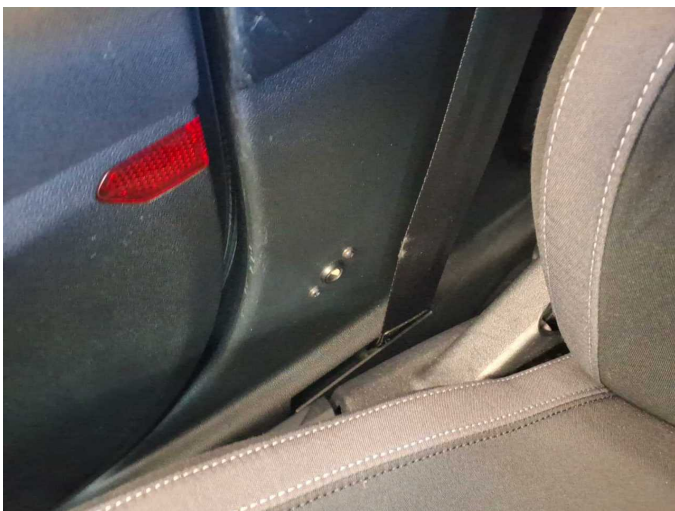
Damage 4: Trim / covers: B-pillar - trim - interior, right side (Fehlbohrungen) - Differs from the original configuration - Replace

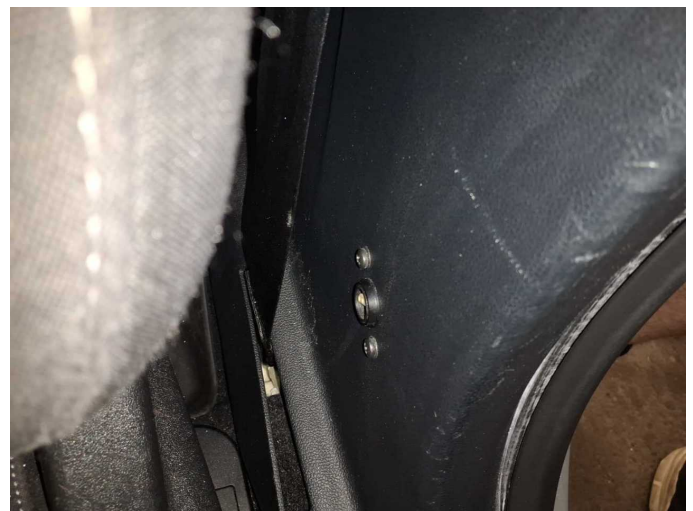
Damage 5: Trim / covers: B-pillar - trim - interior, left side (Fehlbohrungen) - Differs from the original configuration - Replace

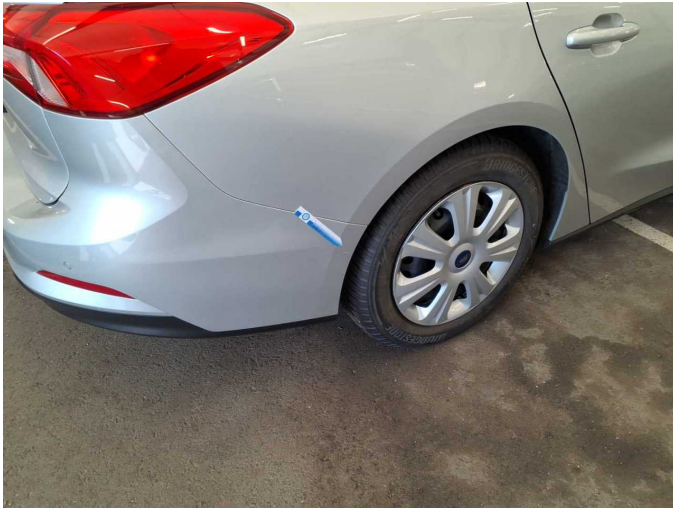
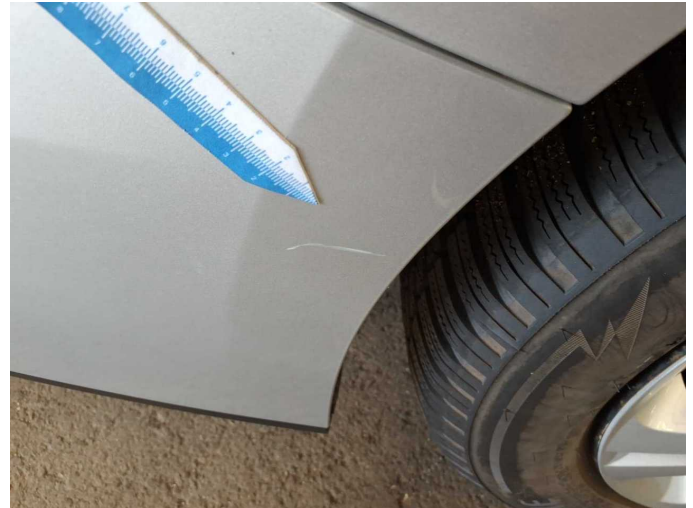
Damage 6: Rear bumper: Rear bumper - Scratched - Smart repair

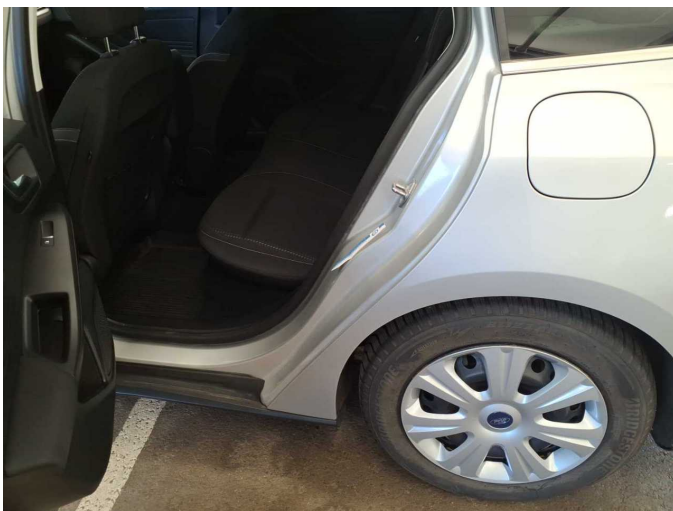
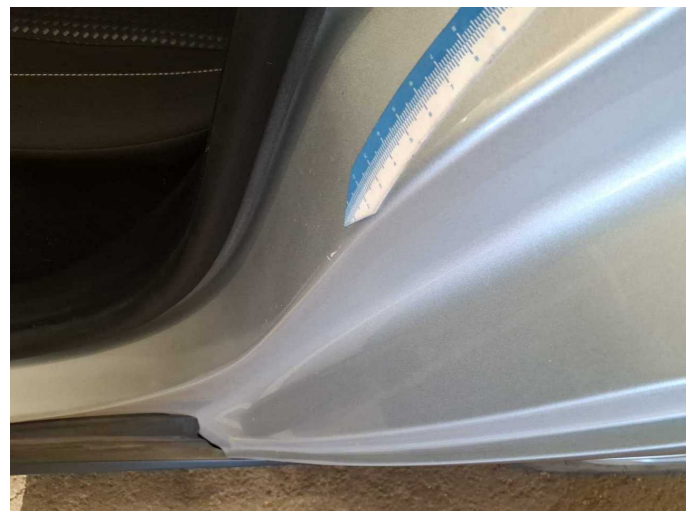
Damage 7: Side panel - rear left side: Sill - Scratched - Smart repair

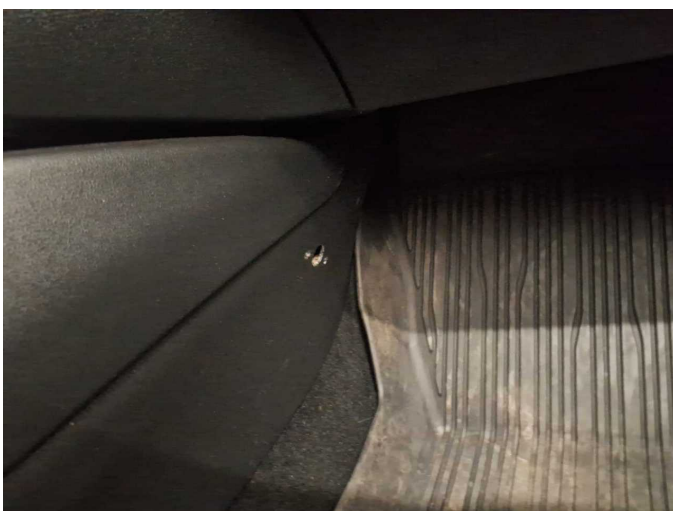
Damage 8: Instrument panel: Centre console - front (Blende rechts, Fehlbohrungen) - Differs from the original configuration - Replace

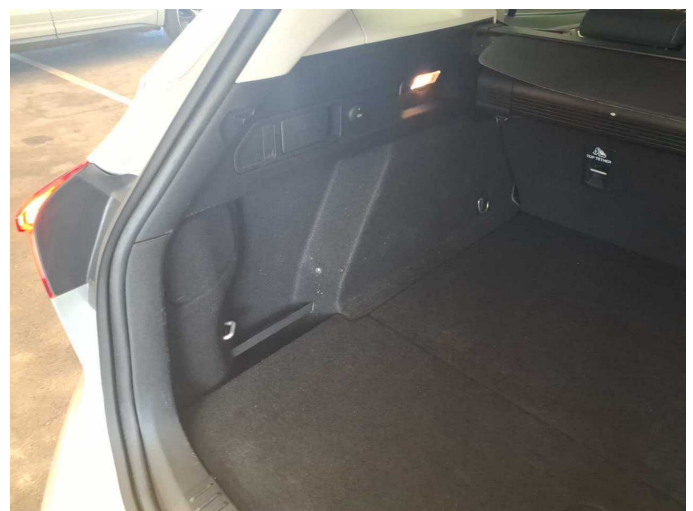
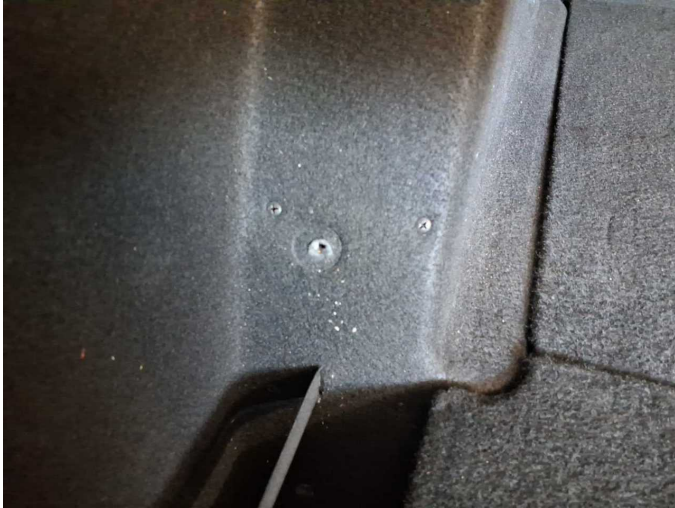
Damage 9: Trim / covers: Cargo area - lining -left side (Fehlbohrungen) - Differs from the original configuration - Replace

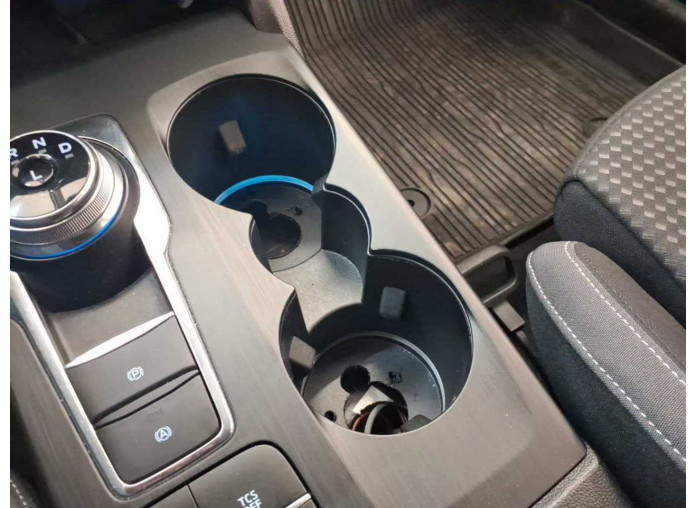
Damage 10: Instrument panel: Centre console - front (Getränkhalter, Fehlbohrungen) - Differs from the original configuration - Replace

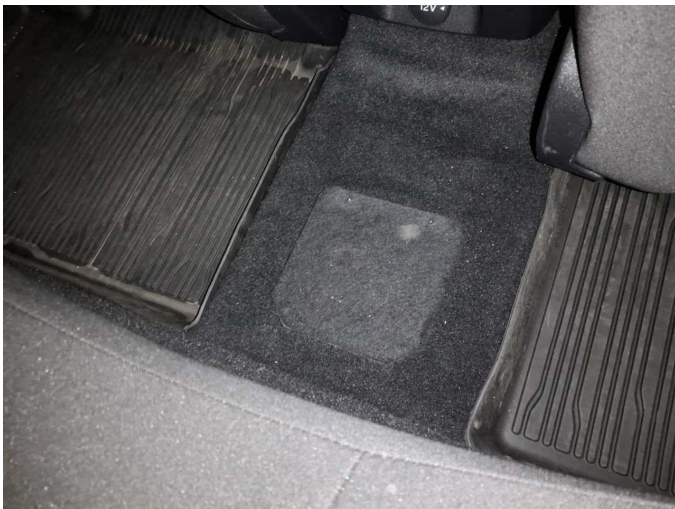
Damage 11: Trim / covers: Carpet - Differs from the original configuration - Replace
