Expertise

Protocol number: 46017412
Order No. / Reference: 26453358
Inspection date: 17 Jun 2026

Model: Vito 114 CDI Kompakt HA Aut. BASE

VIN: W1V44760114167118

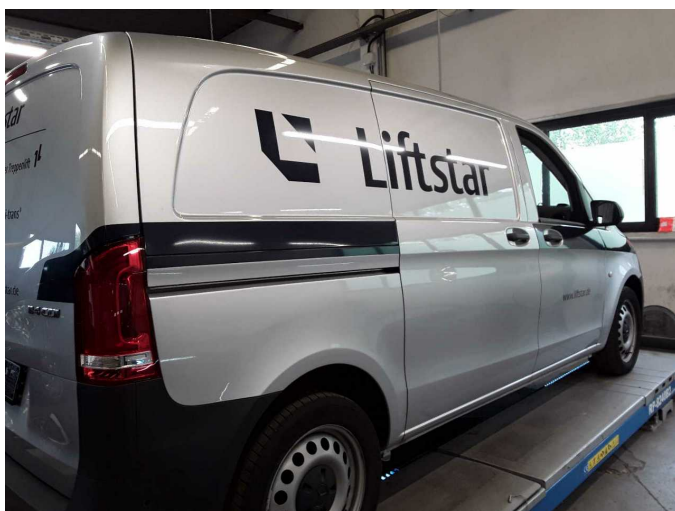
No.	Component group	Description
1	Misc.	Inspection / maintenance - No evidence - No deduction
2	Body	Body - Glued / labelled - De-glue / neutralise
3	Door - rear right side	Door - Scratch(es) - Paint
4	Vehicle glazing	Windscreen (Rissbildung) - Stone chips - Replace

Damage 2: Body: Body - Glued / labelled - De-glue / neutralise

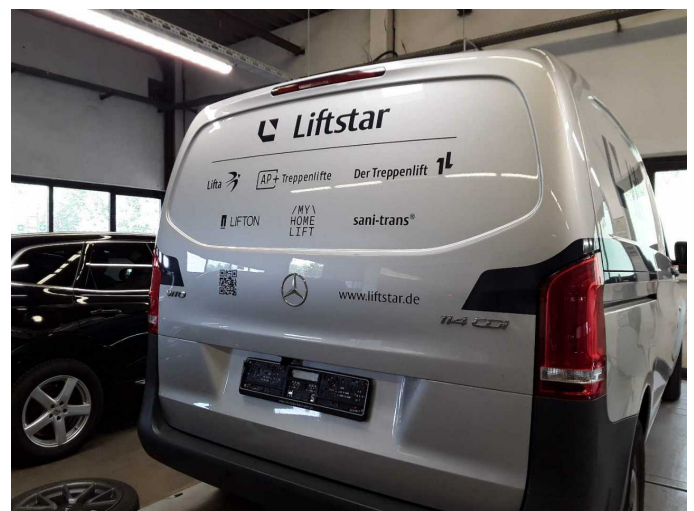
Damage 2: Body: Body - Glued / labelled - De-glue / neutralise

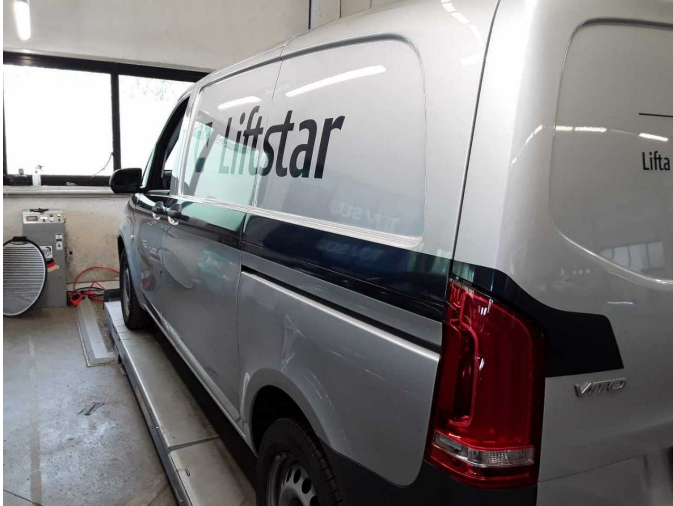
Damage 2: Body: Body - Glued / labelled - De-glue / neutralise

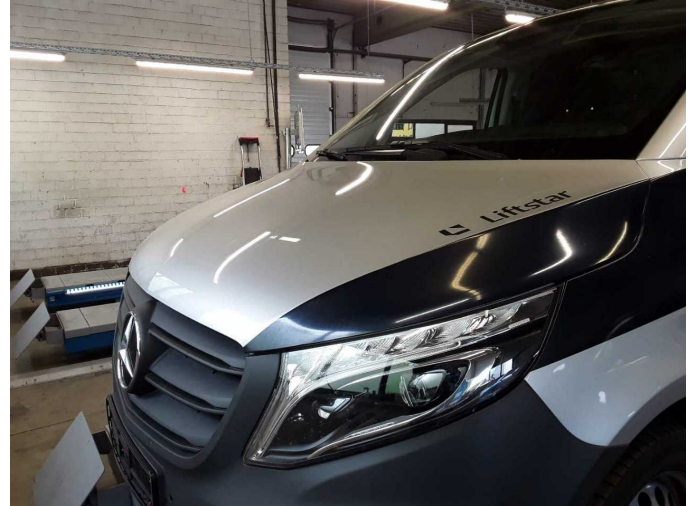
Damage 2: Body: Body - Glued / labelled - De-glue / neutralise

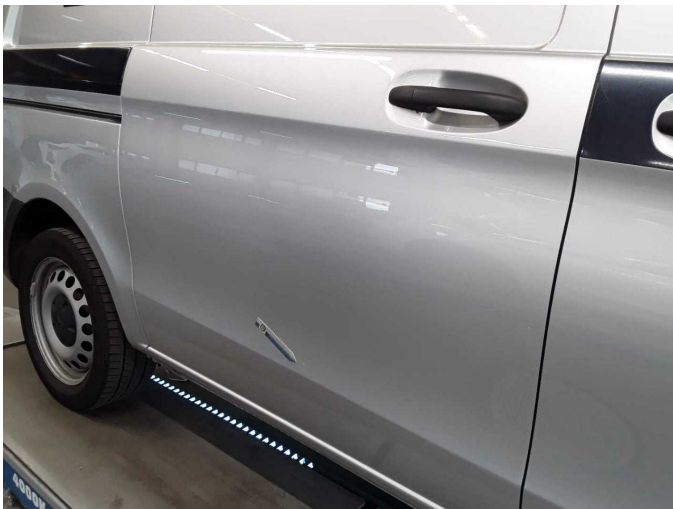
Damage 3: Door - rear right side: Door - Scratch(es) - Paint

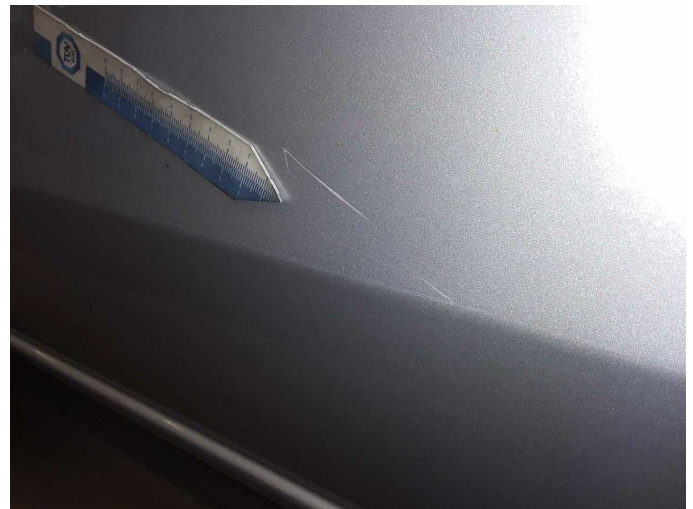
Damage 3: Door - rear right side: Door - Scratch(es) - Paint

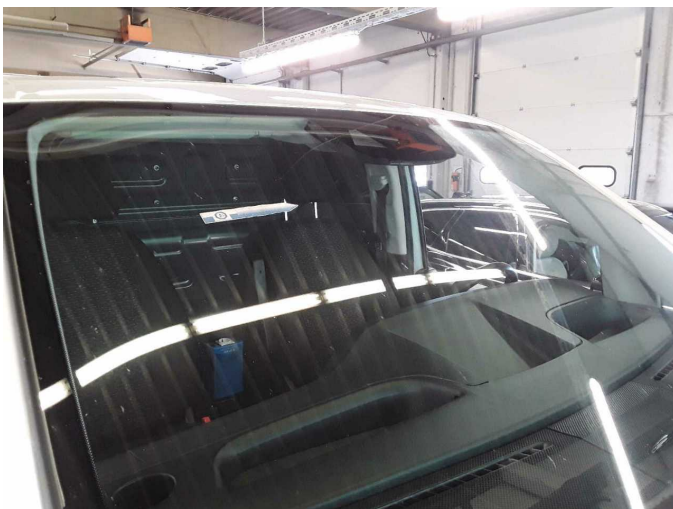
Damage 4: Vehicle glazing: Windscreen (Rissbildung) - Stone chips - Replace

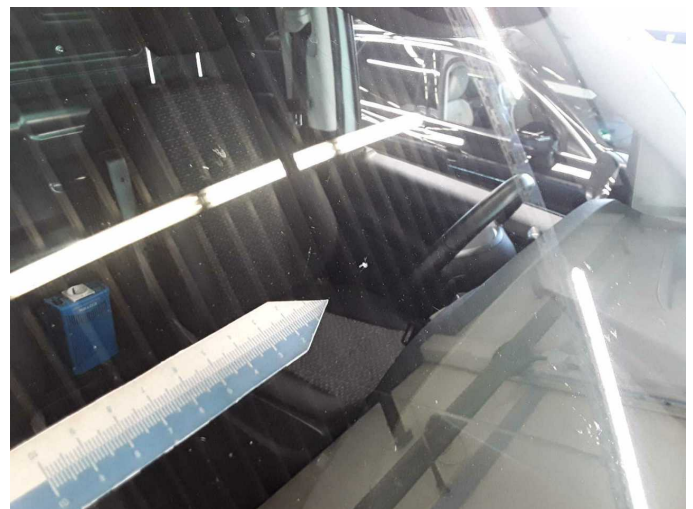
Damage 4: Vehicle glazing: Windscreen (Rissbildung) - Stone chips - Replace

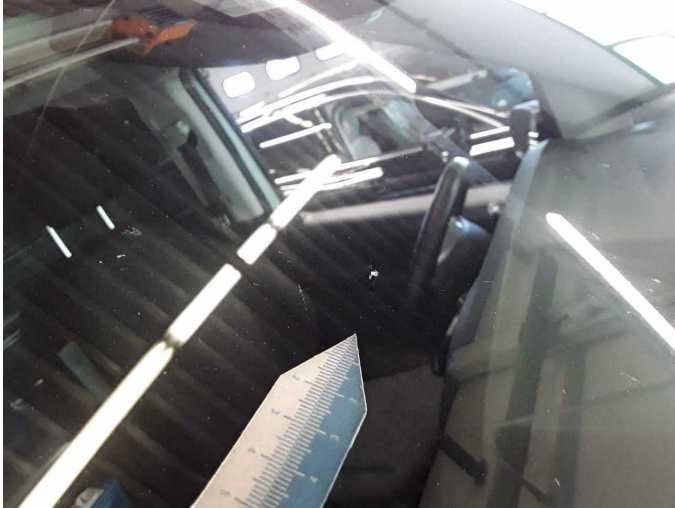
Damage 4: Vehicle glazing: Windscreen (Rissbildung) - Stone chips - Replace

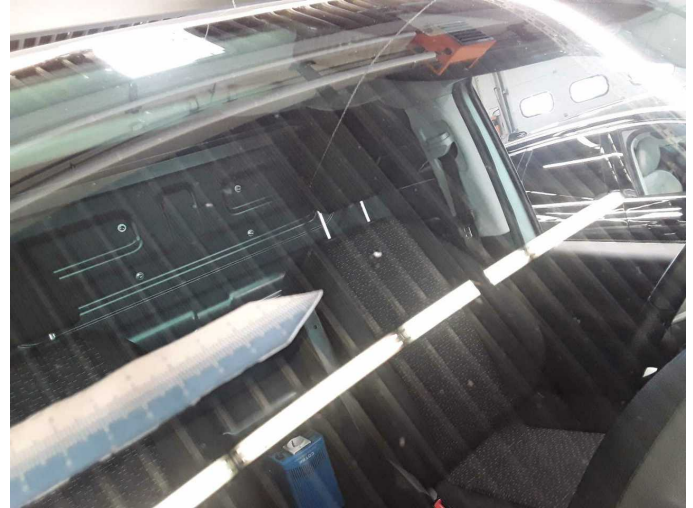
Damage 4: Vehicle glazing: Windscreen (Rissbildung) - Stone chips - Replace

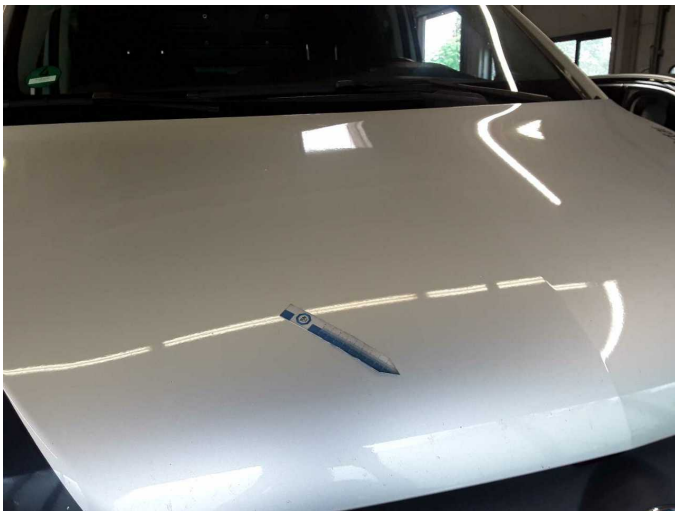
No.	Component group	Description
1	Bonnet	Bonnet - Stone chips - No deduction
2	Interior	Interior - Scratch(es) - No deduction

Wear and tear 1: Bonnet: Bonnet - Stone chips - No deduction

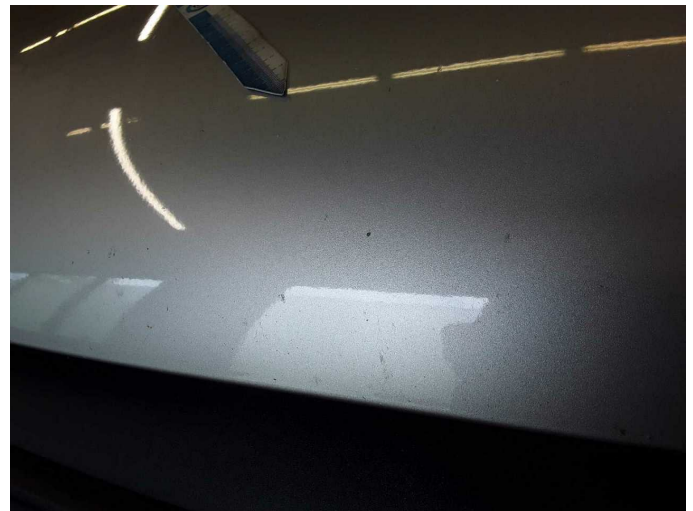
Wear and tear 1: Bonnet: Bonnet - Stone chips - No deduction

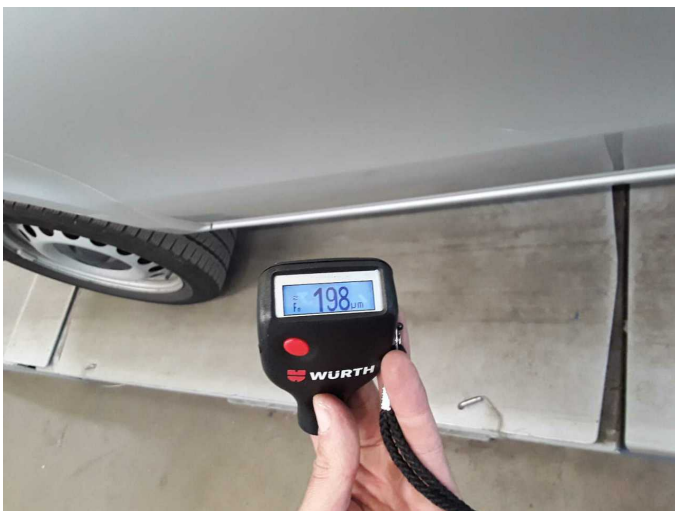
1 Side panel - rear right side, Door - rear right side, Professionally carried out, Invoice of repair done Non-existent

Side panel - rear right side	247 µm	Door - rear right side	198 µm
------------------------------	--------	------------------------	--------

Repainting 1: Side panel - rear right side, Door - rear right side

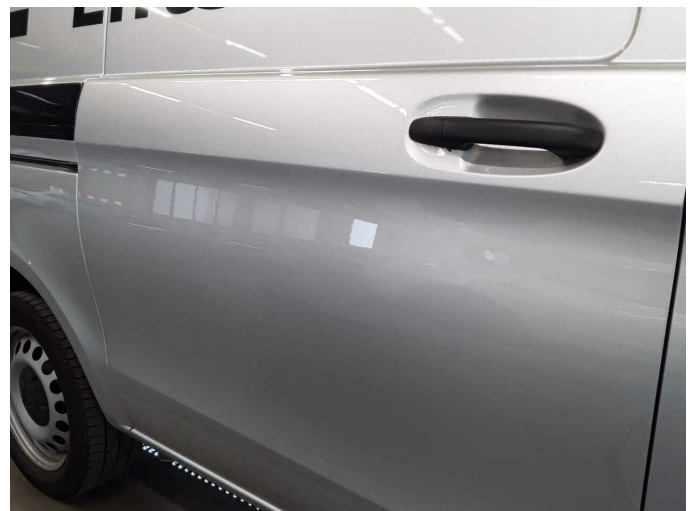
Repainting 1: Side panel - rear right side, Door - rear right side

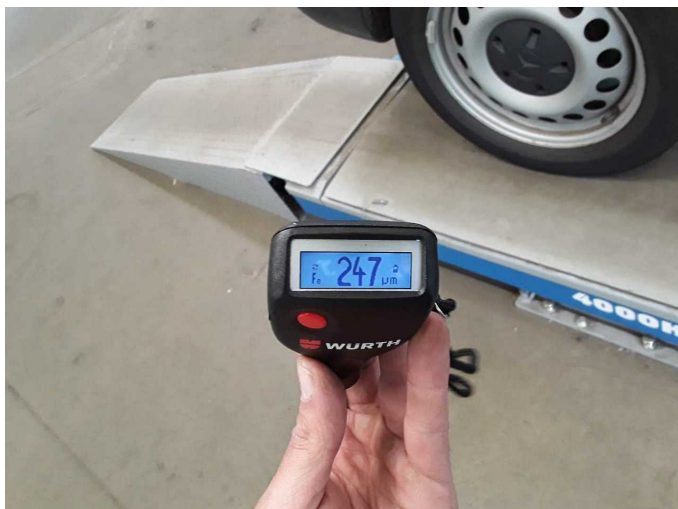
Repainting 1: Side panel - rear right side, Door - rear right side

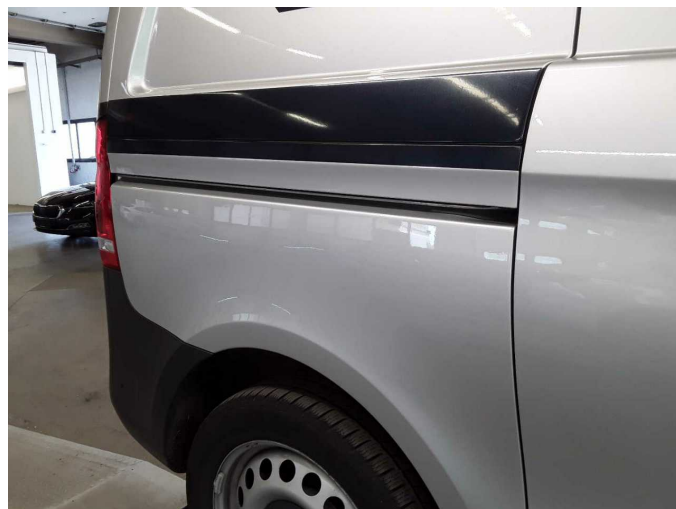
Repainting 1: Side panel - rear right side, Door - rear right side
