Expertise

Protocol number: 45586391
Order No. / Reference: 26344172
Inspection date: 21 May 2026

Model: Passat Variant 2.0 TDI SCR DSG Business

VIN: WVVZZZ3CZPE036517

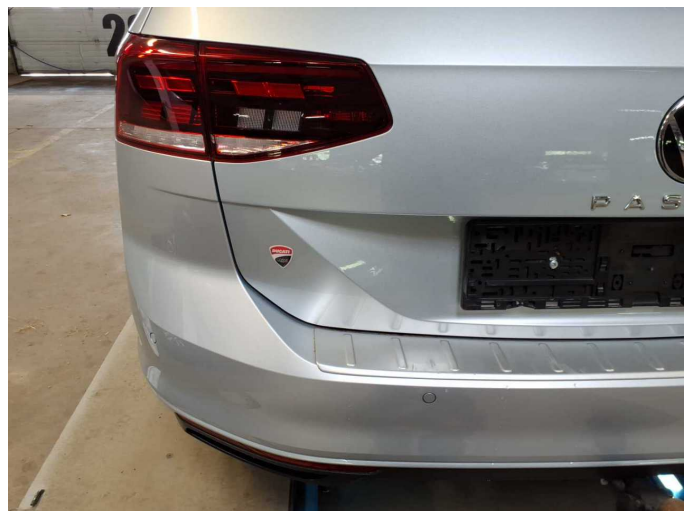
Damage 1: Boot lid / rear door: Boot lid - Glued / labelled - De-glue / neutralise

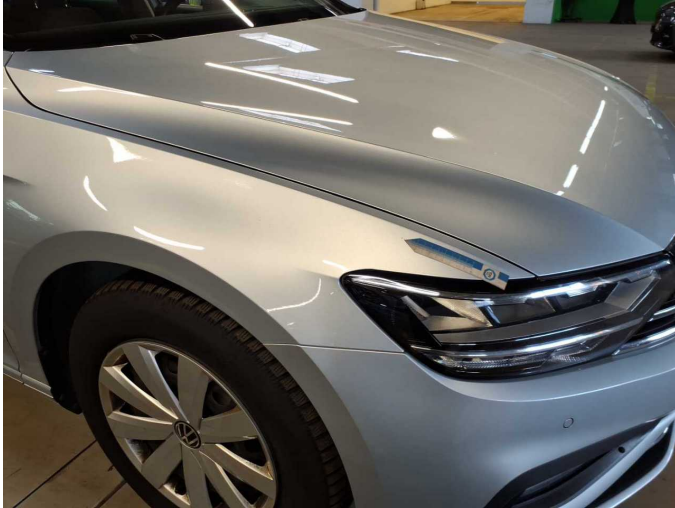
Damage 2: Mudguard - right side: Mudguard - right side - Stone chips - Smart repair

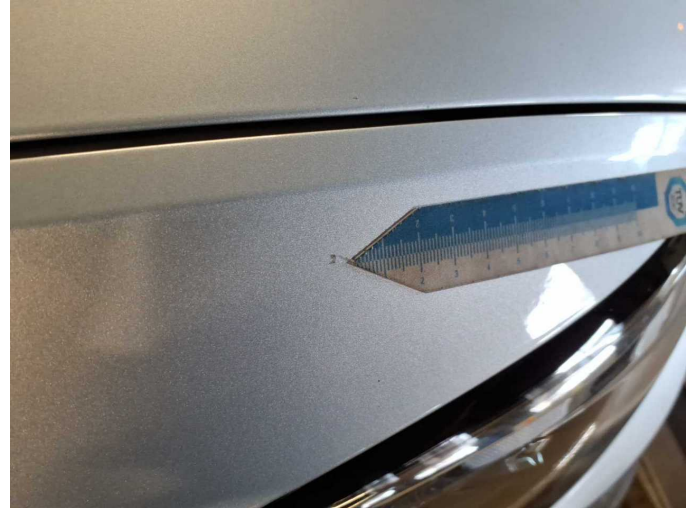
Damage 2: Mudguard - right side: Mudguard - right side - Stone chips - Smart repair

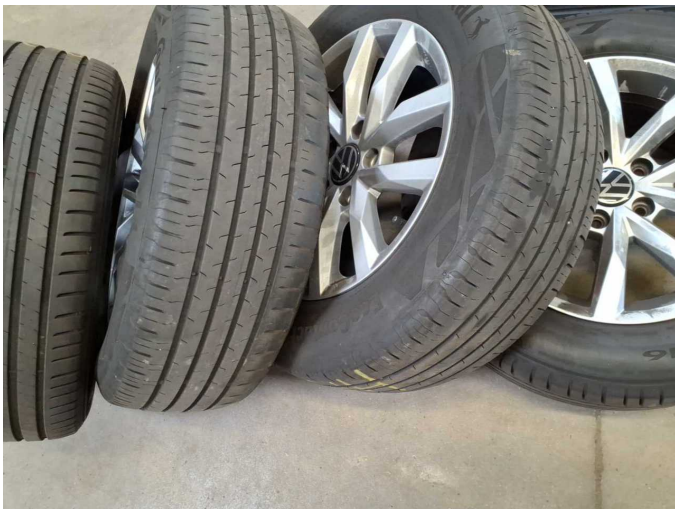
Damage 3: Wheel / tyres: Tyre - right (einseitig abgefahren) - Does not meet the leasing specifications - Replace

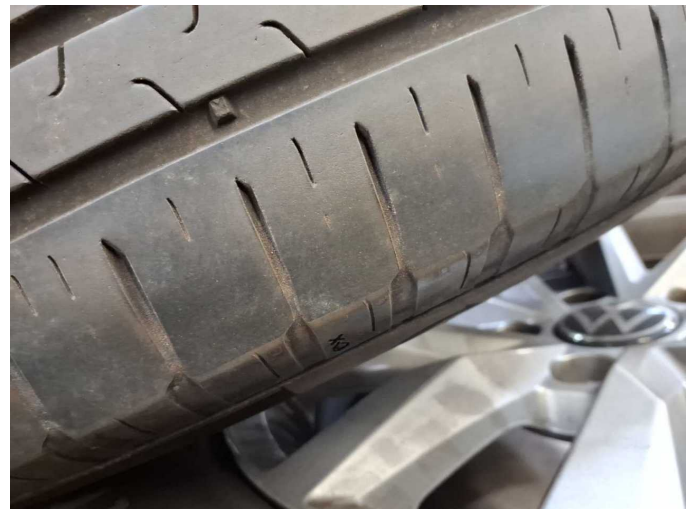
Damage 3: Wheel / tyres: Tyre - right (einseitig abgefahren) - Does not meet the leasing specifications - Replace

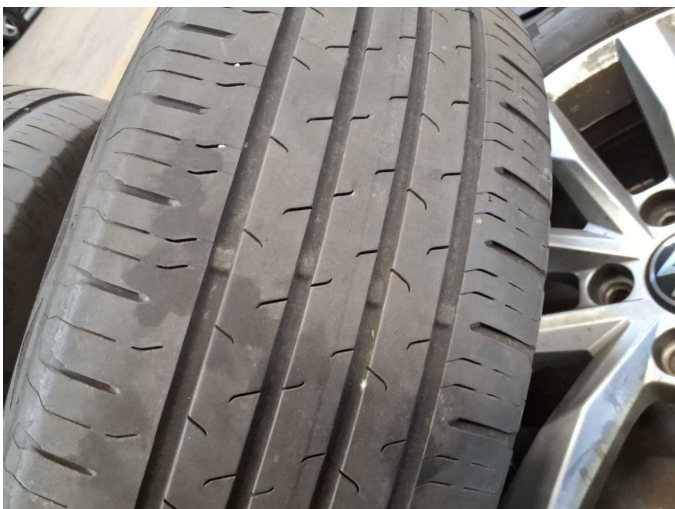
Damage 3: Wheel / tyres: Tyre - right (einseitig abgefahren) - Does not meet the leasing specifications - Replace

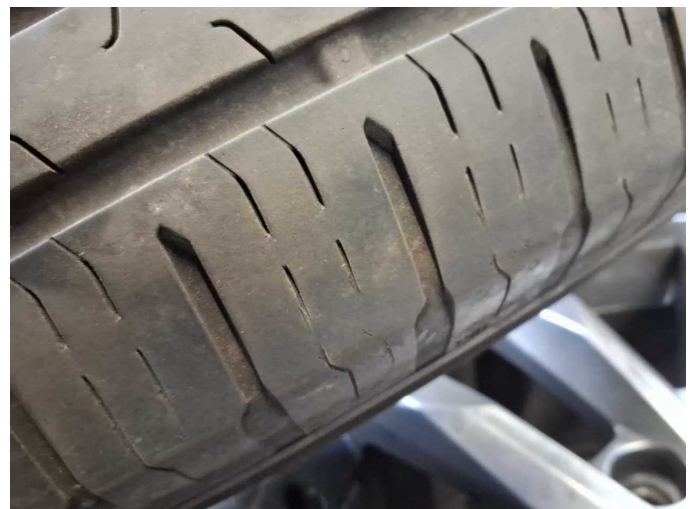
Damage 3: Wheel / tyres: Tyre - right (einseitig abgefahren) - Does not meet the leasing specifications - Replace

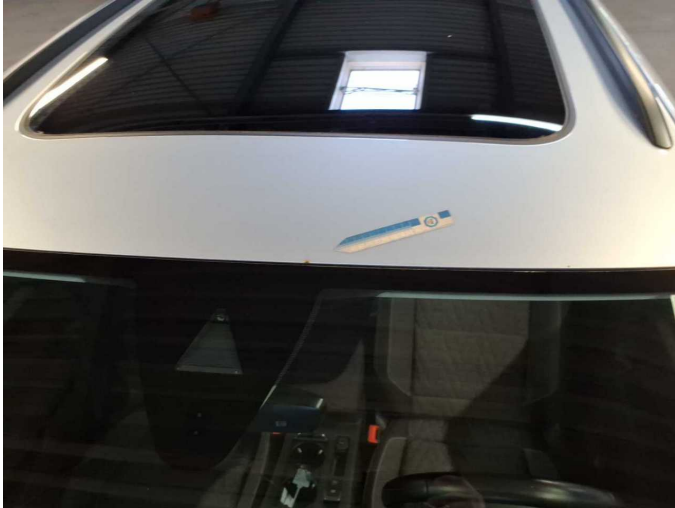
Damage 4: Roof: Roof - Corrosion - Smart repair

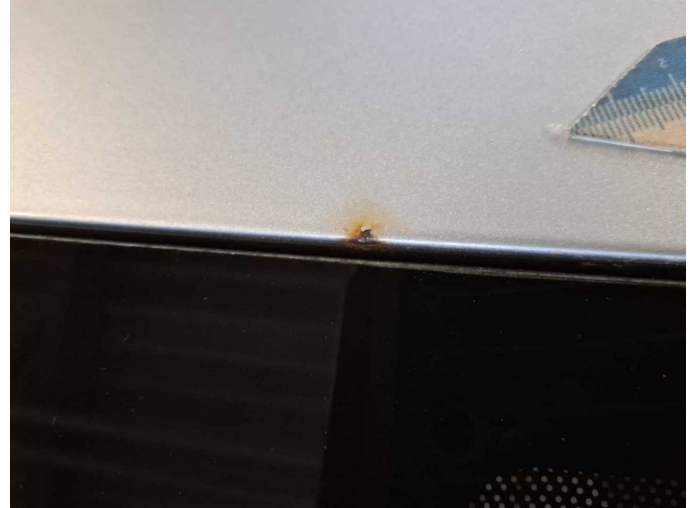
Damage 4: Roof: Roof - Corrosion - Smart repair

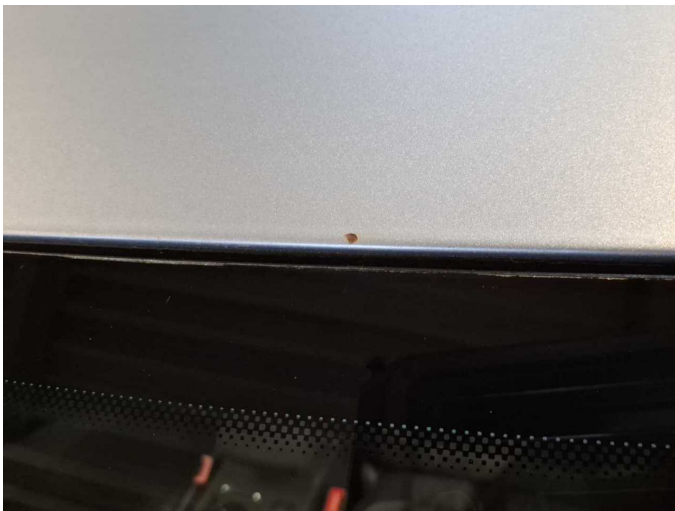
Damage 4: Roof: Roof - Corrosion - Smart repair

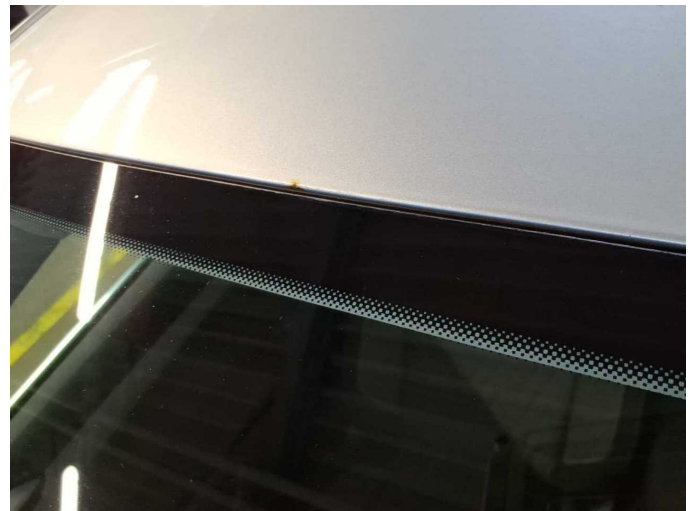
Damage 4: Roof: Roof - Corrosion - Smart repair

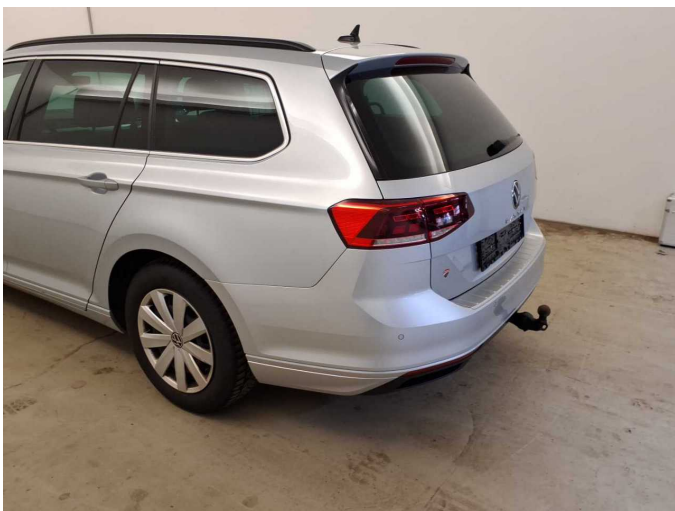
Damage 5: Rear bumper: Rear bumper (Farb unterschied) - Unprofessionally repaired - Paint

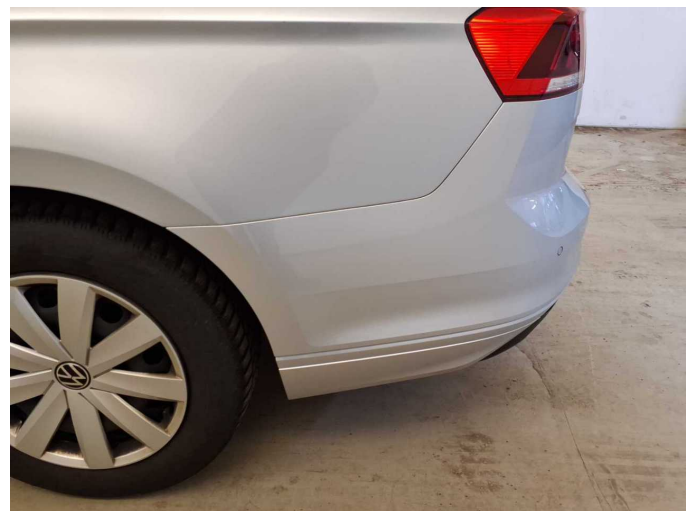
Damage 5: Rear bumper: Rear bumper (Farb unterschied) - Unprofessionally repaired - Paint

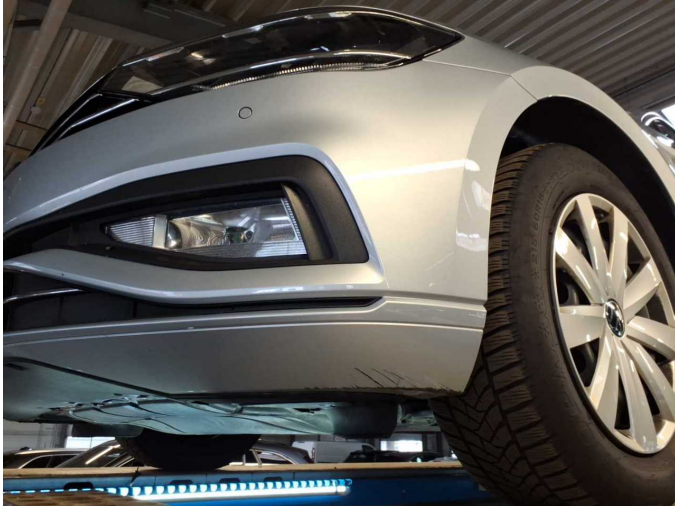
Damage 6: Front bumper: Front bumper - Scratched - Paint

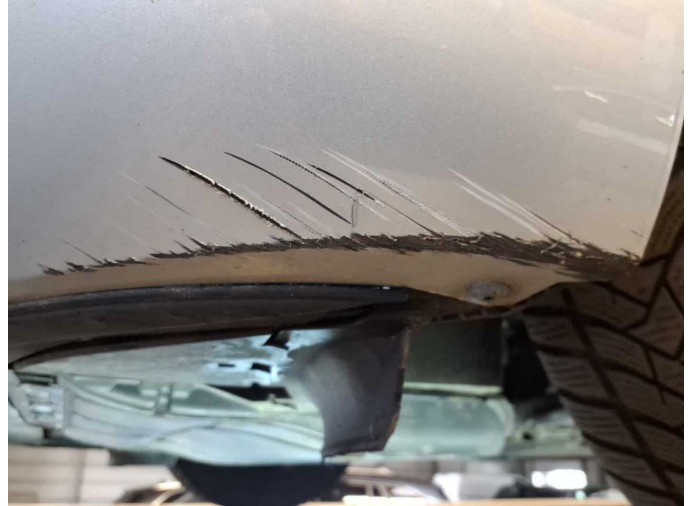
Damage 6: Front bumper: Front bumper - Scratched - Paint

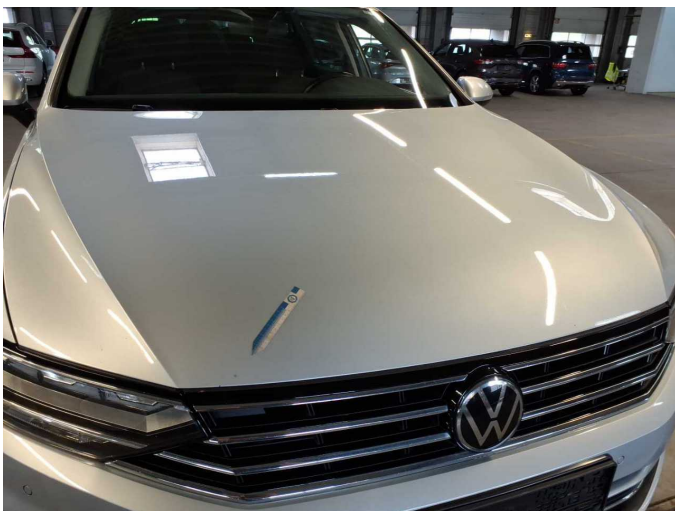
Damage 7: Bonnet: Bonnet - Stone chips - Paint

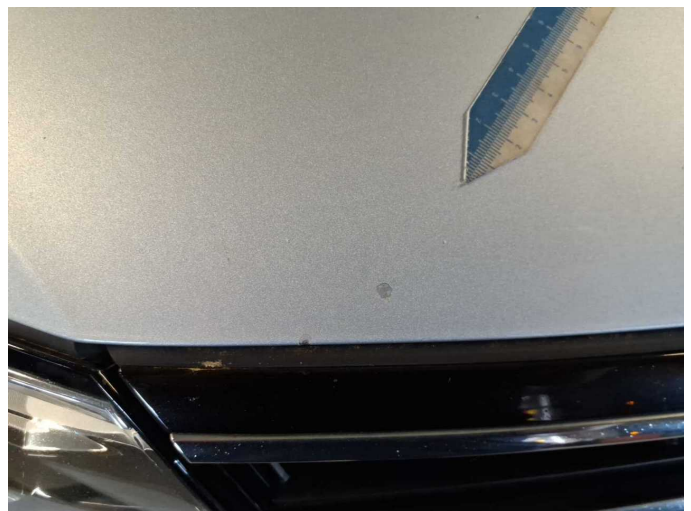
Damage 7: Bonnet: Bonnet - Stone chips - Paint

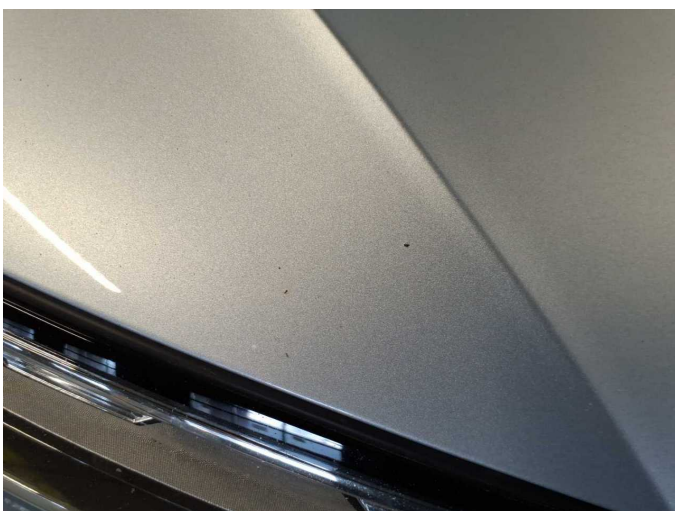
Damage 7: Bonnet: Bonnet - Stone chips - Paint

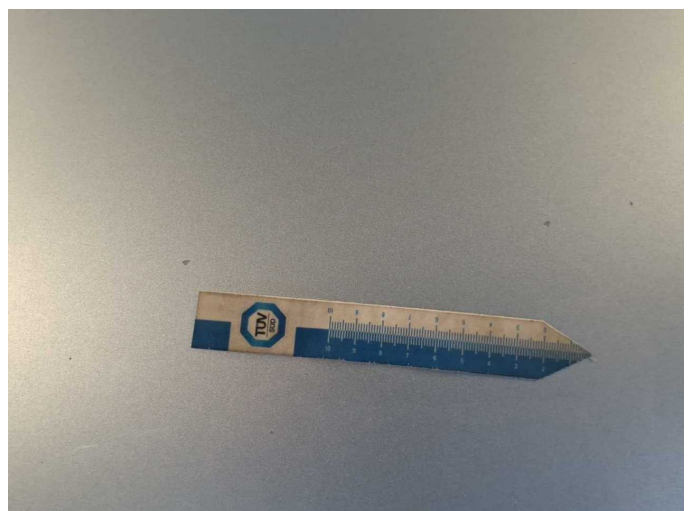
Damage 7: Bonnet: Bonnet - Stone chips - Paint

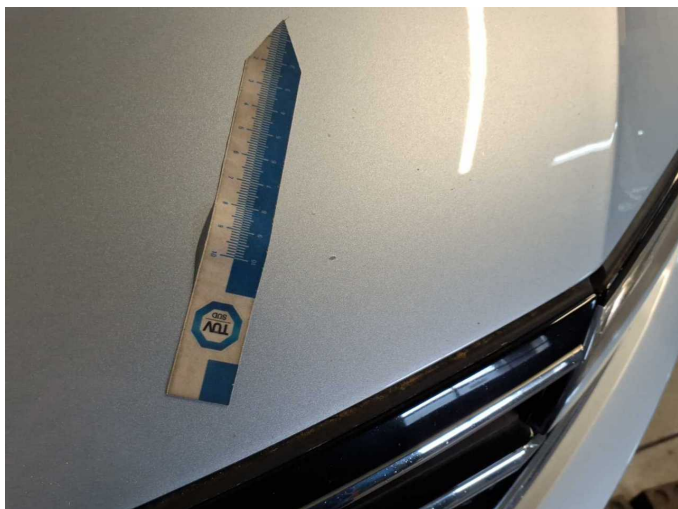
Damage 7: Bonnet: Bonnet - Stone chips - Paint

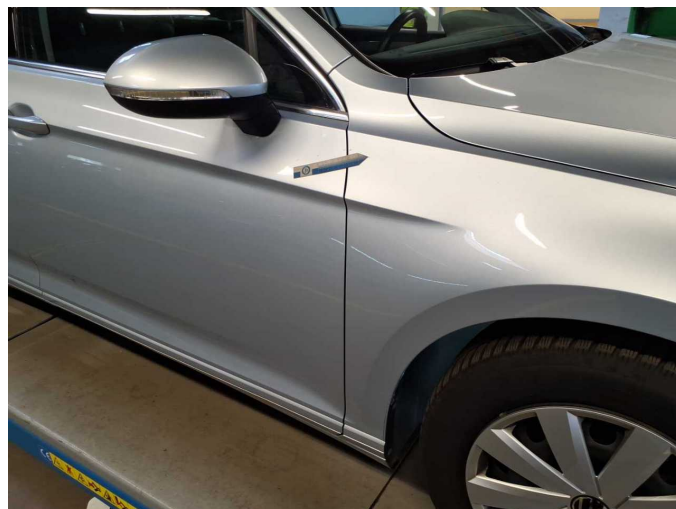
Der kalkulierte Unfall wurde nach bestem Wissen und Gewissen unter eingeschränkten Besichtigungsbedingung im demontagefreien Zustand erstellt. Es können aufgrund verdeckter Beschädigung, Mehrkosten und somit Abweichung der für den Unfall ausgewiesenen Reparaturkosten nicht ausgeschlossen werden.

Accident 1: Side right

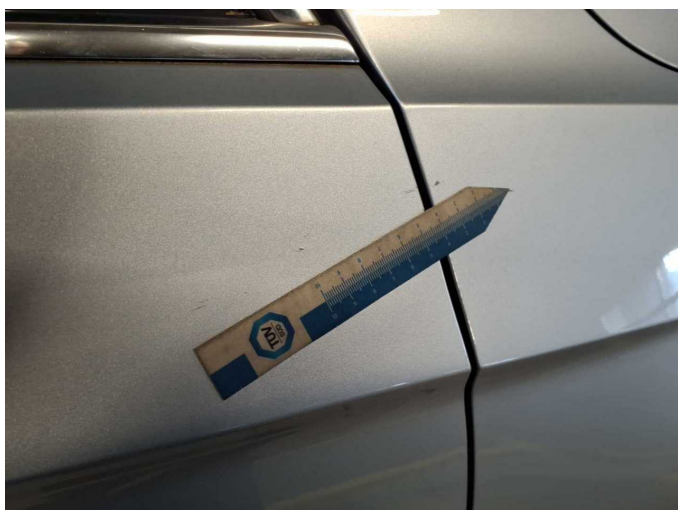
Accident 1: Side right
