Expertise

Protocol number: 45679120
Order No. / Reference: 26317172
Inspection date: 27 May 2026

Manufacturer: Opel

Model: Astra Sports Tourer 1.5 D Automatik Elegance

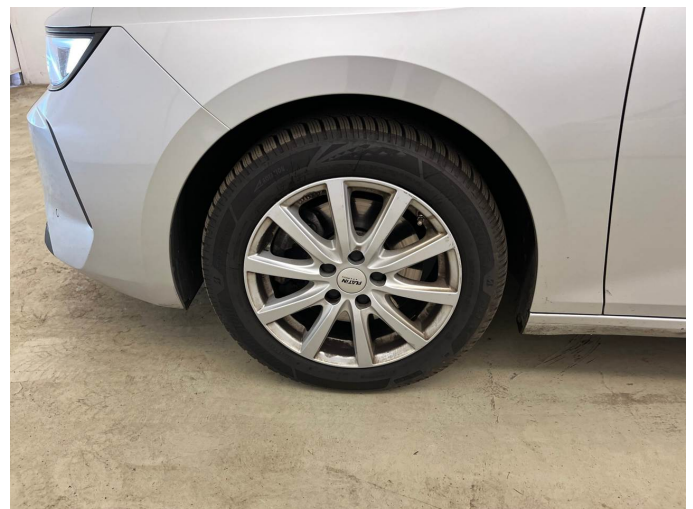
Figure 12: Mounted tyres

#	Tyre size	Type of tyre	Manufacturer	Tread depth
1)	205/55 R16 91H	Winter tyres on Light alloy	Bridgestone	5mm / 5mm
2)	205/55 R16 91H	Winter tyres on Light alloy	Bridgestone	5mm / 5mm

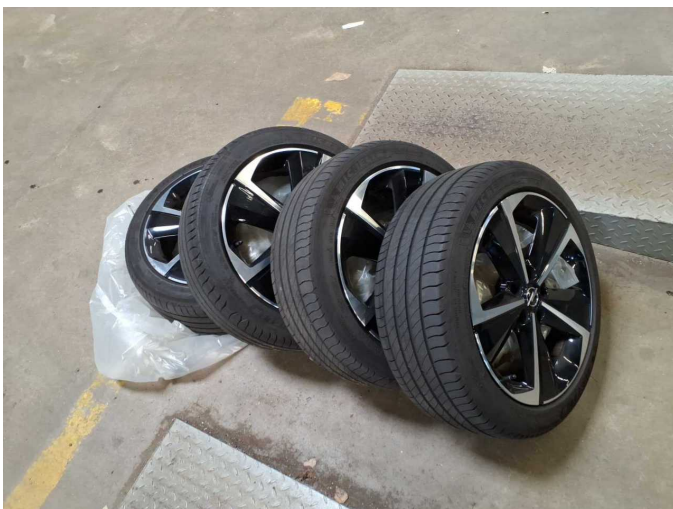
Figure 17: Additional tyres

#	Tyre size	Type of tyre	Manufacturer	Tread depth
1)	225/45 R17 94V	Summer tyres on Light alloy	Michelin	4mm / 4mm
2)	225/45 R17 94V	Summer tyres on Light alloy	Michelin	5mm / 5mm

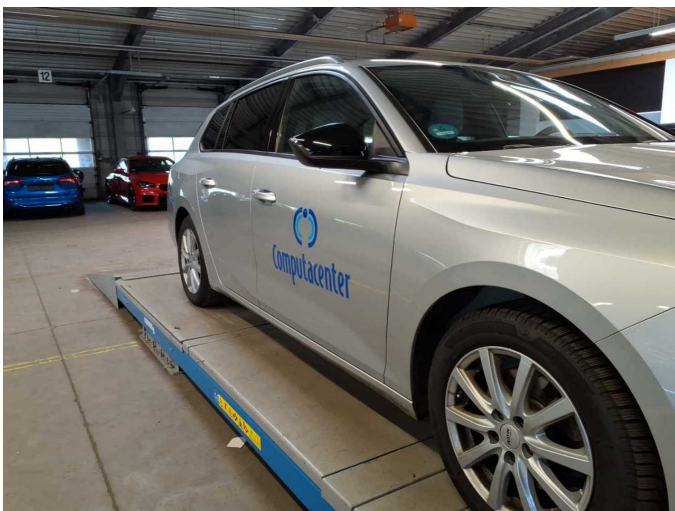
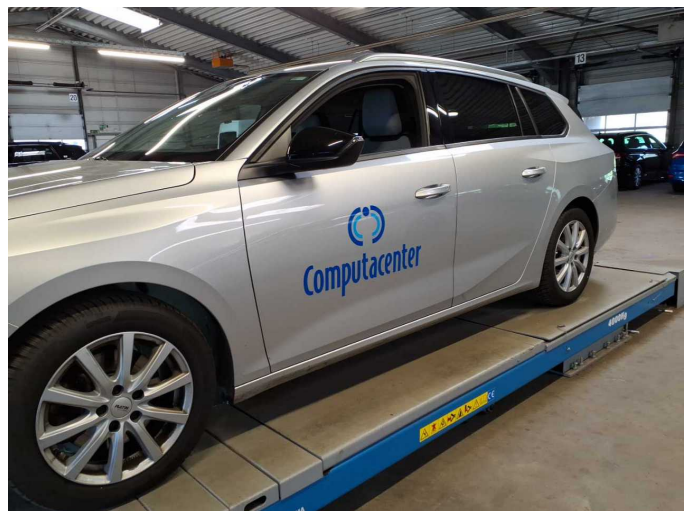
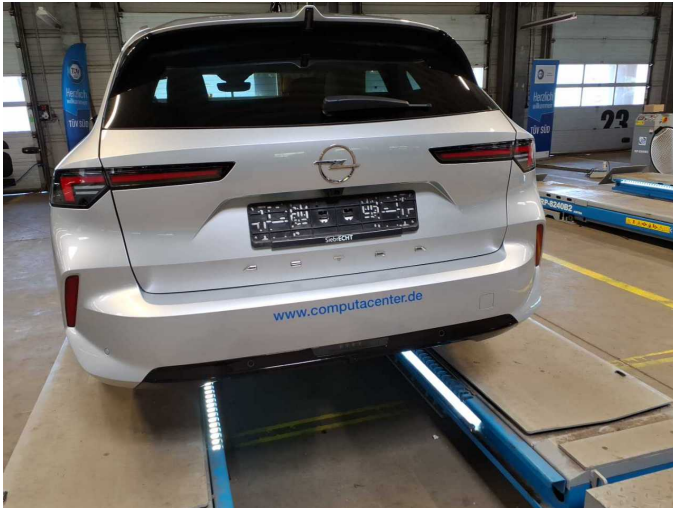
Damage 1: Body: Body - Glued / labelled - De-glue / neutralise

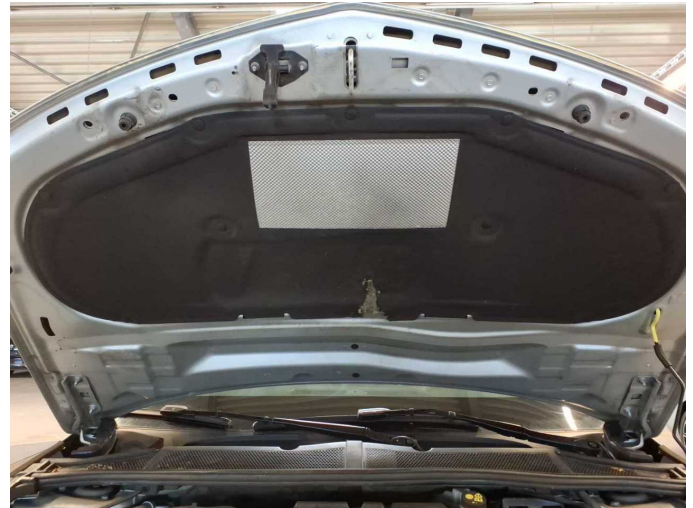
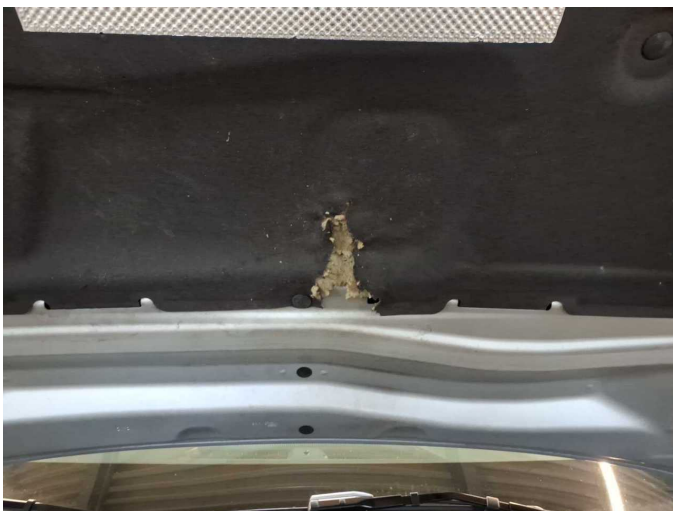
Damage 2: Bonnet: Insulation lining - Damage caused by marten / rodent - Replace

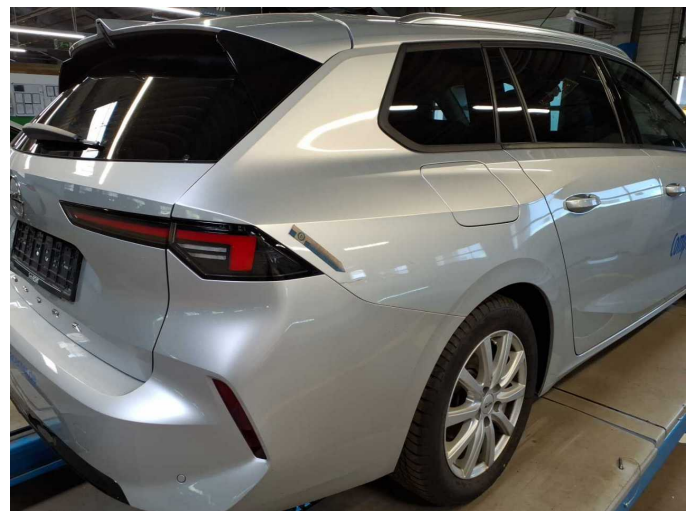
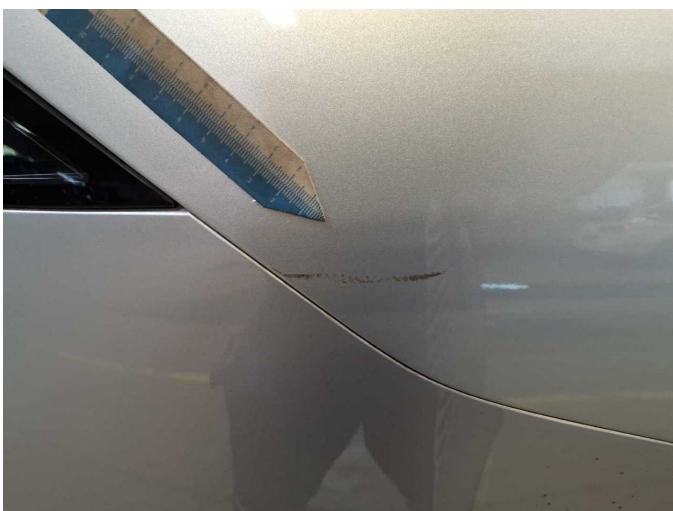
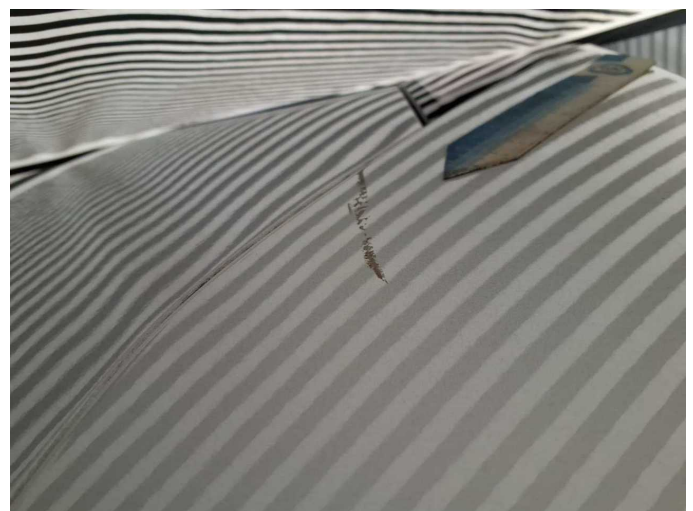
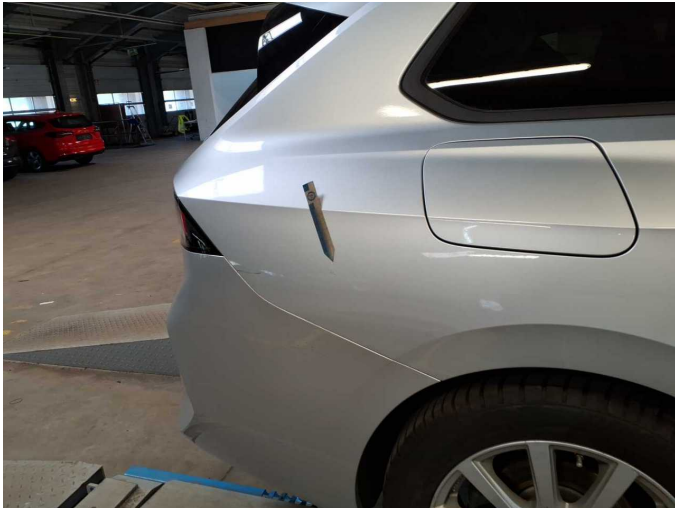
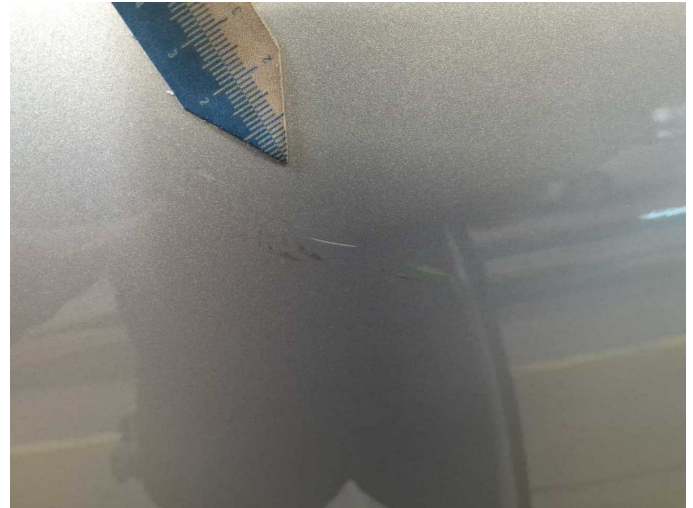
Damage 3: Side panel - rear right side: Side panel - Scratch(es) - Paint

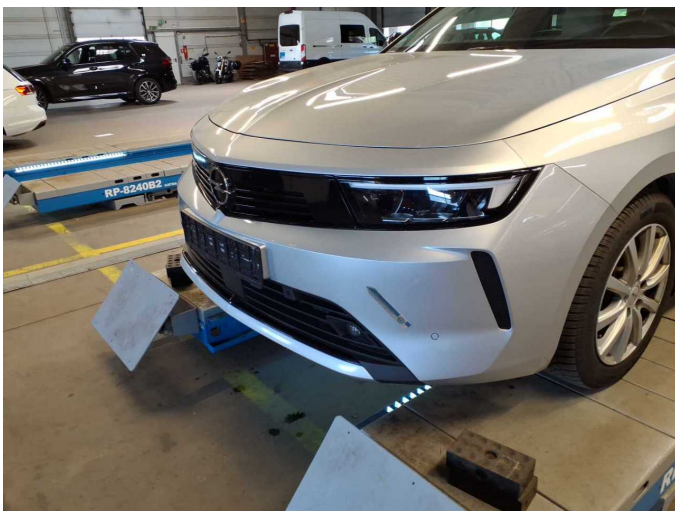
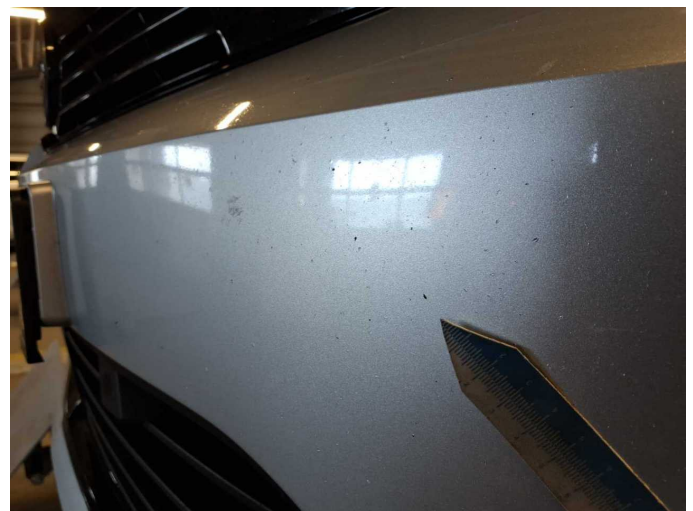
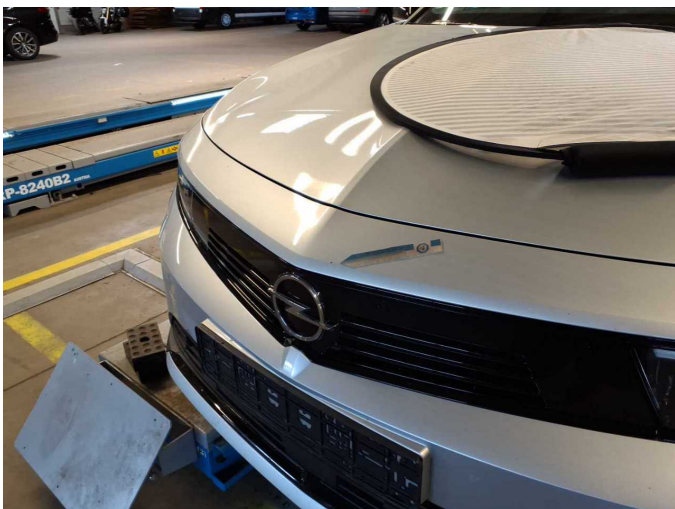
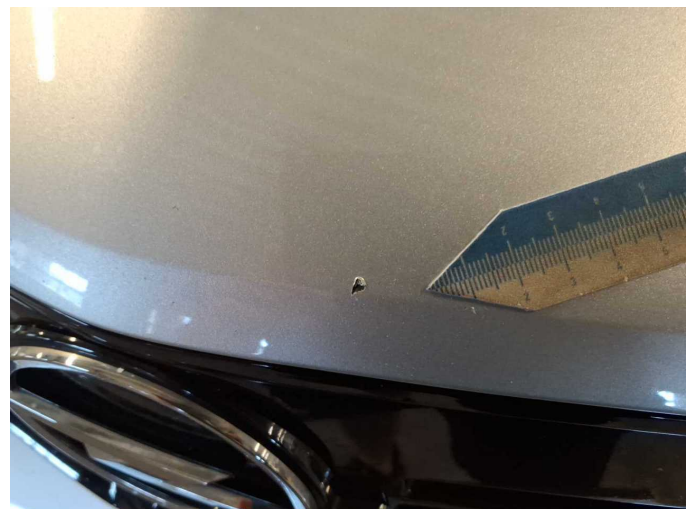
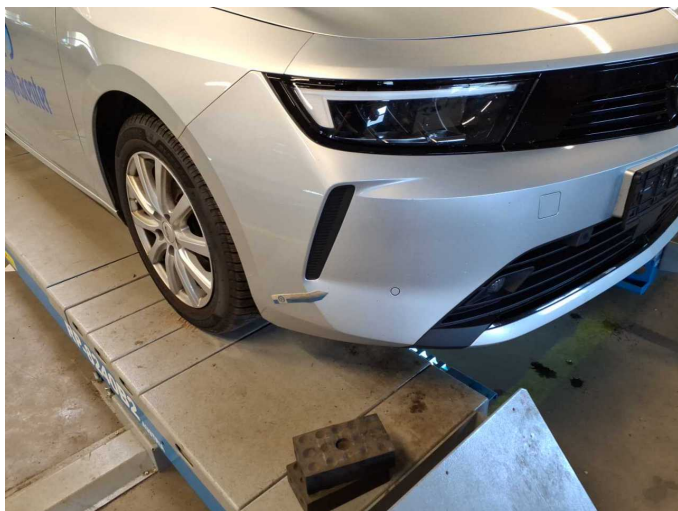
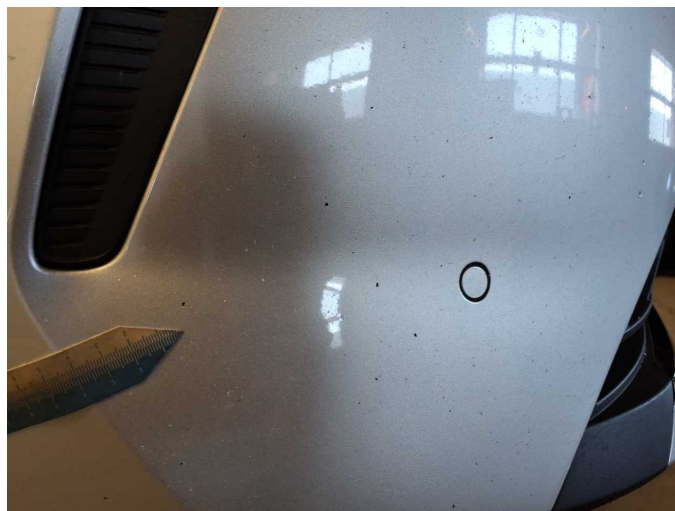
Damage 4: Front bumper: Front bumper (Sandstrahleffekt) - Stone chips - Paint
