Expertise

Protocol number: 46318609
Order No. / Reference: 26612892
Inspection date: 3 Jul 2026

Manufacturer: Opel

Model: Astra 1.5 D Start/Stop Sports Tourer Automatik GS Line

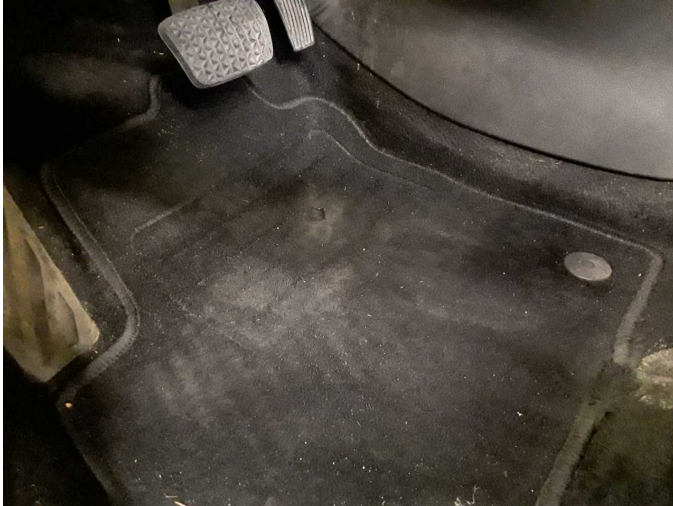
Damage 1: Trim / covers: Floor mats - Damaged - Replace

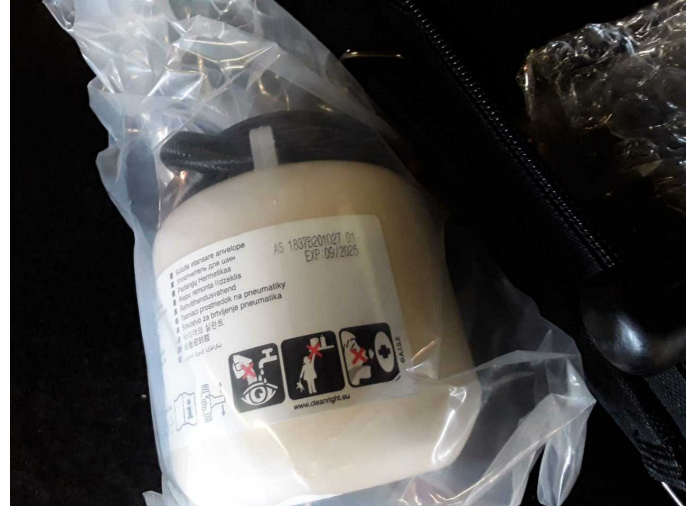
Damage 2: Equipment: Tirefit filler - Expired - Replace

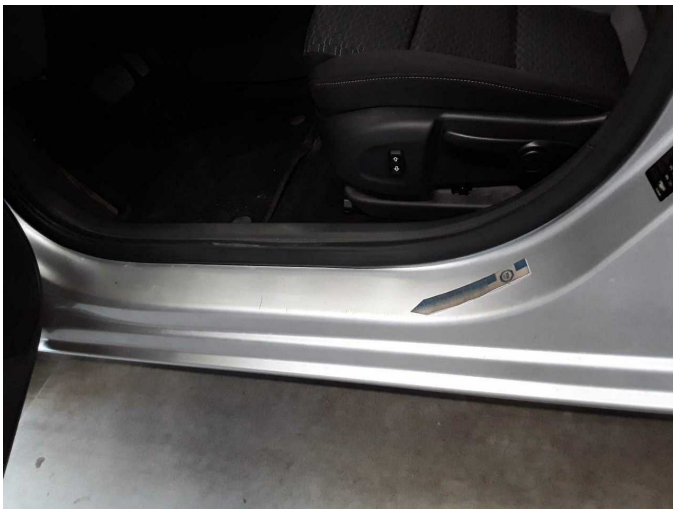
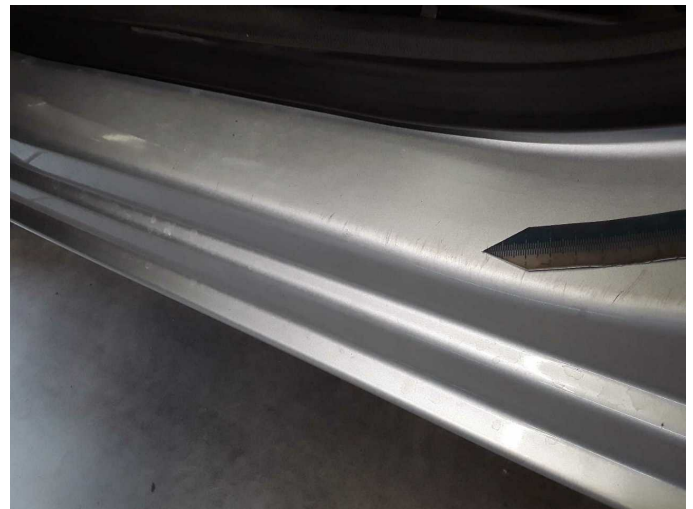
Damage 3: Sill - left side: Sill - Scratch(es) - Smart repair

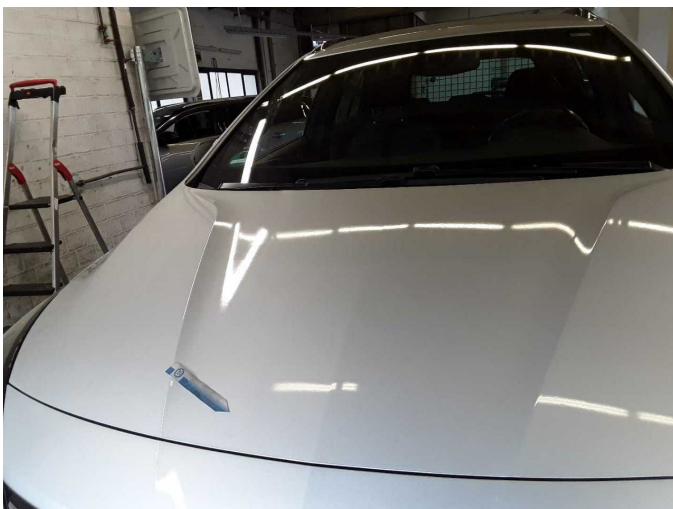
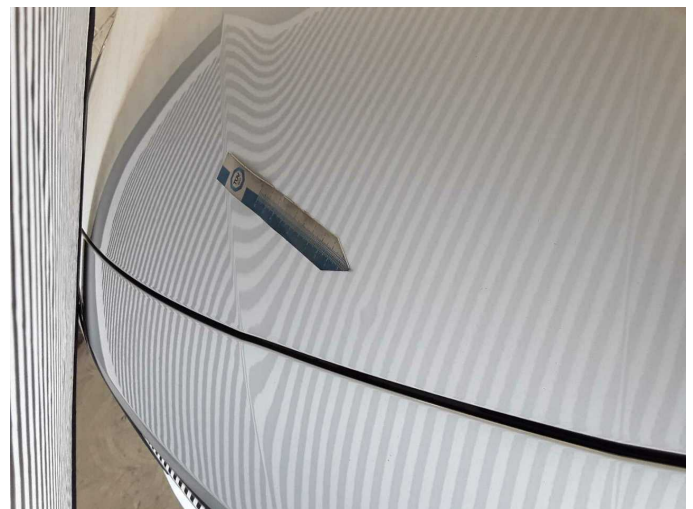
Damage 4: Bonnet: Bonnet - dent(s) - Smooth repair work

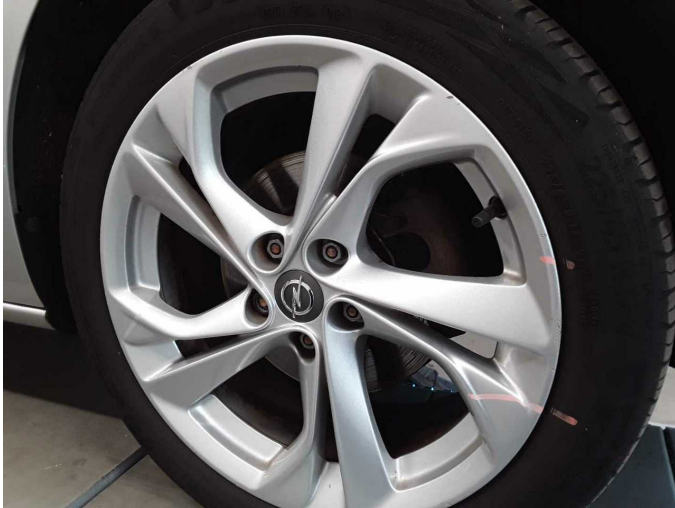
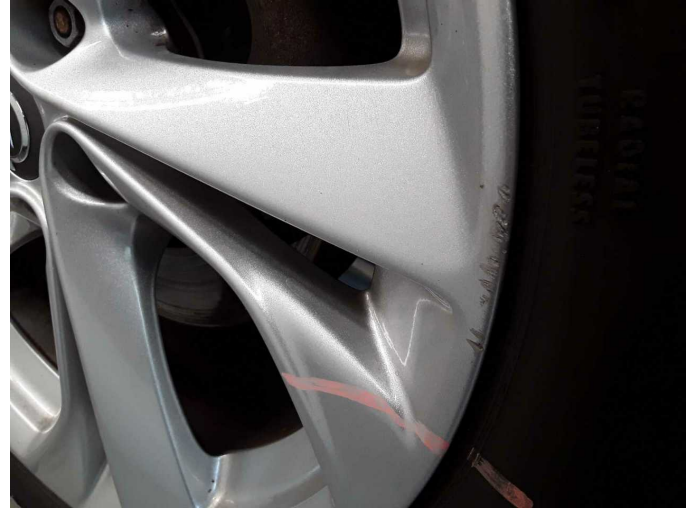
Damage 5: Wheel / tyres: Alloy rim - front right side - Scratch(es) - Loss in value

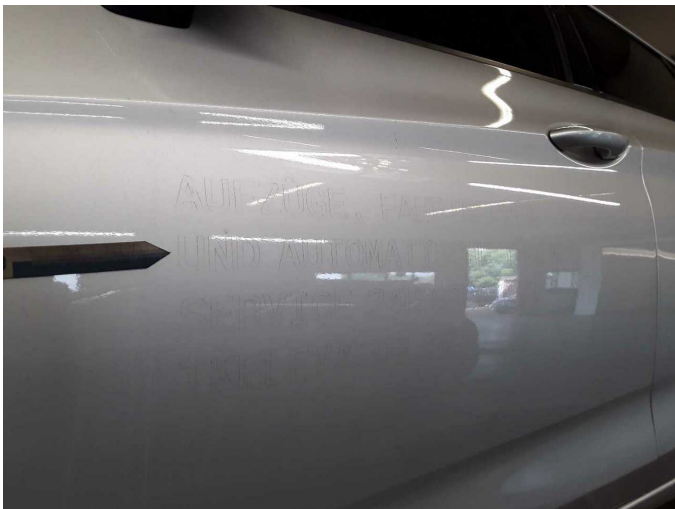
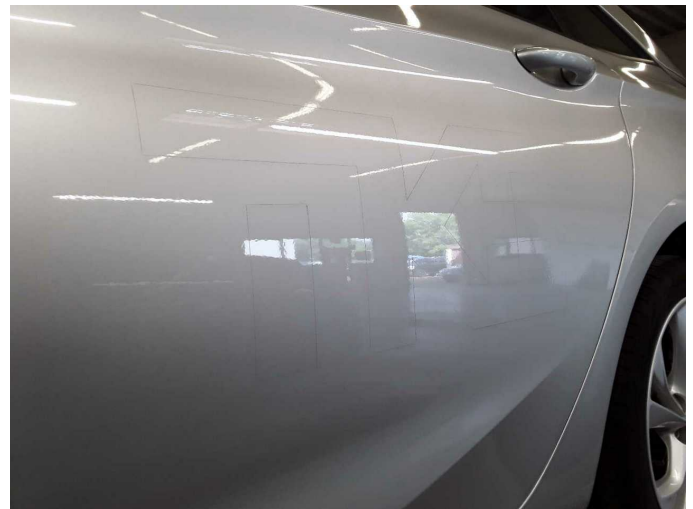
Damage 6: Body: Body (Klebereste) - Glued / labelled - De-glug / neutralise

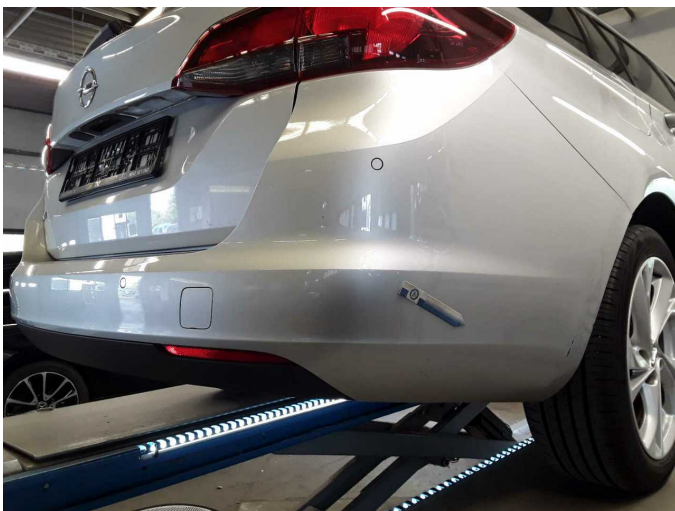
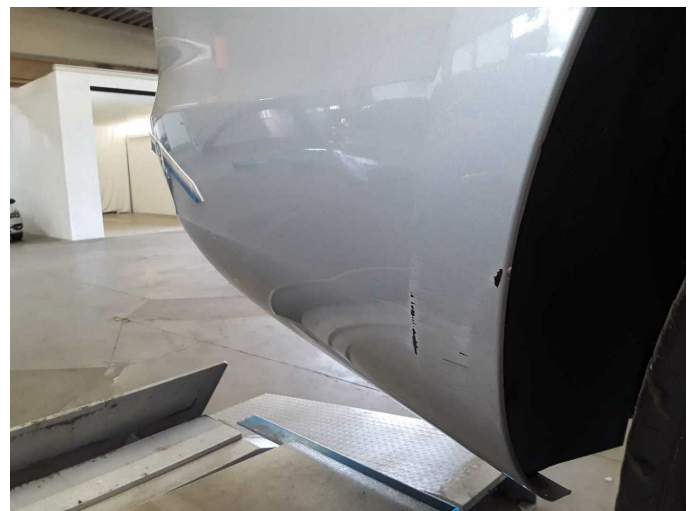
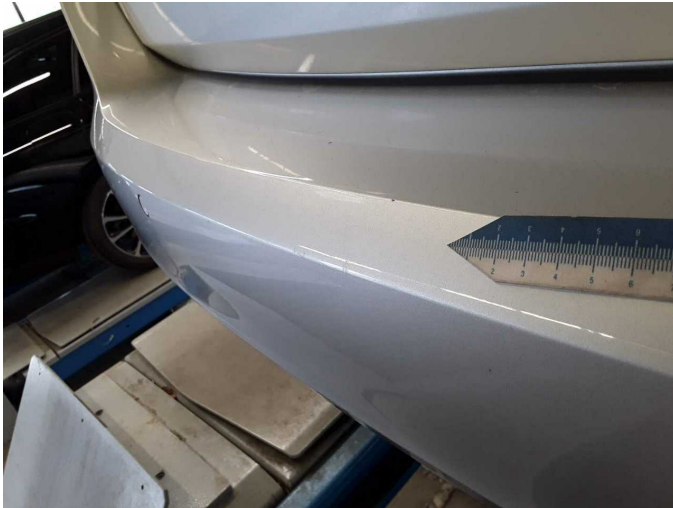
Damage 7: Rear bumper: Rear bumper - Scratch(es) - Paint

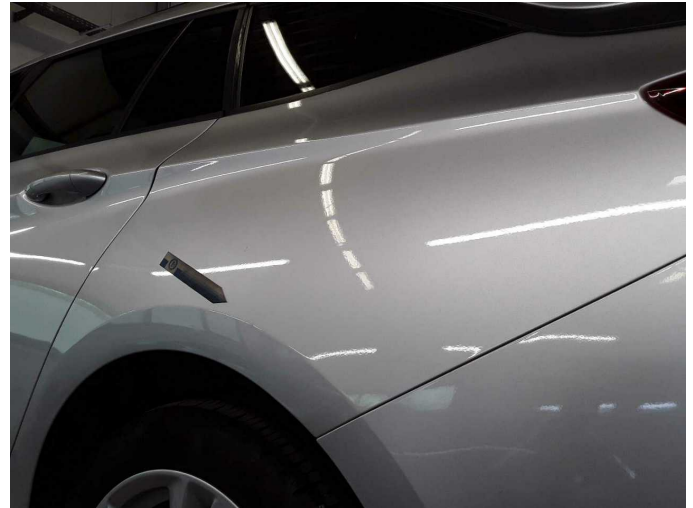
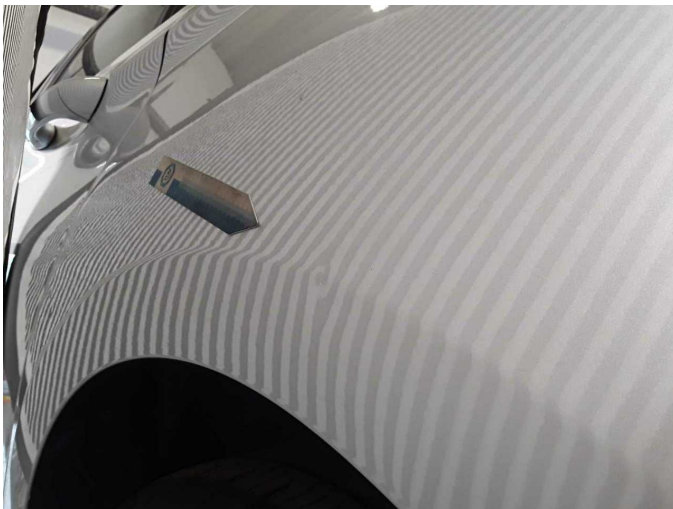
Damage 8: Side panel - rear left side: Side panel - Dent / paintcoat damage - Repair and paint

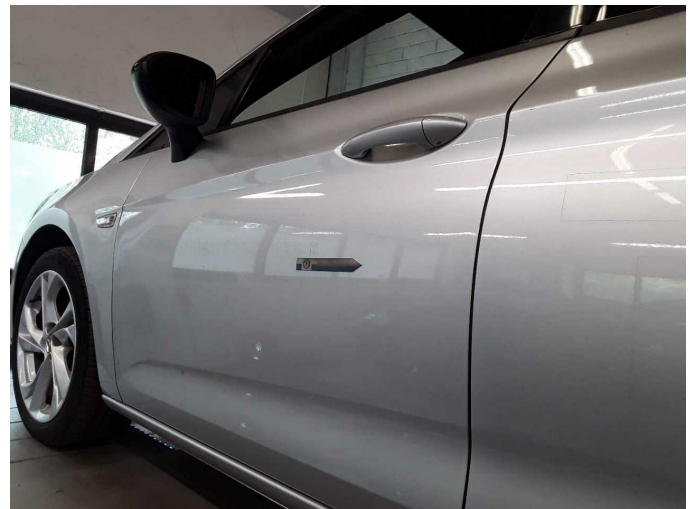
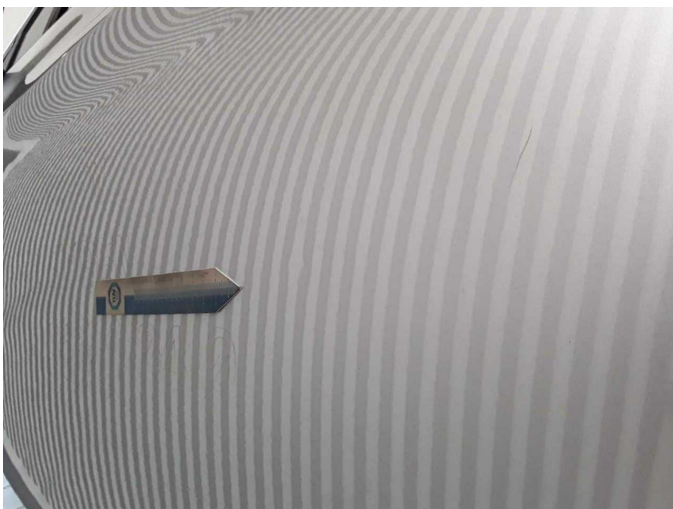
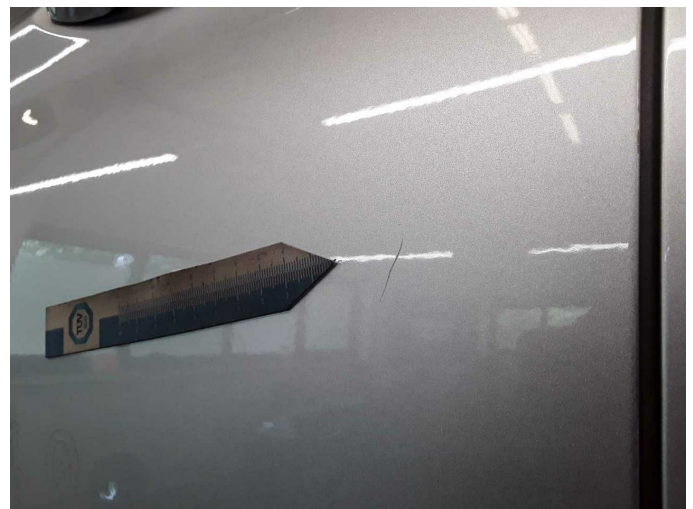
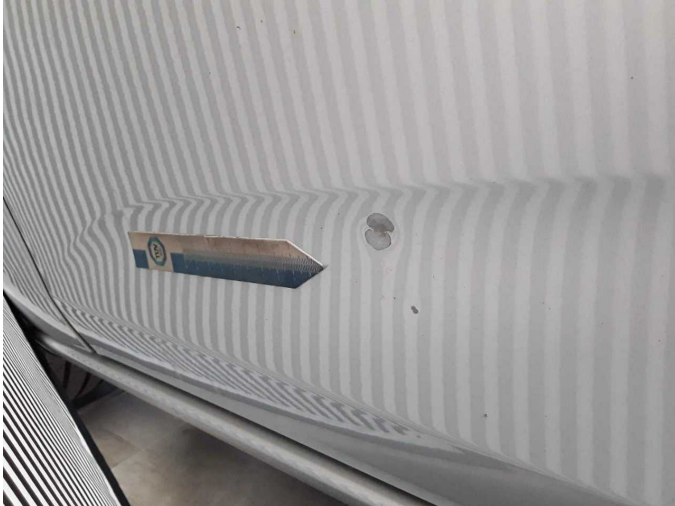
Damage 9: Door - front left side: Door - Dent / paintcoat damage - Repair and paint

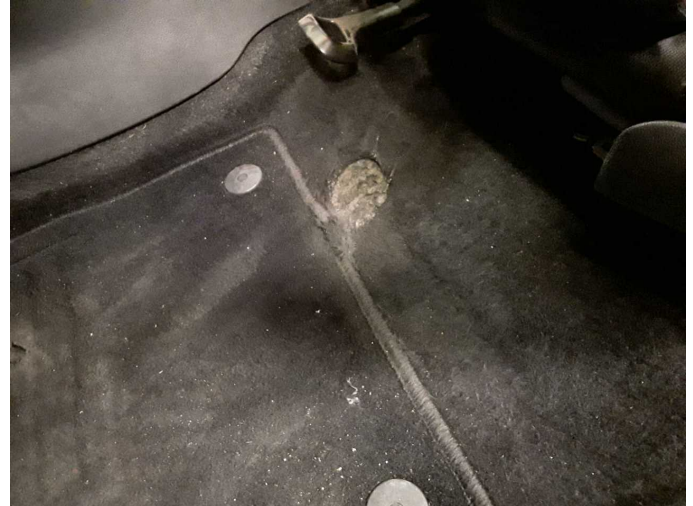
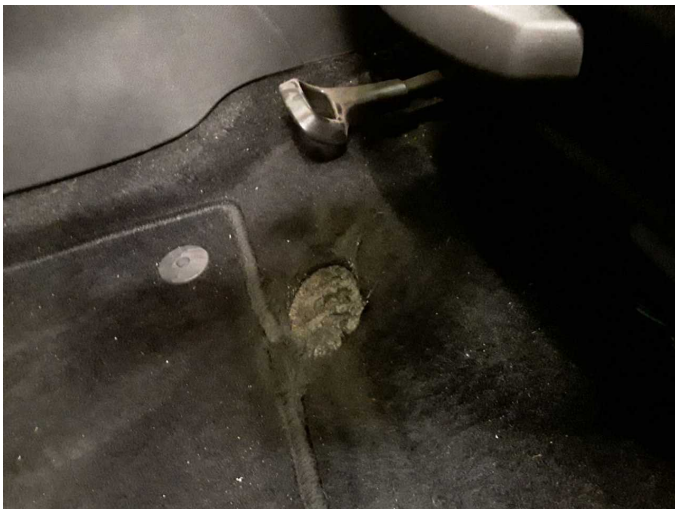
Damage 10: Trim / covers: Carpet - front left side - Damaged - Replace

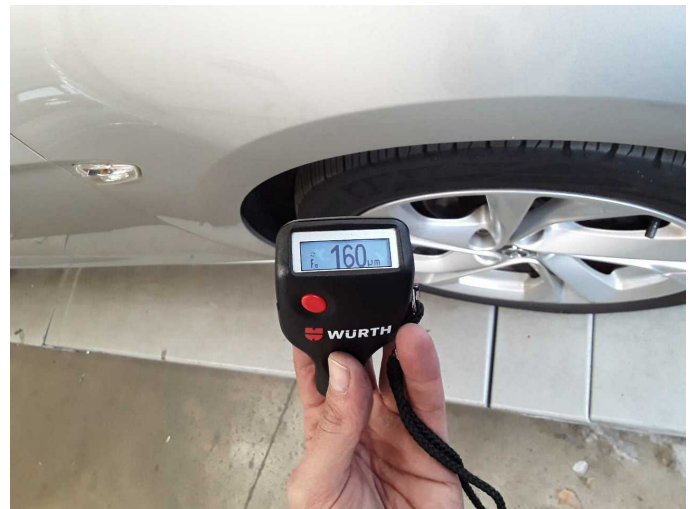
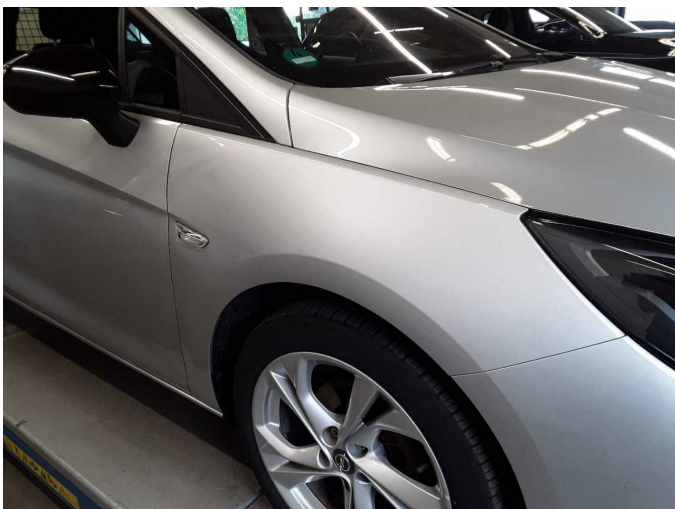
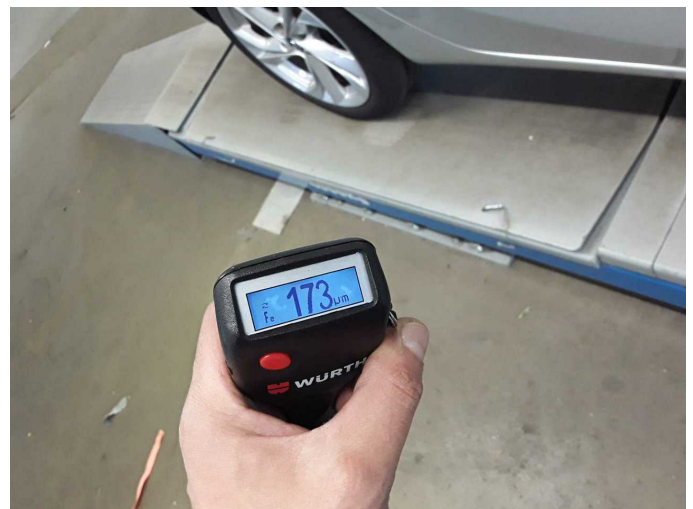
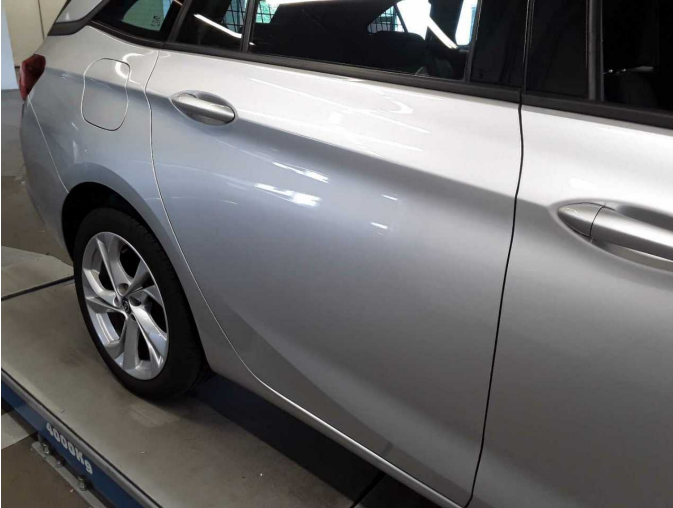
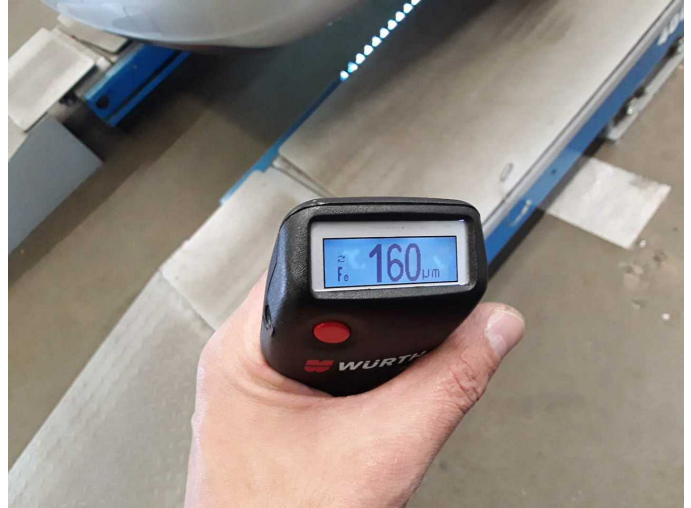
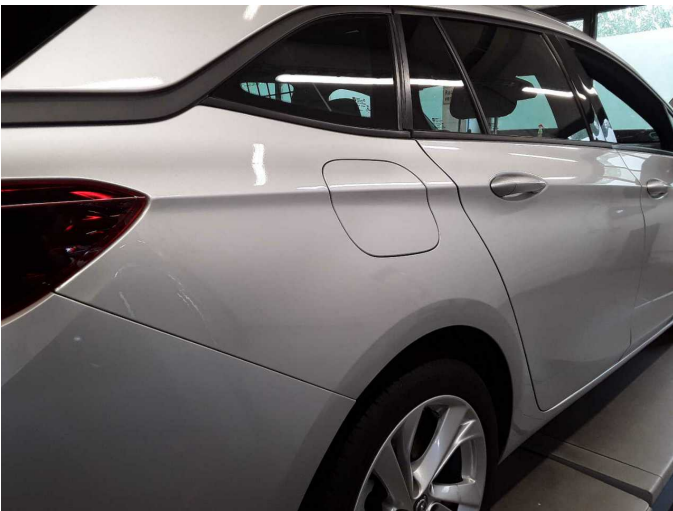
No.	Repainting
1	Mudguard - right side, Side panel - rear right side, Door - rear right side, Professionally carried out, Invoice of repair done Non-existent

Repainting 1: Mudguard - right side, Side panel - rear right side, Door - rear right side
