Expertise

Protocol number: 46044499
Order No. / Reference: 26412890
Inspection date: 19 Jun 2026

Model: Focus Turnier 1.5 EcoBlue Start-Stopp-System Aut. TITANIUM

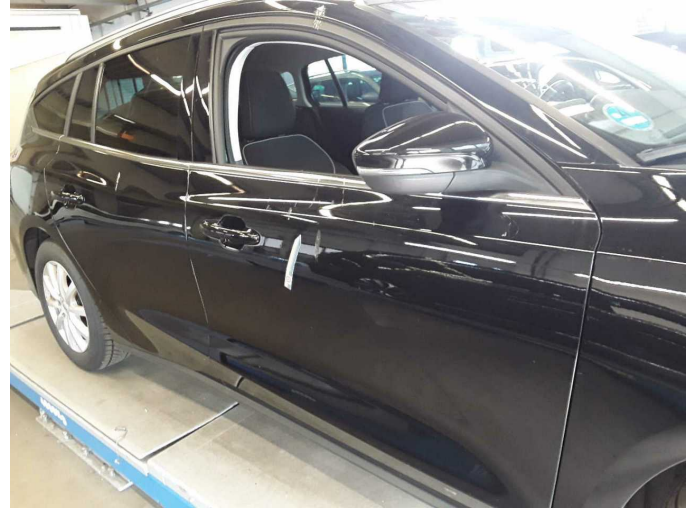
Damage 1: Body: Body (Vogelkot) - Soiled - Clean

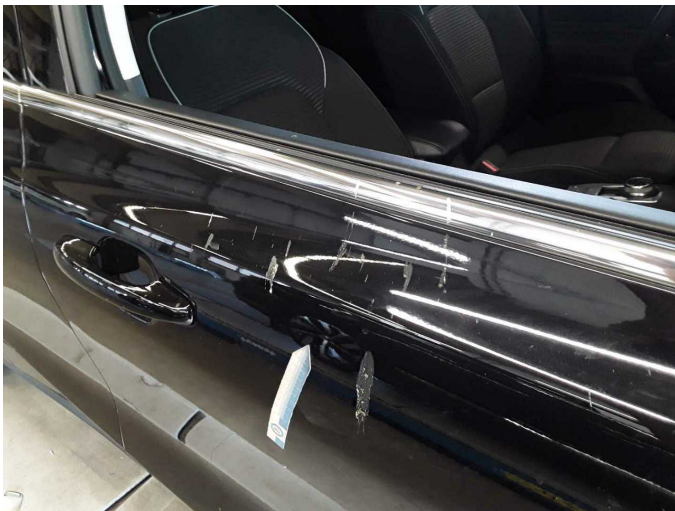
Damage 1: Body: Body (Vogelkot) - Soiled - Clean

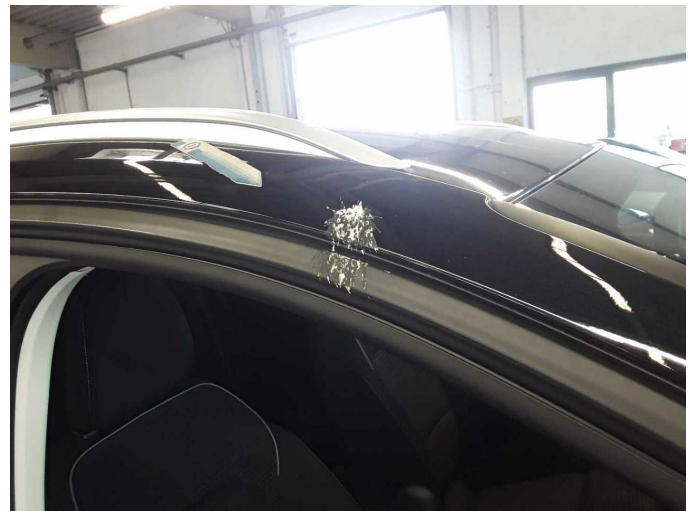
Damage 1: Body: Body (Vogelkot) - Soiled - Clean

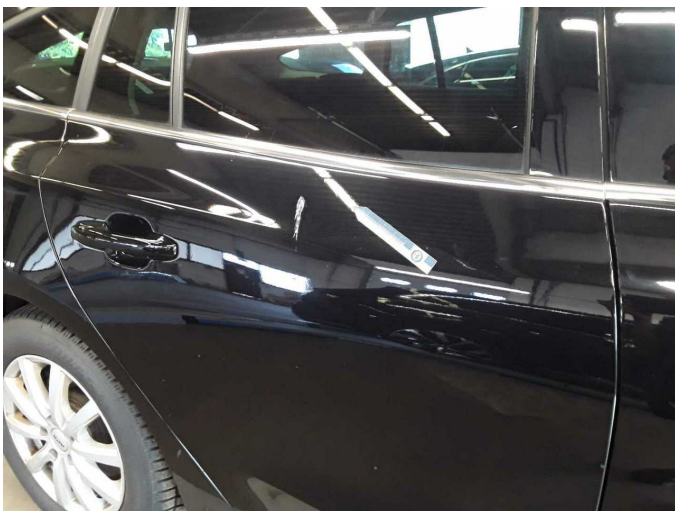
Damage 1: Body: Body (Vogelkot) - Soiled - Clean

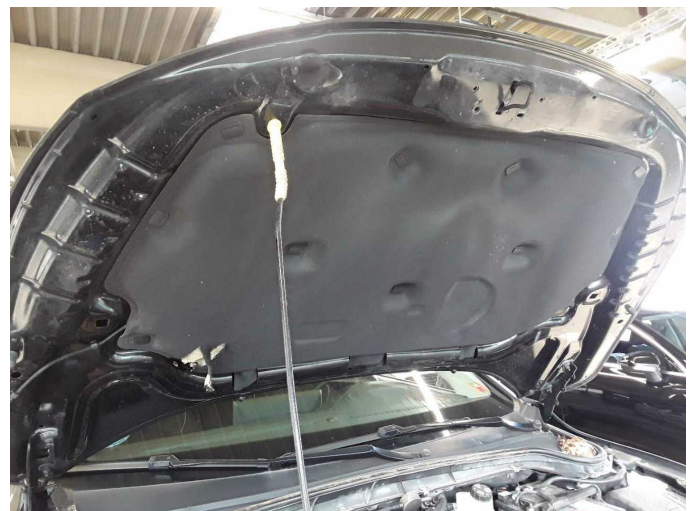
Damage 2: Bonnet: Insulation lining - Damage caused by marten / rodent - Replace

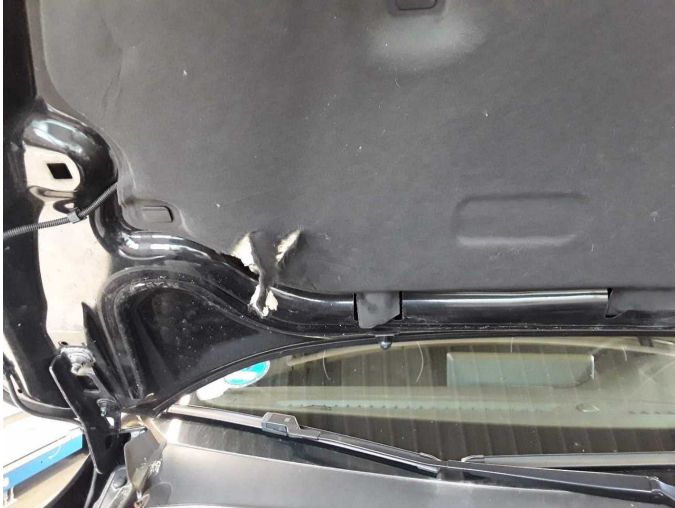
Damage 2: Bonnet: Insulation lining - Damage caused by marten / rodent
- Replace

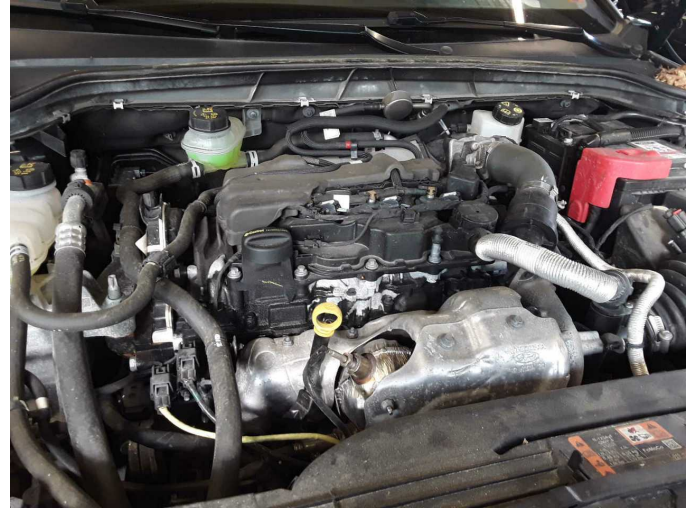
Damage 3: Engine: Engine (Mehrkosten möglich) - Leaking - Diagnosed
and repair if necessary

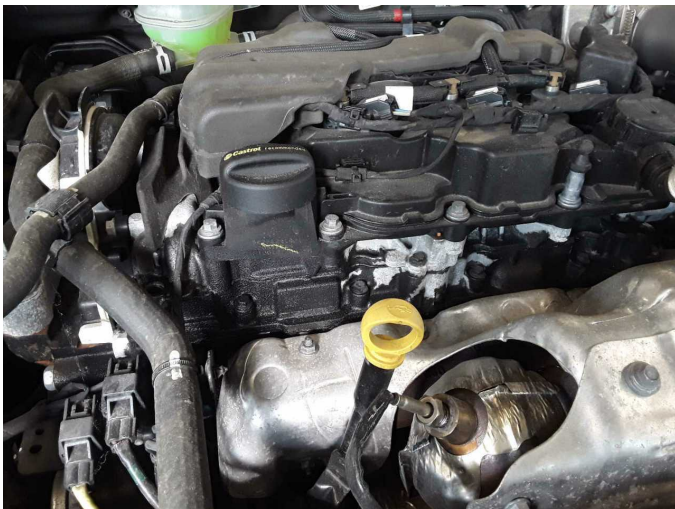
Damage 3: Engine: Engine (Mehrkosten möglich) - Leaking - Diagnosed
and repair if necessary

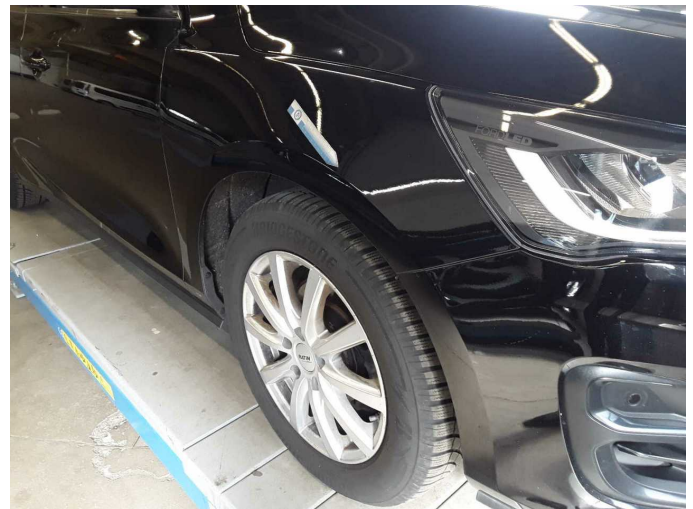
Damage 4: Mudguard - right side: Mudguard - right side - Scratch(es) -
Paint

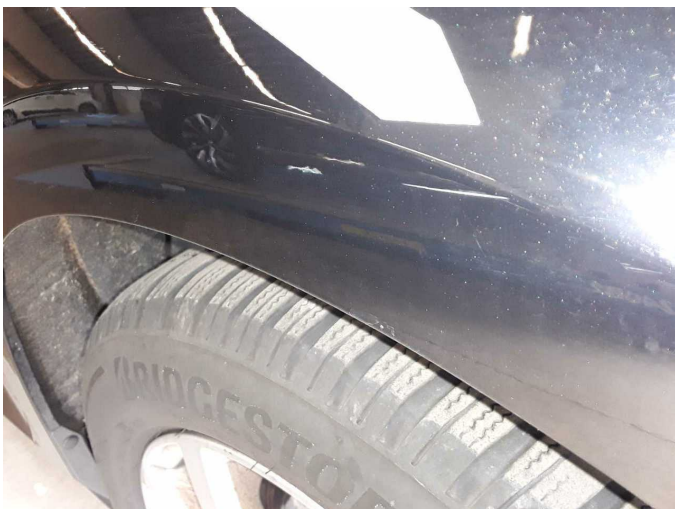
Damage 4: Mudguard - right side: Mudguard - right side - Scratch(es) -
Paint

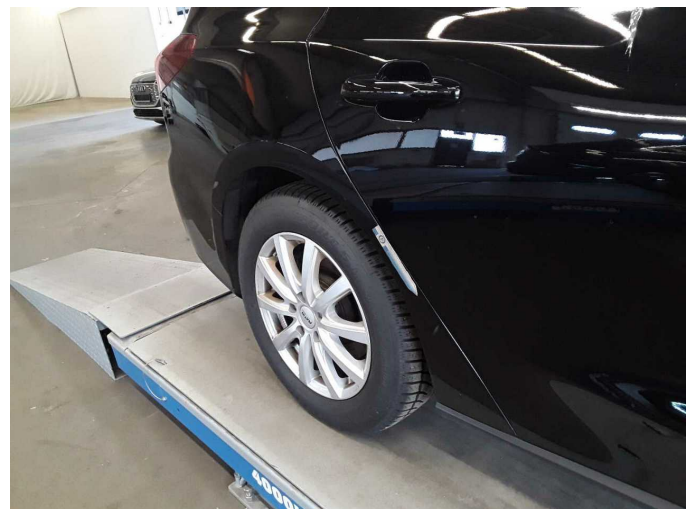
Damage 5: Side panel - rear right side: Side panel - Dent / paintcoat
damage - Repair and paint

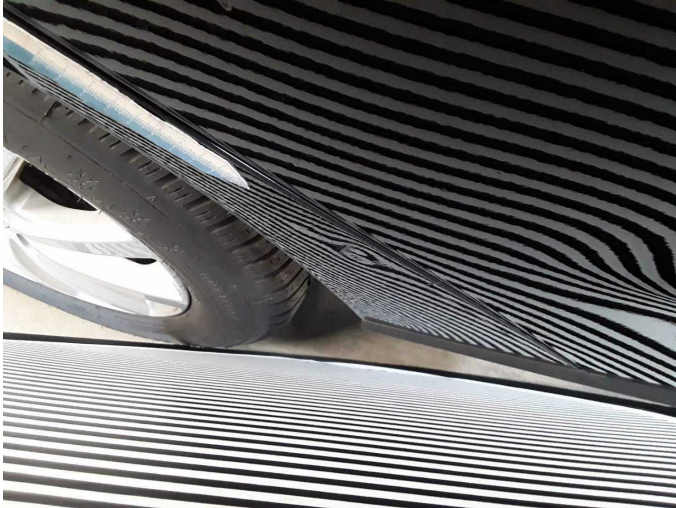
Damage 5: Side panel - rear right side: Side panel - Dent / paintcoat damage - Repair and paint

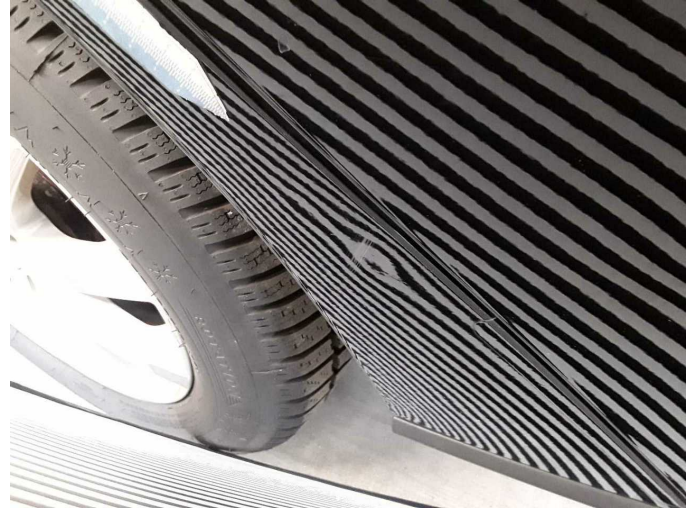
Damage 5: Side panel - rear right side: Side panel - Dent / paintcoat damage - Repair and paint

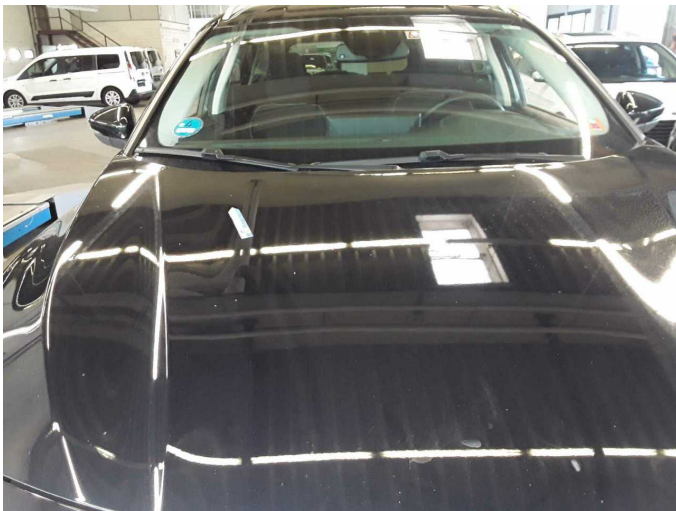
Damage 6: Bonnet: Bonnet - Dent / paintcoat damage - Repair and paint

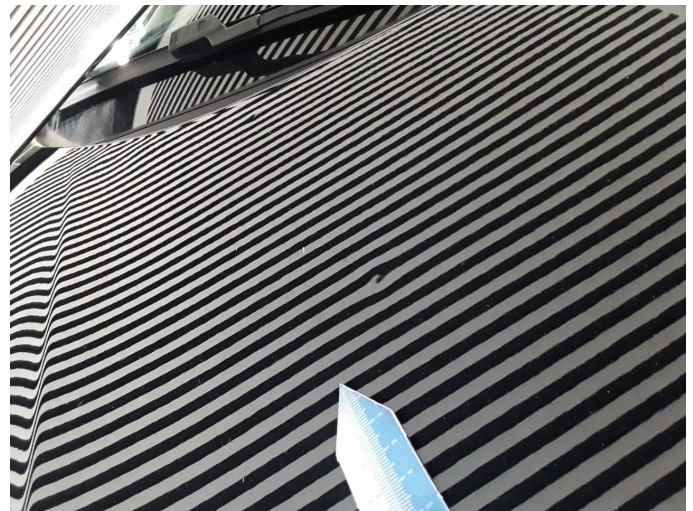
Damage 6: Bonnet: Bonnet - Dent / paintcoat damage - Repair and paint

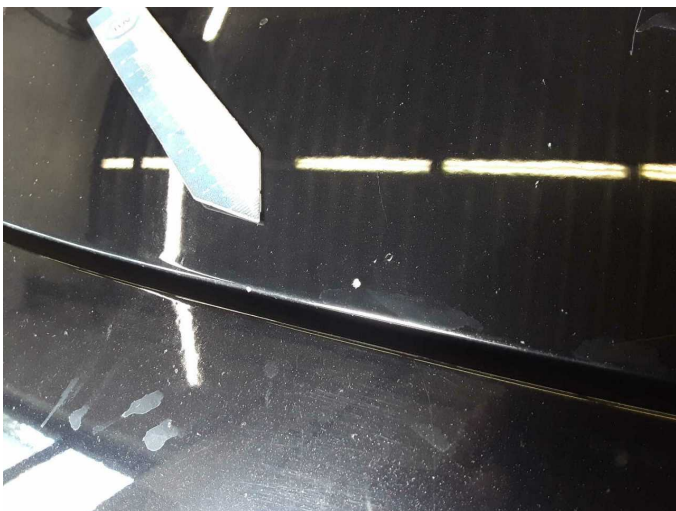
Damage 6: Bonnet: Bonnet - Dent / paintcoat damage - Repair and paint

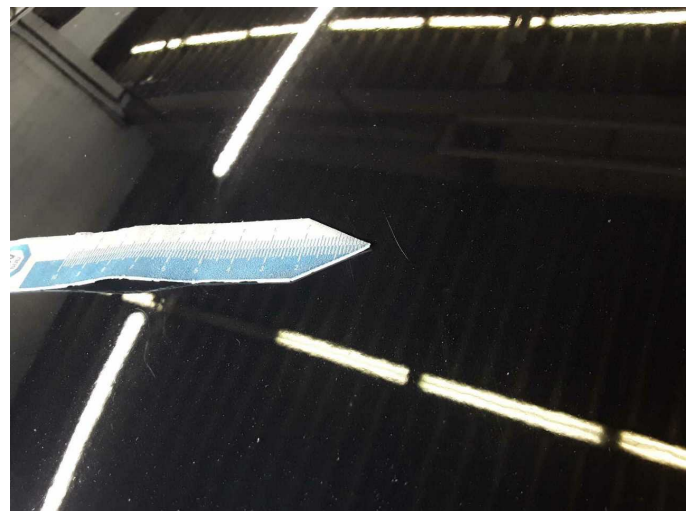
Damage 6: Bonnet: Bonnet - Dent / paintcoat damage - Repair and paint

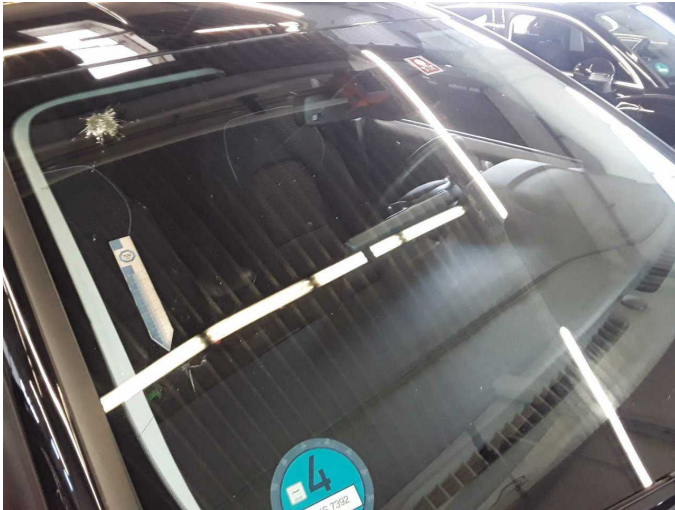
Damage 7: Vehicle glazing: Windscreen (Rissbildung) - Stone chips - Replace

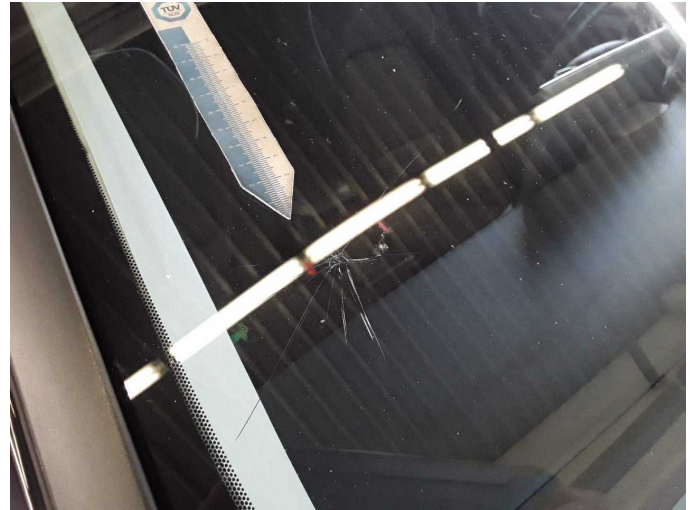
Damage 7: Vehicle glazing: Windscreen (Rissbildung) - Stone chips - Replace

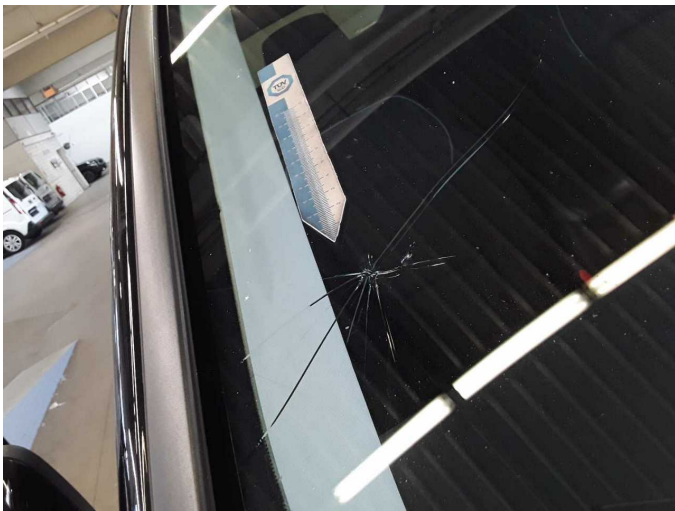
Damage 7: Vehicle glazing: Windscreen (Rissbildung) - Stone chips - Replace

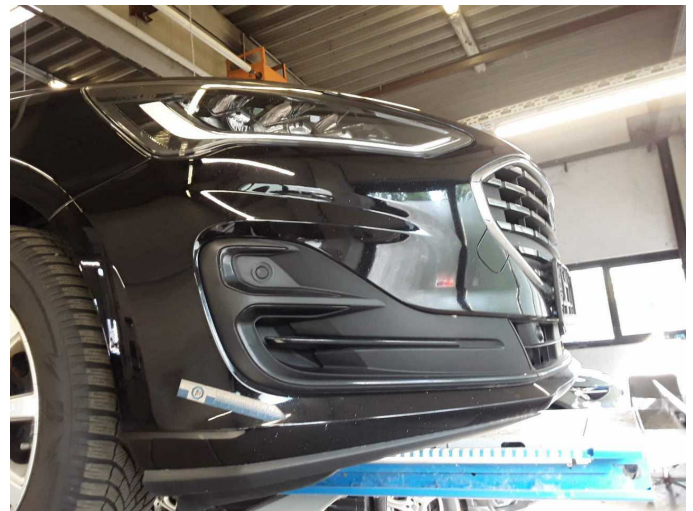
Wear and tear 1: Front bumper: Front bumper - Stone chips - No deduction

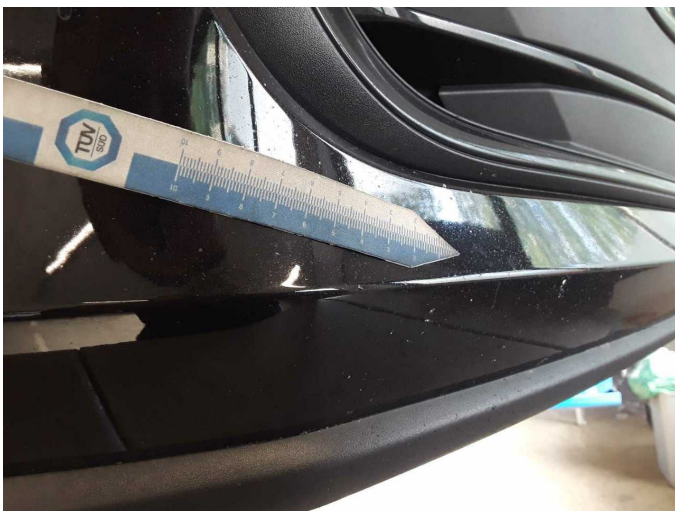
Wear and tear 1: Front bumper: Front bumper - Stone chips - No deduction

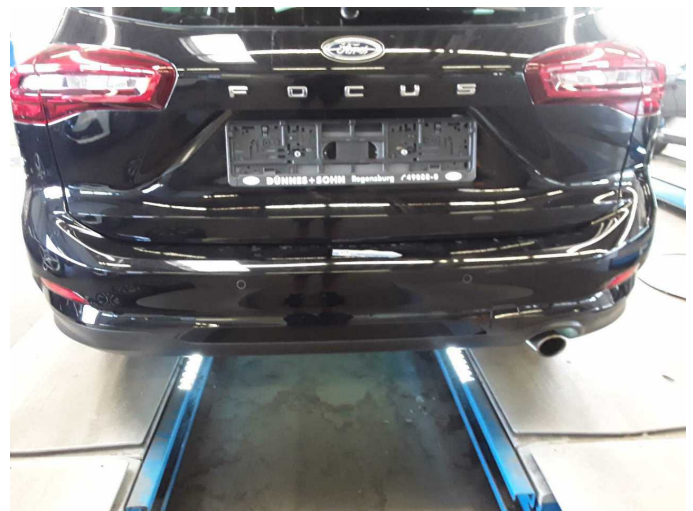
Wear and tear 2: Rear bumper: Rear bumper - Scratch(es) - No deduction

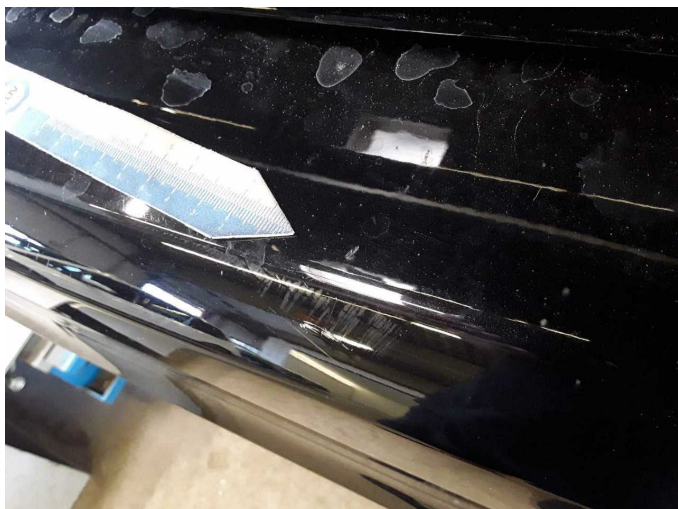
Wear and tear 2: Rear bumper: Rear bumper - Scratch(es) - No deduction
