Expertise

Protocol number: 45868357
Order No. / Reference: 26260877
Inspection date: 9 Jun 2026

Model: 317 CDI Sprinter Standard HA 9G-TRONIC

VIN: W1V9076331P402269

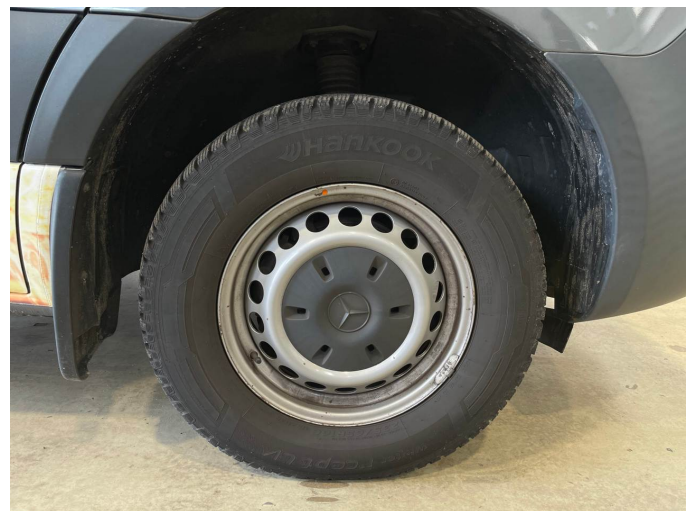
Figure 12: Mounted tyres

#	Tyre size	Type of tyre	Manufacturer	Tread depth
1)	235/65 R16 115R	Winter tyres on Steel rim with wheel cover	Hankook	7mm / 7mm
2)	235/65 R16 115R	Winter tyres on Steel rim with wheel cover	Hankook	4mm / 4mm

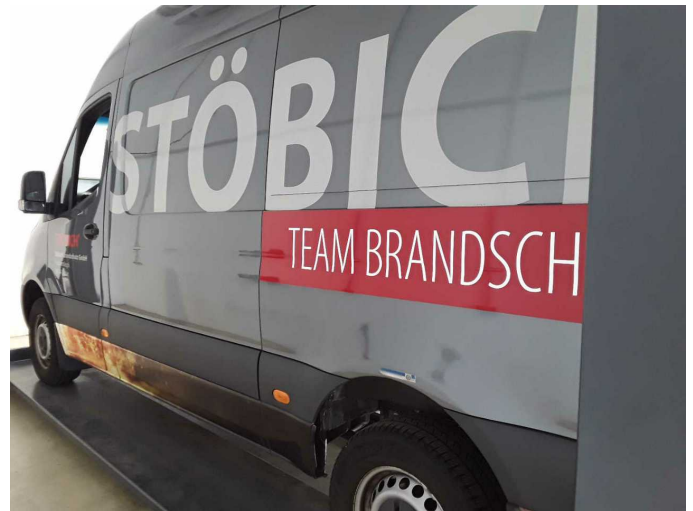
No.	Component group	Description
1	Misc.	Inspection / maintenance - No evidence - No deduction
2	Misc.	Main inspection - No evidence - No deduction
3	Misc.	Inspection / maintenance - No evidence - No deduction
4	Side panel - rear left side	Side panel - Scratched - Smart repair
5	Body	Body - Glued / labelled - De-glue / neutralise
6	Bonnet	Bonnet - Scratch(es) - Paint

Damage 4: Side panel - rear left side: Side panel - Scratched - Smart repair

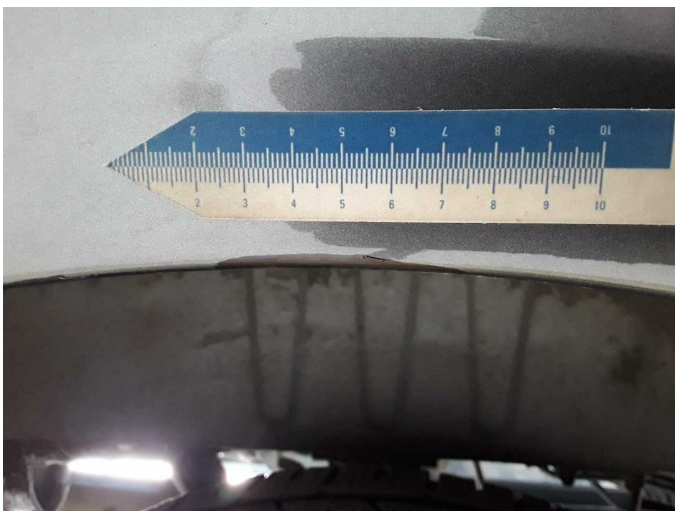
Damage 4: Side panel - rear left side: Side panel - Scratched - Smart repair

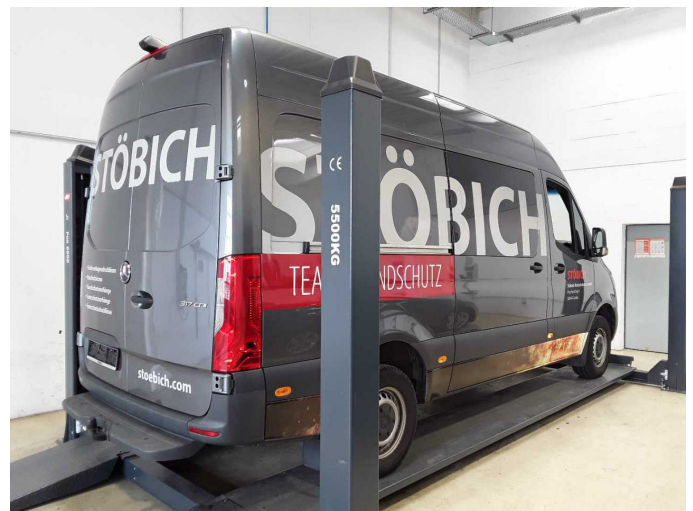
Damage 5: Body - Body - Glued / labelled - De-glue / neutralise

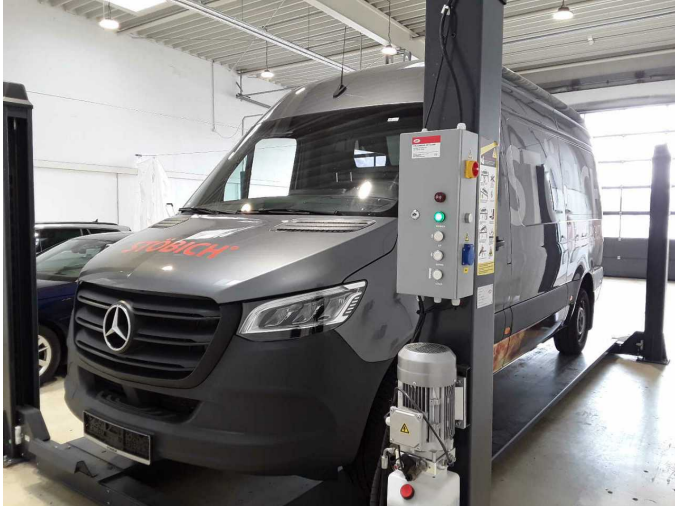
Damage 5: Body: Body - Glued / labelled - De-glue / neutralise

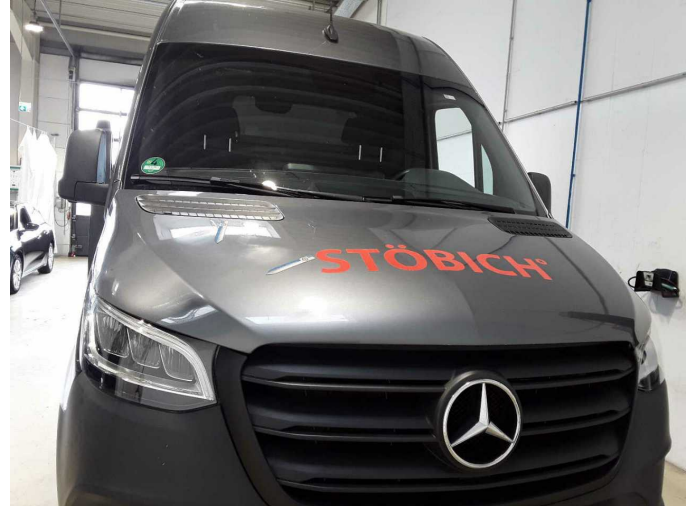
Damage 6: Bonnet: Bonnet - Scratch(es) - Paint

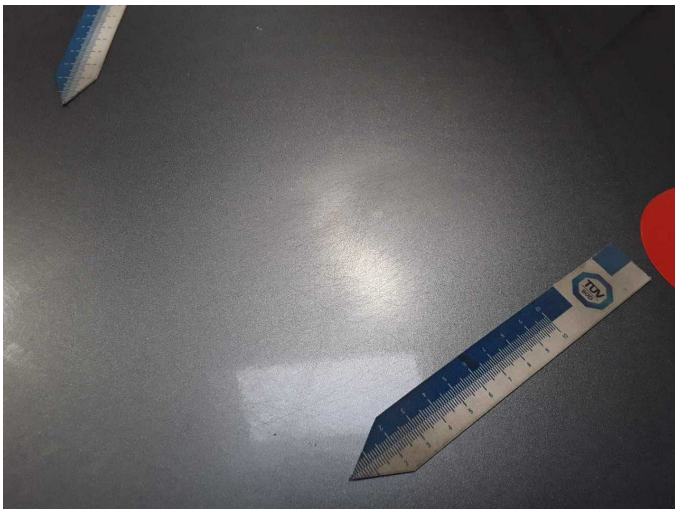
Damage 6: Bonnet: Bonnet - Scratch(es) - Paint

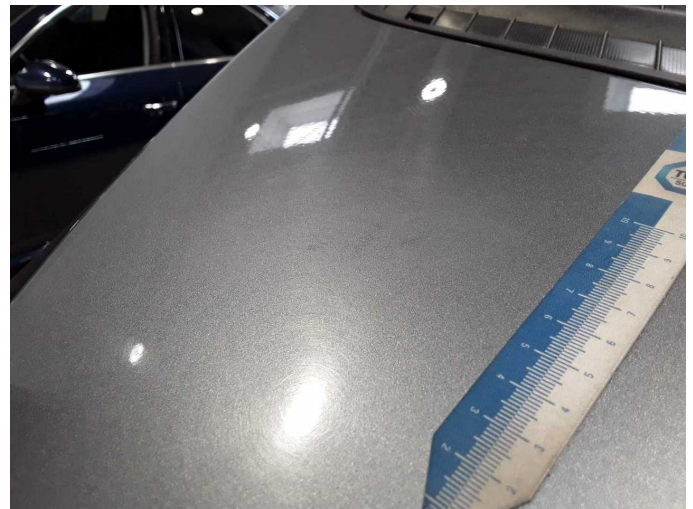
Damage 6: Bonnet: Bonnet - Scratch(es) - Paint

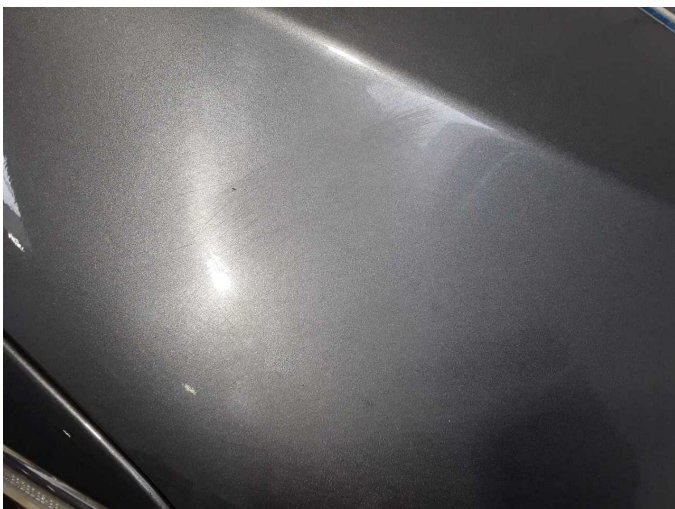
Damage 6: Bonnet: Bonnet - Scratch(es) - Paint

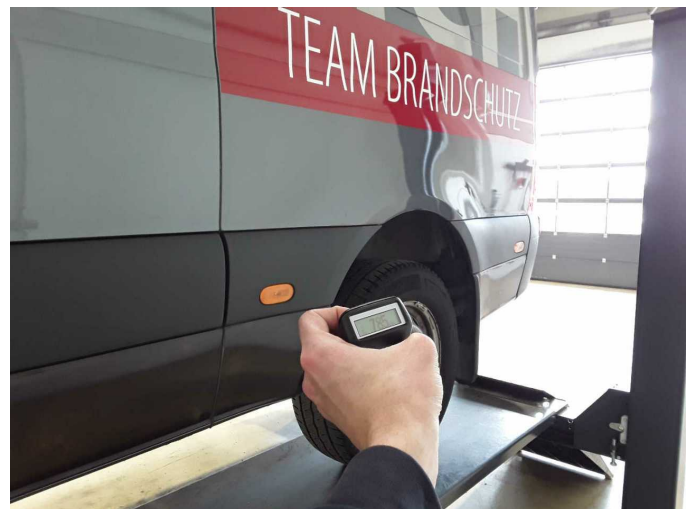
No.	Repainting
1	Side panel - rear left side, Unprofessionally carried out, Invoice of repair done Non-existent

Side panel - rear left side	785 µm
-----------------------------	--------

Repainting 1: Side panel - rear left side

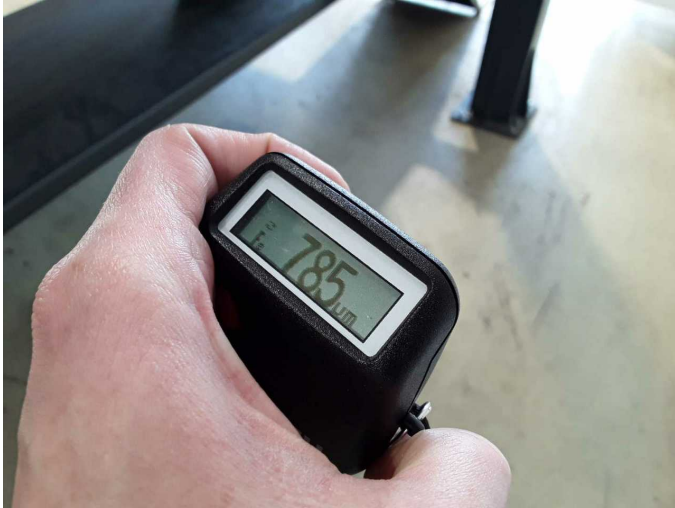
Repainting 1: Side panel - rear left side
