» Overview

» Costs & Value Summary

» Vehicle Data

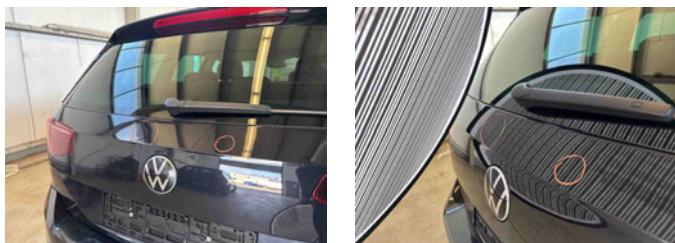
| 10 - Tailgate / Boot - Dent(s) - Paintless dent repair | | Repaircosts: | € 128.00 |

| | | Net cost: | € 128.00 |
| Fixed Price | | | € 40.00 |
| Other work | 4 WU | | € 88.00 |
| Quantity | 2 | | |

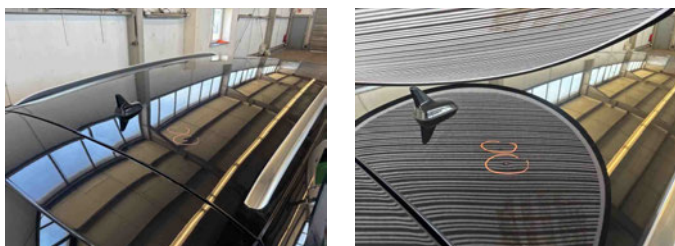
| 11 - Roof - Dent(s) - Paintless dent repair | | Repaircosts: | € 128.00 |

| | | Net cost: | € 128.00 |
| Fixed Price | | | € 40.00 |
| Other work | 4 WU | | € 88.00 |
| Quantity | 2 | | |

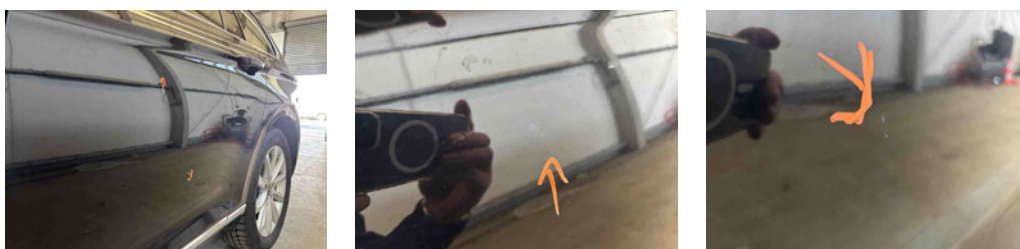
| 12 - Door RL - Scratch(es) - Smart repair | | Repaircosts: | € 120.00 |

| | | Net cost: | € 120.00 |
| Fixed Price | | | € 120.00 |

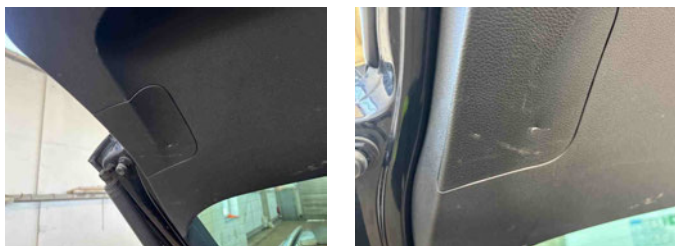
| 3 - Boot door lining L - Scratch(es) - Acceptable | Repaircosts: | € 0.00 |

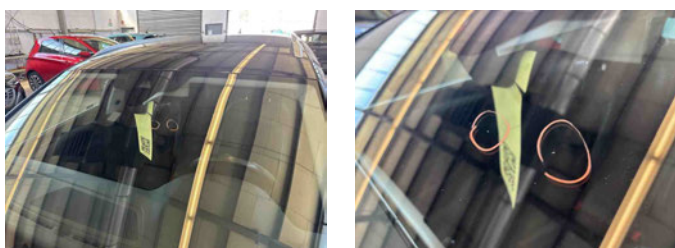
| 4 - Windscreen - Stone chip(s) - Acceptable | Repaircosts: | € 0.00 |
