Expertise

Protocol number: 46692891  
Order No. / Reference: 26721818  
Inspection date: 24 Jul 2026

| Manufacturer: Ford | Model: Focus Turnier 1.5 EcoBlue Start-Stopp-System Aut. TITANIUM |
| VIN: WF0PXXGCHPPJ36009 | |

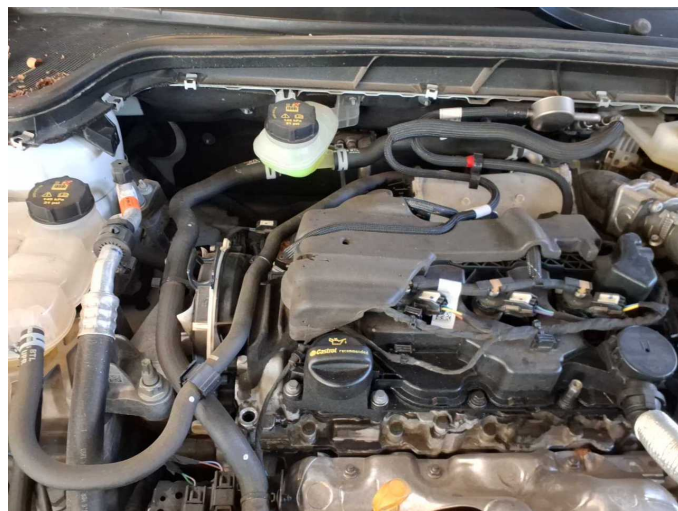
| No. | Component group | Description |
|---|---|---|
| 1 | Engine | Engine cover - Damage caused by marten / rodent - Replace |

**Damage 1:** Engine: Engine cover - Damage caused by marten / rodent - Replace

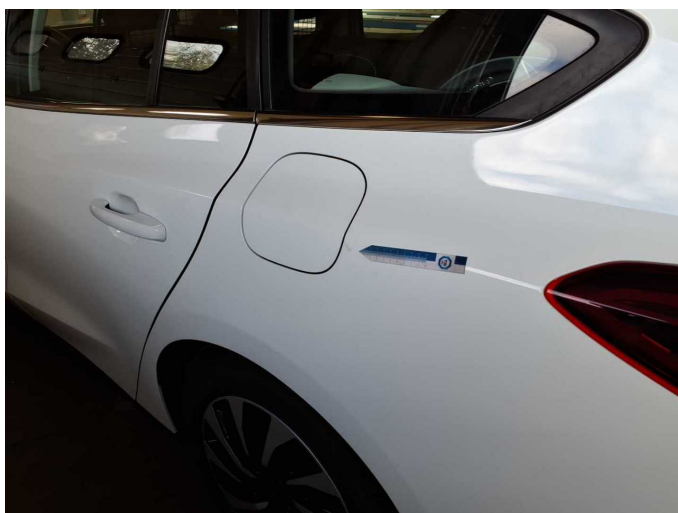
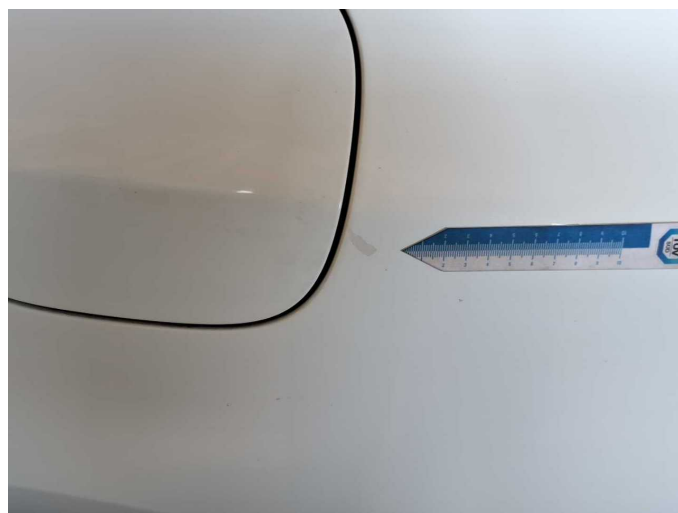
| No. | Component group | Description |
|---|---|---|
| 2 | Side panel - rear left side | Side panel (Klarlackmangel) - Paint defect - Smart repair |

**Damage 2:** Side panel - rear left side: Side panel (Klarlackmangel) - Paint defect - Smart repair

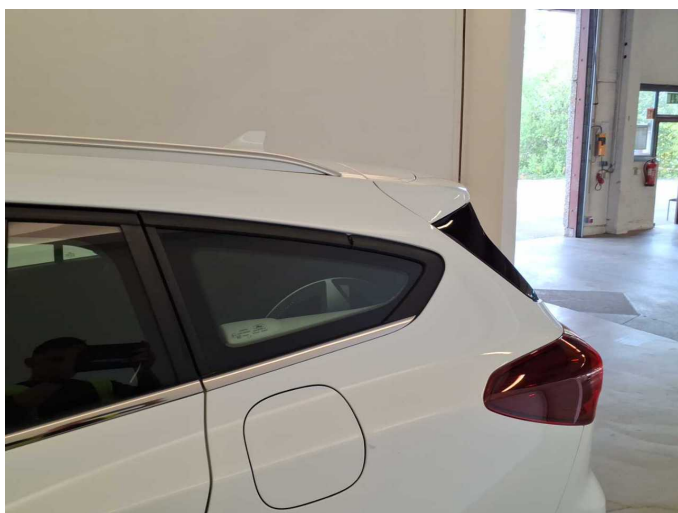
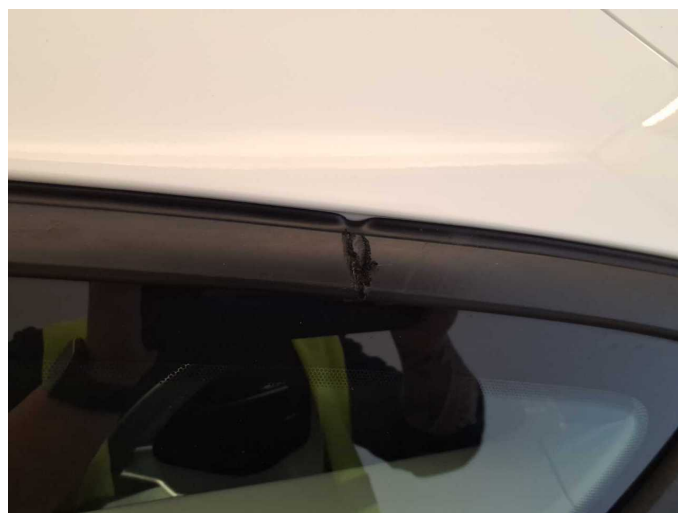
| No. | Component group | Description |
|---|---|---|
| 3 | Vehicle glazing | Triangular window - left side (Dichtung) - Broken / torn - Replace |

**Damage 3:** Vehicle glazing: Triangular window - left side (Dichtung) - Broken / torn - Replace

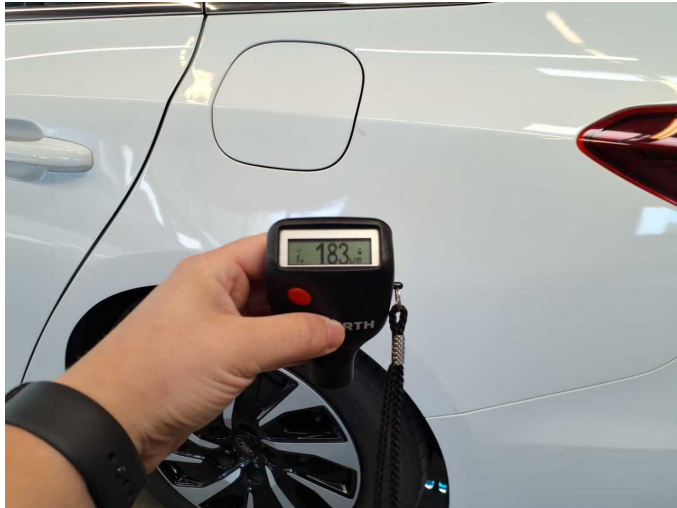
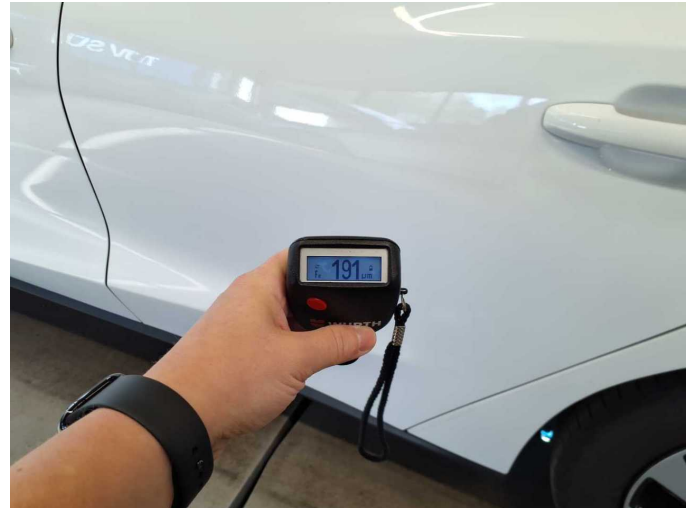
1 Side panel - rear left side, Door - rear left side, Professionally carried out, Invoice of repair done Non-existent

| Side panel - rear left side | 183 µm | Door - rear left side | 191 µm |

**Repainting 1:** Side panel - rear left side, Door - rear left side
