Expertise

Protocol number: 46681268  
Order No. / Reference: 26765854  
Inspection date: 23 Jul 2026

Manufacturer: Volkswagen

Model: ID.3 Performance Upgrade Pro Business

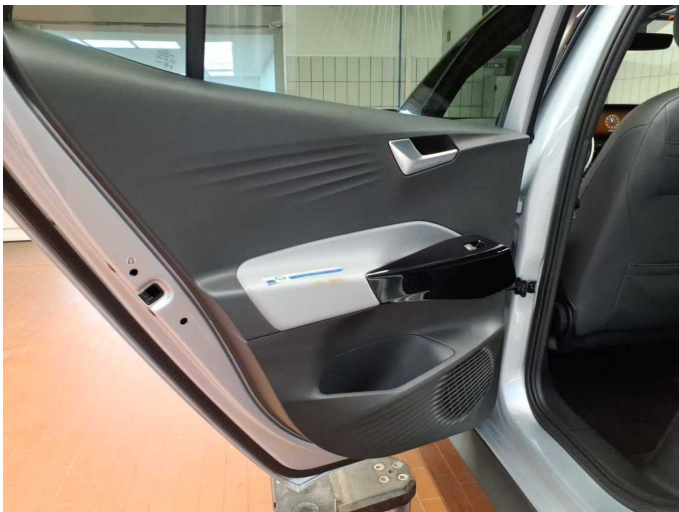
| No. | Component group | Description |
|---|---|---|
| 1 | Trim / covers | Door trim - rear left side - Soiled - Clean |

Damage 1: Trim / covers: Door trim - rear left side - Soiled - Clean

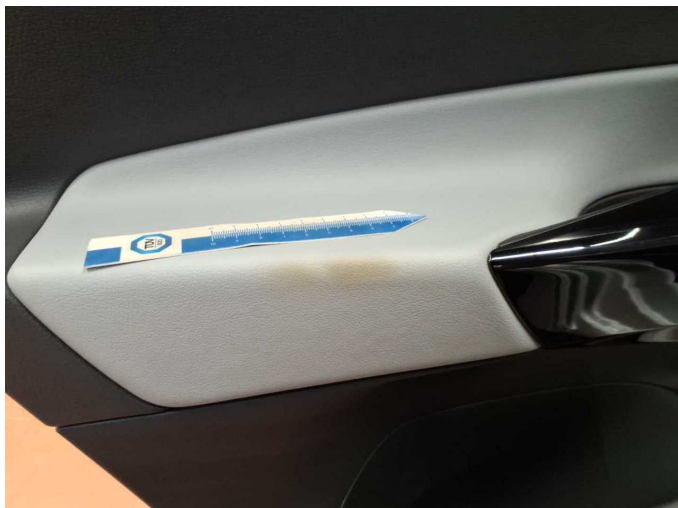
**Damage 1:** Trim / covers: Door trim - rear left side - Soiled - Clean

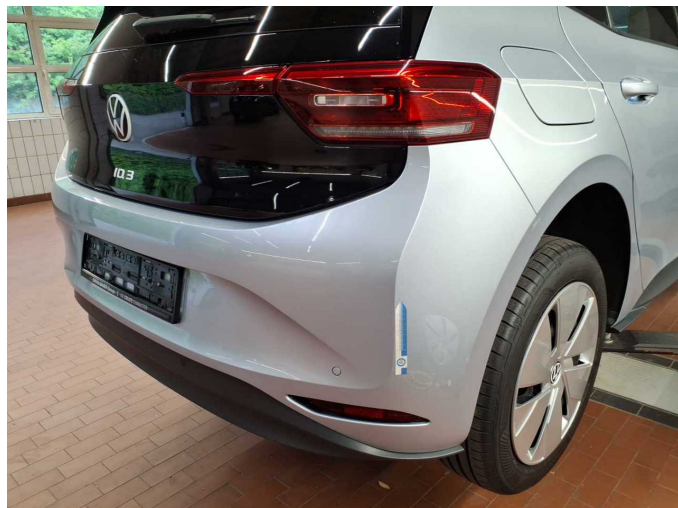
| No. | Component group | Description |
|---|---|---|
| 2 | Rear bumper | Rear bumper - Scratch(es) - Smart repair |

**Damage 2:** Rear bumper: Rear bumper - Scratch(es) - Smart repair

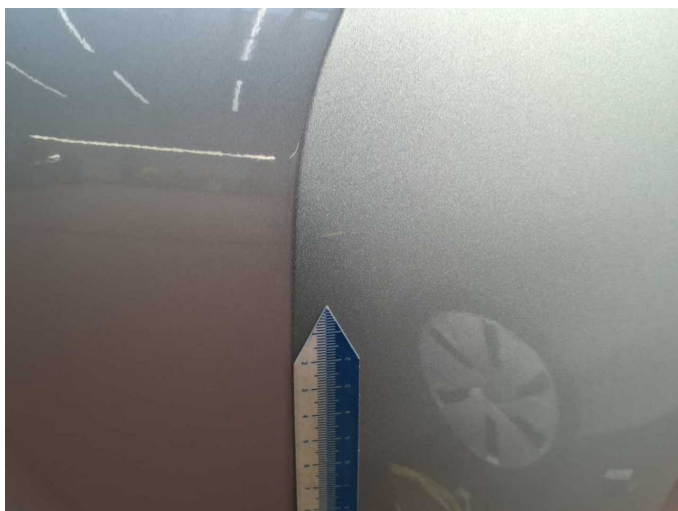
**Damage 2:** Rear bumper: Rear bumper - Scratch(es) - Smart repair

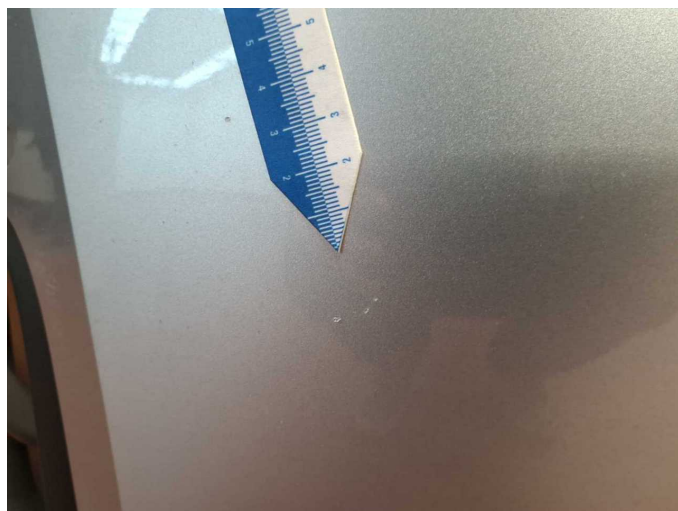
| No. | Component group | Description |
|---|---|---|
| 3 | Front bumper | Front bumper - Stone chips - No deduction |

**Wear and tear 3:** Front bumper: Front bumper - Stone chips - No deduction

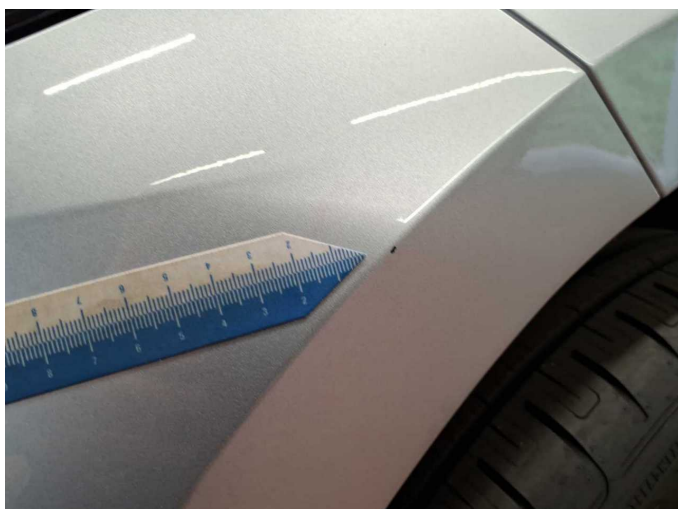
**Wear and tear 3:** Front bumper: Front bumper - Stone chips - No deduction

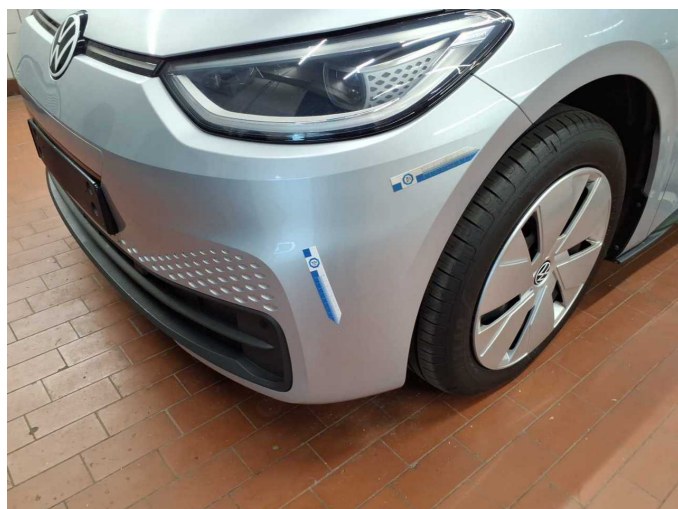
**Wear and tear 3:** Front bumper: Front bumper - Stone chips - No deduction

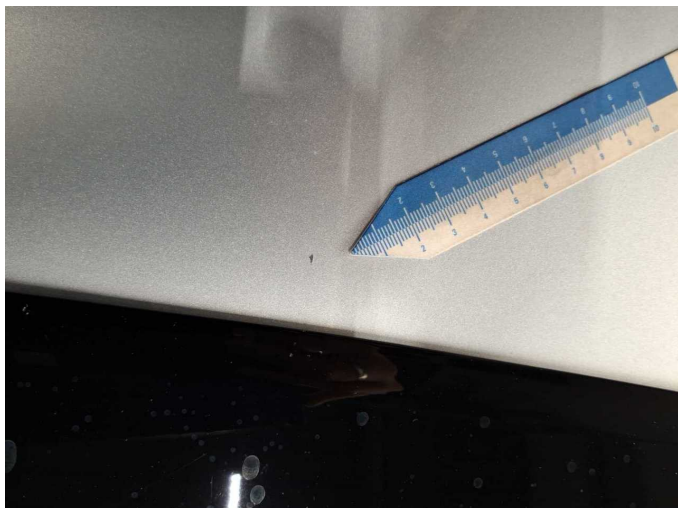
| No. | Component group | Description |
|---|---|---|
| 4 | Bonnet | Bonnet - Scratch(es) - No deduction |

**Wear and tear 4:** Bonnet: Bonnet - Scratch(es) - No deduction

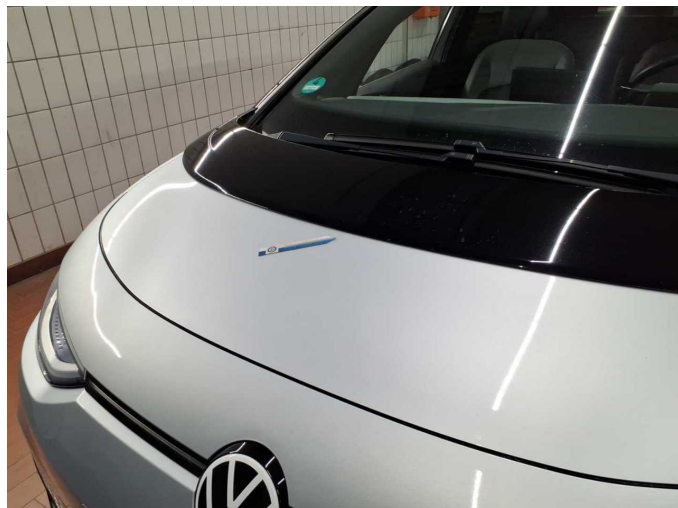
**Wear and tear 4:** Bonnet: Bonnet - Scratch(es) - No deduction

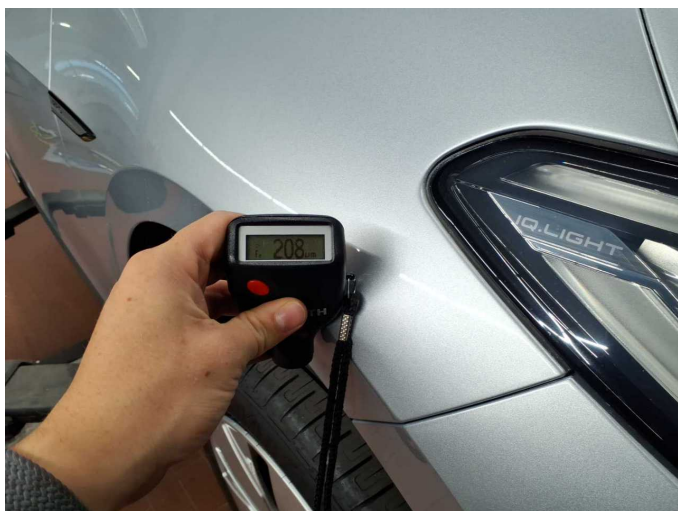
**Repainting 1:** Mudguard - right side

| No. | Repainting |
|---|---|
| 1 | Mudguard - right side, Professionally carried out, Invoice of repair done Non-existent |

| Mudguard - right side | 208 µm | Door - rear left side | 211 µm |

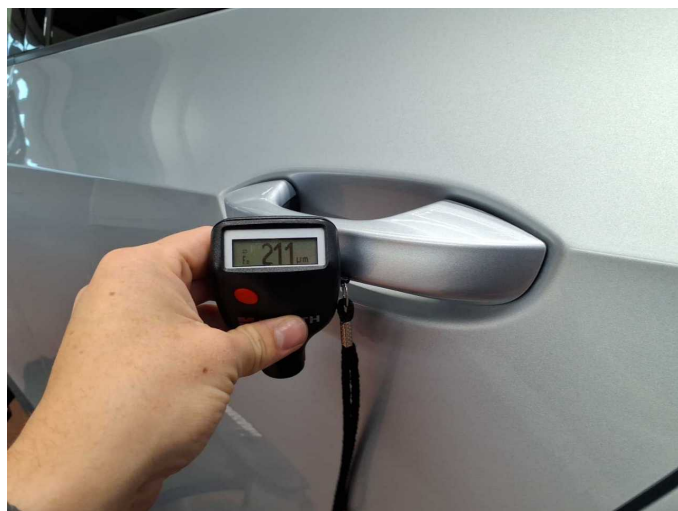
**Repainting 2:** Door - rear left side

| No. | Repainting |
|---|---|
| 2 | Door - rear left side, Professionally carried out, Invoice of repair done Non-existent |

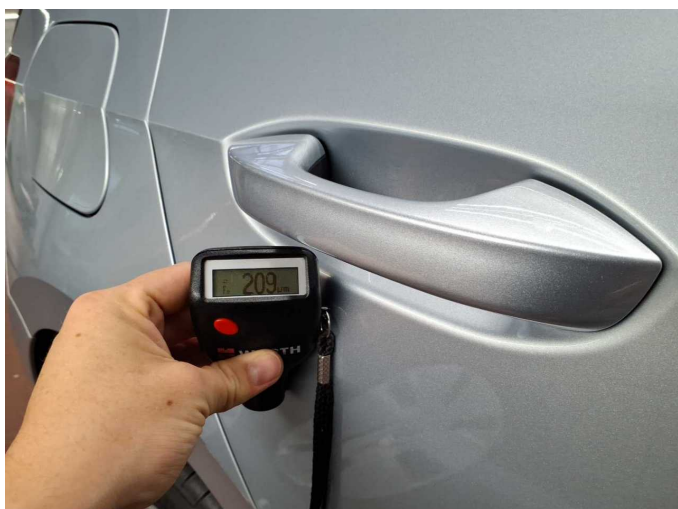
**Repainting 3:** Door - rear right side

| No. | Repainting |
|---|---|
| 3 | Door - rear right side, Professionally carried out, Invoice of repair done Non-existent |

| Door - rear right side | 209 µm | Door - front left side | 202 µm |

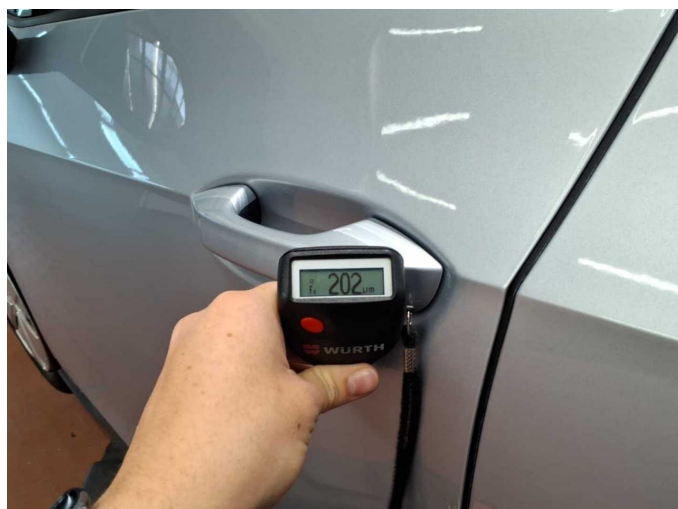
**Repainting 4:** Door - front left side

| No. | Repainting |
|---|---|
| 4 | Door - front left side, Professionally carried out, Invoice of repair done Non-existent |

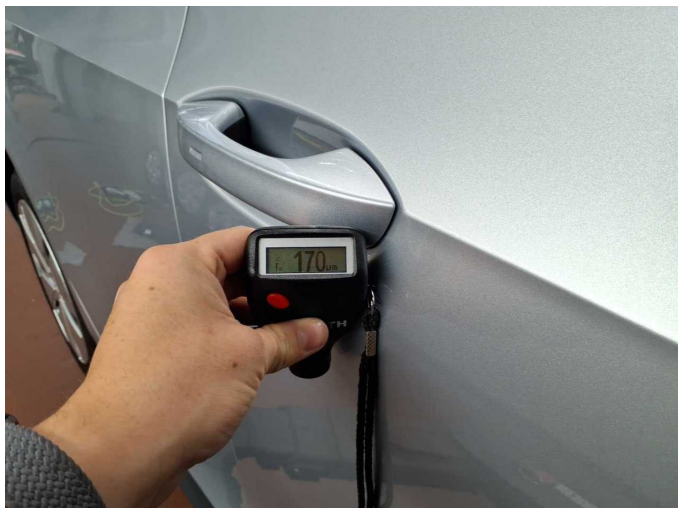
**Repainting 5:** Door - front right side

| No. | Repainting |
|---|---|
| 5 | Door - front right side, Professionally carried out, Invoice of repair done Non-existent |

| Door - front right side | 170 µm | | |
