Expertise

Protocol number: 46124060  
Order No. / Reference: 26528125  
Inspection date: 18 Jun 2026

| Manufacturer: Ford | Model: Focus 1.5 EcoBlue Start-Stopp-System Aut. TITANIUM X |
| VIN: WF0NXXGCHNPD63049 | |

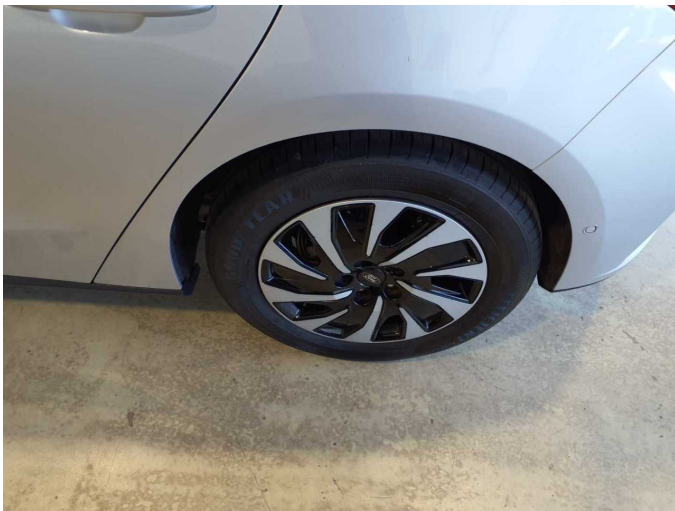
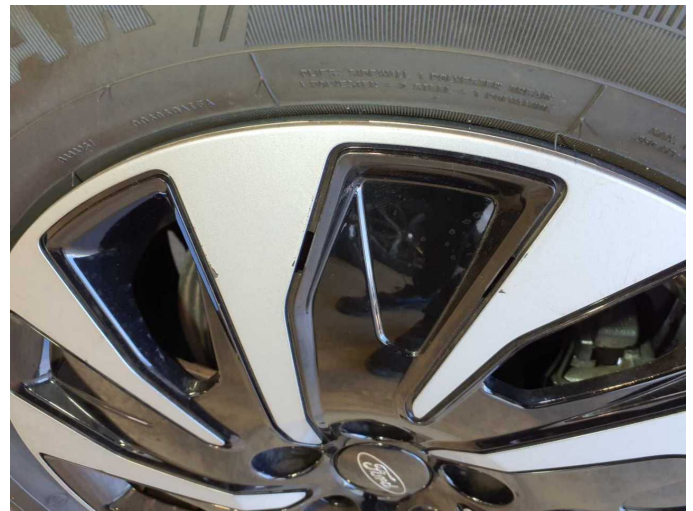
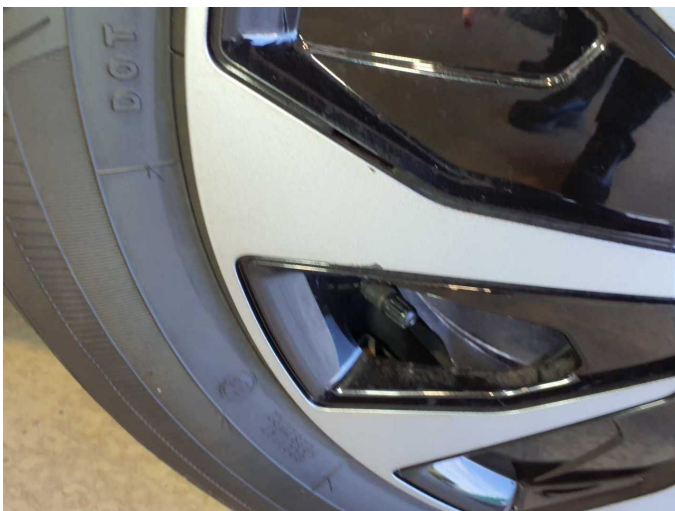
| No. | Component group | Description |
|---|---|---|
| 1 | Wheel / tyres | Wheel cover - rear left side - Scratch(es) - Replace |

Damage 1: Wheel / tyres: Wheel cover - rear left side - Scratch(es) - Replace

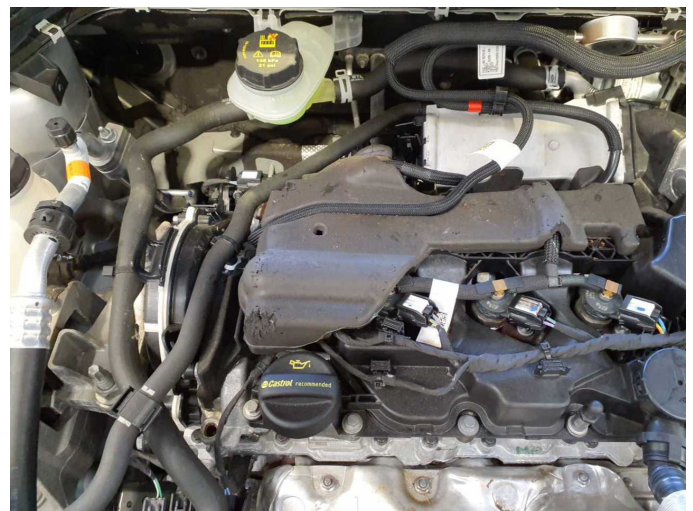
| No. | Component group | Description |
|---|---|---|
| 2 | Misc. | Misc. (Isolierung Motorabdeckung) - Damage caused by marten / rodent - Replace |

Damage 2: Misc.: Misc. (Isolierung Motorabdeckung) - Damage caused by marten / rodent - Replace

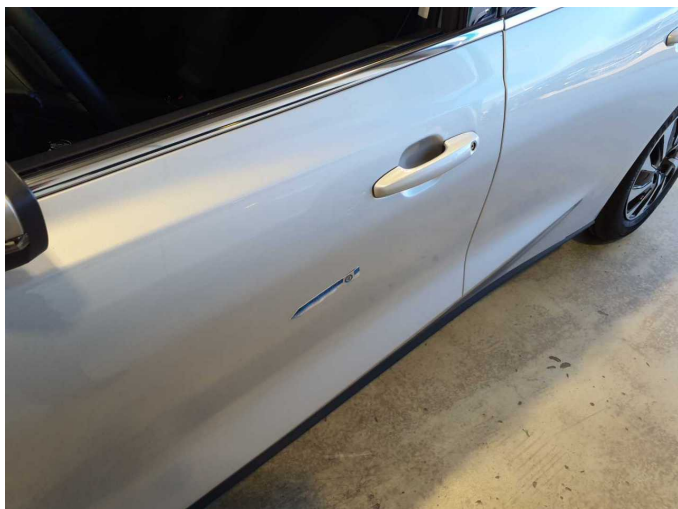
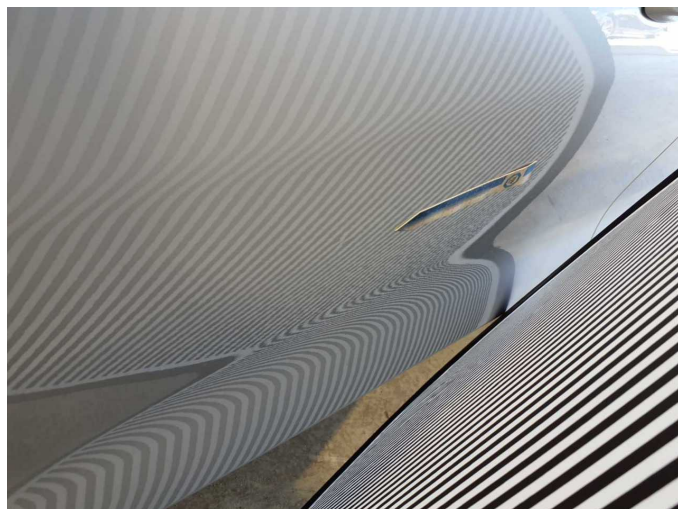
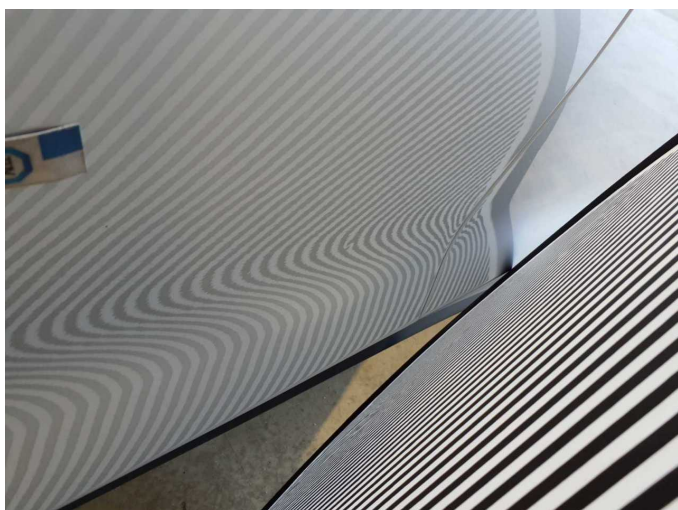
| No. | Component group | Description |
|---|---|---|
| 3 | Door - front left side | Door - dent(s) - Smooth repair work |

**Damage 3:** Door - front left side: Door - dent(s) - Smooth repair work

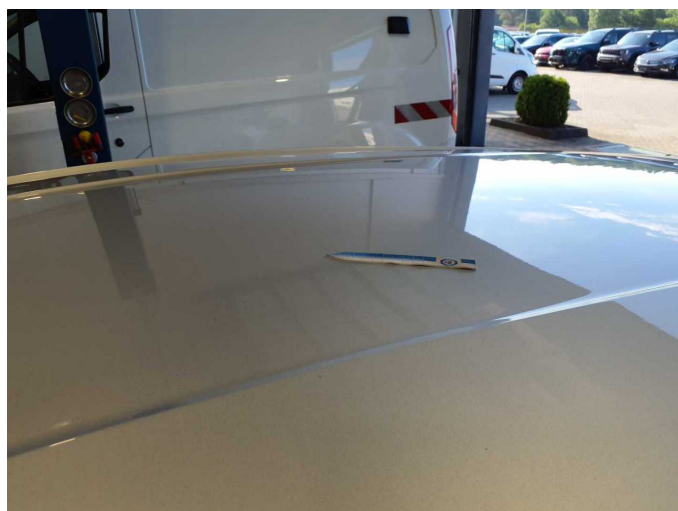
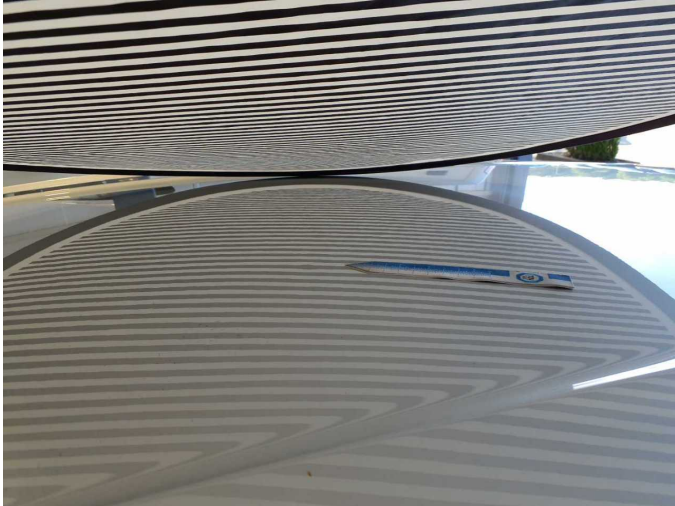
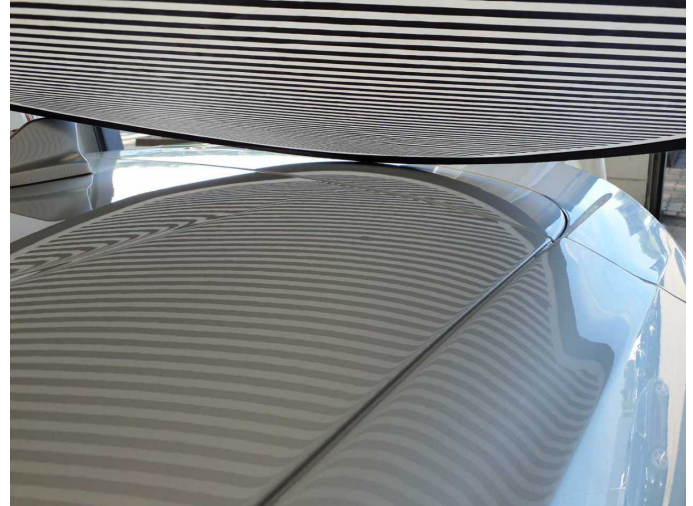
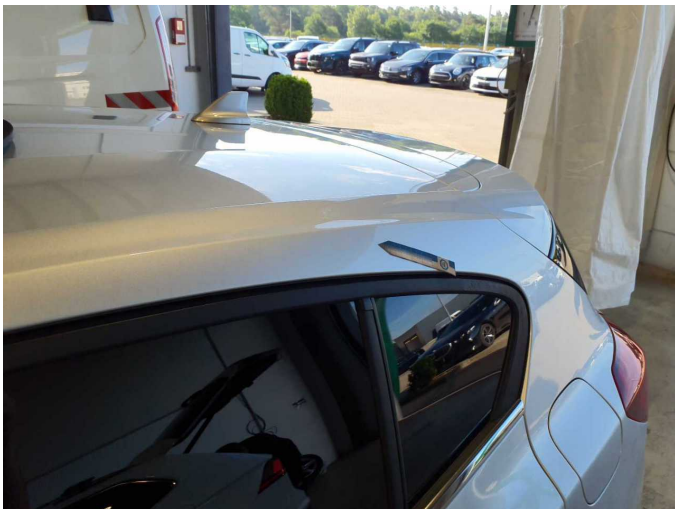
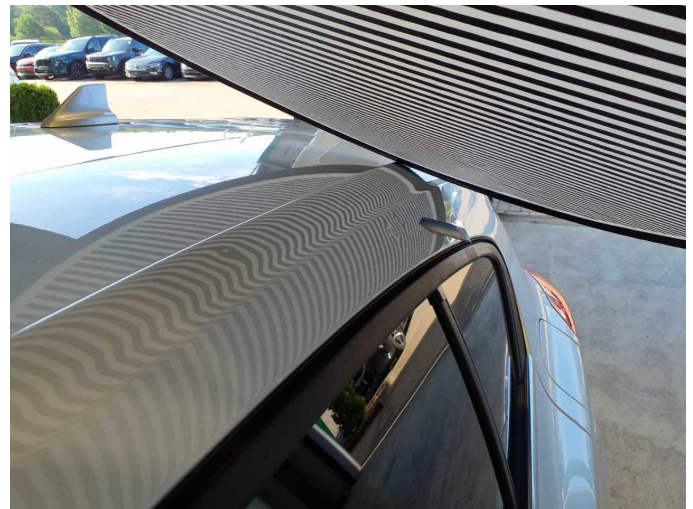
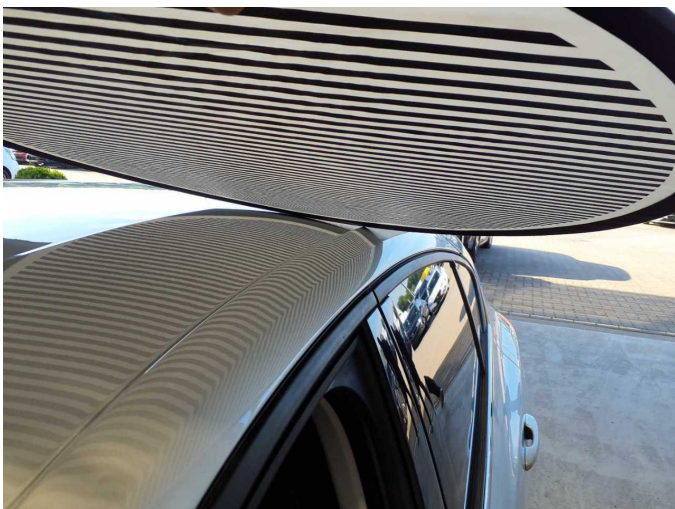
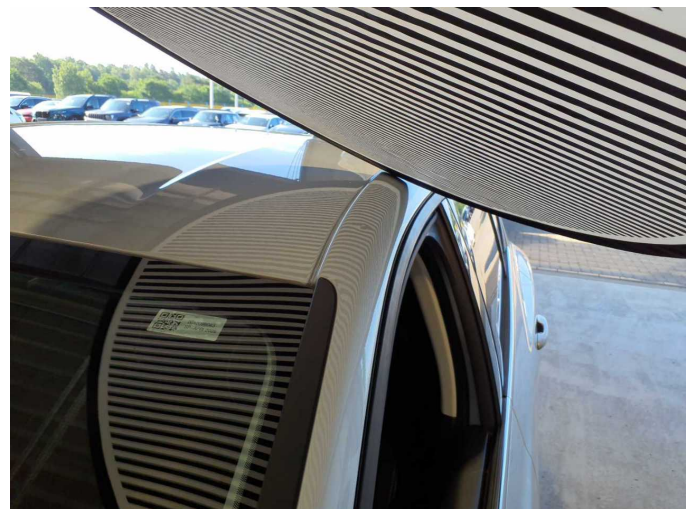
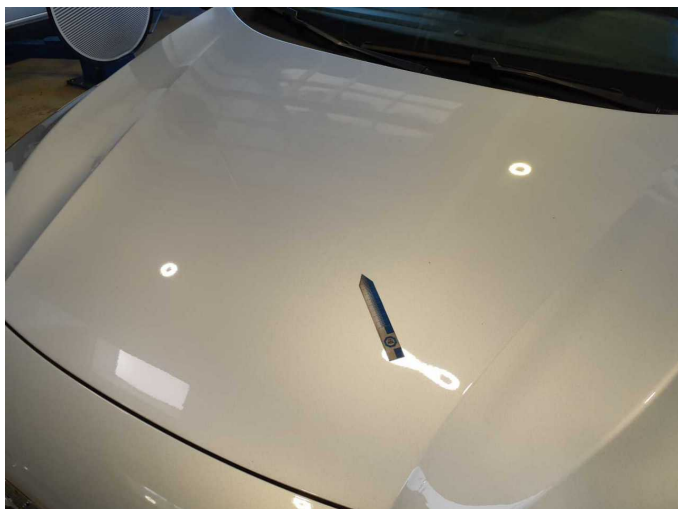
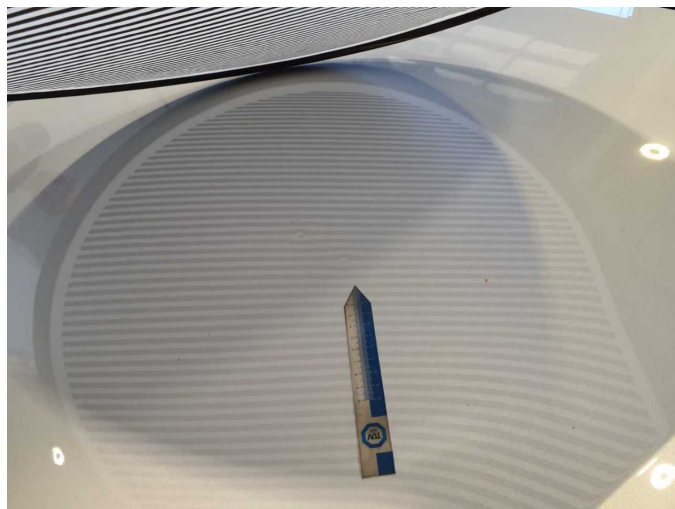
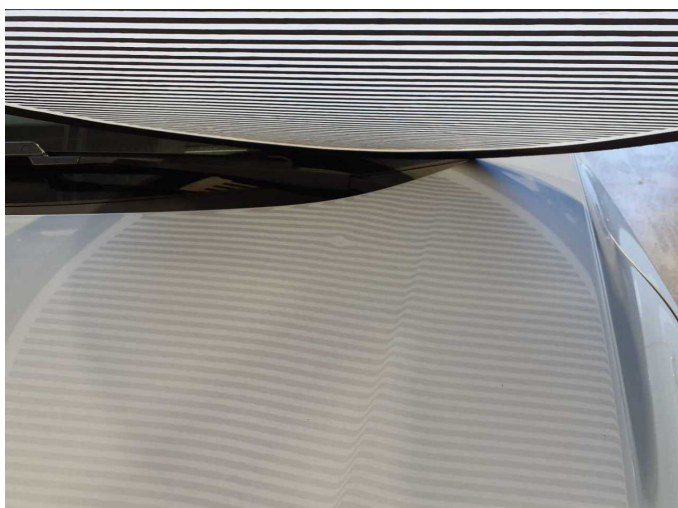
| No. | Component group | Description |
|---|---|---|
| 6 | Body | Body (Mehrkosten möglich) - Damage by hail - repair according to calculation |

**Damage 6:** Body: Body (Mehrkosten möglich) - Damage by hail - repair according to calculation

- Die beigefügte Reparaturkostenkalkulation wurde nach bestem Wissen und Gewissen unter eingeschränkten Besichtigungsbedingung im demontagefreien Zustand erstellt. Es können aufgrund verdeckter Beschädigung erhebliche Mehrkosten und somit Abweichung der für den Unfall ausgewiesenen Reparaturkosten nicht ausgeschlossen werden.

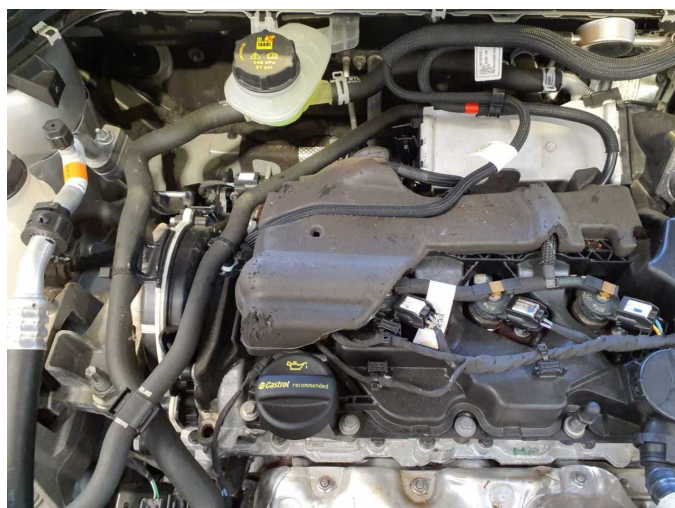
Engine - Engine cover

**Missing part 2:** Engine: Engine cover - Missing - Replace

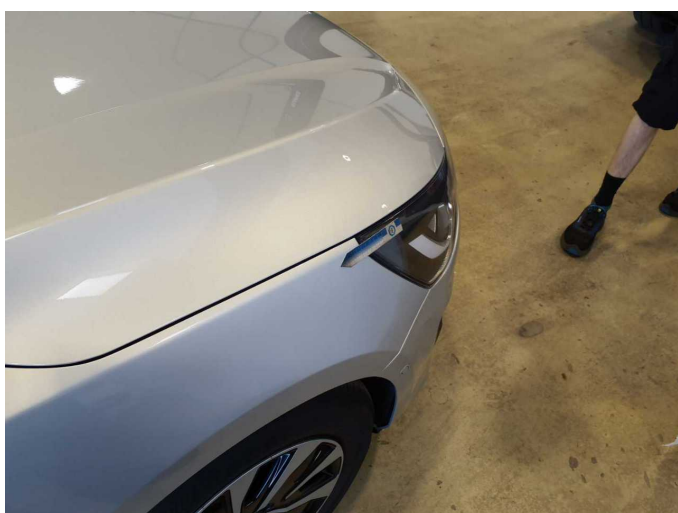
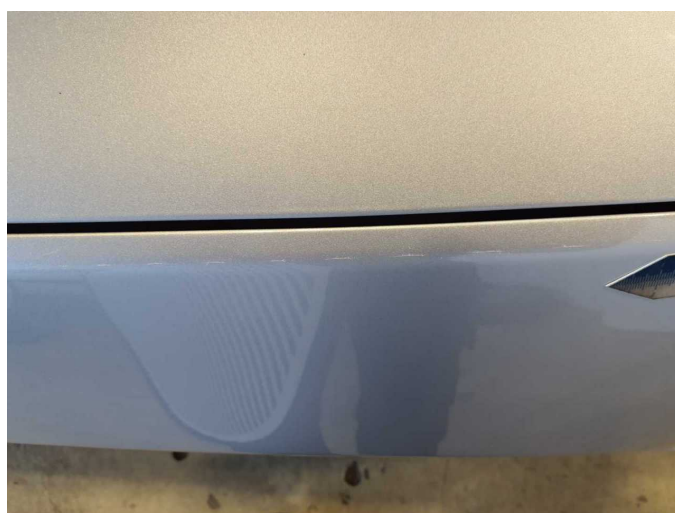
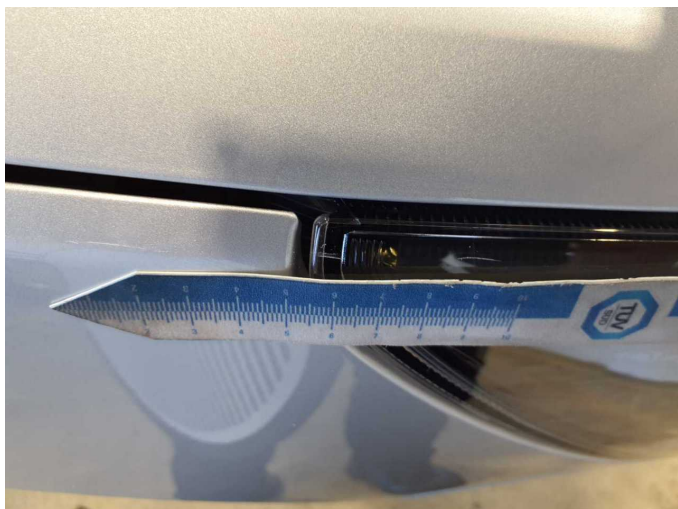
1 Front, Side right

Non-repaired previous damages were found at the vehicle. The necessary repair costs are listed in the expert report or if necessary, are listed in detail in a separately enclosed repair cost calculation.

**Accident 1:** Front, Side right
