## Expertise

Protocol number: 45619243  
Order No. / Reference: 26152392  
Inspection date: 8 May 2026

Model: Vito 116 CDI Extralang HA PRO

VIN: W1VVLCEZ2S4451702

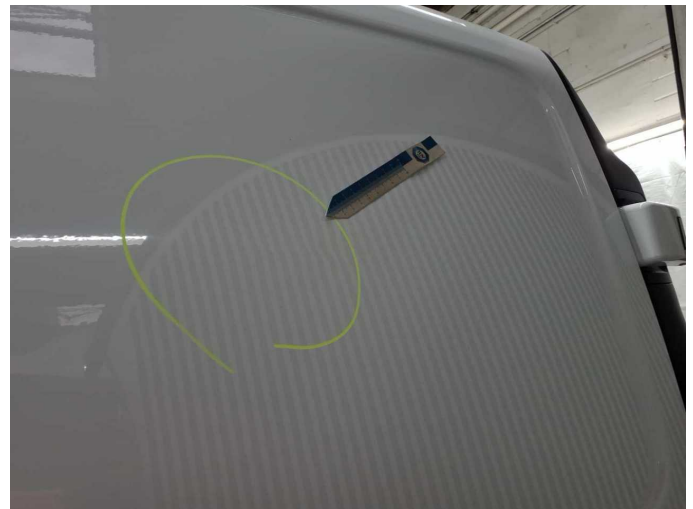
Damage 3: Boot lid / rear door: Rear door - right side - dent(s) - Smooth repair work

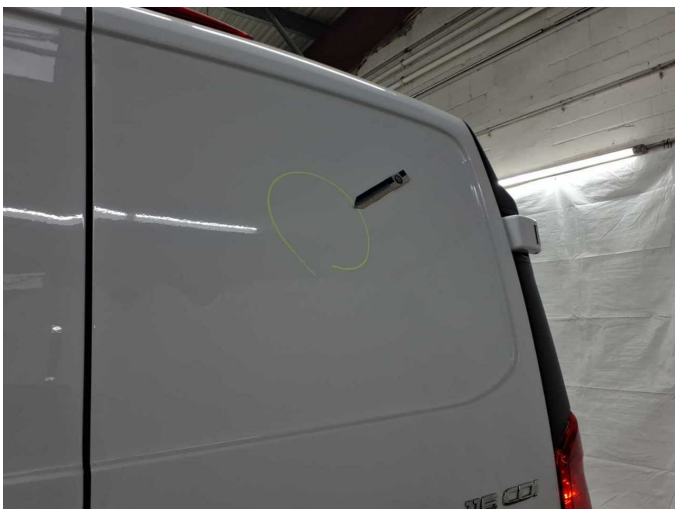
Damage 3: Boot lid / rear door: Rear door - right side - dent(s) - Smooth repair work

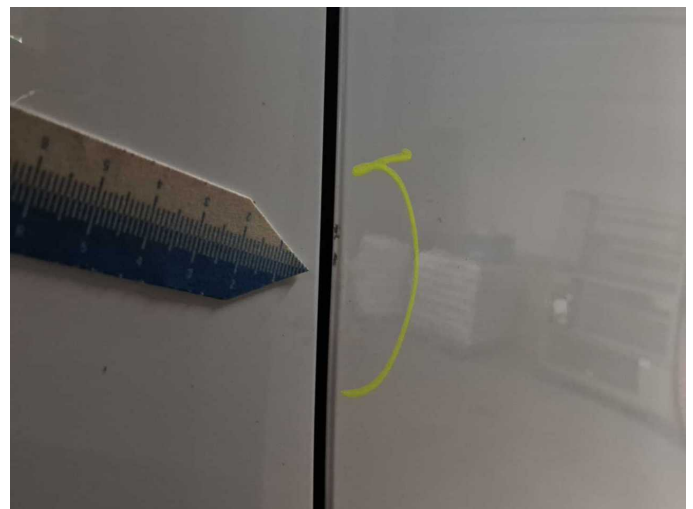
Damage 4: Door - front right side: Door - Scratch(es) - Smart repair work

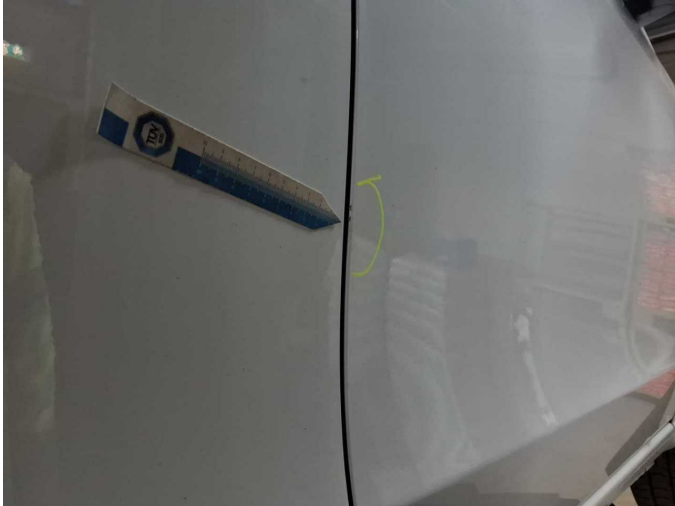
**Damage 4:** Door - front right side: Door - Scratch(es) - Smart repair

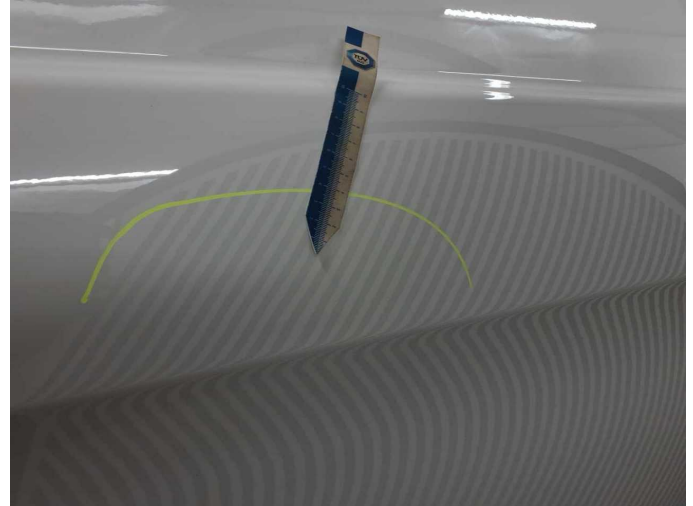
**Damage 5:** Sliding door, right: Sliding door - dent(s) - Smooth repair work

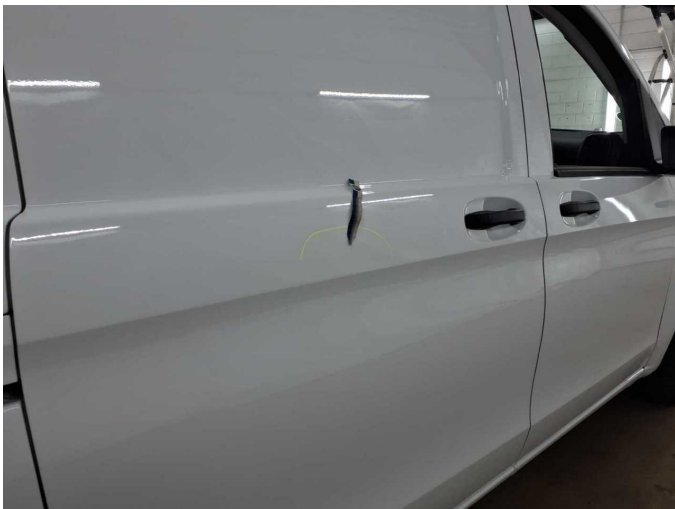
**Damage 5:** Sliding door, right: Sliding door - dent(s) - Smooth repair work

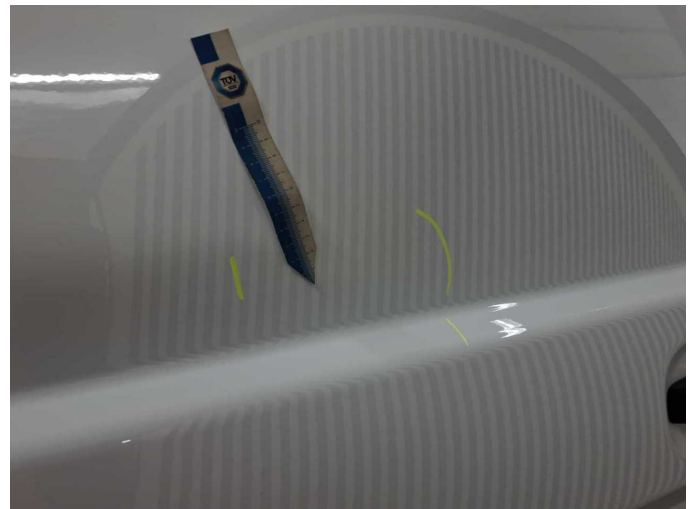
**Damage 5:** Sliding door, right: Sliding door - dent(s) - Smooth repair work

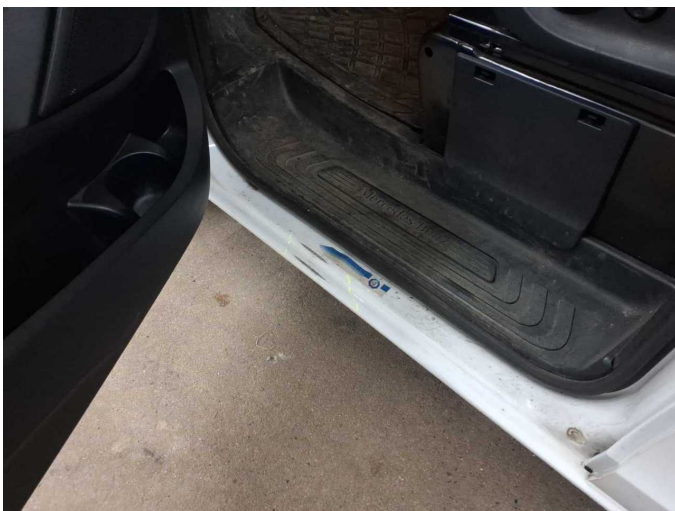
**Damage 6:** Sill - left side: Sill - Scratch(es) - Smart repair

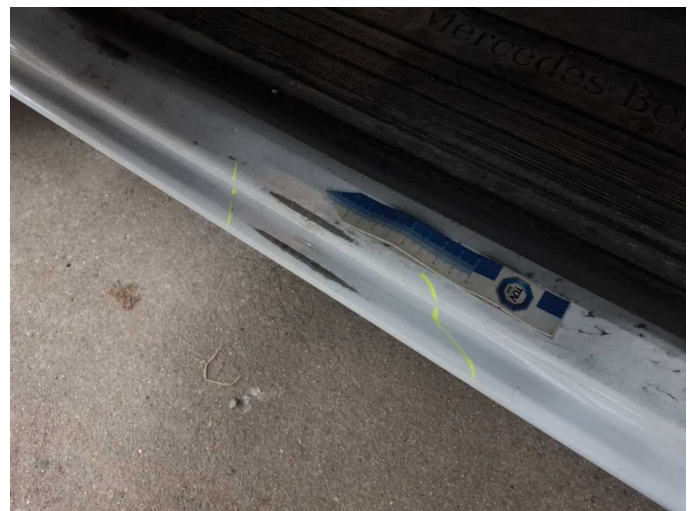
**Damage 6:** Sill - left side: Sill - Scratch(es) - Smart repair

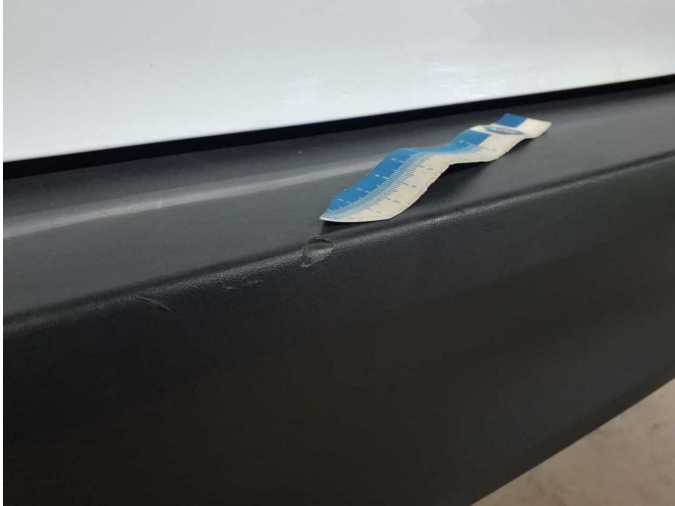
**Damage 7:** Rear bumper: Rear bumper - Dent / paintcoat damage - Loss in value

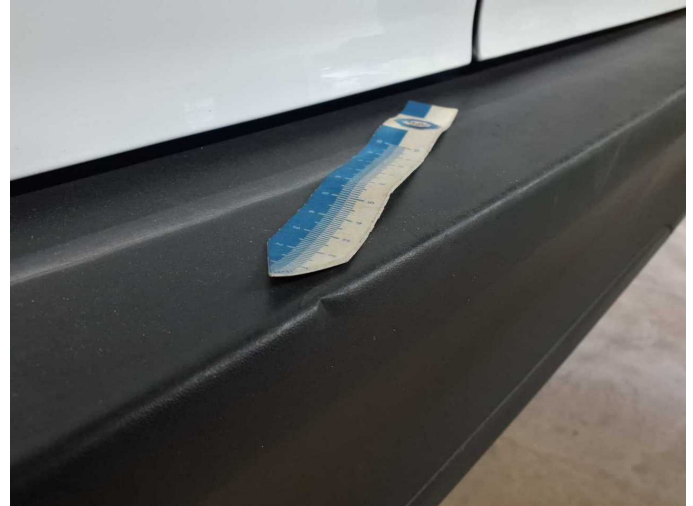
**Damage 7:** Rear bumper: Rear bumper - Dent / paintcoat damage - Loss in value

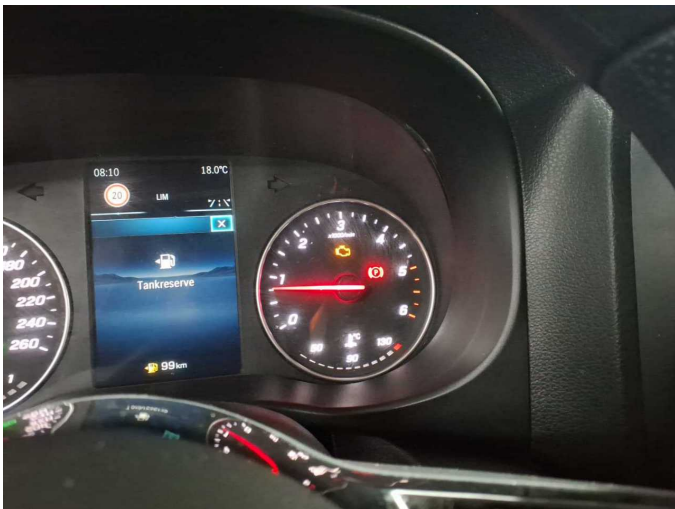
Documents submitted	At the time of the inspection, the vehicle registration certificate Part 2 (title) was available, but the vehicle registration certificate Part 1 (document) was not. (Copy)
VIN comparison	The vehicle identification number (VIN) was read from the vehicle and its conformity with the submitted documents was confirmed by the undersigned during the inspection.
Inspection	The inspection conditions were sufficient for the assessment of the vehicle. Lifting equipment and/or a pit were available for examining the vehicle.
Test drive	No test drive/shunting maneuver was carried out during the inspection of the vehicle.
Engine function test	An engine test run was performed, problem has been detected This is due to the following reason.: Motorkontrolle aktiv

**Damage 8:** Instrument panel: Indicator light (Motorkontrolle, nicht fahrbereit) - on - Perform diagnosis

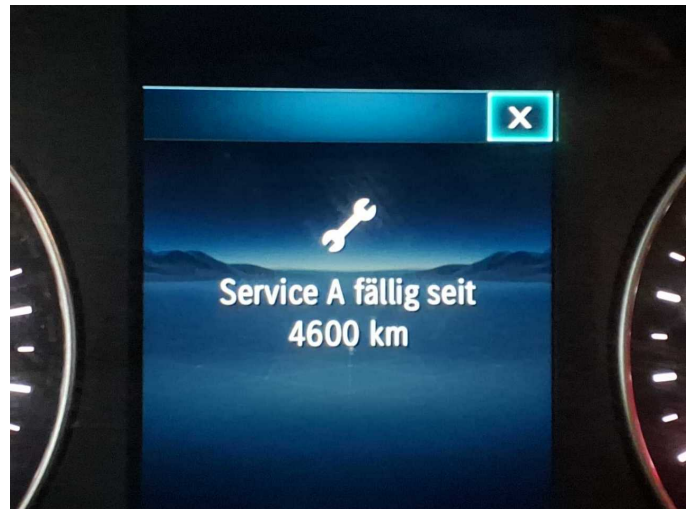
**Damage 9:** Documents: Service book (-4600 km) - Due - Perform

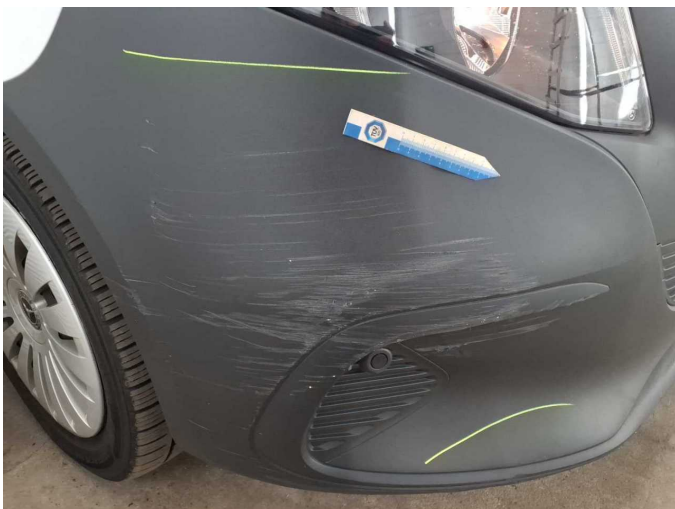
**Damage 10:** Front bumper: Front bumper - Scratched - Replace

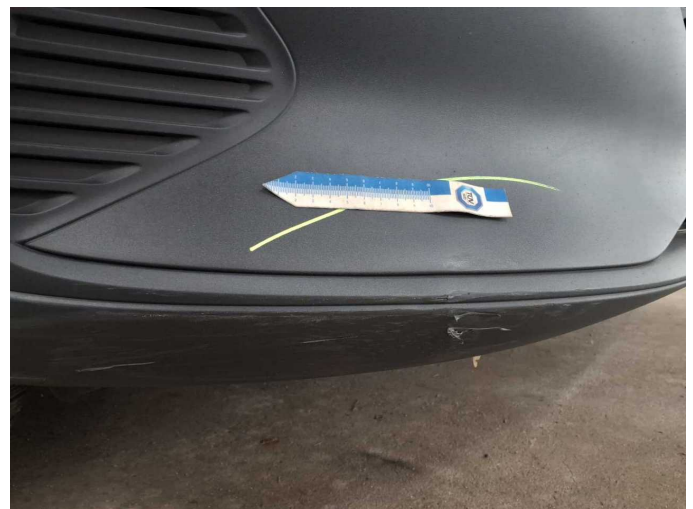
**Damage 10:** Front bumper: Front bumper - Scratched - Replace

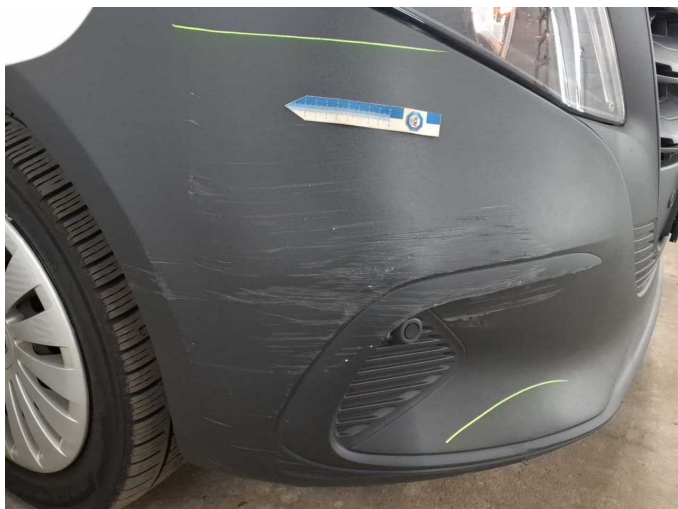
**Damage 10:** Front bumper: Front bumper - Scratched - Replace
