## Expertise

Protocol number: 45807099  
Order No. / Reference: 26344035  
Inspection date: 22 May 2026

Model: 215 CDI Sprinter Doka HA RA 3665 MM 3,0 T

VIN: W1V9072231N139818

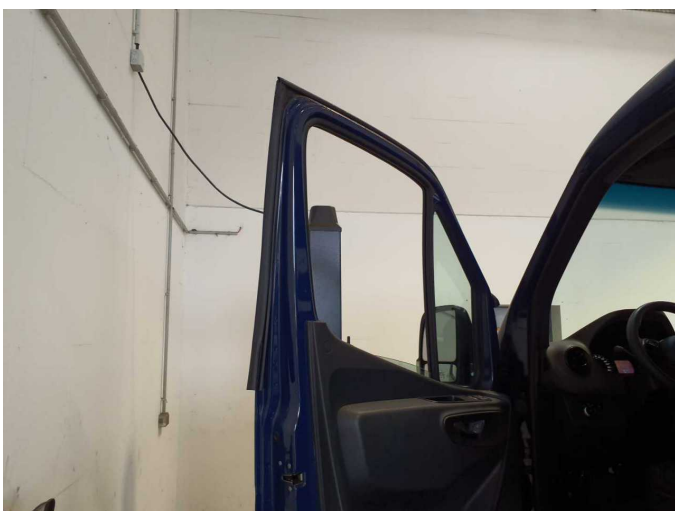
Damage 1: Door - front left side: Door seal - Loose - Un- / install

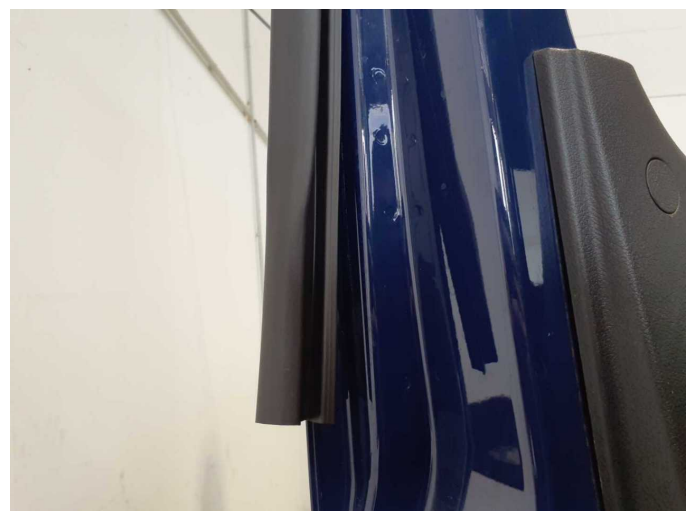
Damage 1: Door - front left side: Door seal - Loose - Un- / install

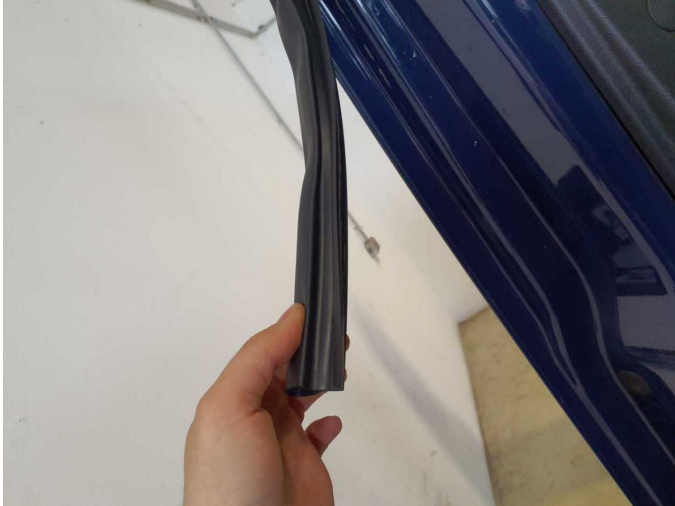
**Damage 1:** Door - front left side: Door seal - Loose - Un- / install

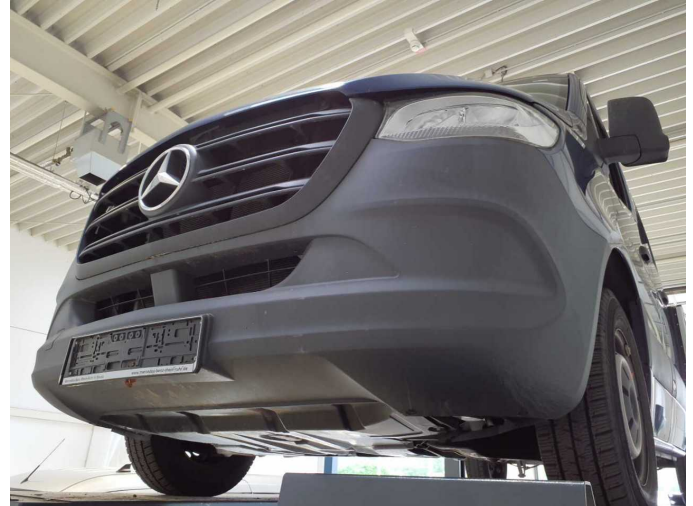
**Damage 2:** Front bumper: Front bumper (unpainted) - Scratch(es) - Loss in value

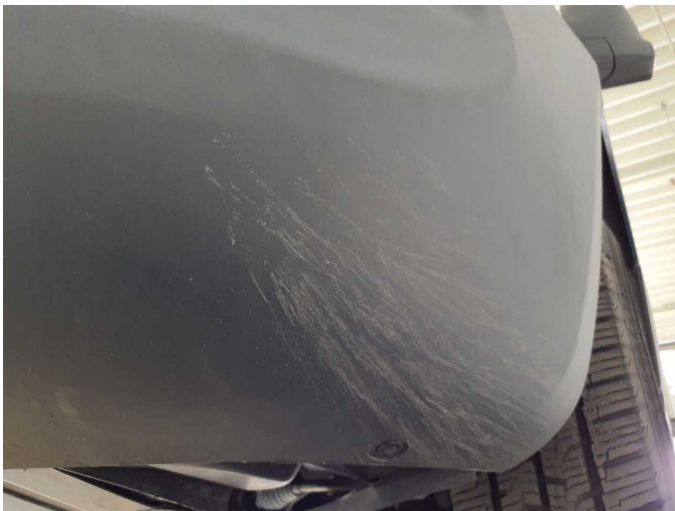
**Damage 2:** Front bumper: Front bumper (unpainted) - Scratch(es) - Loss in value

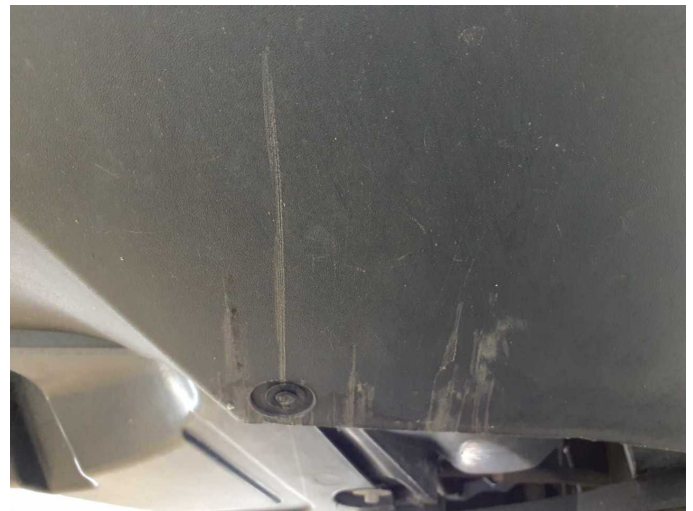
**Damage 2:** Front bumper: Front bumper (unpainted) - Scratch(es) - Loss in value

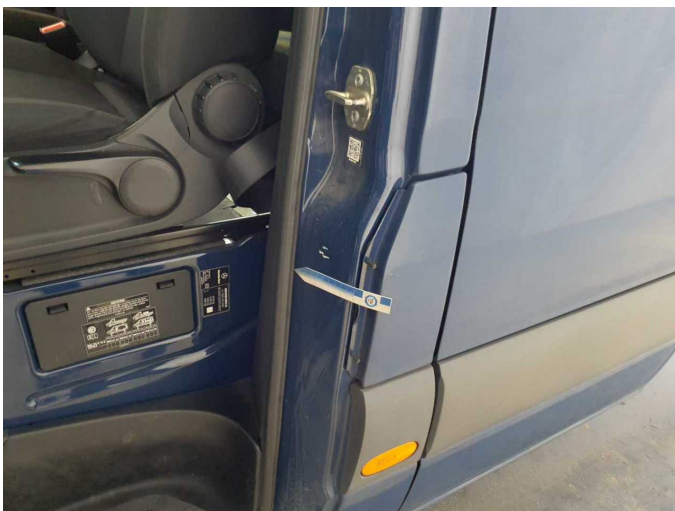
**Damage 3:** Body: B-pillar - left side - Dent / paintcoat damage - Smart repair

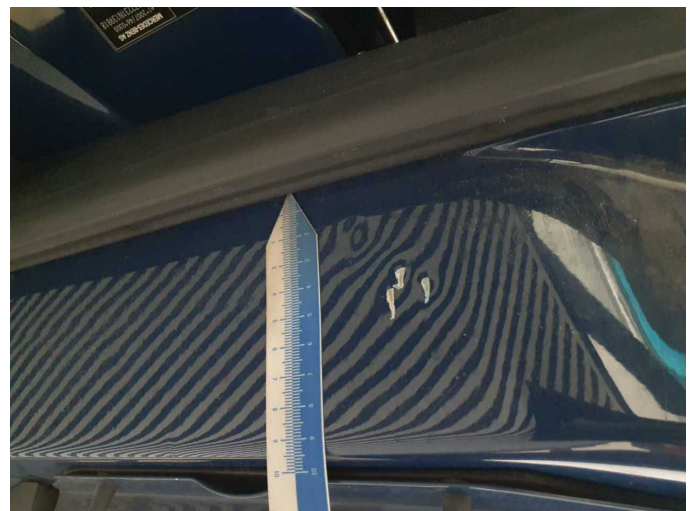
**Damage 3:** Body: B-pillar - left side - Dent / paintcoat damage - Smart repair

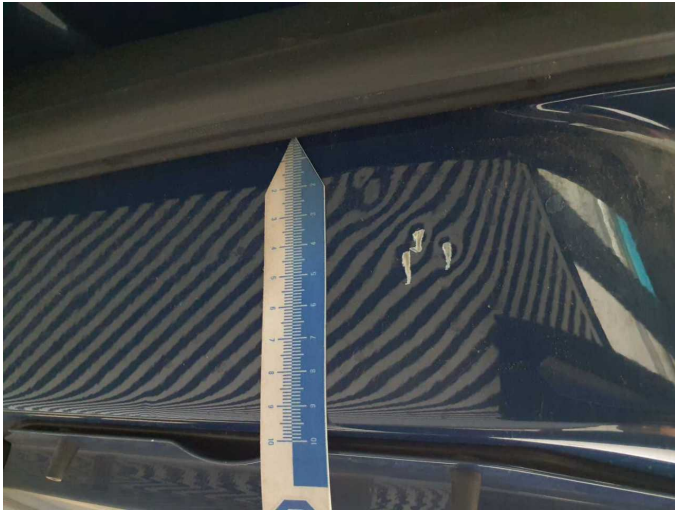
**Damage 3:** Body: B-pillar - left side - Dent / paintcoat damage - Smart repair

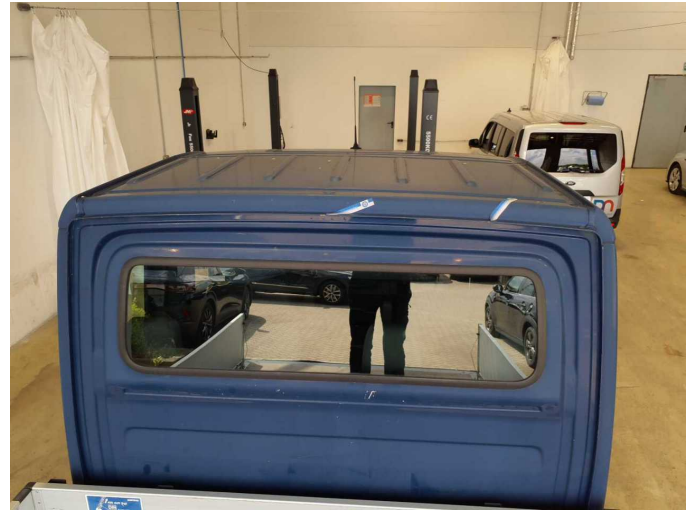
**Damage 4:** Roof: Roof (Dachkante) - Corrosion - Smart repair

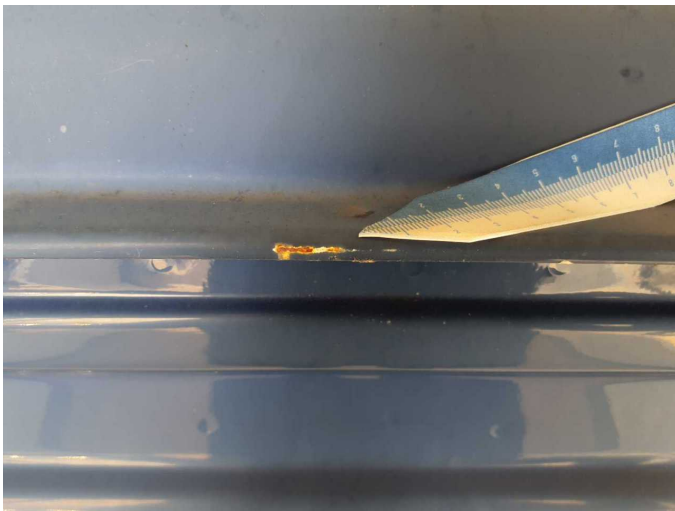
**Damage 4:** Roof: Roof (Dachkante) - Corrosion - Smart repair

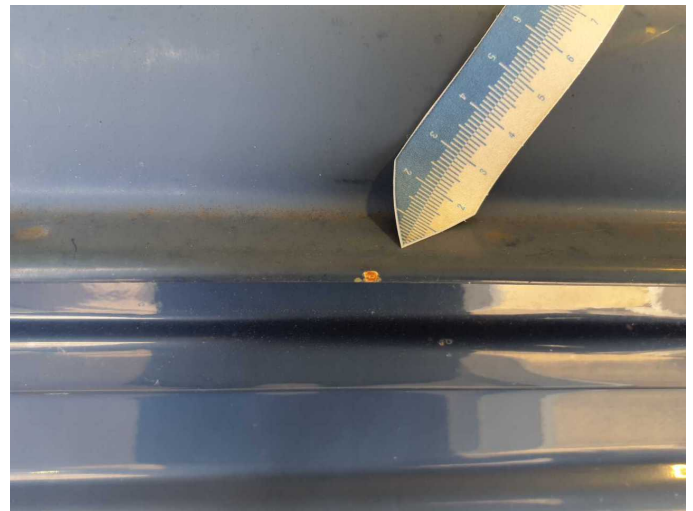
**Damage 4:** Roof: Roof (Dachkante) - Corrosion - Smart repair

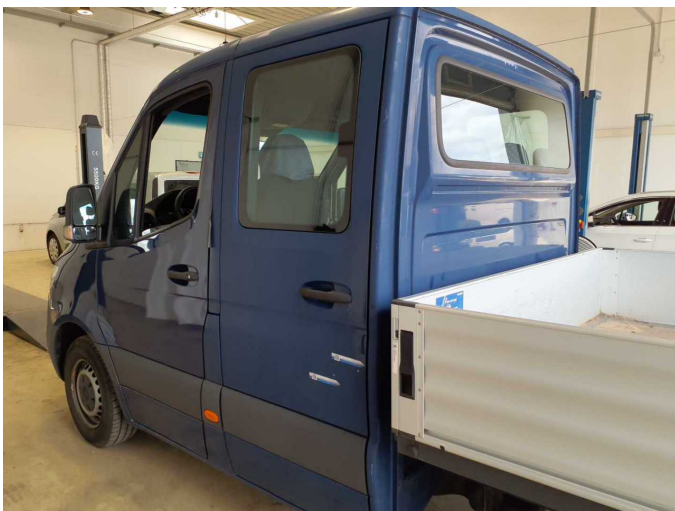
**Damage 6:** Door - rear left side: Door - Dent / paintcoat damage - Smart repair

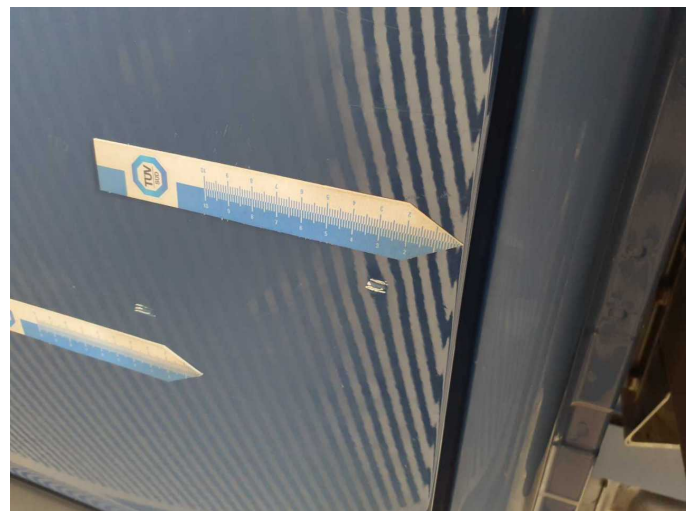
**Damage 6:** Door - rear left side: Door - Dent / paintcoat damage - Smart repair

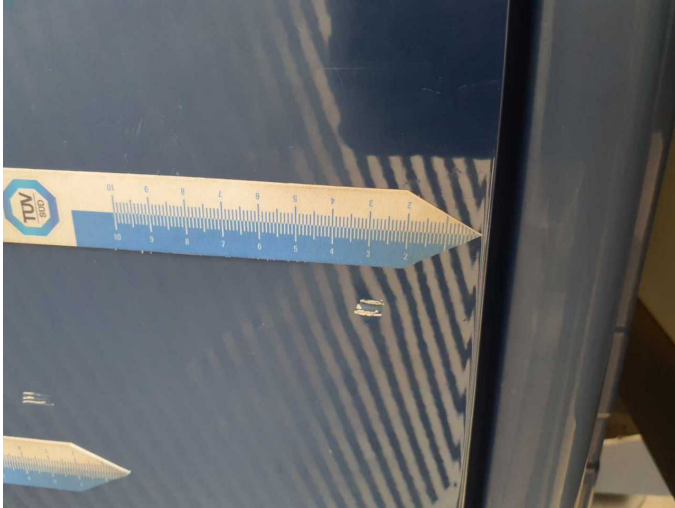
**Damage 6:** Door - rear left side: Door - Dent / paintcoat damage - Smart repair

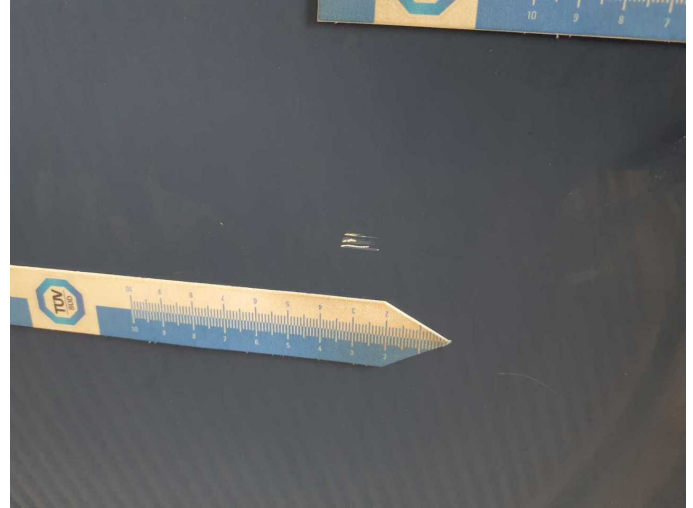
**Damage 6:** Door - rear left side: Door - Dent / paintcoat damage - Smart repair

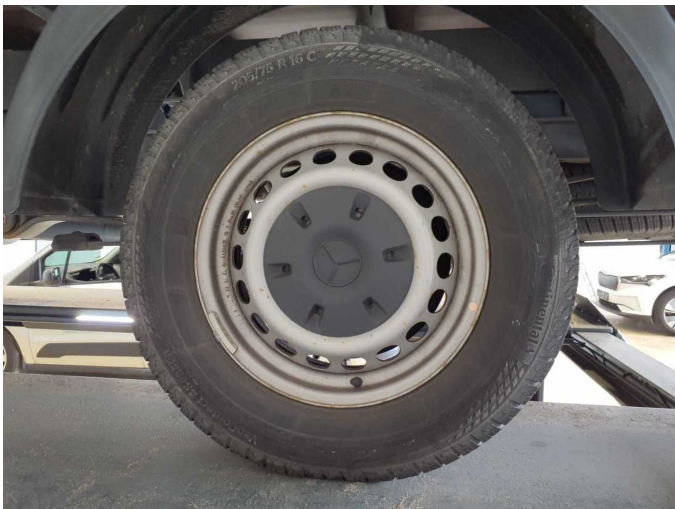
**Damage 7:** Wheel / tyres: Tyre - right (Keine Winterreifeneigenschaften) - Does not meet the leasing specifications - Replace

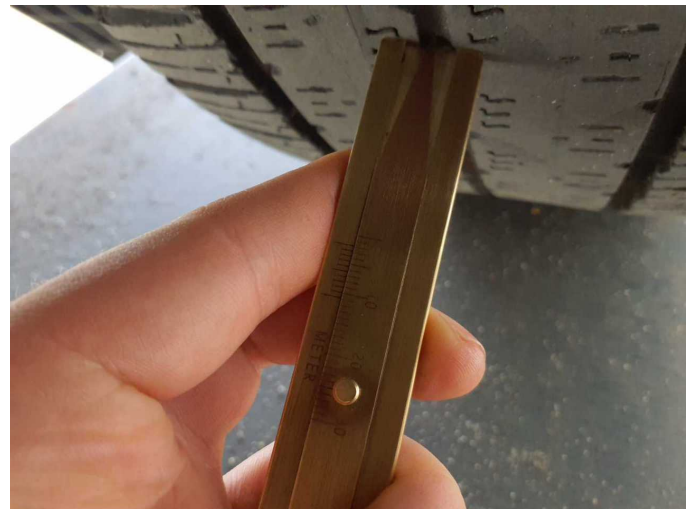
**Damage 7:** Wheel / tyres: Tyre - right (Keine Winterreifeneigenschaften) - Does not meet the leasing specifications - Replace

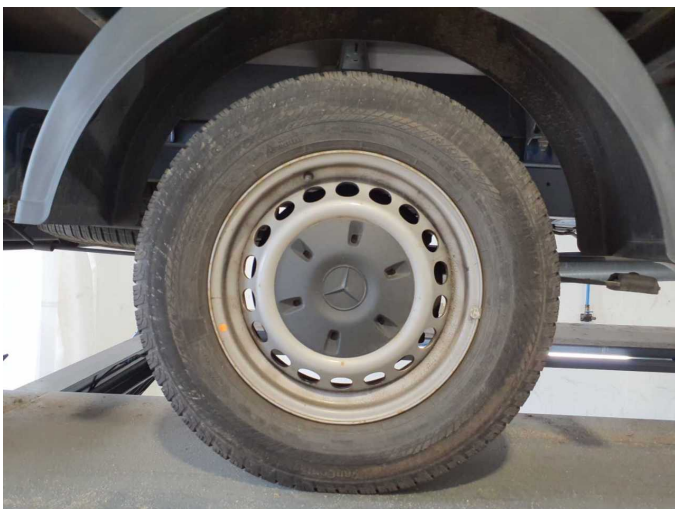
**Damage 7:** Wheel / tyres: Tyre - right (Keine Winterreifeneigenschaften) - Does not meet the leasing specifications - Replace

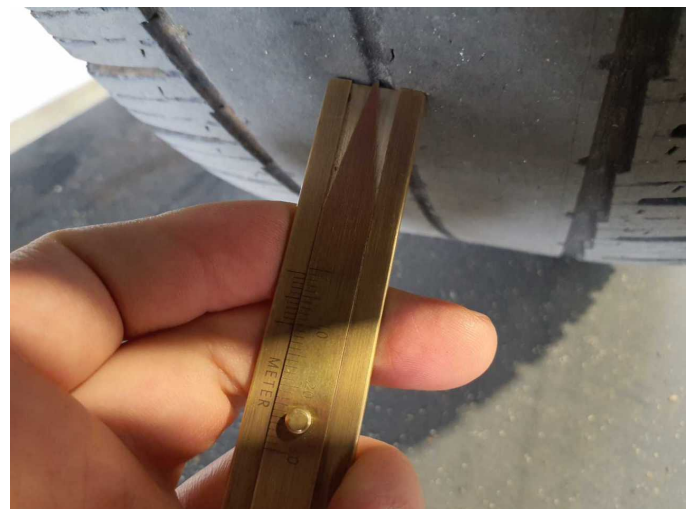
**Damage 7:** Wheel / tyres: Tyre - right (Keine Winterreifeneigenschaften) - Does not meet the leasing specifications - Replace

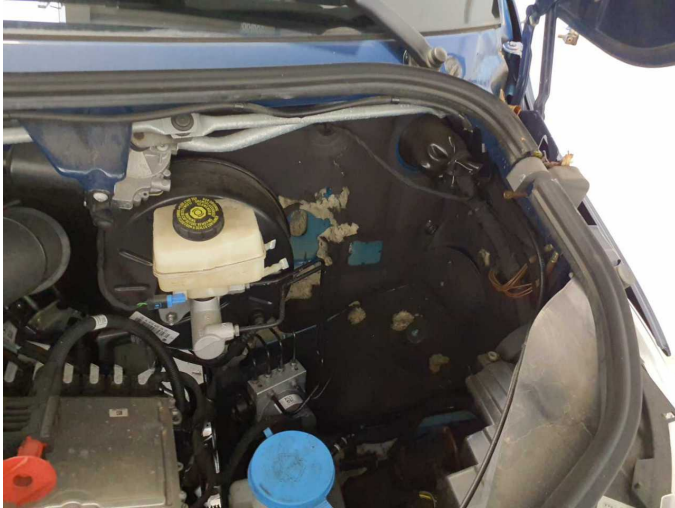
**Damage 8:** Cab: Insulation lining - Damage caused by marten / rodent - Replace

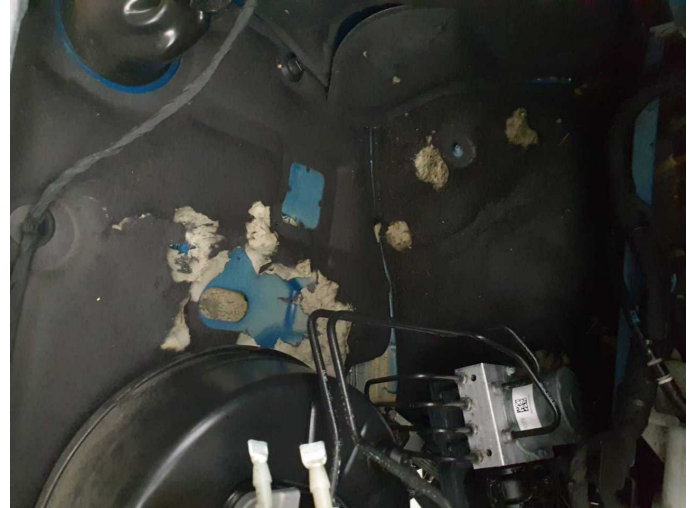
**Damage 8:** Cab: Insulation lining - Damage caused by marten / rodent - Replace

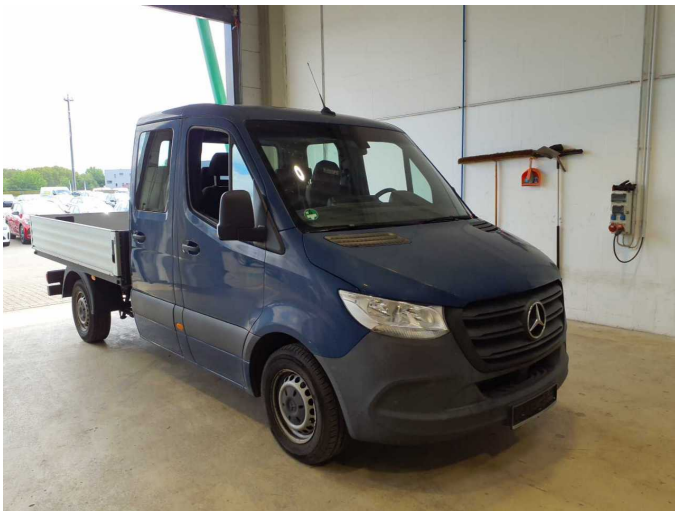
**Damage 9:** Body: Body (Stellenweise matt) - Paint defect - Conditioning

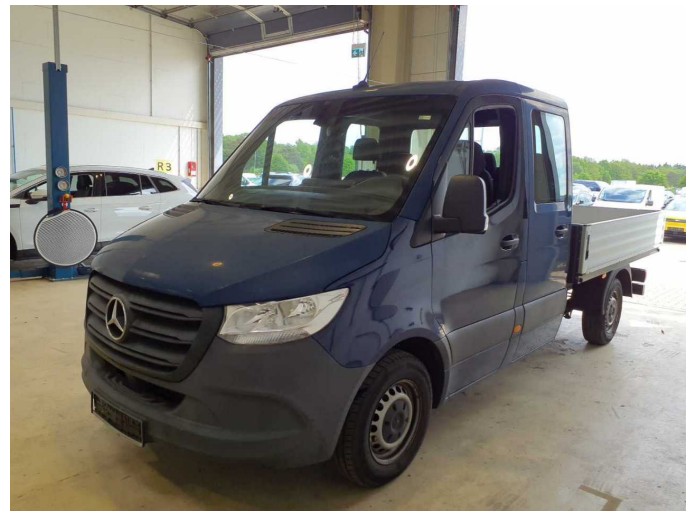
**Damage 9:** Body: Body (Stellenweise matt) - Paint defect - Conditioning

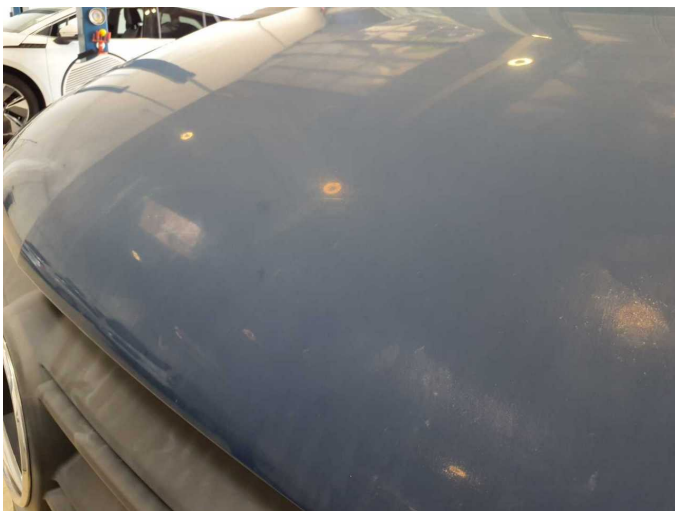
**Damage 9:** Body: Body (Stellenweise matt) - Paint defect - Conditioning

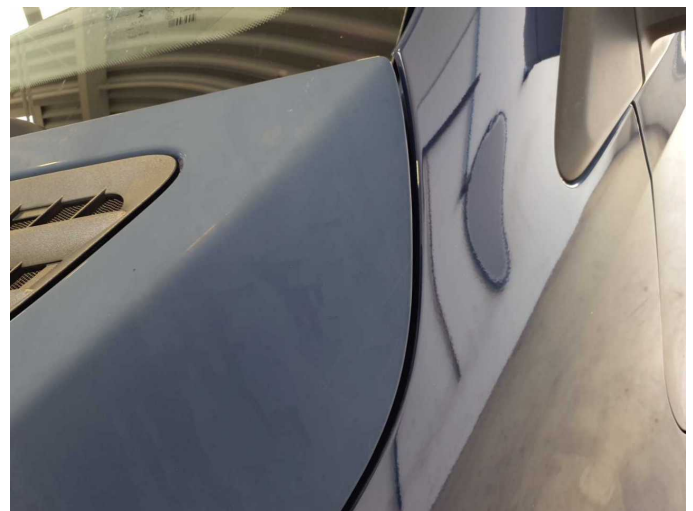
**Damage 9:** Body: Body (Stellenweise matt) - Paint defect - Conditioning

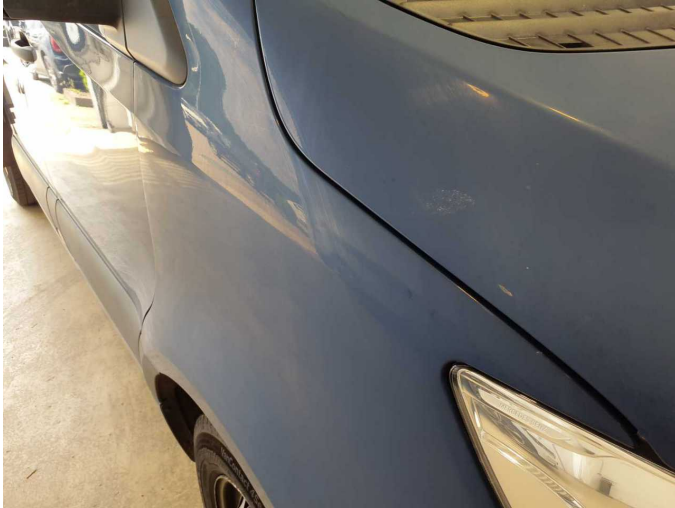
**Damage 9:** Body: Body (Stellenweise matt) - Paint defect - Conditioning

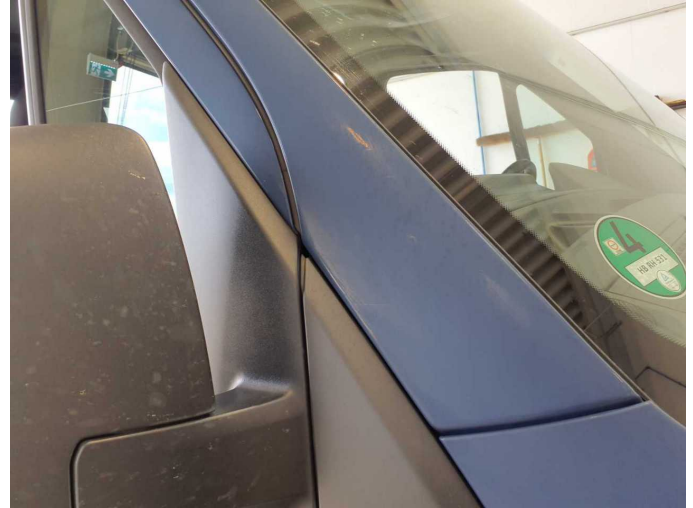
**Damage 9:** Body: Body (Stellenweise matt) - Paint defect - Conditioning

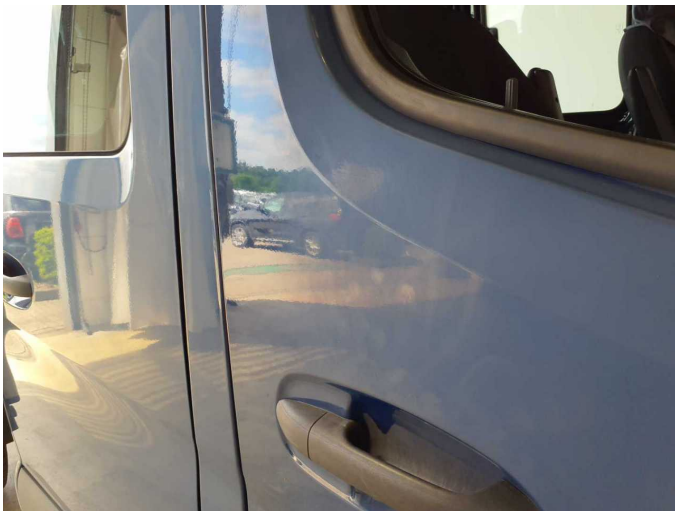
**Damage 9:** Body: Body (Stellenweise matt) - Paint defect - Conditioning

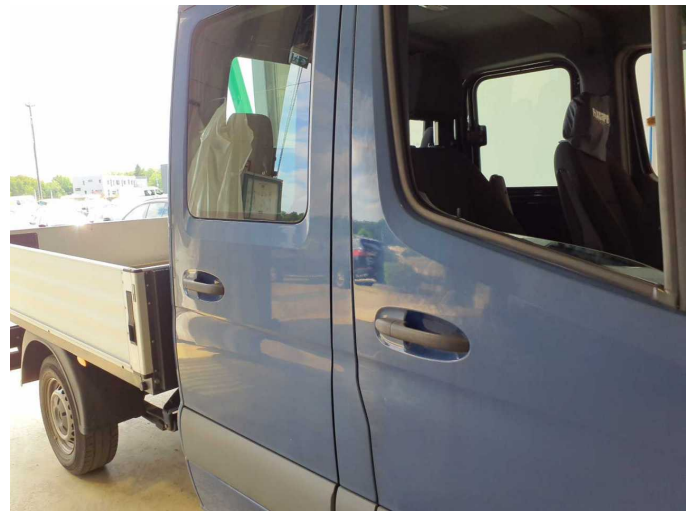
**Damage 9:** Body: Body (Stellenweise matt) - Paint defect - Conditioning

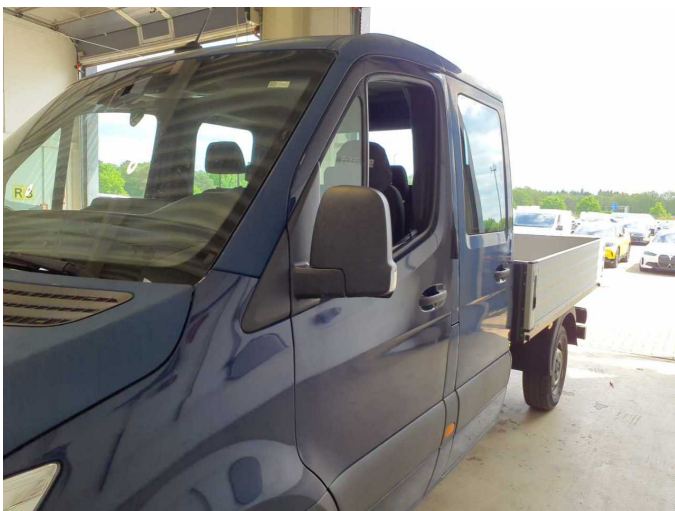
**Damage 9:** Body: Body (Stellenweise matt) - Paint defect - Conditioning

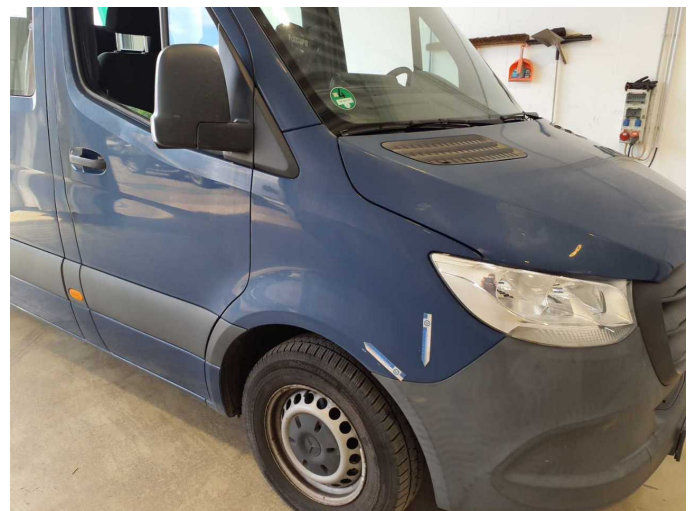
**Damage 10:** Mudguard - right side: Mudguard - right side - Scratch(es) - Paint

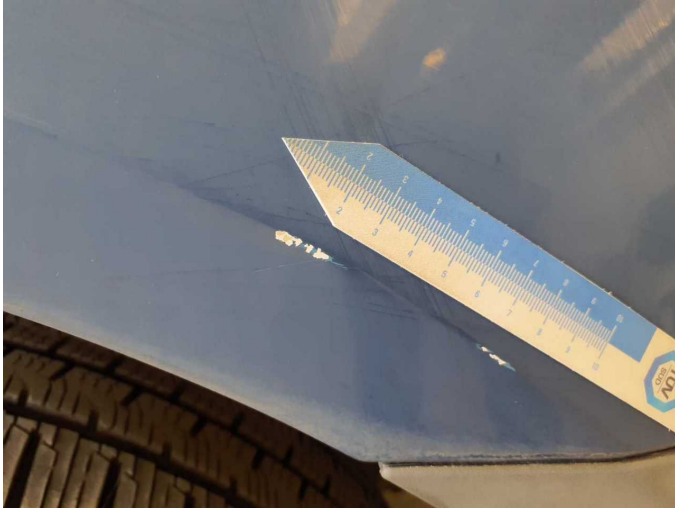
**Damage 10:** Mudguard - right side: Mudguard - right side - Scratch(es) - Paint

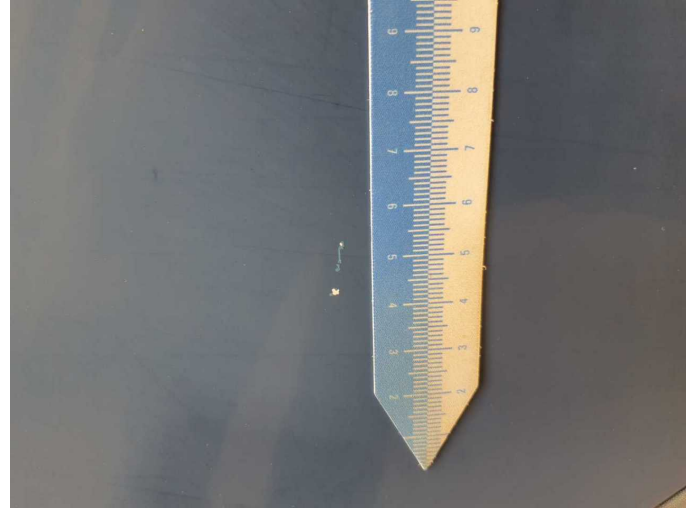
**Damage 10:** Mudguard - right side: Mudguard - right side - Scratch(es) - Paint

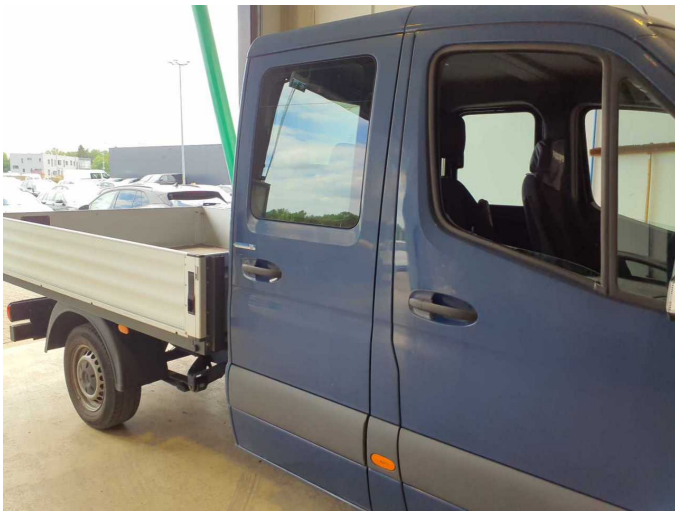
**Damage 11:** Door - rear right side: Door - Dent / paintcoat damage - Repair and paint

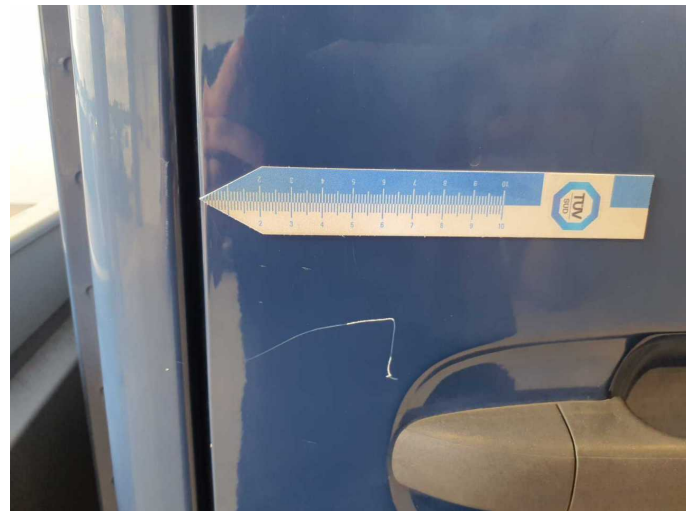
**Damage 11:** Door - rear right side: Door - Dent / paintcoat damage - Repair and paint

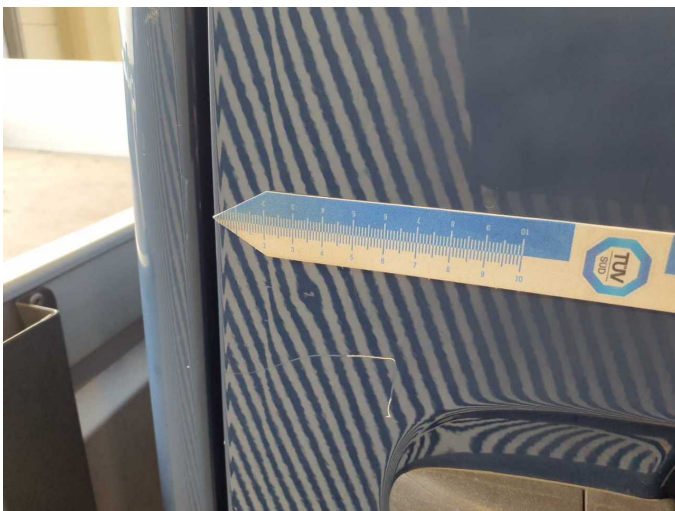
**Damage 11:** Door - rear right side: Door - Dent / paintcoat damage - Repair and paint

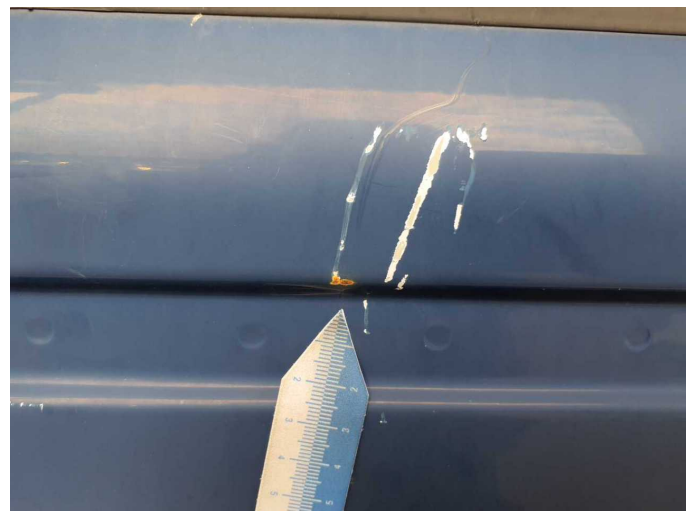
**Damage 12:** Cab: Rear panel - Corrosion - Repair and paint

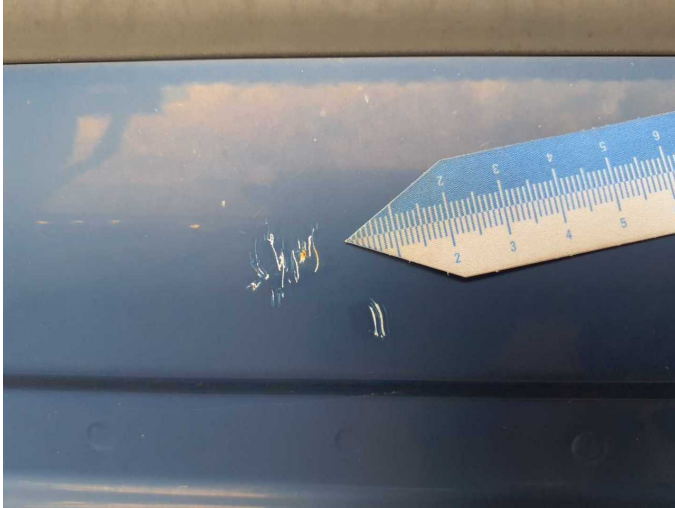
**Damage 12:** Cab: Rear panel - Corrosion - Repair and paint

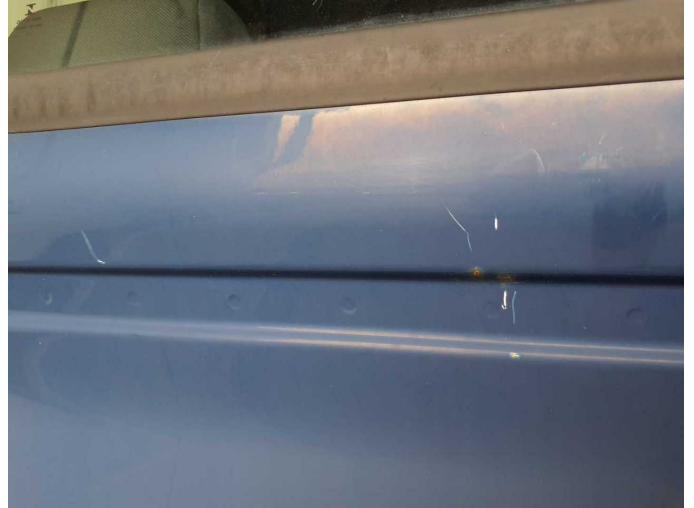
**Damage 12:** Cab: Rear panel - Corrosion - Repair and paint

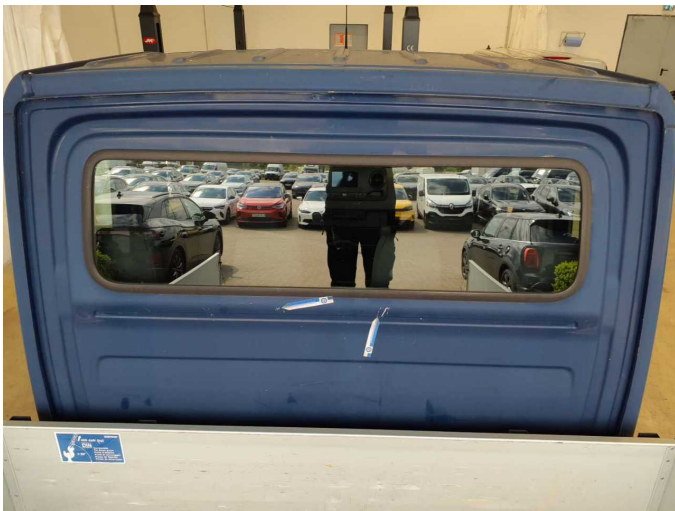
**Damage 12:** Cab: Rear panel - Corrosion - Repair and paint

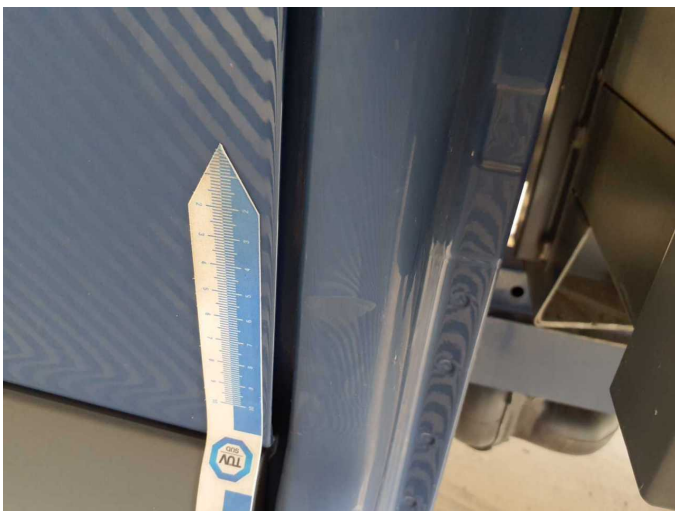
**Damage 12:** Cab: Rear panel - Corrosion - Repair and paint
