## Condition Report

DEKRA/ /20260507

| Brand | SKODA | VIN | TMBAH7NP8N7052535 | Drive Wheel | Front-wheel-drive | First Registration | 2022.07.12 |
| Model | Superb | Year Built | 2022 | Color | Grey | Fuel Type | Diesel |

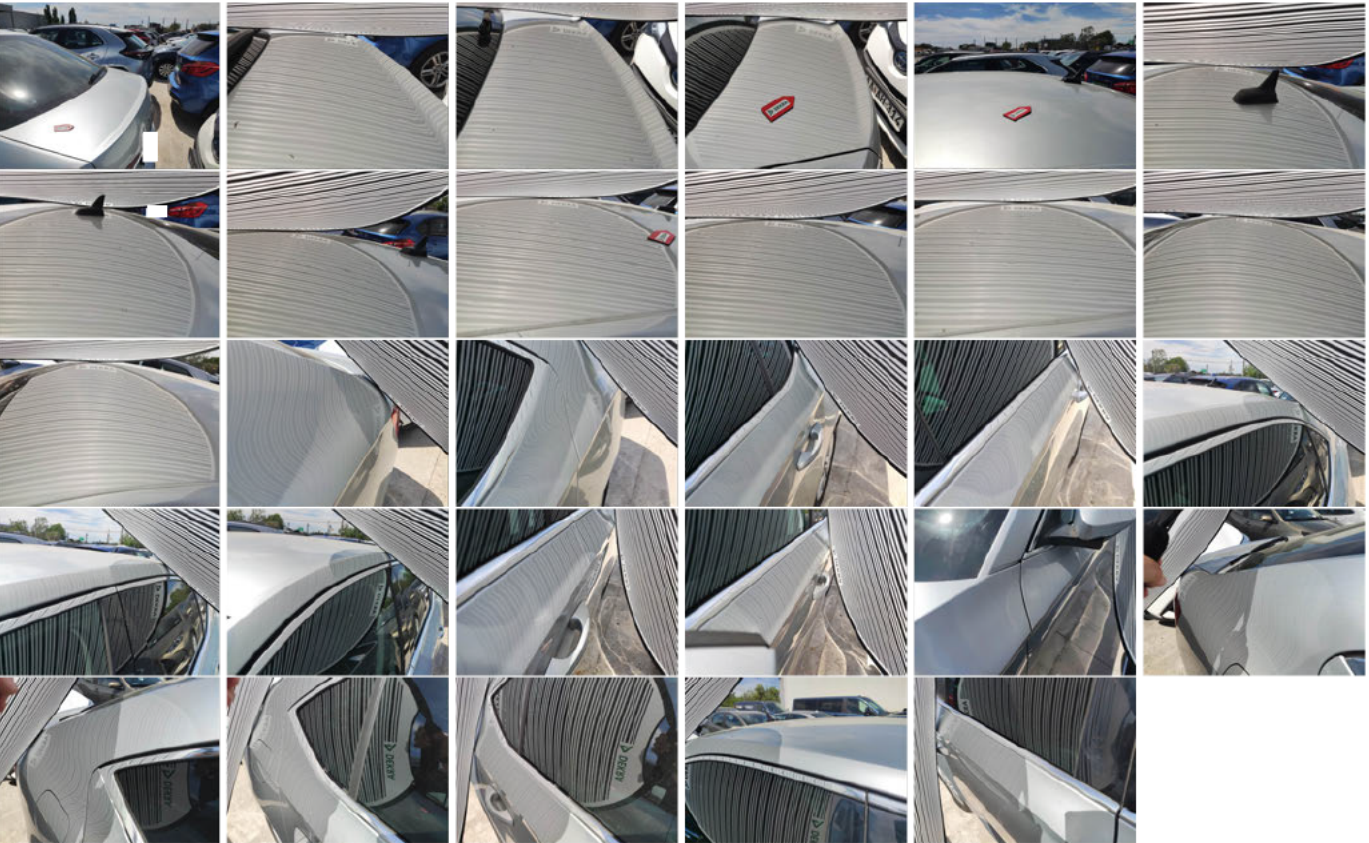
| Part | Karosszéria | Damage | Hail damaged | Repair Method | Smart repairment |
