Expertise

Protocol number: 46536184  
Order No. / Reference: 26649007  
Inspection date: 15 Jul 2026

Manufacturer: Opel

Model: Astra Sports Tourer 1.5 D Automatik Elegance

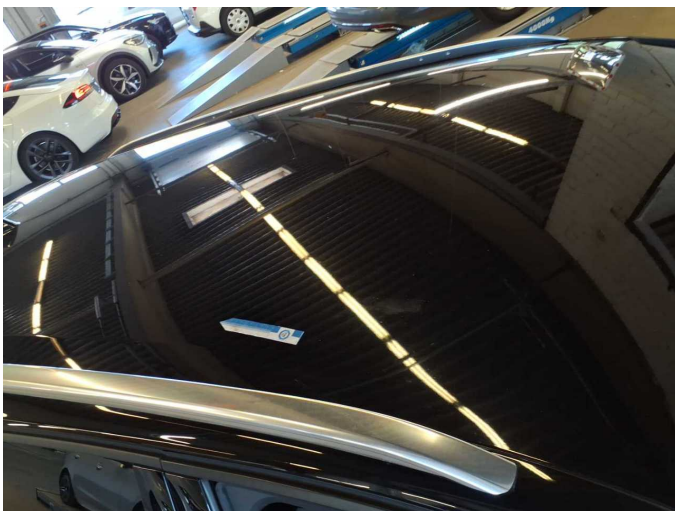
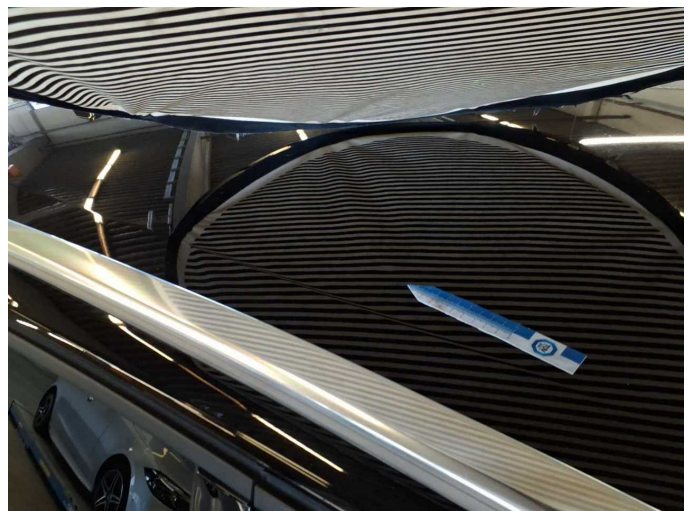
| No. | Component group | Description |
|---|---|---|
| 1 | Roof | Roof - dent(s) - Smooth repair work |

Damage 1: Roof: Roof - dent(s) - Smooth repair work

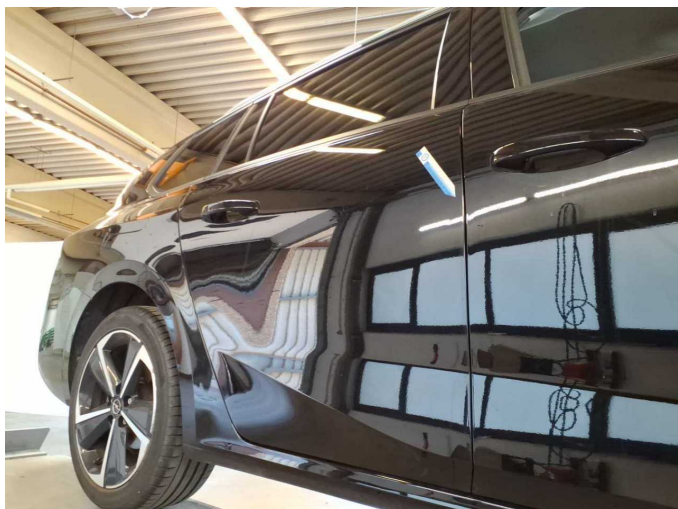
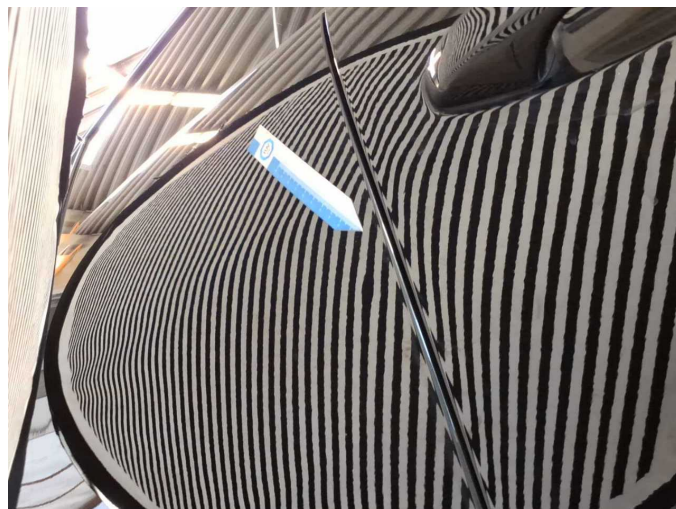
| No. | Component group | Description |
|---|---|---|
| 2 | Door - rear right side | Door - dent(s) - Smooth repair work |

**Damage 2:** Door - rear right side: Door - dent(s) - Smooth repair work

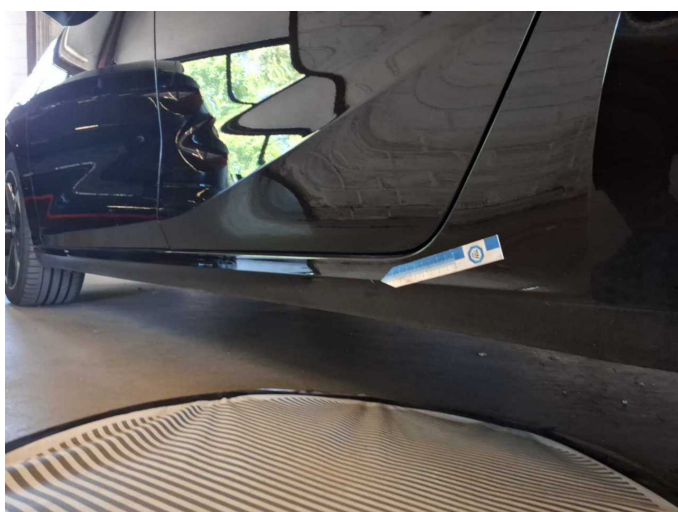
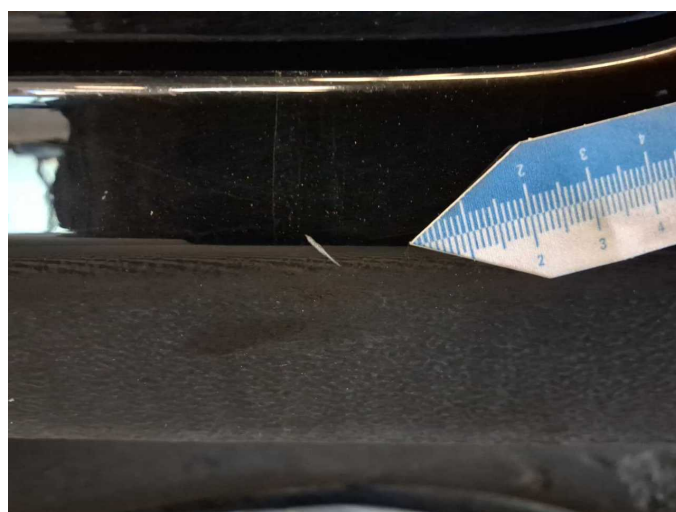
| No. | Component group | Description |
|---|---|---|
| 3 | Sill - left side | Sill - Scratch(es) - Smart repair |

**Damage 3:** Sill - left side: Sill - Scratch(es) - Smart repair

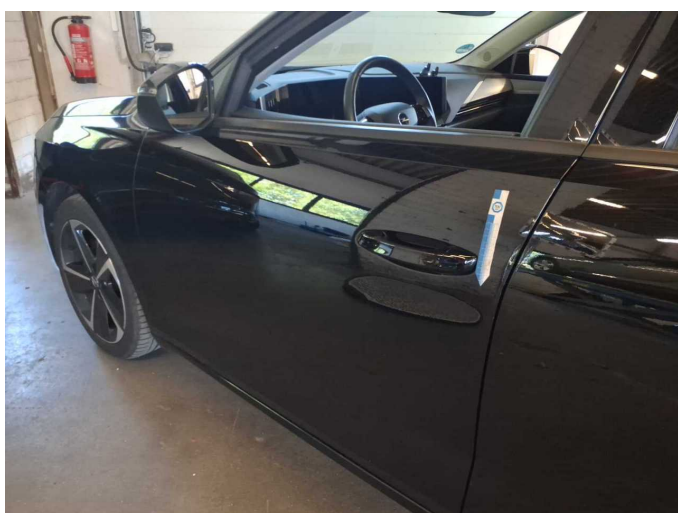
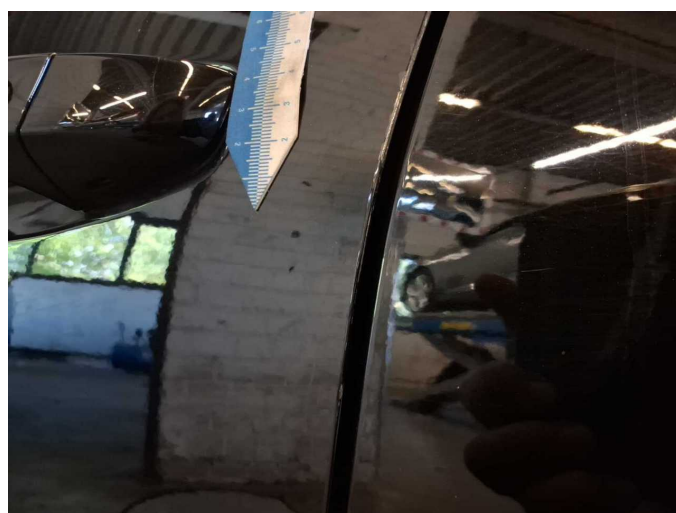
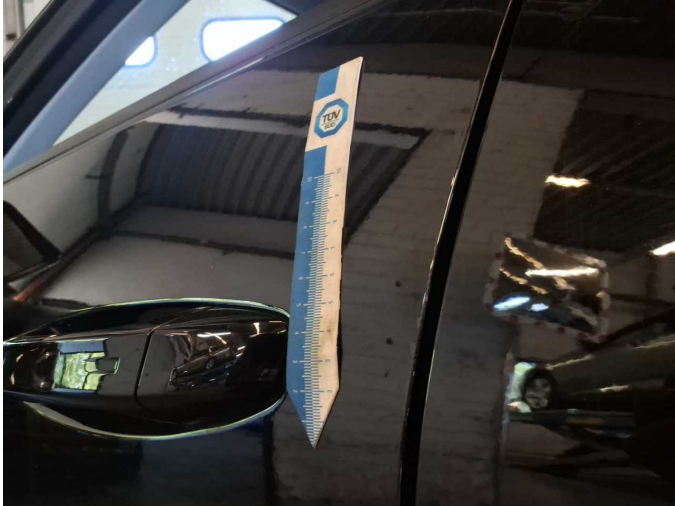
| No. | Component group | Description |
|---|---|---|
| 4 | Door - front left side | Door edge - Scratched - Smart repair |

**Damage 4:** Door - front left side: Door edge - Scratched - Smart repair

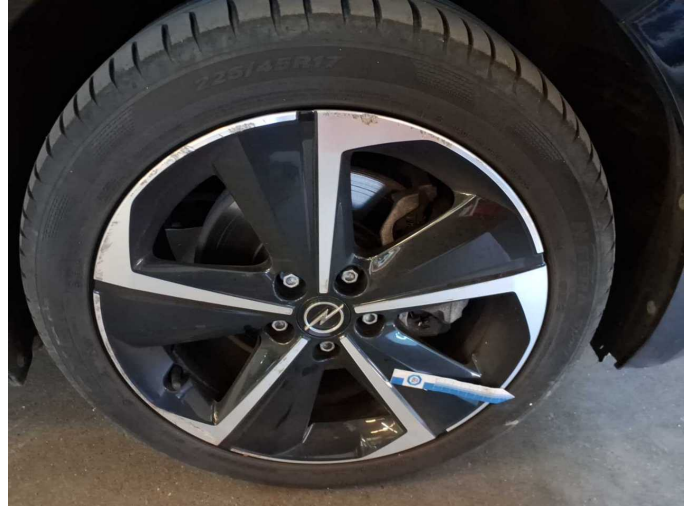
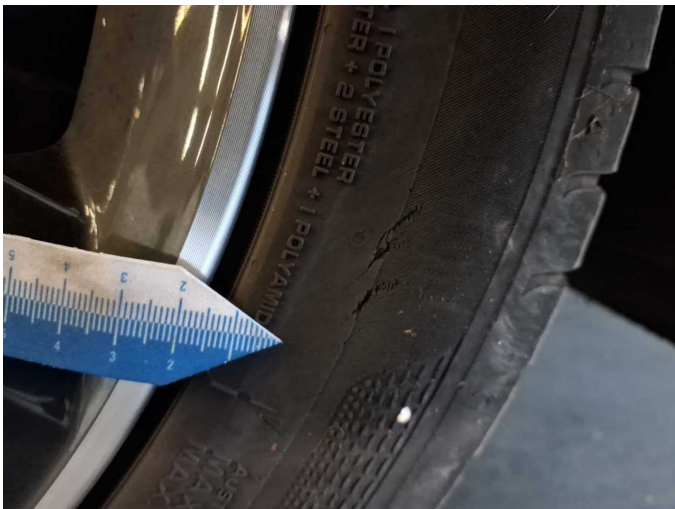
| No. | Component group | Description |
|---|---|---|
| 5 | Wheel / tyres | Tyre - front right side (nicht fahrbereit) - Broken / torn - Replace |

**Damage 5:** Wheel / tyres: Tyre - front right side (nicht fahrbereit) - Broken / torn - Replace

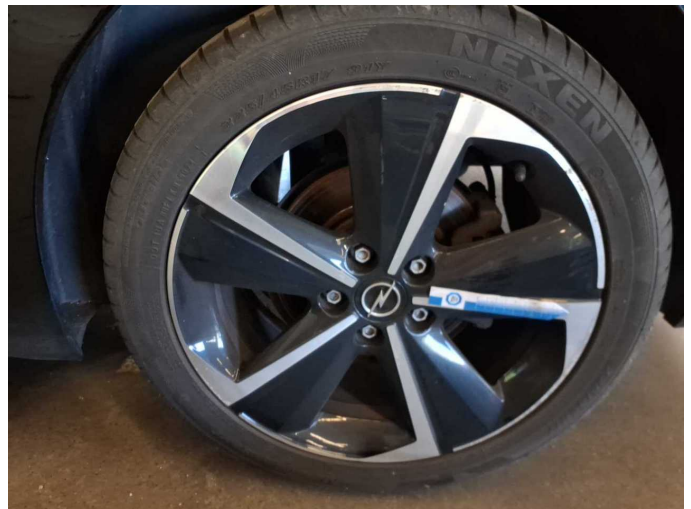
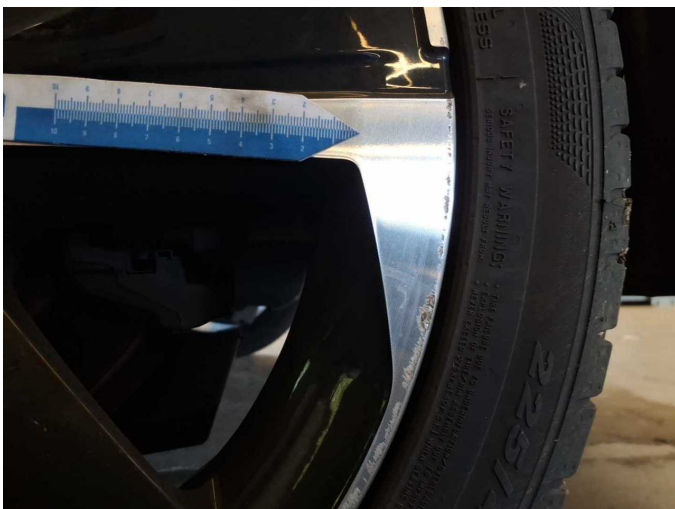
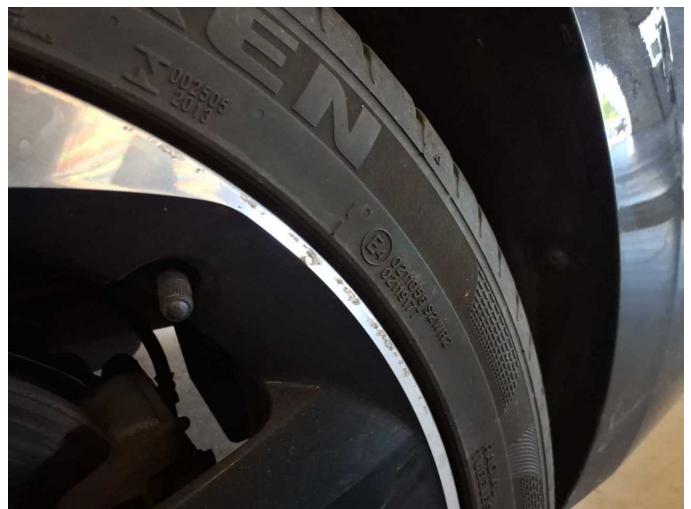
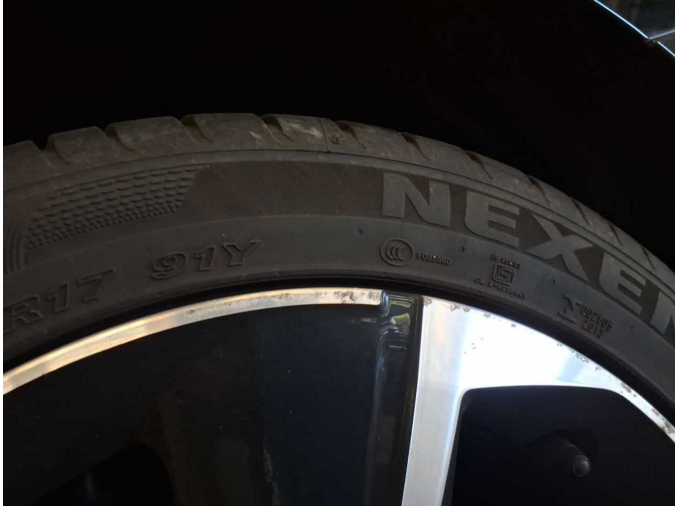
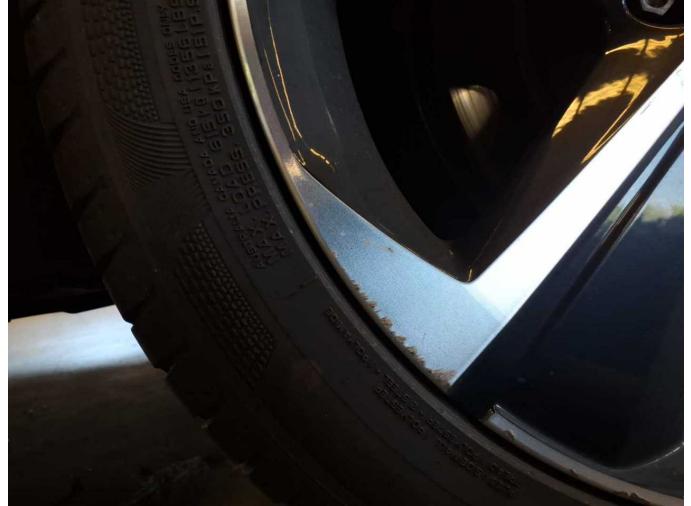
| No. | Component group | Description |
|---|---|---|
| 6 | Wheel / tyres | Alloy rim - rear left side - Scratched - Loss in value |

**Damage 6:** Wheel / tyres: Alloy rim - rear left side - Scratched - Loss in value

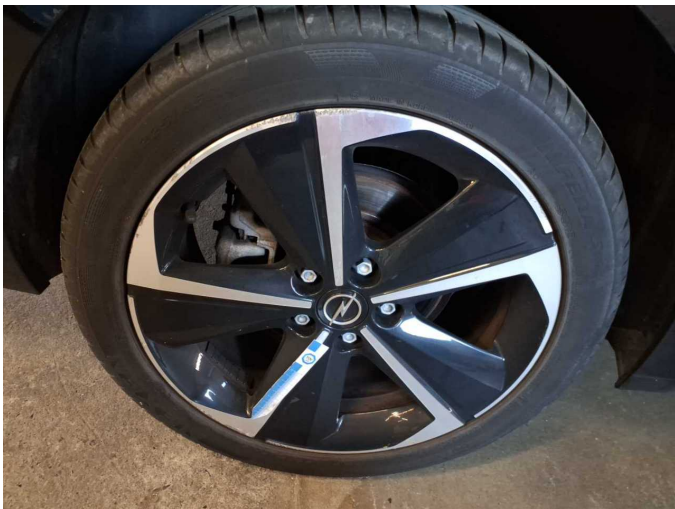
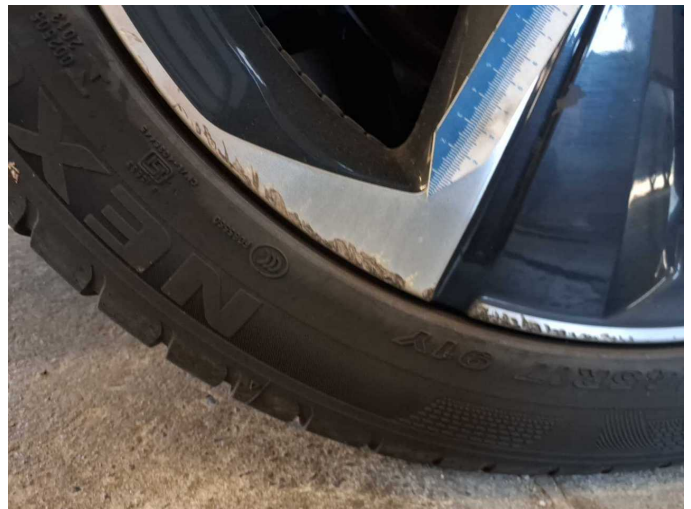
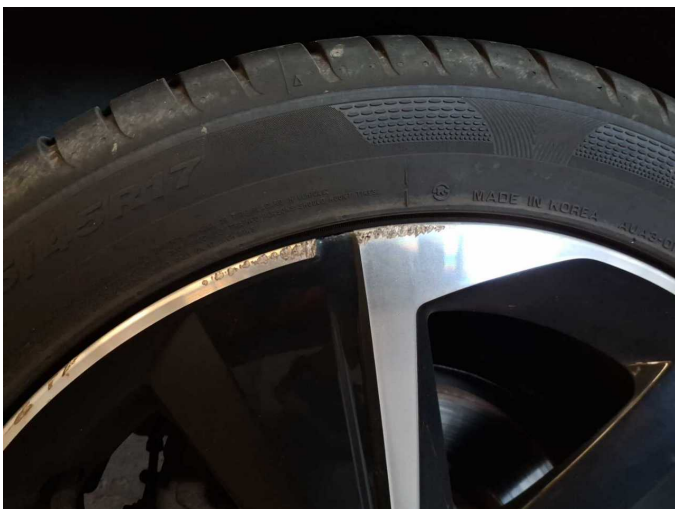
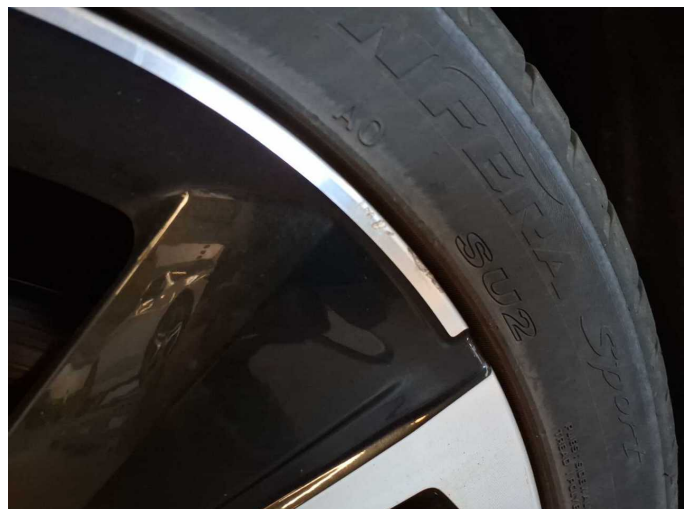
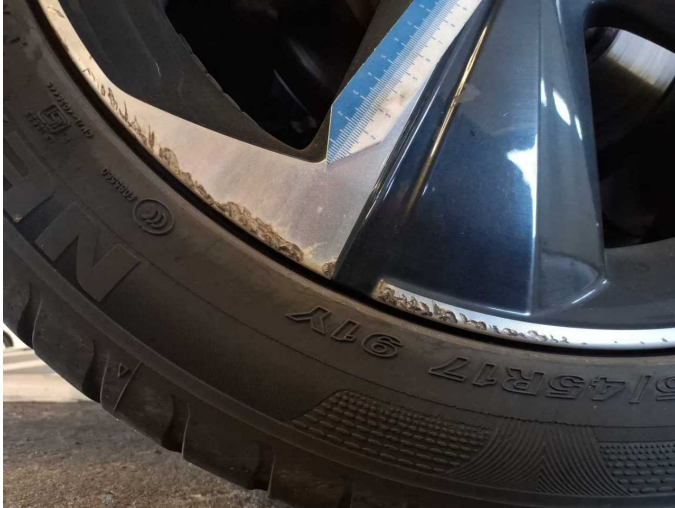
| No. | Component group | Description |
|---|---|---|
| 7 | Wheel / tyres | Alloy rim - rear right side (Materialabtrag) - Scratched - Replace |

**Damage 7:** Wheel / tyres: Alloy rim - rear right side (Materialabtrag) - Scratched - Replace

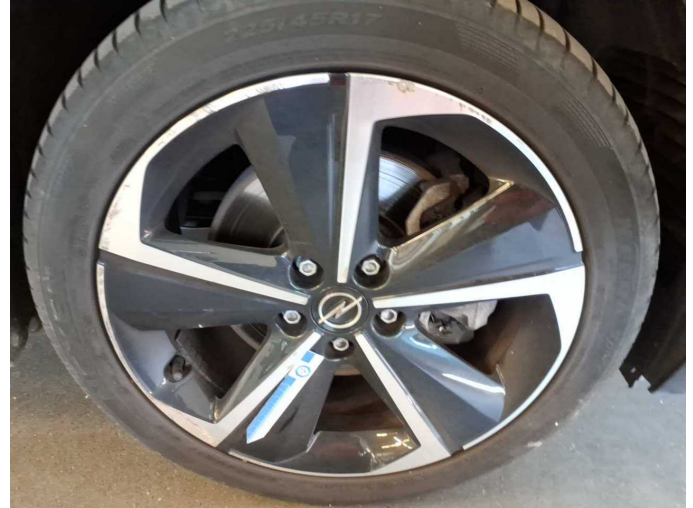
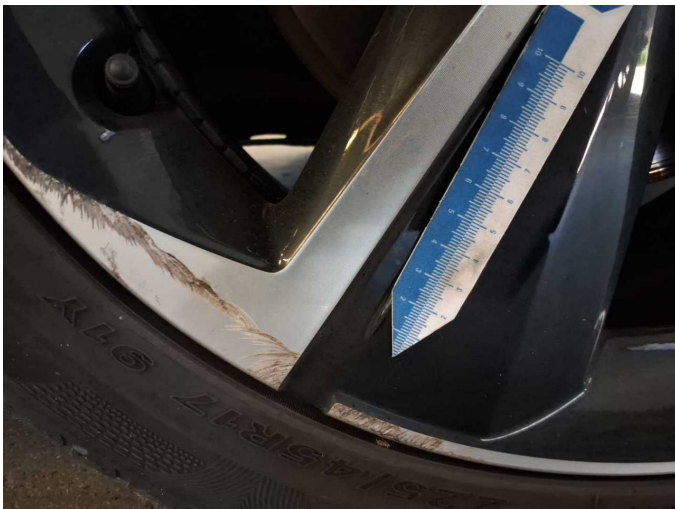
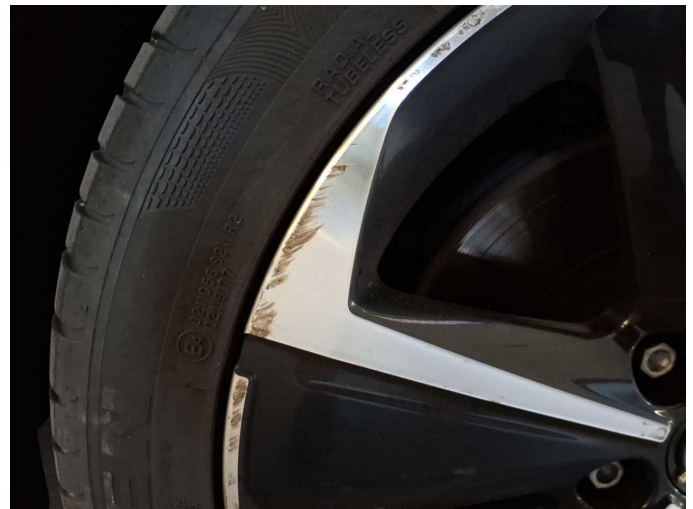
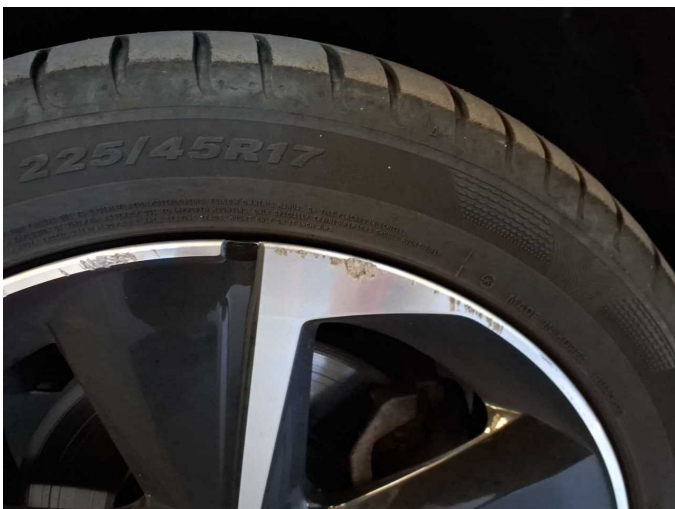
| No. | Component group | Description |
|---|---|---|
| 8 | Wheel / tyres | Alloy rim - front right side (Materialabtrag) - Scratched - Replace |

**Damage 8:** Wheel / tyres: Alloy rim - front right side (Materialabtrag) - Scratched - Replace

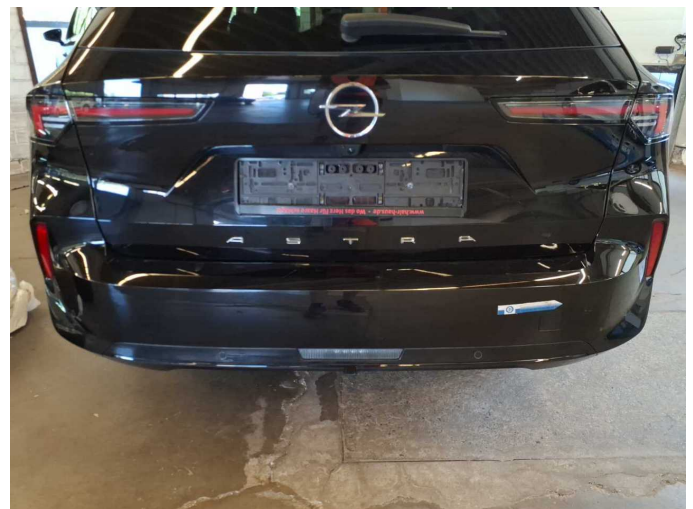
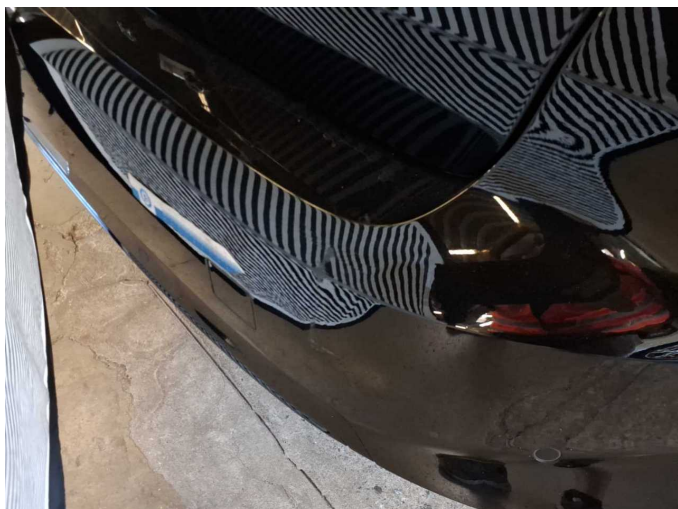
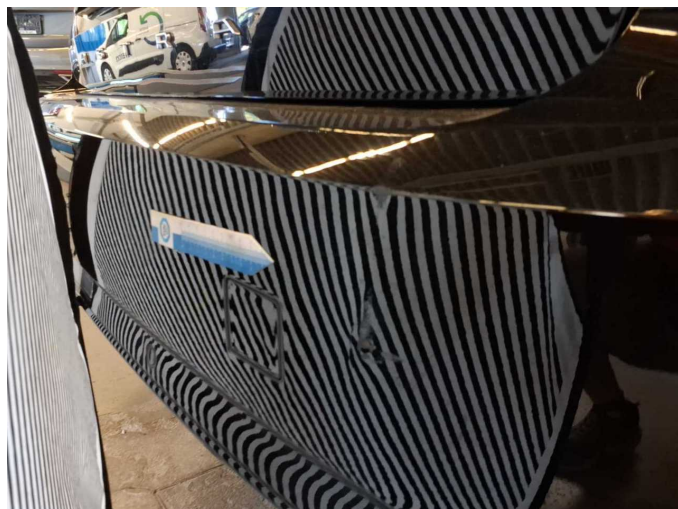
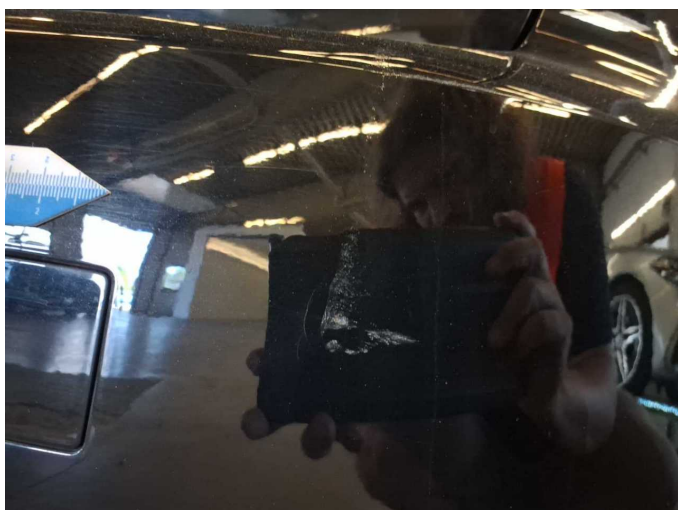
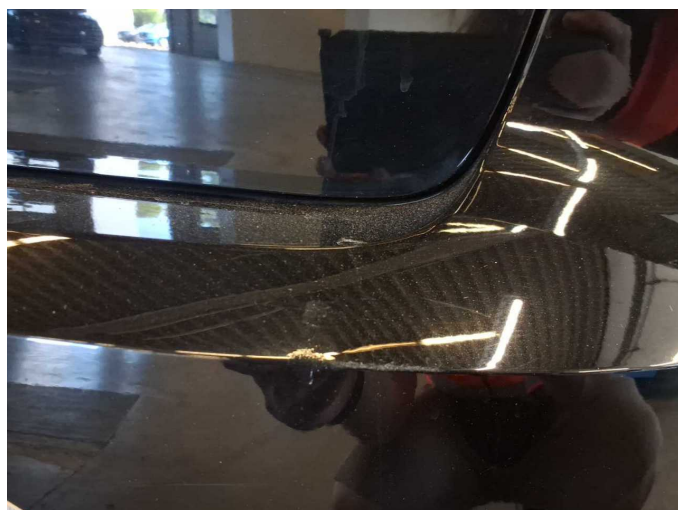
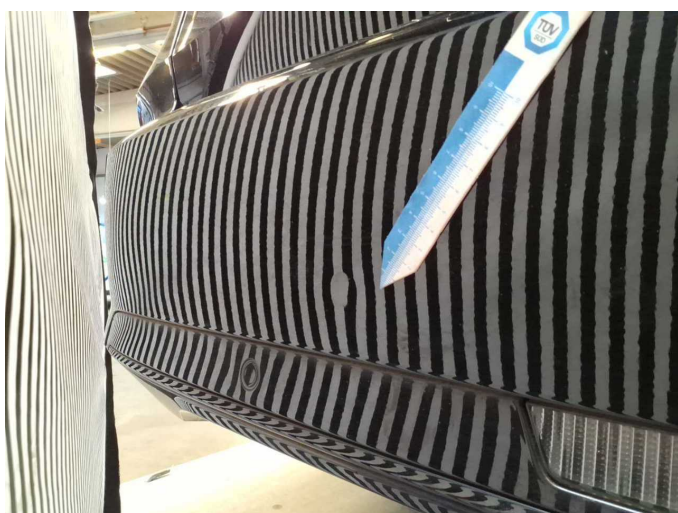
| No. | Component group | Description |
|---|---|---|
| 9 | Rear bumper | Rear bumper - Dent / paintcoat damage - Repair and paint |

**Damage 9:** Rear bumper: Rear bumper - Dent / paintcoat damage - Repair and paint

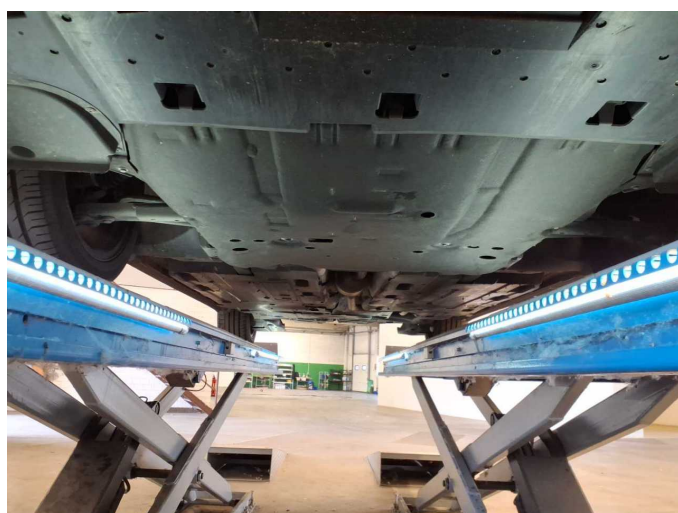
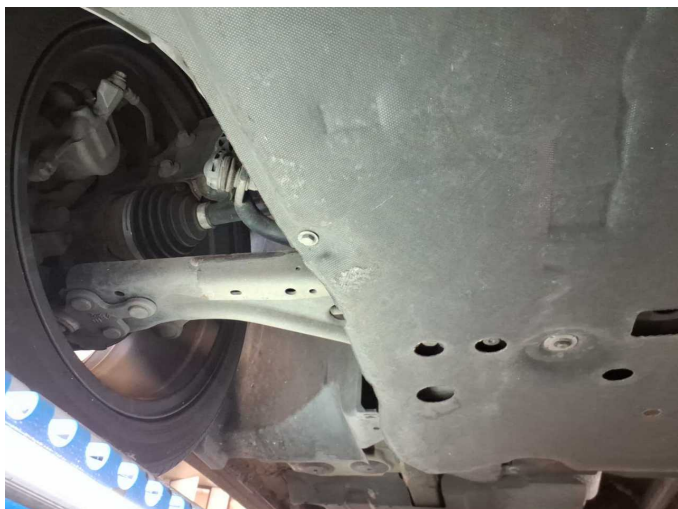
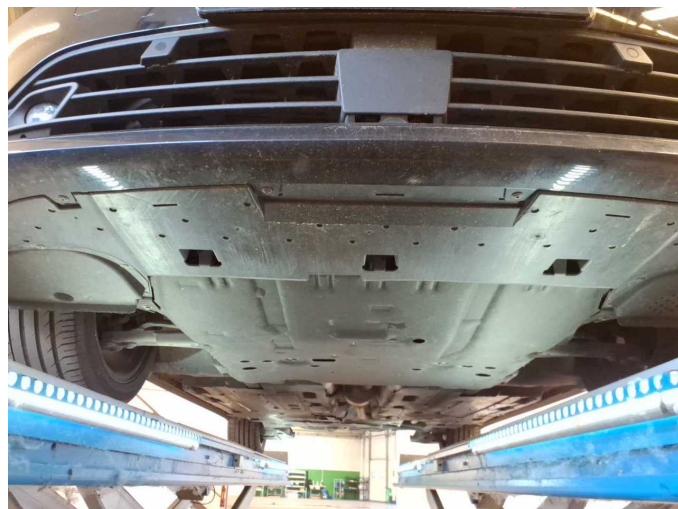
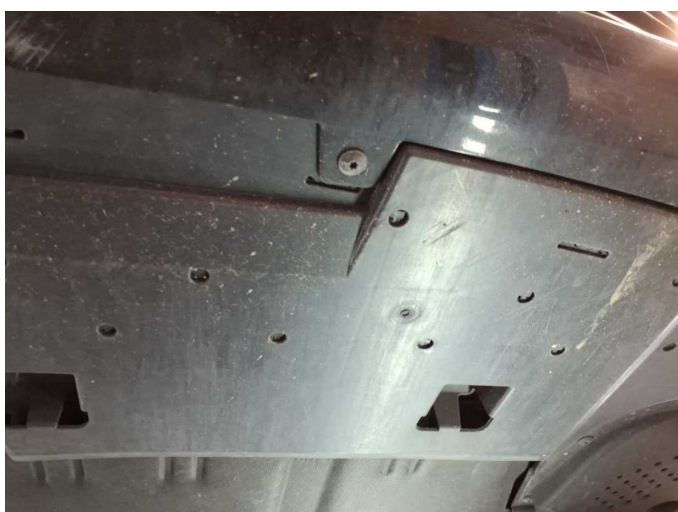
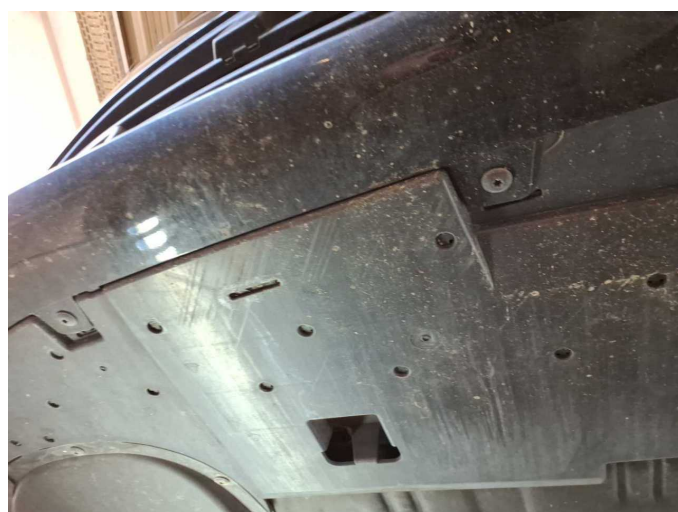
| No. | Component group | Description |
|---|---|---|
| 1 | Body | Underbody panelling - Scratched - No deduction |

**Wear and tear 1:** Body: Underbody panelling - Scratched - No deduction

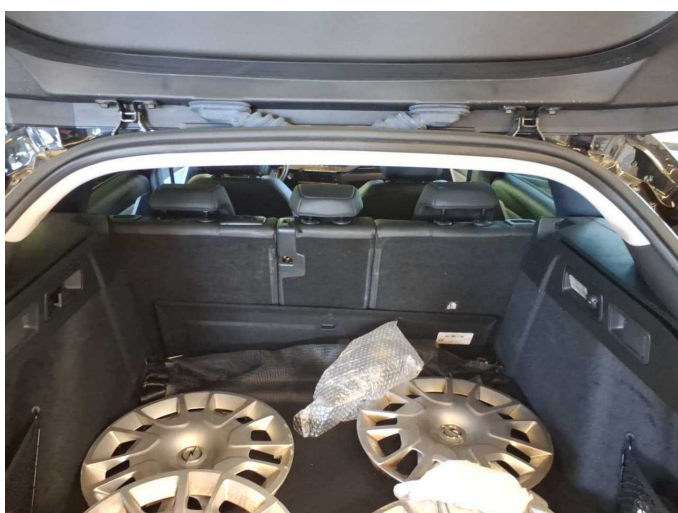
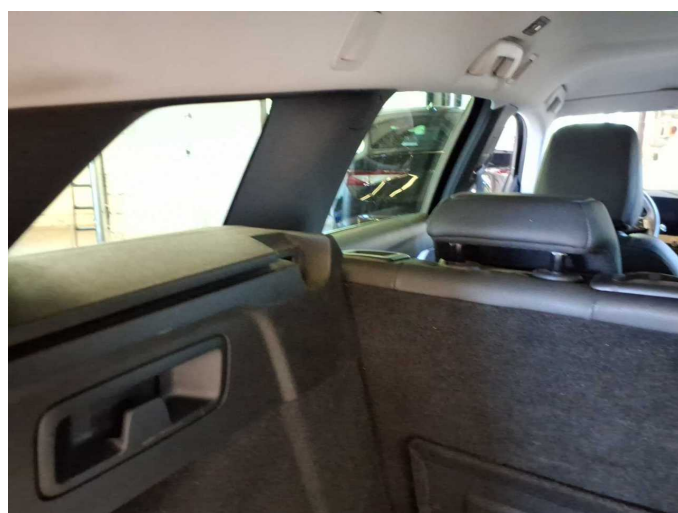
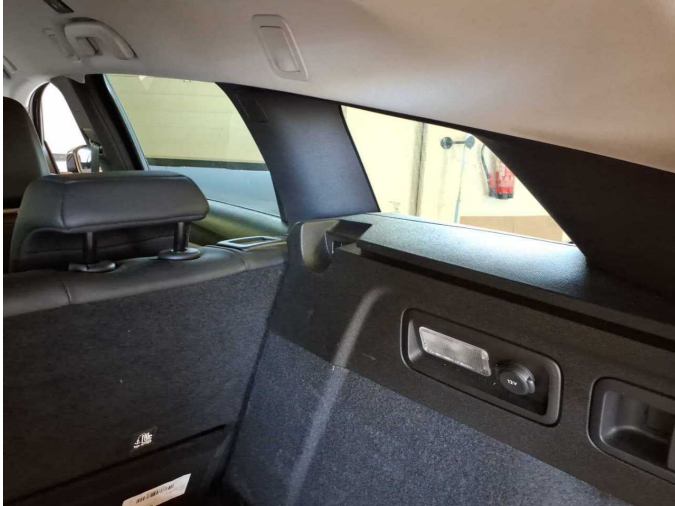
Interior - Rear shelf

**Missing part 1:** Interior: Rear shelf - Missing - Replace

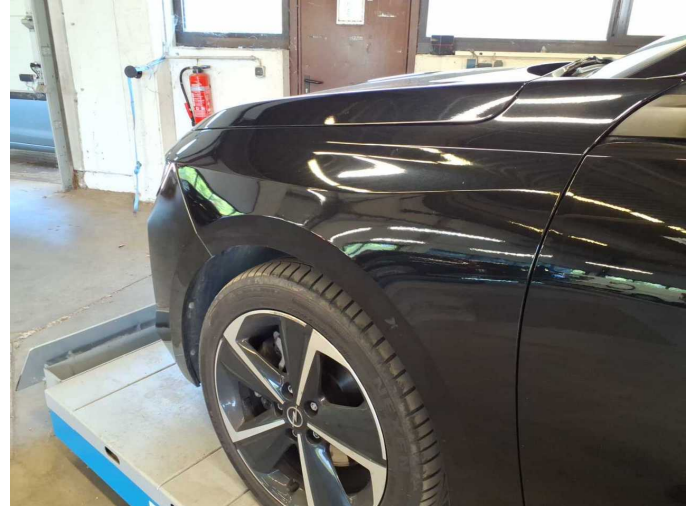
| No. | Repainting |
|---|---|
| 1 | Mudguard - left side |

| Mudguard - left side | 236 µm |

**Repainting 1:** Mudguard - left side
