Expertise

Protocol number: 46058500  
Order No. / Reference: 26527639  
Inspection date: 19 Jun 2026

Manufacturer: Skoda  
VIN: TMBJJ8NX8PY100350

Model: Octavia Combi 2.0 TDI DSG Ambition

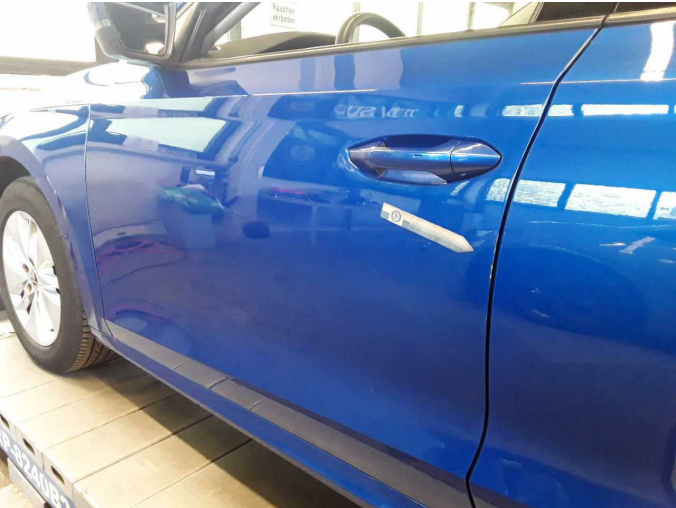
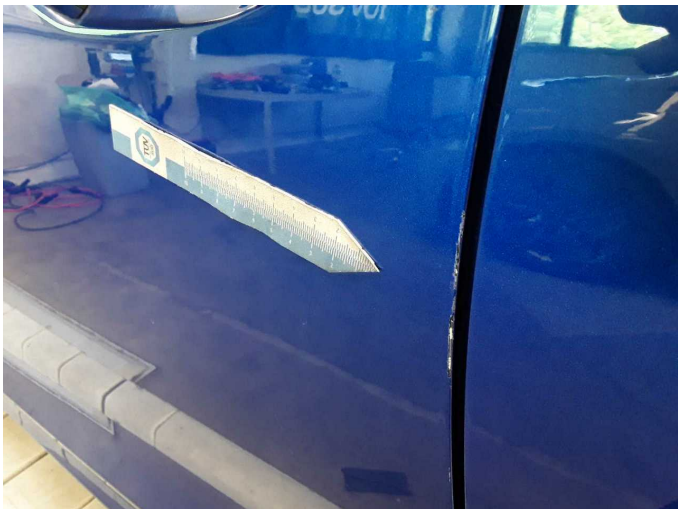
| No. | Component group | Description |
|---|---|---|
| 1 | Door - front left side | Door - Scratch(es) - Smart repair |

Damage 1: Door - front left side: Door - Scratch(es) - Smart repair

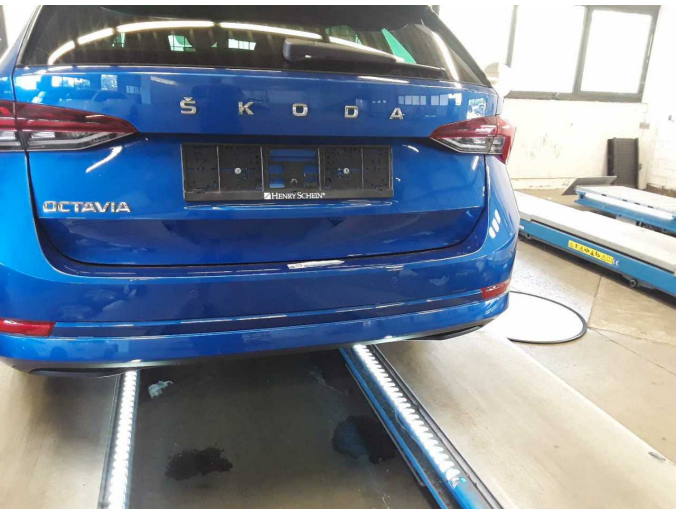
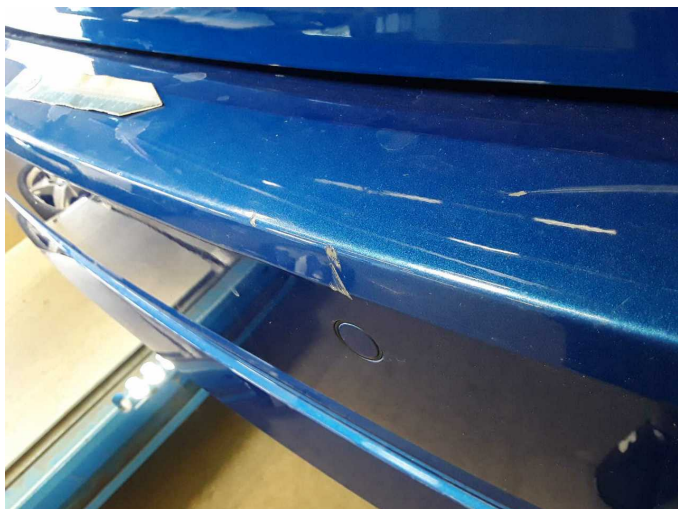
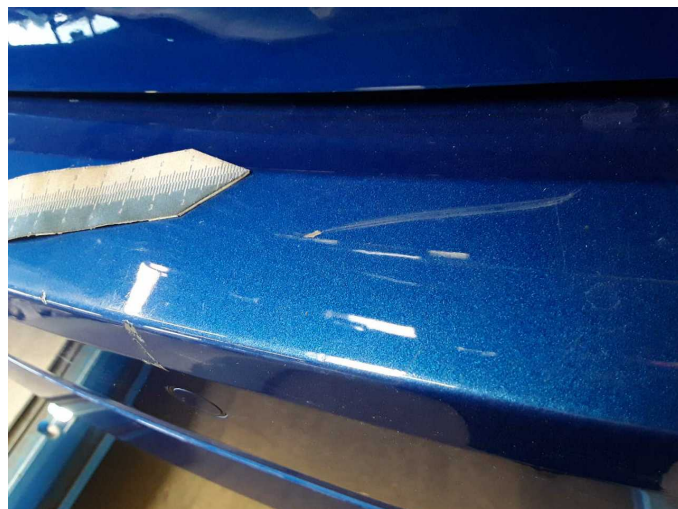
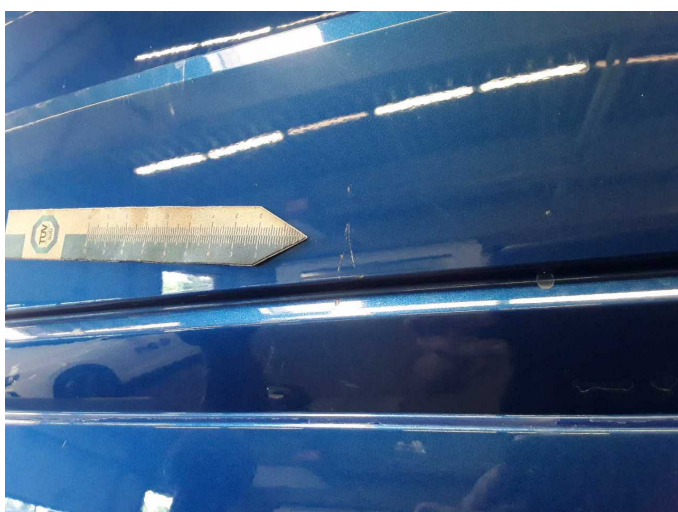
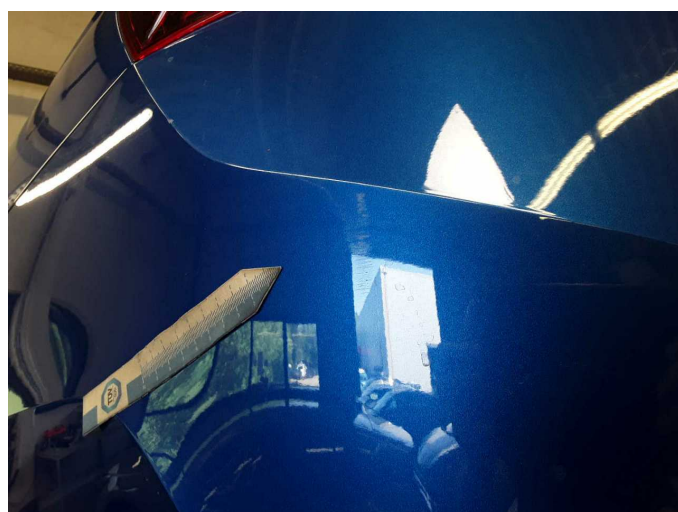
| No. | Component group | Description |
|---|---|---|
| 2 | Rear bumper | Rear bumper - Scratch(es) - Paint |

Damage 2: Rear bumper: Rear bumper - Scratch(es) - Paint

**Damage 2:** Rear bumper: Rear bumper - Scratch(es) - Paint

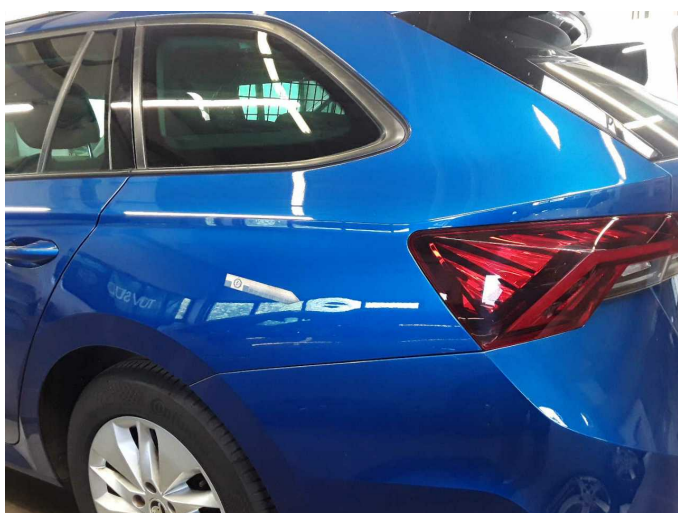
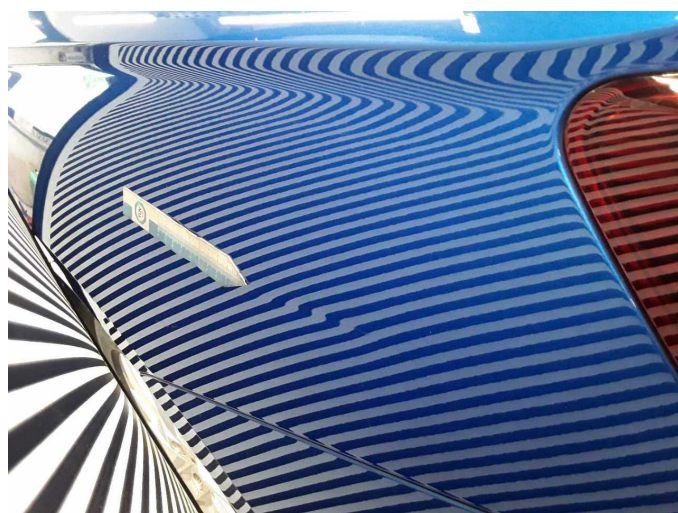
| No. | Component group | Description |
|---|---|---|
| 3 | Side panel - rear left side | Side panel - Deformed - Repair and paint |

**Damage 3:** Side panel - rear left side: Side panel - Deformed - Repair and paint

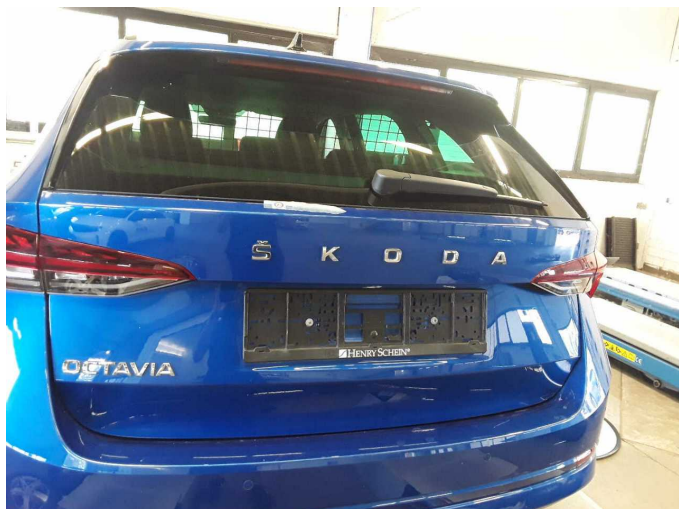
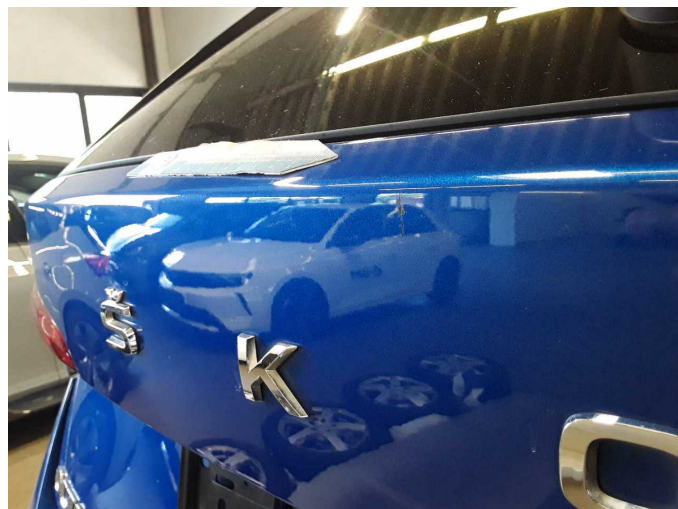
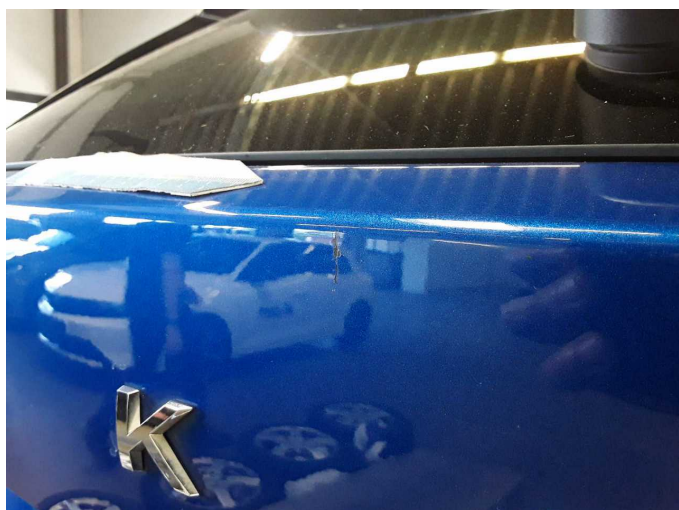
| No. | Component group | Description |
|---|---|---|
| 4 | Boot lid / rear door | Boot lid - Scratch(es) - Paint |

**Damage 4:** Boot lid / rear door: Boot lid - Scratch(es) - Paint

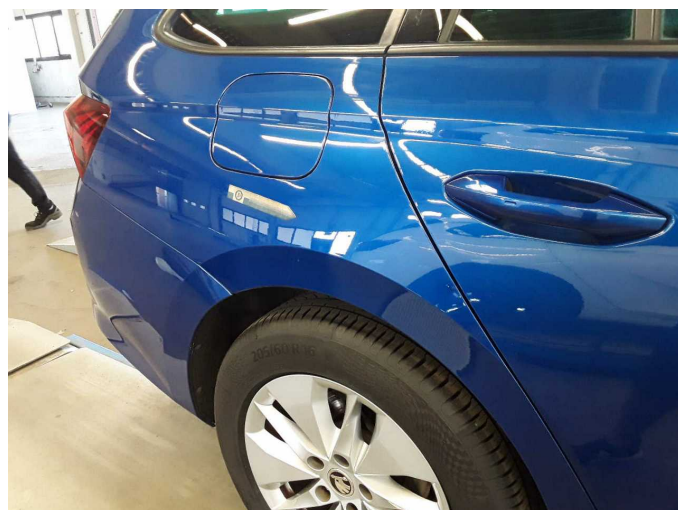
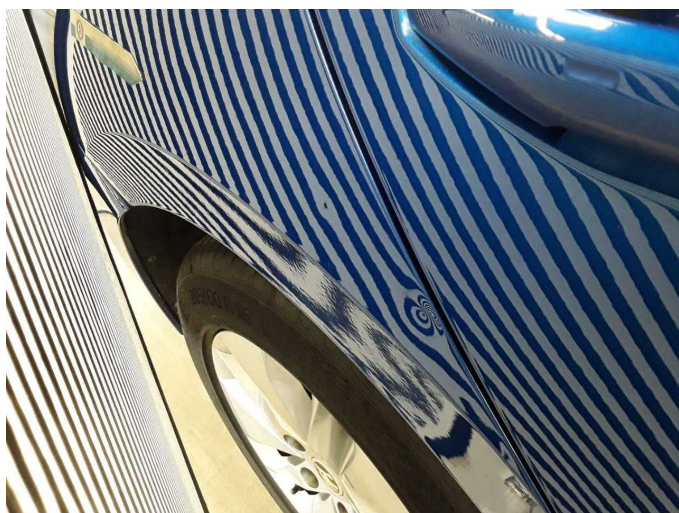
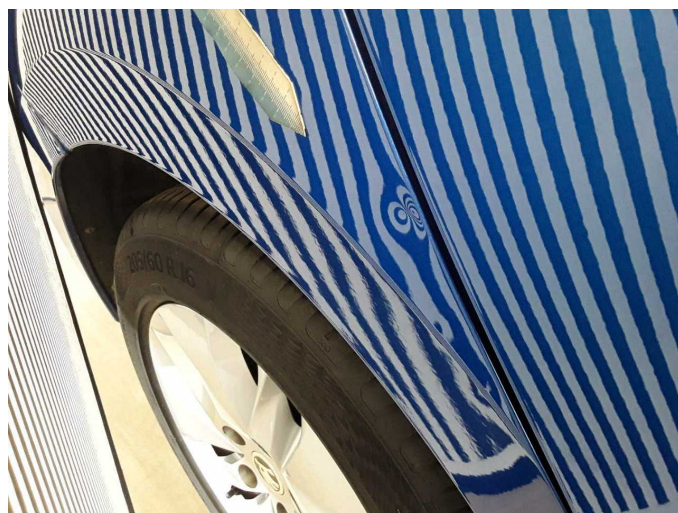
| No. | Component group | Description |
|---|---|---|
| 5 | Side panel - rear right side | Side panel - Deformed - Repair and paint |

**Damage 5:** Side panel - rear right side: Side panel - Deformed - Repair and paint

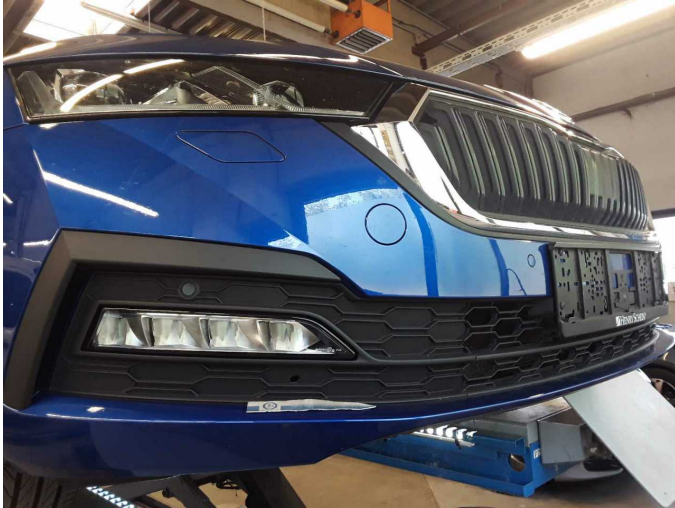
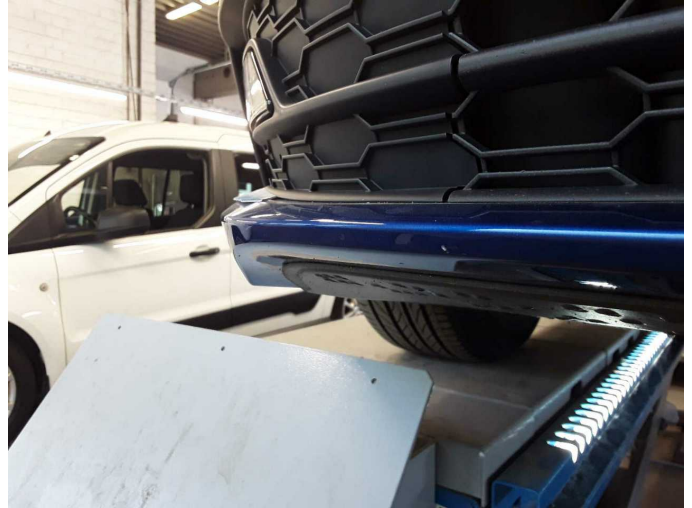
| No. | Component group | Description |
|---|---|---|
| 2 | Front bumper | Front bumper - Stone chips - No deduction |

**Wear and tear 2:** Front bumper: Front bumper - Stone chips - No deduction

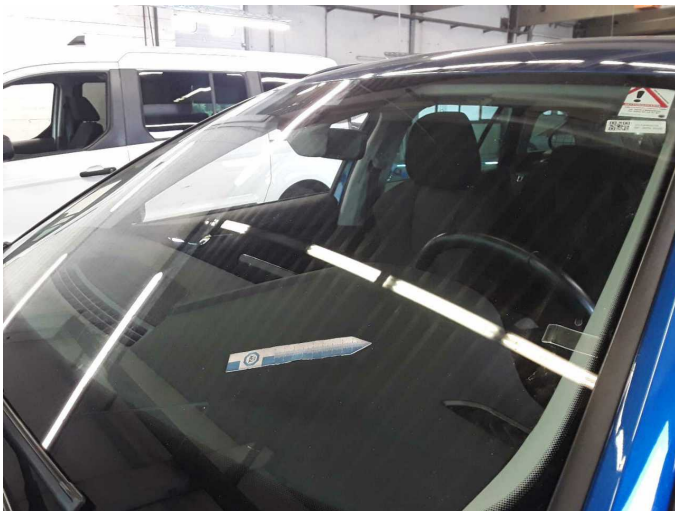
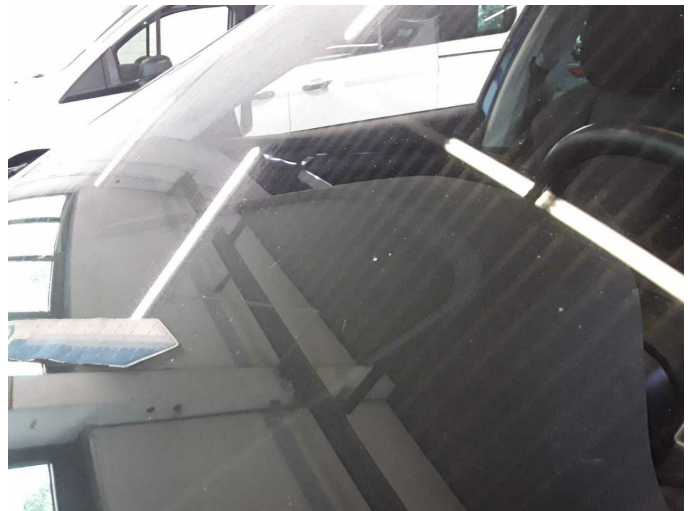
| No. | Component group | Description |
|---|---|---|
| 3 | Vehicle glazing | Windscreen - Stone chips - No deduction |

**Wear and tear 3:** Vehicle glazing: Windscreen - Stone chips - No deduction

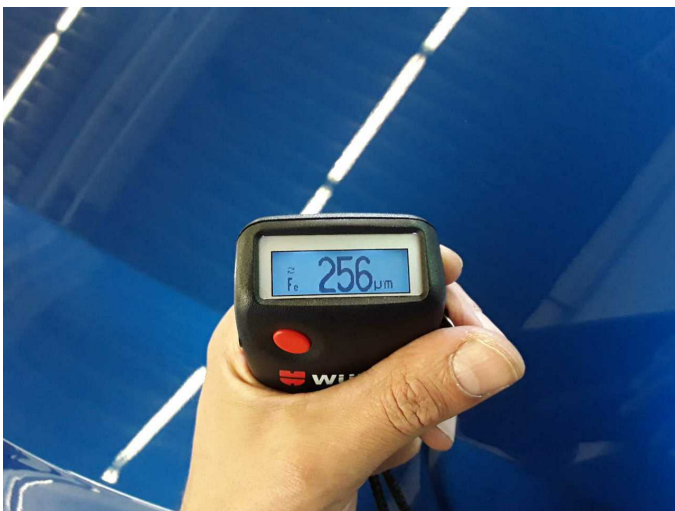
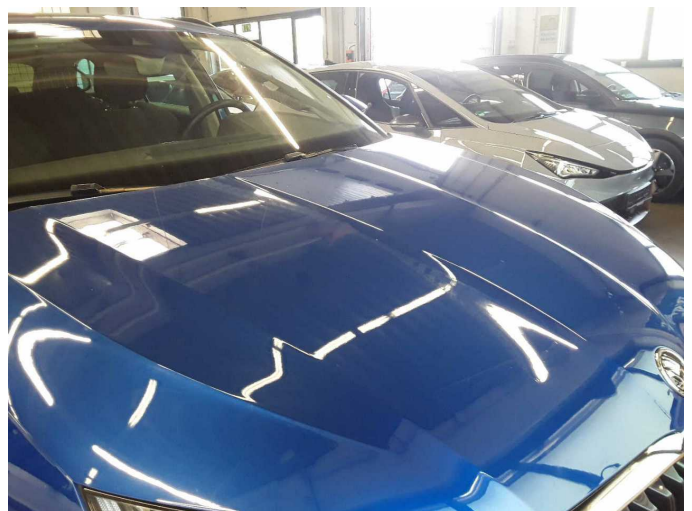
1 Bonnet, Professionally carried out, Invoice of repair done Non-existent

Bonnet 256 µm |

**Repainting 1:** Bonnet
