Expertise

Protocol number: 46510641  
Order No. / Reference: 26029381  
Inspection date: 13 Jul 2026

Manufacturer: Mercedes-Benz  
VIN: W1VVLGFZ0T4568105

Model: Vito 116 CDI Tourer Extralang Aut. PRO

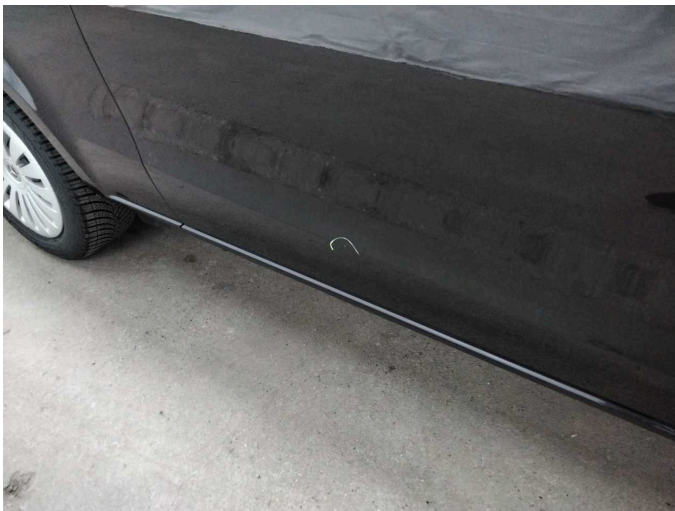
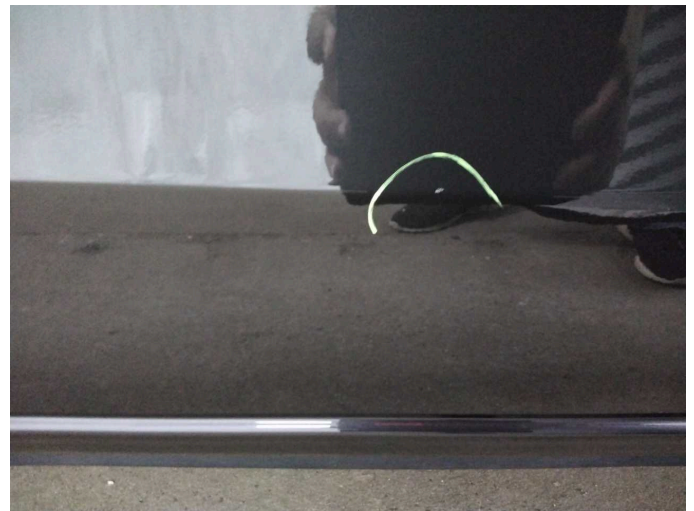
| No. | Component group | Description |
|---|---|---|
| 1 | Sliding door, right | Sliding door with glass panel - Scratch(es) - Smart repair |

**Damage 1:** Sliding door, right: Sliding door with glass panel - Scratch(es)  
- Smart repair

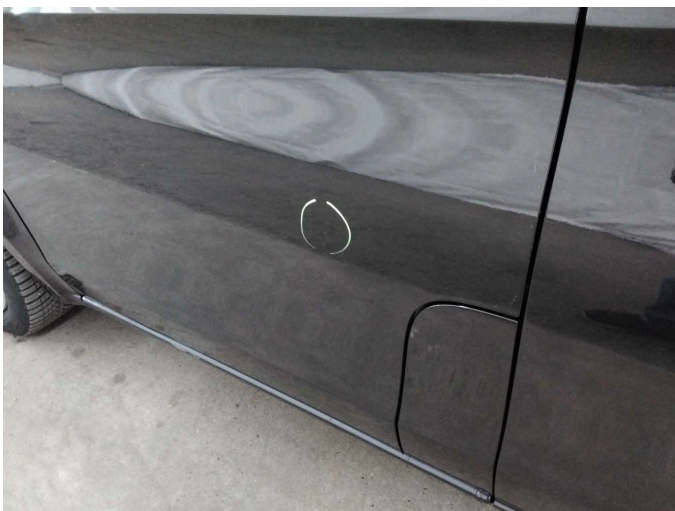
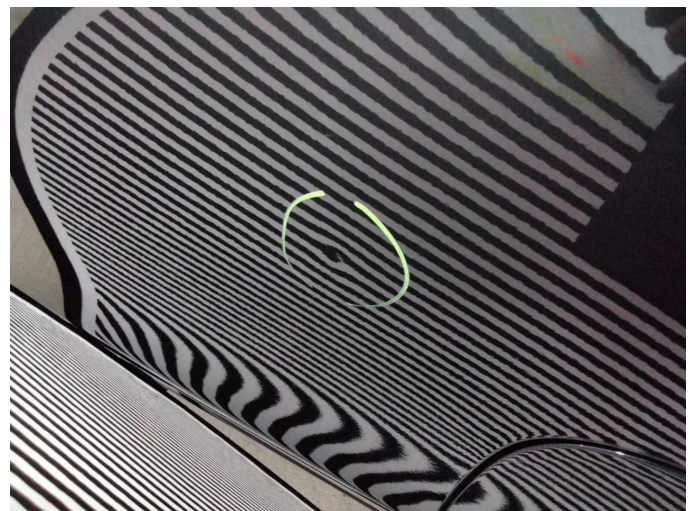
| No. | Component group | Description |
|---|---|---|
| 2 | Door - front left side | Door - Dent / paintcoat damage - Smart repair |

**Damage 2:** Door - front left side: Door - Dent / paintcoat damage - Smart repair

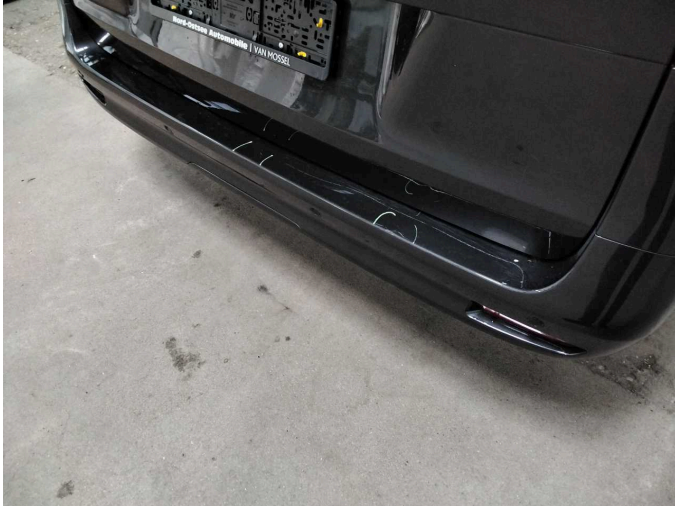
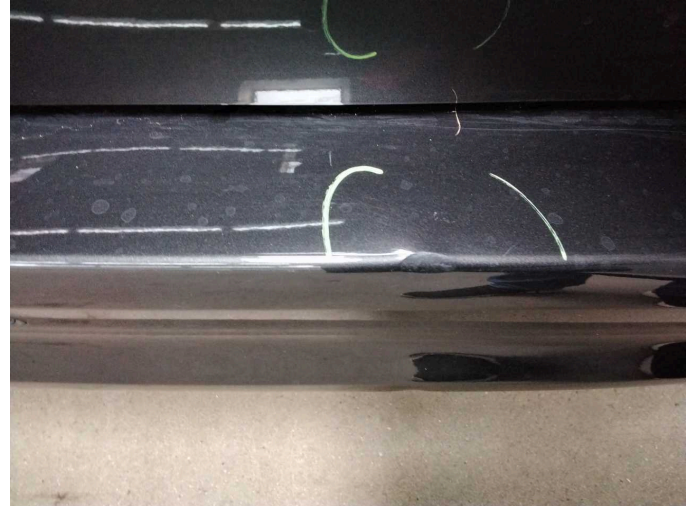
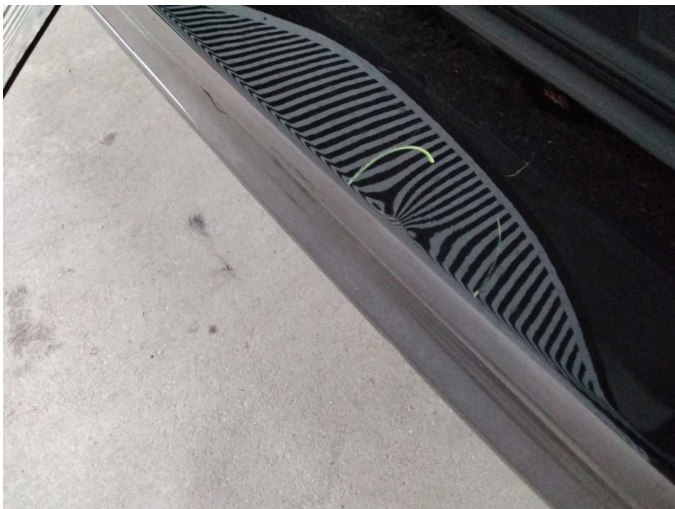
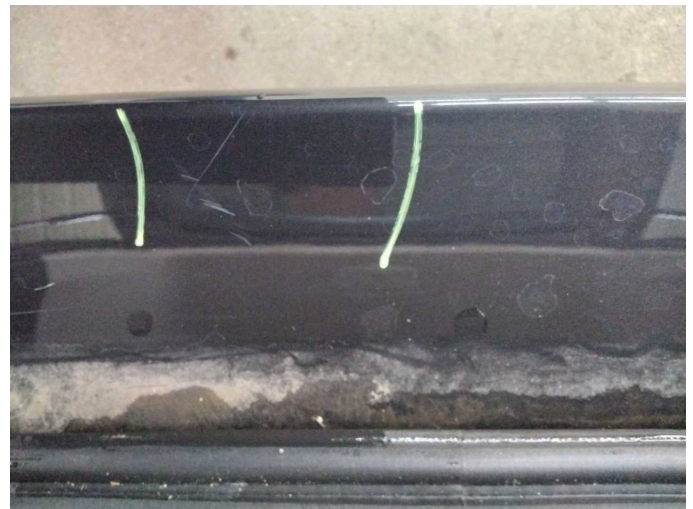
| No. | Component group | Description |
|---|---|---|
| 3 | Rear bumper | Rear bumper - Dent / paintcoat damage - Repair and paint |

**Damage 3:** Rear bumper: Rear bumper - Dent / paintcoat damage - Repair and paint

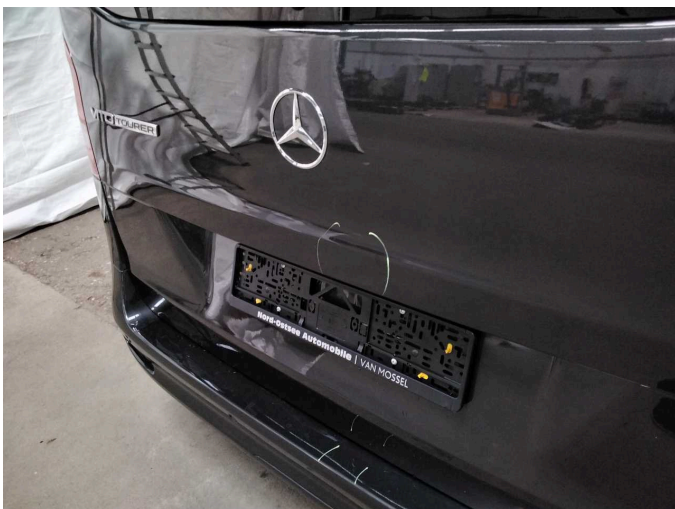
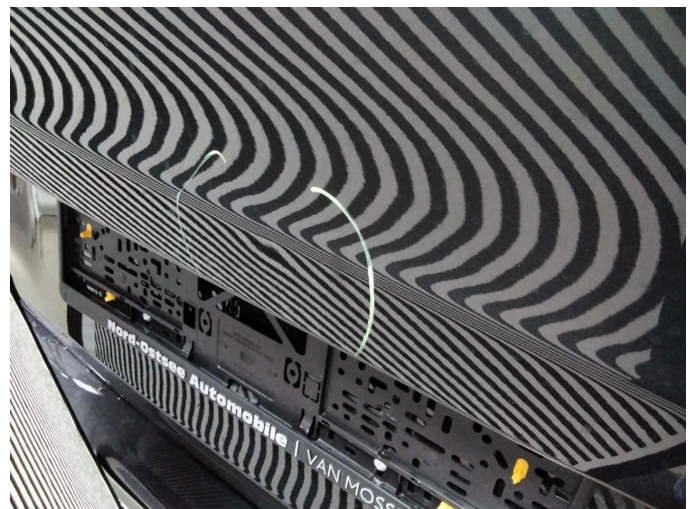
| No. | Component group | Description |
|---|---|---|
| 5 | Boot lid / rear door | Boot lid - dent(s) - No deduction |

**Wear and tear 5:** Boot lid / rear door: Boot lid - dent(s) - No deduction

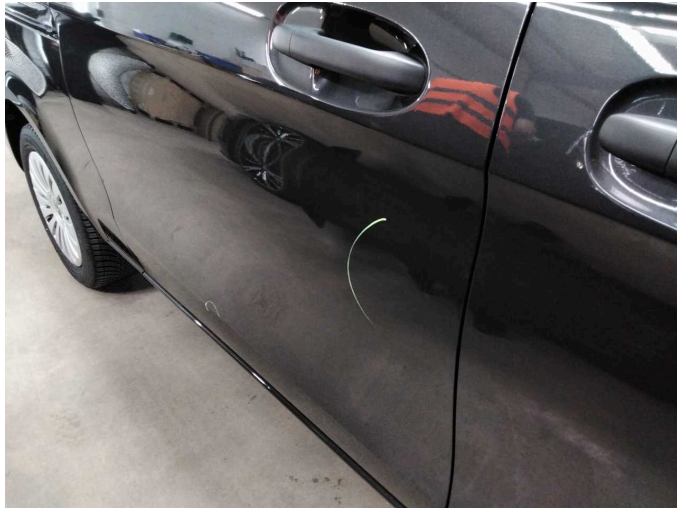
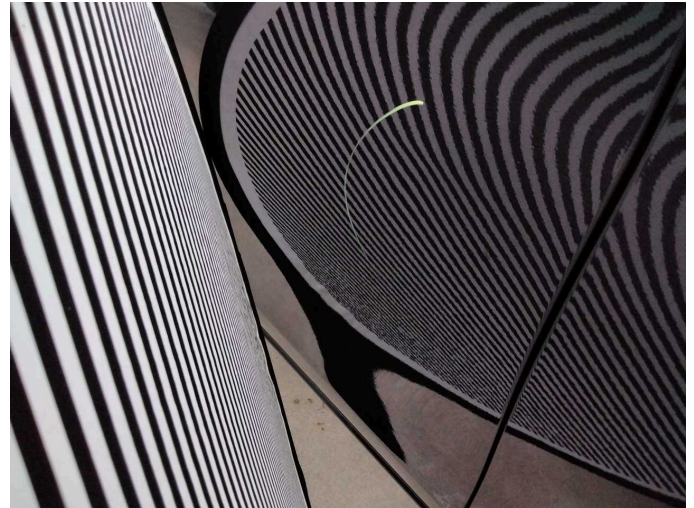
| No. | Component group | Description |
|---|---|---|
| 6 | Sliding door, right | Sliding door with glass panel - dent(s) - No deduction |

**Wear and tear 6:** Sliding door, right: Sliding door with glass panel - dent(s) - No deduction
