Expertise

Protocol number: 46318844  
Order No. / Reference: 26603995  
Inspection date: 2 Jul 2026

Manufacturer: CUPRA

Model: Born 170kW/77kWh

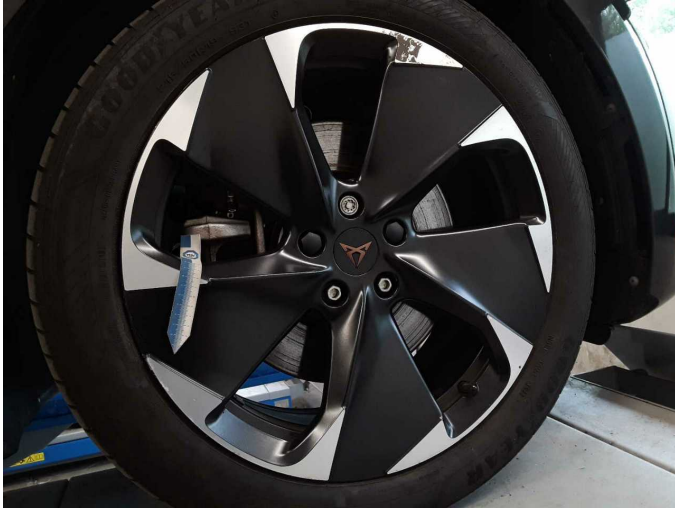
| No. | Component group | Description |
|---|---|---|
| 1 | Wheel / tyres | Alloy rim - front right side - Scratch(es) - Loss in value |

**Damage 1:** Wheel / tyres: Alloy rim - front right side - Scratch(es) - Loss in value

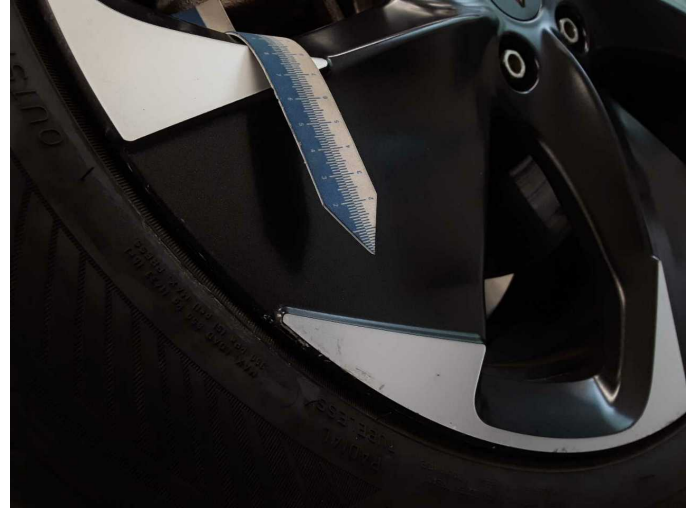
**Damage 1:** Wheel / tyres: Alloy rim - front right side - Scratch(es) - Loss in value

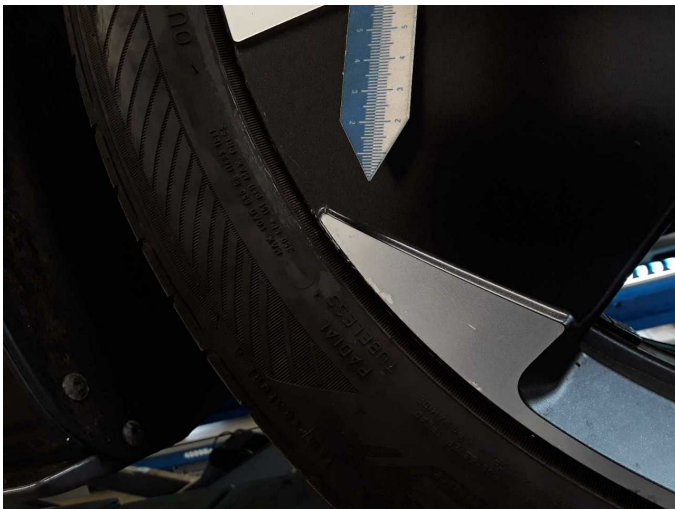
**Damage 1:** Wheel / tyres: Alloy rim - front right side - Scratch(es) - Loss in value

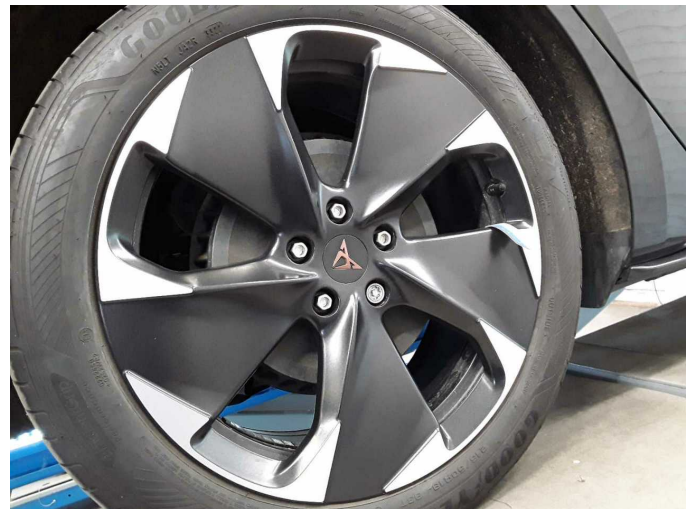
| No. | Component group | Description |
|---|---|---|
| 2 | Wheel / tyres | Alloy rim - rear right side - Scratch(es) - Loss in value |

**Damage 2:** Wheel / tyres: Alloy rim - rear right side - Scratch(es) - Loss in value

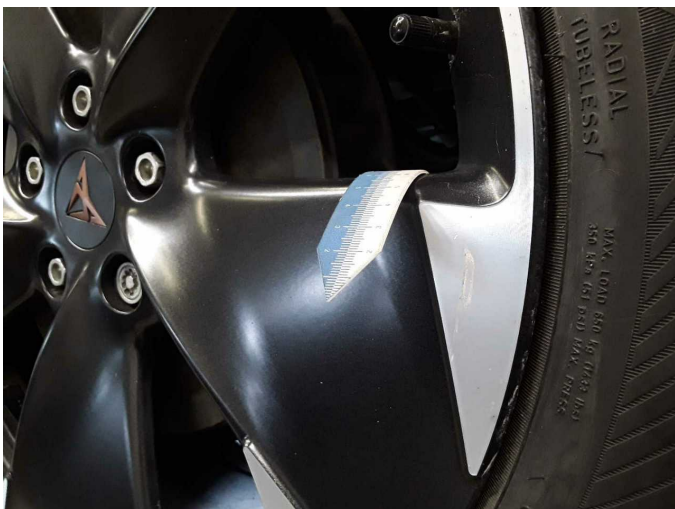
**Damage 2:** Wheel / tyres: Alloy rim - rear right side - Scratch(es) - Loss in value

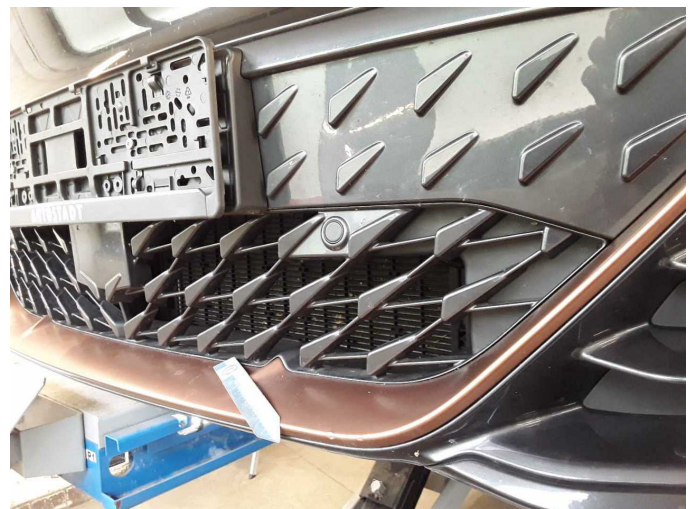
| No. | Component group | Description |
|---|---|---|
| 3 | Front bumper | Spoiler - Deformed - Smart repair |

**Damage 3:** Front bumper: Spoiler - Deformed - Smart repair

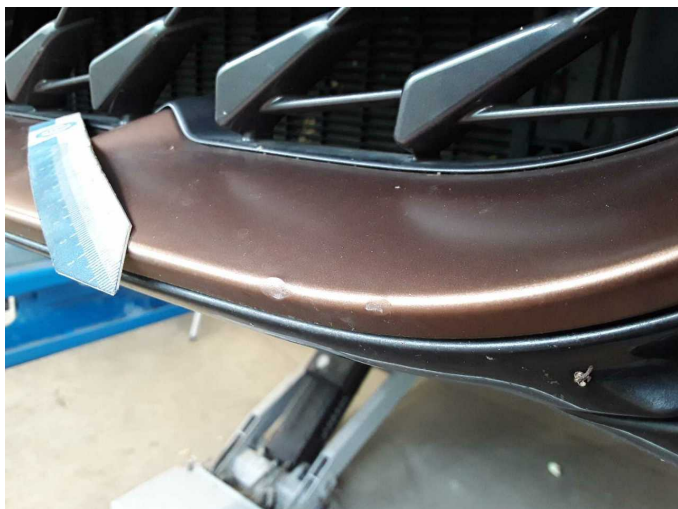
**Damage 3:** Front bumper: Spoiler - Deformed - Smart repair

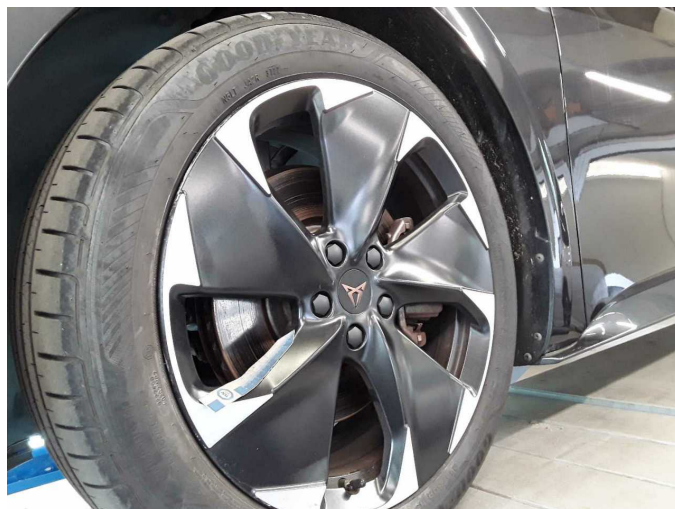
| No. | Component group | Description |
|---|---|---|
| 4 | Wheel / tyres | Alloy rim - front left side - Scratch(es) - Loss in value |

**Damage 4:** Wheel / tyres: Alloy rim - front left side - Scratch(es) - Loss in value

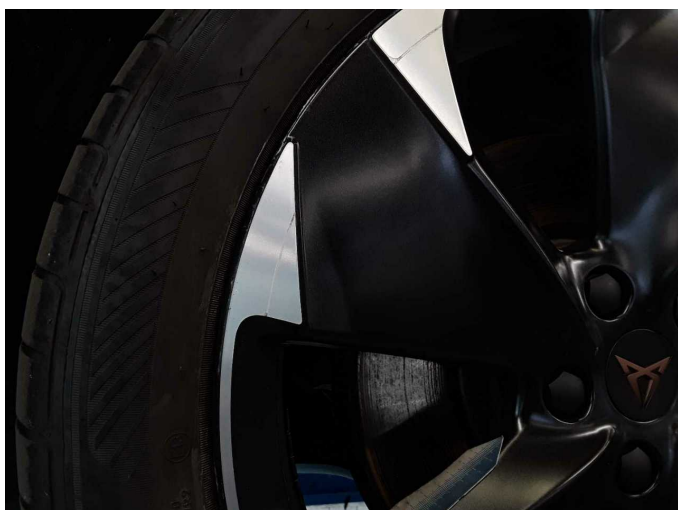
**Damage 4:** Wheel / tyres: Alloy rim - front left side - Scratch(es) - Loss in value
