Expertise

Protocol number: 46401422  
Order No. / Reference: 26597811  
Inspection date: 8 Jul 2026

Manufacturer: Opel

Model: Astra 1.5 D Start/Stop Edition

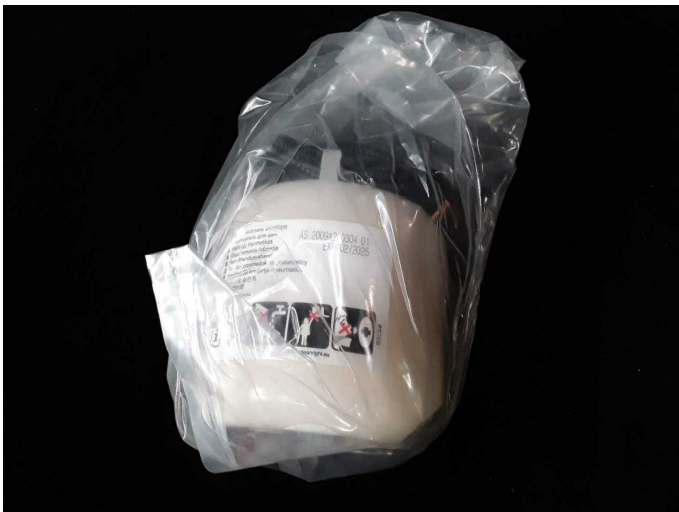
| No. | Component group | Description |
|---|---|---|
| 2 | Equipment | Tirefit filler - Expired - Replace |

Damage 2: Equipment: Tirefit filler - Expired - Replace

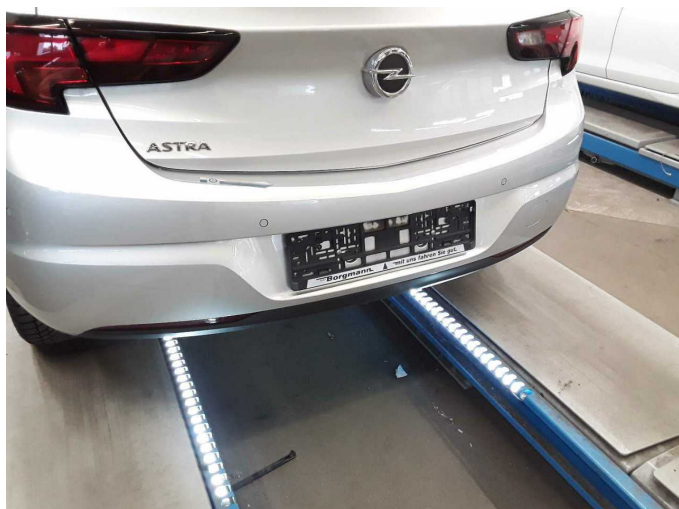
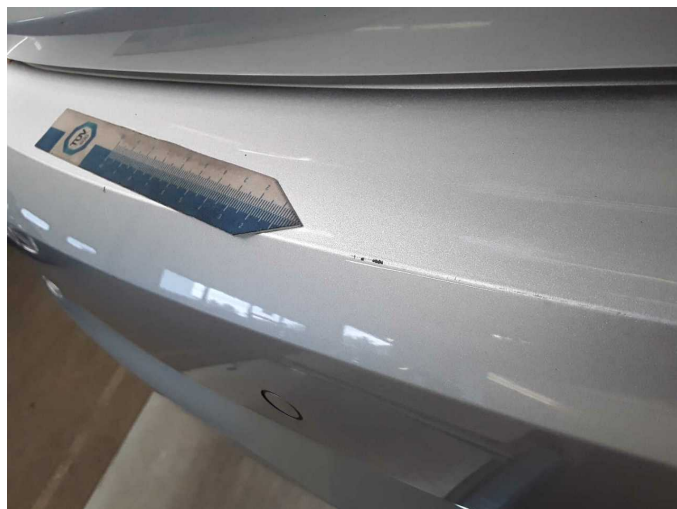
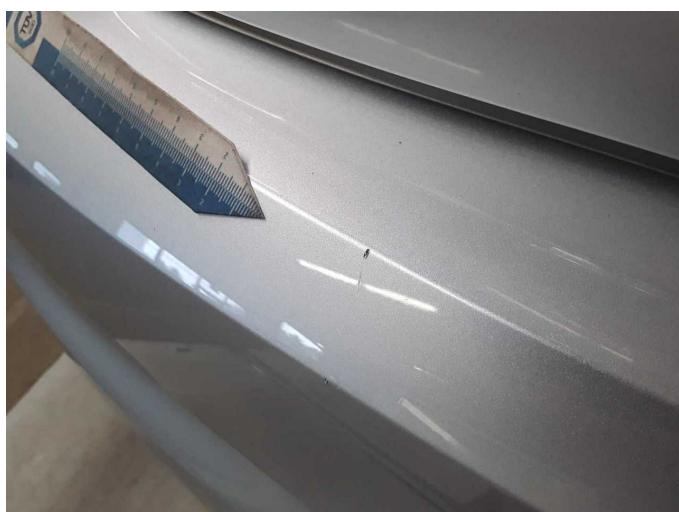
| No. | Component group | Description |
|---|---|---|
| 3 | Rear bumper | Rear bumper - Scratch(es) - Smart repair |

**Damage 3:** Rear bumper: Rear bumper - Scratch(es) - Smart repair

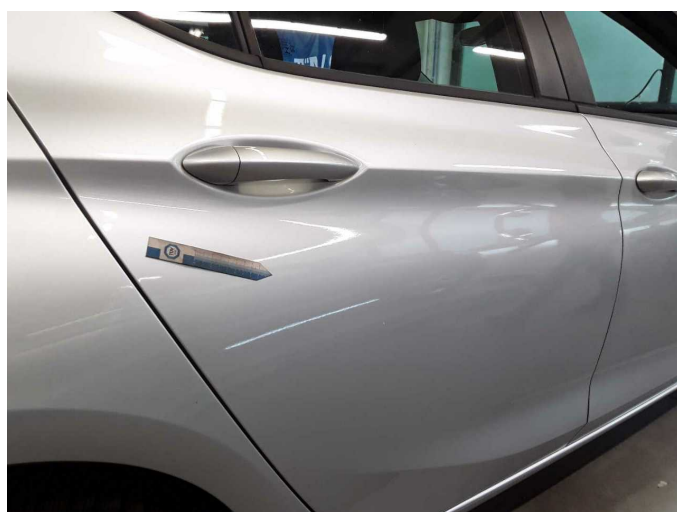
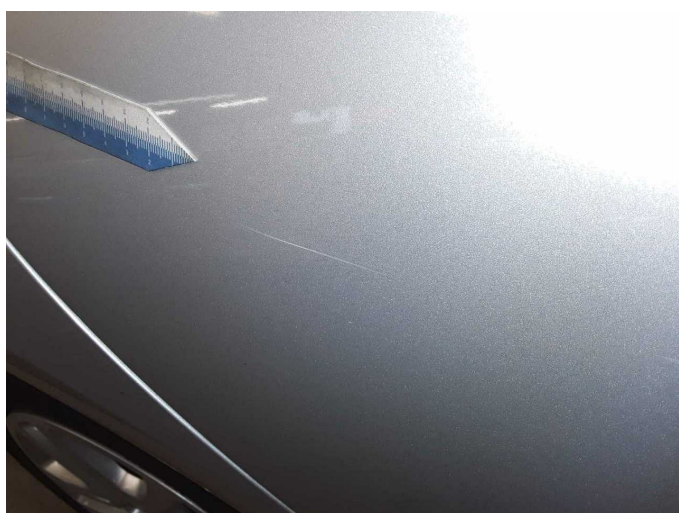
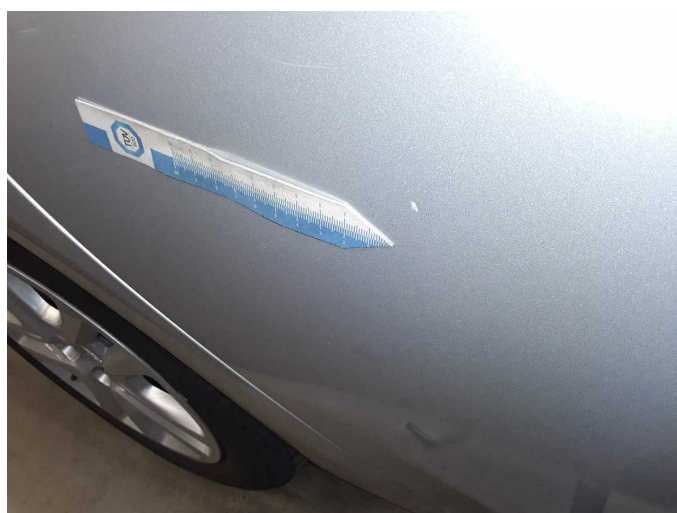
| No. | Component group | Description |
|---|---|---|
| 4 | Door - rear right side | Door - Scratch(es) - Paint |

**Damage 4:** Door - rear right side: Door - Scratch(es) - Paint

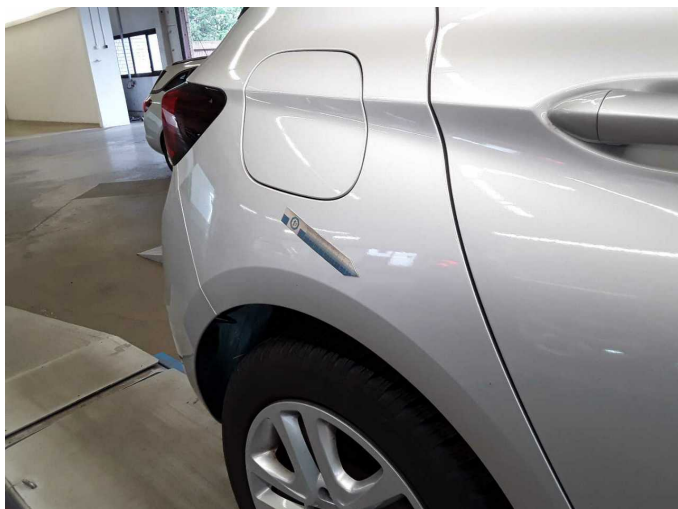
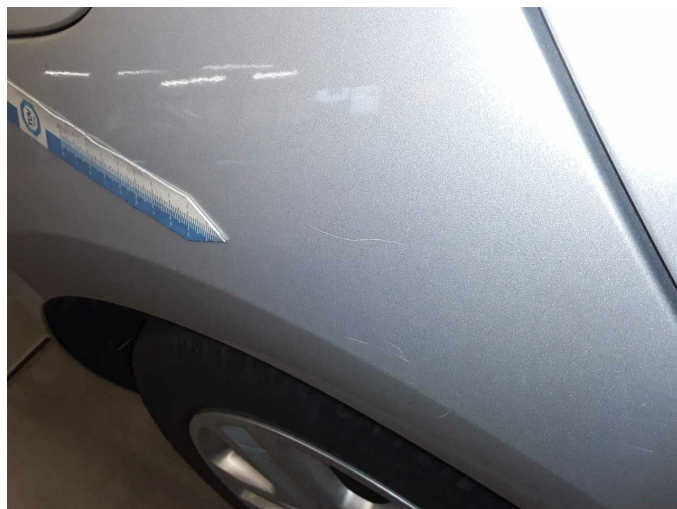
| No. | Component group | Description |
|---|---|---|
| 5 | Side panel - rear right side | Side panel - Scratch(es) - Paint |

**Damage 5:** Side panel - rear right side: Side panel - Scratch(es) - Paint

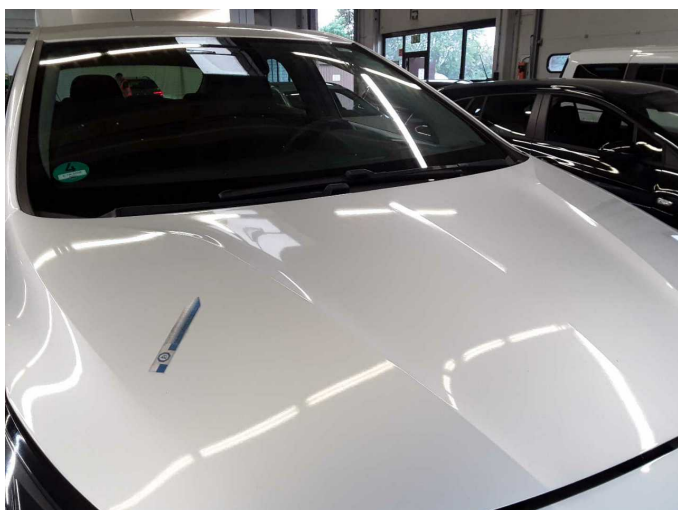
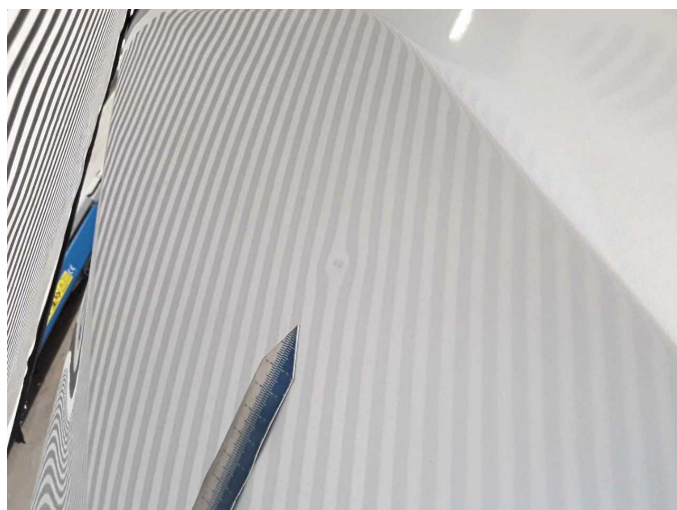
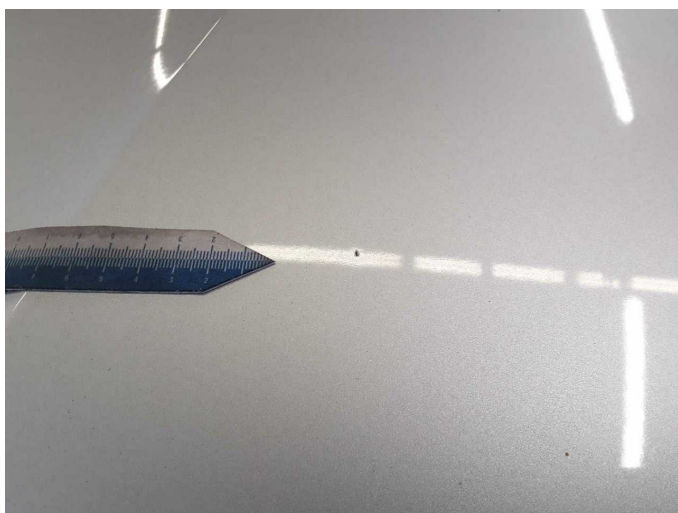
| No. | Component group | Description |
|---|---|---|
| 6 | Bonnet | Bonnet - Dent / paintcoat damage - Repair and paint |

**Damage 6:** Bonnet: Bonnet - Dent / paintcoat damage - Repair and paint
