## Expertise

Protocol number: 45085419  
Order No. / Reference: 26019484  
Inspection date: 20 Apr 2026

Model: 5008 BlueHDi 180 EAT8 GT Pack

VIN: VF3MJEHZUNS027197

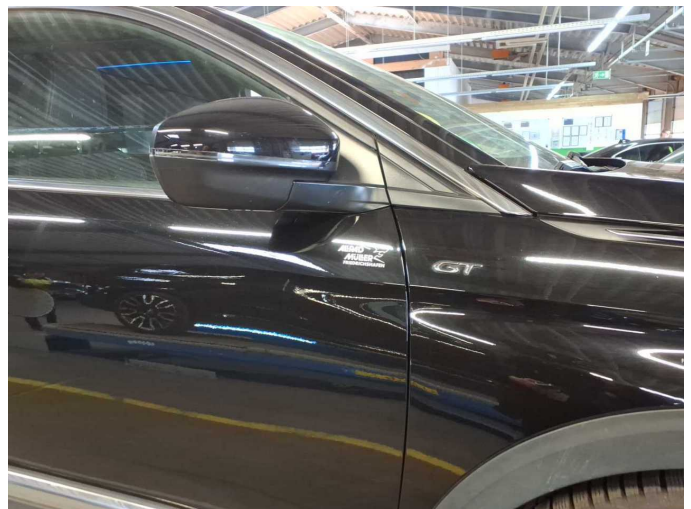
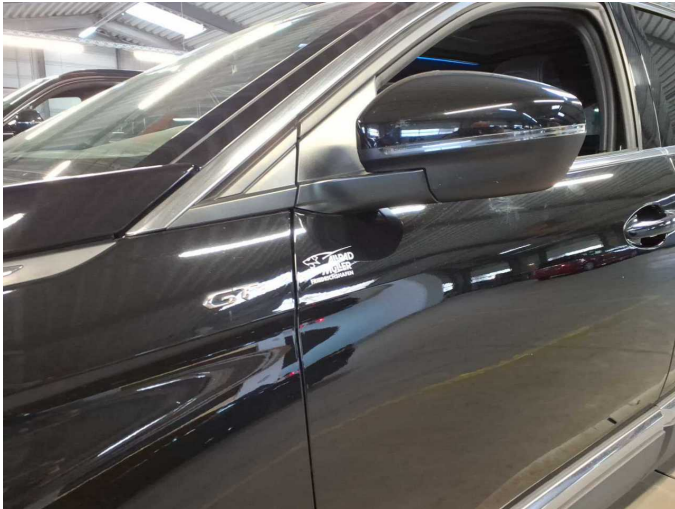
Damage 1: Body: Body - Glued / labelled - De-glue / neutralise

**Damage 1:** Body: Body - Glued / labelled - De-glug / neutralise

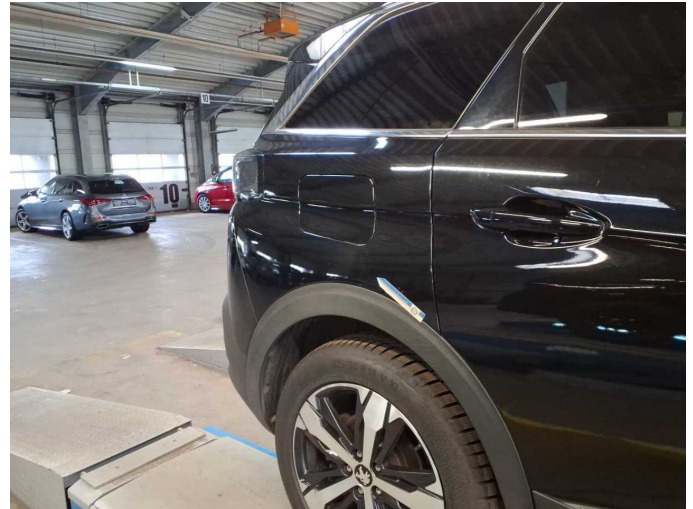
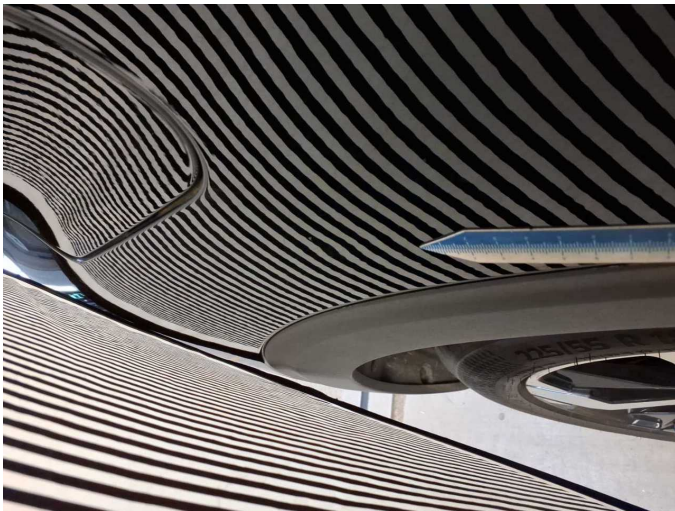
**Damage 2:** Side panel - rear right side: Side panel - dent(s) - Smooth repair work

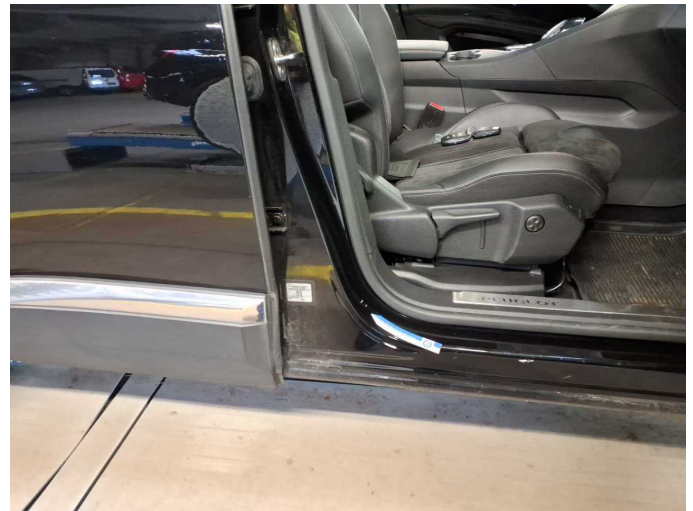
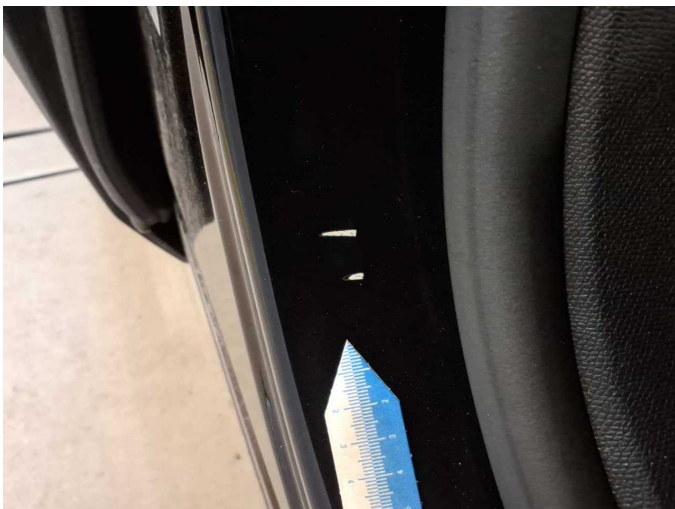
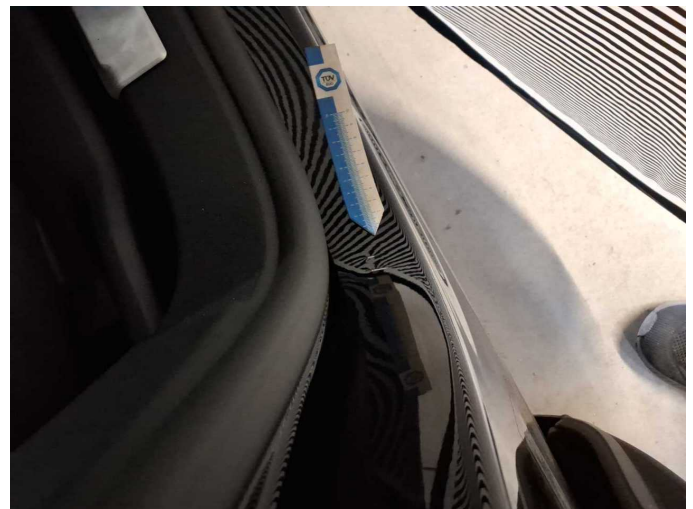
**Damage 3:** Sill - right side: Sill - Dent / paintcoat damage - Smart repair

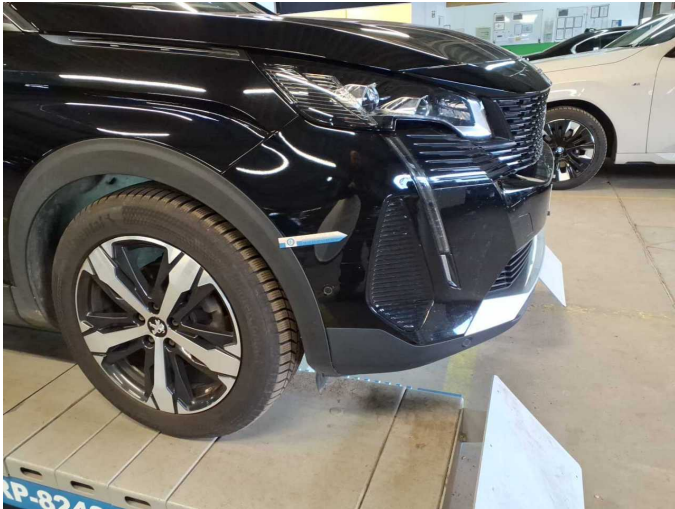
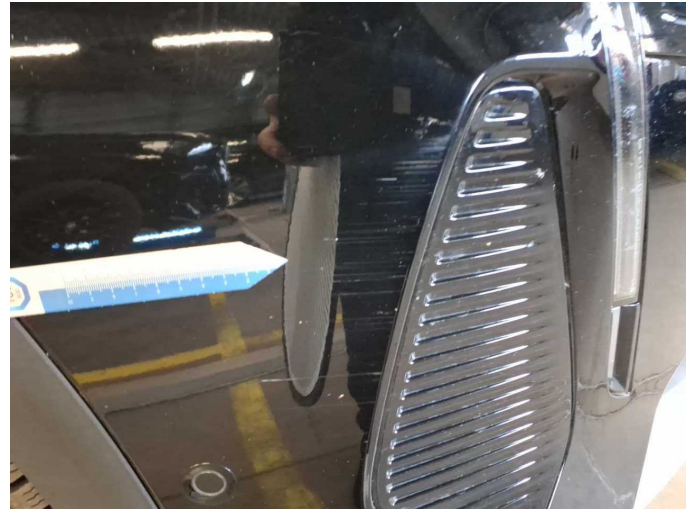
**Damage 4:** Front bumper: Front bumper - Scratch(es) - Smart repair

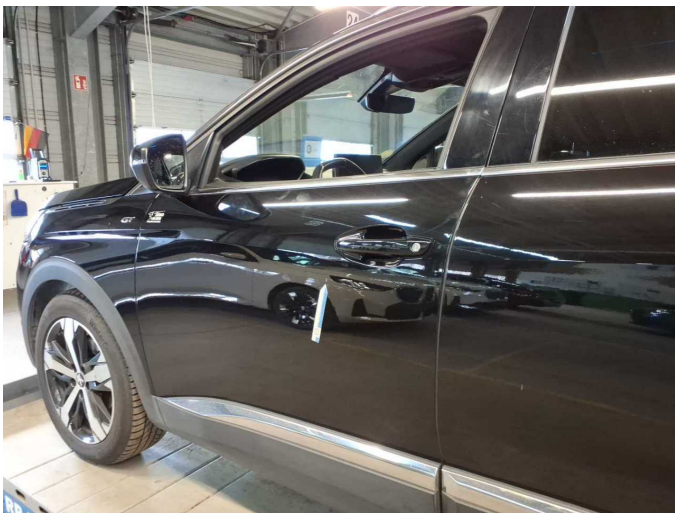
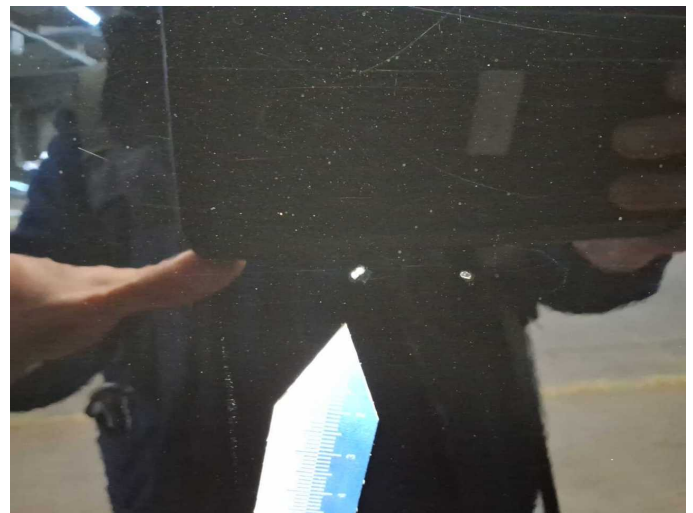
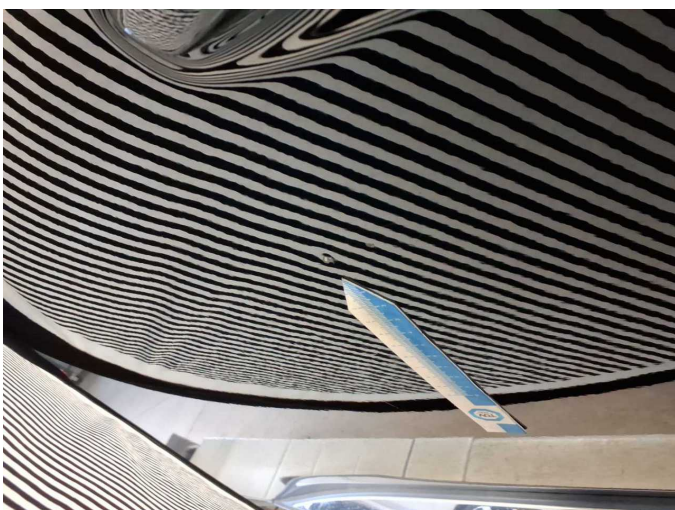
**Damage 5:** Door - front left side: Door - Dent / paintcoat damage - Repair and paint

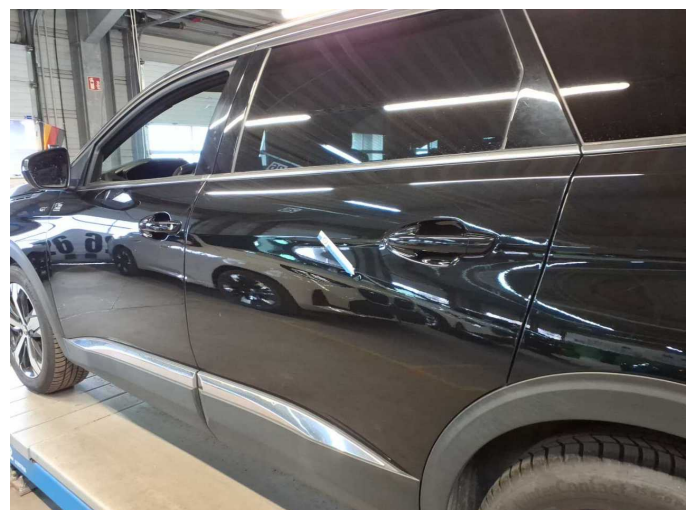
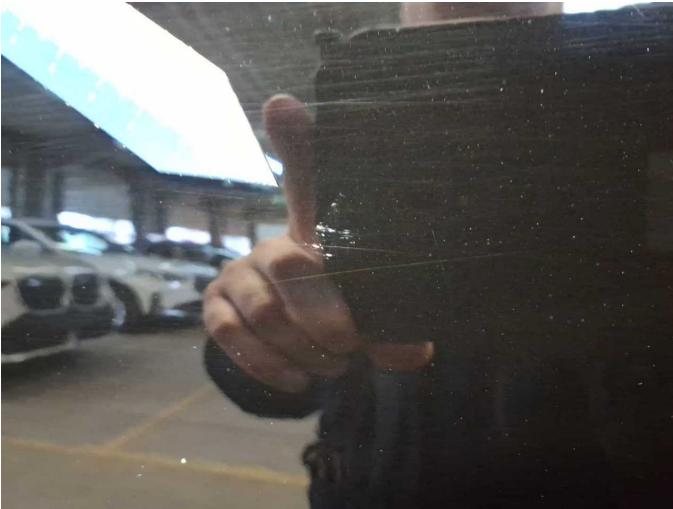
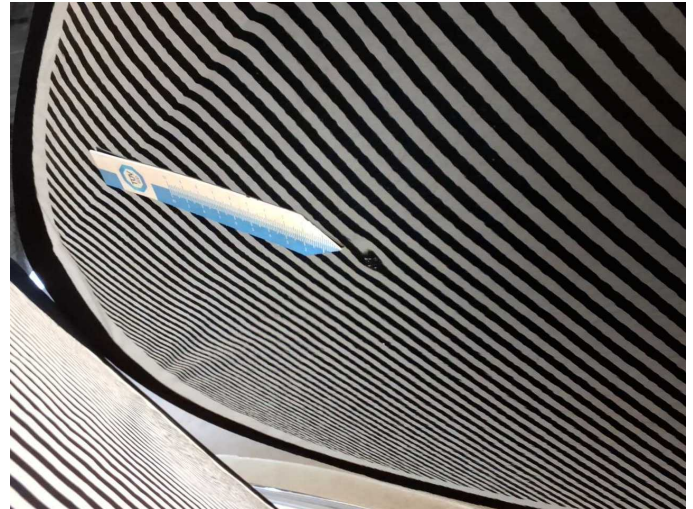
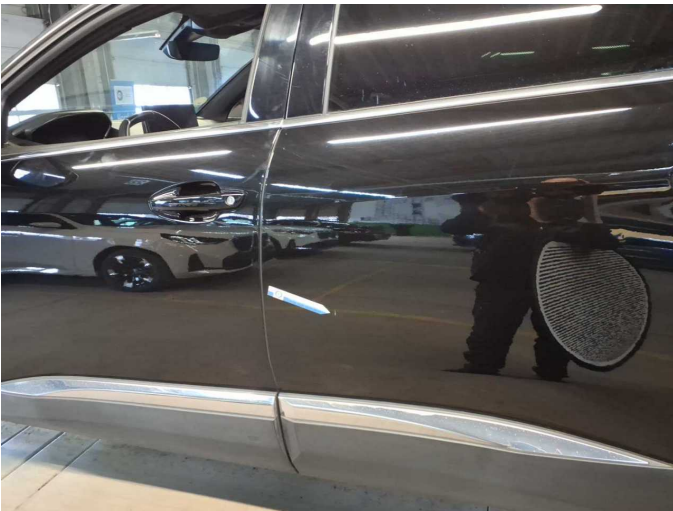
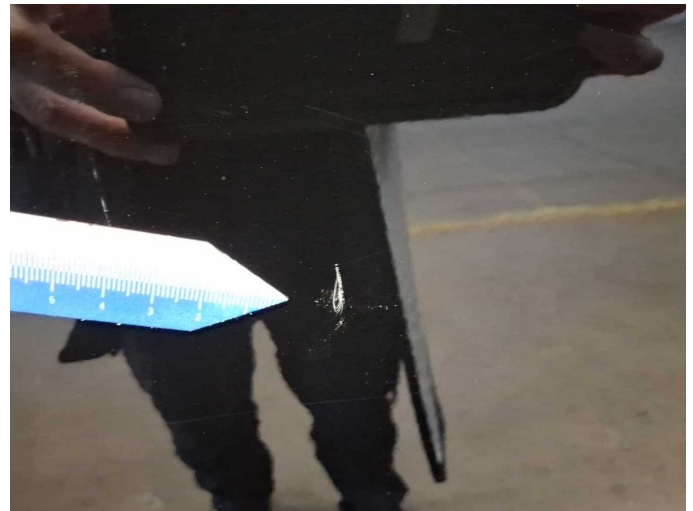
**Damage 6:** Door - rear left side: Door - Dent / paintcoat damage - Repair and paint

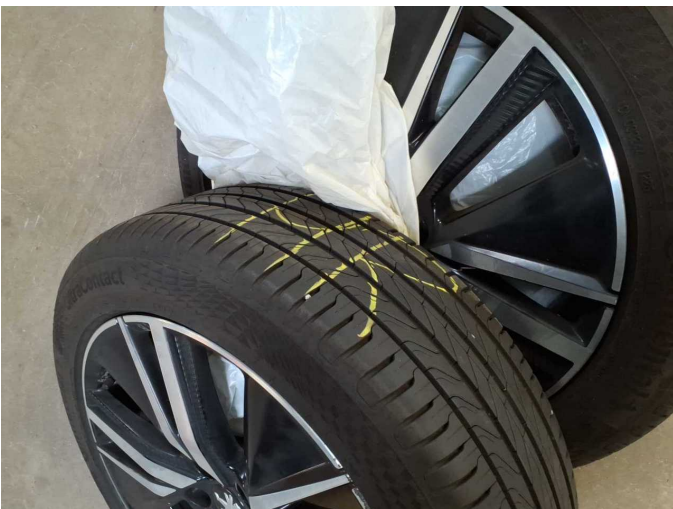
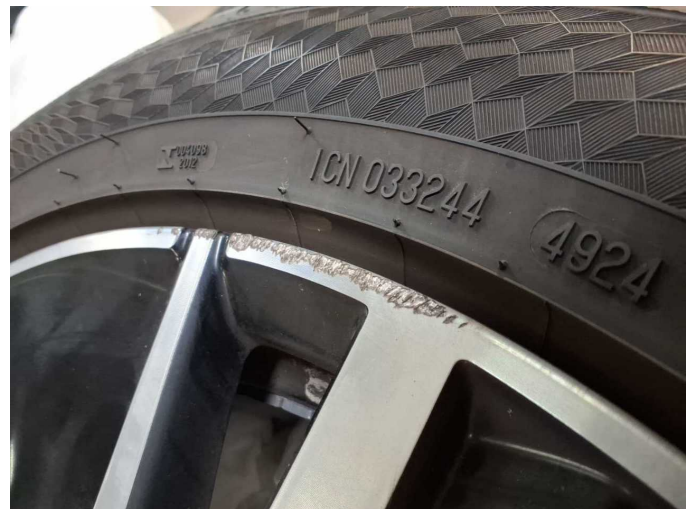
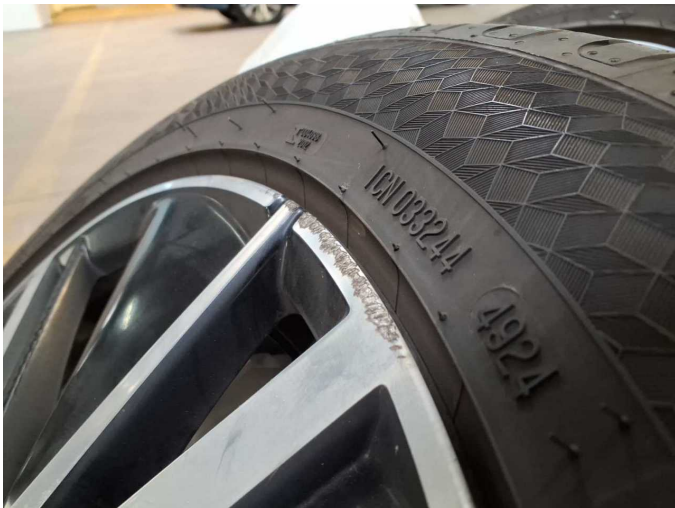
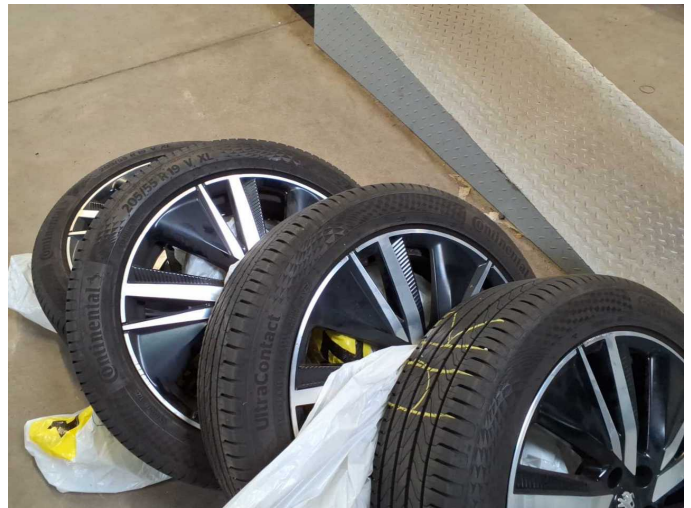
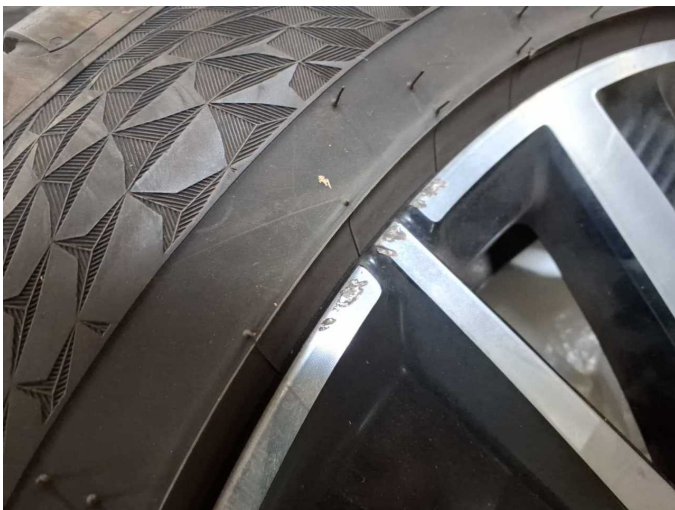
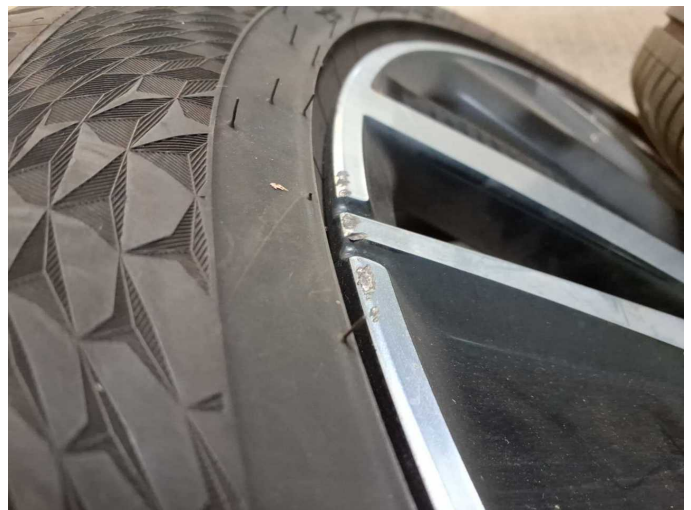
**Damage 7:** 2nd wheel set: 2 alloy rims (Materialabtrag) - Scratched - Replace

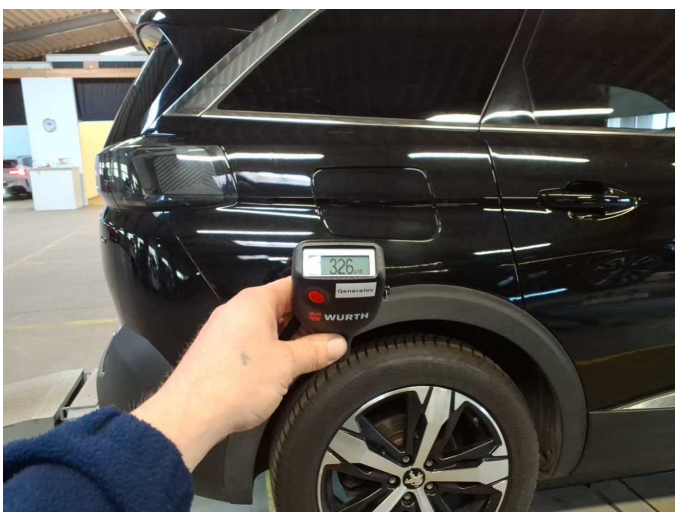
**Repainting 1:** Side panel - rear right side

No.	Repainting
1	Side panel - rear right side, Professionally carried out, Invoice of repair done Non-existent
2	Door - rear right side, Professionally carried out, Invoice of repair done Non-existent

Side panel - rear right side	326 µm	Door - rear right side	217 µm
------------------------------	--------	------------------------	--------
