## Expertise

Protocol number: 46170658  
Order No. / Reference: 26535220  
Inspection date: 25 Jun 2026

Manufacturer: Opel

Model: Corsa 1.5 Diesel Start/Stop Edition

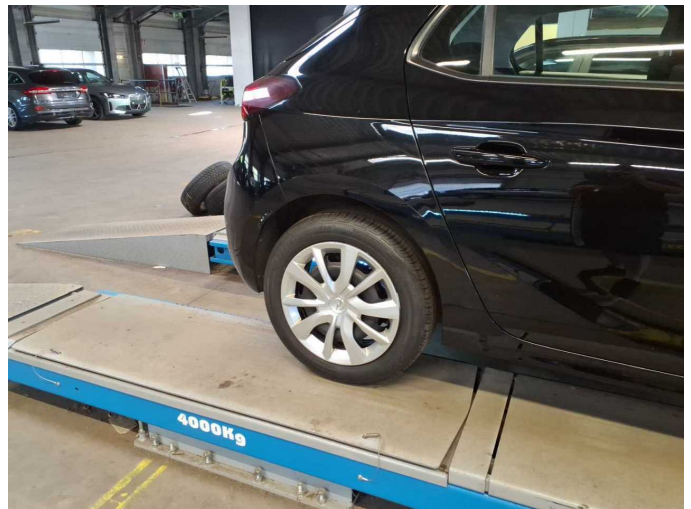
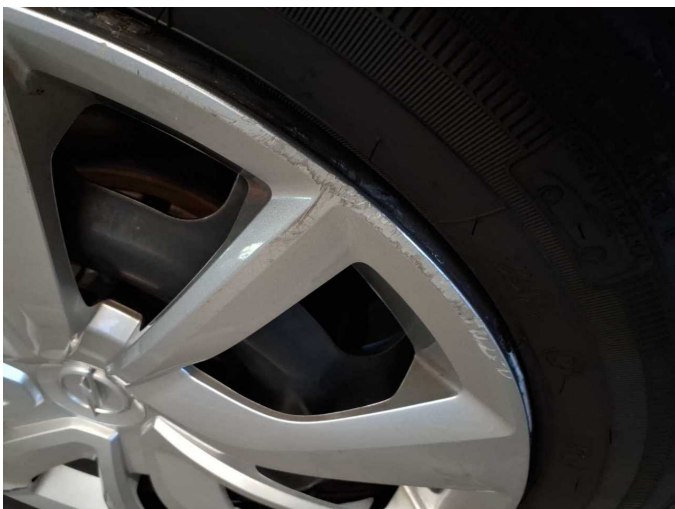
Damage 1: Wheel / tyres: Wheel cover - rear right side - Scratched - Replace

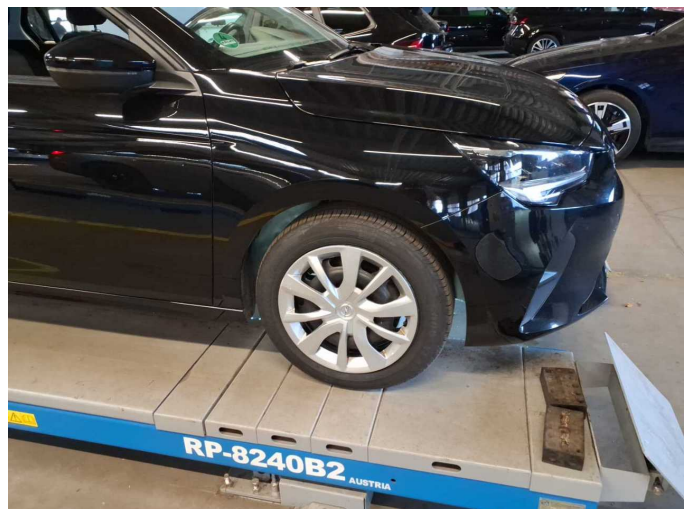
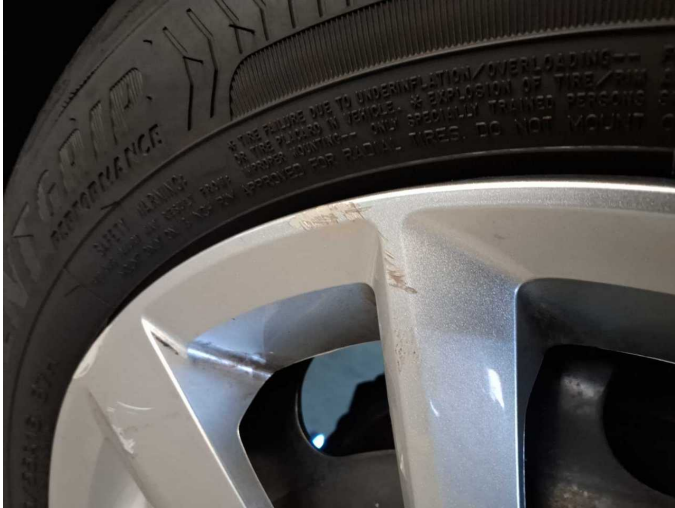
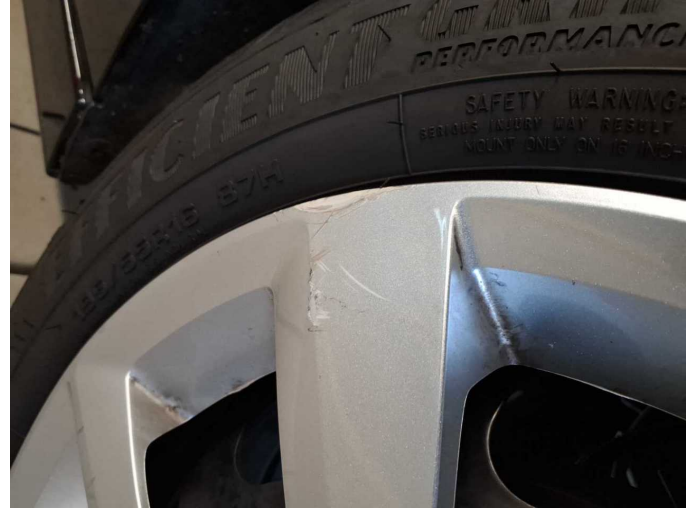
Damage 2: Wheel / tyres: Wheel cover - front right side - Scratched - Replace

**Damage 2:** Wheel / tyres: Wheel cover - front right side - Scratched - Replace

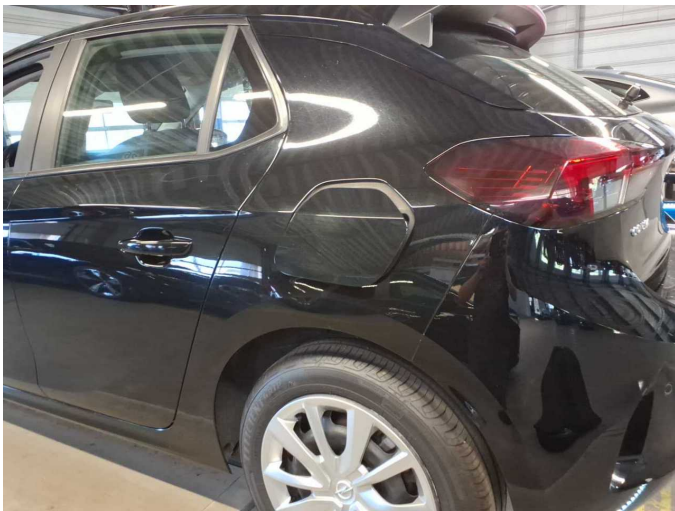
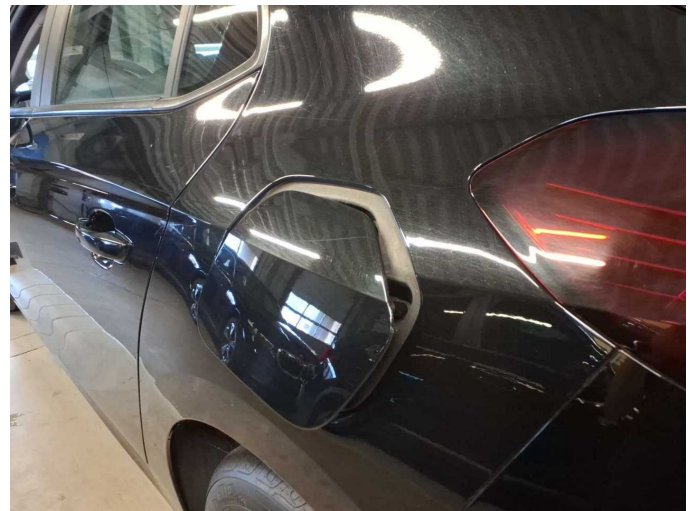
**Damage 3:** Fuel system: Tank flap (ggf. Kostenerweiterung) - Malposition - Repair

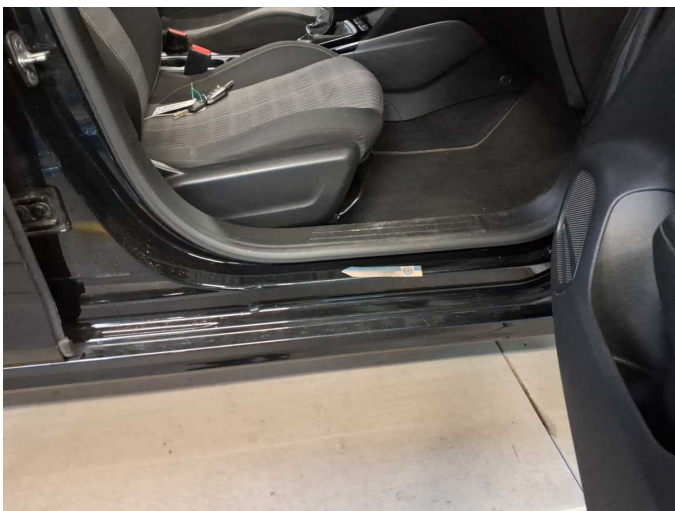
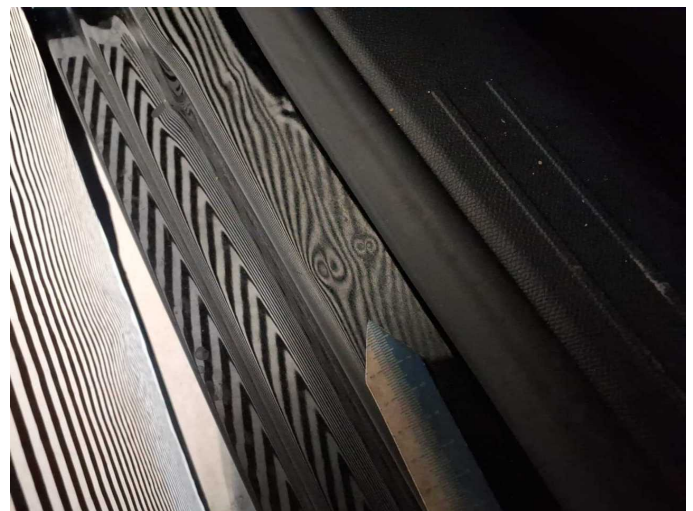
**Damage 4:** Sill - right side: Sill - dent(s) - Smooth repair work

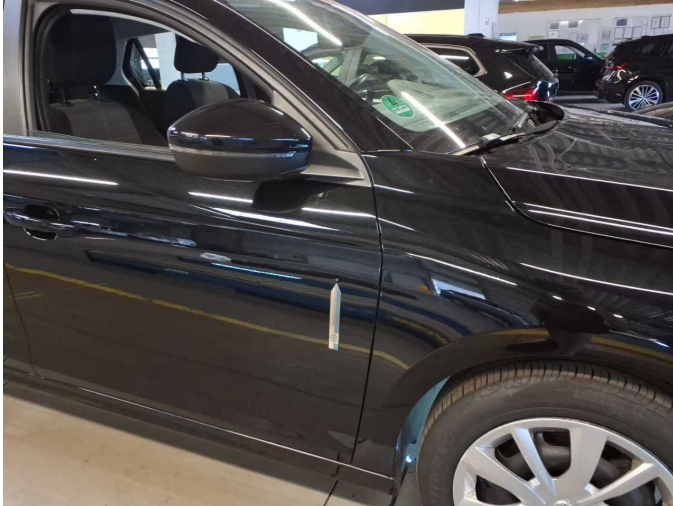
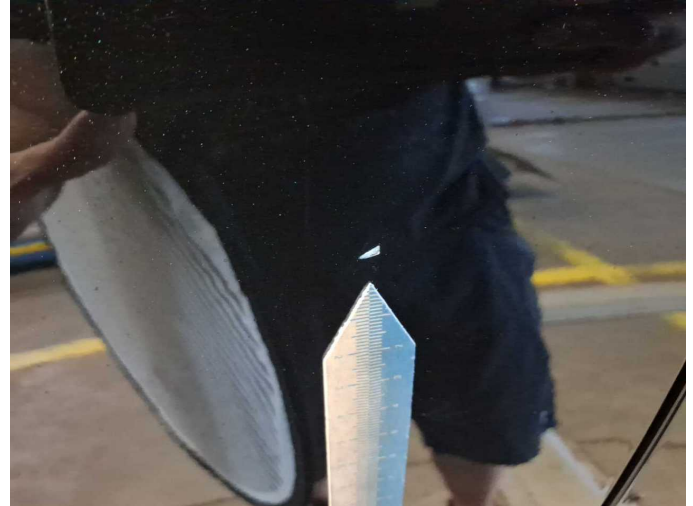
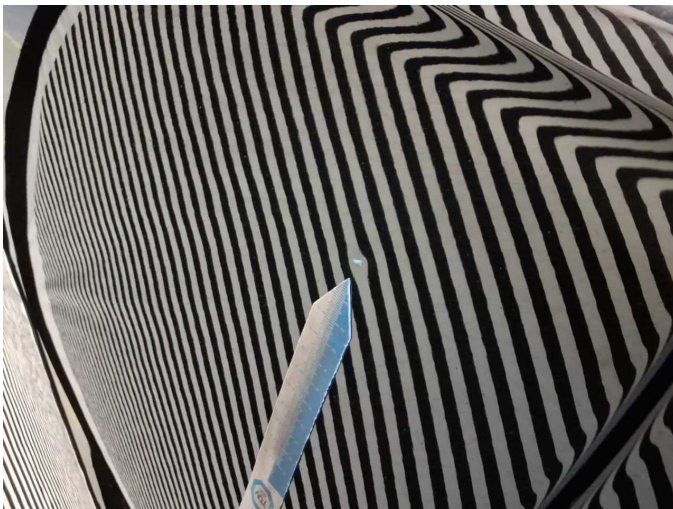
**Damage 5:** Door - front right side: Door - Dent / paintcoat damage - Smart repair

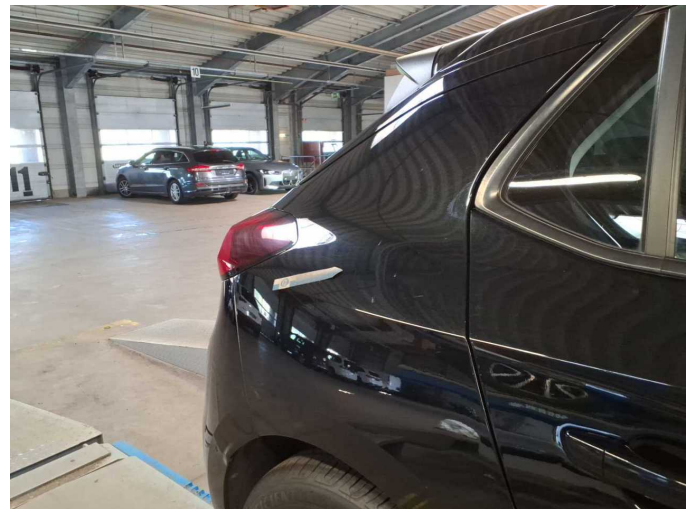
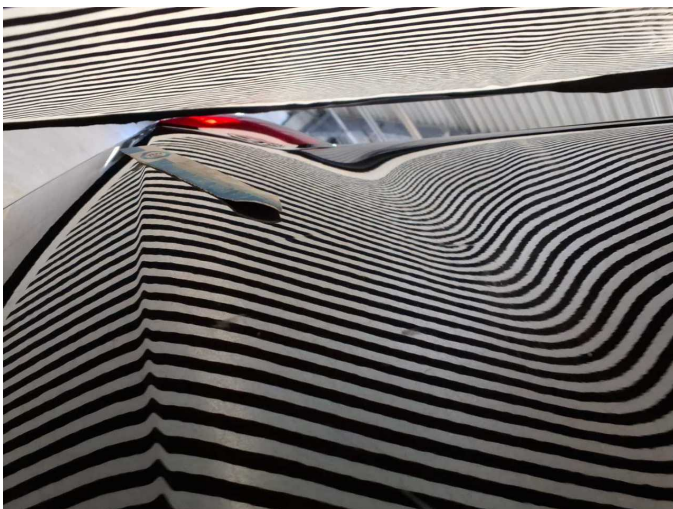
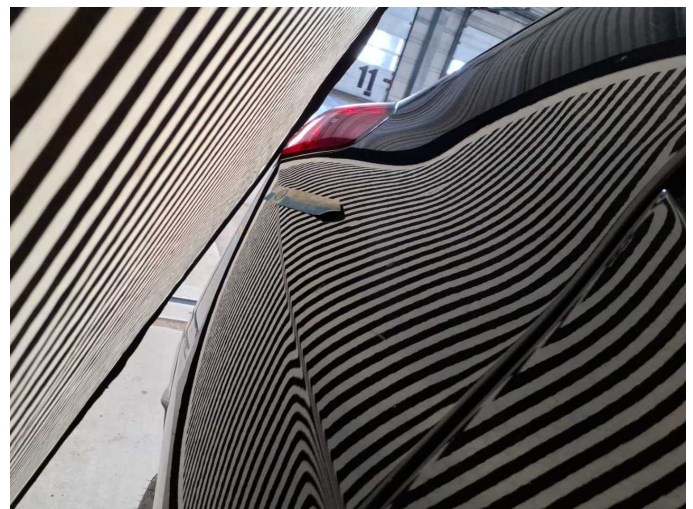
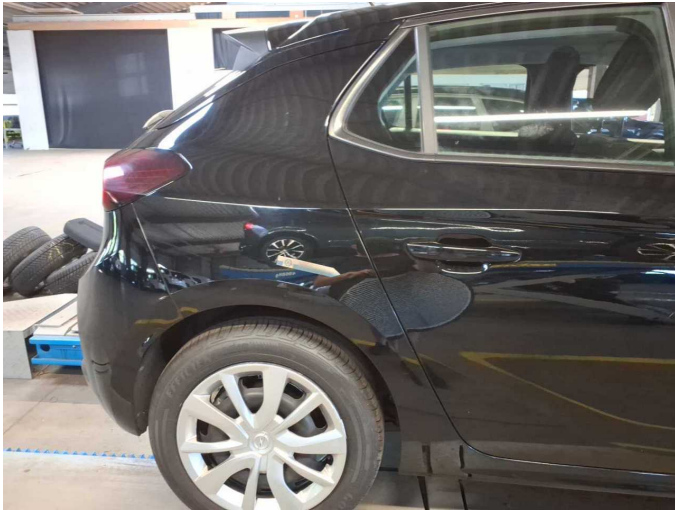
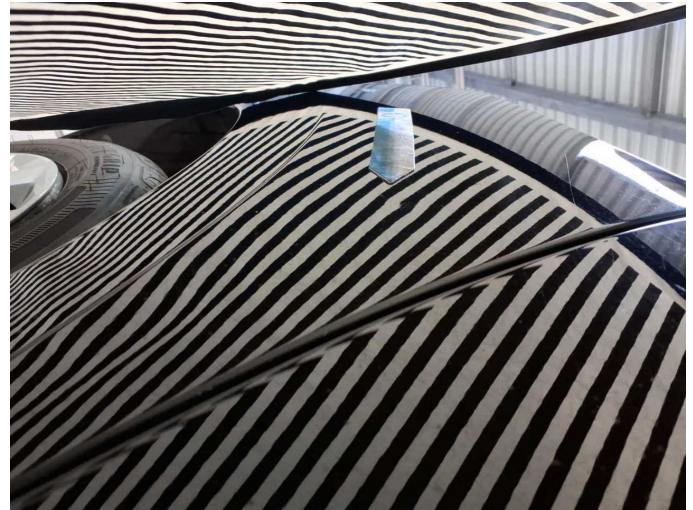
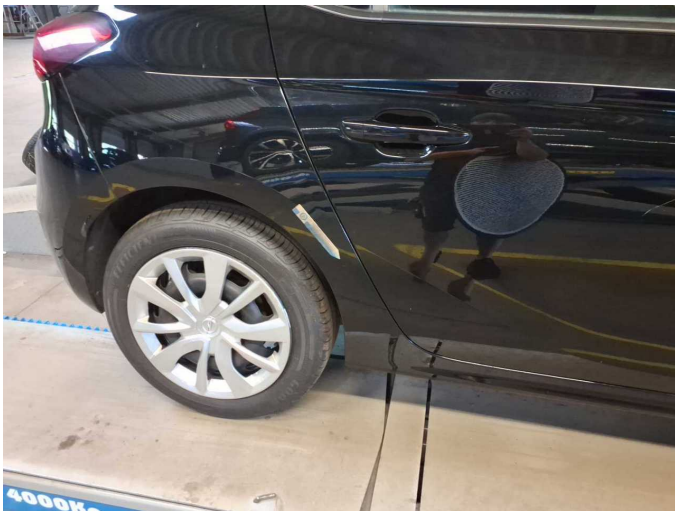
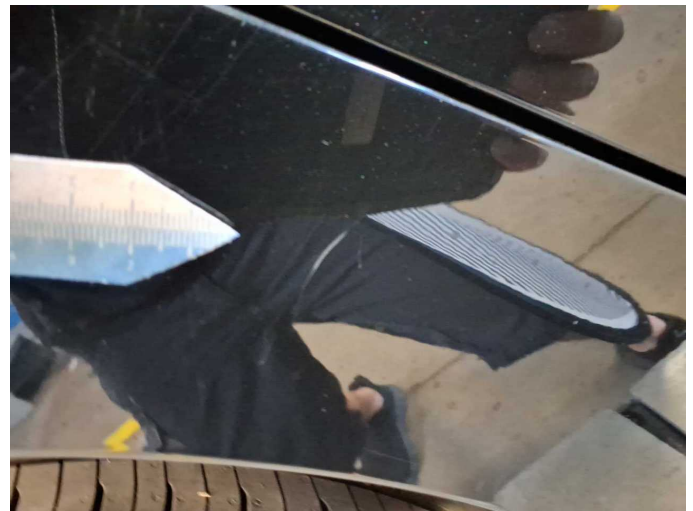
**Damage 6:** Side panel - rear right side: Side panel - Dent / paintcoat damage - Smart repair

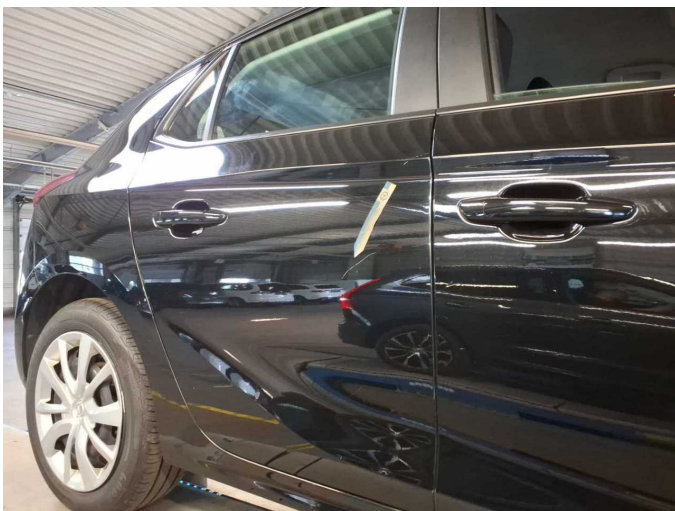
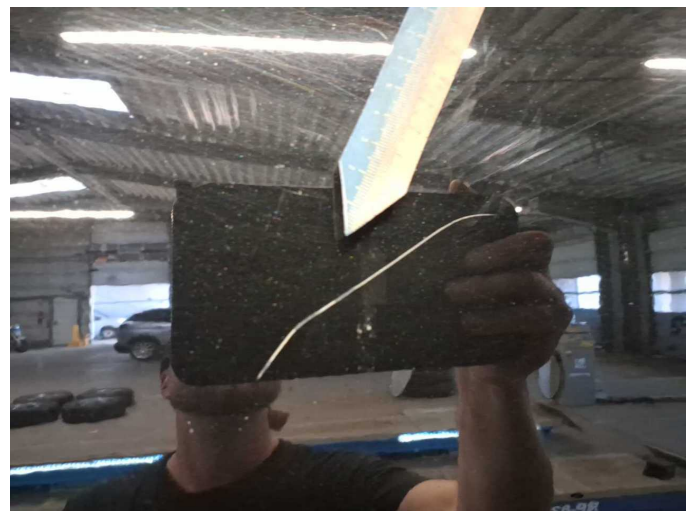
**Damage 7:** Door - rear right side: Door - Scratch(es) - Smart repair

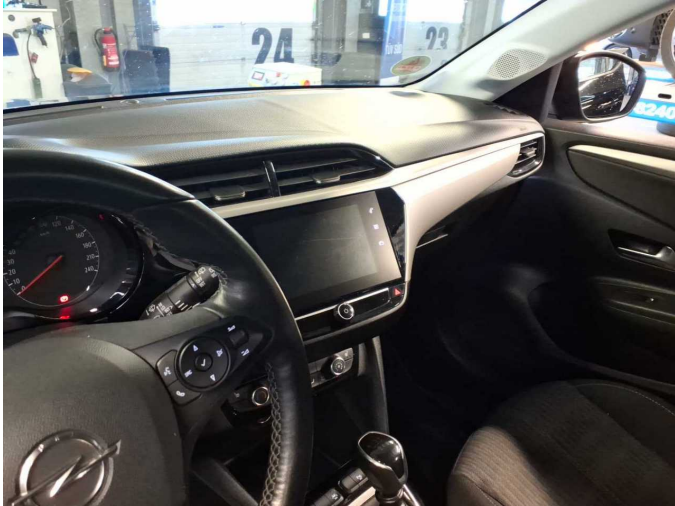
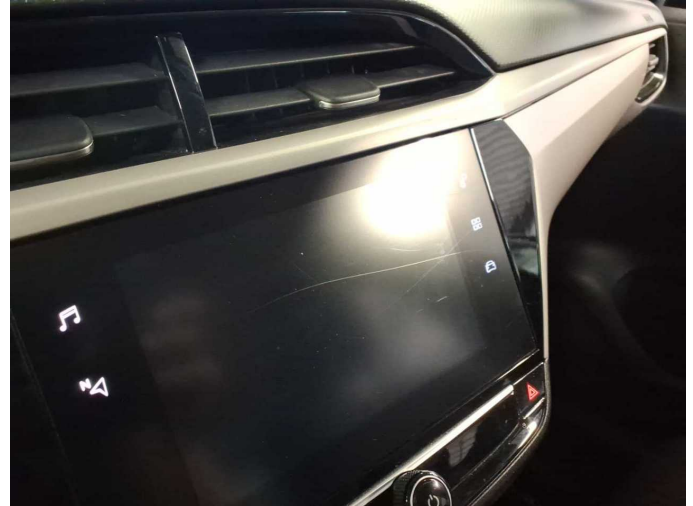
**Damage 8:** Multimedia system: Entertainment (Display) - Scratched - Loss in value

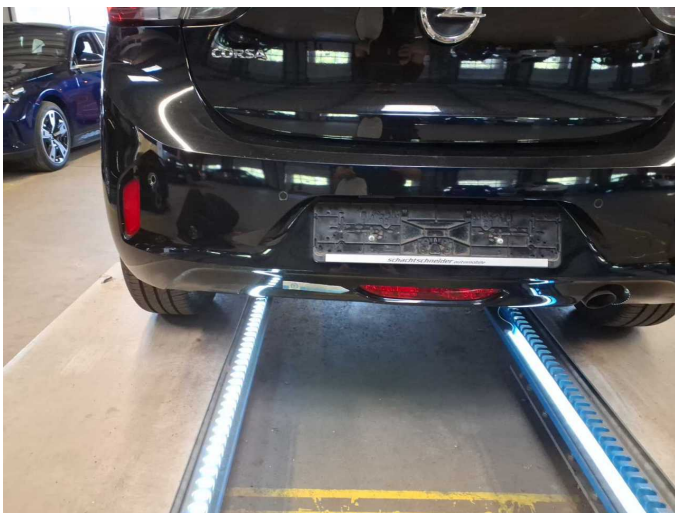
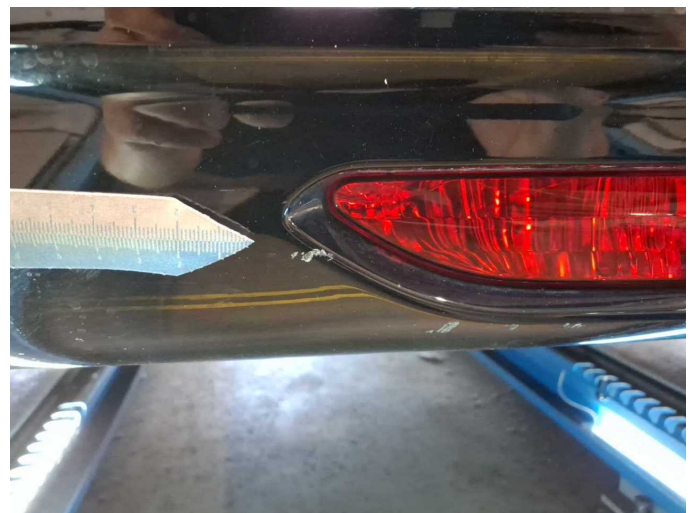
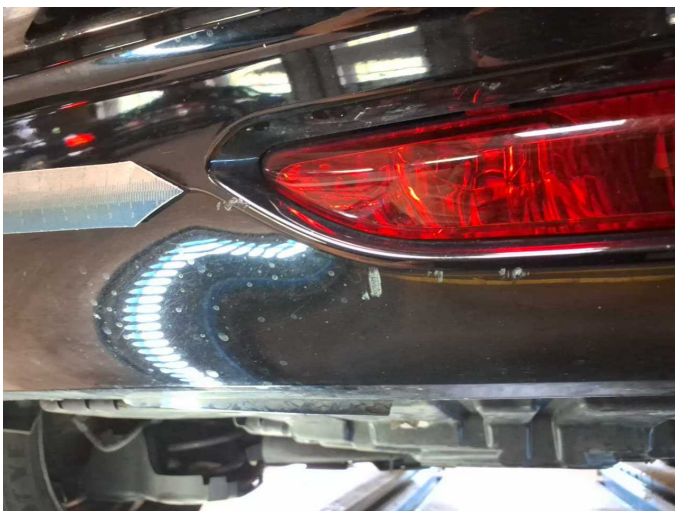
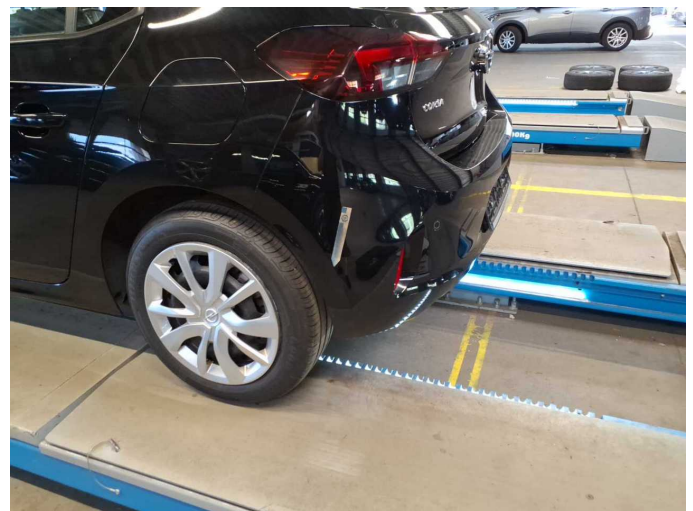
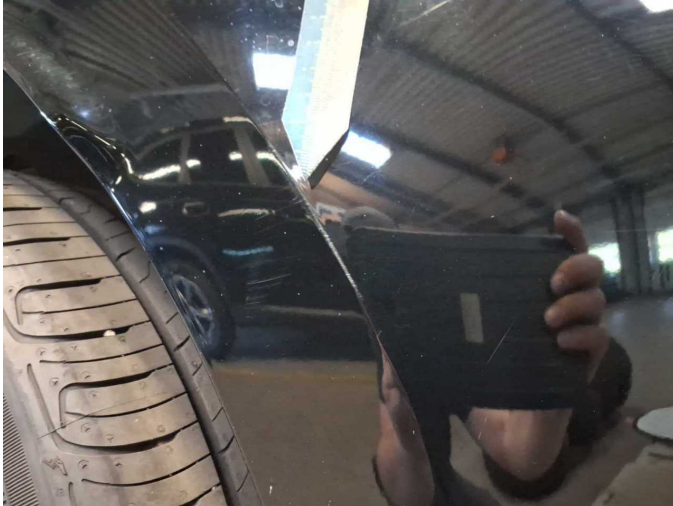
**Damage 9:** Rear bumper: Rear bumper - Scratched - Paint

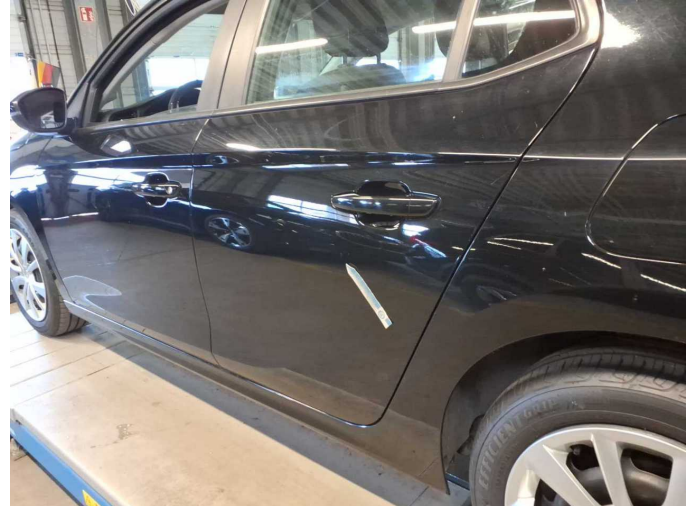
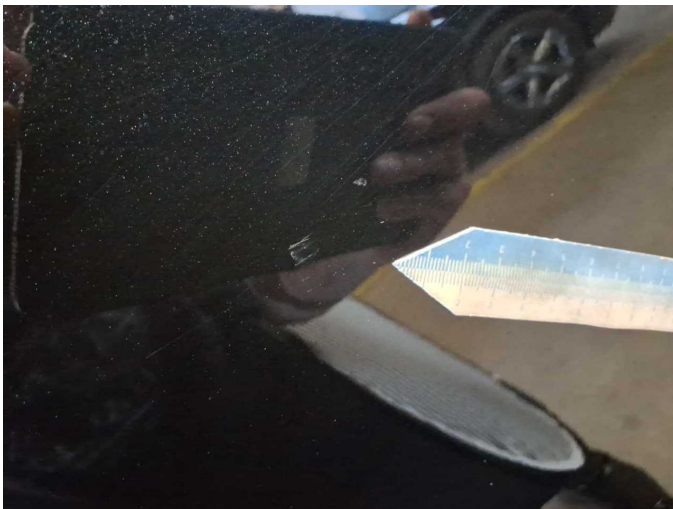
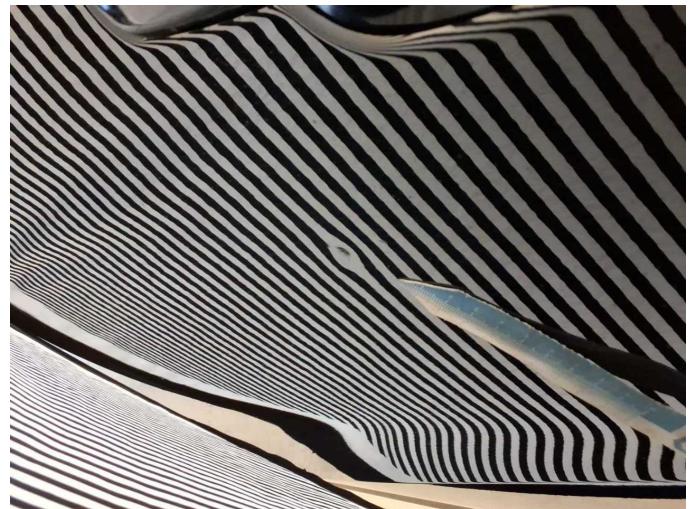
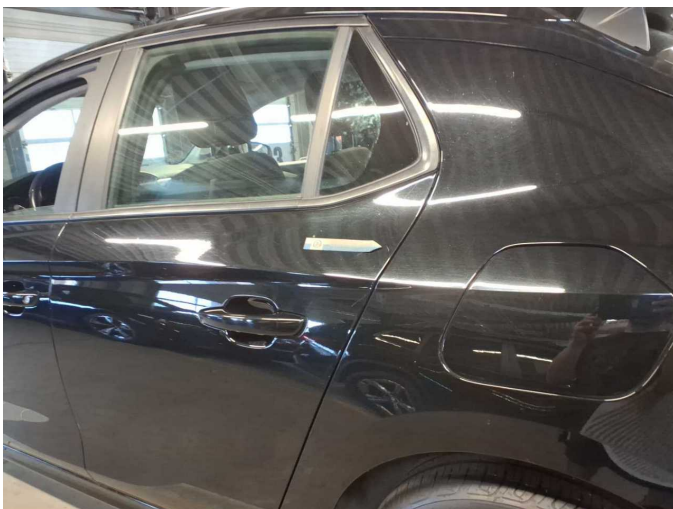
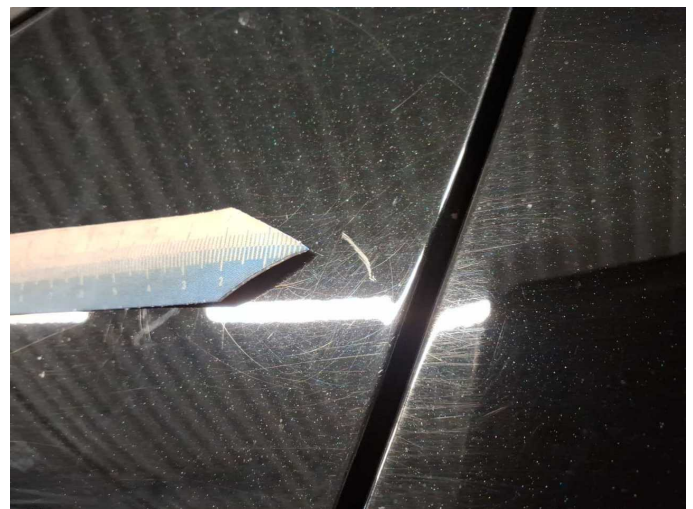
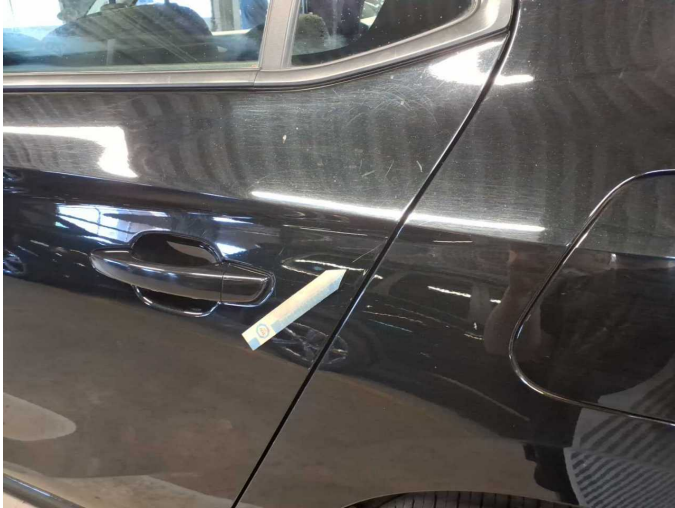
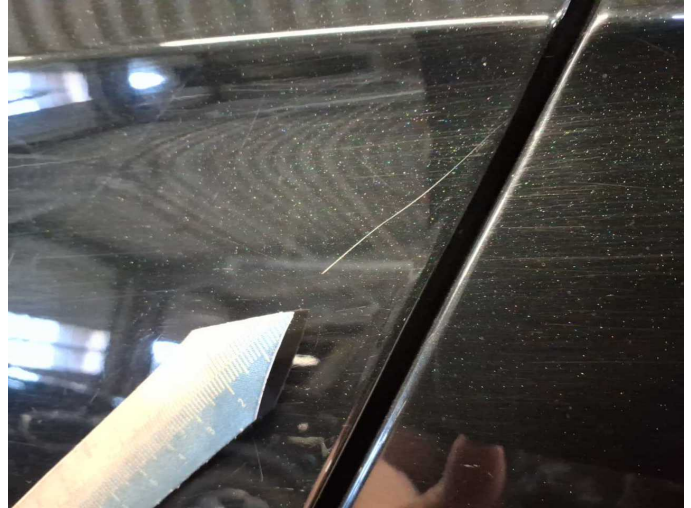
**Damage 10:** Door - rear left side: Door - Dent / paintcoat damage - Repair and paint

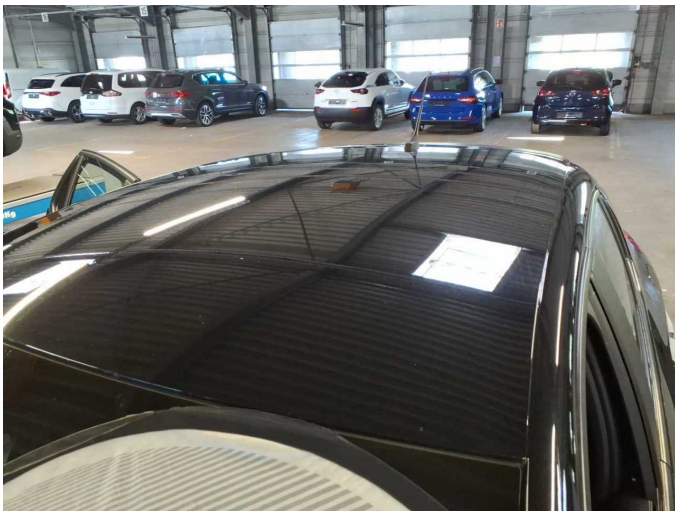
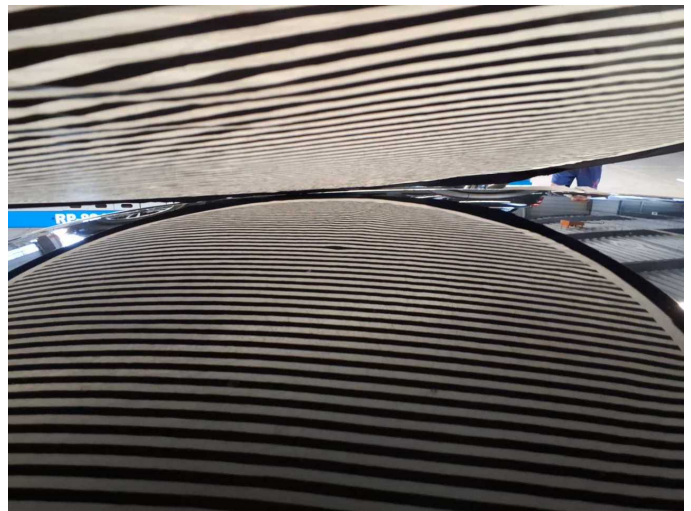
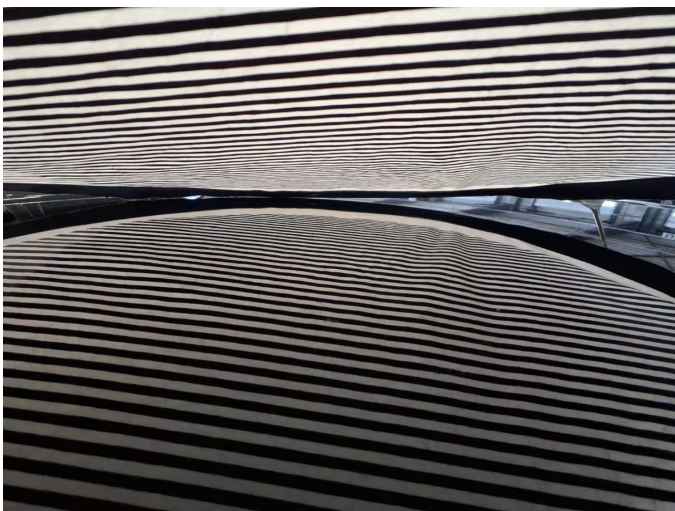
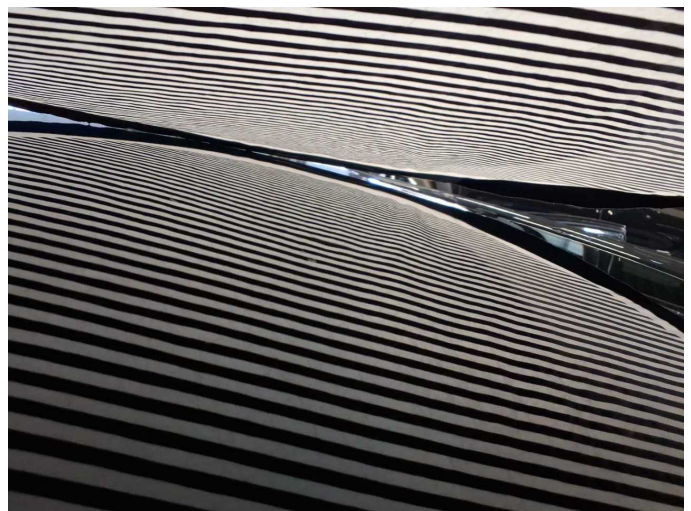
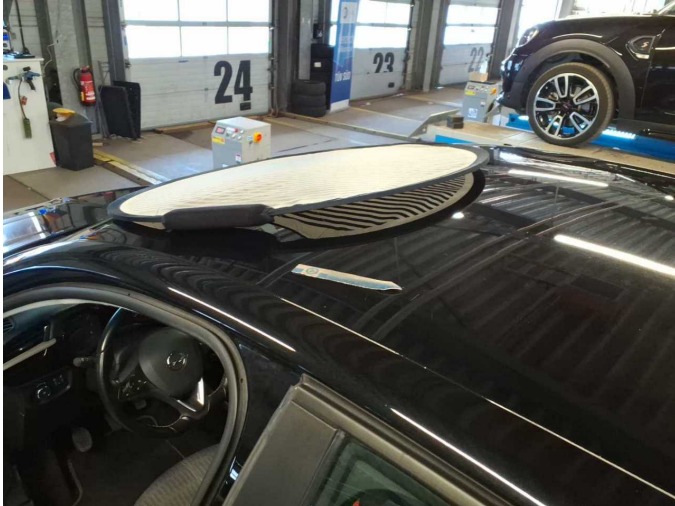
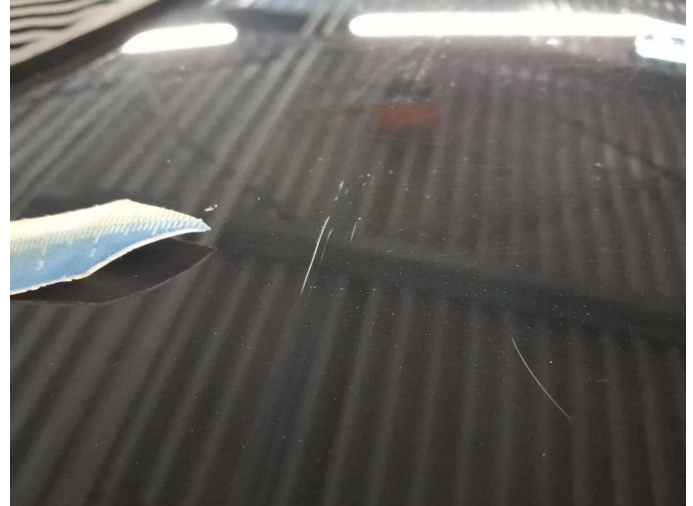
**Damage 11:** Roof: Roof - Dent / paintcoat damage - Repair and paint

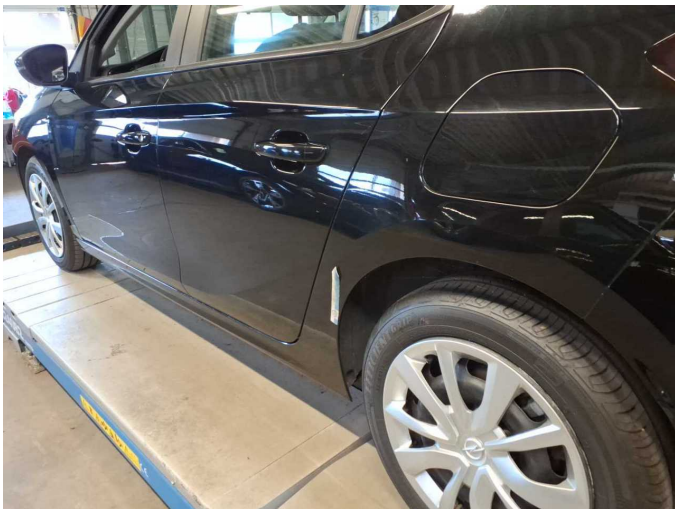
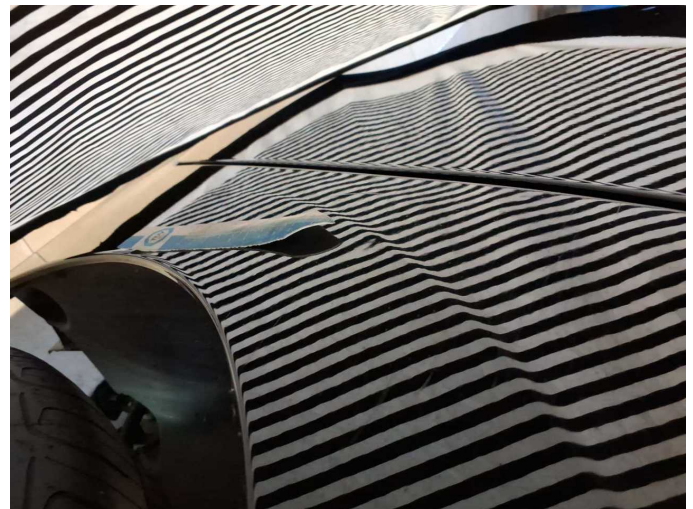
**Wear and tear 4:** Side panel - rear left side: Side panel - dent(s) - No deduction

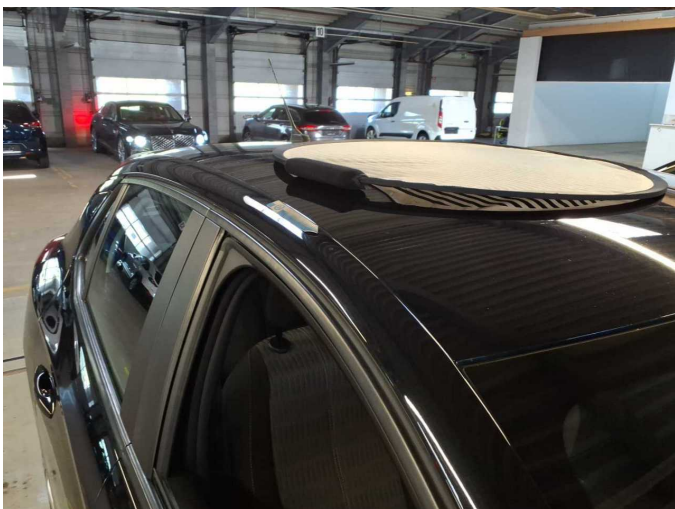
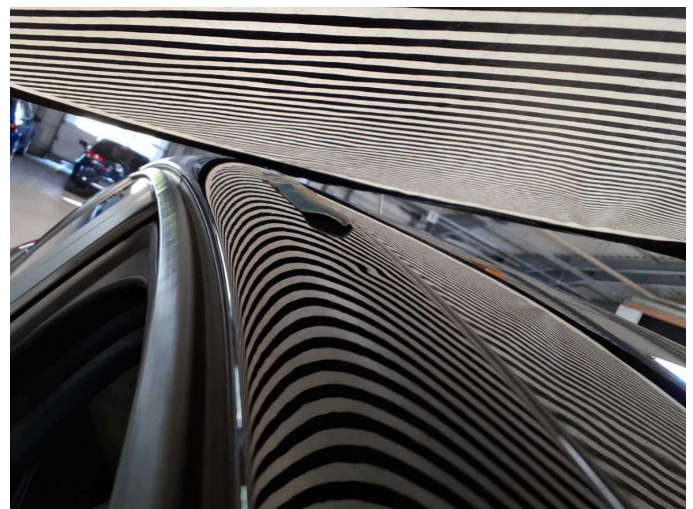
**Wear and tear 5:** Roof: Roof rail - right side - dent(s) - No deduction

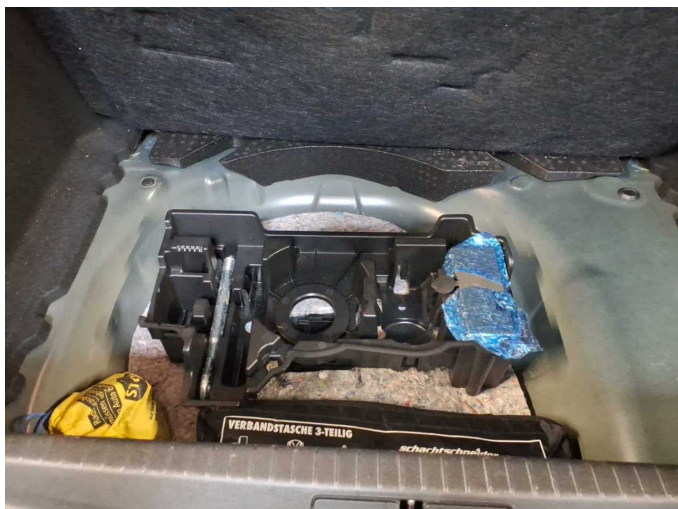
**Missing part 1:** Equipment: Tirefit filler - Missing - Replace
