Expertise

Protocol number: 46732163  
Order No. / Reference: 26396987-1  
Inspection date: 21 Jul 2026

Manufacturer: Ford

Model: Kuga 2.0 EcoBlue Aut. TITANIUM

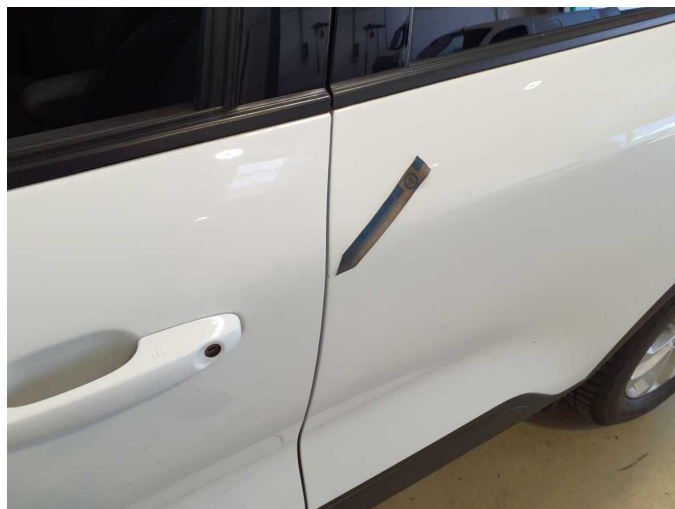
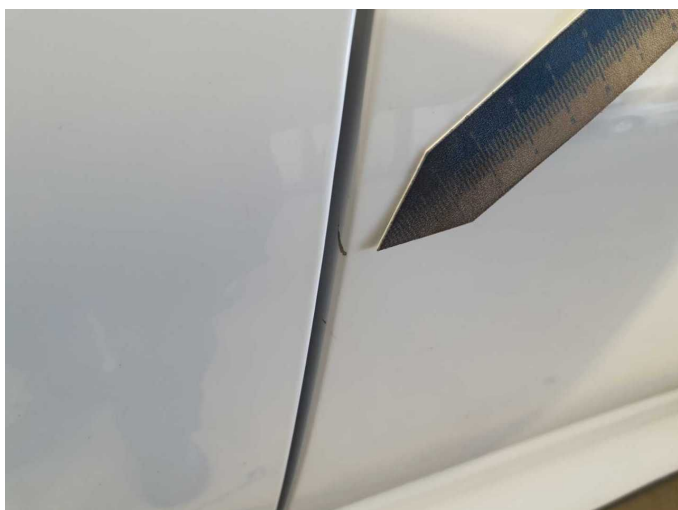
| No. | Component group | Description |
|---|---|---|
| 2 | Door - rear left side | Door edge - Scratch(es) - Smart repair |

**Damage 2:** Door - rear left side: Door edge - Scratch(es) - Smart repair

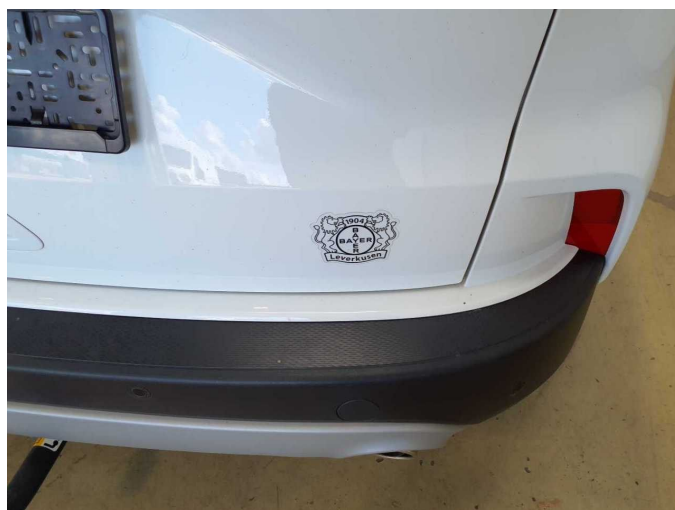
| No. | Component group | Description |
|---|---|---|
| 3 | Boot lid / rear door | Boot lid - Glued / labelled - De-glue / neutralise |

**Damage 3:** Boot lid / rear door: Boot lid - Glued / labelled - De-glue / neutralise

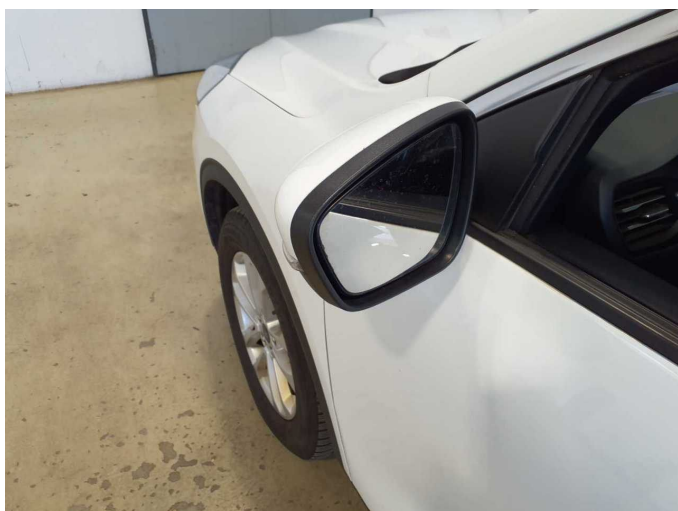
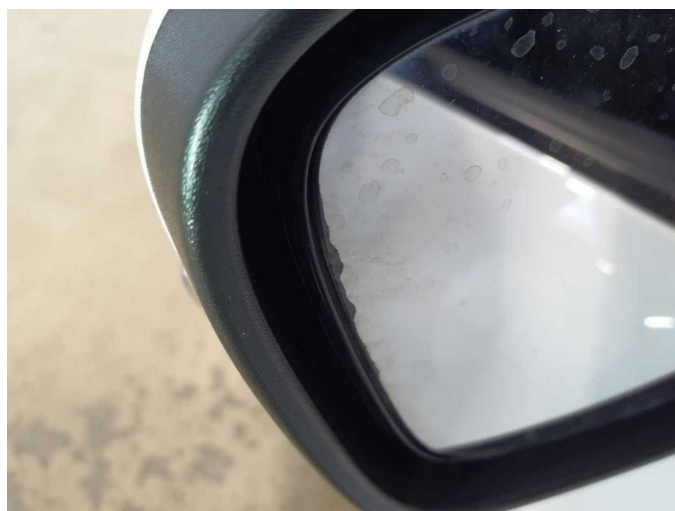
| No. | Component group | Description |
|---|---|---|
| 4 | Wing mirror - left side | Mirror glass - Scratch(es) - Replace |

**Damage 4:** Wing mirror - left side: Mirror glass - Scratch(es) - Replace

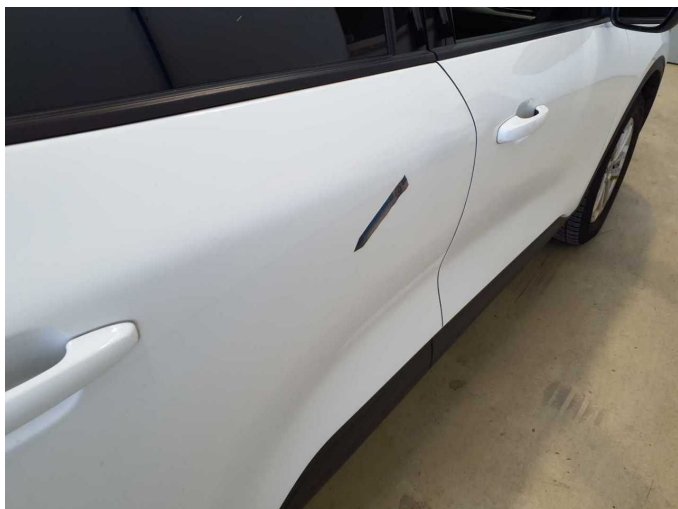
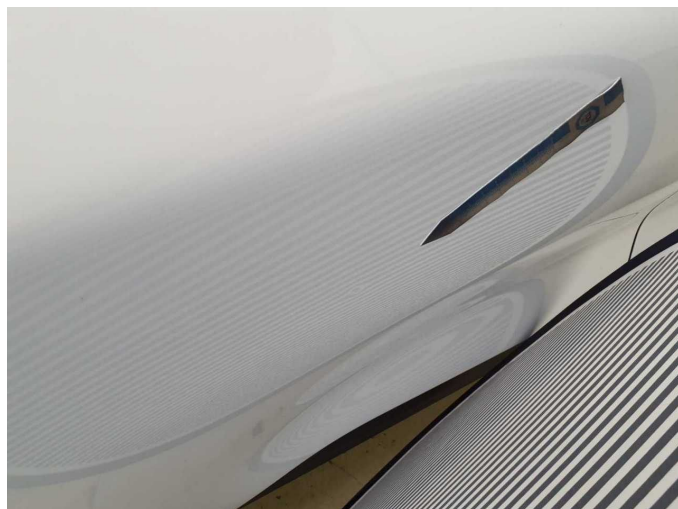
| No. | Component group | Description |
|---|---|---|
| 5 | Door - rear right side | Door - dent(s) - Smooth repair work |

**Damage 5:** Door - rear right side: Door - dent(s) - Smooth repair work

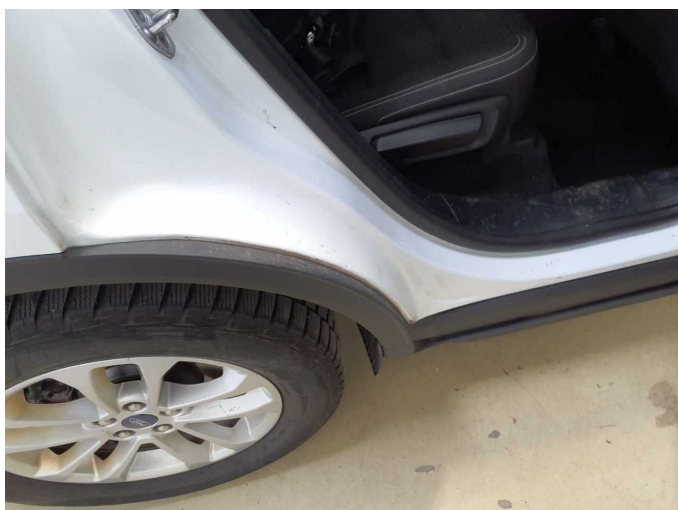
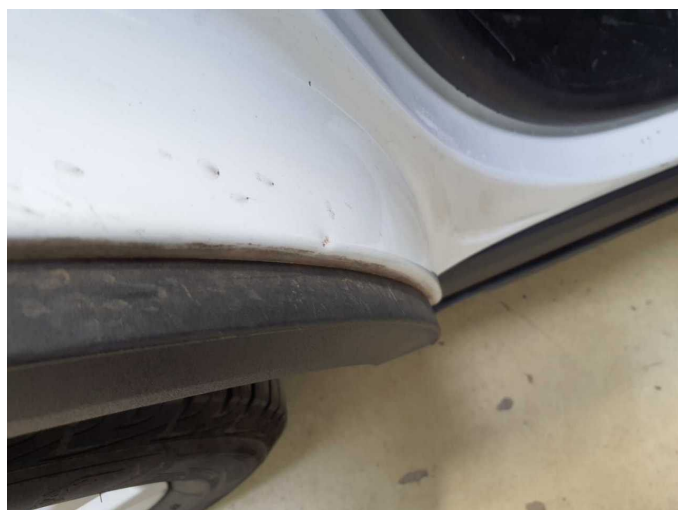
| No. | Component group | Description |
|---|---|---|
| 6 | Side panel - rear right side | Sill - dent(s) - Smart repair |

**Damage 6:** Side panel - rear right side: Sill - dent(s) - Smart repair

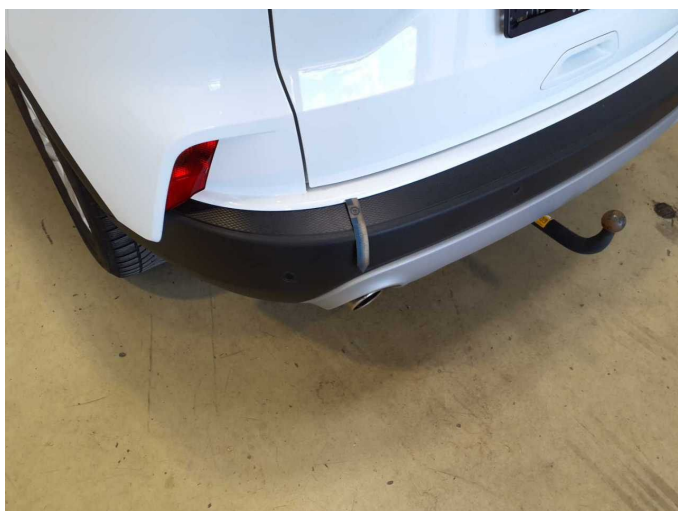
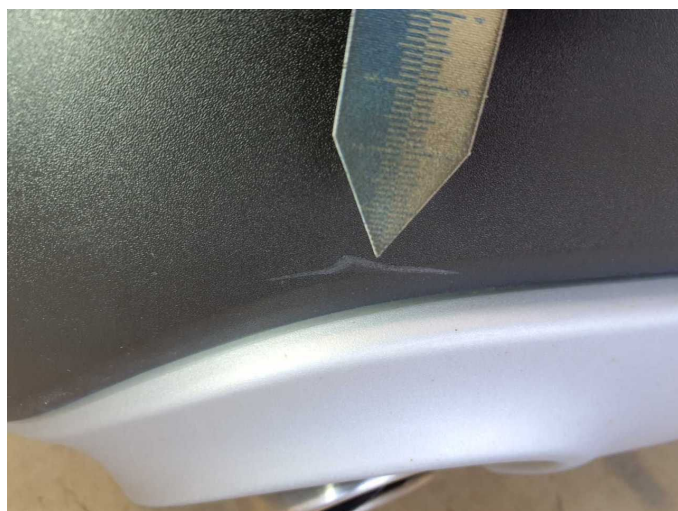
| No. | Component group | Description |
|---|---|---|
| 7 | Rear bumper | Rear bumper (unpainted) - Scratch(es) - Loss in value |

**Damage 7:** Rear bumper: Rear bumper (unpainted) - Scratch(es) - Loss in value

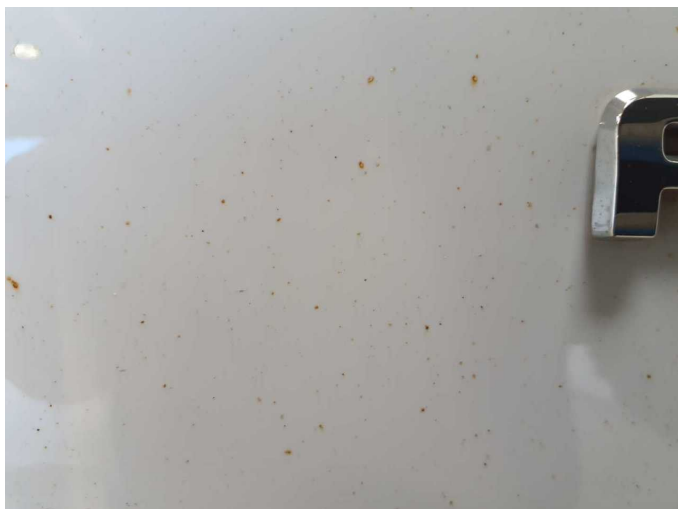
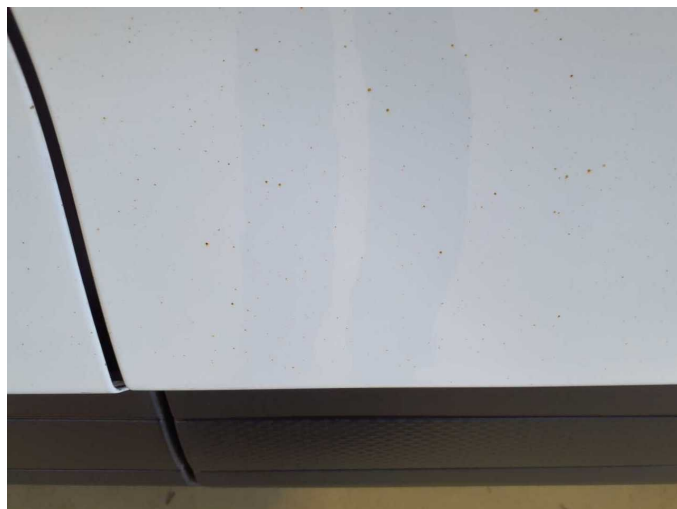
| No. | Component group | Description |
|---|---|---|
| 8 | Body | Body (Flugrost) - Stone chips - Conditioning |

**Damage 8:** Body: Body (Flugrost) - Stone chips - Conditioning

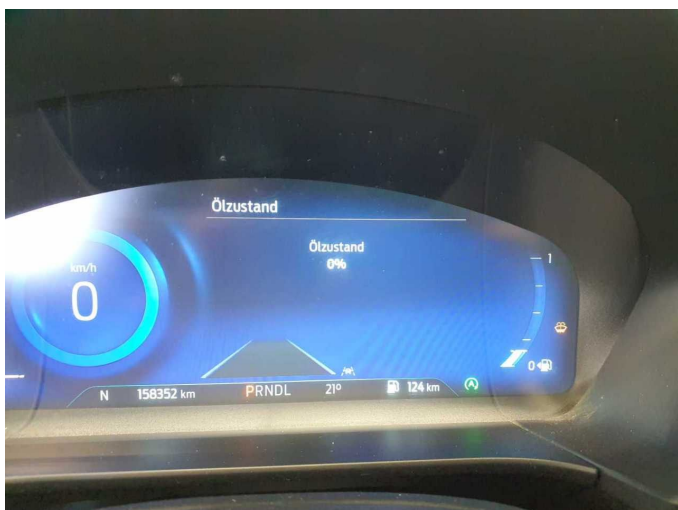
| No. | Component group | Description |
|---|---|---|
| 9 | Misc. | Inspection / maintenance - Due - Perform |

**Damage 9:** Misc.: Inspection / maintenance - Due - Perform

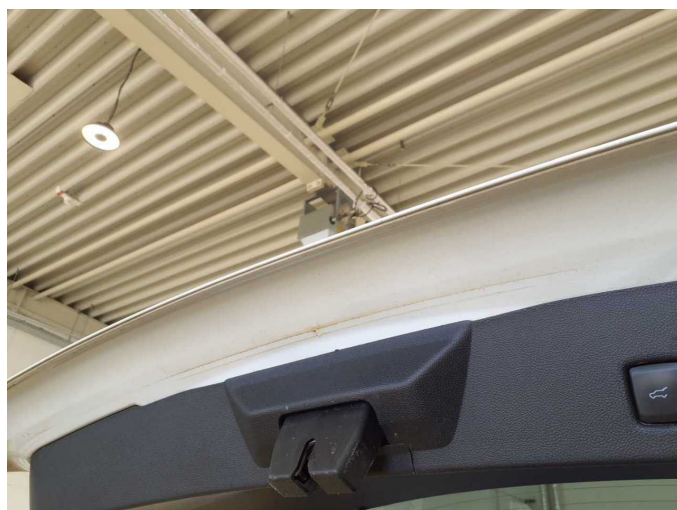
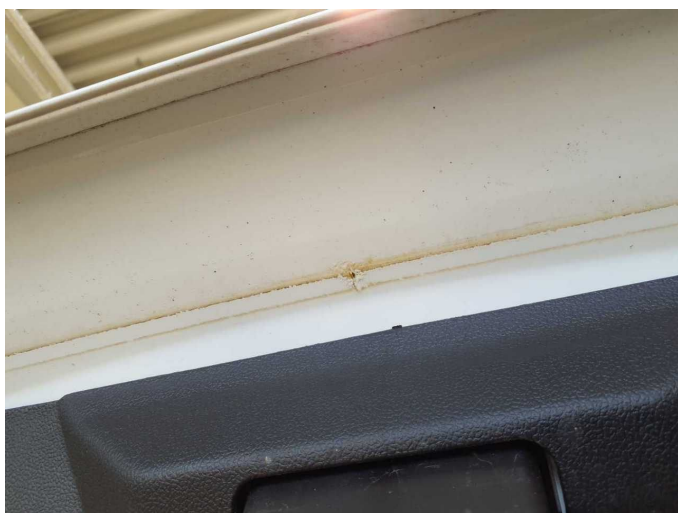
| No. | Component group | Description |
|---|---|---|
| 10 | Boot lid / rear door | Boot lid - Corrosion - Repair and paint |

**Damage 10:** Boot lid / rear door: Boot lid - Corrosion - Repair and paint

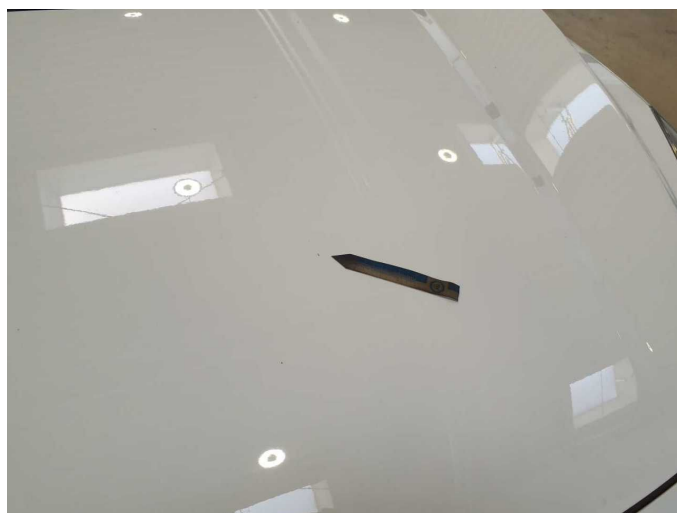
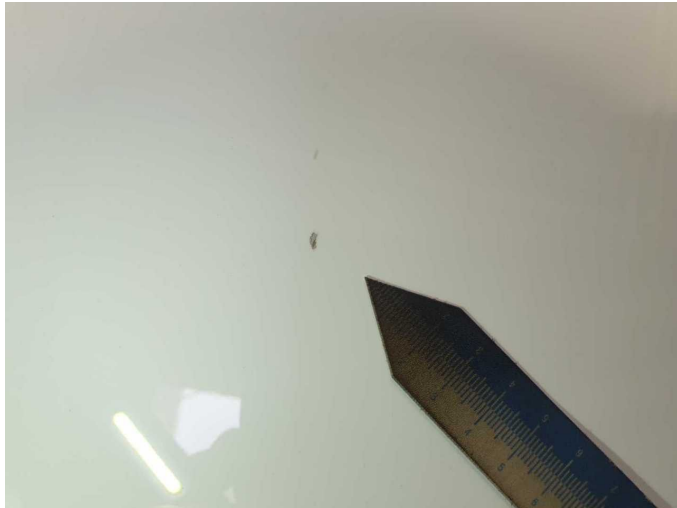
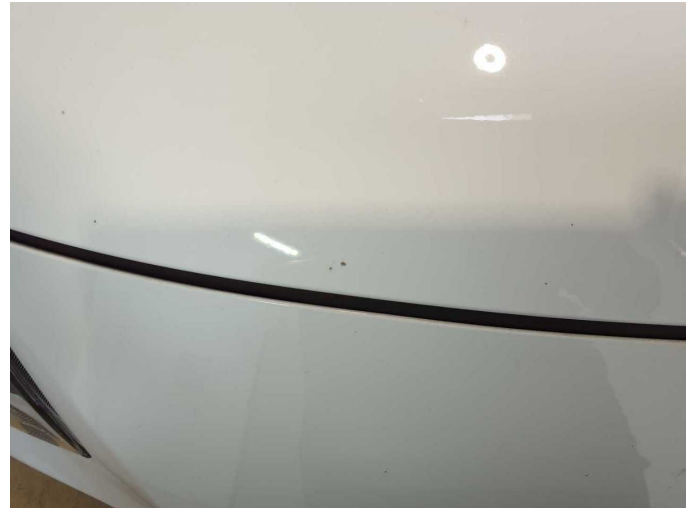
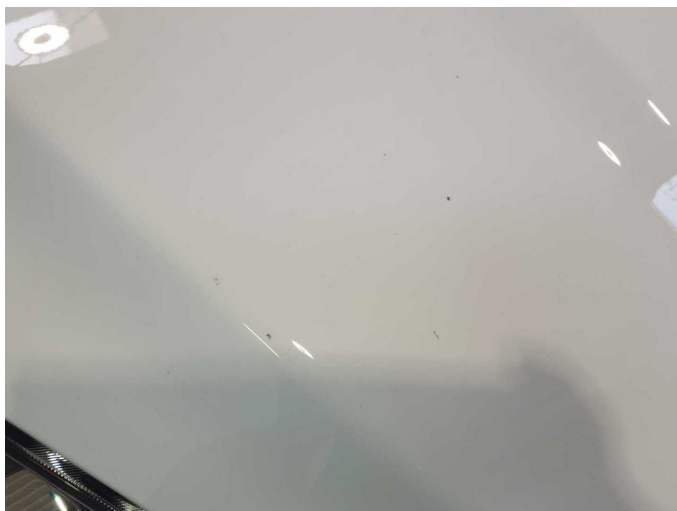
| No. | Component group | Description |
|---|---|---|
| 11 | Bonnet | Bonnet - Stone chips - Paint |

**Damage 11:** Bonnet: Bonnet - Stone chips - Paint

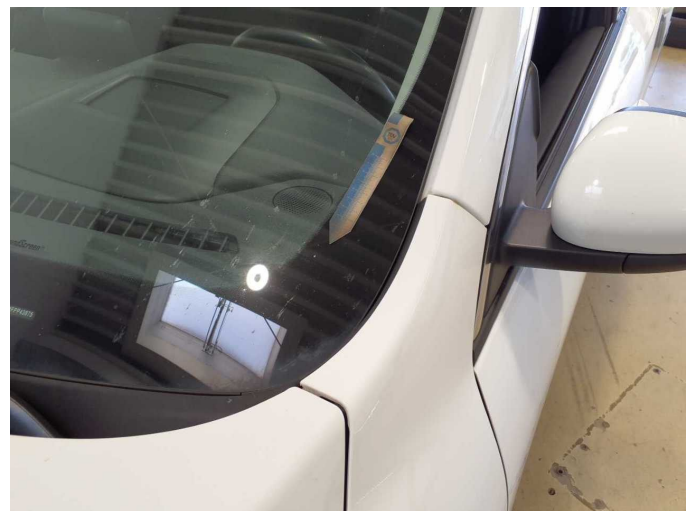
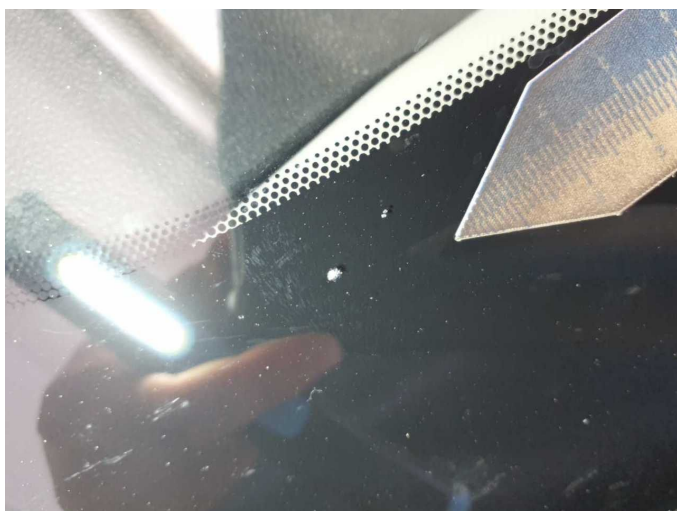
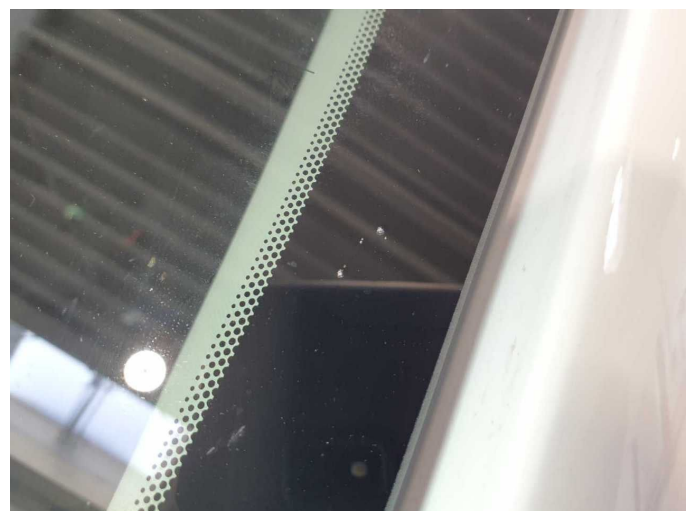
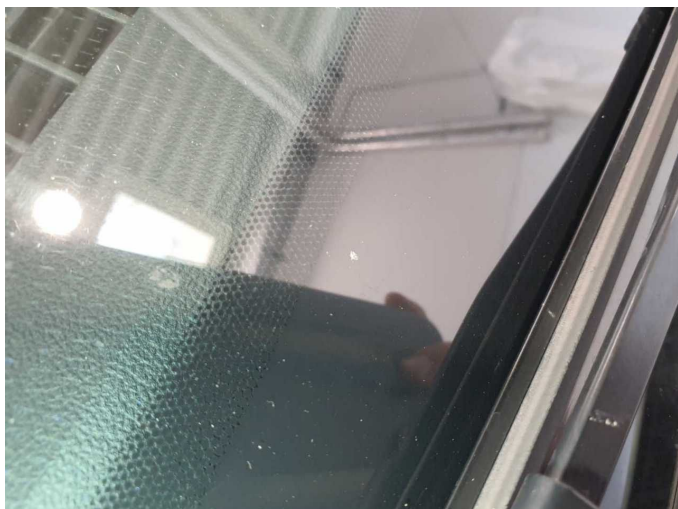
| No. | Component group | Description |
|---|---|---|
| 12 | Vehicle glazing | Windscreen - Stone chips - Replace |

**Damage 12:** Vehicle glazing: Windscreen - Stone chips - Replace

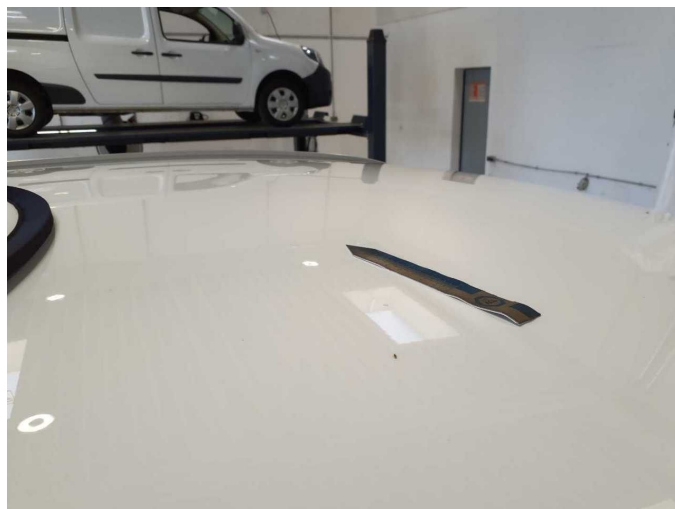
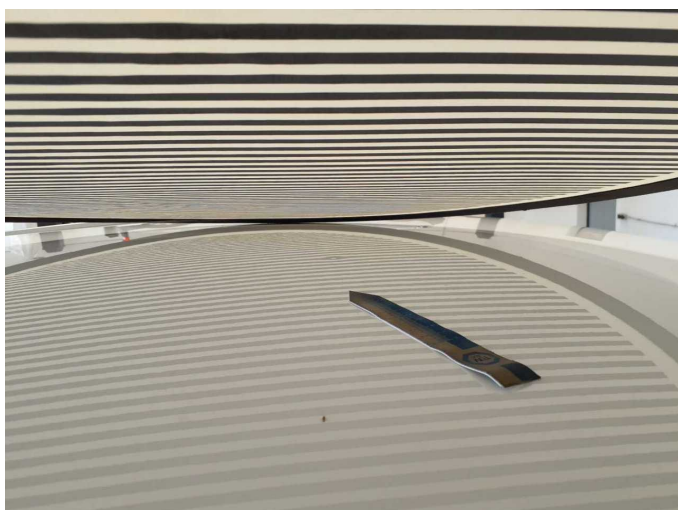
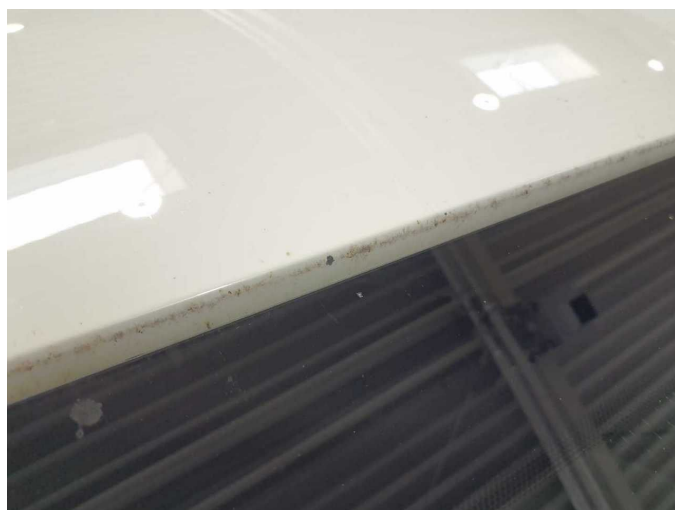
| No. | Component group | Description |
|---|---|---|
| 13 | Roof | Roof (+ Kratzer, beginnende Korrosion) - Dent / paintcoat damage - Paint |

**Damage 13:** Roof: Roof (+ Kratzer, beginnende Korrosion) - Dent / paintcoat damage - Paint

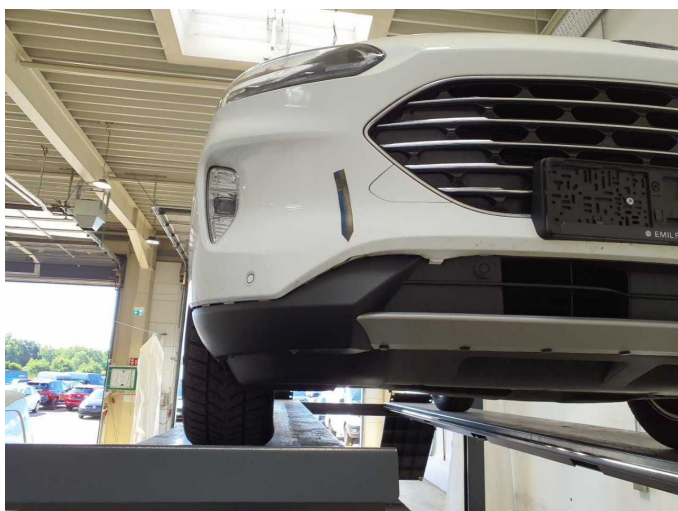
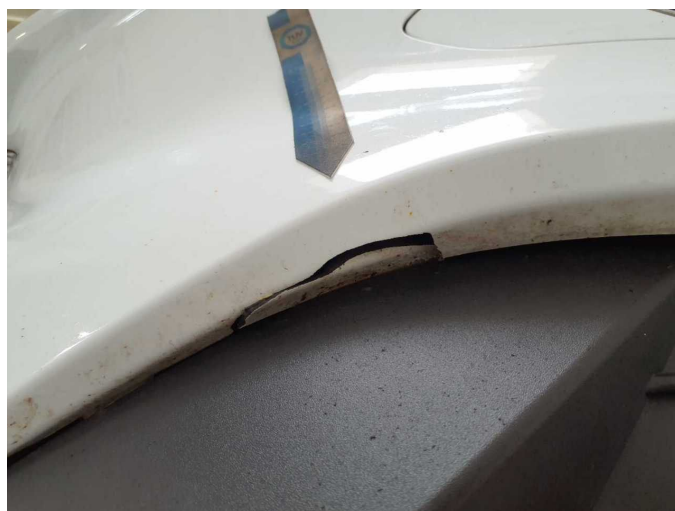
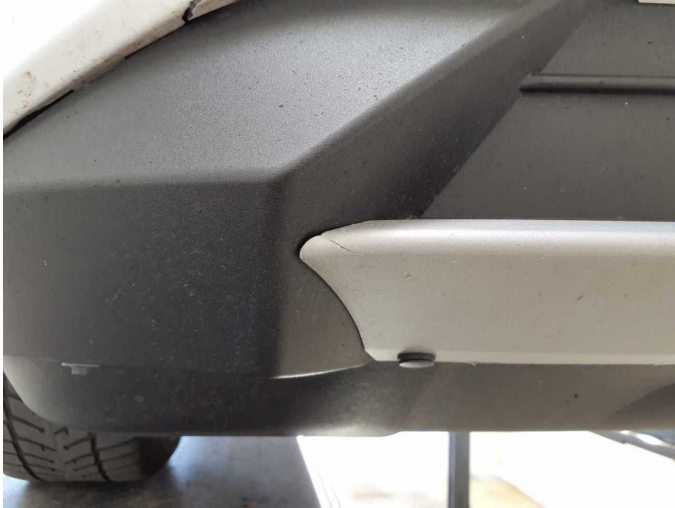
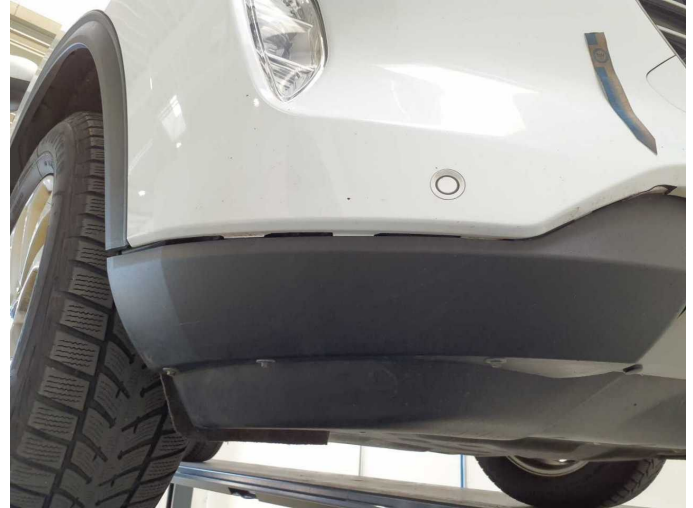
| No. | Component group | Description |
|---|---|---|
| 14 | Front bumper | Front bumper (Inklusive anbauteile) - Broken / torn - Replace |

**Damage 14:** Front bumper: Front bumper (Inklusive anbauteile) - Broken / torn - Replace
