## Expertise

Protocol number: 46299474  
Order No. / Reference: 26520999  
Inspection date: 2 Jul 2026

Manufacturer: Opel

Model: Mokka-e Elegance

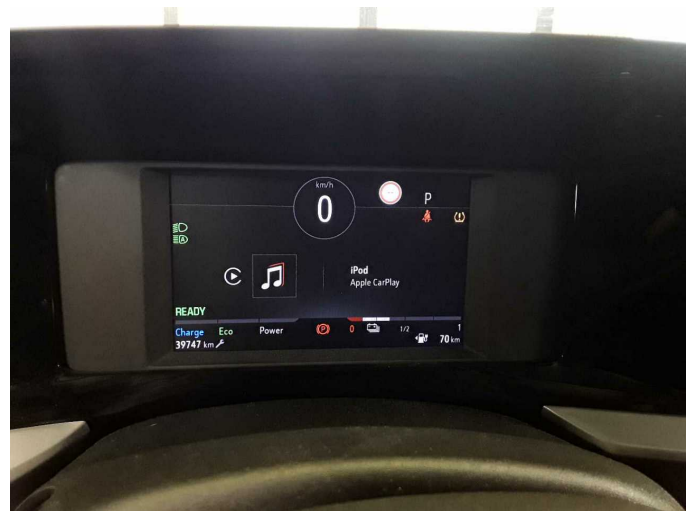
Damage 1: Wheel / tyres: Pressure sensor - on - Perform diagnosis

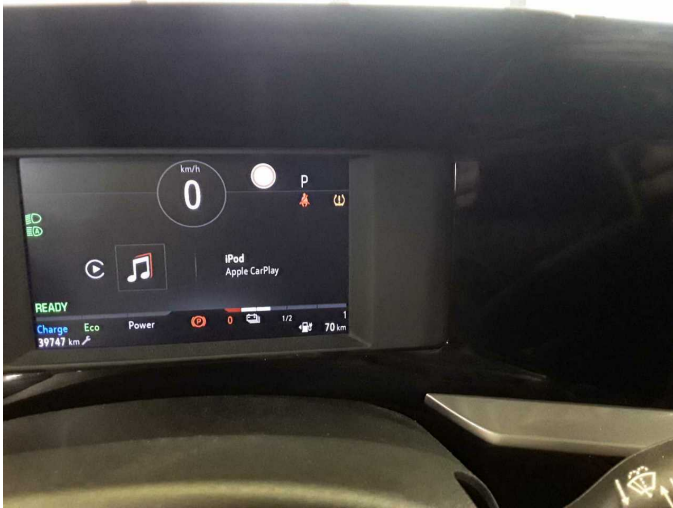
**Damage 1:** Wheel / tyres: Pressure sensor - on - Perform diagnosis

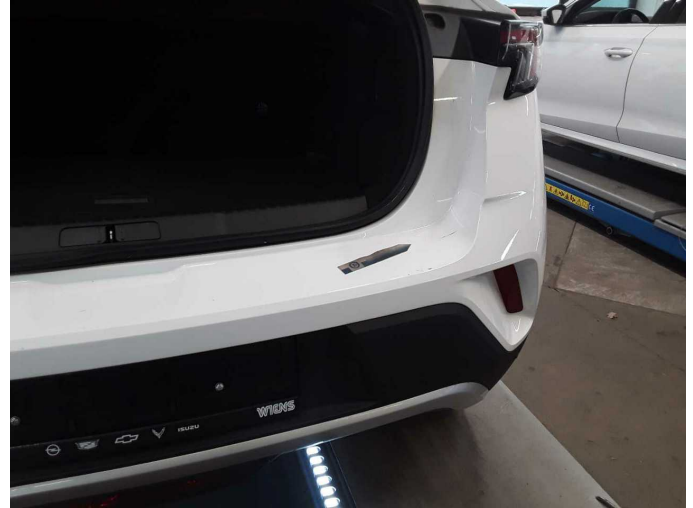
**Damage 2:** Rear bumper: Rear bumper - Scratch(es) - Smart repair

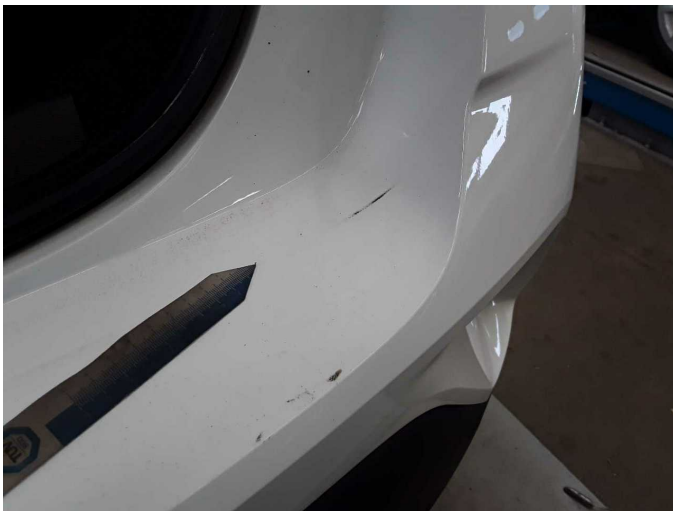
**Damage 2:** Rear bumper: Rear bumper - Scratch(es) - Smart repair

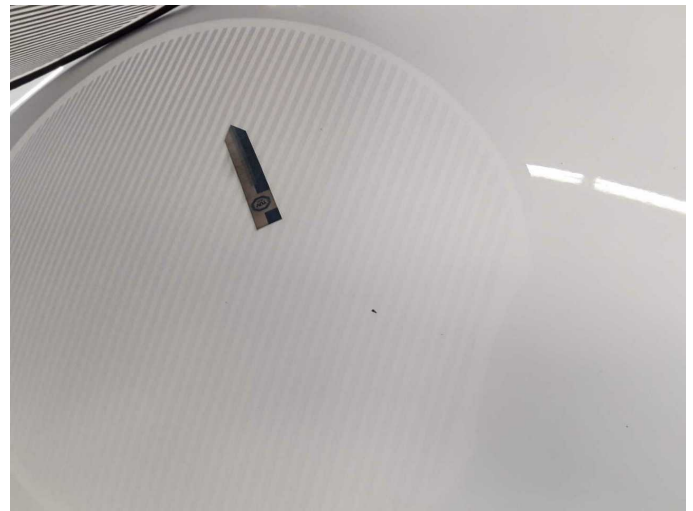
**Damage 4:** Roof: Roof (3 Dellen) - dent(s) - Smooth repair work

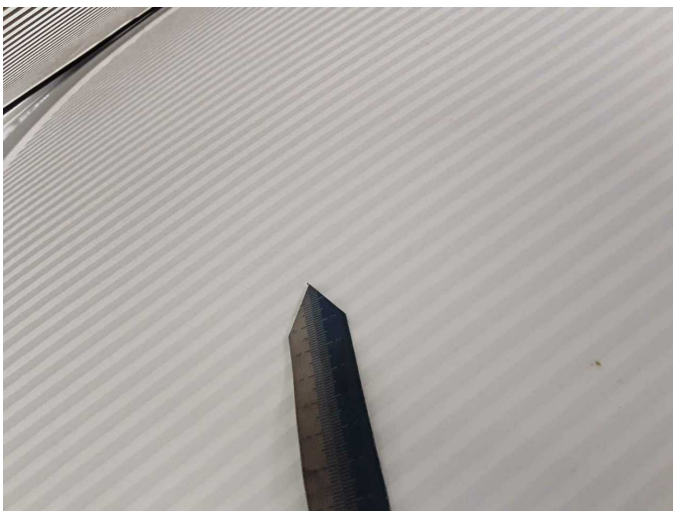
**Damage 4:** Roof: Roof (3 Dellen) - dent(s) - Smooth repair work

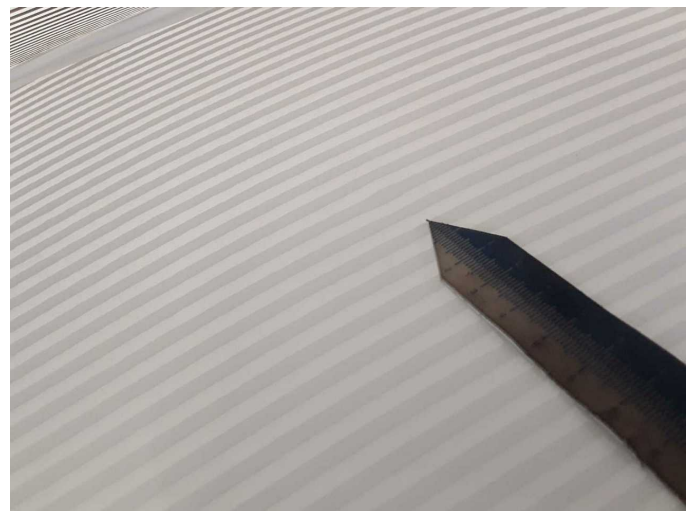
**Damage 4:** Roof: Roof (3 Dellen) - dent(s) - Smooth repair work
