Expertise

Protocol number: 43895660
Order number / reference: 25720846
Inspection date: 10 Feb 2026

Manufacturer: Opel

Model: Movano 2.3 D L2H2 2WD VA S&S Easytronic

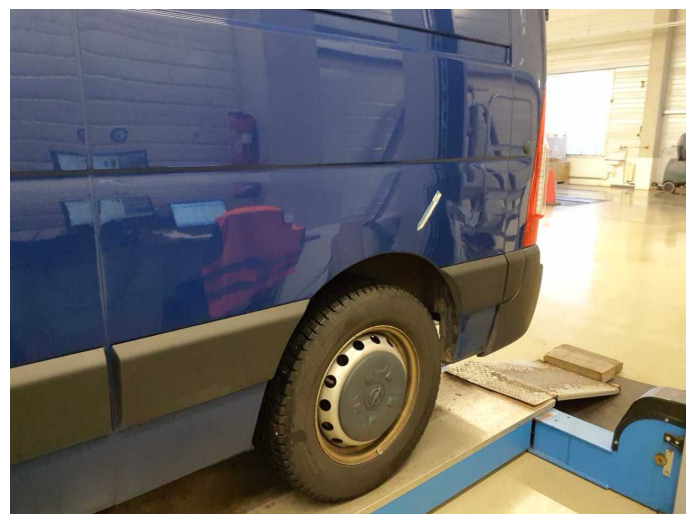
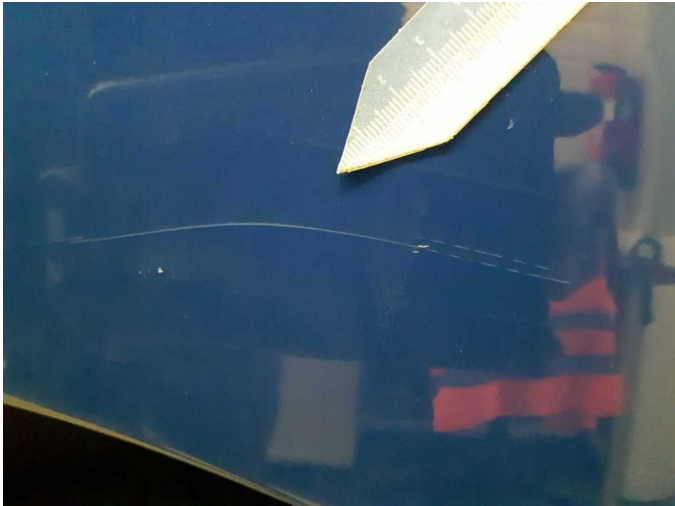
Damage 2: Side panel - rear left side: Side panel - Scratch(es) - Smart repair

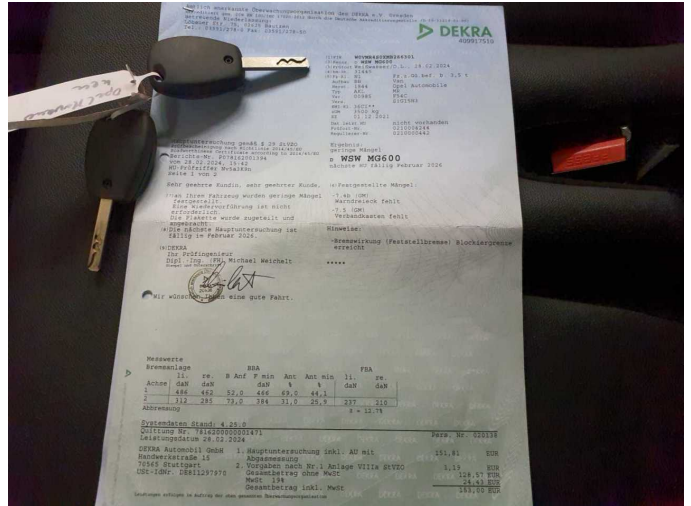
Damage 3: Misc.: Main inspection (02.2026) - Due - Perform

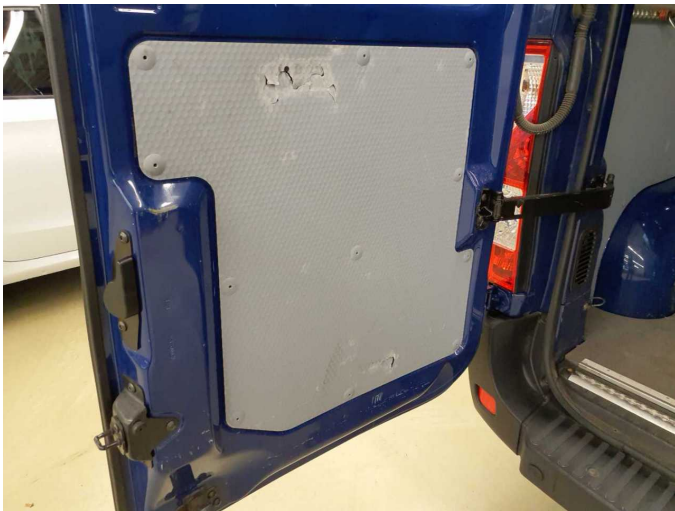
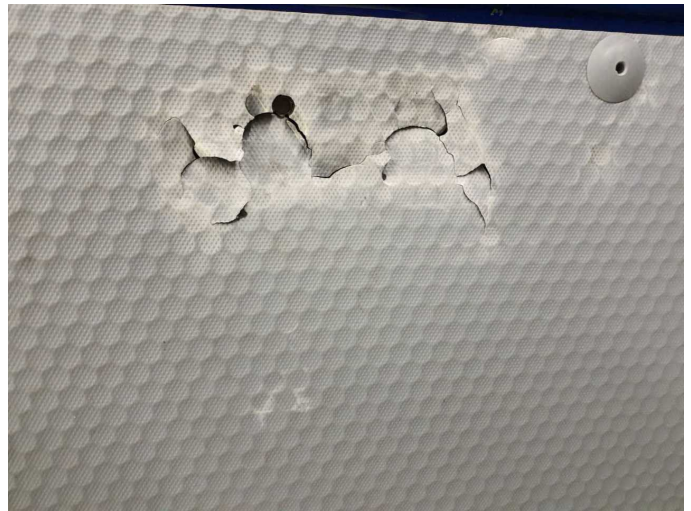
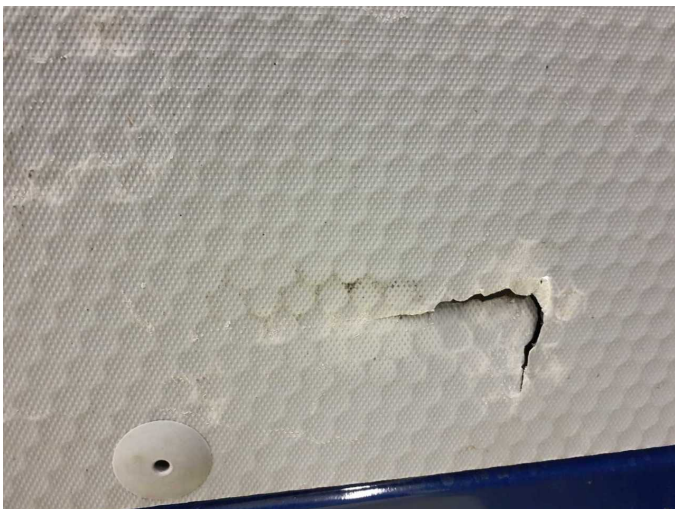
Damage 4: Boot lid / rear door: Trim washable - lower - Broken / torn - Replace

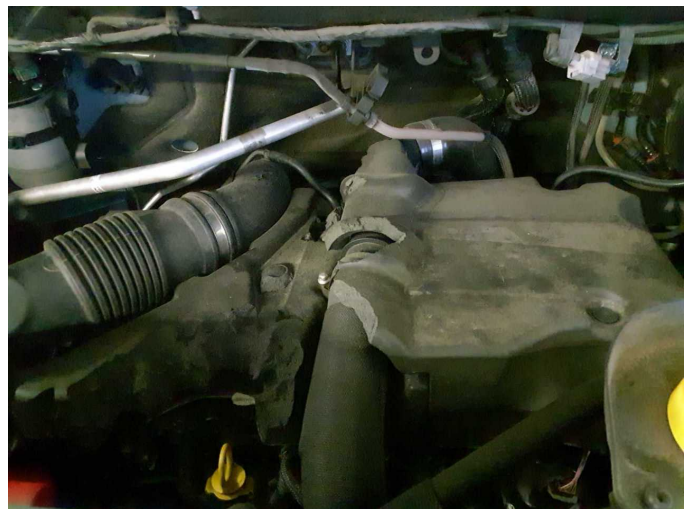
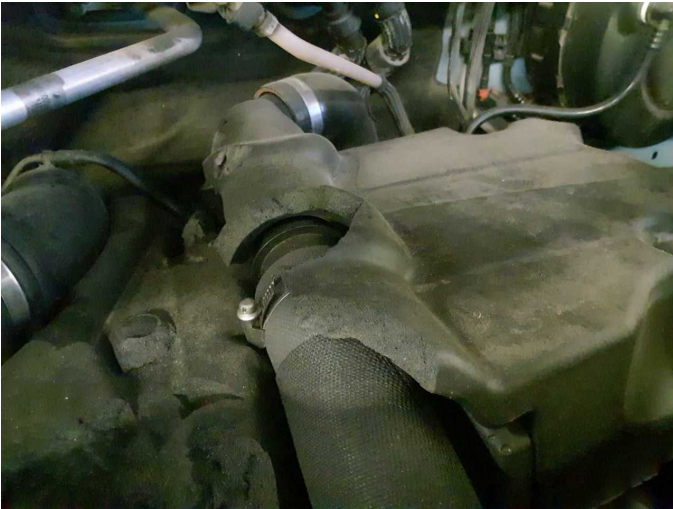
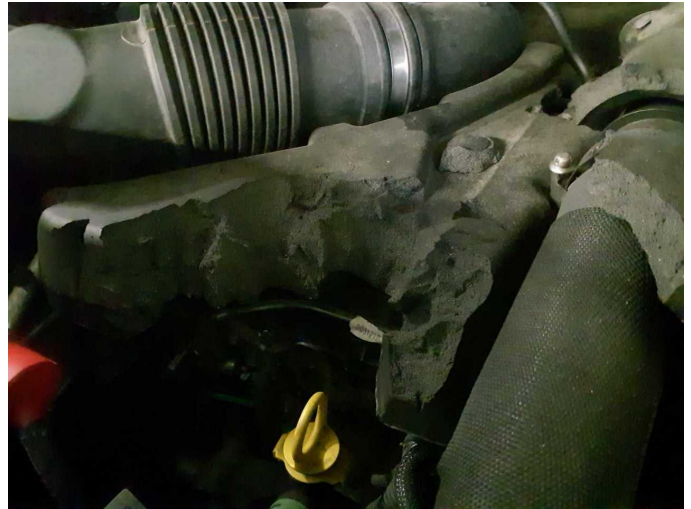
Damage 5: Cab: Insulation lining - Damage caused by marten / rodent - Replace

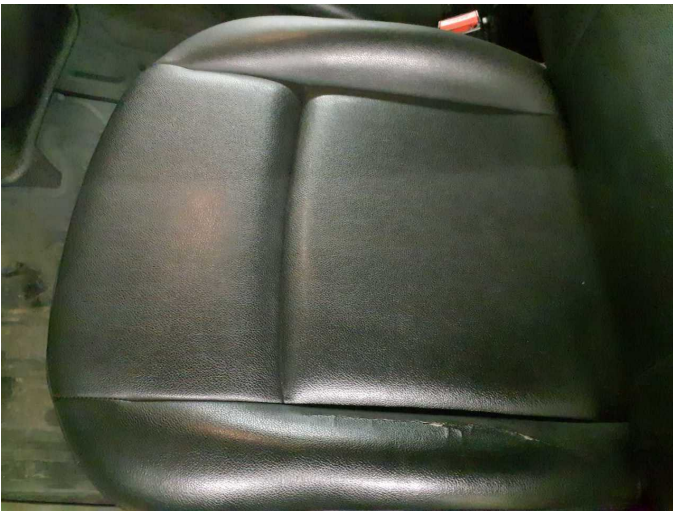
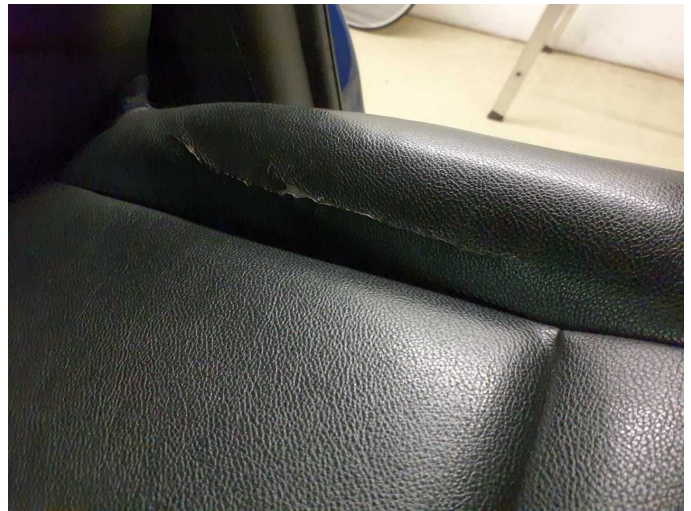
Damage 6: Seat - front: Seat cover - left side - Broken / torn - Replace

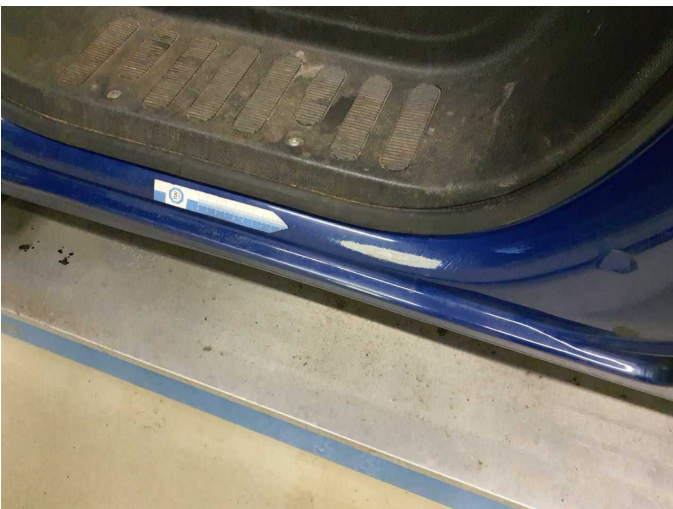
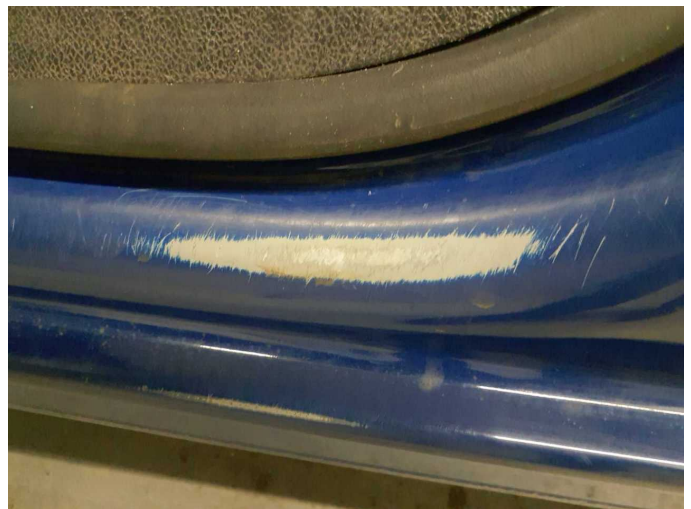
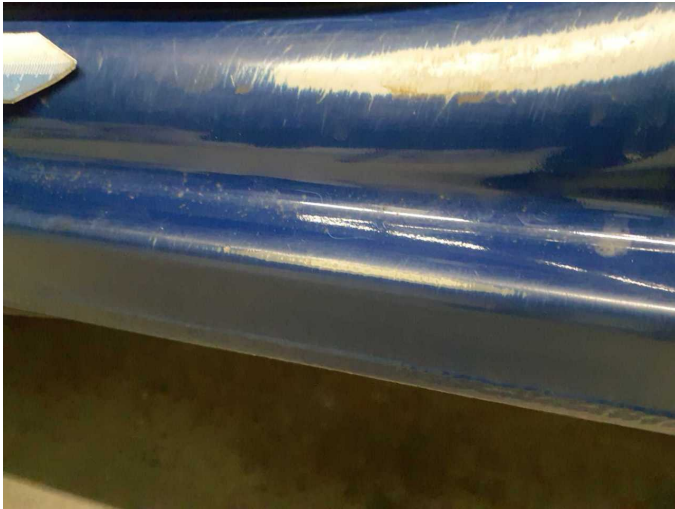
Damage 7: Sill - left side: Sill - Paint defect - Paint

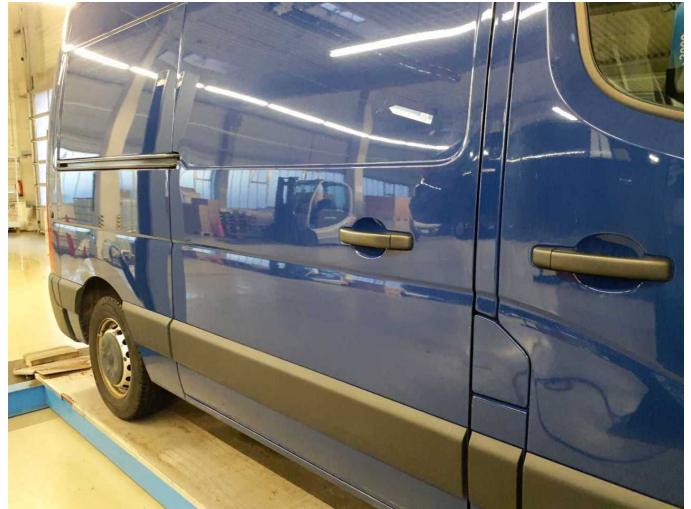
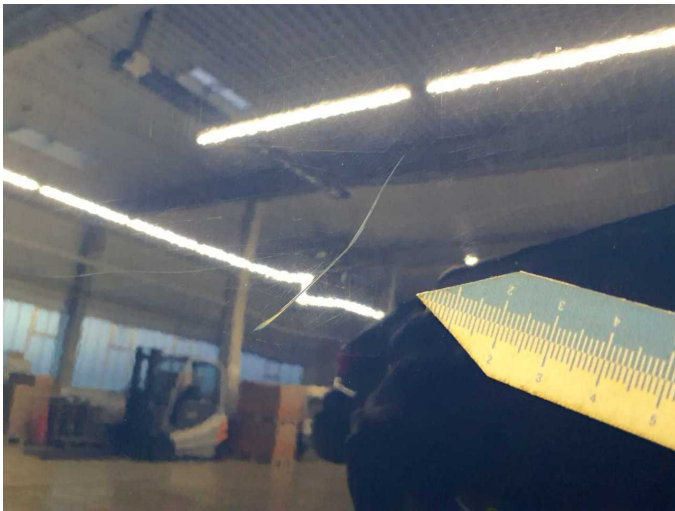
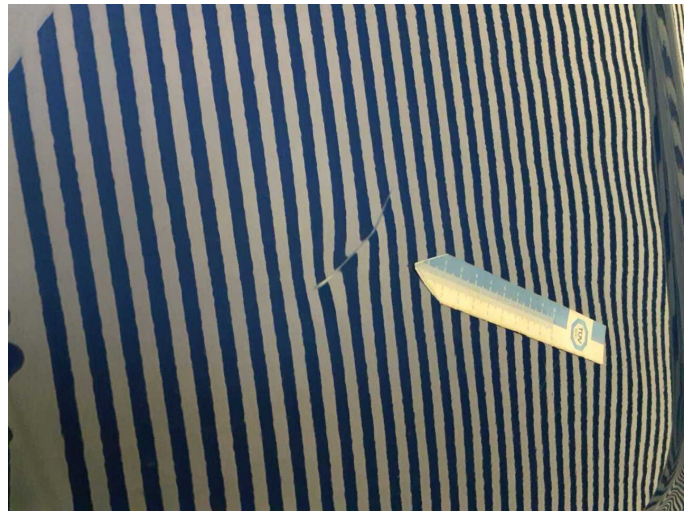
Damage 8: Sliding door, right: Sliding door - Dent / paintcoat damage - Repair and paint

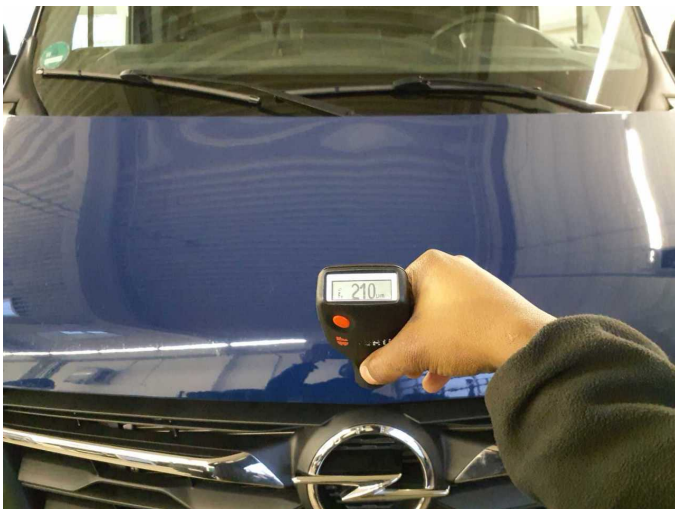
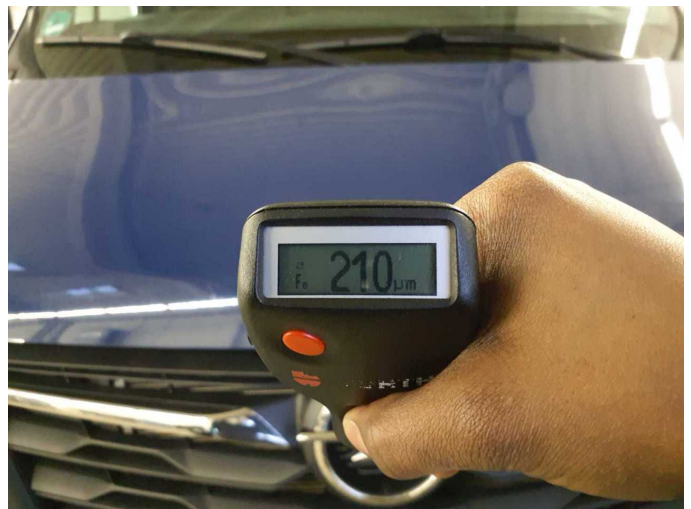
- 1 Bonnet, Professionally carried out

Bonnet 210 µm |

Repainting 1: Bonnet
