## 2-esy-944

2-ESY-944 · ST-line 1.0i Ecoboost 100pk 74kw · 28 July 2026 · Zaventem (BE)

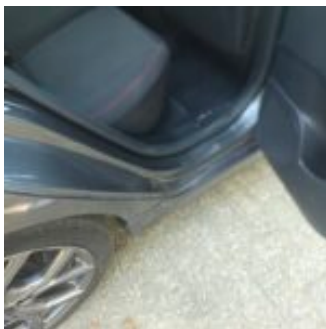
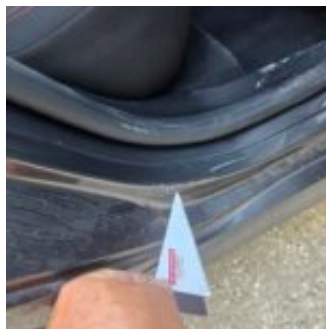
Skirt – Right

Small scratch(es)

Acceptable

No

Spray

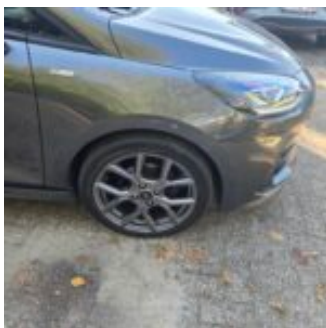
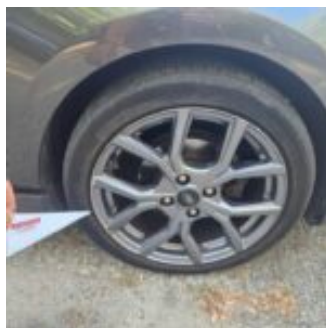
Alloy – Right Front

Damaged

Acceptable

No

Rim repair

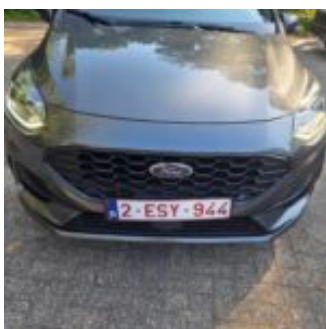
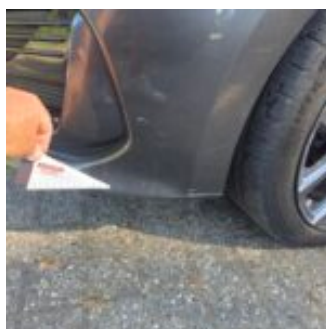
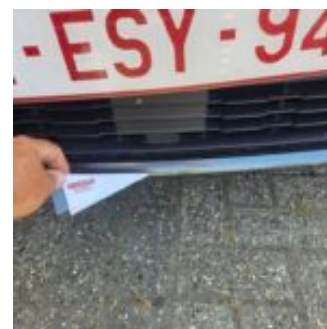
Bumper – Front

Scratch(es)

Acceptable

No

Spray

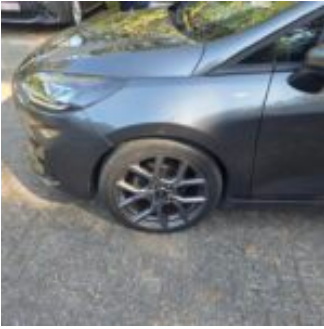
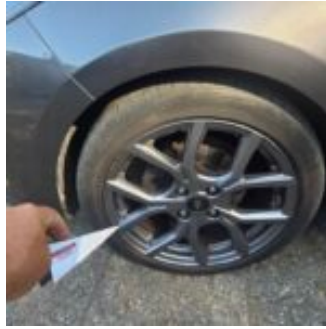
Damage Part  
Alloy - Left Front

Damage Type  
Damaged

Acceptable  
No

Repair Type  
Rim repair

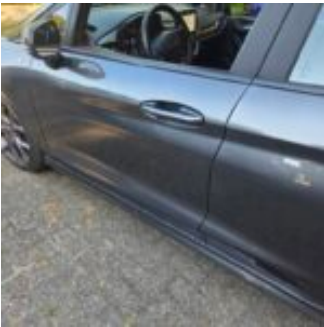
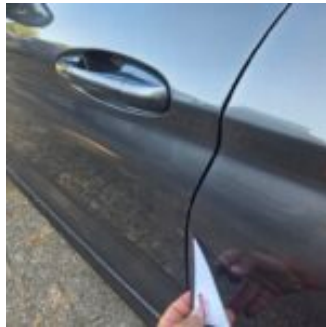
Damage Part  
Frontdoor - Left

Damage Type  
Door-edge chipped

Acceptable  
Yes

Repair Type  
Acceptable

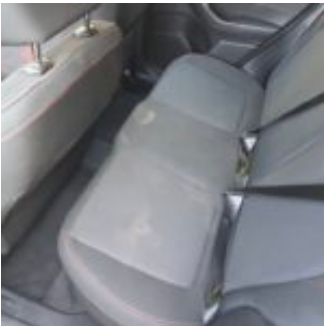
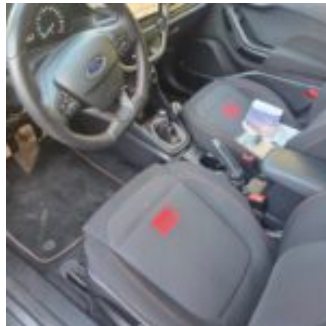
Damage Part  
Interior

Damage Type  
Stains & dirt

Acceptable  
No

Repair Type  
Cleaning

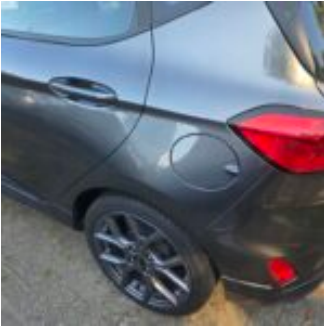
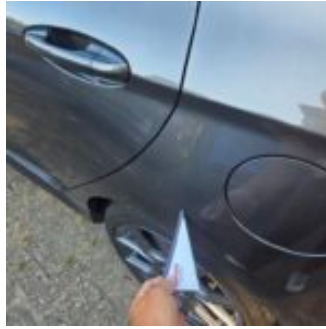
Fender – Rear Left

Small scratch(es)

Acceptable

Yes
