Expertise

Protocol number: 45519350
Order No. / Reference: 26260022
Inspection date: 8 May 2026

Manufacturer: Opel

Model: Astra Sports Tourer 1.5 D Automatik Elegance

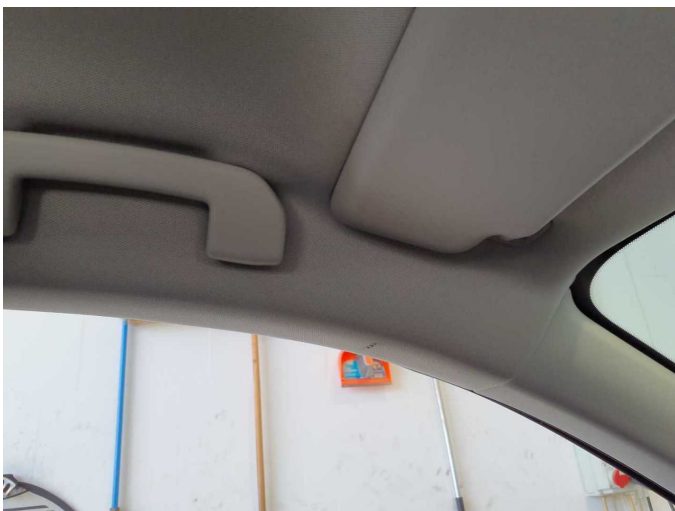
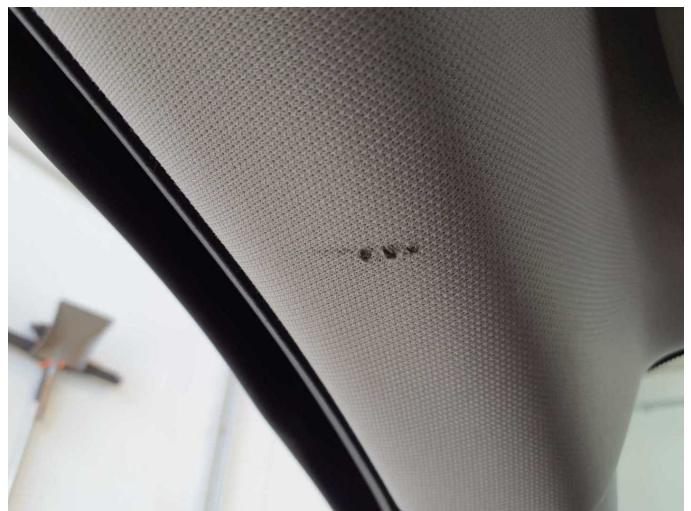
Damage 1: Trim / covers: Roof lining - Scratch(es) - Smart repair

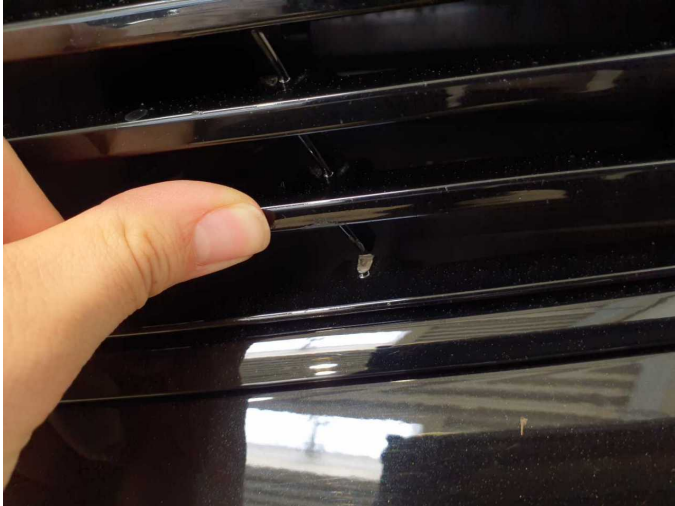
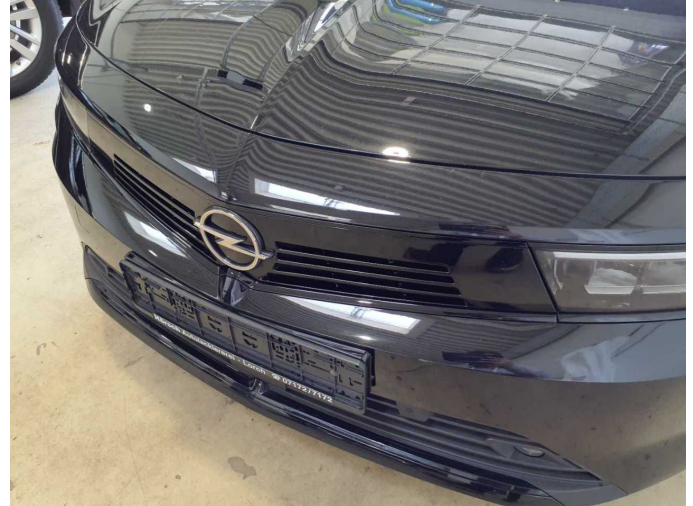
Damage 3: Bonnet: Radiator grille - Broken / torn - Replace

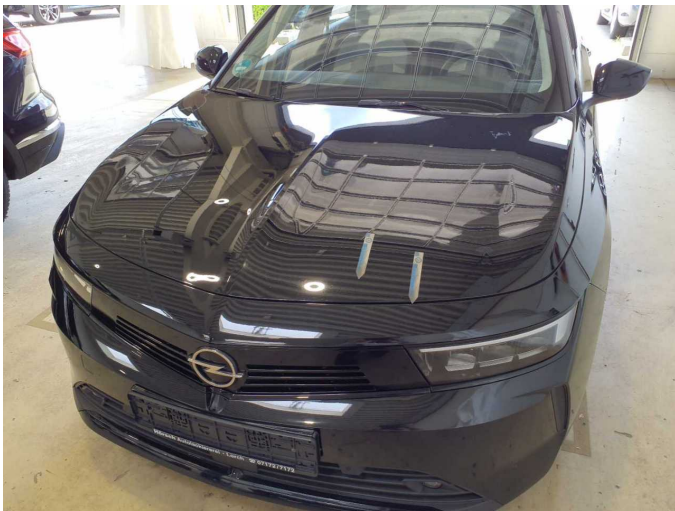
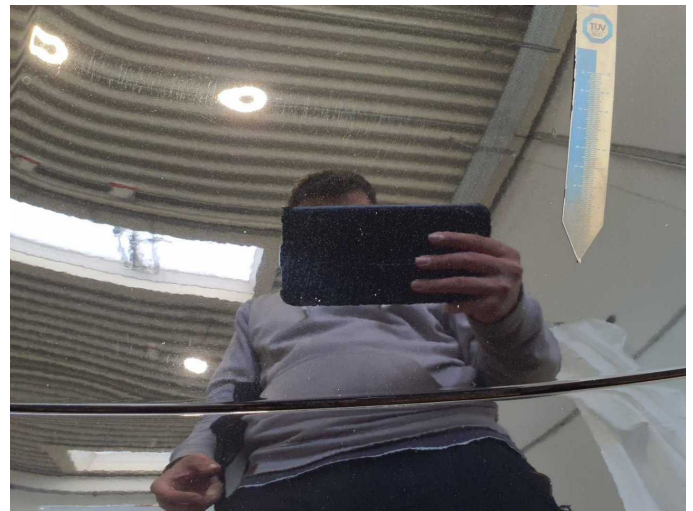
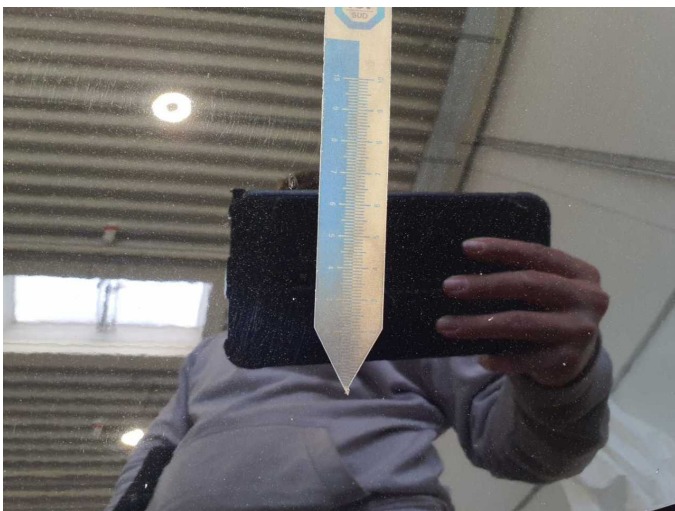
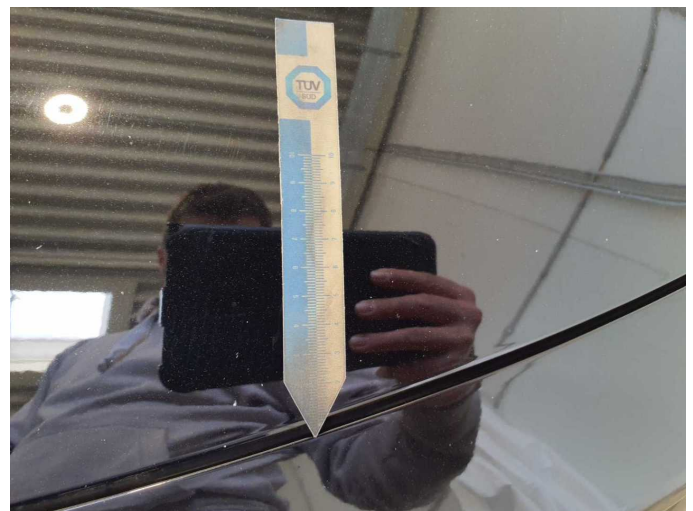
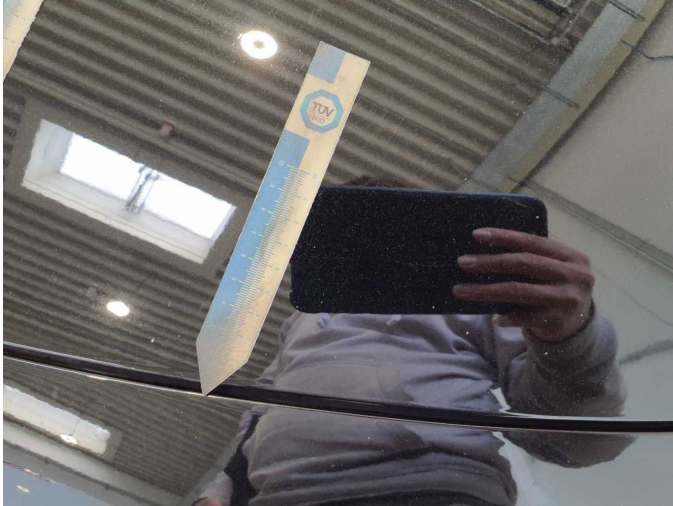
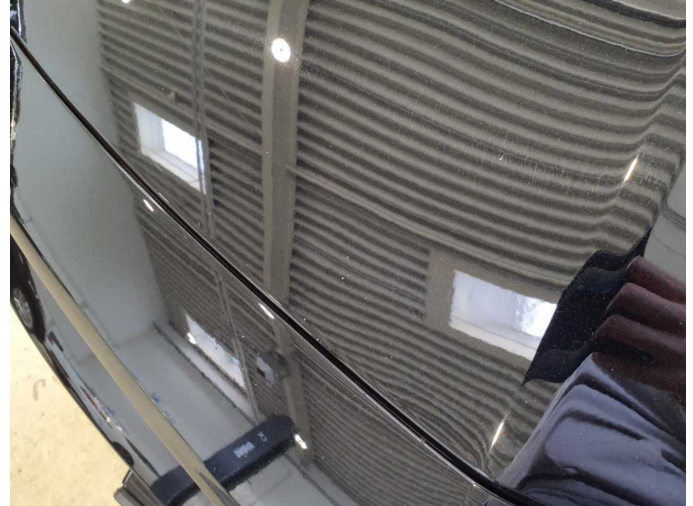
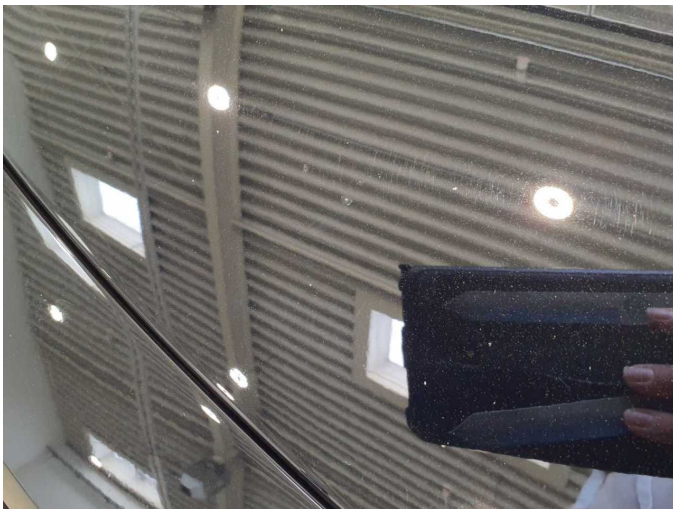
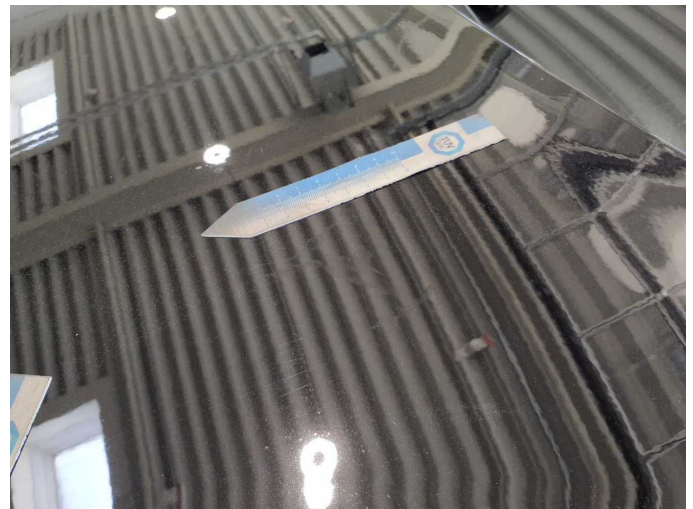
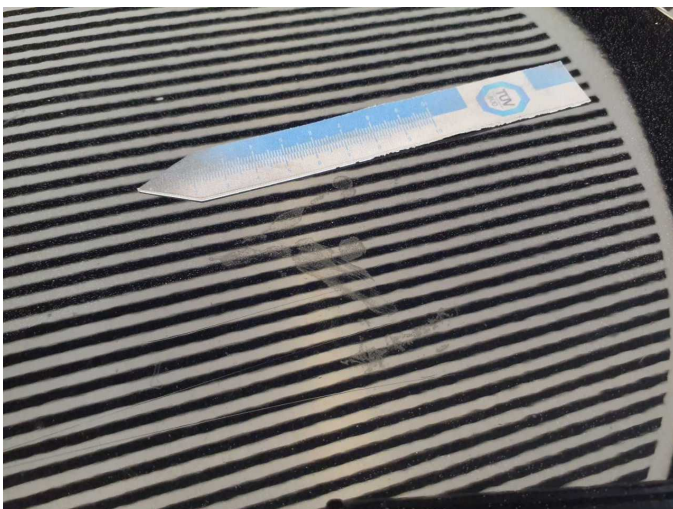
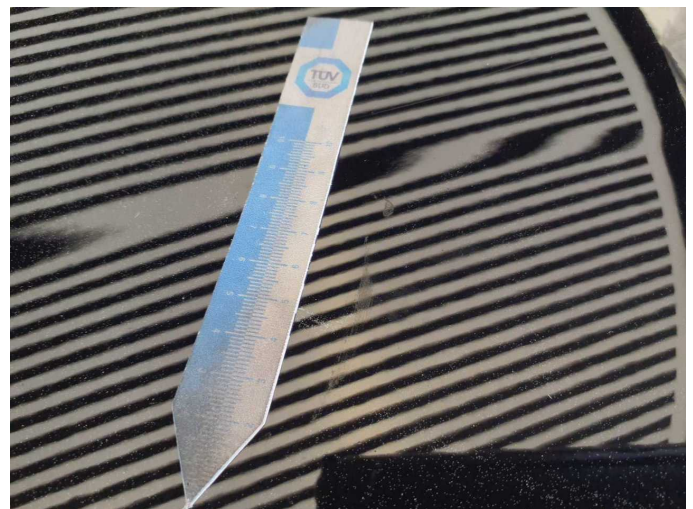
Damage 4: Bonnet: Bonnet (Anätzung) - Paint defect - Paint

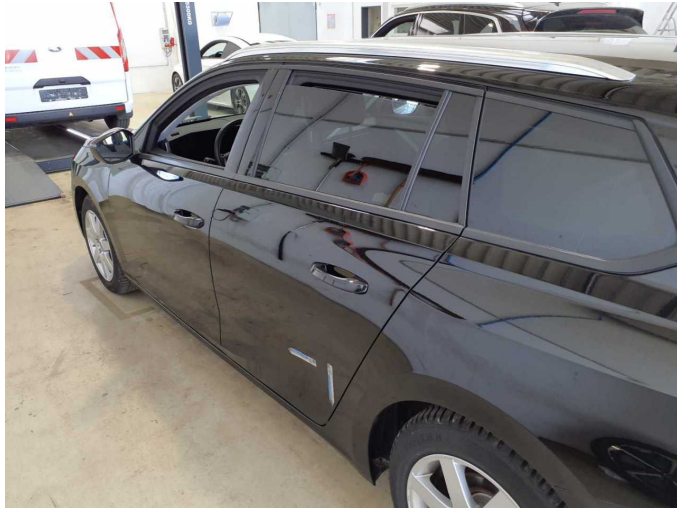
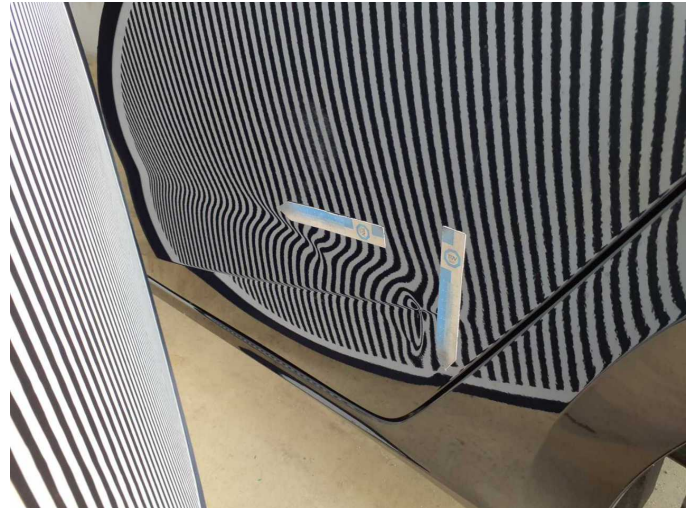
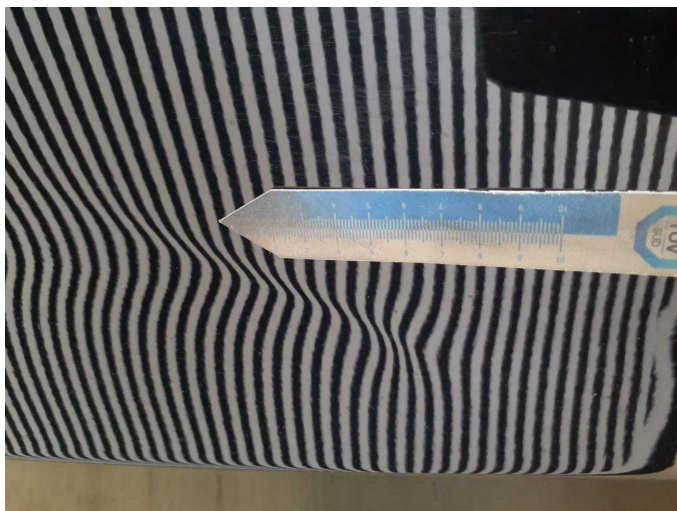
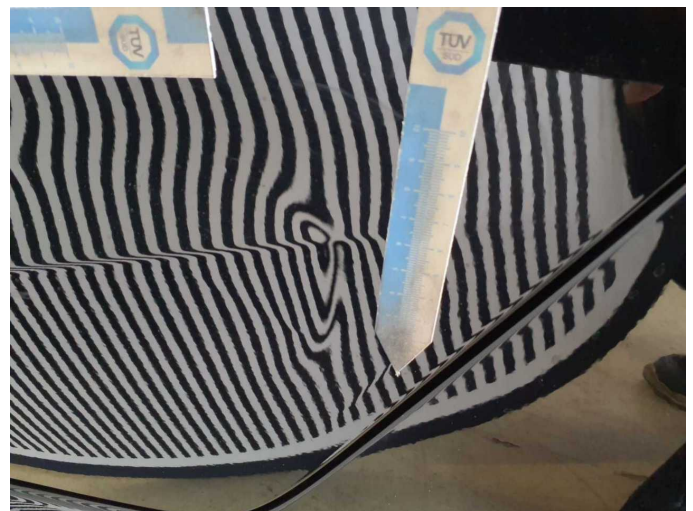
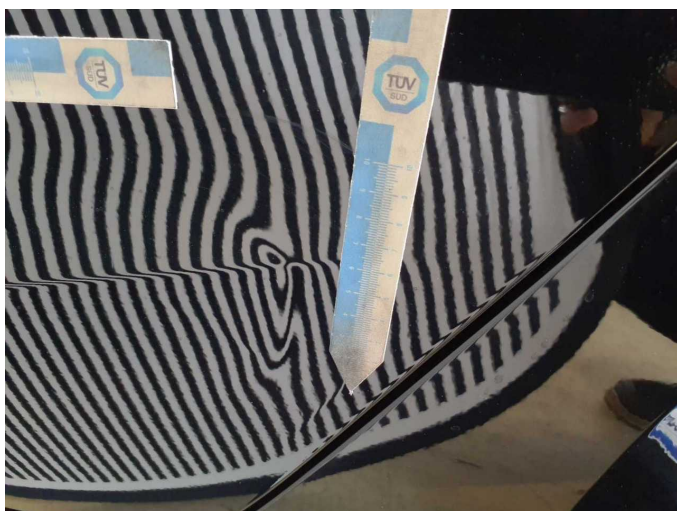
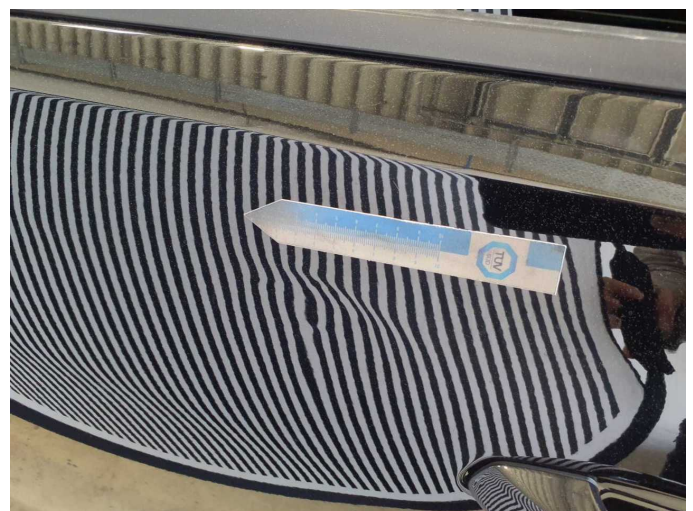
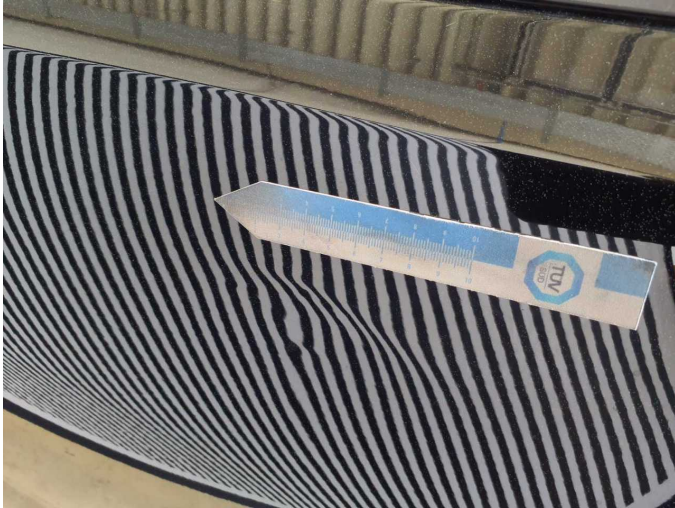
Damage 6: Door - rear left side: Door - Deformed - Repair and paint

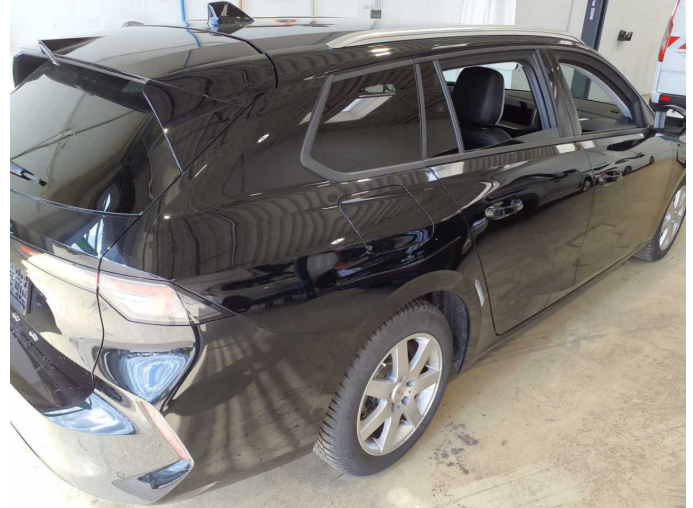
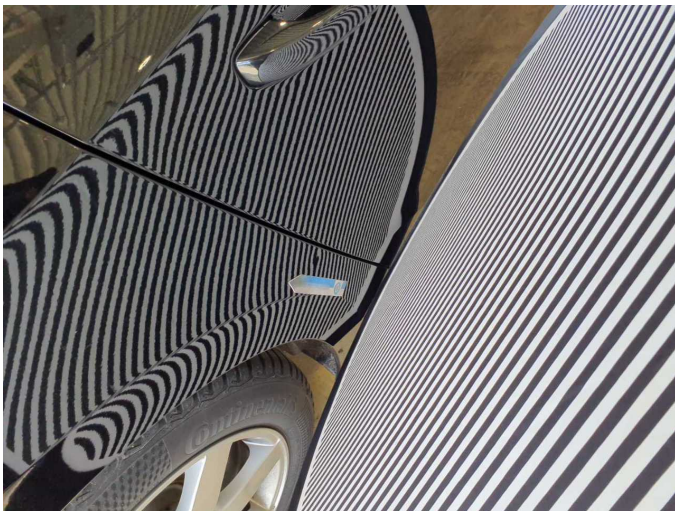
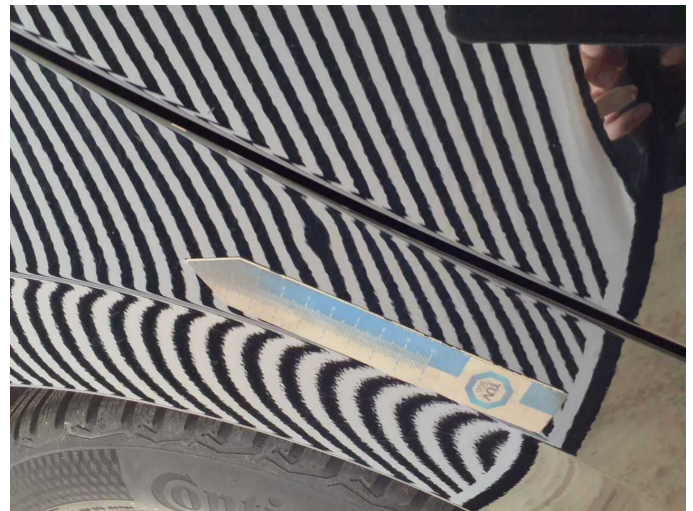
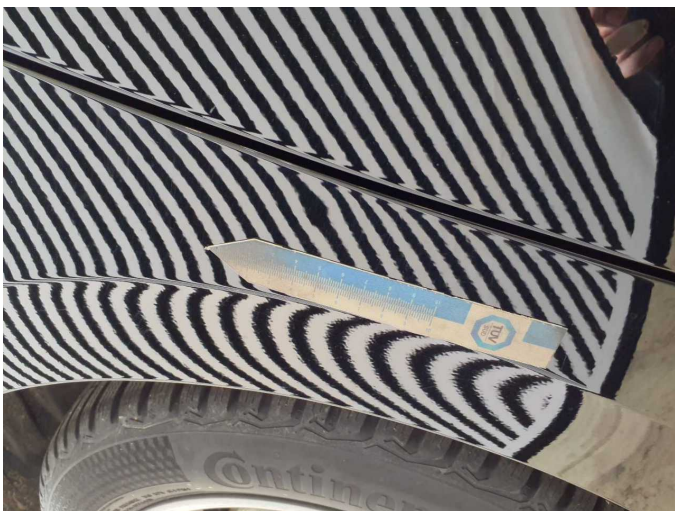
Wear and tear 3: Side panel - rear right side: Side panel - dent(s) - No deduction
