Expertise

Protocol number: 46617204  
Order No. / Reference: 26712657  
Inspection date: 17 Jul 2026

Model: Panamera 4 E-Hybrid Platinum Edition

VIN: WP0ZZZ97ZNL126611

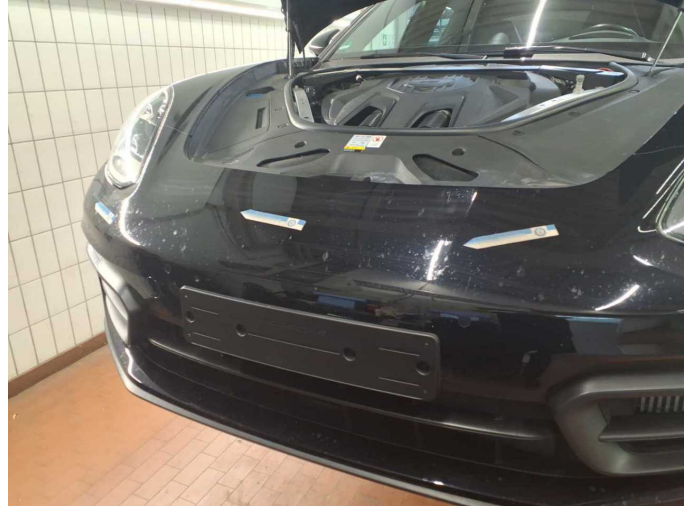
| No. | Component group | Description |
|---|---|---|
| 1 | Front bumper | Front bumper (Viele Oberflächenkratzer-Mehrkosten möglich) - Scratch(es) - Conditioning |

**Damage 1:** Front bumper: Front bumper (Viele Oberflächenkratzer-Mehrkosten möglich) - Scratch(es) - Conditioning

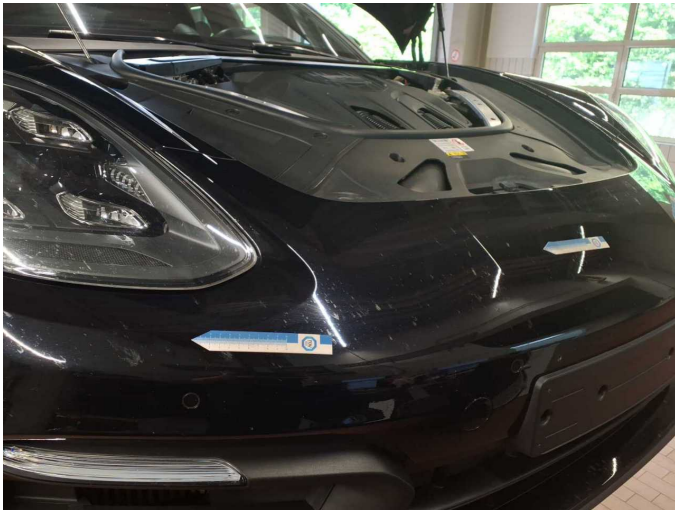
**Damage 1:** Front bumper: Front bumper (Viele Oberflächenkratzer-Mehrkosten möglich) - Scratch(es) - Conditioning

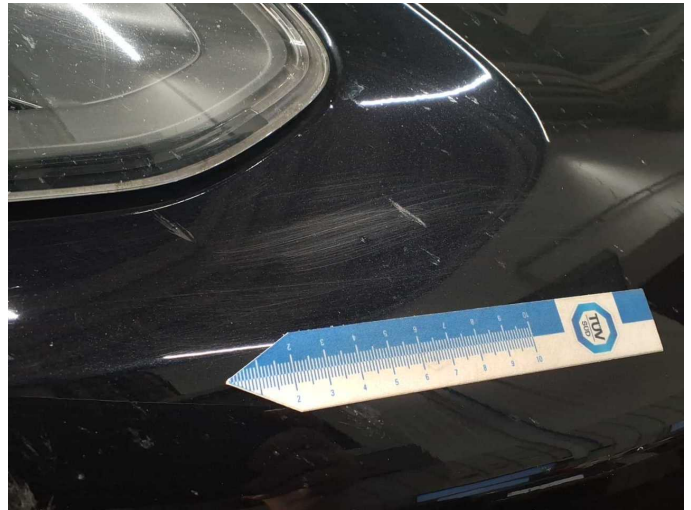
**Damage 1:** Front bumper: Front bumper (Viele Oberflächenkratzer-Mehrkosten möglich) - Scratch(es) - Conditioning

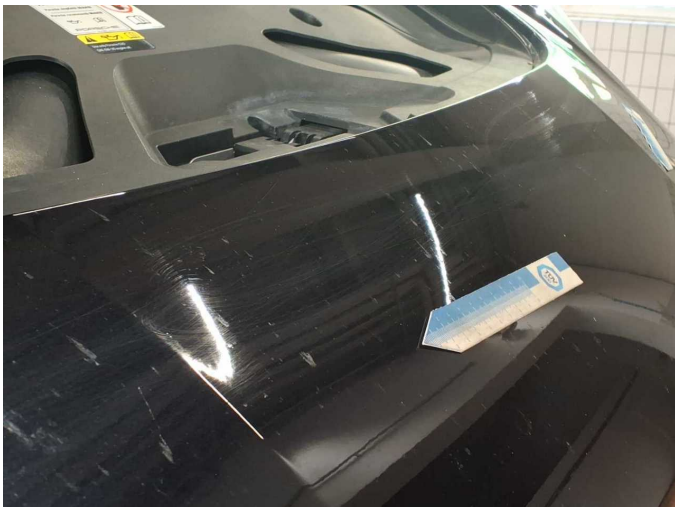
**Damage 1:** Front bumper: Front bumper (Viele Oberflächenkratzer-Mehrkosten möglich) - Scratch(es) - Conditioning

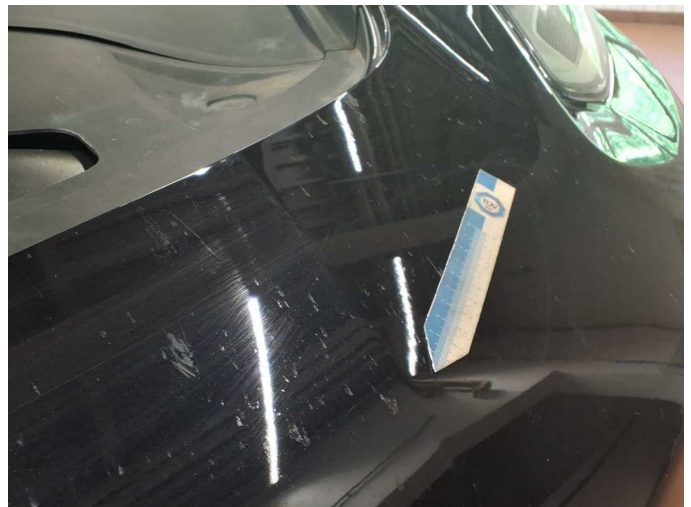
**Damage 1:** Front bumper: Front bumper (Viele Oberflächenkratzer-Mehrkosten möglich) - Scratch(es) - Conditioning

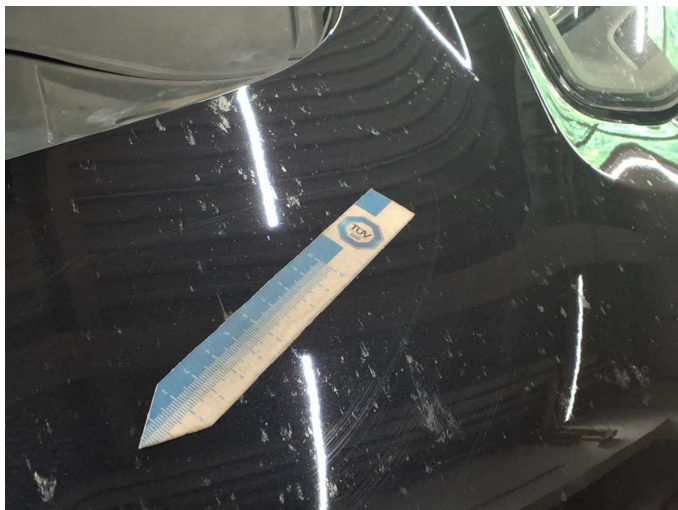
**Damage 1:** Front bumper: Front bumper (Viele Oberflächenkratzer-Mehrkosten möglich) - Scratch(es) - Conditioning

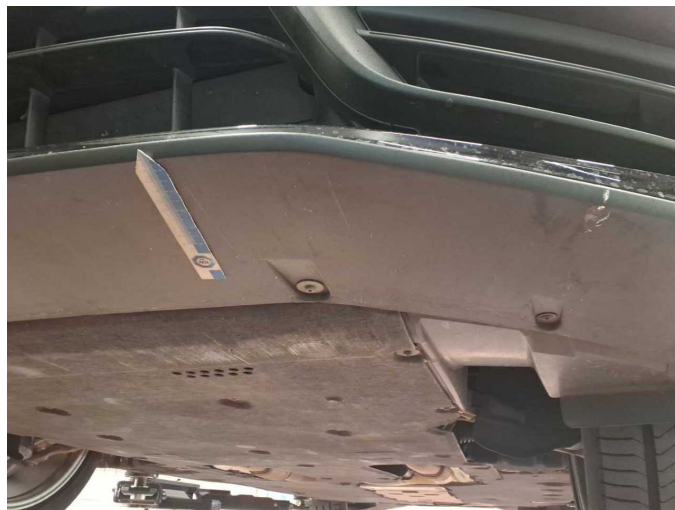
| No. | Component group | Description |
|---|---|---|
| 3 | Front bumper | Spoiler - Scratched - Loss in value |

**Damage 3:** Front bumper: Spoiler - Scratched - Loss in value

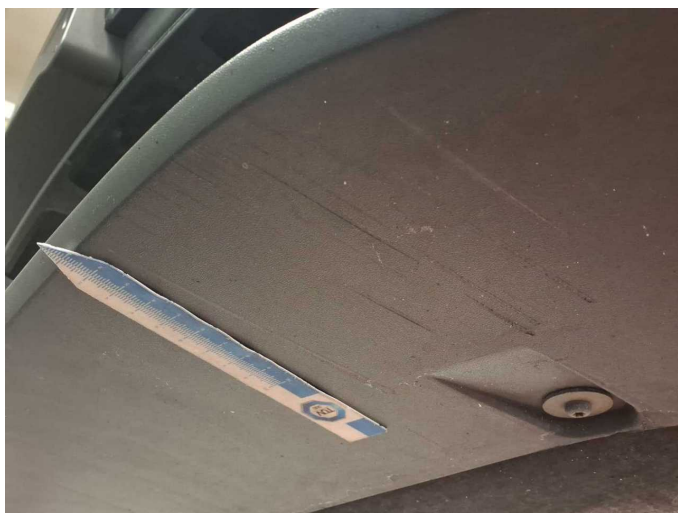
**Damage 3:** Front bumper: Spoiler - Scratched - Loss in value

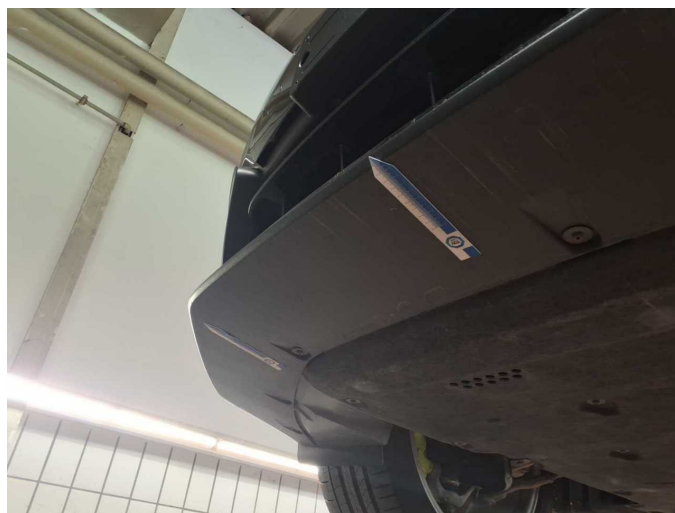
**Damage 3:** Front bumper: Spoiler - Scratched - Loss in value

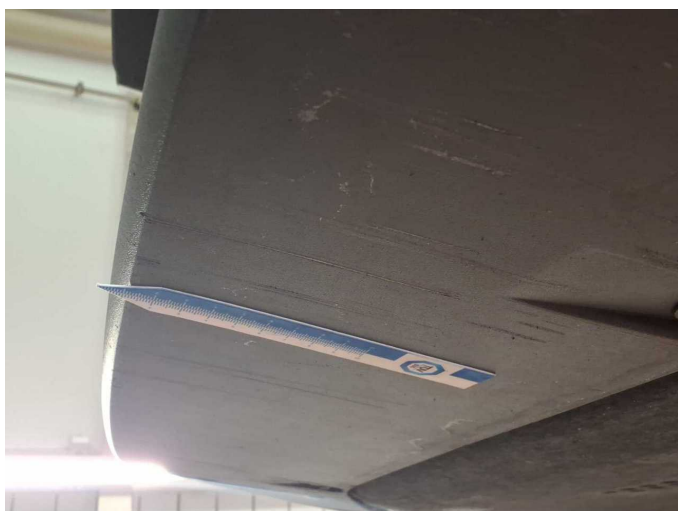
**Damage 3:** Front bumper: Spoiler - Scratched - Loss in value

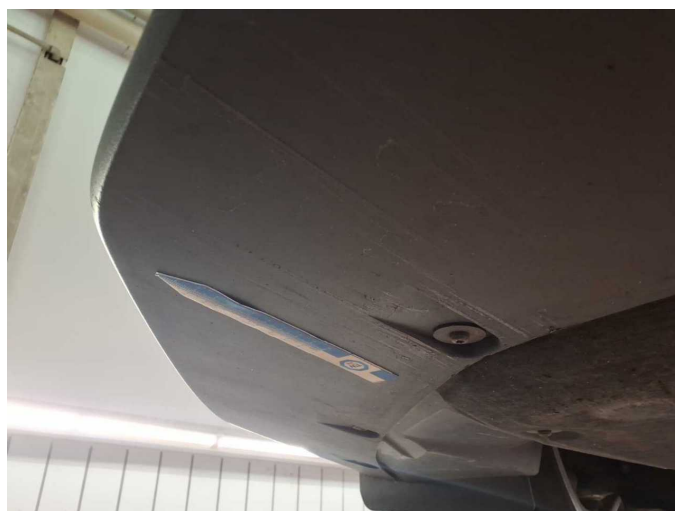
**Damage 3:** Front bumper: Spoiler - Scratched - Loss in value

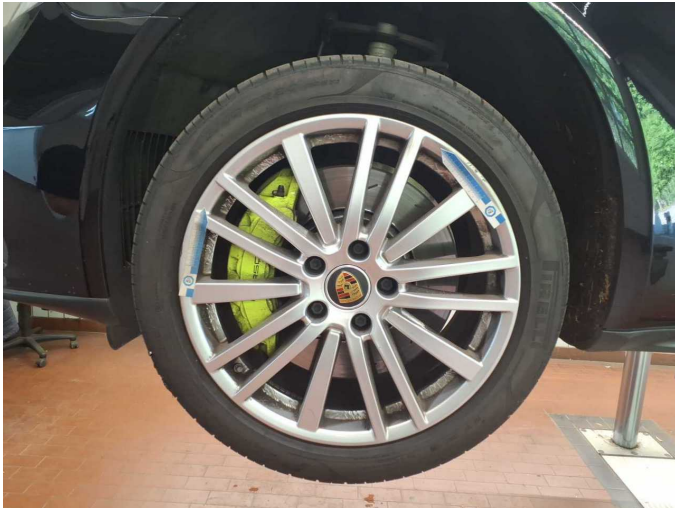
| No. | Component group | Description |
|---|---|---|
| 5 | Wheel / tyres | Alloy rim - front left side - Scratched - Loss in value |

**Damage 5:** Wheel / tyres: Alloy rim - front left side - Scratched - Loss in value

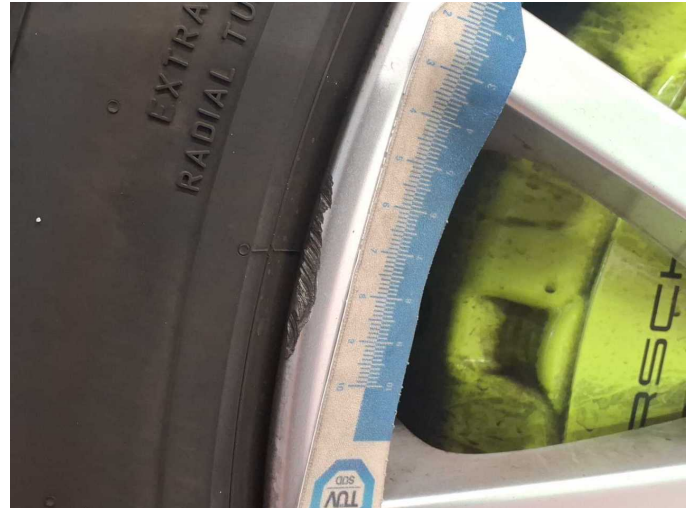
**Damage 5:** Wheel / tyres: Alloy rim - front left side - Scratched - Loss in value

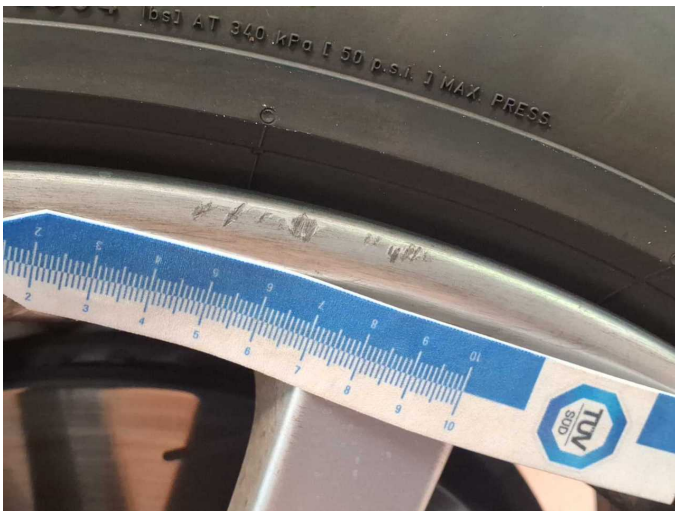
**Damage 5:** Wheel / tyres: Alloy rim - front left side - Scratched - Loss in value

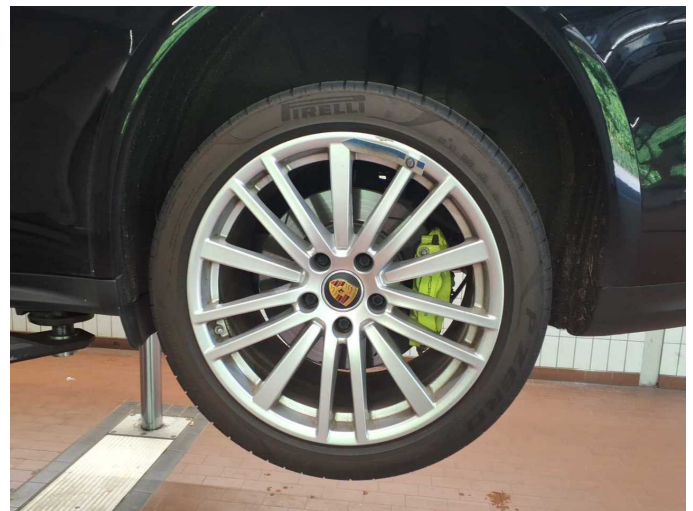
| No. | Component group | Description |
|---|---|---|
| 6 | Wheel / tyres | Alloy rim - rear left side - Scratched - Loss in value |

**Damage 6:** Wheel / tyres: Alloy rim - rear left side - Scratched - Loss in value

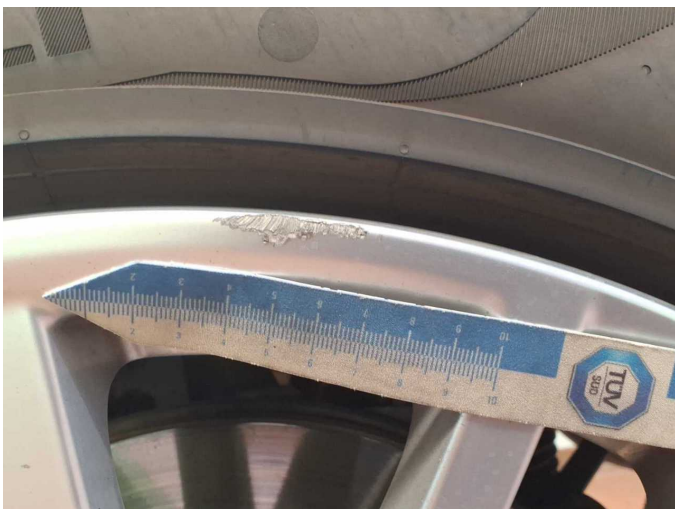
**Damage 6:** Wheel / tyres: Alloy rim - rear left side - Scratched - Loss in value

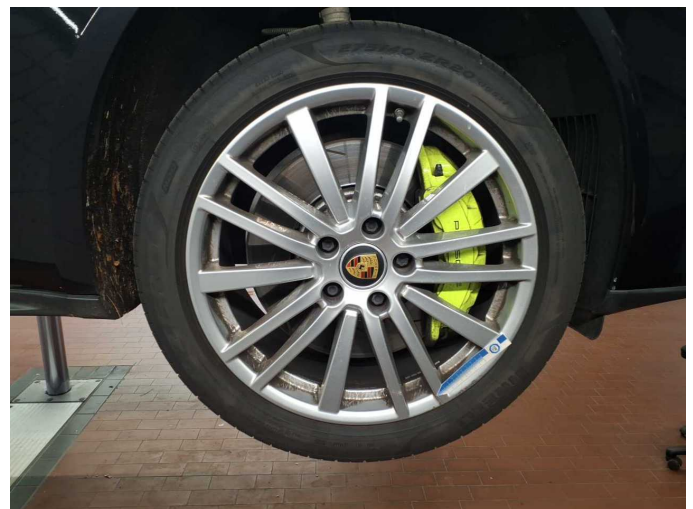
| No. | Component group | Description |
|---|---|---|
| 7 | Wheel / tyres | Alloy rim - front right side - Scratched - Loss in value |

**Damage 7:** Wheel / tyres: Alloy rim - front right side - Scratched - Loss in value

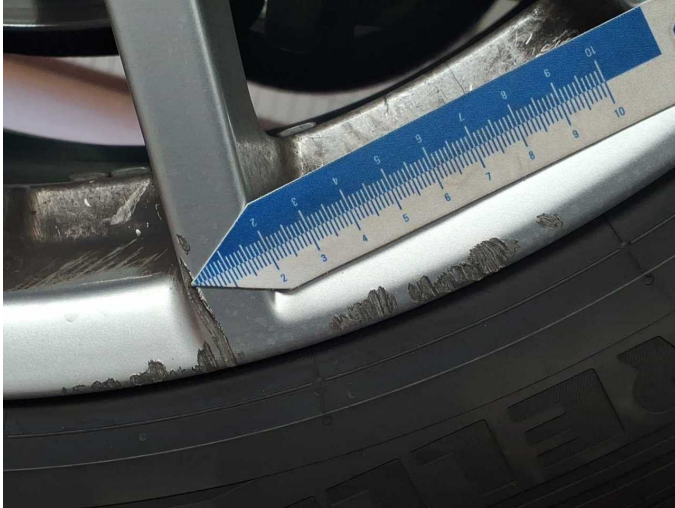
**Damage 7:** Wheel / tyres: Alloy rim - front right side - Scratched - Loss in value

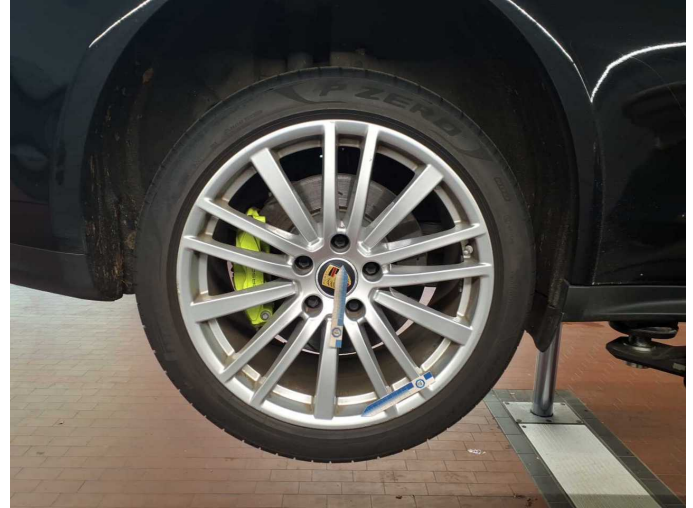
| No. | Component group | Description |
|---|---|---|
| 8 | Wheel / tyres | Alloy rim - rear right side (+ Nabendeckel) - Scratched - Loss in value |

**Damage 8:** Wheel / tyres: Alloy rim - rear right side (+ Nabendeckel) - Scratched - Loss in value

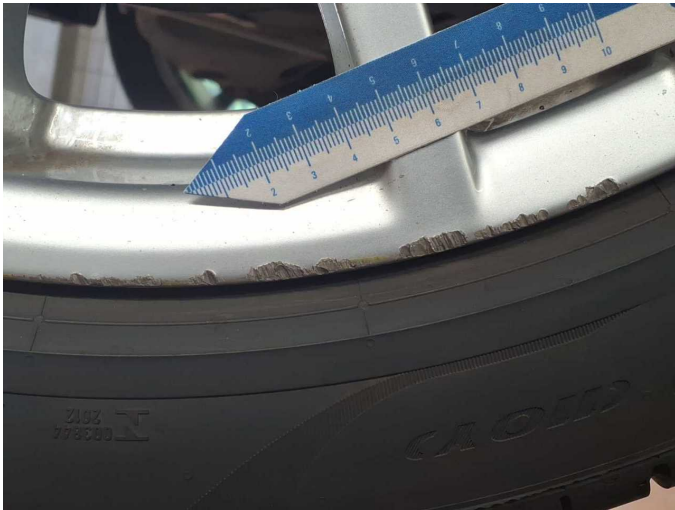
**Damage 8:** Wheel / tyres: Alloy rim - rear right side (+ Nabendeckel) - Scratched - Loss in value

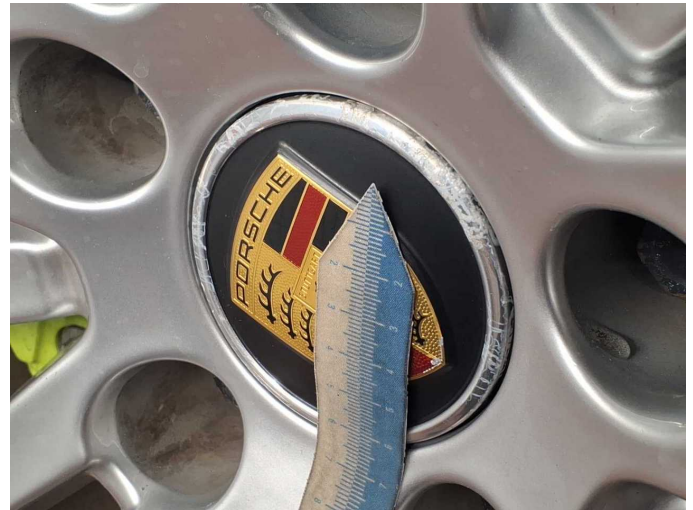
**Damage 8:** Wheel / tyres: Alloy rim - rear right side (+ Nabendeckel) - Scratched - Loss in value

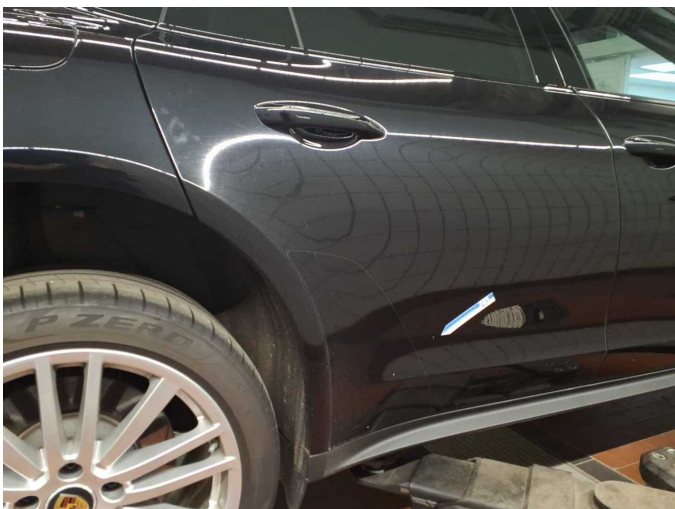
| No. | Component group | Description |
|---|---|---|
| 9 | Door - rear right side | Door (Rostunterwandert+ Steinschläge) - Corrosion - Repair and paint |

**Damage 9:** Door - rear right side: Door (Rostunterwandert+ Steinschläge) - Corrosion - Repair and paint

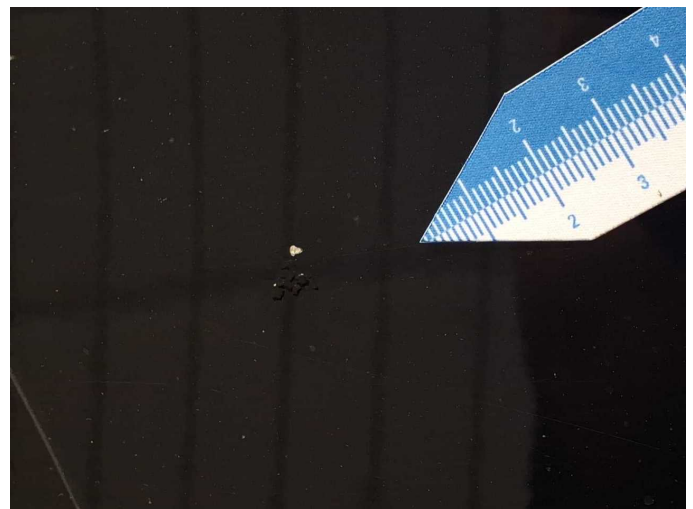
**Damage 9:** Door - rear right side: Door (Rostunterwandert+ Steinschläge) - Corrosion - Repair and paint

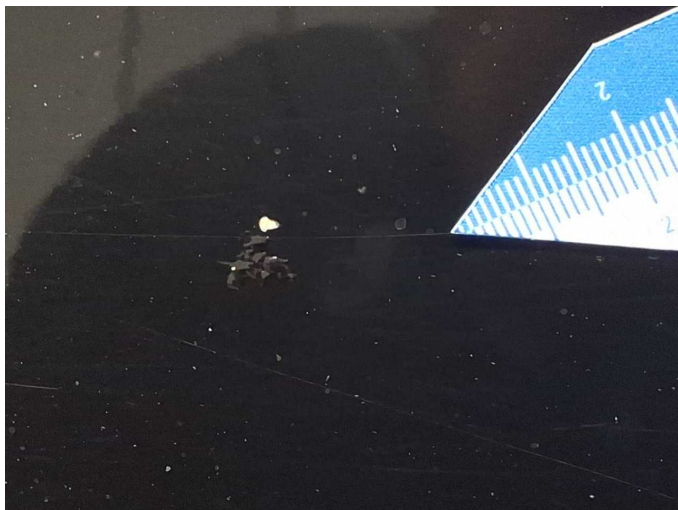
**Damage 9:** Door - rear right side: Door (Rostunterwandert+ Steinschläge) - Corrosion - Repair and paint

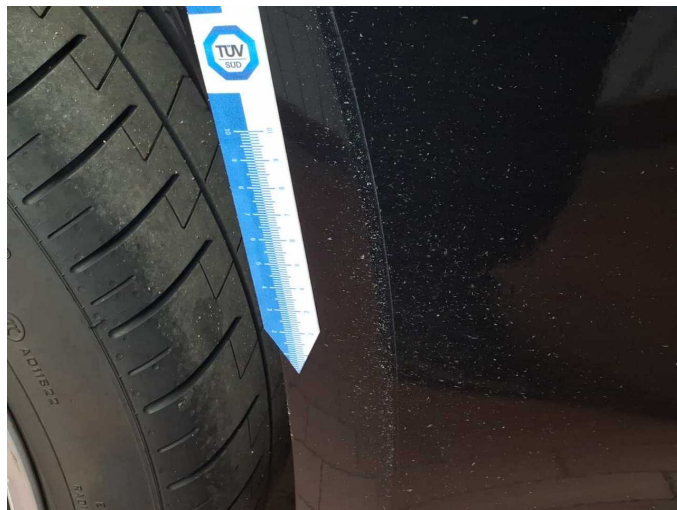
**Damage 9:** Door - rear right side: Door (Rostunterwandert+ Steinschläge) - Corrosion - Repair and paint

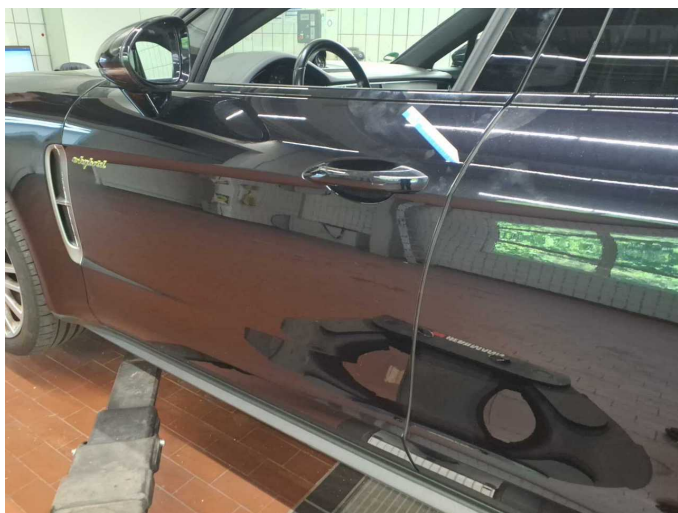
**Wear and tear 2:** Door - front left side: Door edge - Scratch(es) - No deduction

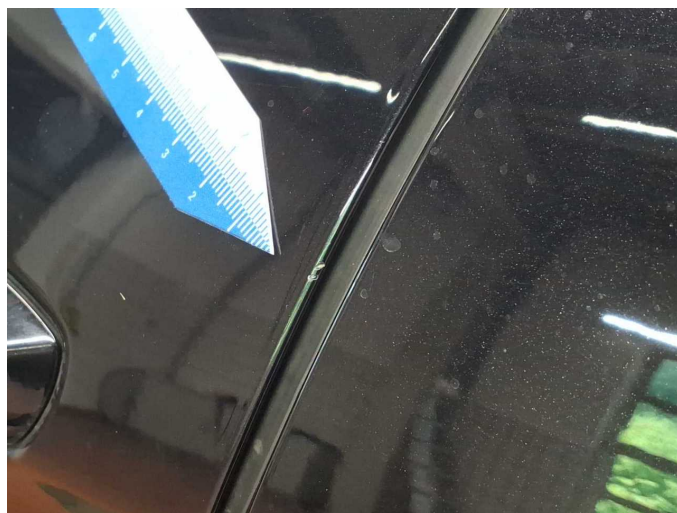
**Wear and tear 2:** Door - front left side: Door edge - Scratch(es) - No deduction

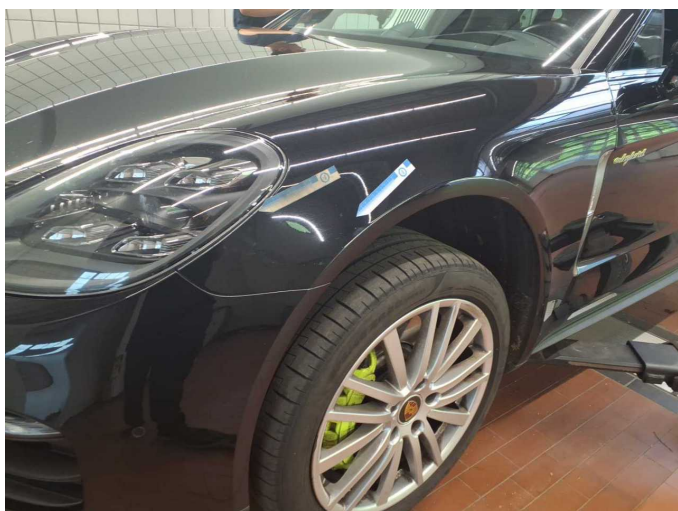
**Wear and tear 3:** Mudguard - left side: Mudguard - left side - Stone chips - No deduction

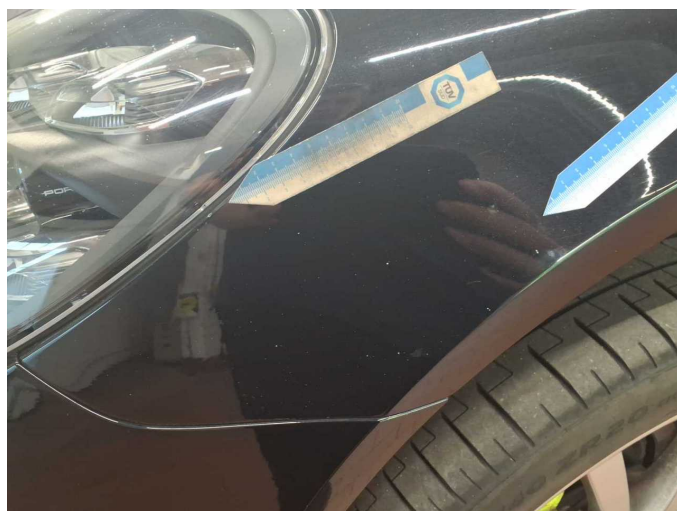
**Wear and tear 3:** Mudguard - left side: Mudguard - left side - Stone chips - No deduction

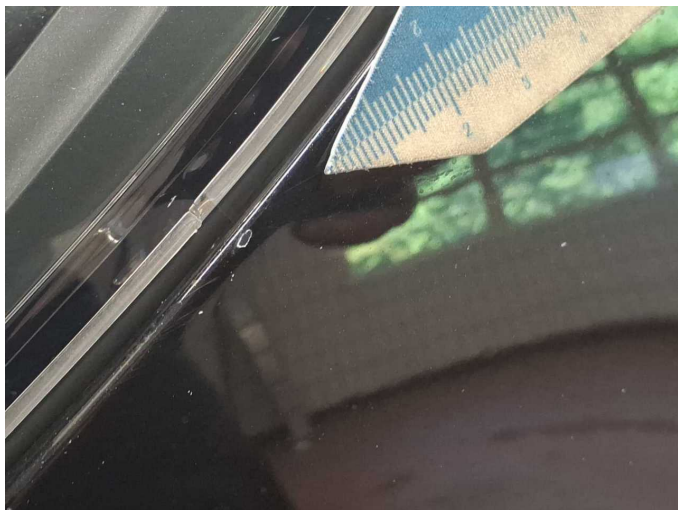
**Wear and tear 3:** Mudguard - left side: Mudguard - left side - Stone chips  
- No deduction

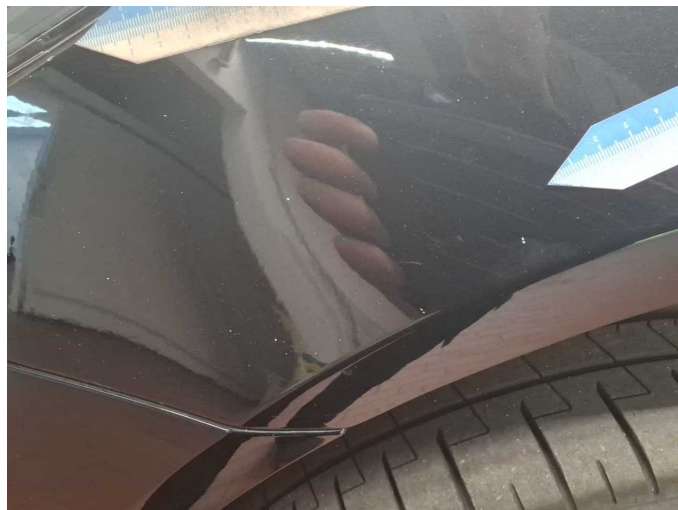
**Wear and tear 3:** Mudguard - left side: Mudguard - left side - Stone chips  
- No deduction

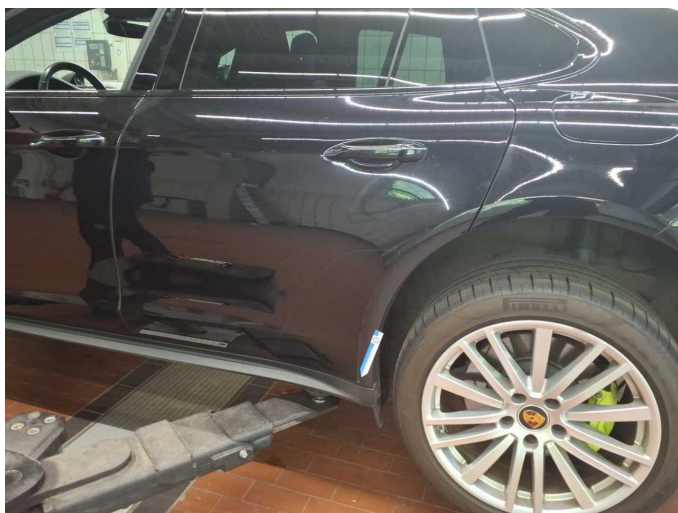
**Wear and tear 4:** Door - rear left side: Door - Stone chips - No deduction

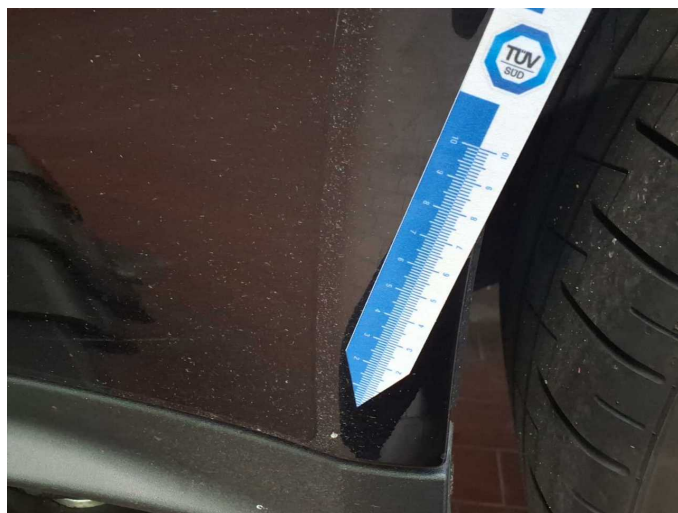
**Wear and tear 4:** Door - rear left side: Door - Stone chips - No deduction

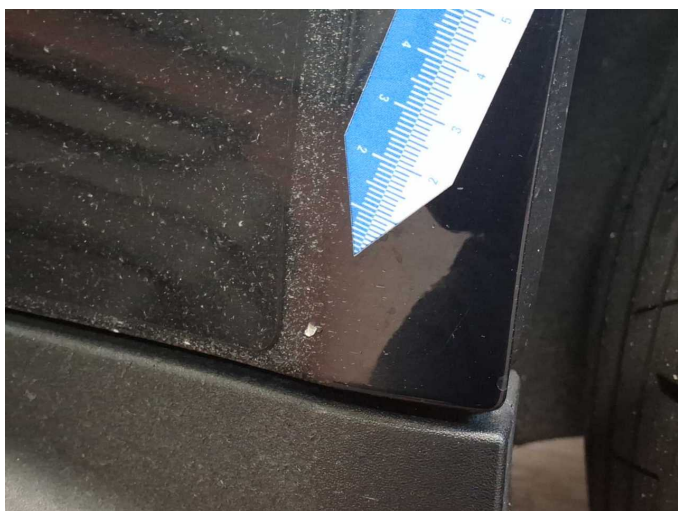
**Wear and tear 4:** Door - rear left side: Door - Stone chips - No deduction

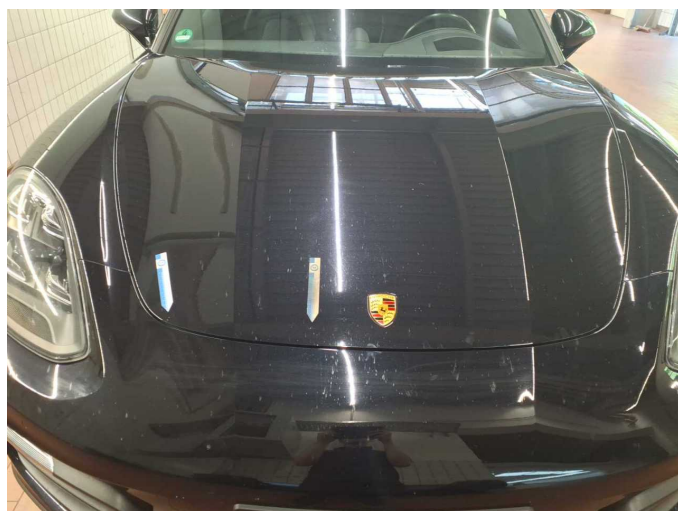
**Wear and tear 5:** Bonnet: Bonnet - Stone chips - No deduction

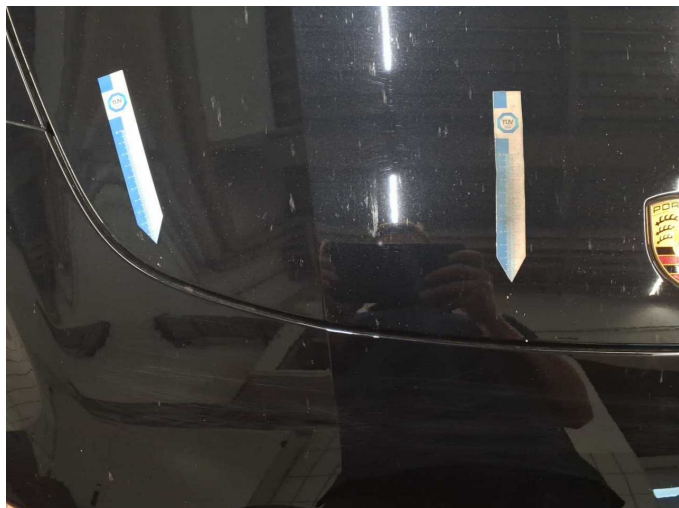
**Wear and tear 5:** Bonnet: Bonnet - Stone chips - No deduction

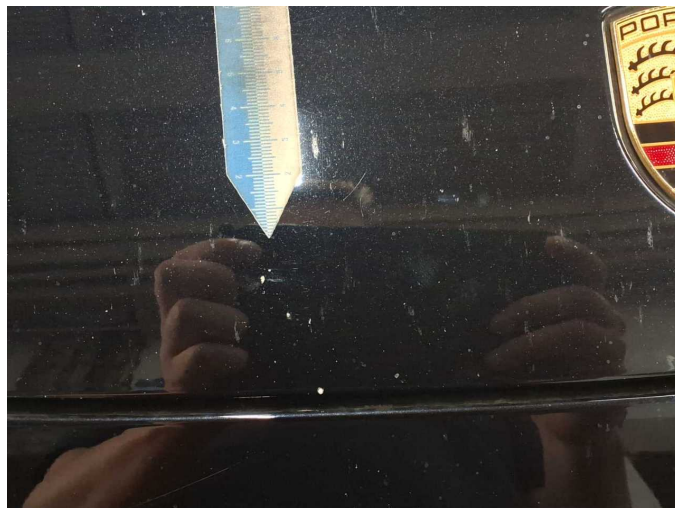
**Wear and tear 5:** Bonnet: Bonnet - Stone chips - No deduction

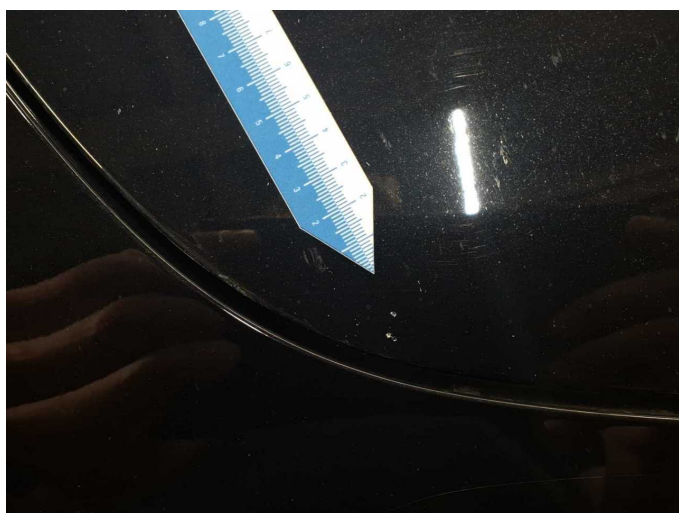
**Wear and tear 5:** Bonnet: Bonnet - Stone chips - No deduction

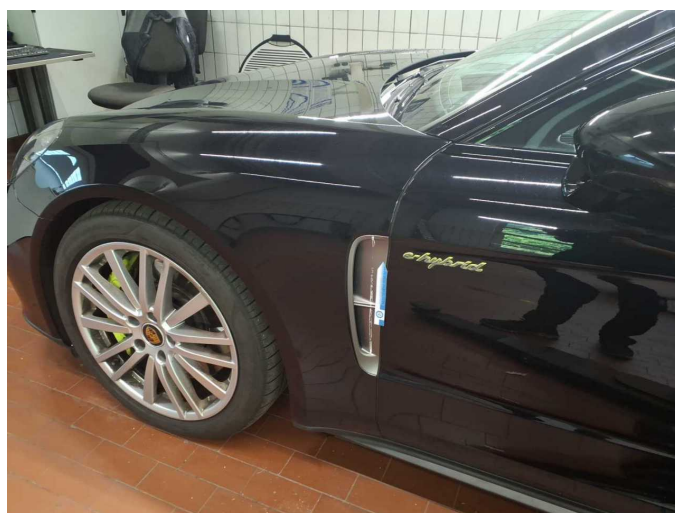
**Wear and tear 6:** Mudguard - left side: Mudguard - left side - Soiled - No deduction

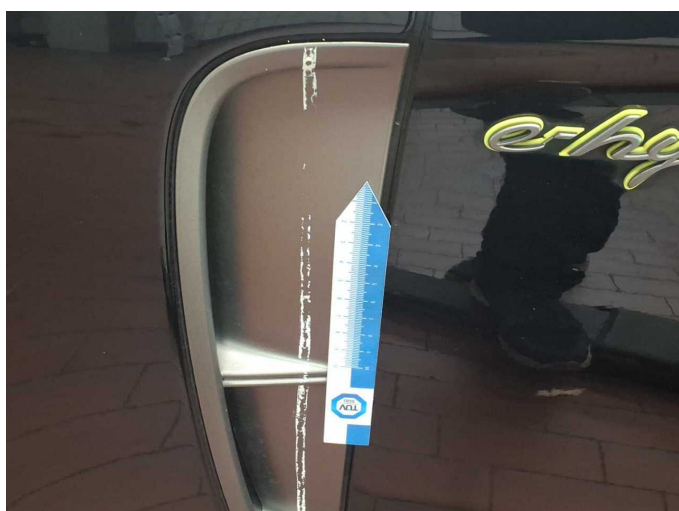
**Wear and tear 6:** Mudguard - left side: Mudguard - left side - Soiled - No deduction

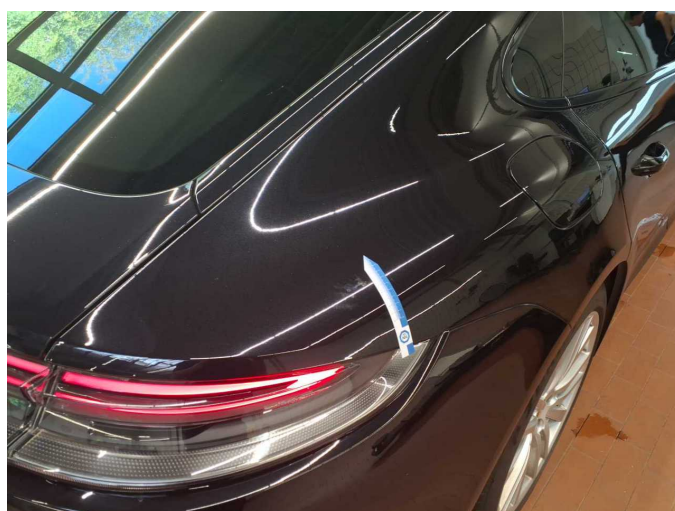
| No. | Component group | Description |
|---|---|---|
| 7 | Side panel - rear right side | Side panel - Scratch(es) - Cover / polish |

**Wear and tear 7:** Side panel - rear right side: Side panel - Scratch(es) - Cover / polish

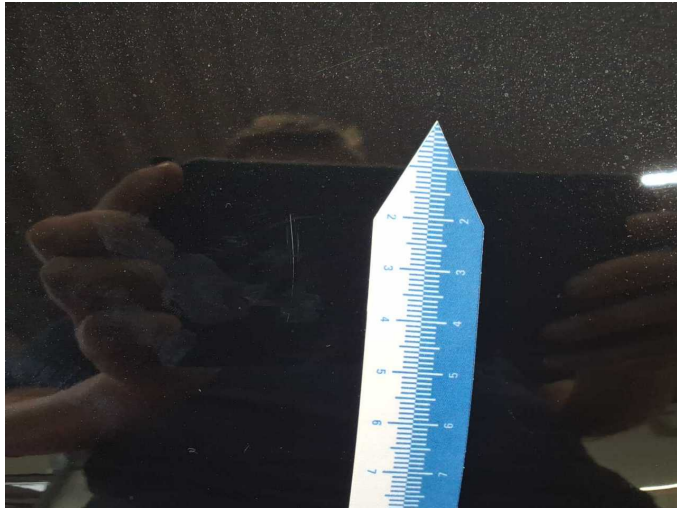
**Wear and tear 7:** Side panel - rear right side: Side panel - Scratch(es) - Cover / polish

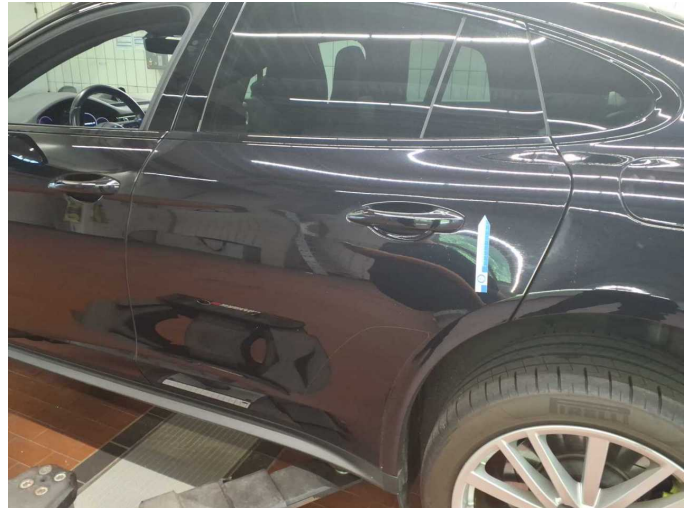
| No. | Component group | Description |
|---|---|---|
| 8 | Door - rear left side | Door - Scratch(es) - Cover / polish |

**Wear and tear 8:** Door - rear left side: Door - Scratch(es) - Cover / polish

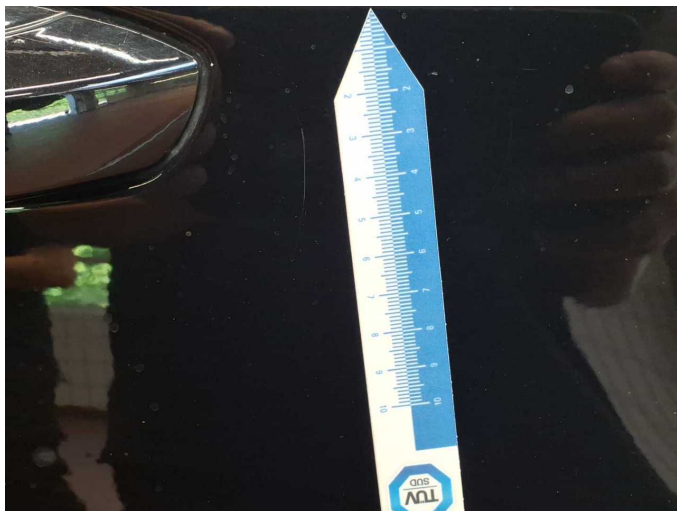
**Wear and tear 8:** Door - rear left side: Door - Scratch(es) - Cover / polish
