## Expertise

Protocol number: 46062290  
 Order No. / Reference: 26580488  
 Inspection date: 19 Jun 2026

Model: Movano 2.2 D L2H2 2WD VA verstärkt Edition

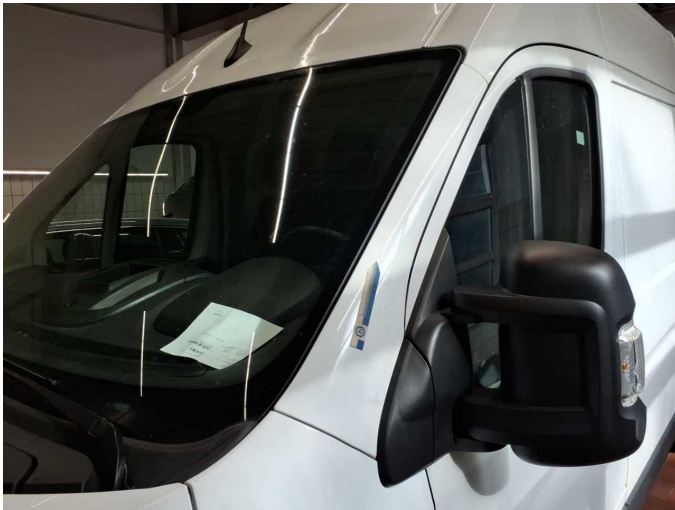
Damage 1: Body: A-pillar - left side - dent(s) - Smooth repair work

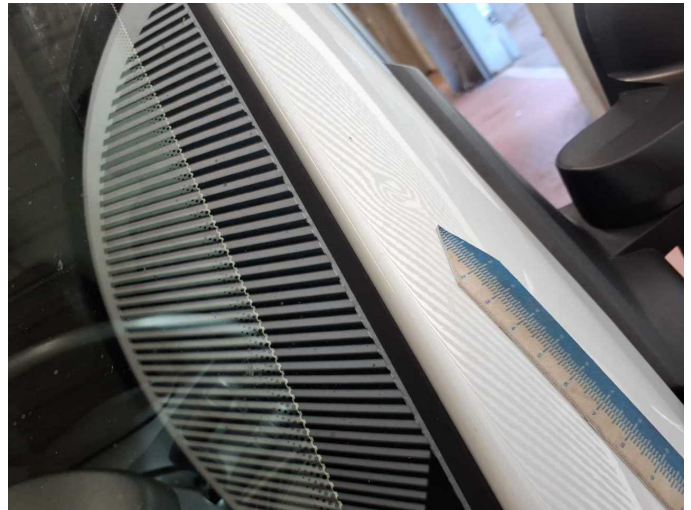
Damage 1: Body: A-pillar - left side - dent(s) - Smooth repair work

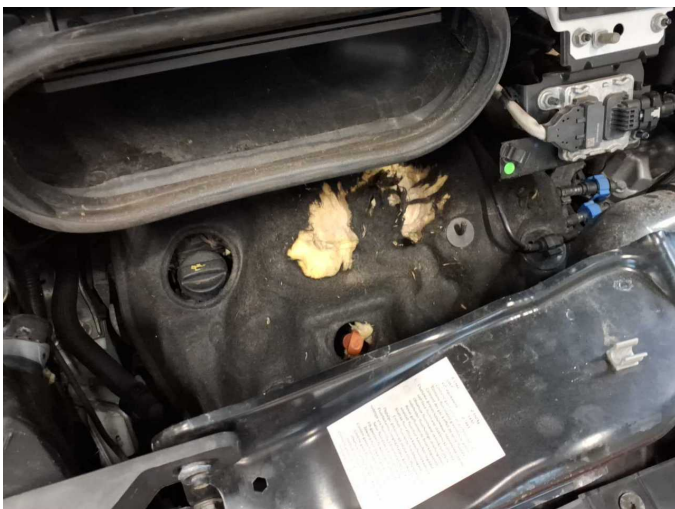
Damage 2: Engine: Engine cover (Isolierung Motor) - Damage caused by marten / rodent - Replace

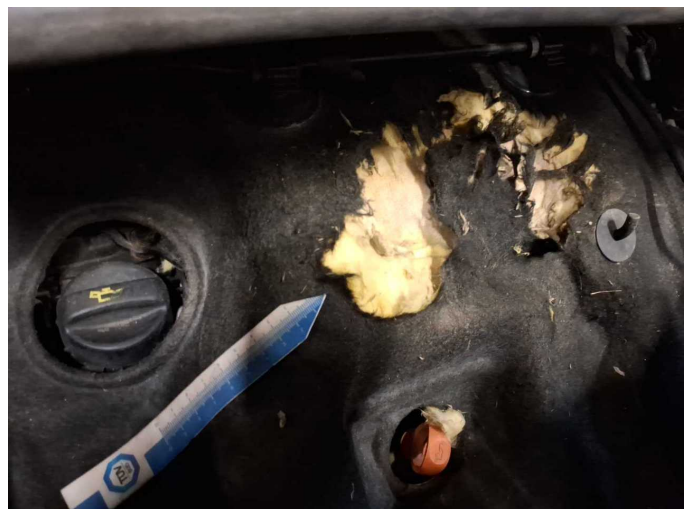
Damage 2: Engine: Engine cover (Isolierung Motor) - Damage caused by marten / rodent - Replace

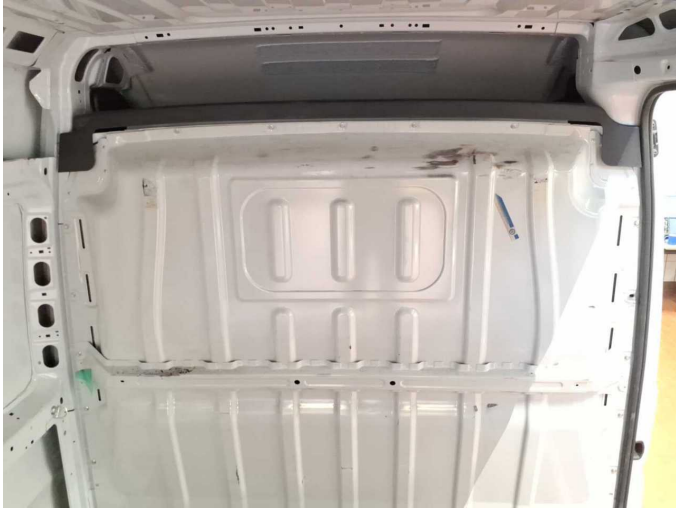
**Damage 3:** Body: Partition wall - Dent / paintcoat damage - Loss in value

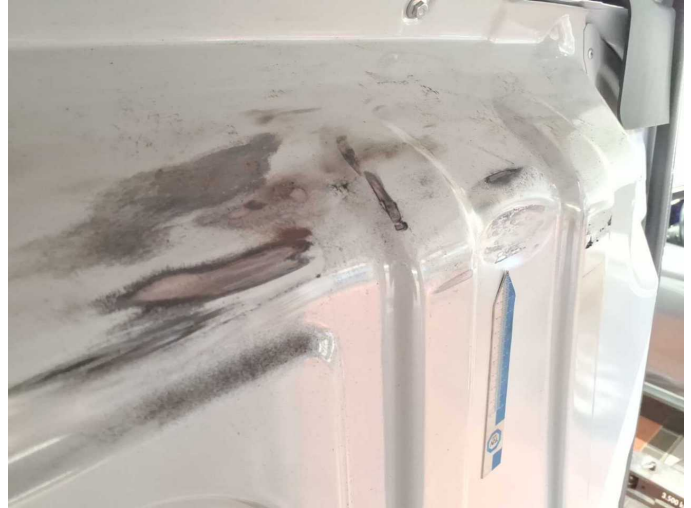
**Damage 3:** Body: Partition wall - Dent / paintcoat damage - Loss in value

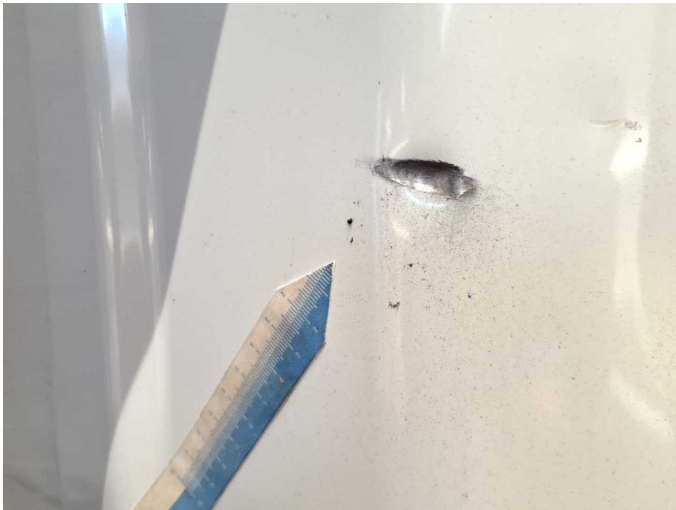
**Damage 3:** Body: Partition wall - Dent / paintcoat damage - Loss in value

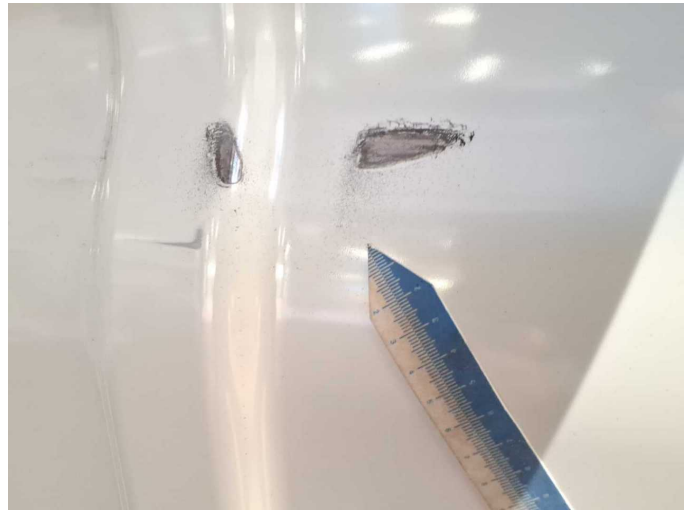
**Damage 3:** Body: Partition wall - Dent / paintcoat damage - Loss in value

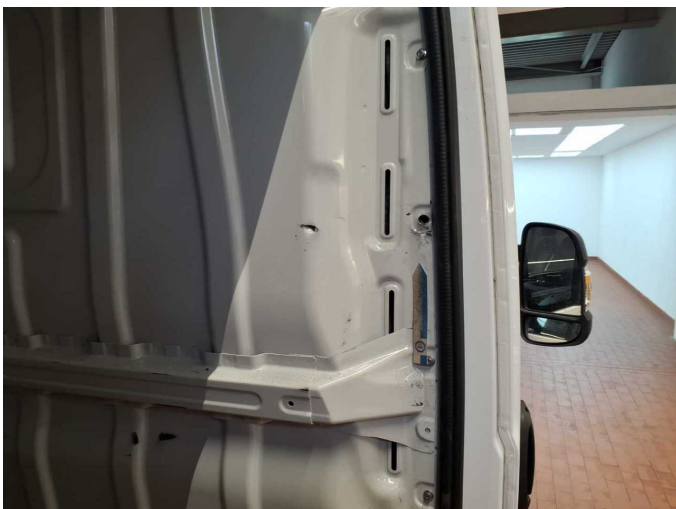
**Damage 3:** Body: Partition wall - Dent / paintcoat damage - Loss in value

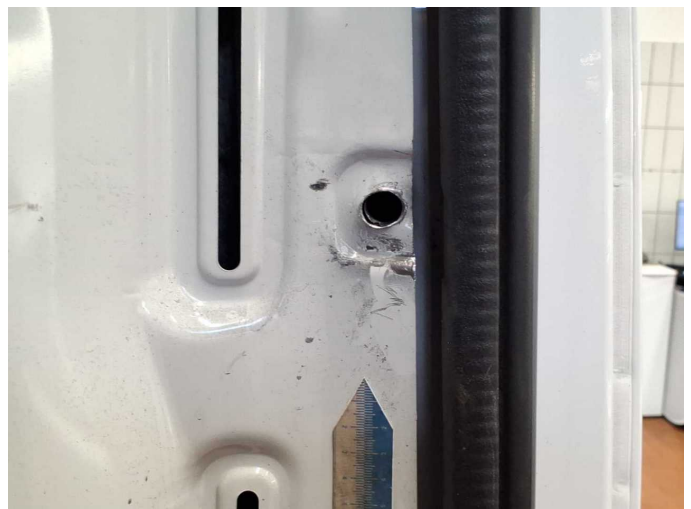
**Damage 3:** Body: Partition wall - Dent / paintcoat damage - Loss in value

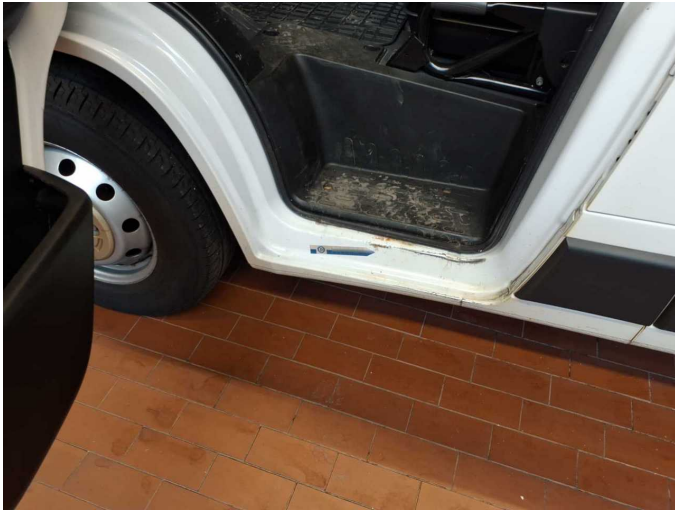
**Damage 4:** Sill - left side: Sill - Scratch(es) - Smart repair

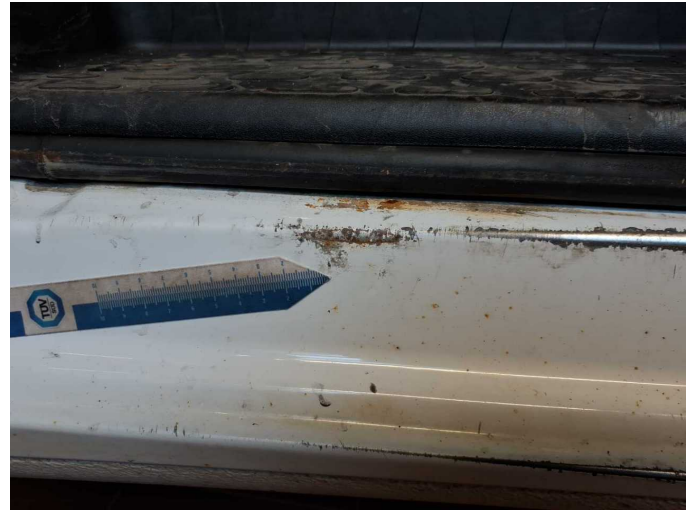
**Damage 4:** Sill - left side: Sill - Scratch(es) - Smart repair

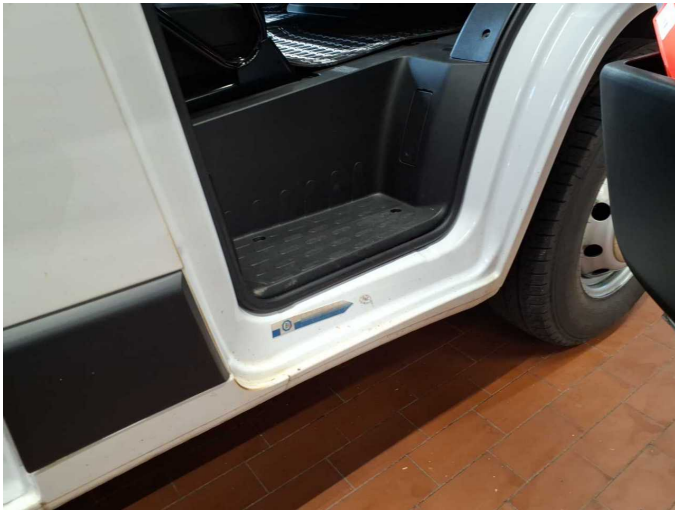
**Damage 5:** Sill - right side: Sill (Verätzung) - Paint defect - Smart repair

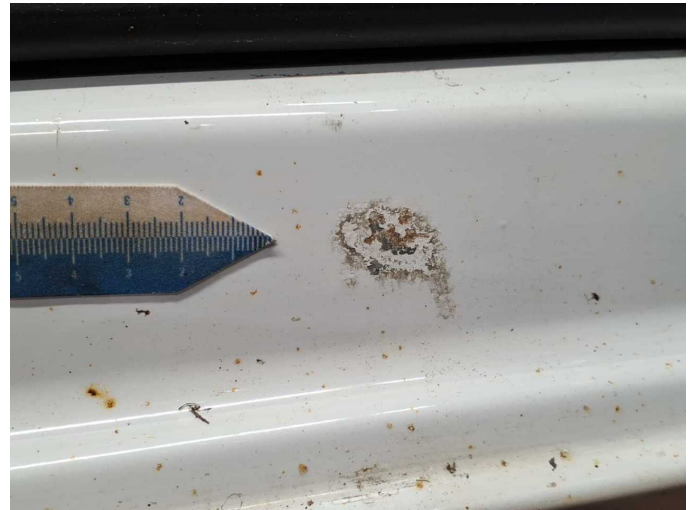
**Damage 5:** Sill - right side: Sill (Verätzung) - Paint defect - Smart repair

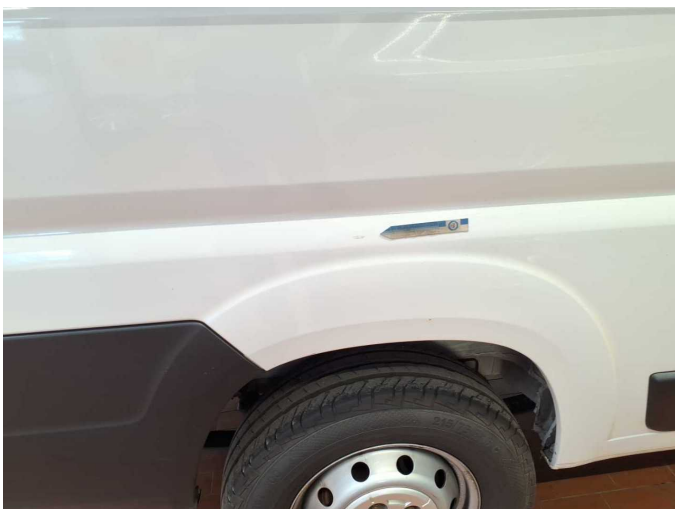
**Damage 6:** Side panel - rear right side: Side panel (unten) - Scratch(es) - Smart repair

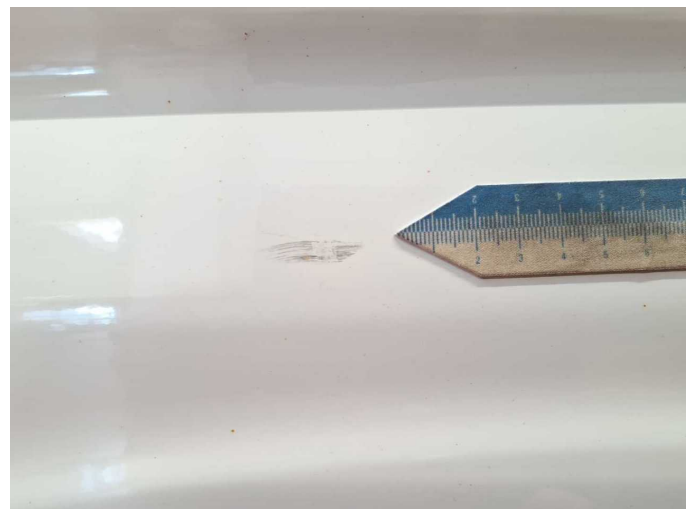
**Damage 6:** Side panel - rear right side: Side panel (unten) - Scratch(es) - Smart repair

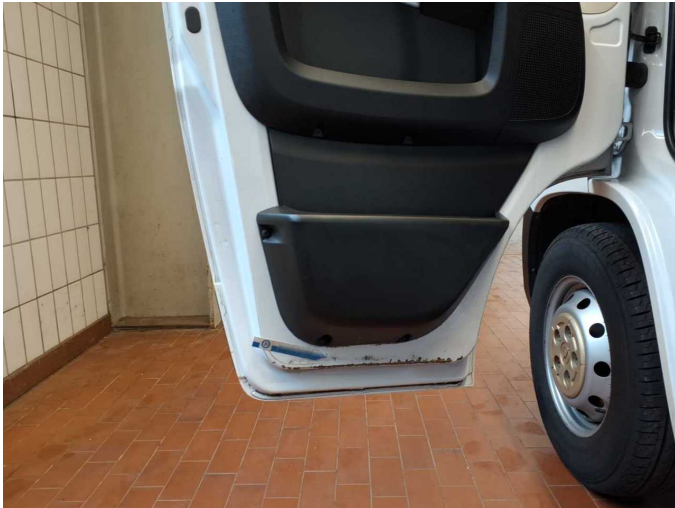
**Damage 7:** Door - front left side: Door (Unten / innen) - Corrosion - Loss in value

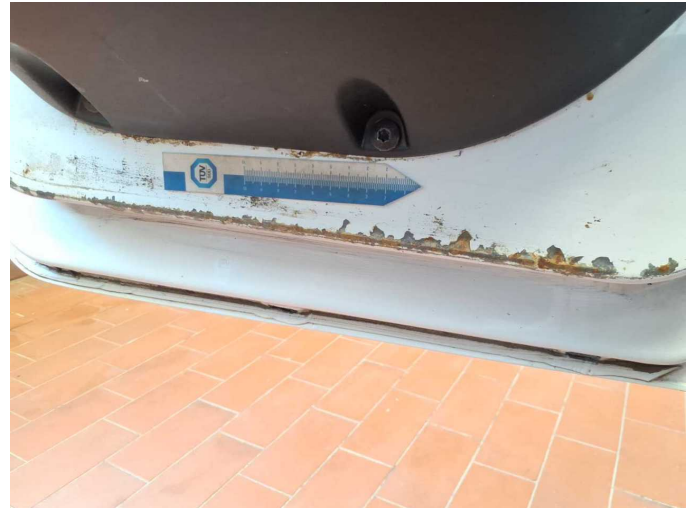
**Damage 7:** Door - front left side: Door (Unten / innen) - Corrosion - Loss in value

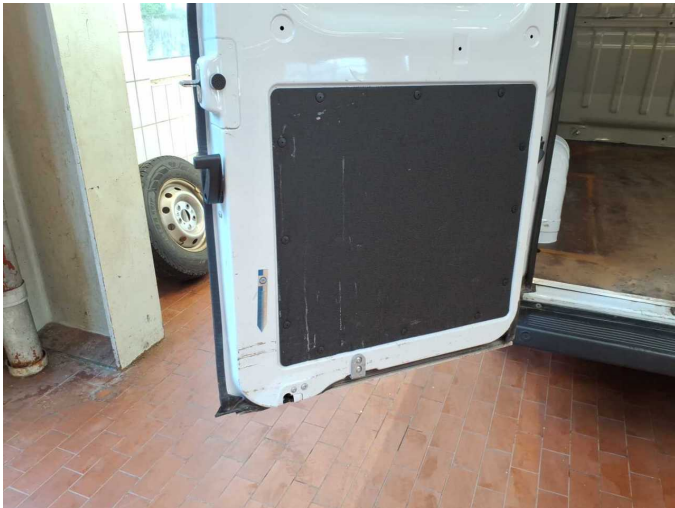
**Damage 8:** Boot lid / rear door: Rear door - left side (Innen) - Dent / paintcoat damage - Loss in value

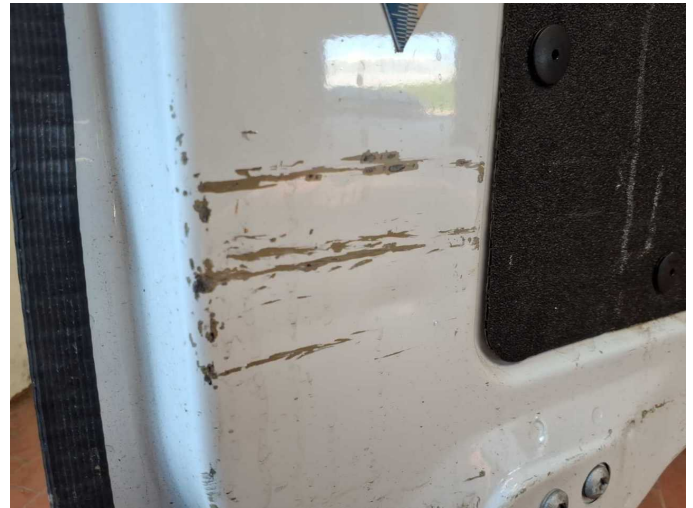
**Damage 8:** Boot lid / rear door: Rear door - left side (Innen) - Dent / paintcoat damage - Loss in value

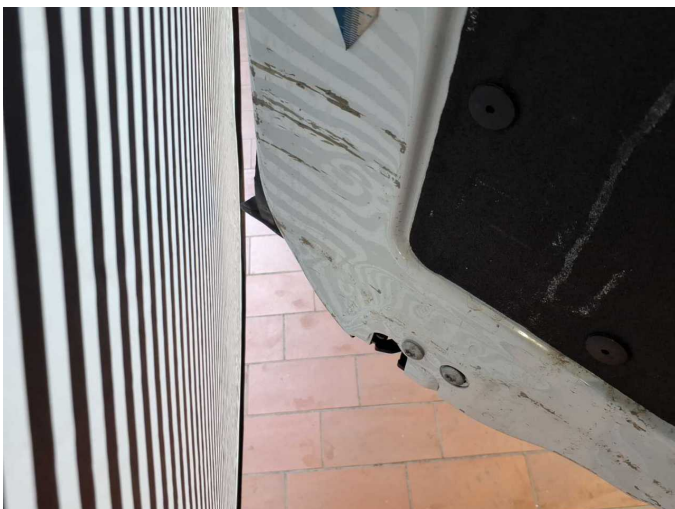
**Damage 8:** Boot lid / rear door: Rear door - left side (Innen) - Dent / paintcoat damage - Loss in value

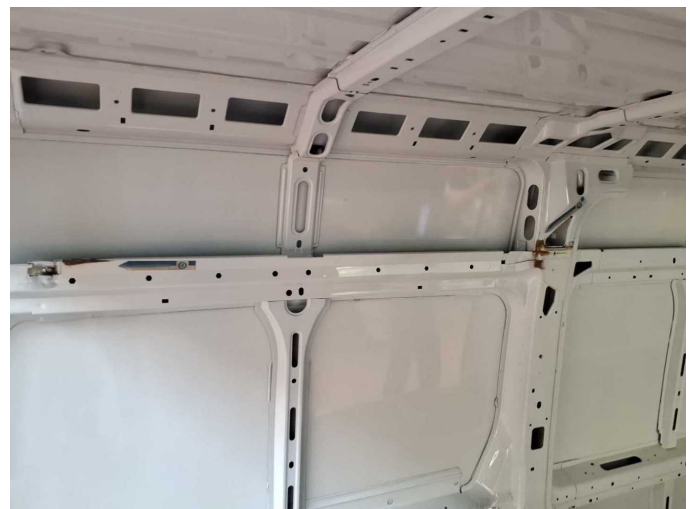
**Damage 9:** Side panel - rear left side: Side panel (Innen) - Corrosion - Smart repair

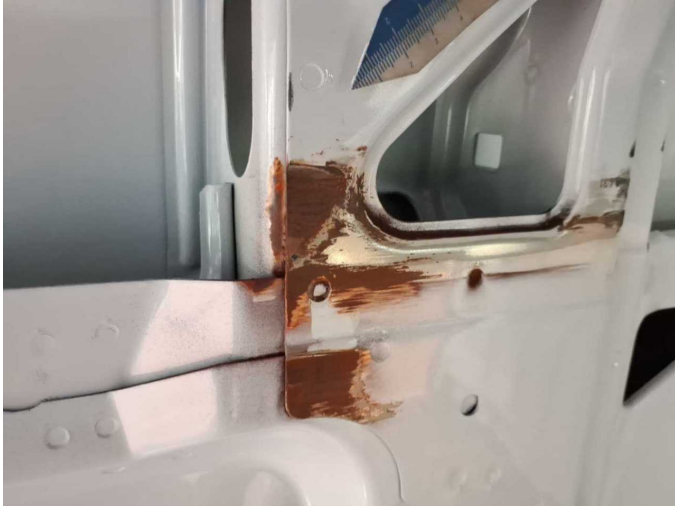
**Damage 9:** Side panel - rear left side: Side panel (Innen) - Corrosion - Smart repair

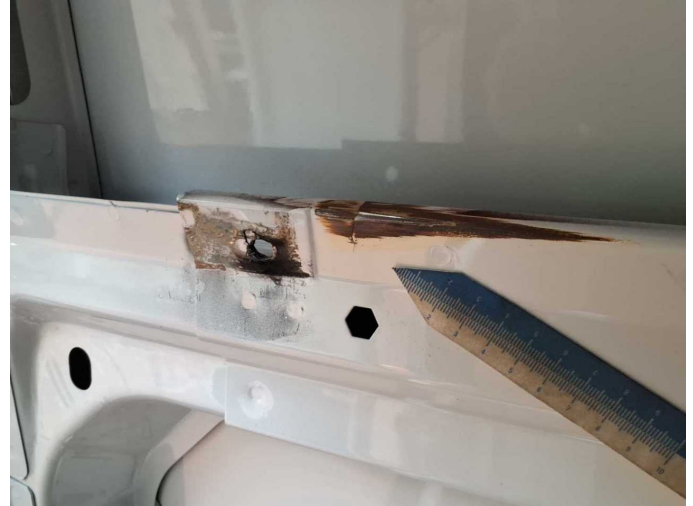
**Damage 9:** Side panel - rear left side: Side panel (Innen) - Corrosion - Smart repair

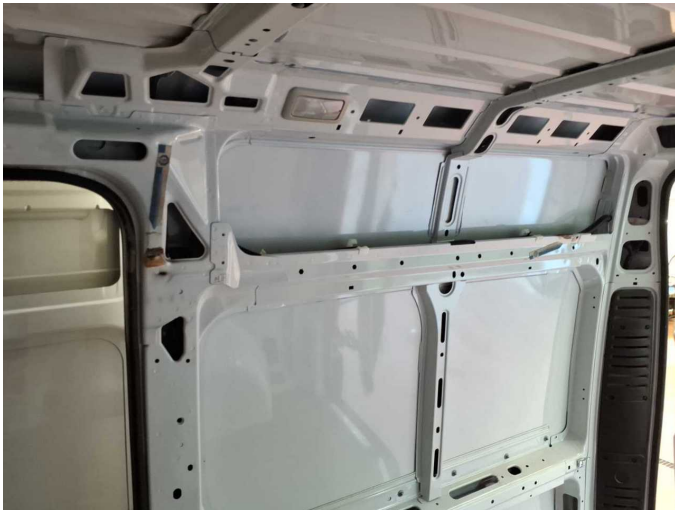
**Damage 10:** Side panel - rear right side: Side panel (Innen) - Corrosion - Smart repair

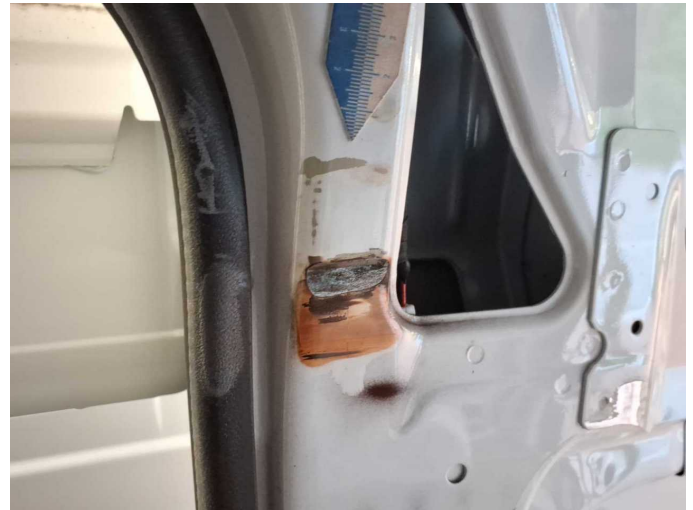
**Damage 10:** Side panel - rear right side: Side panel (Innen) - Corrosion - Smart repair

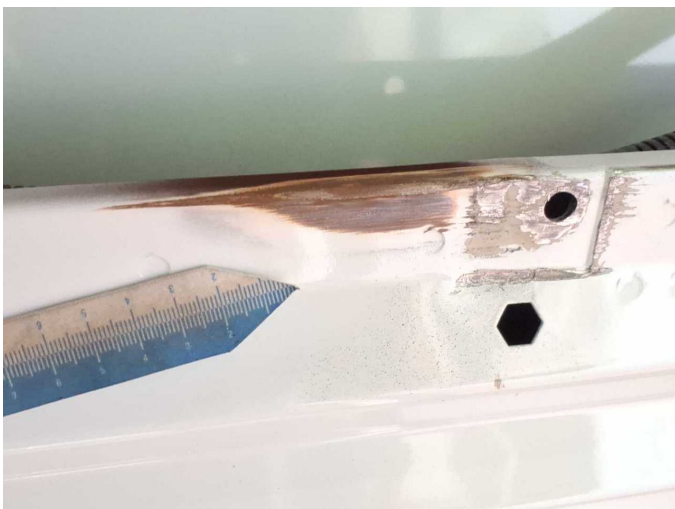
**Damage 10:** Side panel - rear right side: Side panel (Innen) - Corrosion - Smart repair

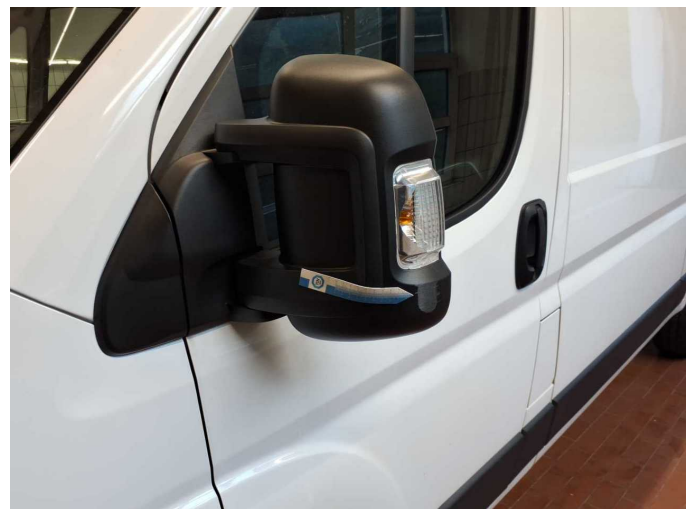
**Damage 11:** Wing mirror - left side: Mirror housing (Spiegelblinker li. gebrochen) - Broken / torn - Replace

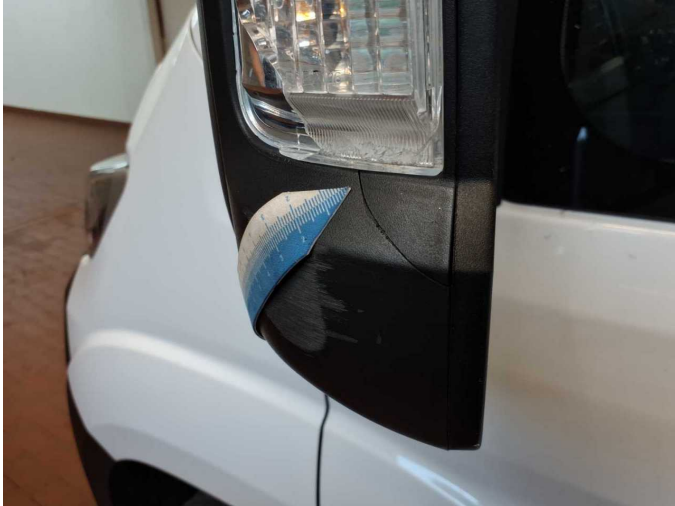
**Damage 11:** Wing mirror - left side: Mirror housing (Spiegelblinker li. gebrochen) - Broken / torn - Replace

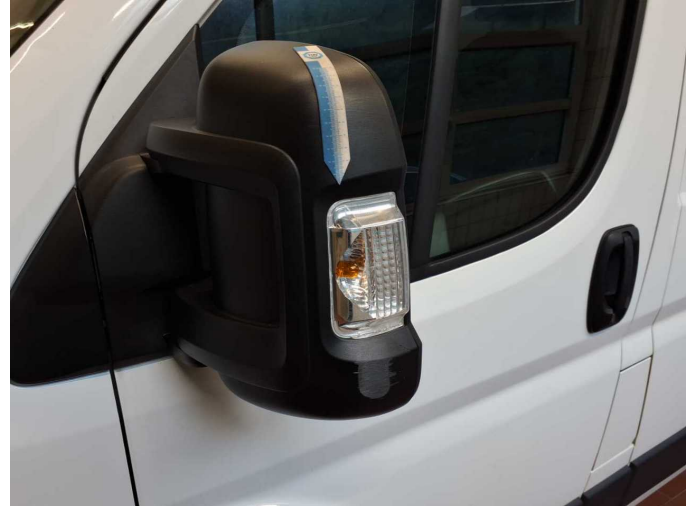
**Damage 11:** Wing mirror - left side: Mirror housing (Spiegelblinker li. gebrochen) - Broken / torn - Replace

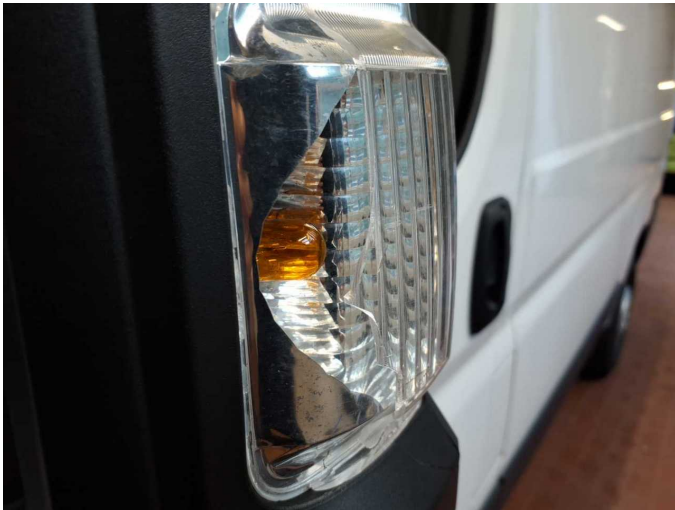
**Damage 11:** Wing mirror - left side: Mirror housing (Spiegelblinker li. gebrochen) - Broken / torn - Replace

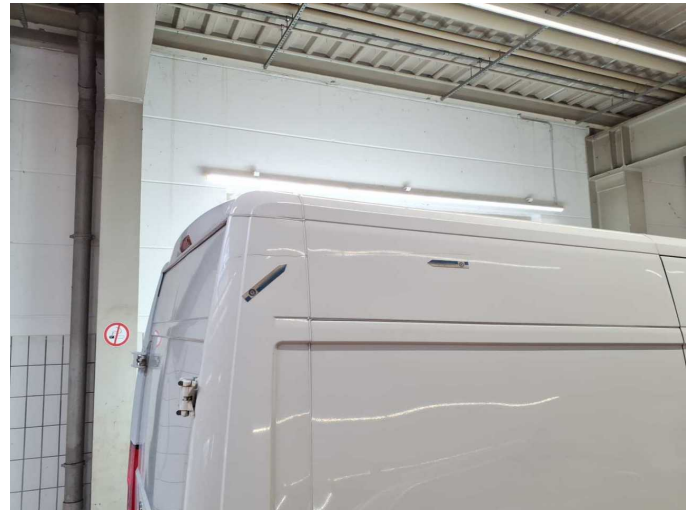
**Damage 12:** Side panel - rear right side: Side panel (Oben + Delle) - Scratched - Repair and paint

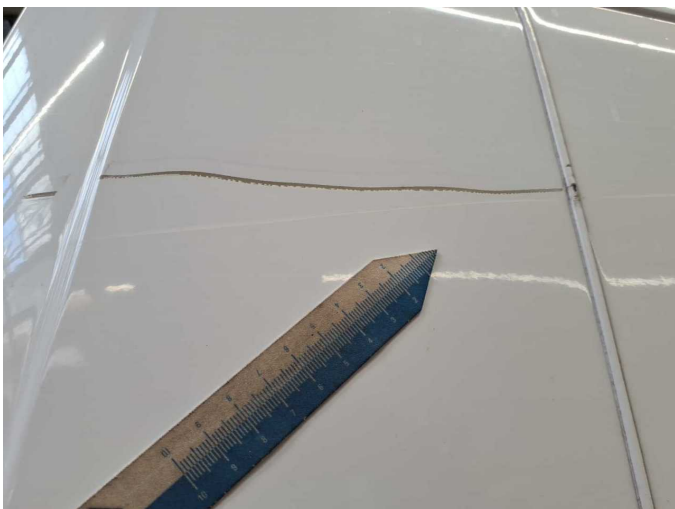
**Damage 12:** Side panel - rear right side: Side panel (Oben + Delle) - Scratched - Repair and paint

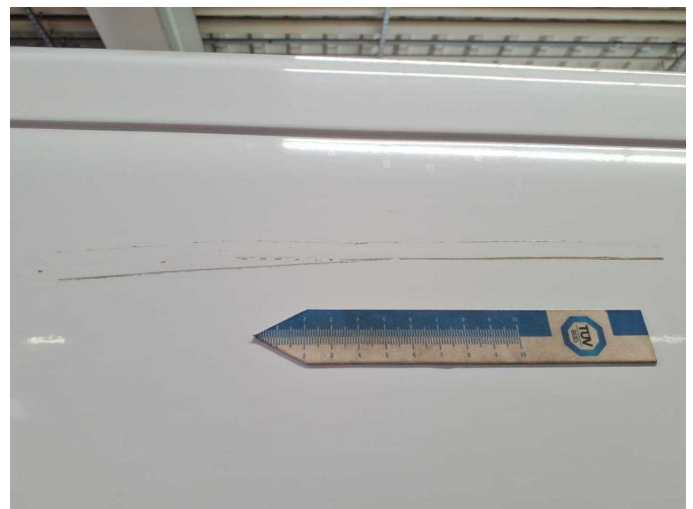
**Damage 12:** Side panel - rear right side: Side panel (Oben + Delle) - Scratched - Repair and paint

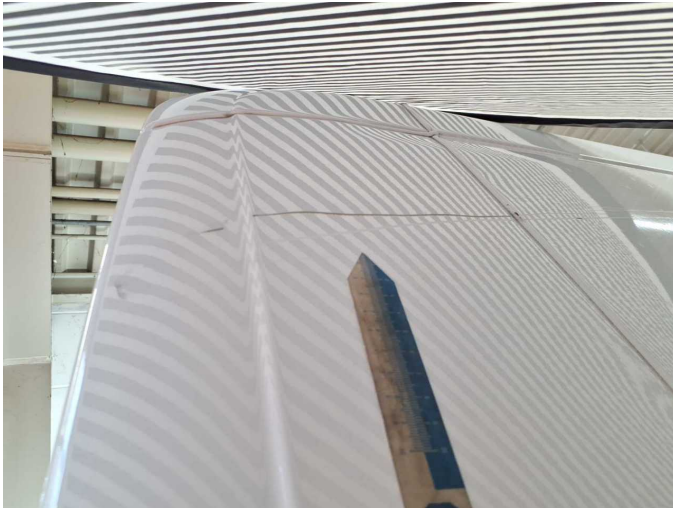
**Damage 12:** Side panel - rear right side: Side panel (Oben + Delle) - Scratched - Repair and paint

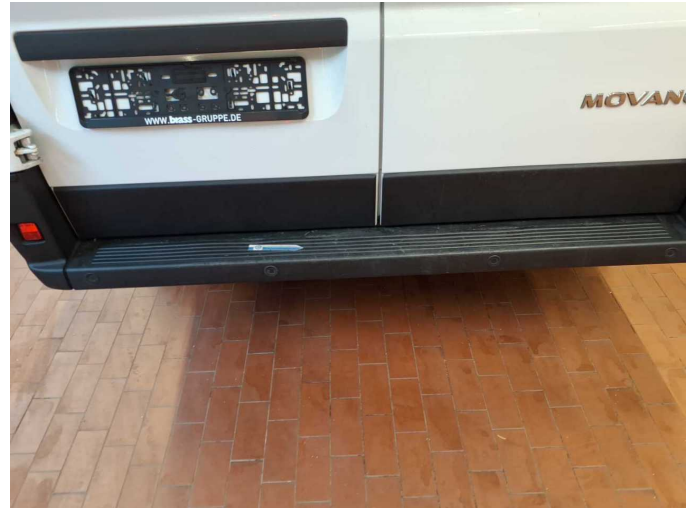
**Wear and tear 1:** Rear bumper: Rear bumper (unpainted) - Scratched - No deduction

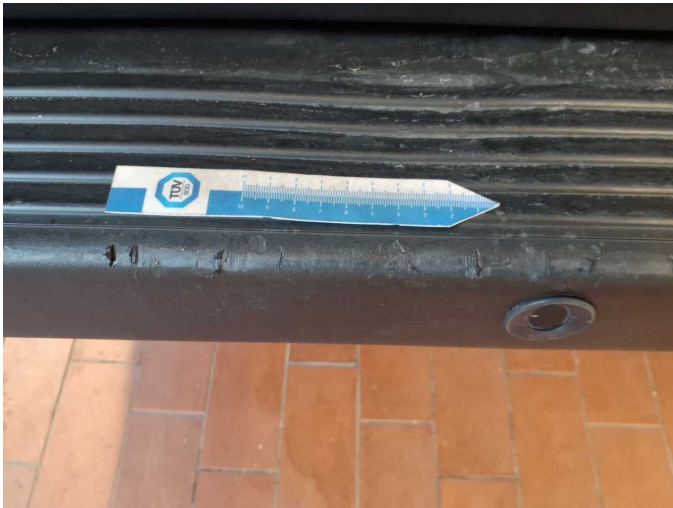
**Wear and tear 1:** Rear bumper: Rear bumper (unpainted) - Scratched - No deduction

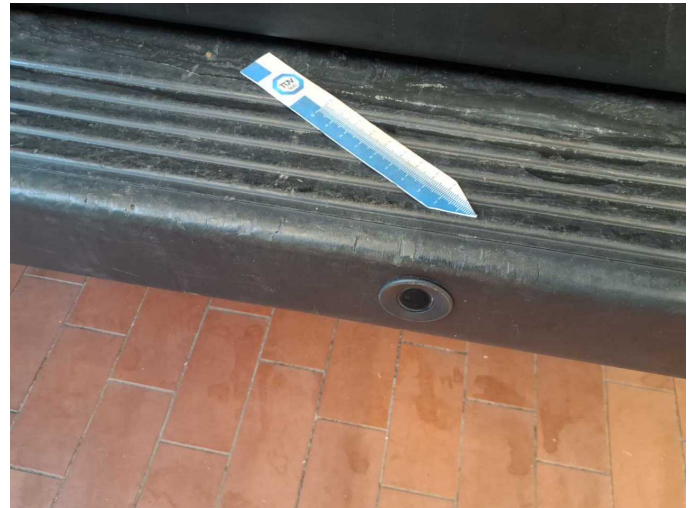
**Wear and tear 1:** Rear bumper: Rear bumper (unpainted) - Scratched - No deduction

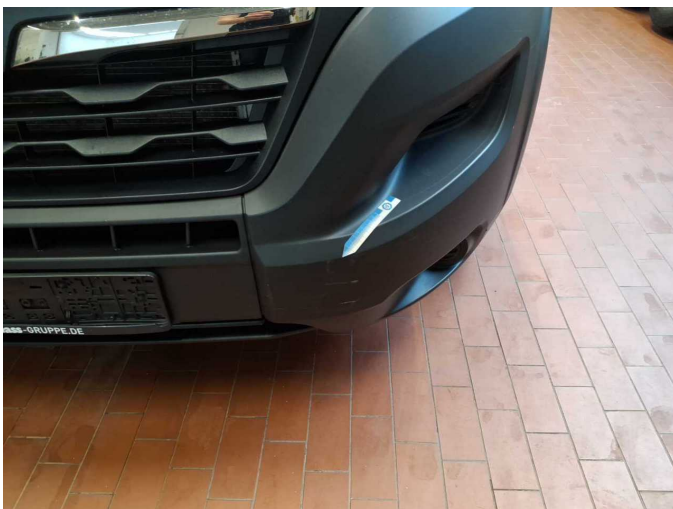
**Wear and tear 2:** Front bumper: Bumper - front left side - Scratch(es) - No deduction

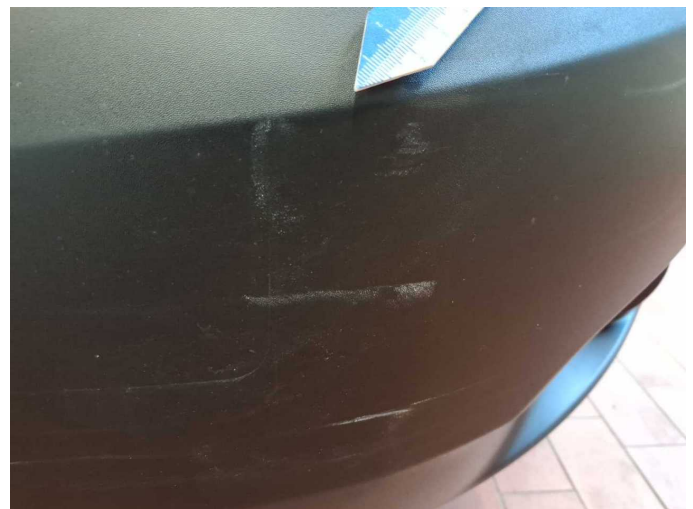
**Wear and tear 2:** Front bumper: Bumper - front left side - Scratch(es) - No deduction

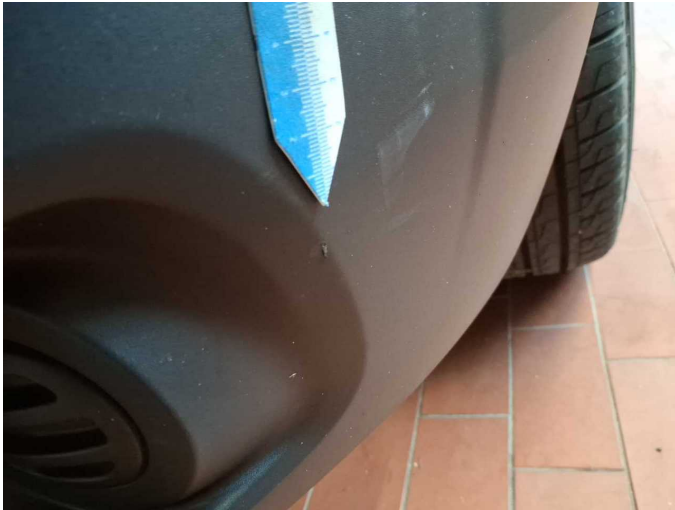
**Wear and tear 2:** Front bumper: Bumper - front left side - Scratch(es) - No deduction

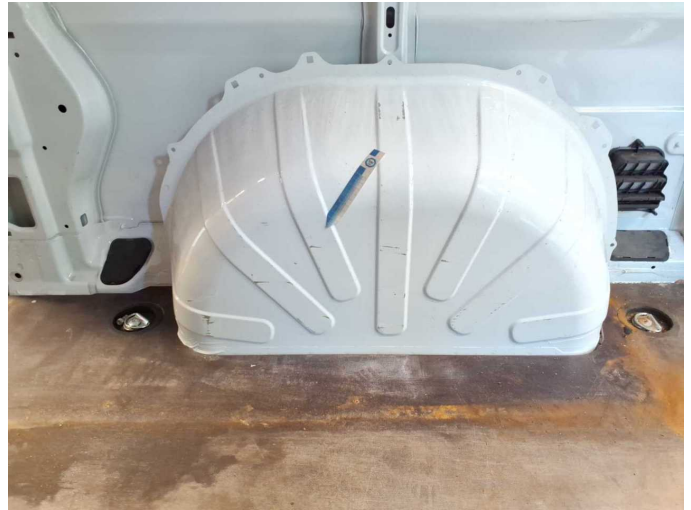
**Wear and tear 3:** Body: Wheel well - rear right side (Innen) - Scratch(es) - No deduction

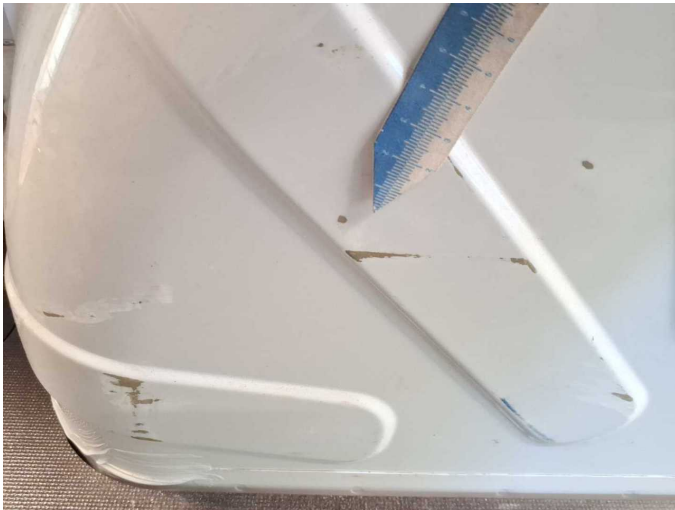
**Wear and tear 3:** Body: Wheel well - rear right side (Innen) - Scratch(es) - No deduction

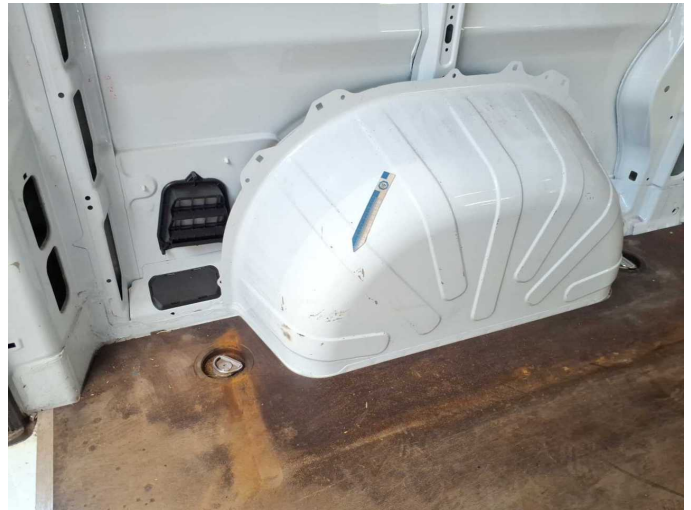
**Wear and tear 4:** Body: Wheel well - rear left side (Innen) - Scratch(es) - No deduction

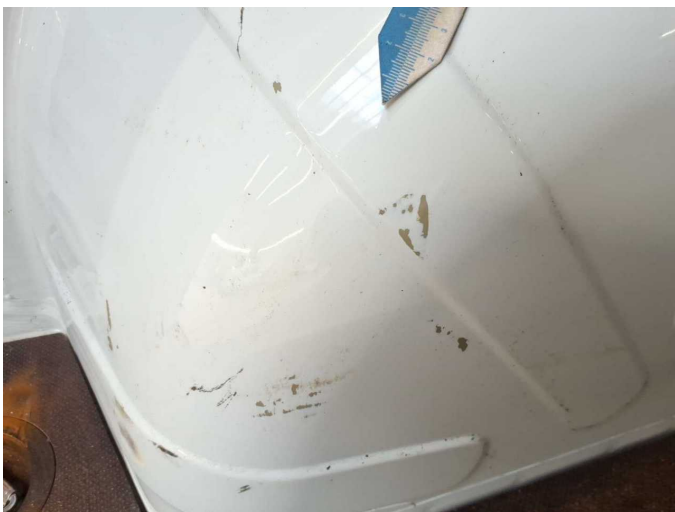
**Wear and tear 4:** Body: Wheel well - rear left side (Innen) - Scratch(es) - No deduction

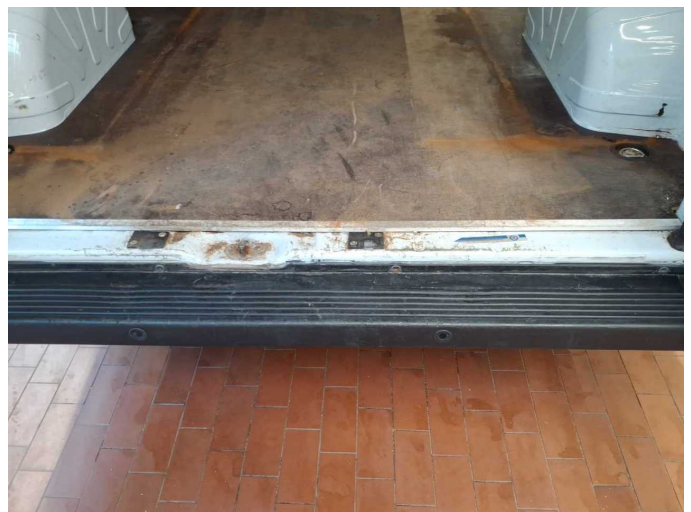
**Wear and tear 5:** Rear of vehicle: Foot plate - Scratch(es) - No deduction

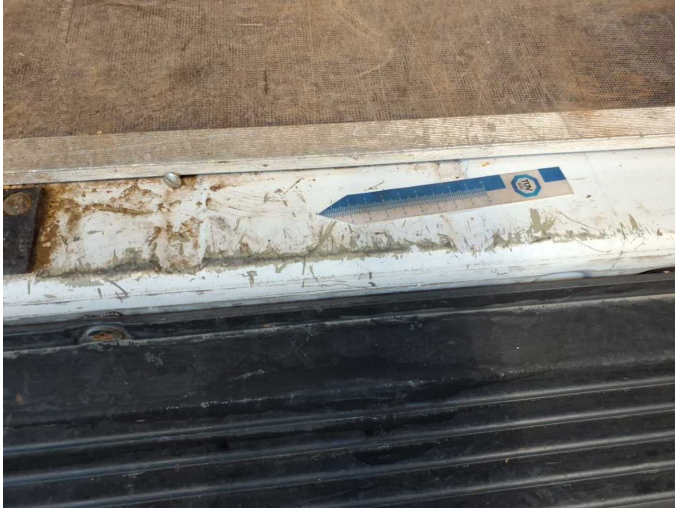
**Wear and tear 5:** Rear of vehicle: Foot plate - Scratch(es) - No deduction

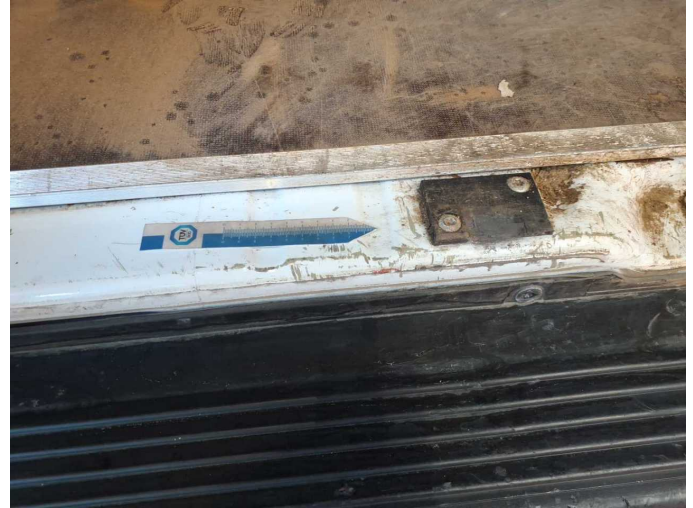
**Wear and tear 5:** Rear of vehicle: Foot plate - Scratch(es) - No deduction

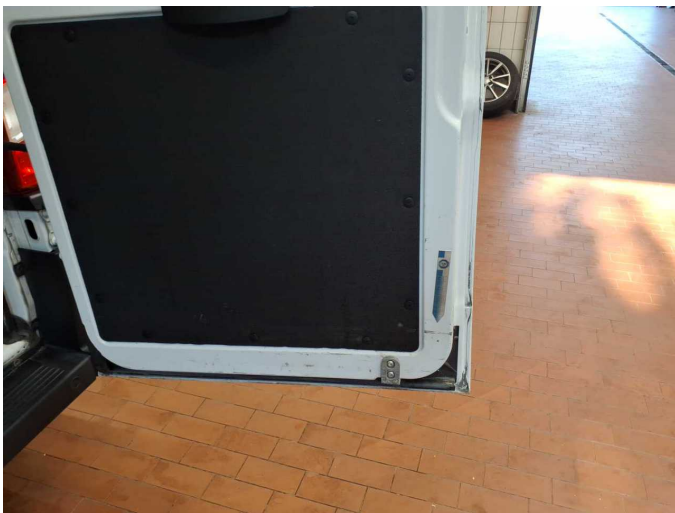
**Wear and tear 6:** Boot lid / rear door: Rear door - right side (Innen) - Scratch(es) - No deduction

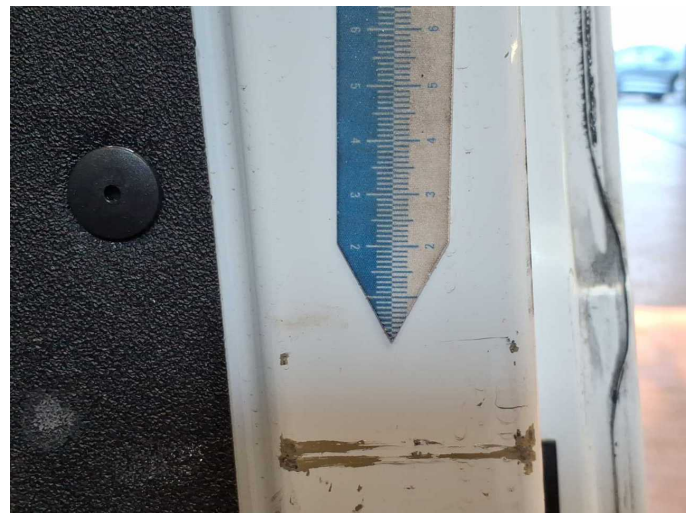
**Wear and tear 6:** Boot lid / rear door: Rear door - right side (Innen) - Scratch(es) - No deduction

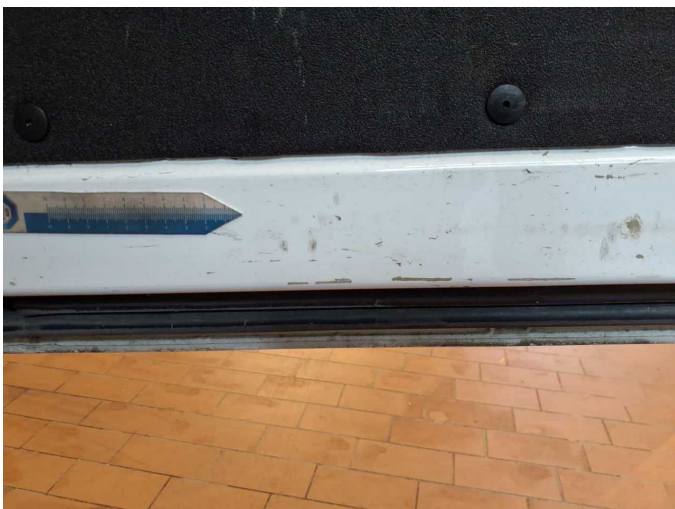
**Wear and tear 6:** Boot lid / rear door: Rear door - right side (Innen) - Scratch(es) - No deduction

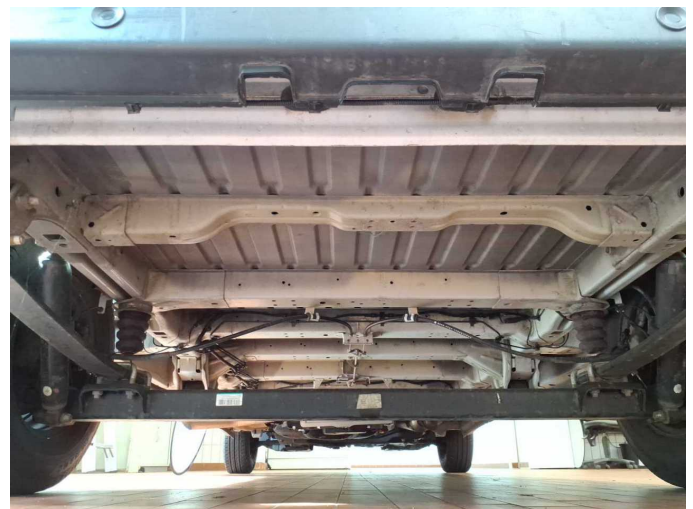
**Missing part 1:** Equipment: Spare wheel - Missing - Replace
