Expertise

Protocol number: 46346868
Order No. / Reference: 26595600
Inspection date: 3 Jul 2026

Manufacturer: Peugeot

Model: 208 Elektromotor 136 Allure

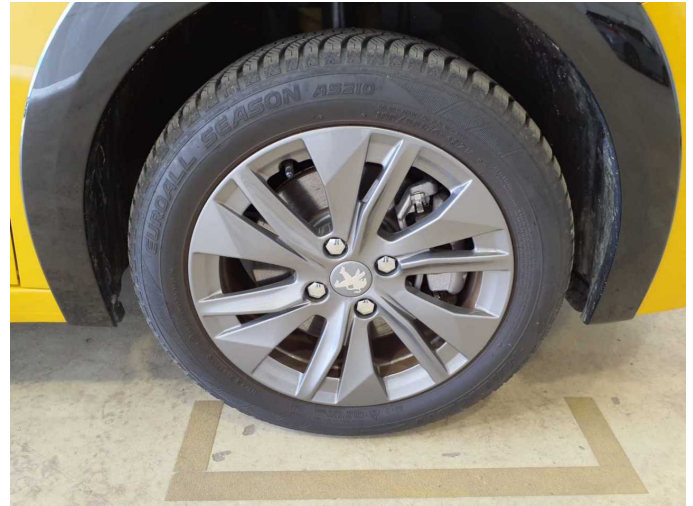
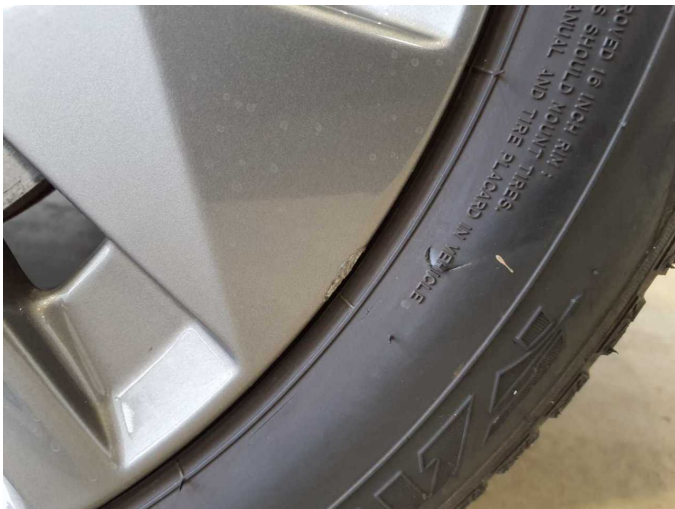
Damage 2: Wheel / tyres: Alloy rim - front right side - Scratch(es) - Loss in value

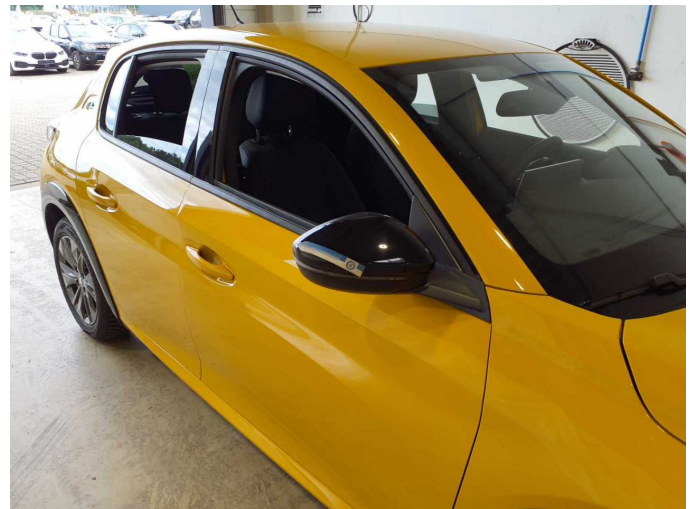
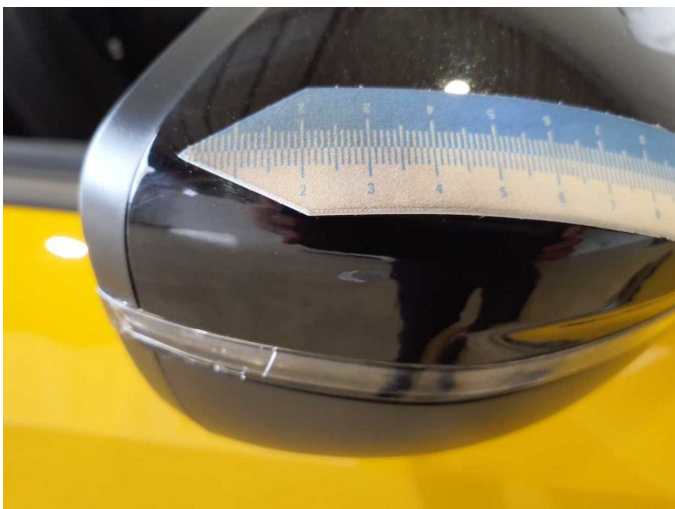
Damage 3: Wing mirror - right side: Cap - Scratch(es) - Smart repair

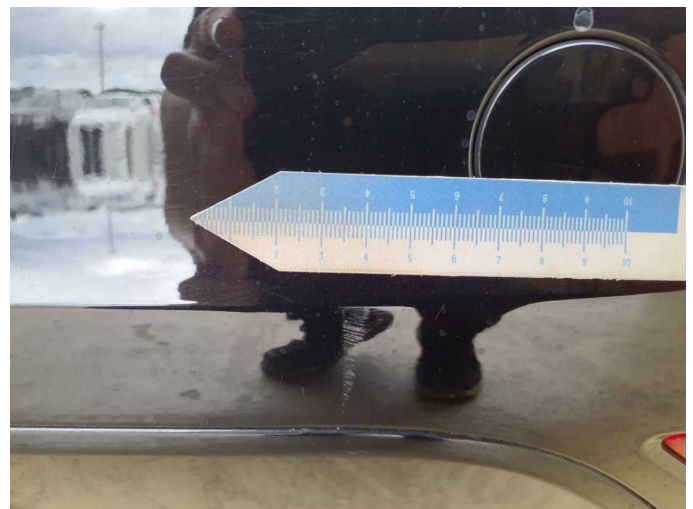
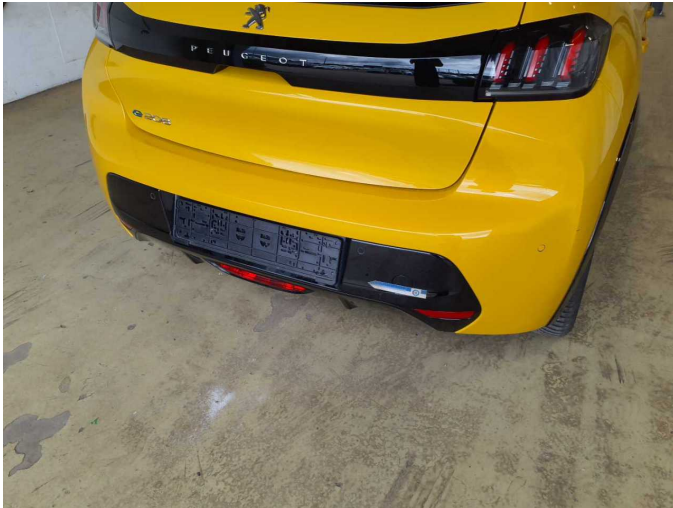
Damage 4: Rear bumper: Spoiler - Scratch(es) - Loss in value

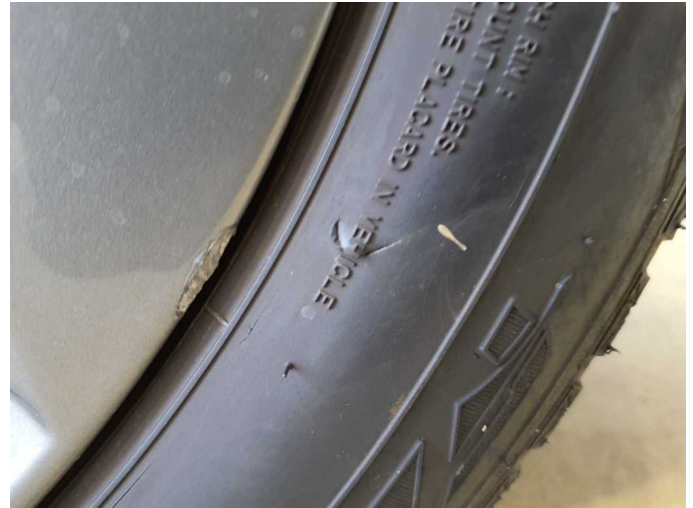
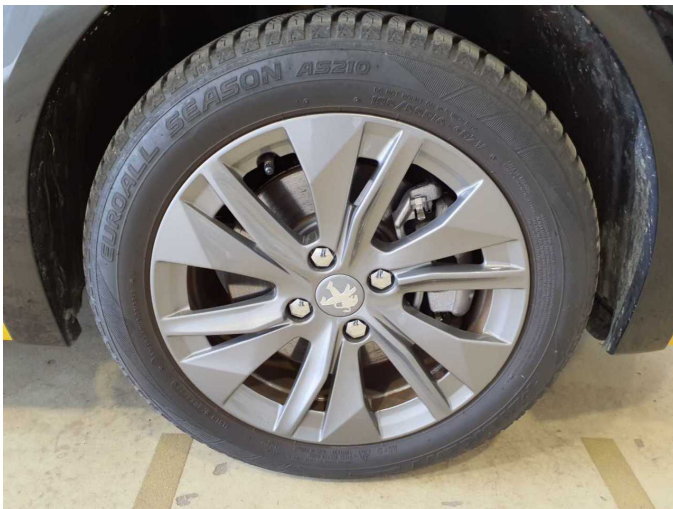
Damage 5: Wheel / tyres: Tyre - front right side - Broken / torn - Replace

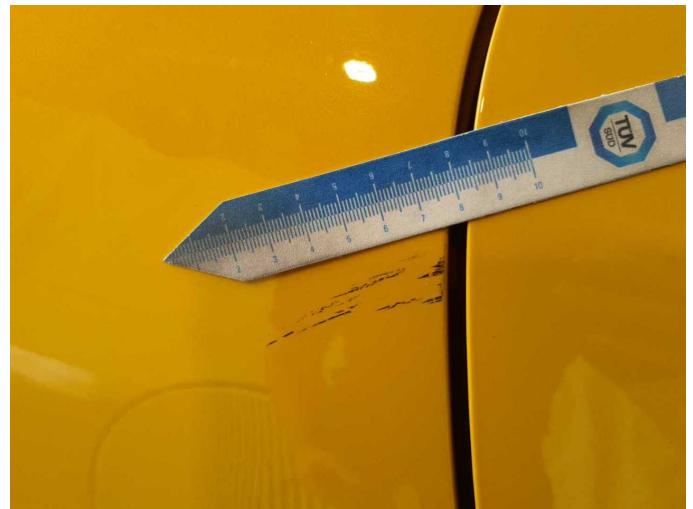
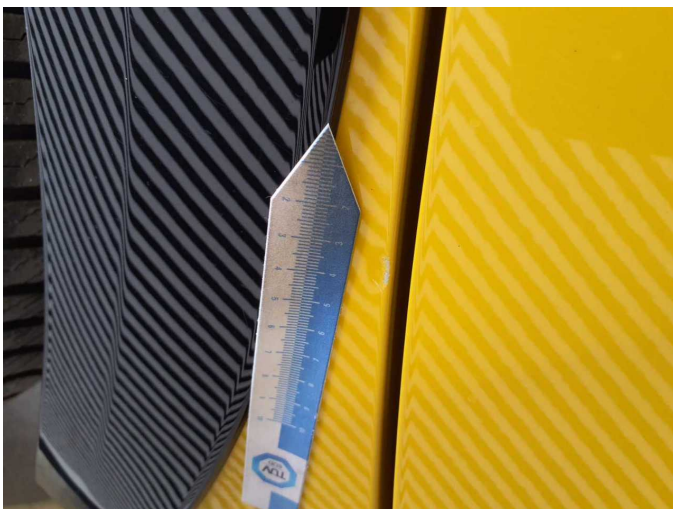
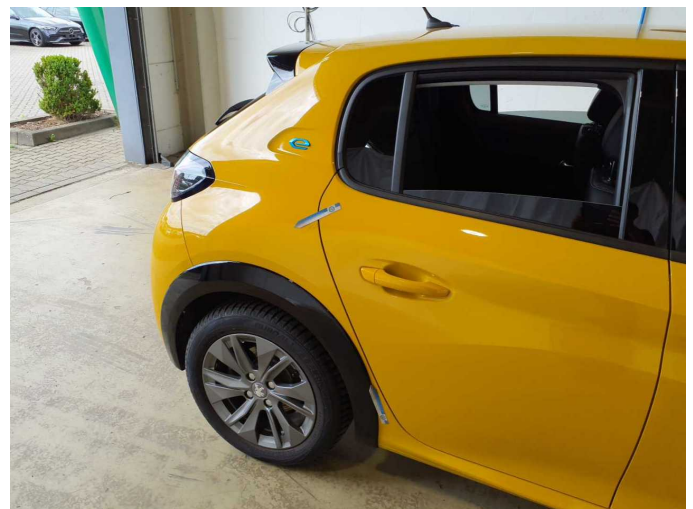
Damage 6: Side panel - rear right side: Side panel - Dent / paintcoat damage - Smart repair

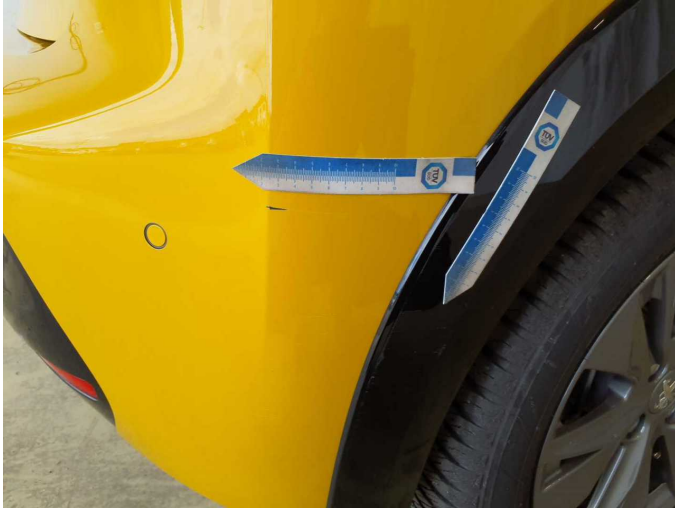
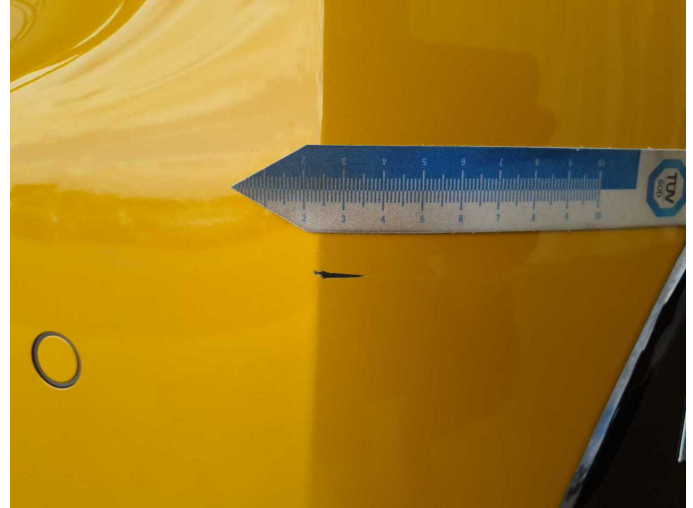
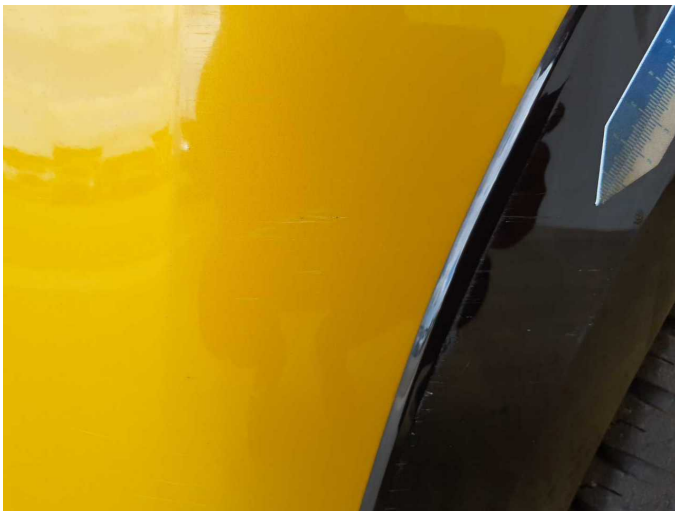
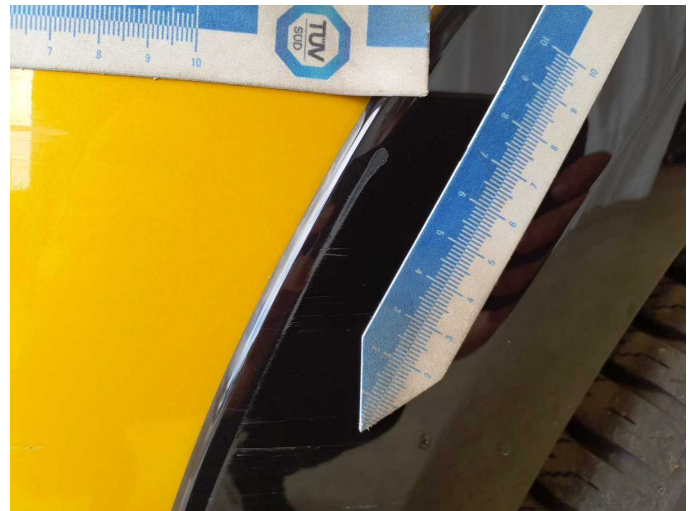
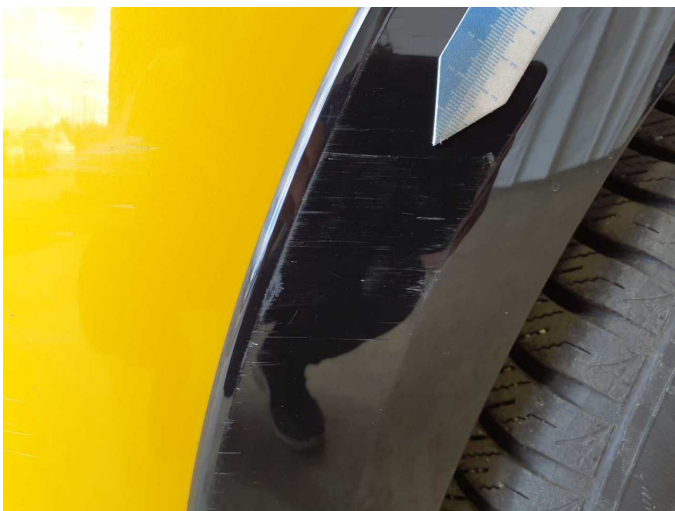
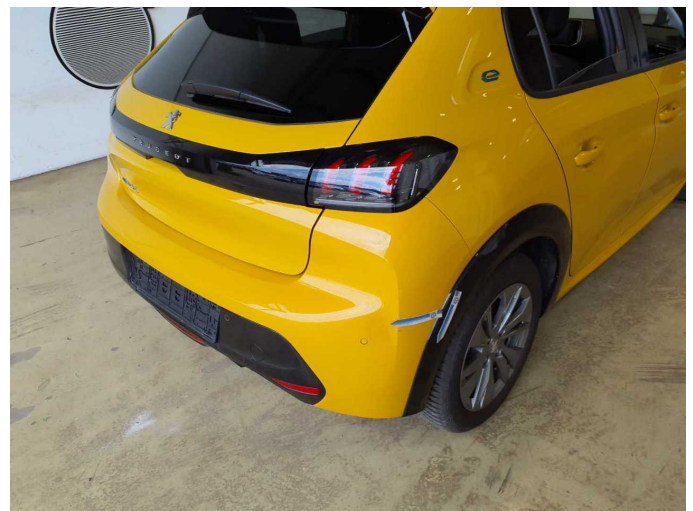
No.	Accident
1	Rear, Side right

Accident 1: Rear, Side right
