Expertise

Protocol number: 46322761  
Order No. / Reference: 26642110  
Inspection date: 30 Jun 2026

Manufacturer: MAN  
VIN: WMA03VUY0P9022593

Model: TGE 3,5T 4x2F (03V)

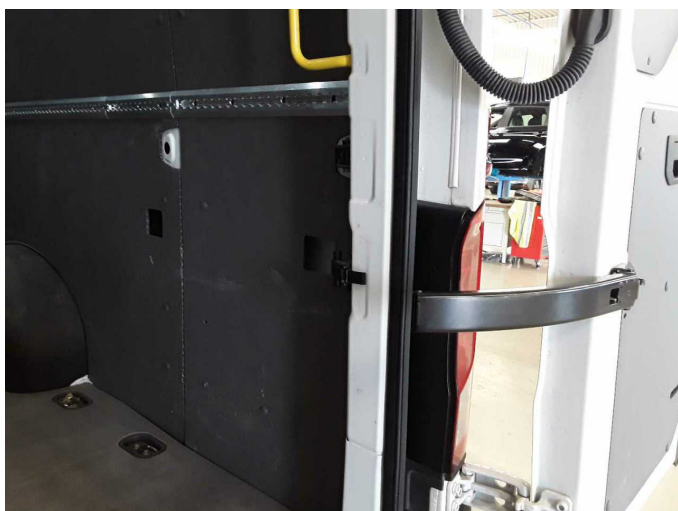
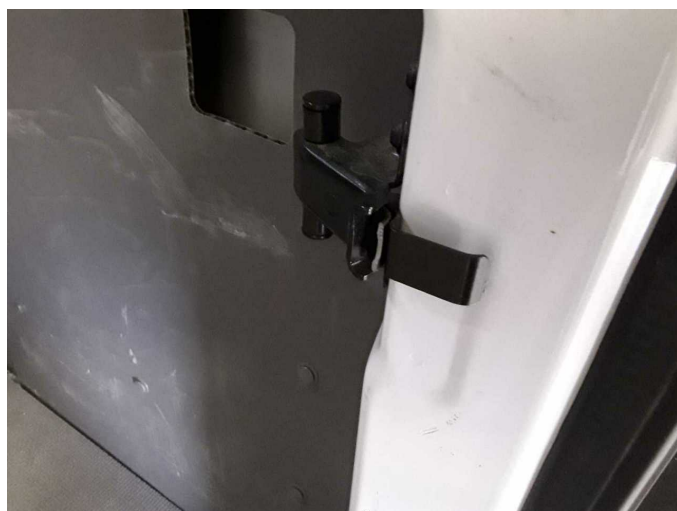
| No. | Component group | Description |
|---|---|---|
| 1 | Boot lid / rear door | Door check strap / arrestor (rechts) - Broken / torn - Replace |

**Damage 1:** Boot lid / rear door: Door check strap / arrestor (rechts) - Broken / torn - Replace

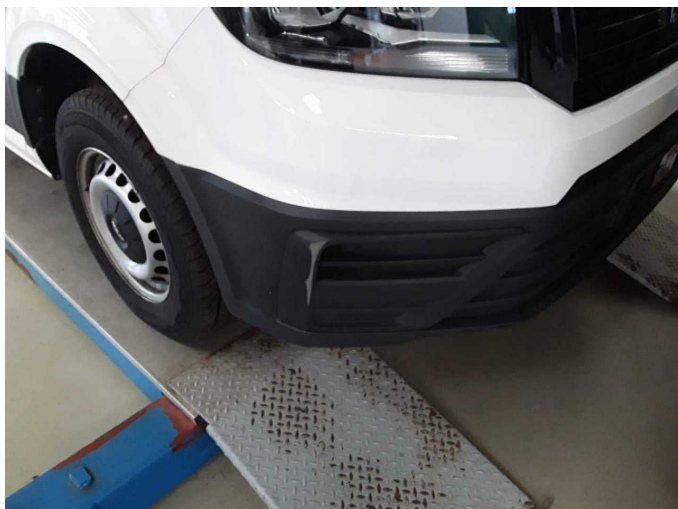
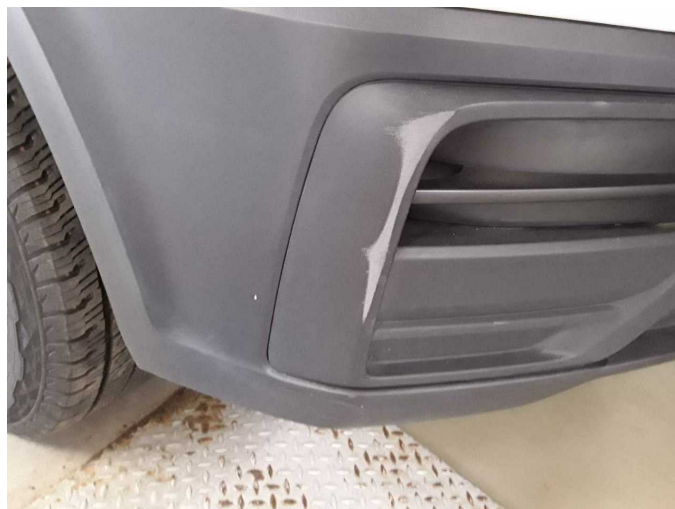
| No. | Component group | Description |
|---|---|---|
| 2 | Front bumper | Front bumper - Scratch(es) - Replace |

**Damage 2:** Front bumper: Front bumper - Scratch(es) - Replace

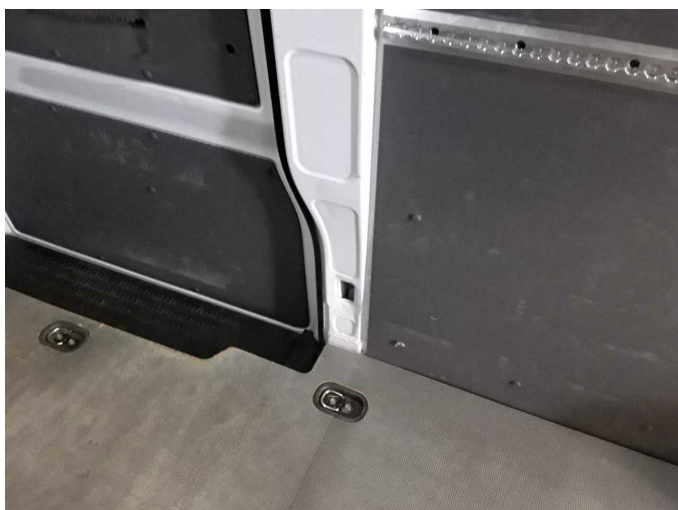
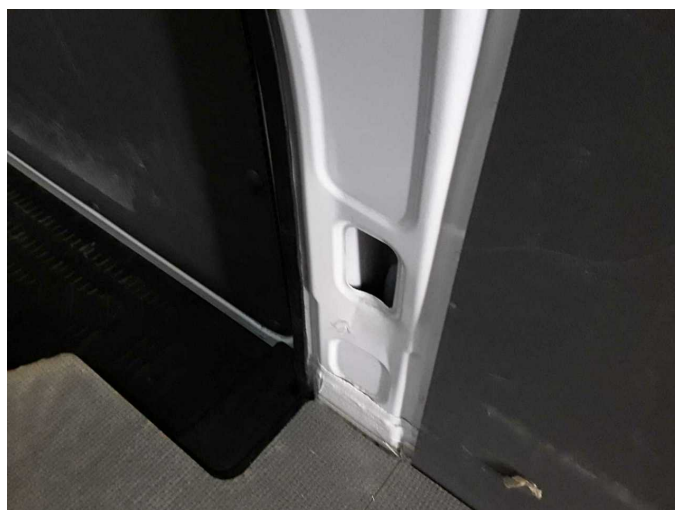
| No. | Component group | Description |
|---|---|---|
| 3 | Body | C-pillar - right side (innen) - Deformed - Repair and paint |

**Damage 3:** Body: C-pillar - right side (innen) - Deformed - Repair and paint

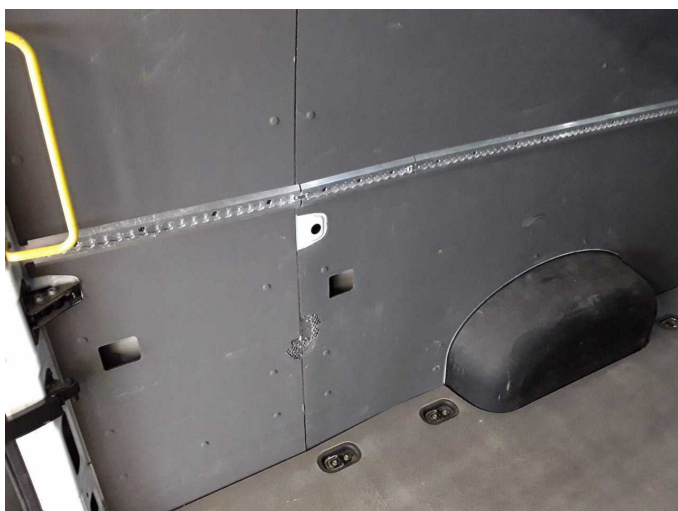
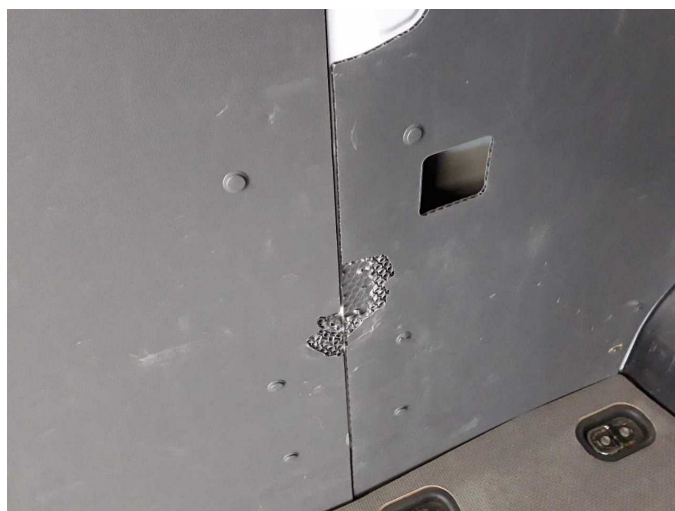
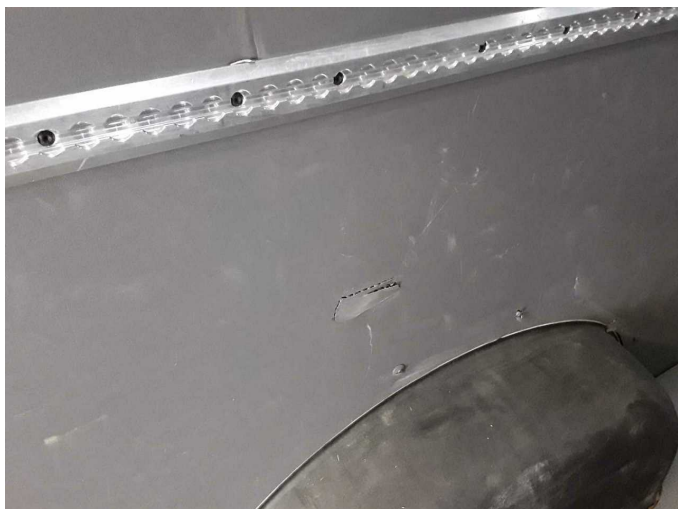
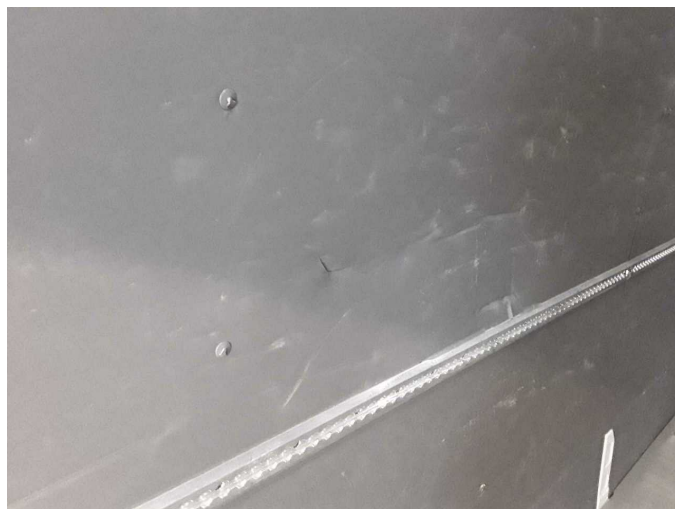
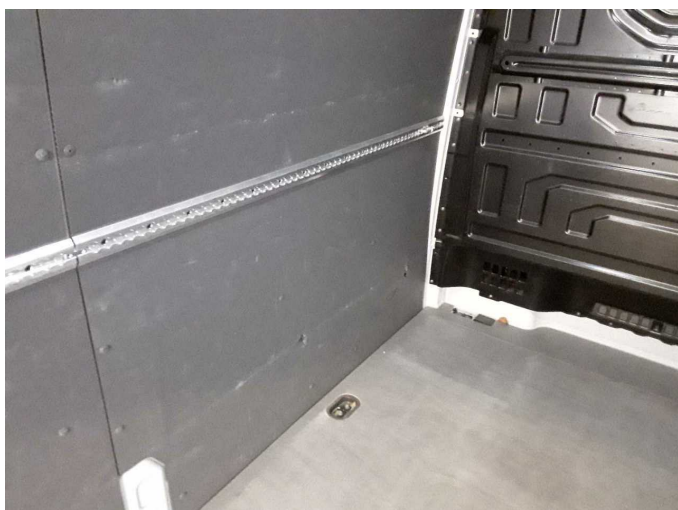
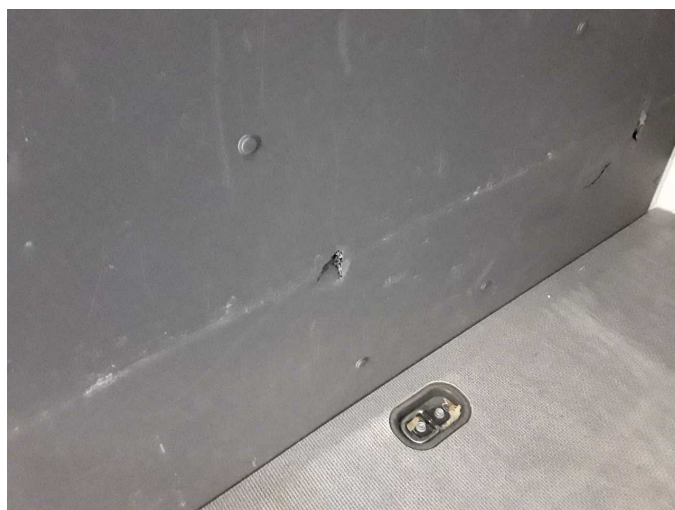
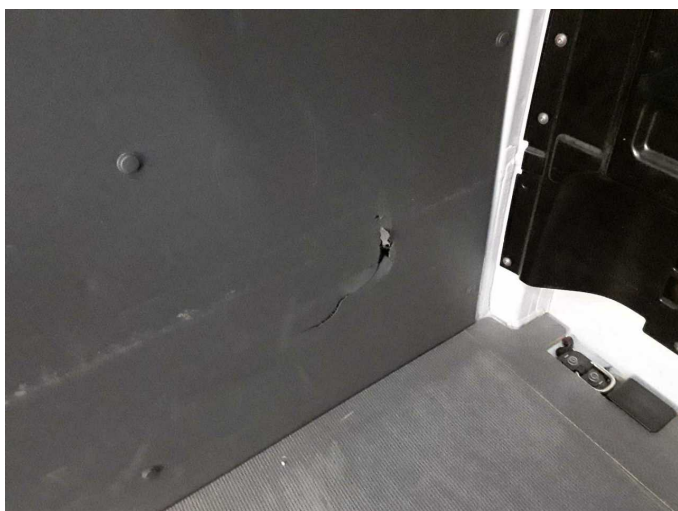
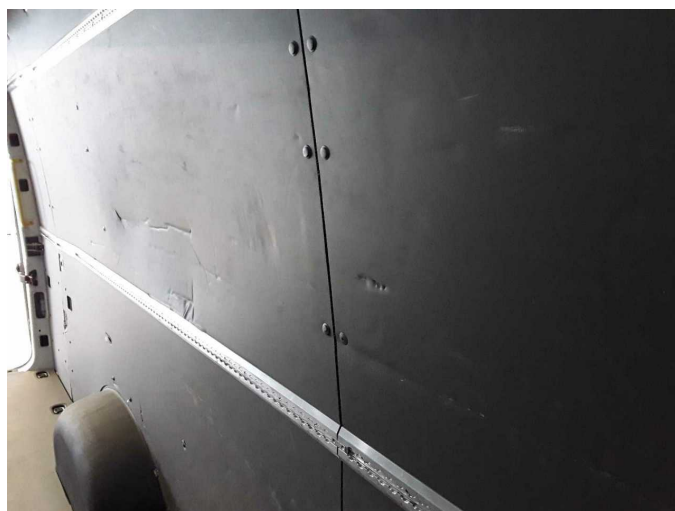
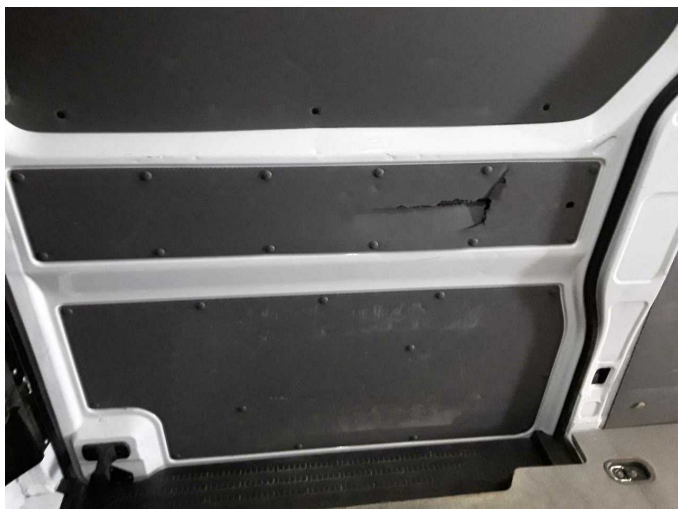
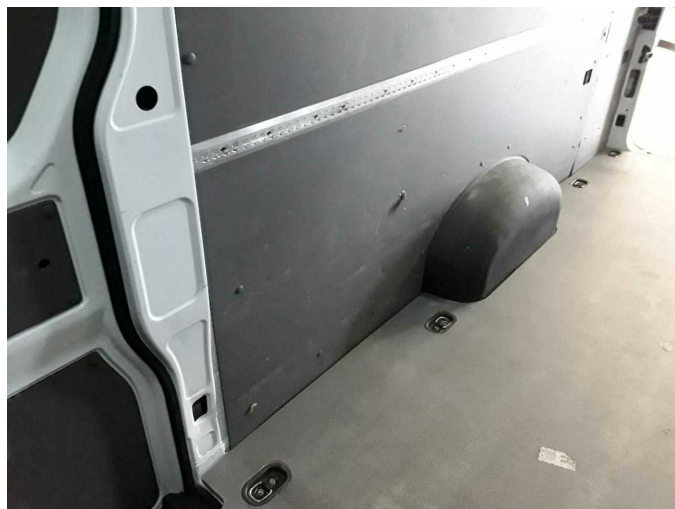
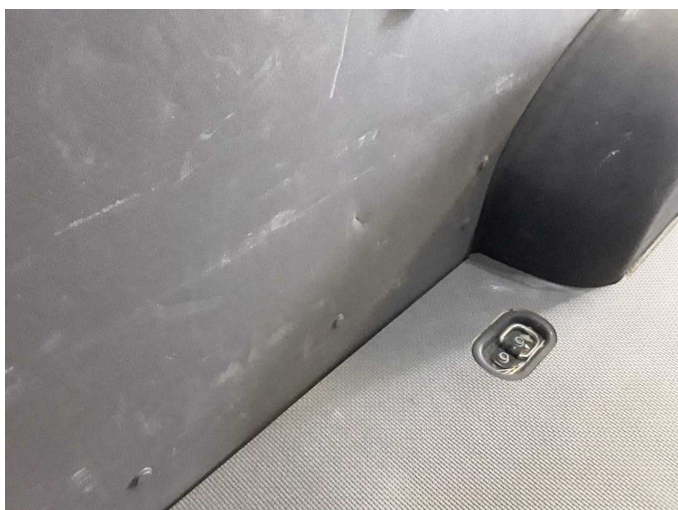
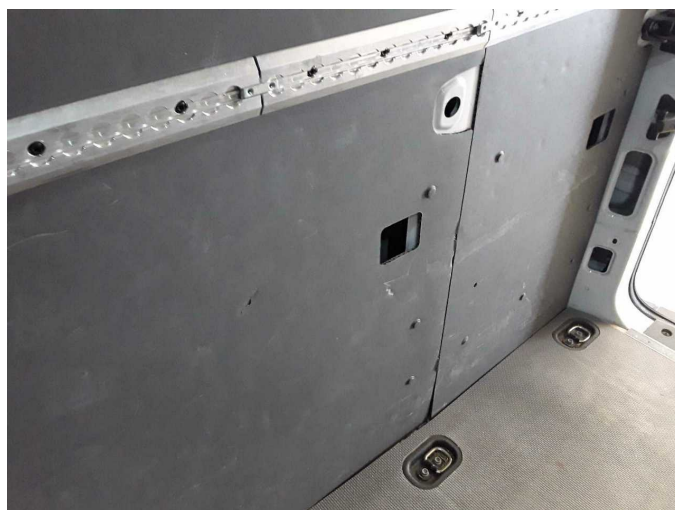
| No. | Component group | Description |
|---|---|---|
| 4 | Interior | Interior (Laderaumverkleidungen) - Broken / torn - Replace |

**Damage 4:** Interior: Interior (Laderaumverkleidungen) - Broken / torn - Replace

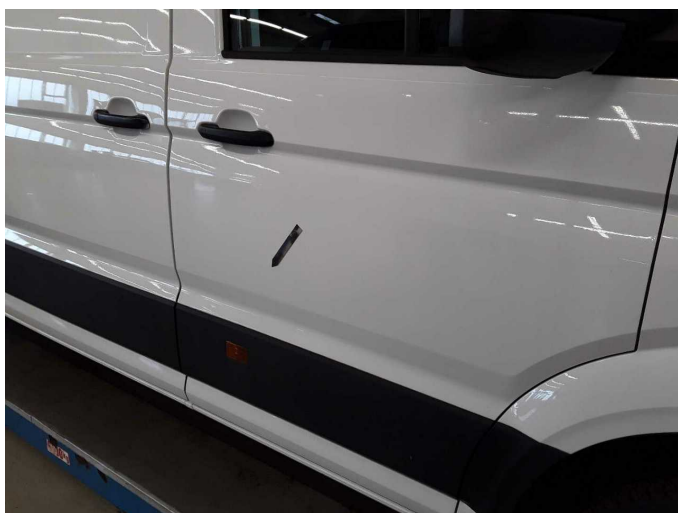
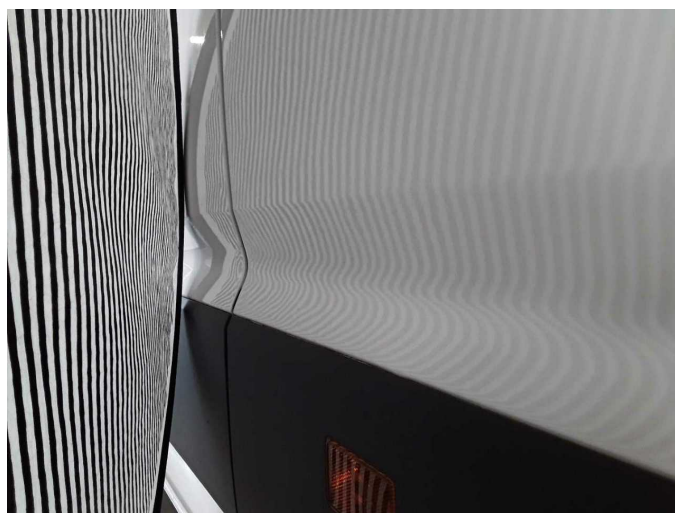
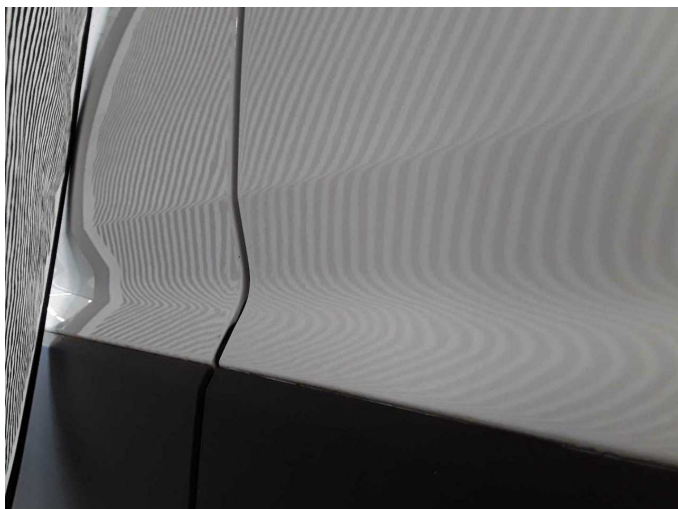
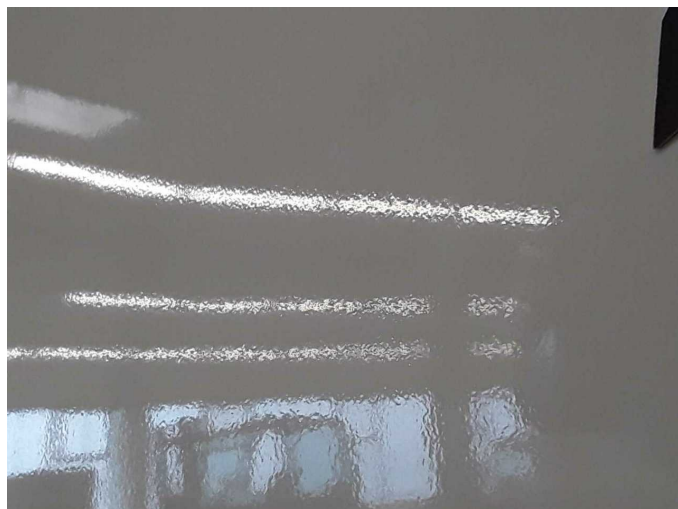
| No. | Component group | Description |
|---|---|---|
| 5 | Door - front right side | Door (wellig) - Unprofessionally repaired - Repair and paint |

**Damage 5:** Door - front right side: Door (wellig) - Unprofessionally repaired - Repair and paint

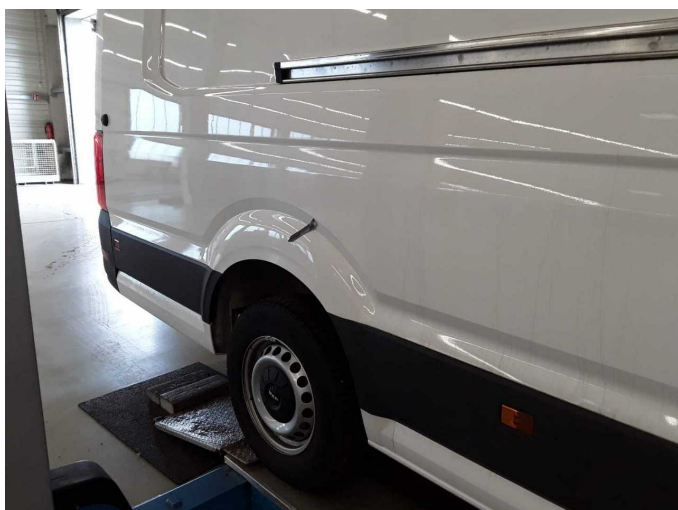
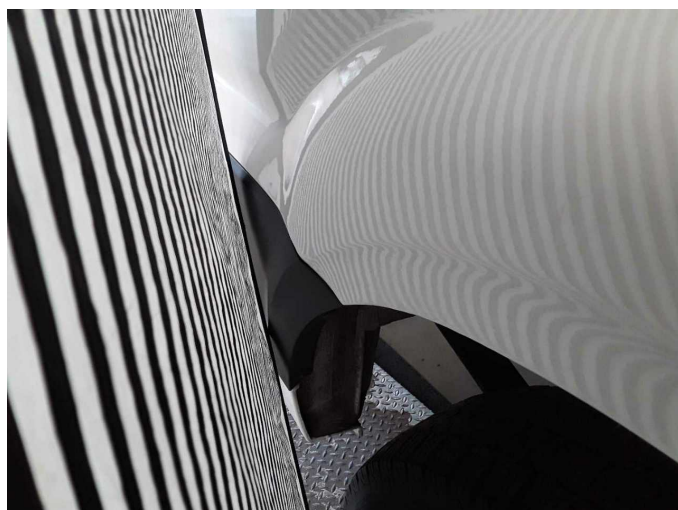
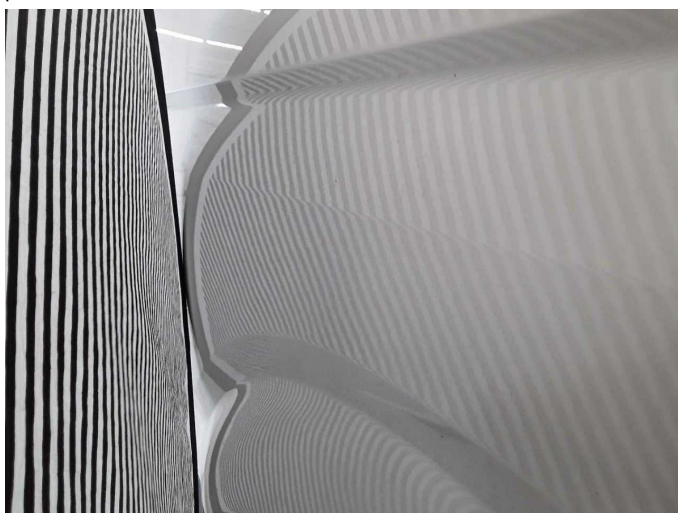
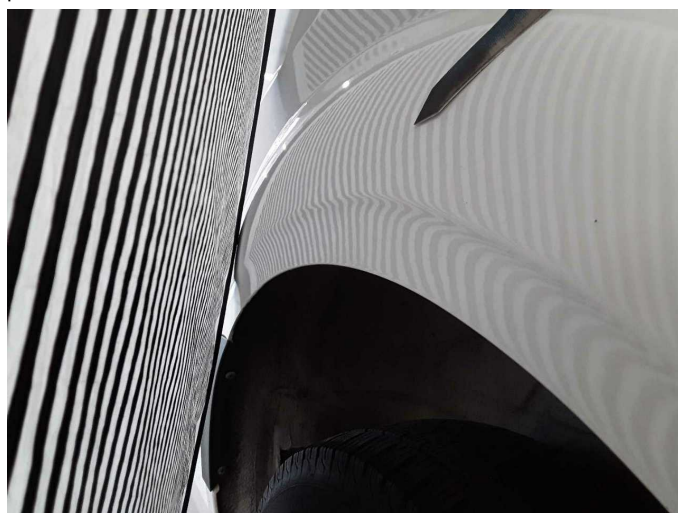
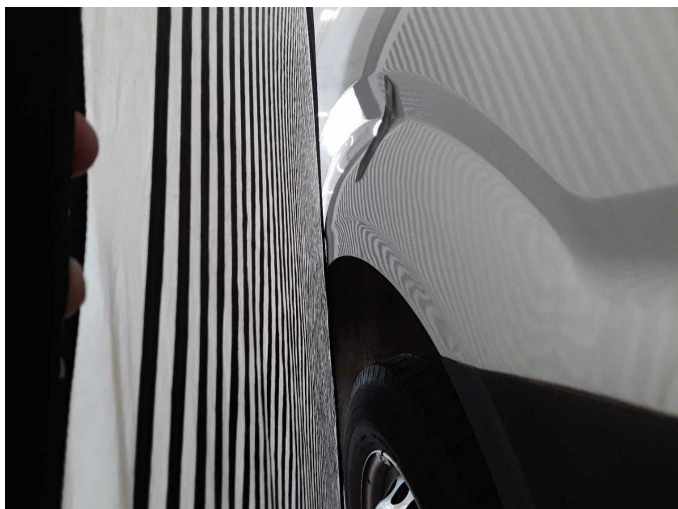
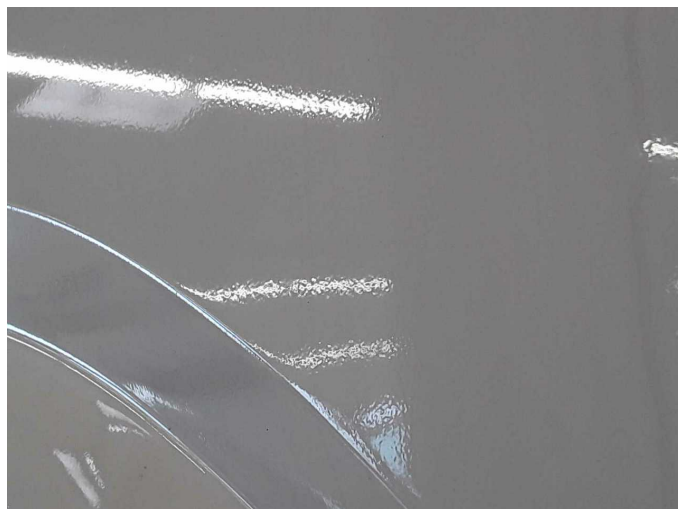
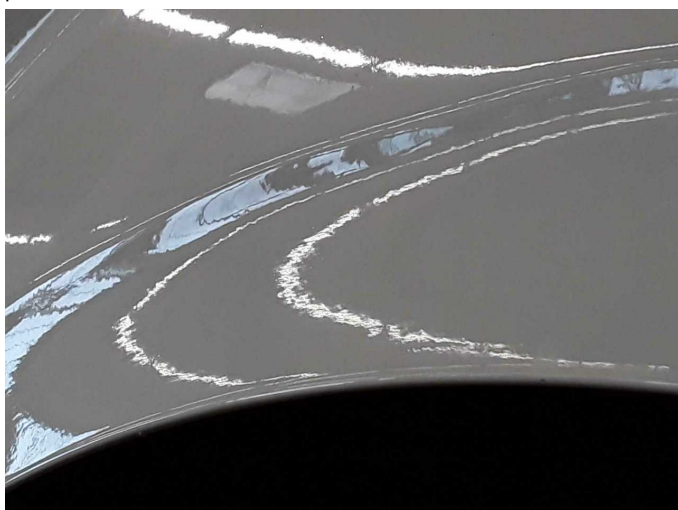
| No. | Component group | Description |
|---|---|---|
| 6 | Side panel - rear right side | Side panel (Orangenhaut / wolkig / wellig / Schleifspuren) - Unprofessionally repaired - Repair and paint |

**Damage 6:** Side panel - rear right side: Side panel (Orangenhaut / wolkig / wellig / Schleifspuren) - Unprofessionally repaired - Repair and paint

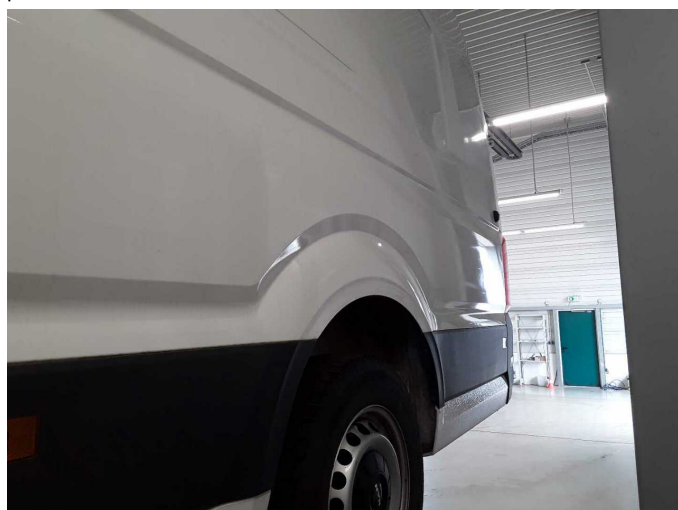
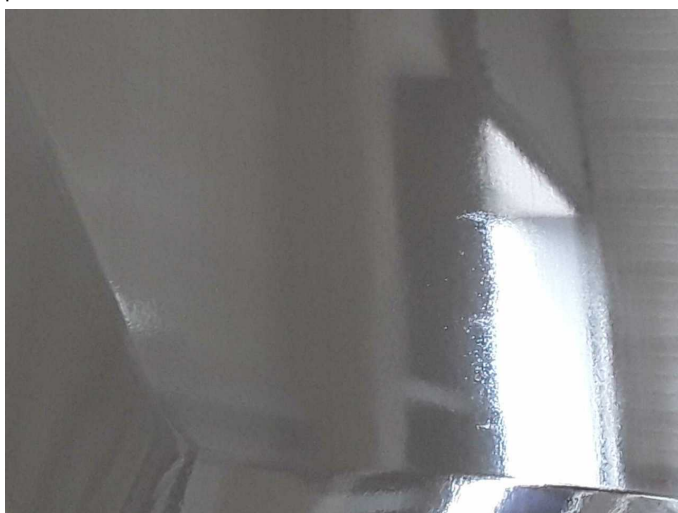
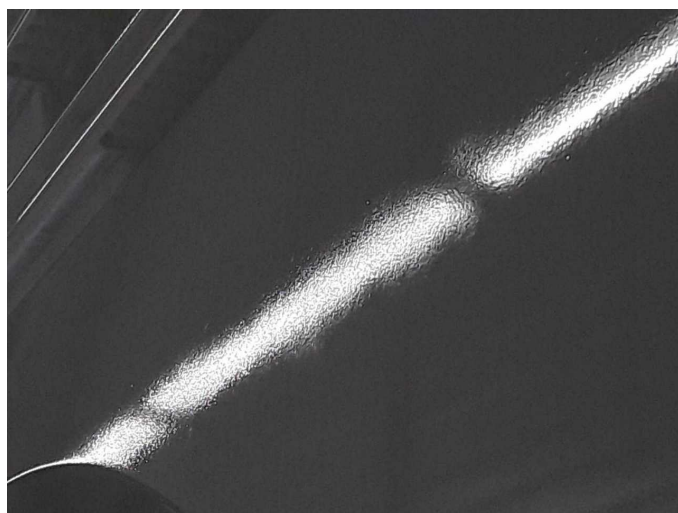
| No. | Component group | Description |
|---|---|---|
| 7 | Side panel - rear left side | Side panel (Orangenhaut) - Unprofessionally repaired - Repair and paint |

**Damage 7:** Side panel - rear left side: Side panel (Orangenhaut) - Unprofessionally repaired - Repair and paint

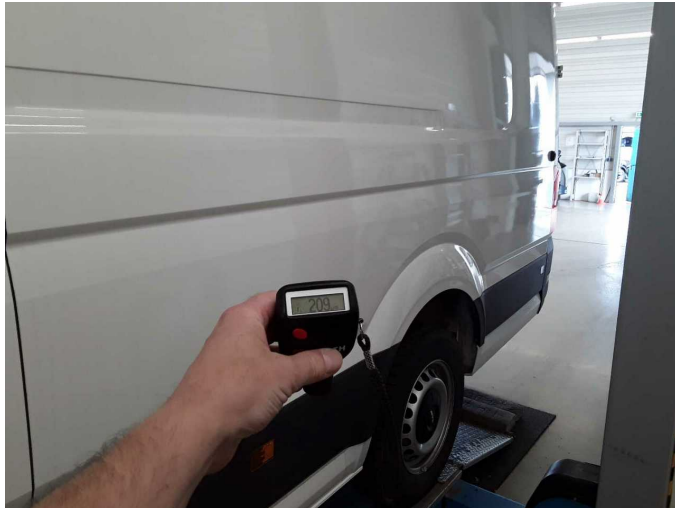
**Side panel - rear left side:** 209  $\mu\text{m}$

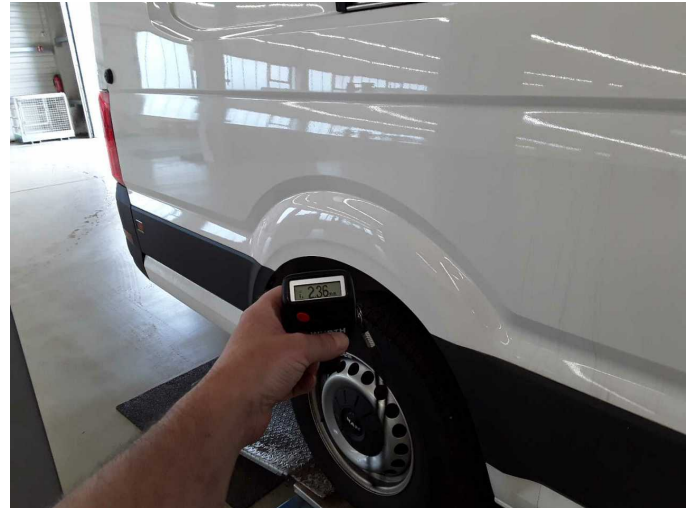
**Side panel - rear right side:** 2,360  $\mu\text{m}$

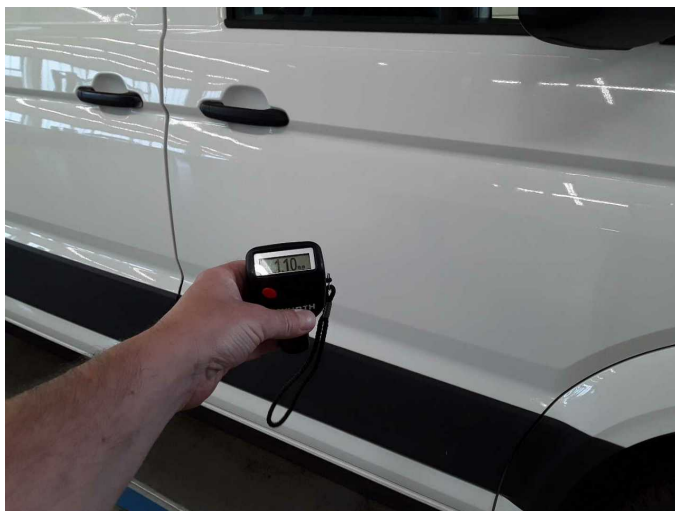
**Door - front right side:** 1,100  $\mu\text{m}$
