Expertise

Protocol number: 45986314  
Order No. / Reference: 26307612  
Inspection date: 17 Jun 2026

Manufacturer: Opel

Model: Astra Sports Tourer 1.2 Turbo Automatik GS

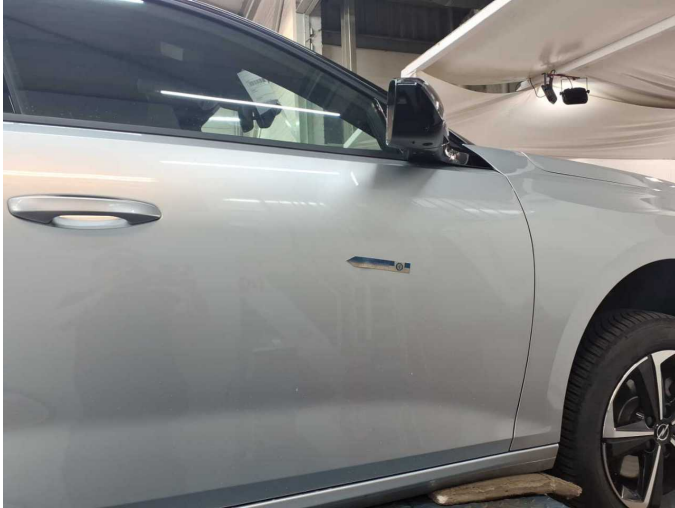
| No. | Component group | Description |
|---|---|---|
| 1 | Door - front left side | Door (Polieren) - Scratch(es) - Smart repair |

**Damage 1:** Door - front left side: Door (Polieren) - Scratch(es) - Smart repair

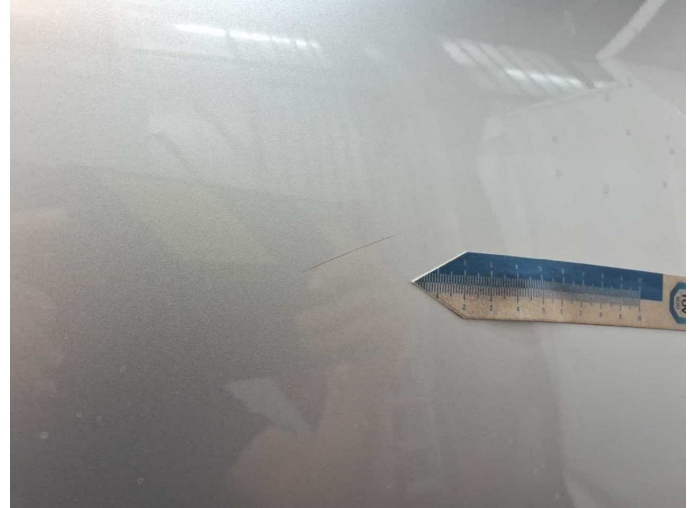
**Damage 1:** Door - front left side: Door (Polieren) - Scratch(es) - Smart repair

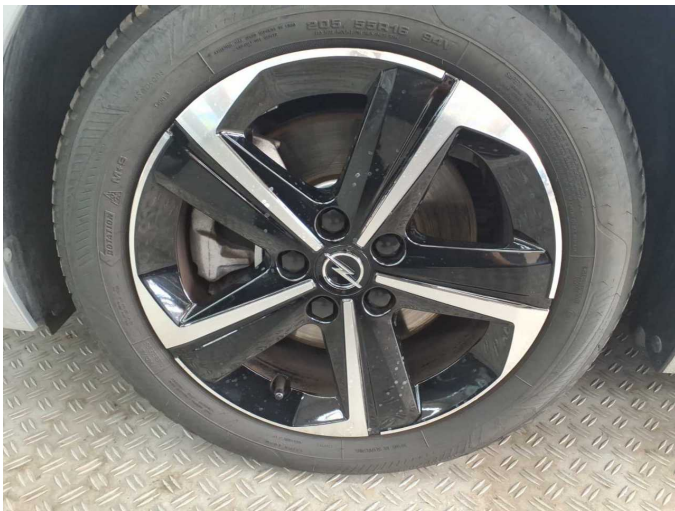
| No. | Component group | Description |
|---|---|---|
| 2 | Wheel / tyres | Alloy rim - front left side - Scratch(es) - Loss in value |

**Damage 2:** Wheel / tyres: Alloy rim - front left side - Scratch(es) - Loss in value

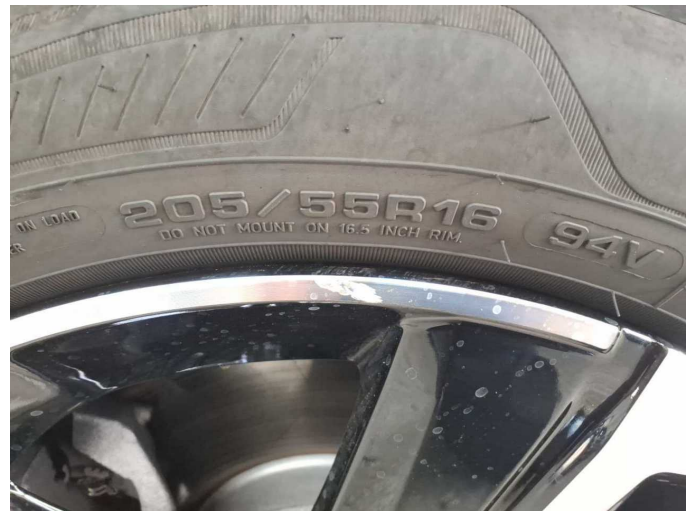
**Damage 2:** Wheel / tyres: Alloy rim - front left side - Scratch(es) - Loss in value

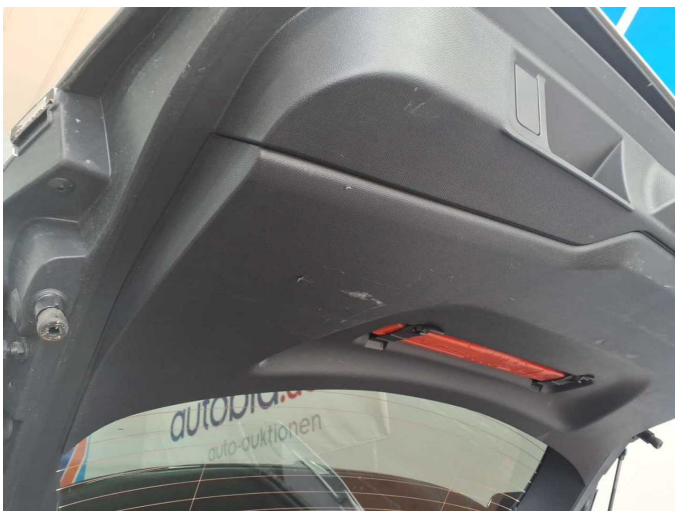
| No. | Component group | Description |
|---|---|---|
| 3 | Trim / covers | Boot lid - interior trim - Scratch(es) - Loss in value |

**Damage 3:** Trim / covers: Boot lid - interior trim - Scratch(es) - Loss in value

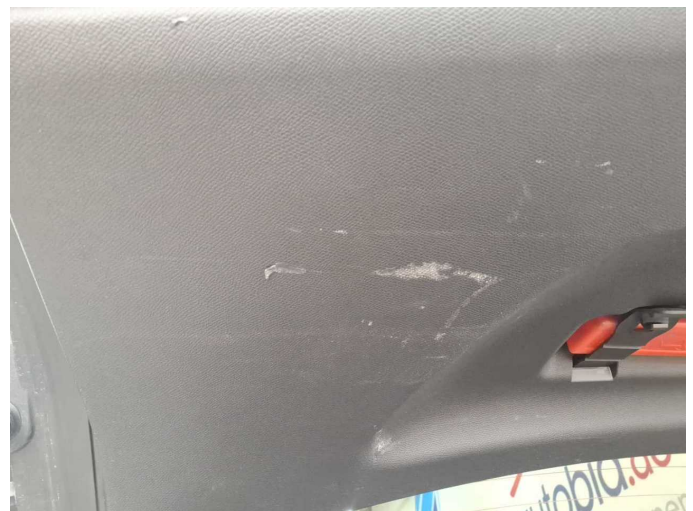
**Damage 3:** Trim / covers: Boot lid - interior trim - Scratch(es) - Loss in value

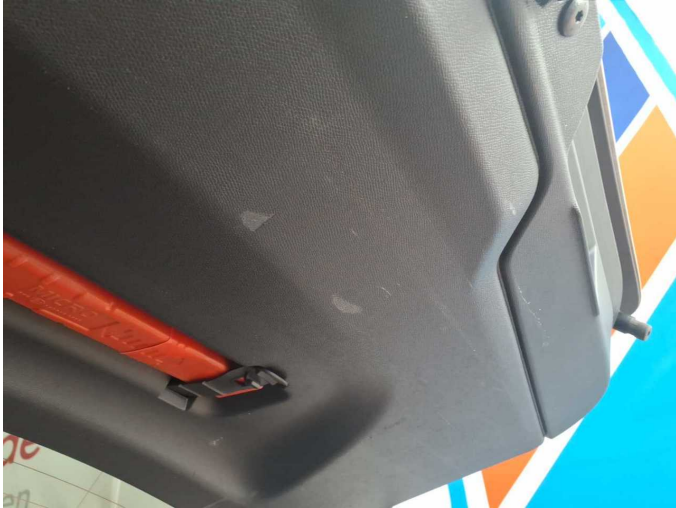
**Damage 3:** Trim / covers: Boot lid - interior trim - Scratch(es) - Loss in value

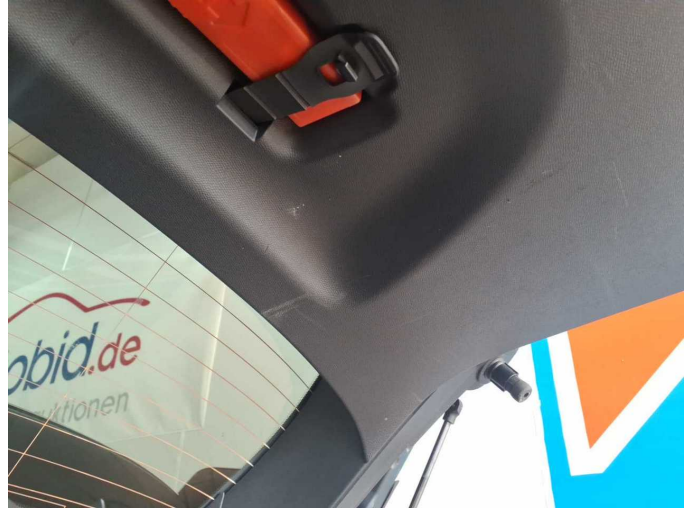
**Damage 3:** Trim / covers: Boot lid - interior trim - Scratch(es) - Loss in value

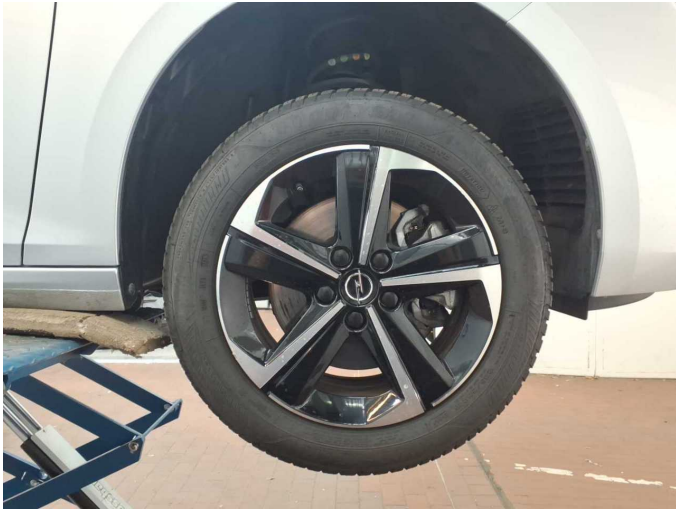
| No. | Component group | Description |
|---|---|---|
| 4 | Wheel / tyres | Alloy rim - front right side - Scratch(es) - Loss in value |

**Damage 4:** Wheel / tyres: Alloy rim - front right side - Scratch(es) - Loss in value

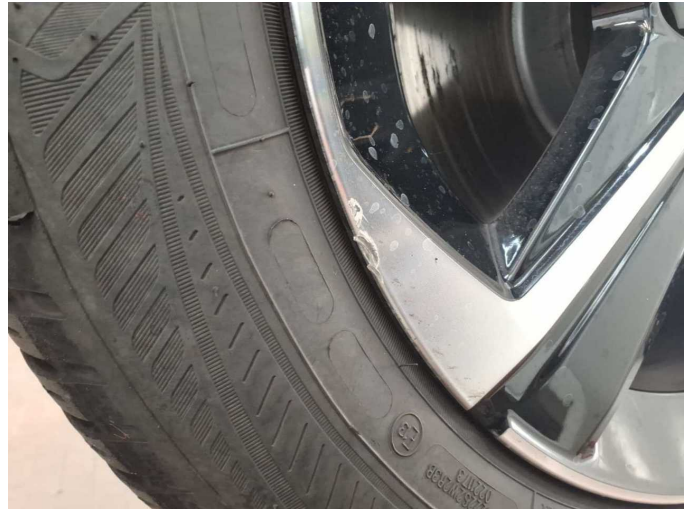
**Damage 4:** Wheel / tyres: Alloy rim - front right side - Scratch(es) - Loss in value

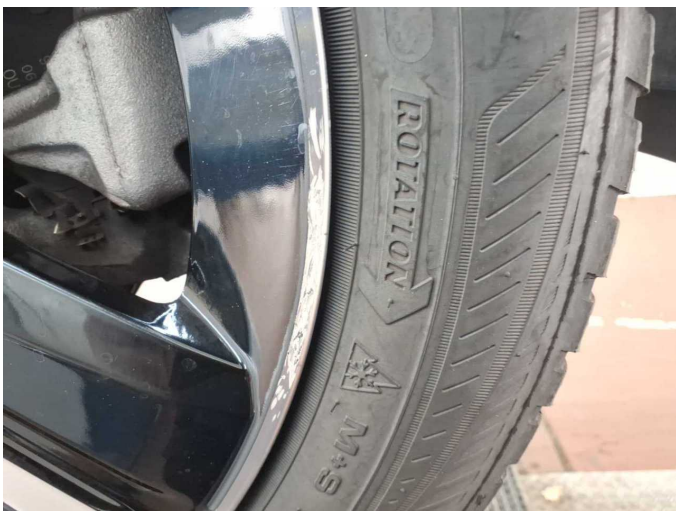
**Damage 4:** Wheel / tyres: Alloy rim - front right side - Scratch(es) - Loss in value
