Expertise

Protocol number: 46374799
Order No. / Reference: 26472594
Inspection date: 6 Jul 2026

Model: Boxer HDi 335 L2H2 S&S Pro

VIN: VF3YCBNFB12N60167

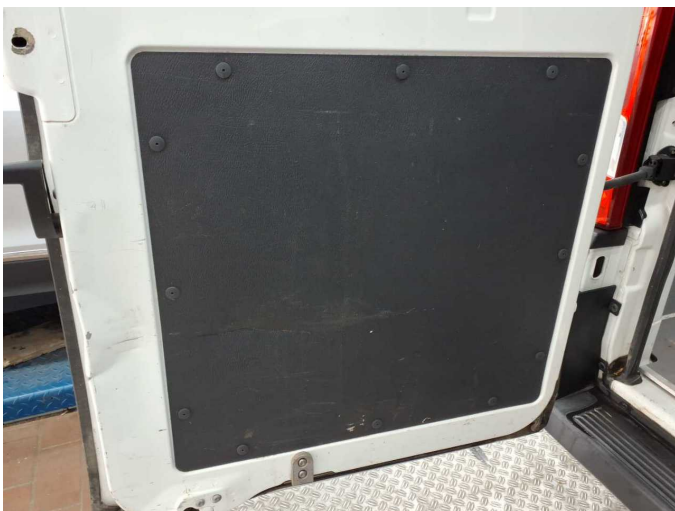
Damage 1: Boot lid / rear door: Rear door - left side (Verkleidung unten) - Broken / torn - Replace

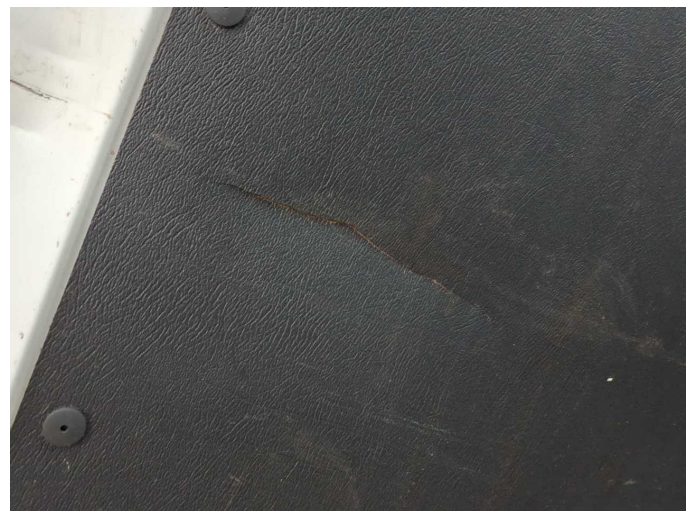
Damage 1: Boot lid / rear door: Rear door - left side (Verkleidung unten) - Broken / torn - Replace

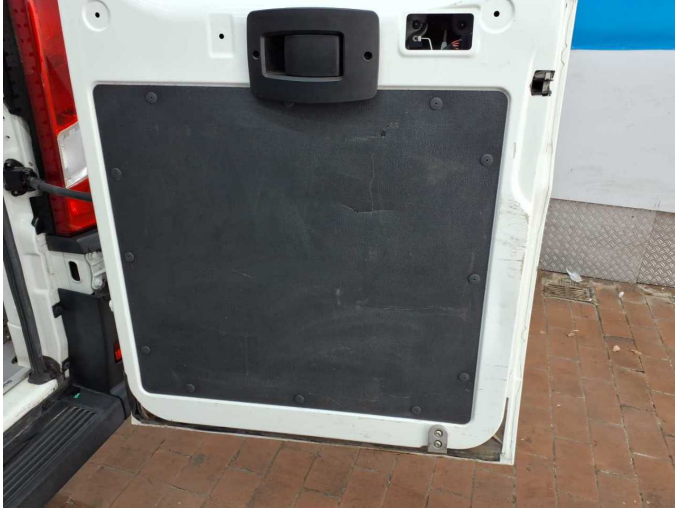
Damage 2: Boot lid / rear door: Rear door - right side (Verkleidung unten)
- Broken / torn - Replace

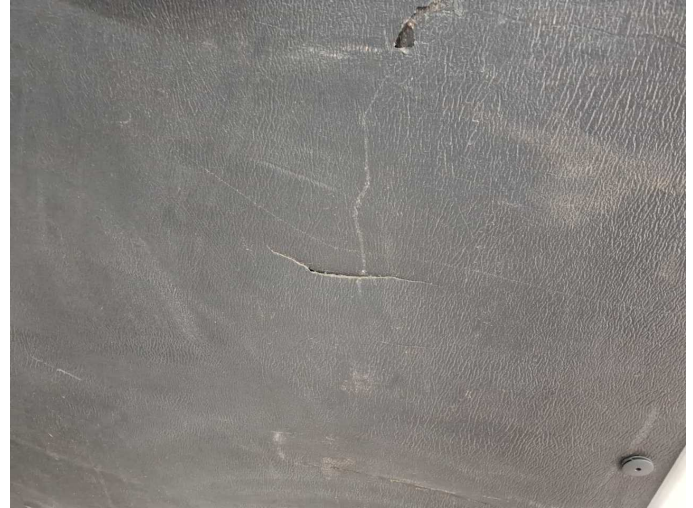
Damage 2: Boot lid / rear door: Rear door - right side (Verkleidung unten)
- Broken / torn - Replace

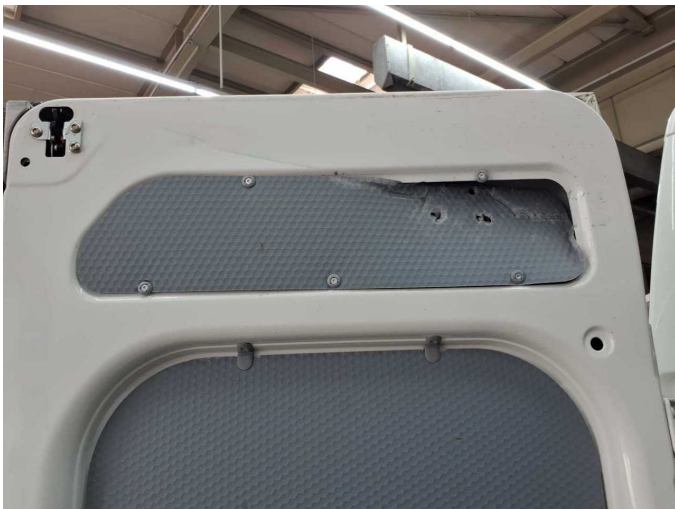
Damage 3: Boot lid / rear door: Rear door - left side (Verkleidung oben)
- Broken / torn - Replace

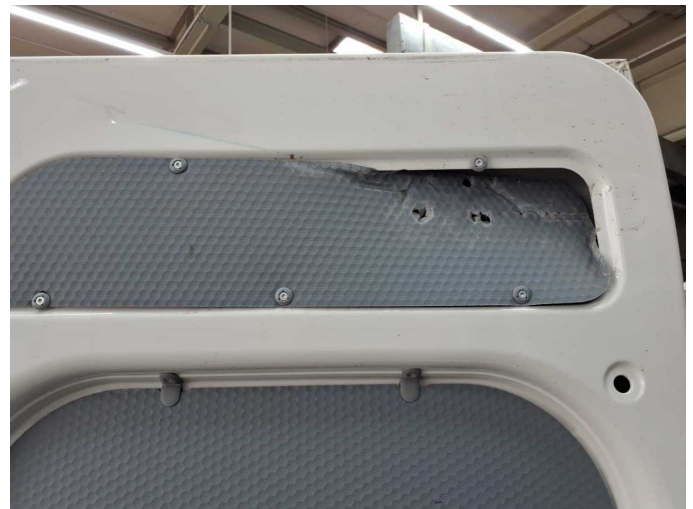
Damage 3: Boot lid / rear door: Rear door - left side (Verkleidung oben)
- Broken / torn - Replace

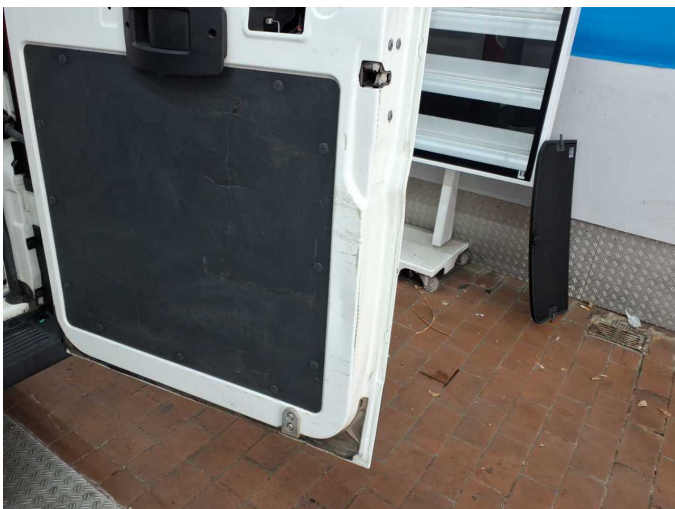
Damage 4: Boot lid / rear door: Rear door - right side - Scratch(es) -
Paint

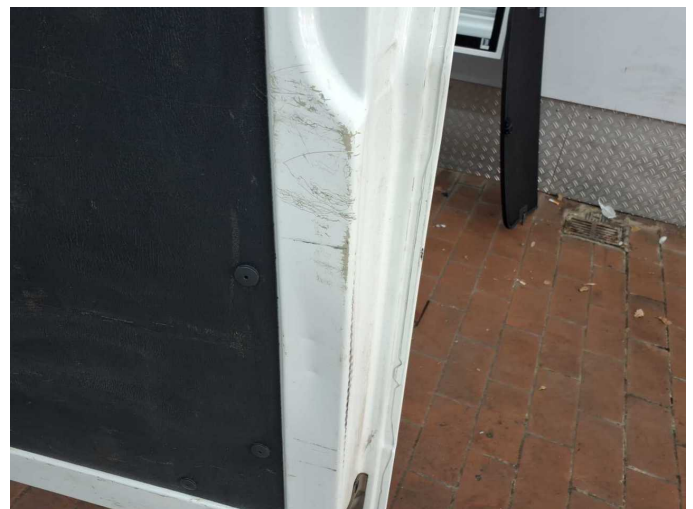
Damage 4: Boot lid / rear door: Rear door - right side - Scratch(es) -
Paint

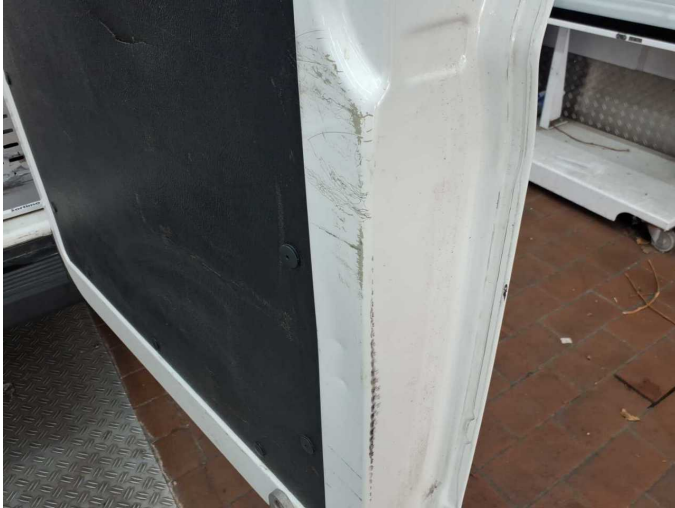
Damage 4: Boot lid / rear door: Rear door - right side - Scratch(es) - Paint

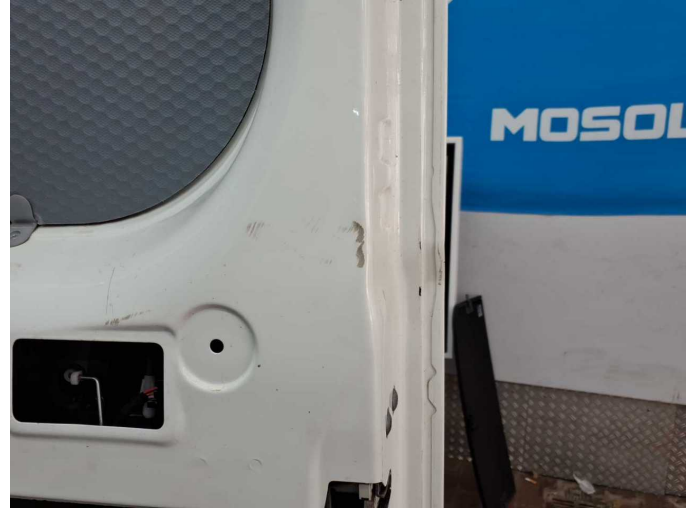
Damage 4: Boot lid / rear door: Rear door - right side - Scratch(es) - Paint

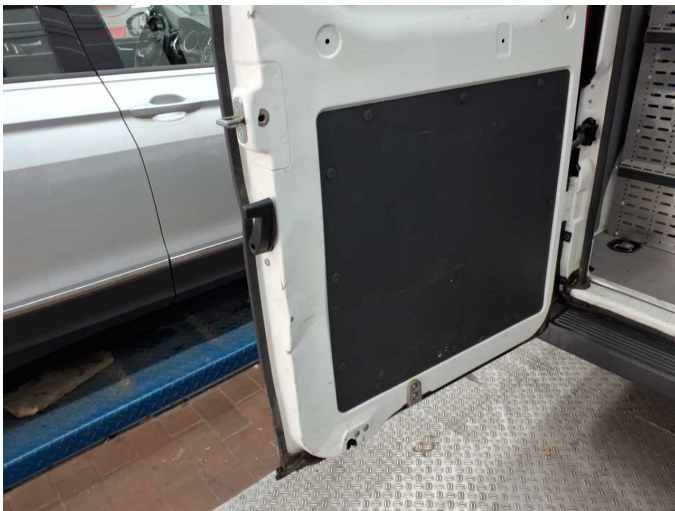
Damage 5: Boot lid / rear door: Rear door - left side - Dent / paintcoat damage - Replace

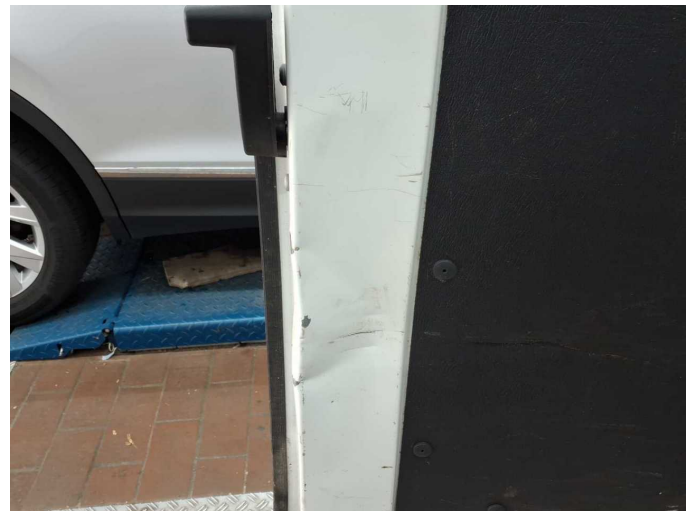
Damage 5: Boot lid / rear door: Rear door - left side - Dent / paintcoat damage - Replace

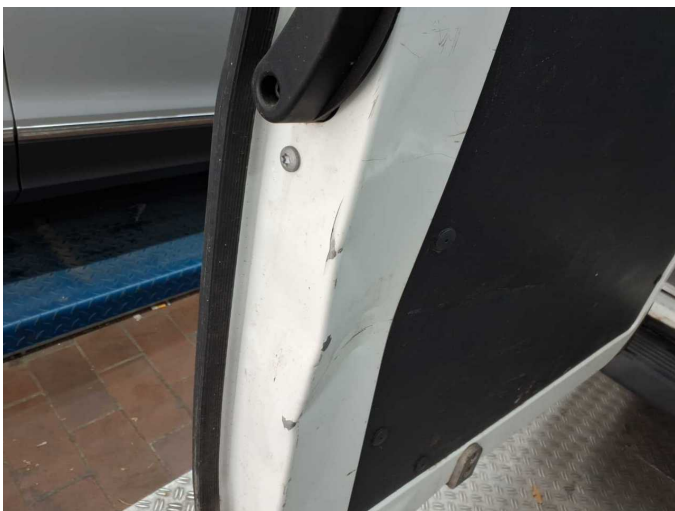
Damage 5: Boot lid / rear door: Rear door - left side - Dent / paintcoat damage - Replace

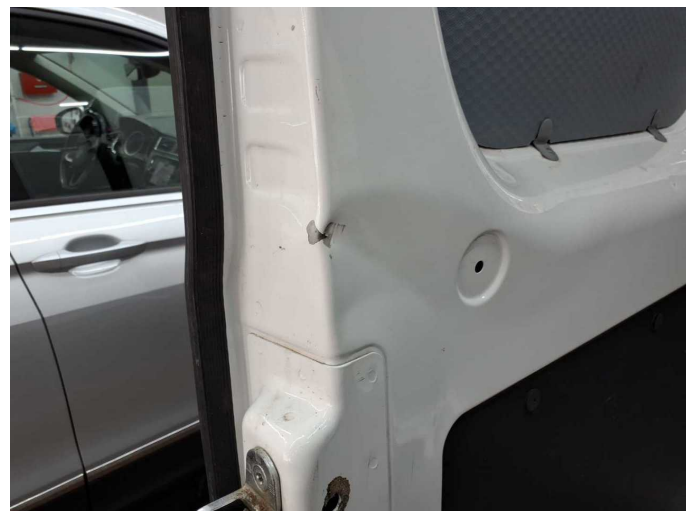
Damage 5: Boot lid / rear door: Rear door - left side - Dent / paintcoat damage - Replace

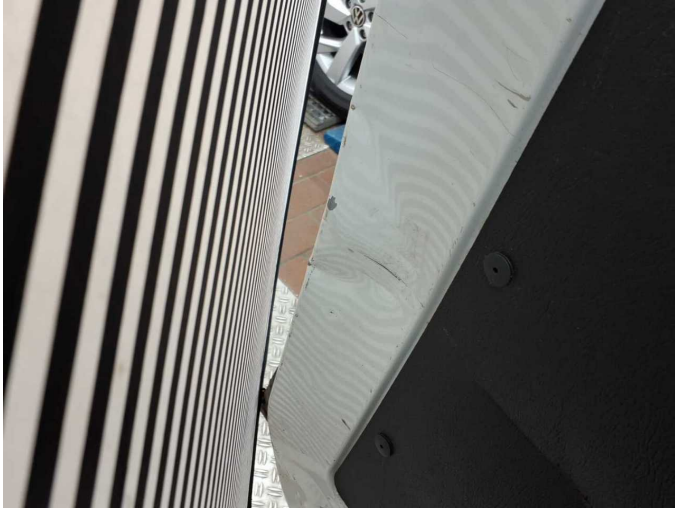
Damage 5: Boot lid / rear door: Rear door - left side - Dent / paintcoat damage - Replace

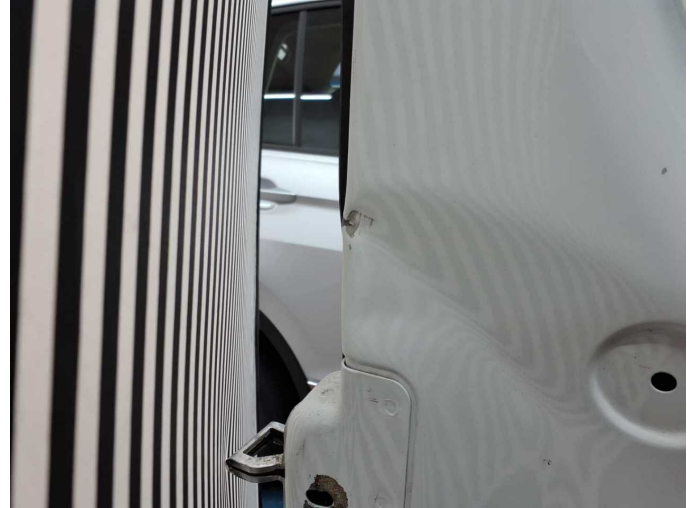
Damage 5: Boot lid / rear door: Rear door - left side - Dent / paintcoat damage - Replace

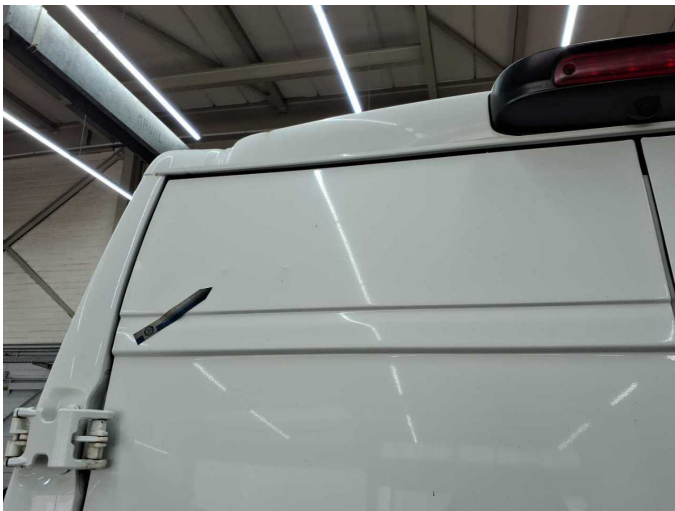
Damage 5: Boot lid / rear door: Rear door - left side - Dent / paintcoat damage - Replace

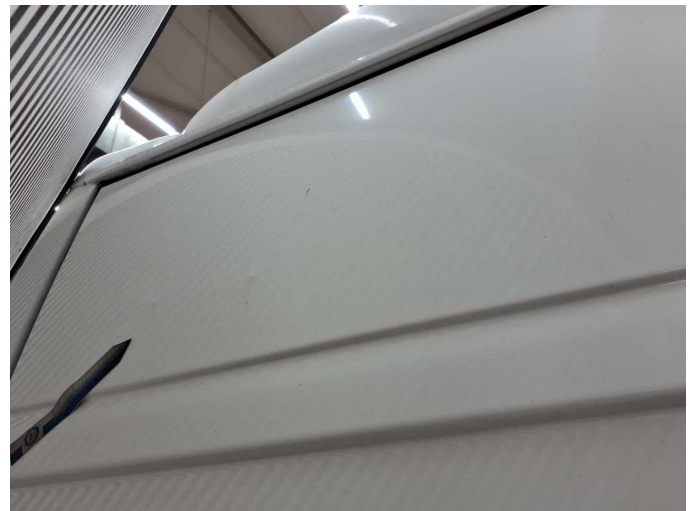
Damage 5: Boot lid / rear door: Rear door - left side - Dent / paintcoat damage - Replace
