Expertise

Protocol number: 46619019  
Order No. / Reference: 26550382  
Inspection date: 17 Jul 2026

Model: Vito 116 CDI Extralang HA Aut. BASE

VIN: W1V44760513892013

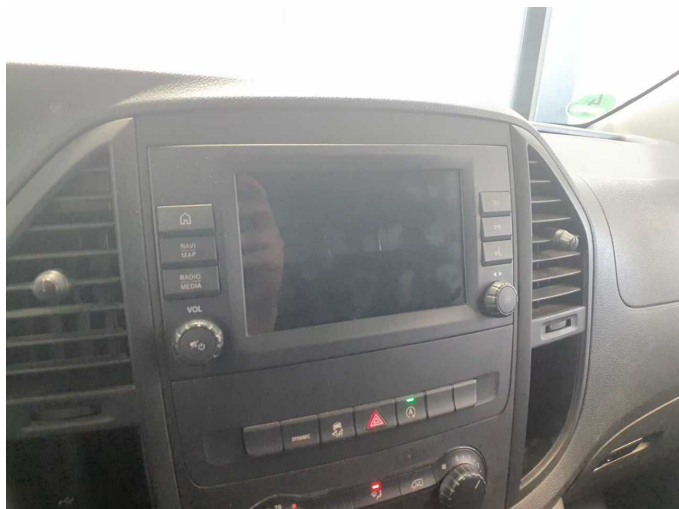
| No. | Component group | Description |
|---|---|---|
| 2 | Multimedia system | Screen - Non-operational - Perform diagnosis |

**Damage 2:** Multimedia system: Screen - Non-operational - Perform diagnosis

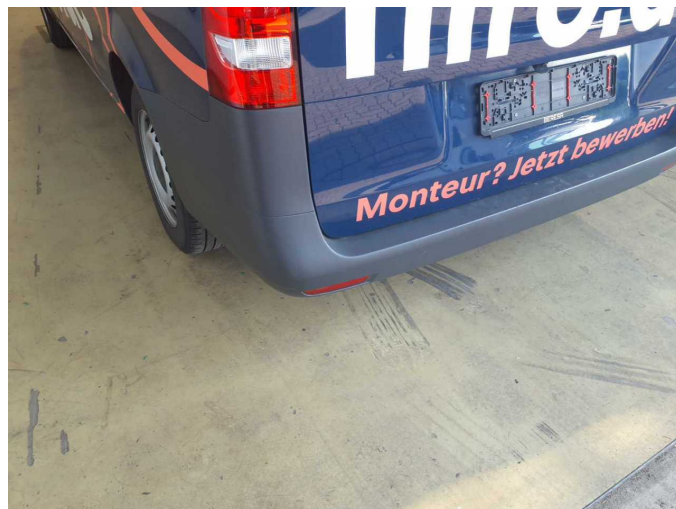
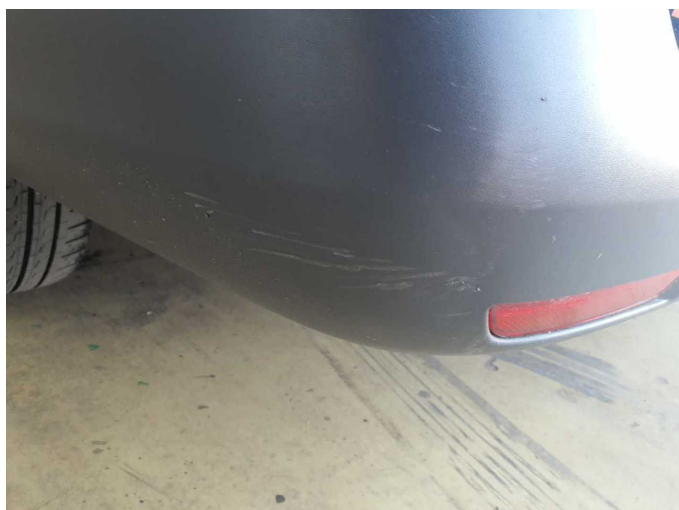
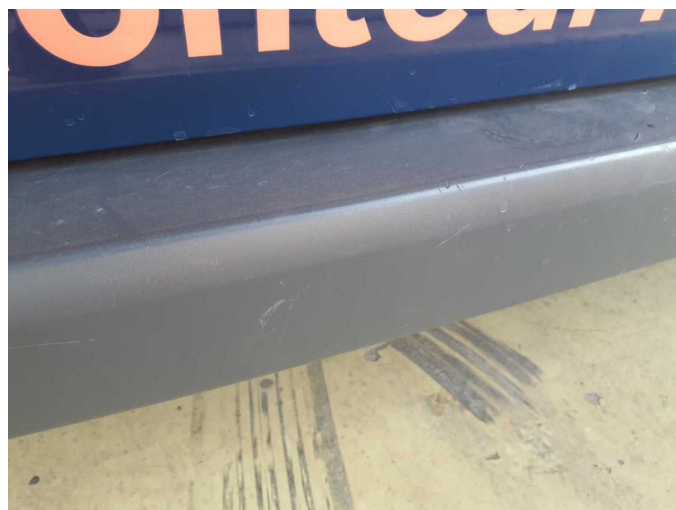
| No. | Component group | Description |
|---|---|---|
| 3 | Rear bumper | Rear bumper - Scratch(es) - Loss in value |

**Damage 3:** Rear bumper: Rear bumper - Scratch(es) - Loss in value

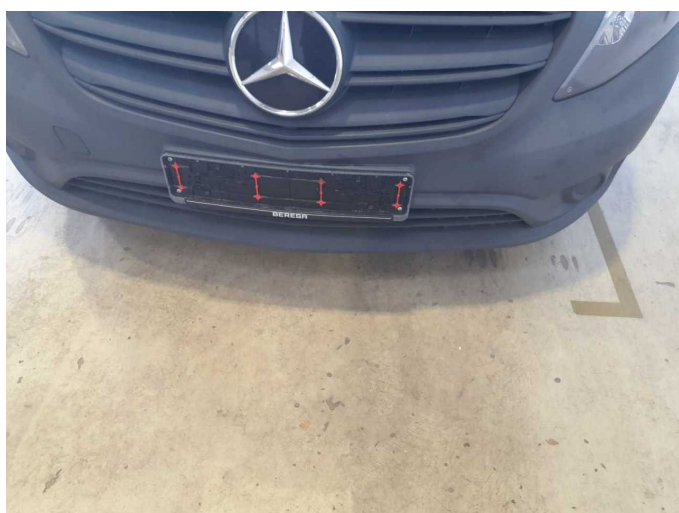
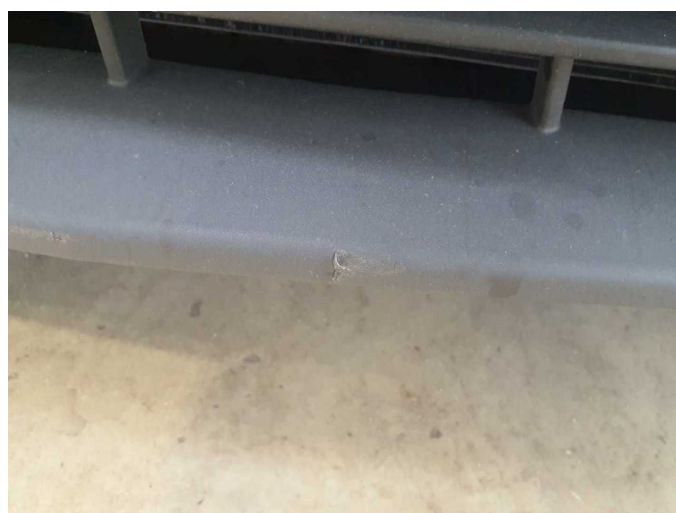
| No. | Component group | Description |
|---|---|---|
| 4 | Front bumper | Front bumper - Scratch(es) - Loss in value |

**Damage 4:** Front bumper: Front bumper - Scratch(es) - Loss in value

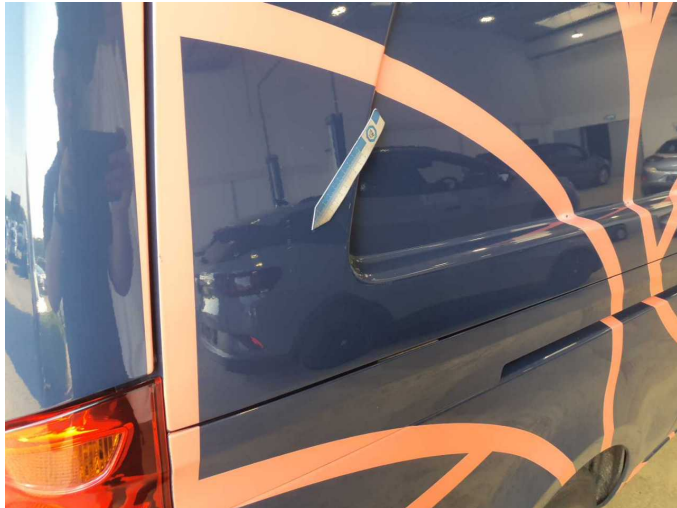
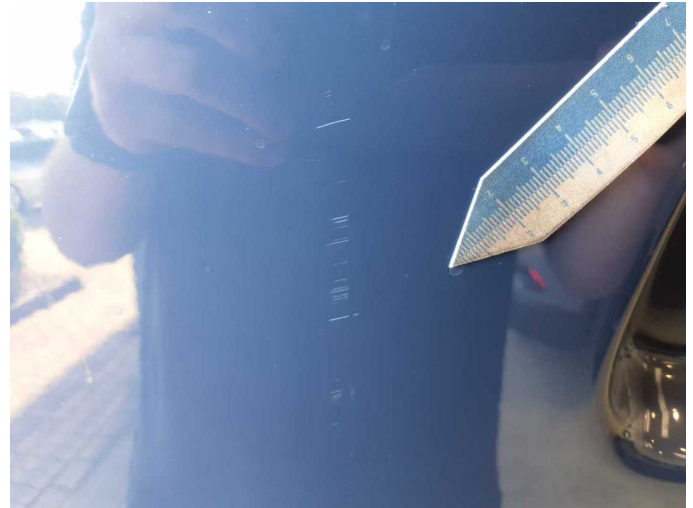
| No. | Component group | Description |
|---|---|---|
| 5 | Side panel - rear right side | Side panel - Scratch(es) - Smart repair |

**Damage 5:** Side panel - rear right side: Side panel - Scratch(es) - Smart repair

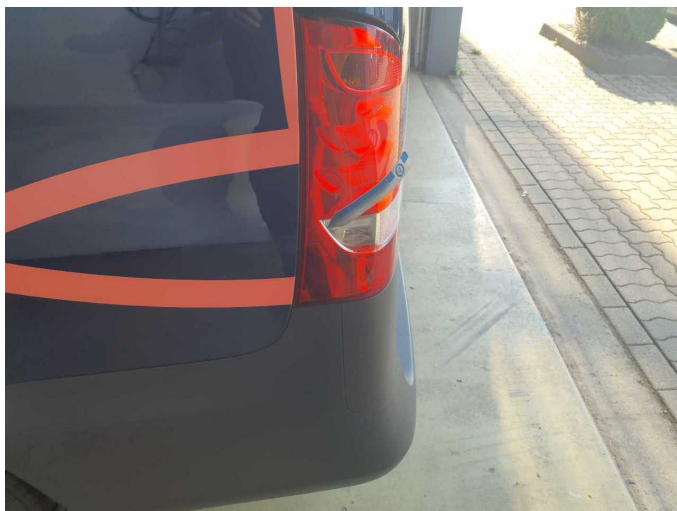
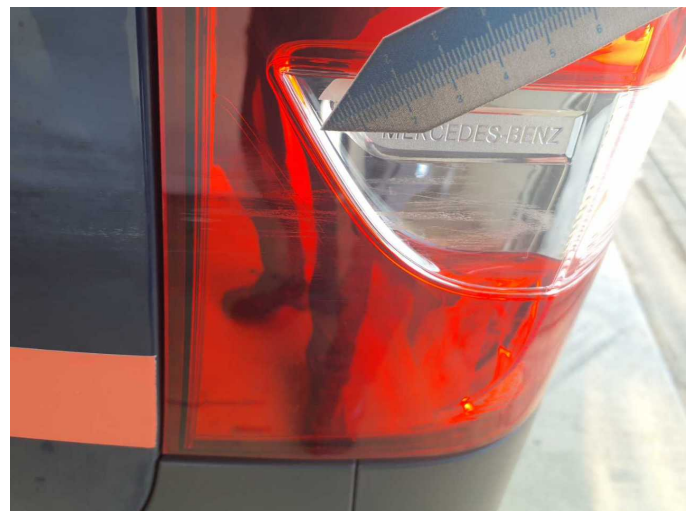
| No. | Component group | Description |
|---|---|---|
| 6 | Tail light | Tail lamp - left side - Scratch(es) - Replace |

**Damage 6:** Tail light: Tail lamp - left side - Scratch(es) - Replace

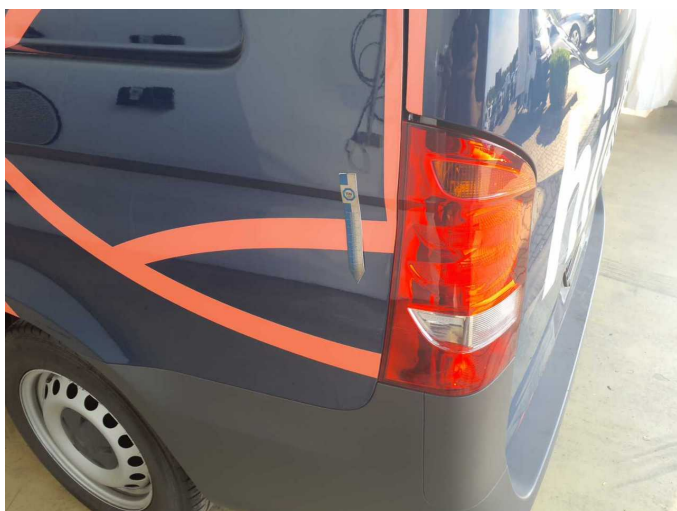
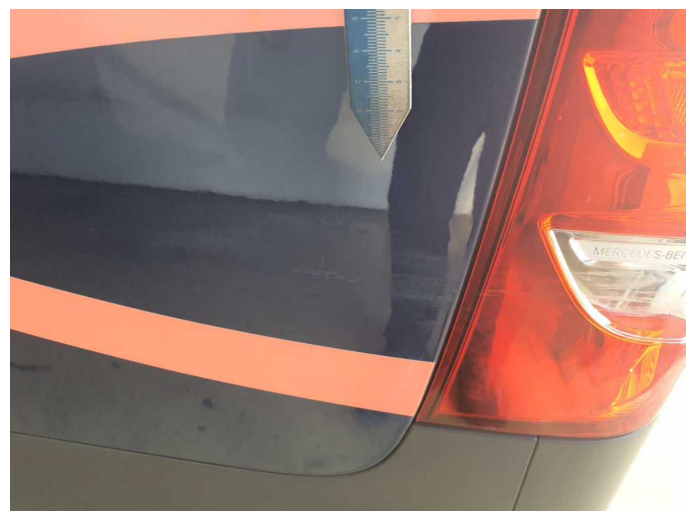
| No. | Component group | Description |
|---|---|---|
| 7 | Side panel - rear left side | Side panel - Scratch(es) - Smart repair |

**Damage 7:** Side panel - rear left side: Side panel - Scratch(es) - Smart repair

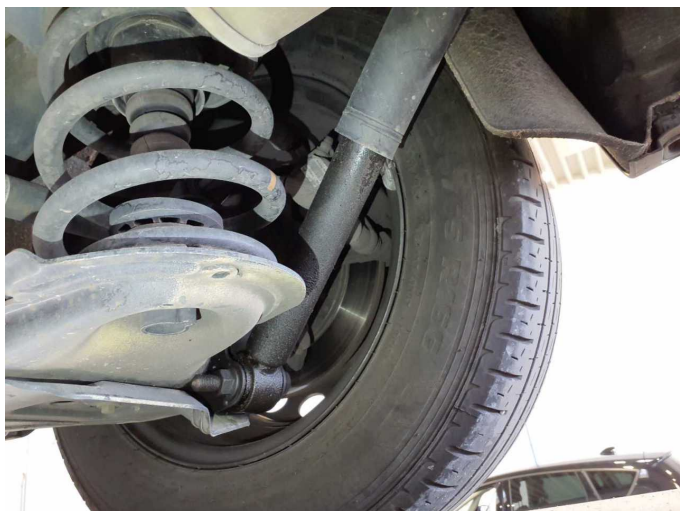
| No. | Component group | Description |
|---|---|---|
| 8 | Rear axle | Shock absorber - right side - Leaking - Replace |

**Damage 8:** Rear axle: Shock absorber - right side - Leaking - Replace

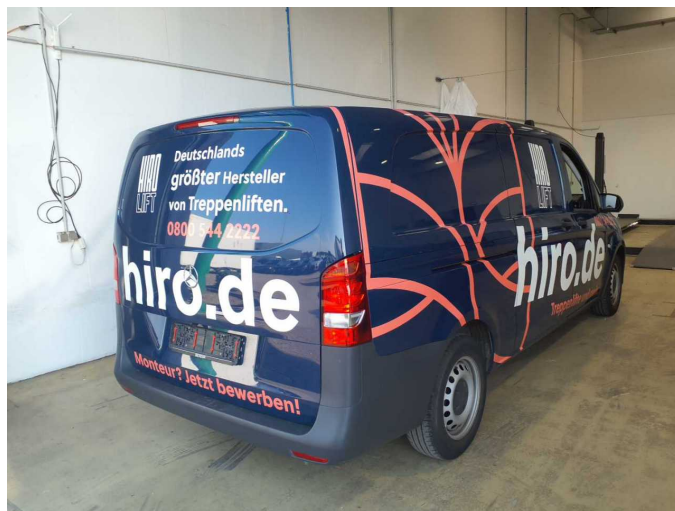
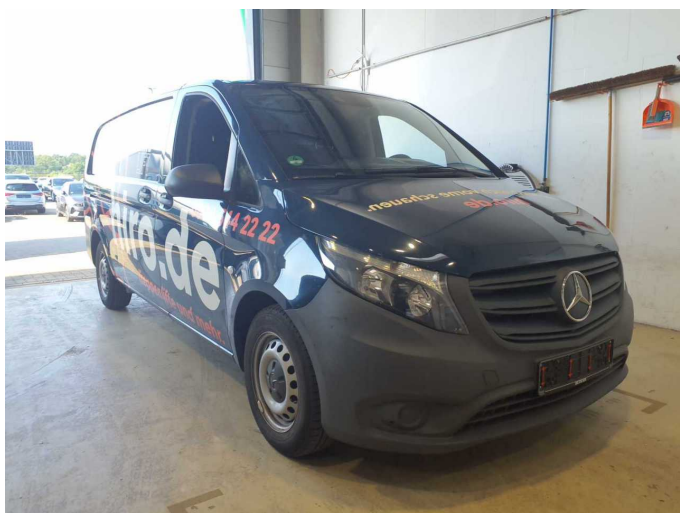
| No. | Component group | Description |
|---|---|---|
| 9 | Body | Body - Glued / labelled - De-glue / neutralise |

**Damage 9:** Body: Body - Glued / labelled - De-glue / neutralise

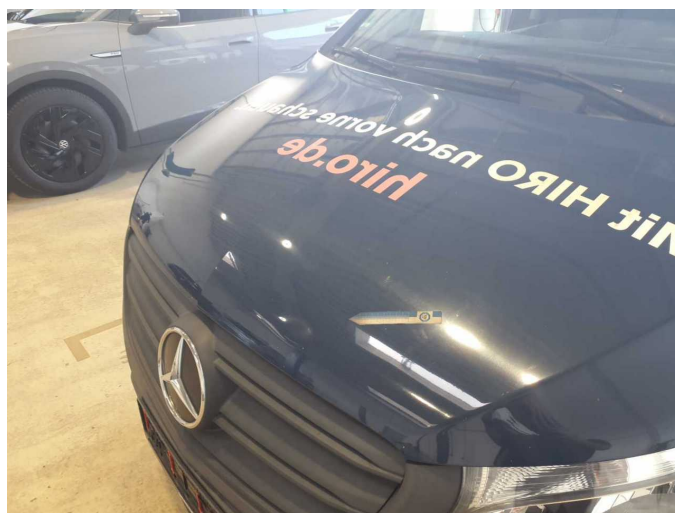
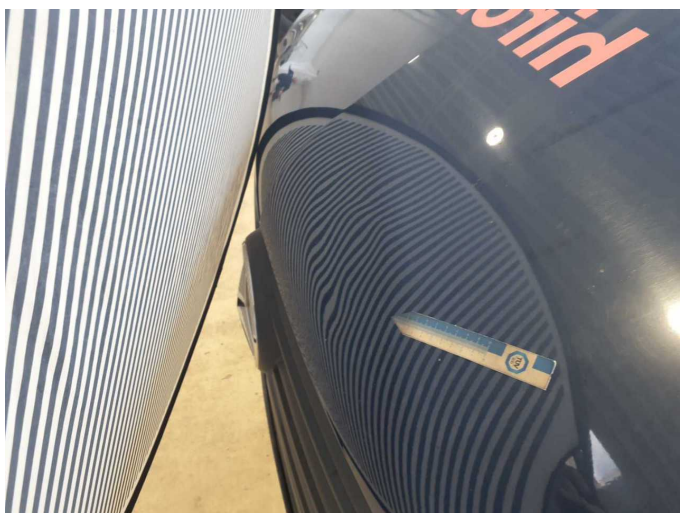
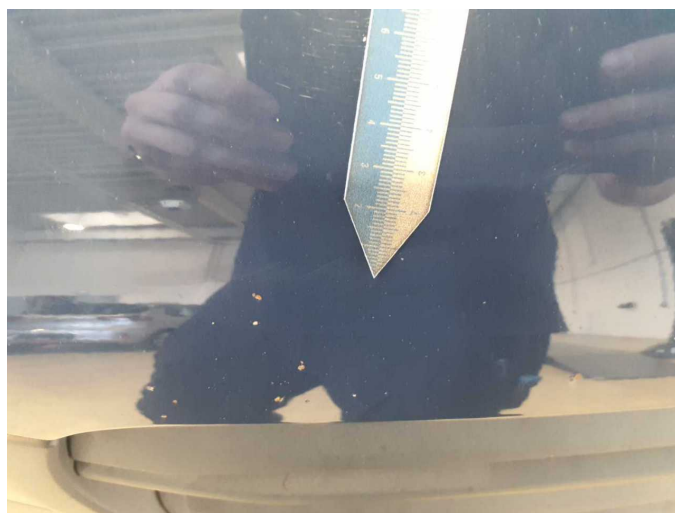
| No. | Component group | Description |
|---|---|---|
| 10 | Bonnet | Bonnet - dent(s) - Repair and paint |

**Damage 10:** Bonnet: Bonnet - dent(s) - Repair and paint

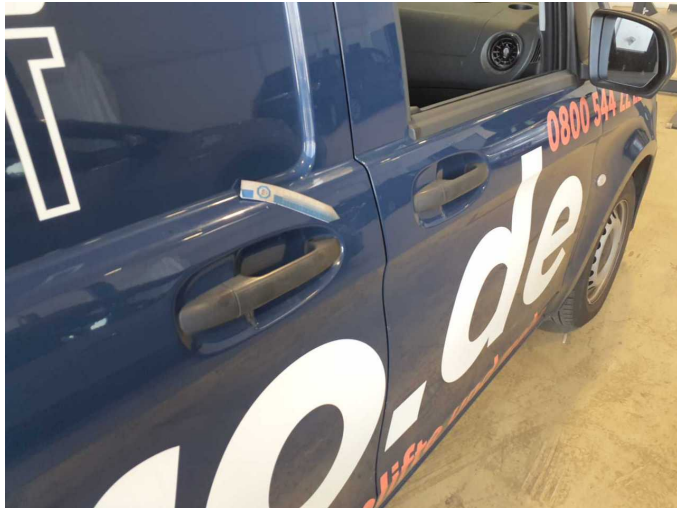
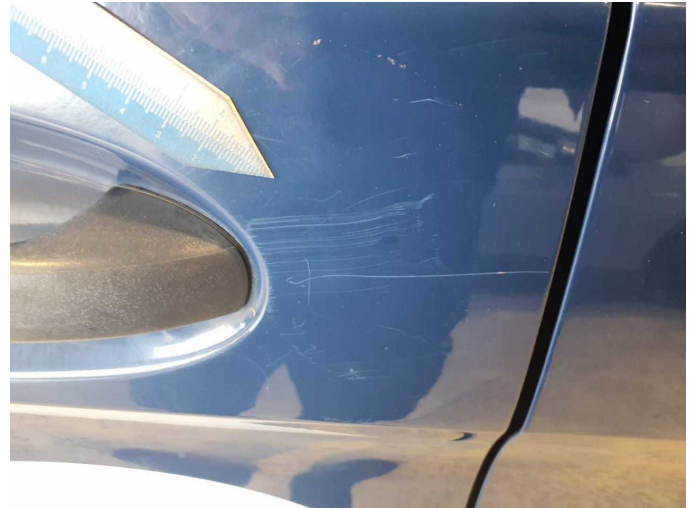
| No. | Component group | Description |
|---|---|---|
| 11 | Sliding door, right | Sliding door - Scratch(es) - Paint |

**Damage 11:** Sliding door, right: Sliding door - Scratch(es) - Paint
