Expertise

Protocol number: 46778954  
Order No. / Reference: 26747475  
Inspection date: 29 Jul 2026

Manufacturer: Seat

Model: Ateca 2.0 TDI FR

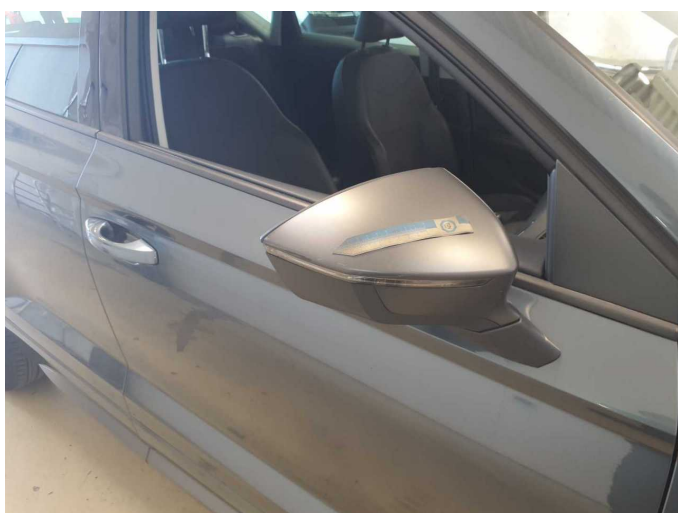
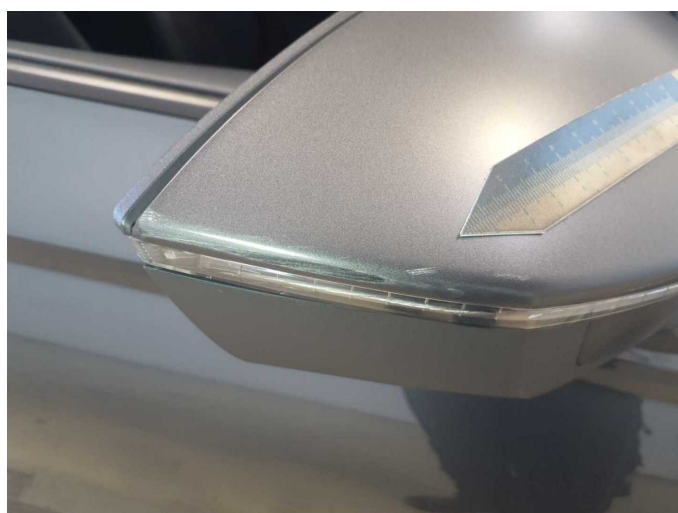
| No. | Component group | Description |
|---|---|---|
| 2 | Wing mirror - right side | Cap - Scratch(es) - Smart repair |

Damage 2: Wing mirror - right side: Cap - Scratch(es) - Smart repair

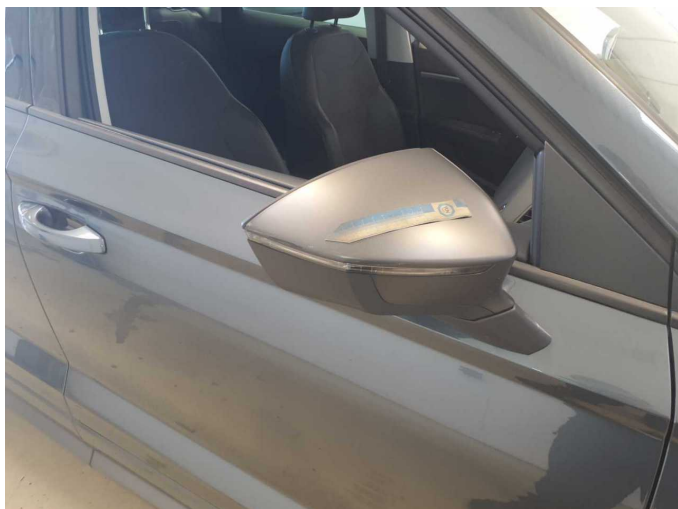
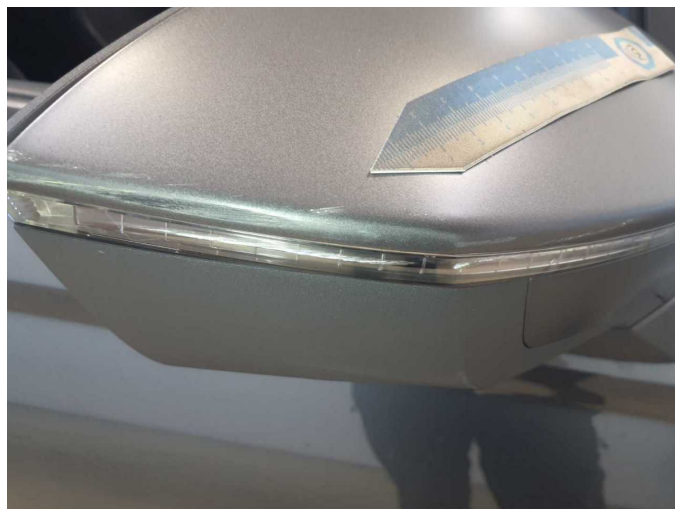
| No. | Component group | Description |
|---|---|---|
| 3 | Indicator - front | Mirror - right side - Scratch(es) - Replace |

**Damage 3:** Indicator - front: Mirror - right side - Scratch(es) - Replace

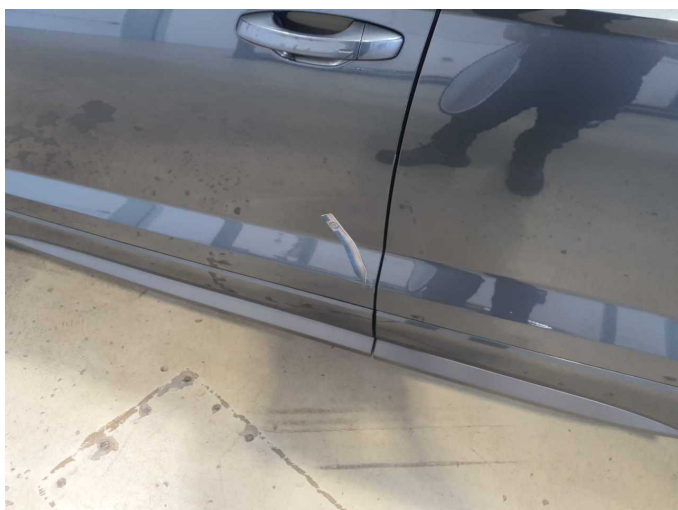
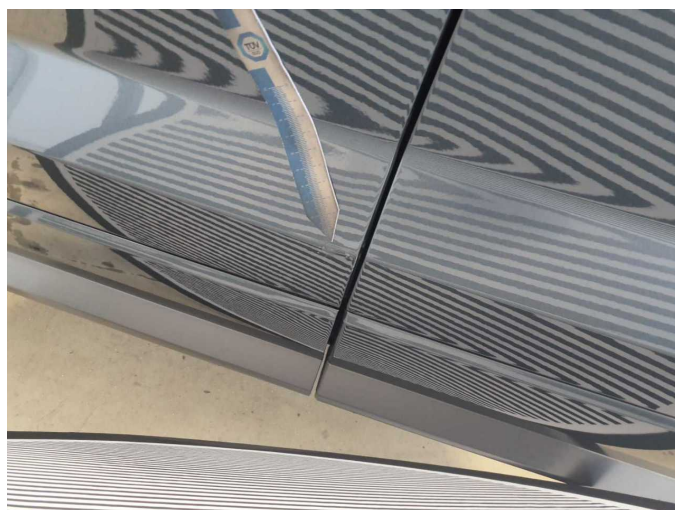
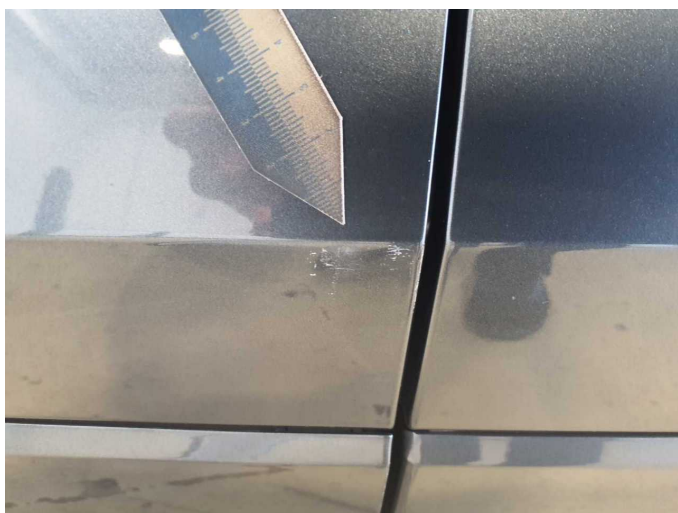
| No. | Component group | Description |
|---|---|---|
| 4 | Door - front left side | Door - Dent / paintcoat damage - Smart repair |

**Damage 4:** Door - front left side: Door - Dent / paintcoat damage - Smart repair

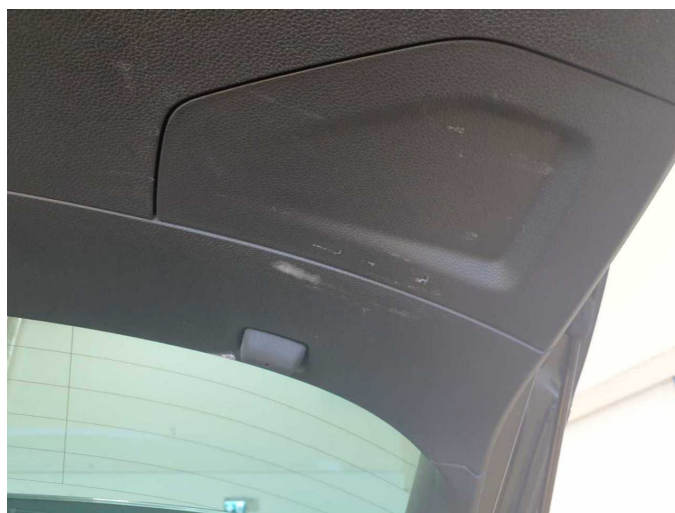
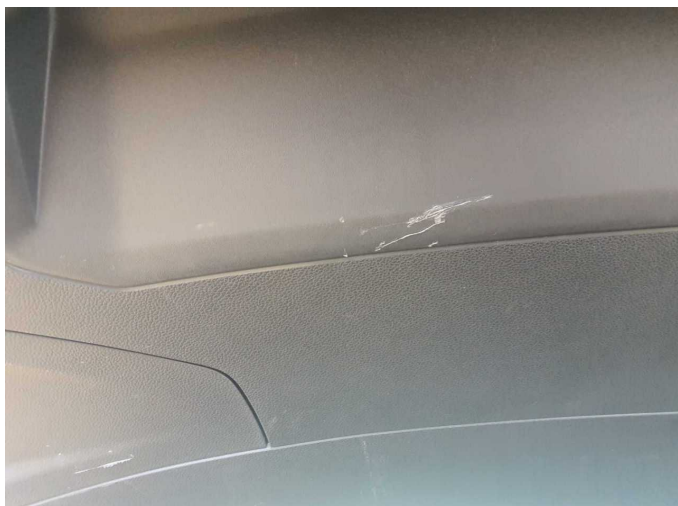
| No. | Component group | Description |
|---|---|---|
| 5 | Trim / covers | Boot lid - interior trim - Scratch(es) - Replace |

**Damage 5:** Trim / covers: Boot lid - interior trim - Scratch(es) - Replace

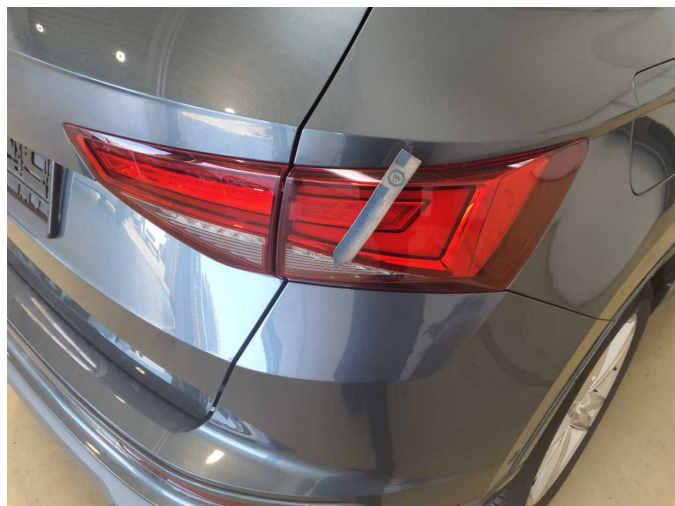
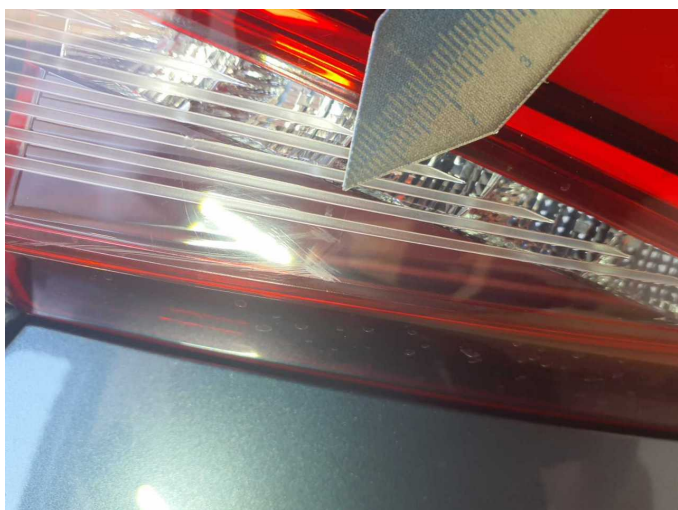
| No. | Component group | Description |
|---|---|---|
| 6 | Tail light | Tail lamp - right side - Scratch(es) - Replace |

**Damage 6:** Tail light: Tail lamp - right side - Scratch(es) - Replace

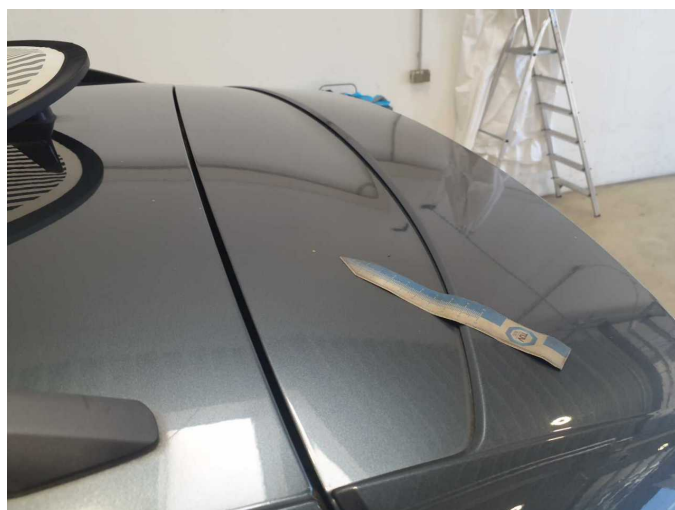
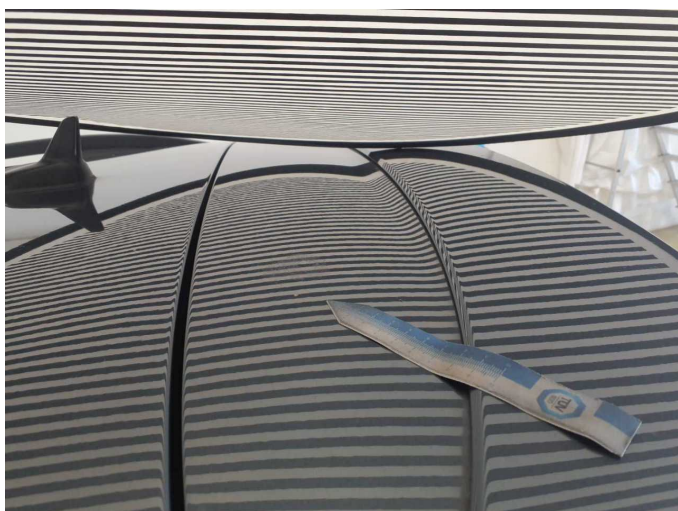
| No. | Component group | Description |
|---|---|---|
| 7 | Boot lid / rear door | Rear spoiler (Anätzung) - Paint defect - Lacquer |

**Damage 7:** Boot lid / rear door: Rear spoiler (Anätzung) - Paint defect - Lacquer

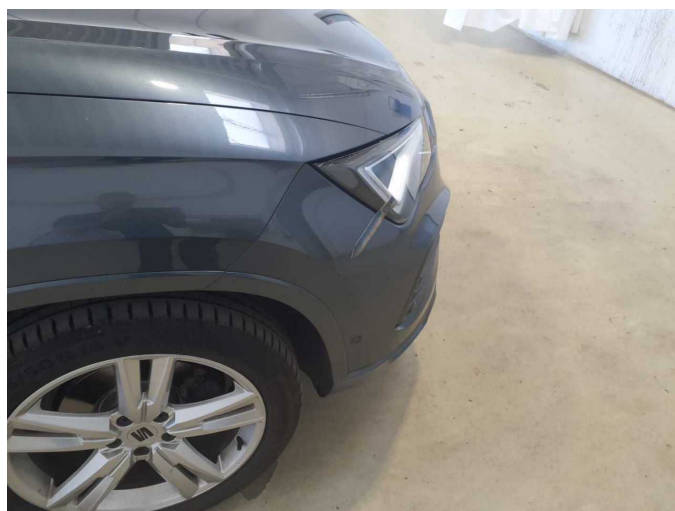
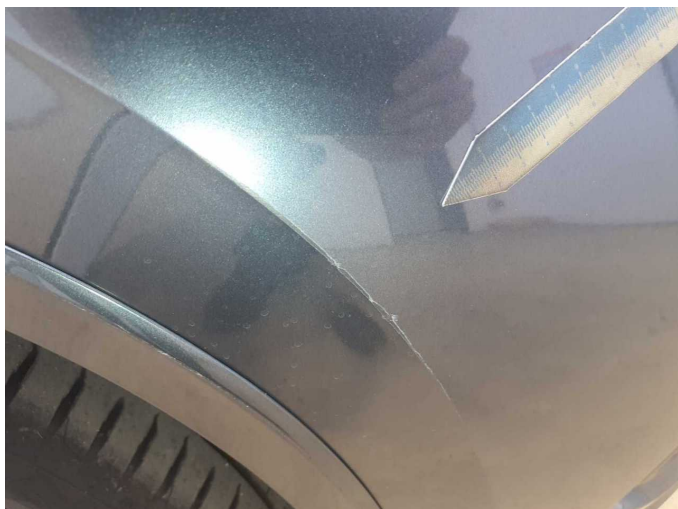
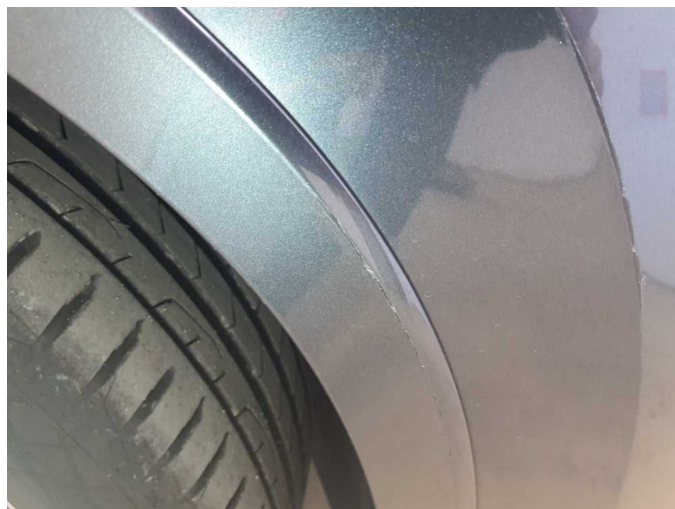
| No. | Component group | Description |
|---|---|---|
| 8 | Front bumper | Front bumper (Inklusive anbauteile) - Scratch(es) - Paint |

**Damage 8:** Front bumper: Front bumper (Inklusive anbauteile) - Scratch(es) - Paint

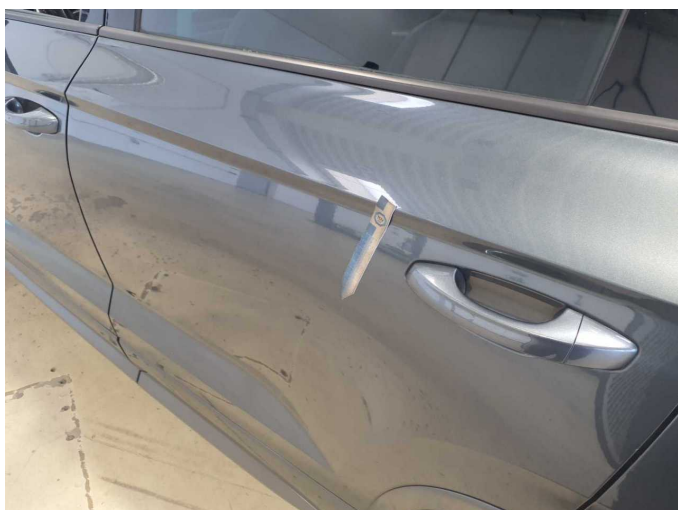
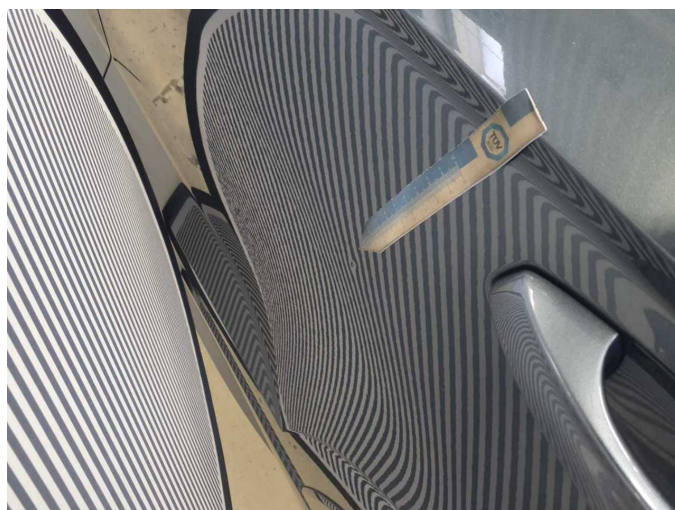
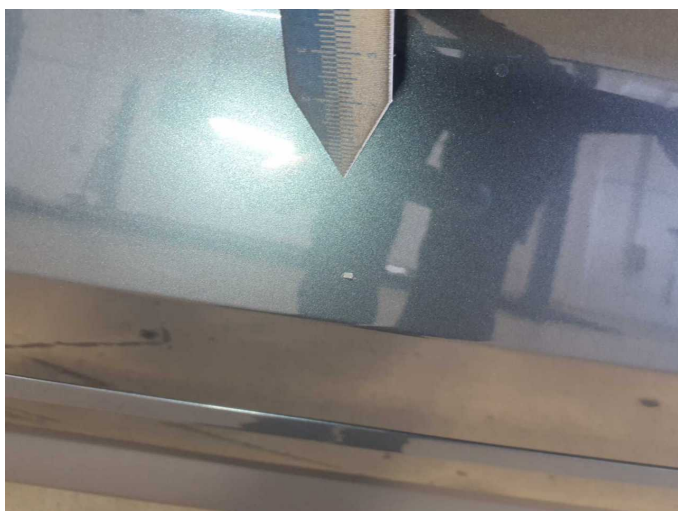
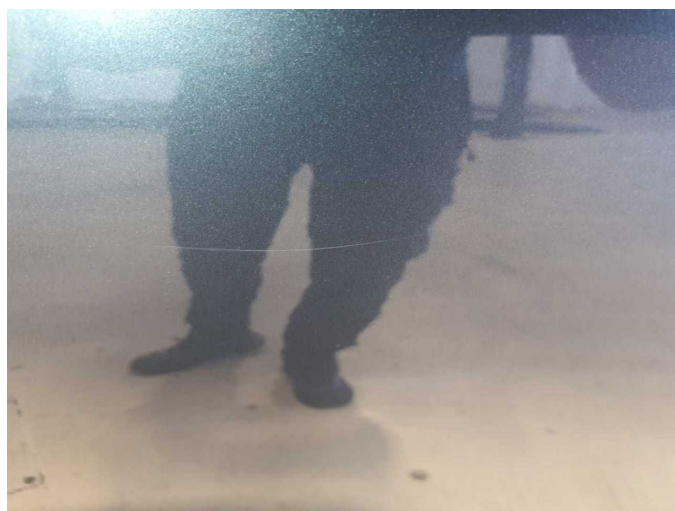
| No. | Component group | Description |
|---|---|---|
| 9 | Door - rear left side | Door - Dent / paintcoat damage - Repair and paint |

**Damage 9:** Door - rear left side: Door - Dent / paintcoat damage - Repair and paint

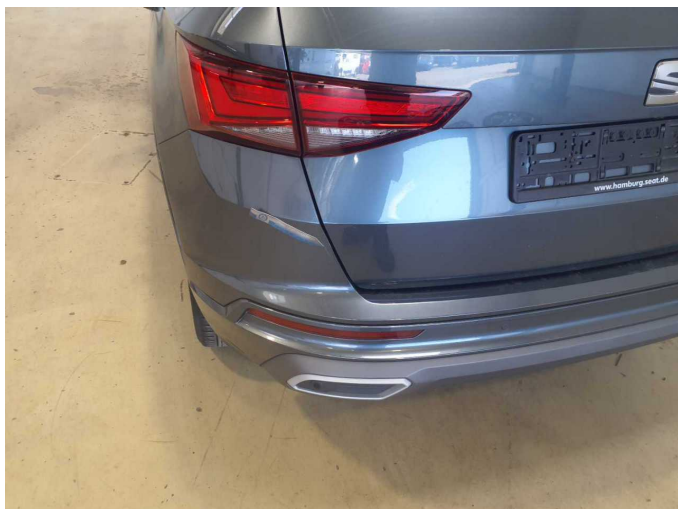
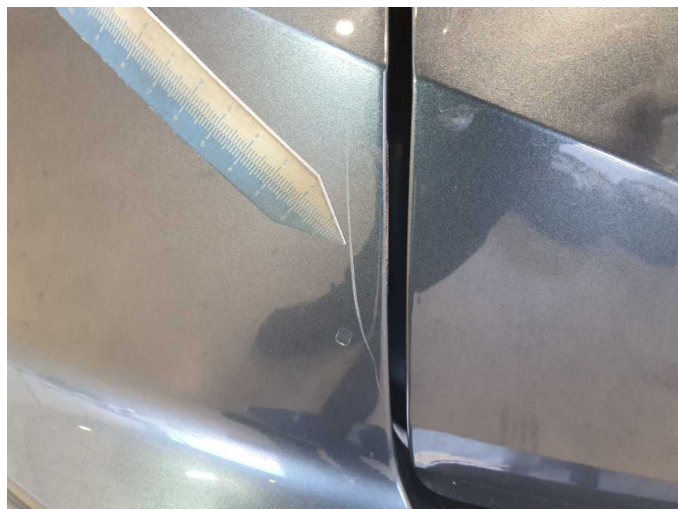
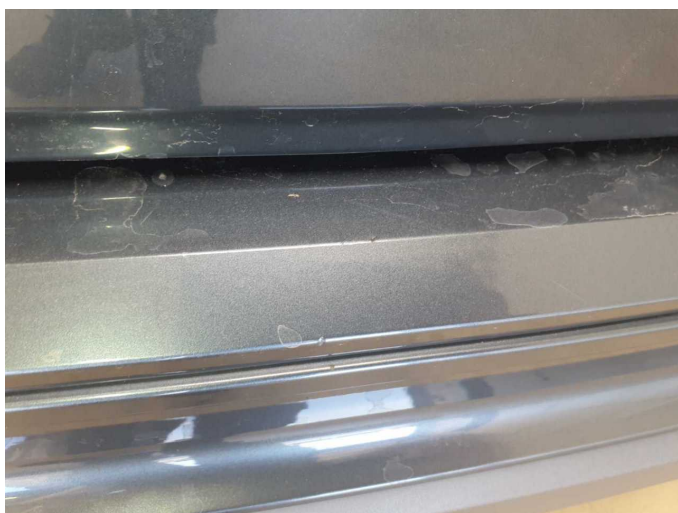
| No. | Component group | Description |
|---|---|---|
| 10 | Rear bumper | Rear bumper - Scratch(es) - Paint |

**Damage 10:** Rear bumper: Rear bumper - Scratch(es) - Paint

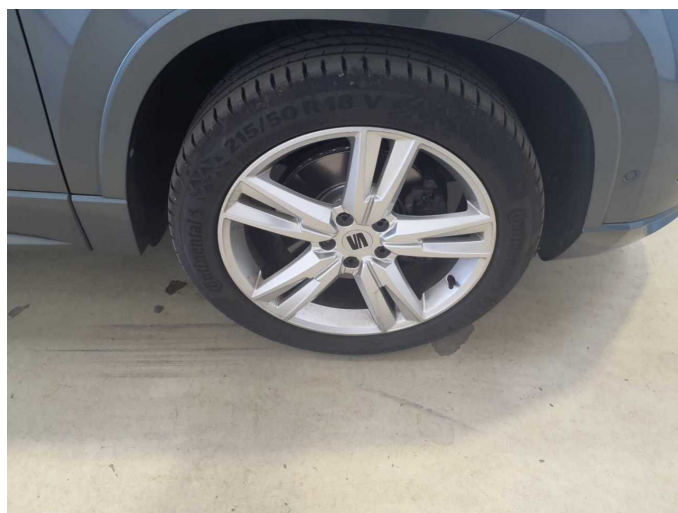
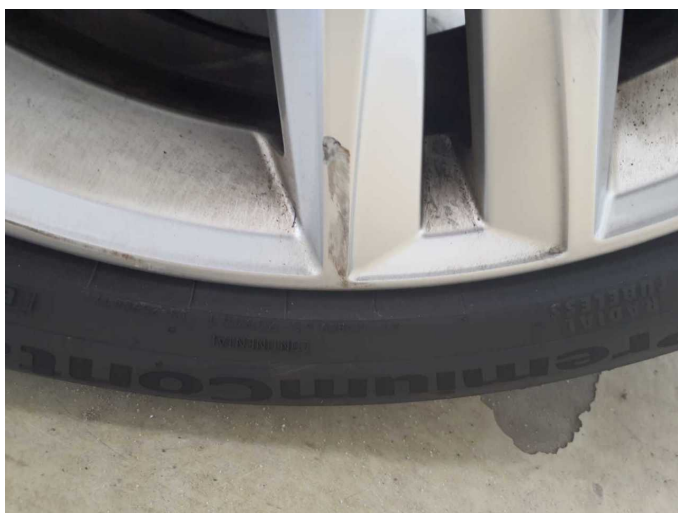
| No. | Component group | Description |
|---|---|---|
| 11 | Wheel / tyres | Alloy rim - front right side - Scratch(es) - Replace |

**Damage 11:** Wheel / tyres: Alloy rim - front right side - Scratch(es) - Replace

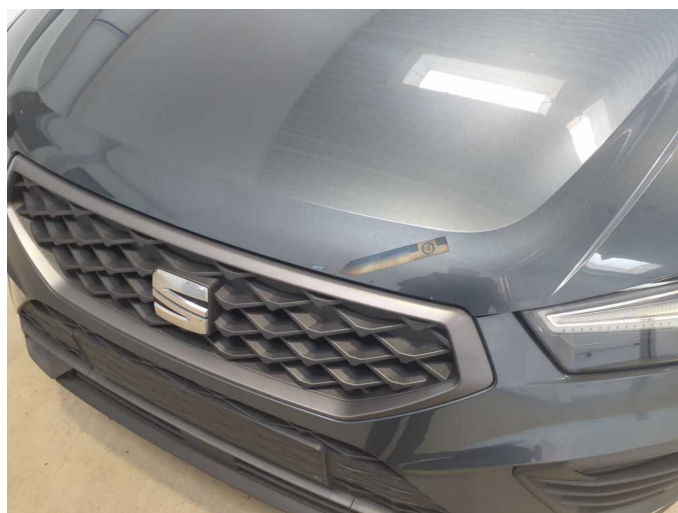
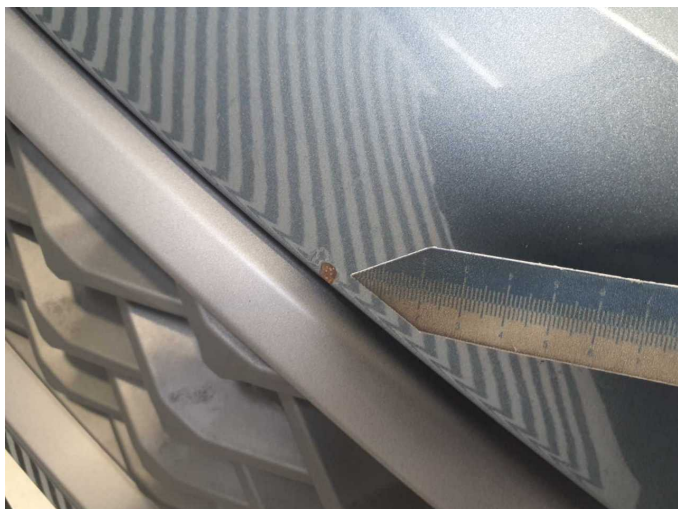
| No. | Component group | Description |
|---|---|---|
| 12 | Bonnet | Bonnet - Corrosion - Paint |

**Damage 12:** Bonnet: Bonnet - Corrosion - Paint

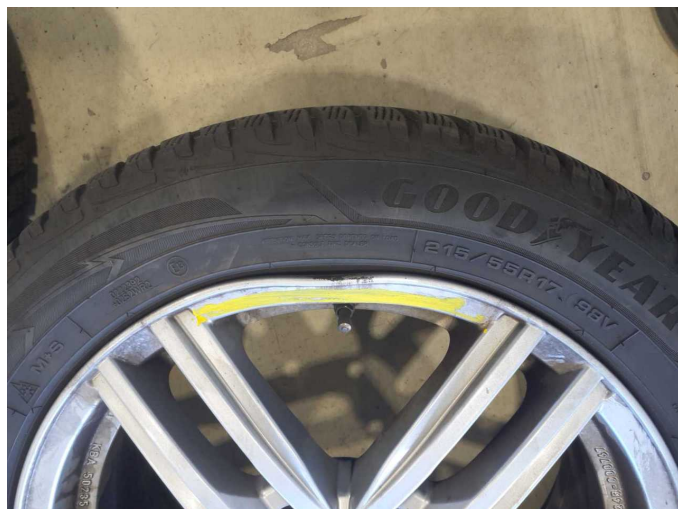
| No. | Component group | Description |
|---|---|---|
| 1 | 2nd wheel set | 1 alloy rim - Deformed - No deduction |

**Wear and tear 1:** 2nd wheel set: 1 alloy rim - Deformed - No deduction

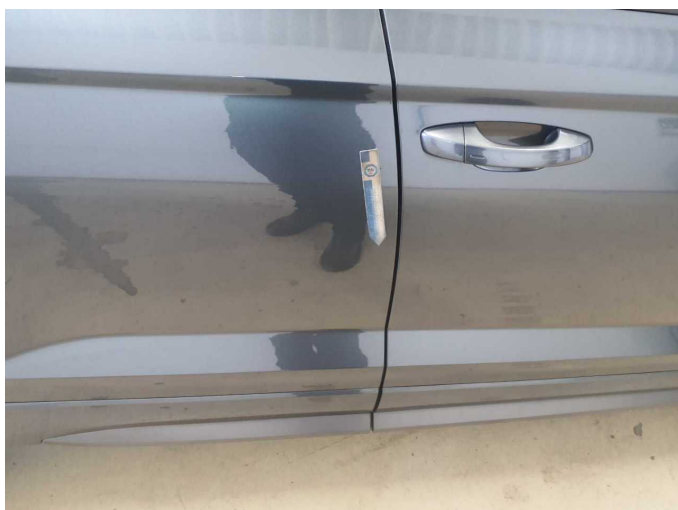
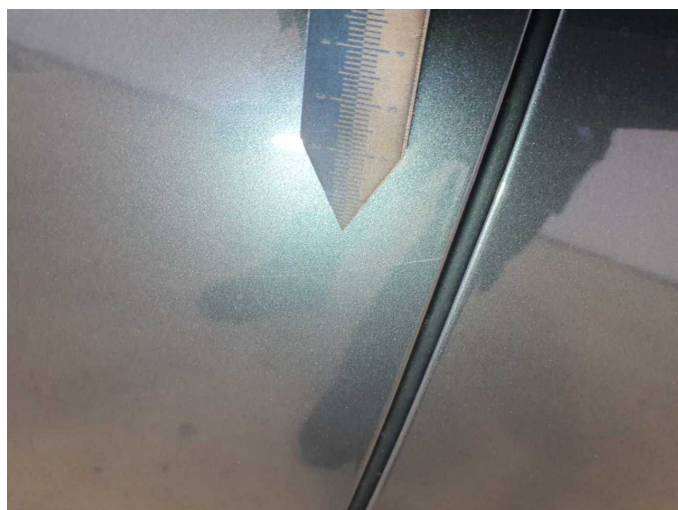
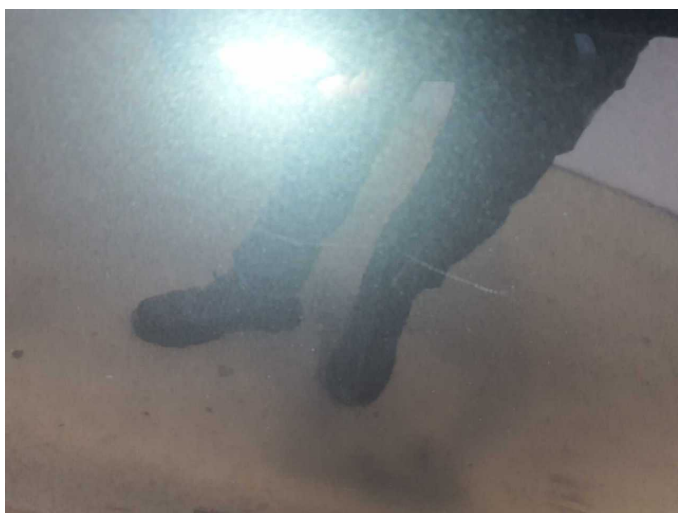
| No. | Component group | Description |
|---|---|---|
| 4 | Door - rear right side | Door - Scratch(es) - Cover / polish |

**Wear and tear 4:** Door - rear right side: Door - Scratch(es) - Cover / polish
