Expertise

Protocol number: 46195138
Order No. / Reference: 26504607
Inspection date: 26 Jun 2026

Model: 508 SW BlueHDi 130 EAT8 GT

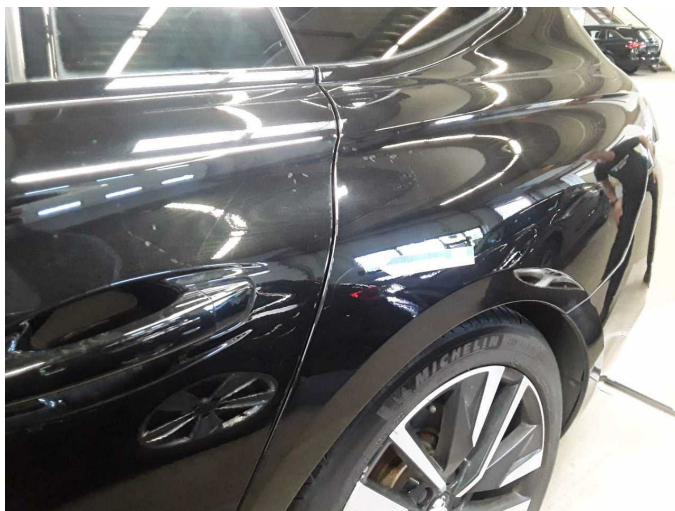
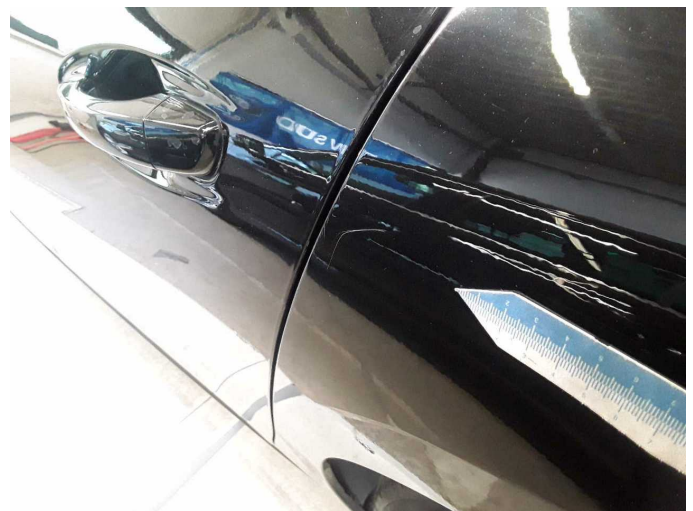
Damage 1: Side panel - rear left side: Side panel - Scratch(es) - Smart repair

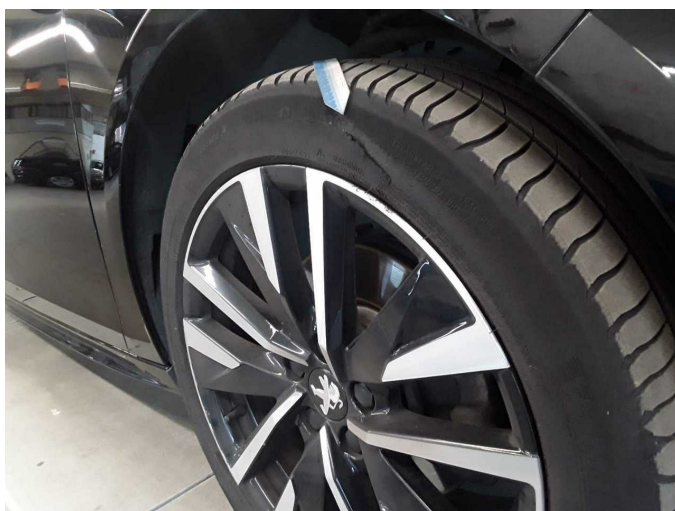
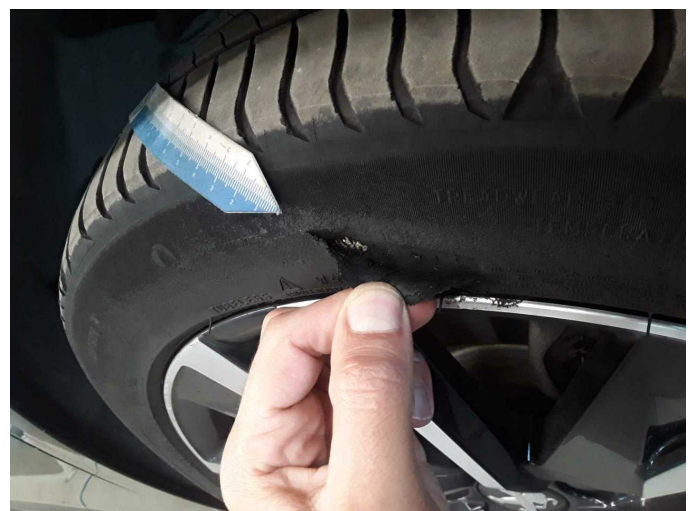
Damage 2: Wheel / tyres: Tyre - front right side - Damaged - Replace

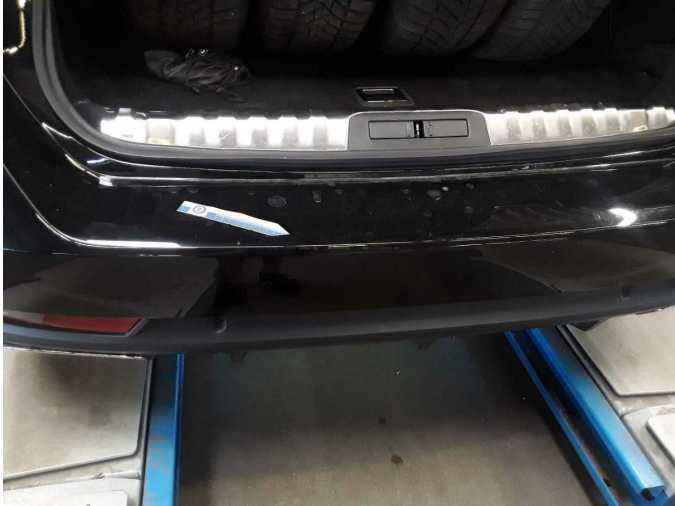
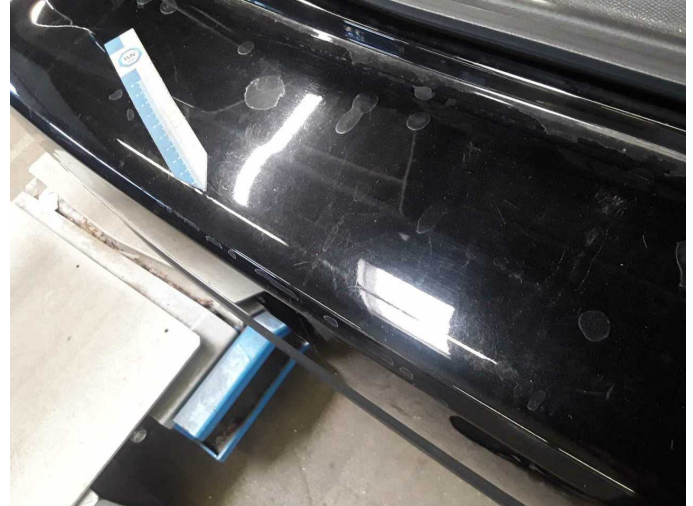
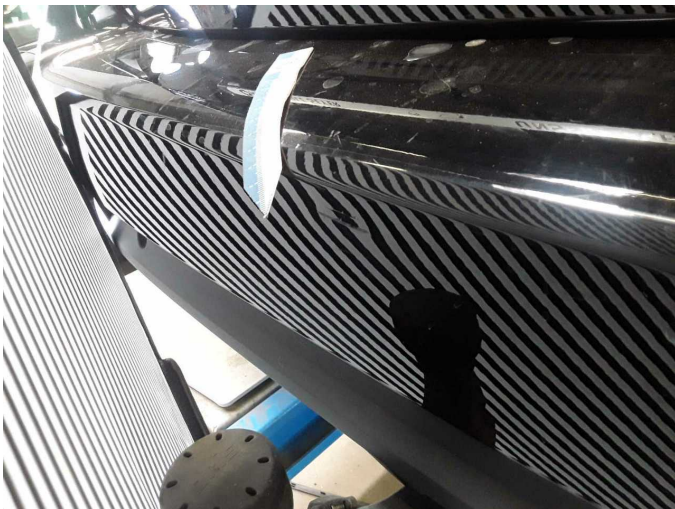
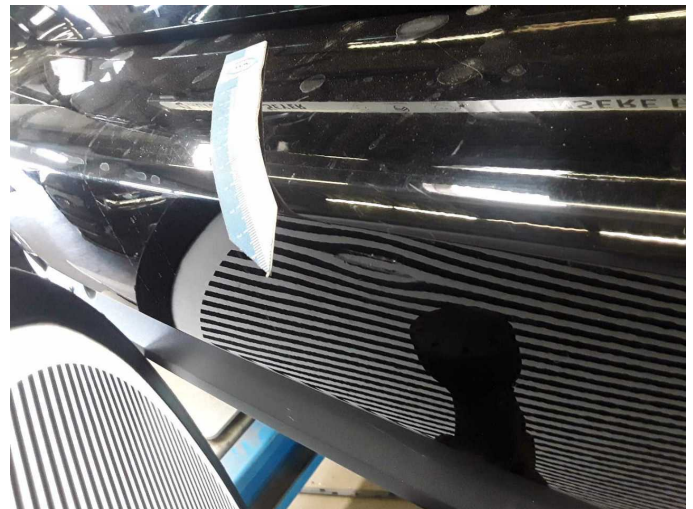
Damage 3: Rear bumper: Rear bumper - Dent / paintcoat damage - Smart repair

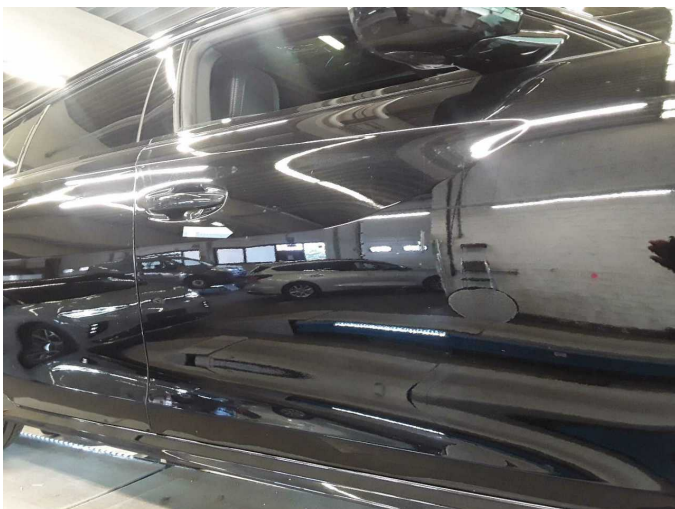
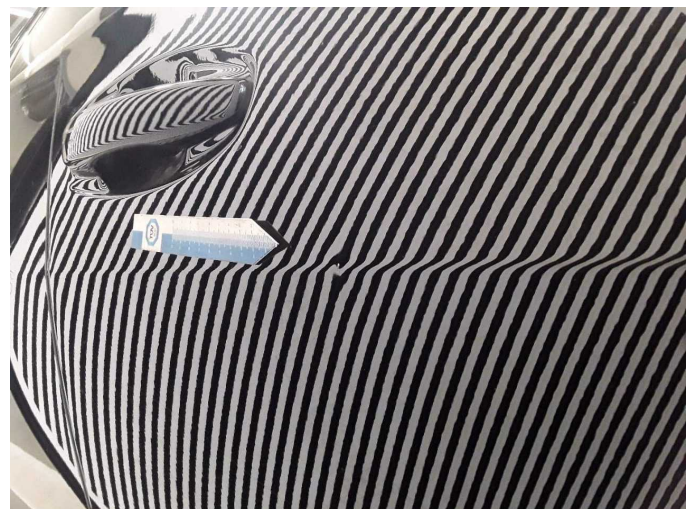
Damage 4: Door - front right side: Door - Dent / paintcoat damage - Smart repair

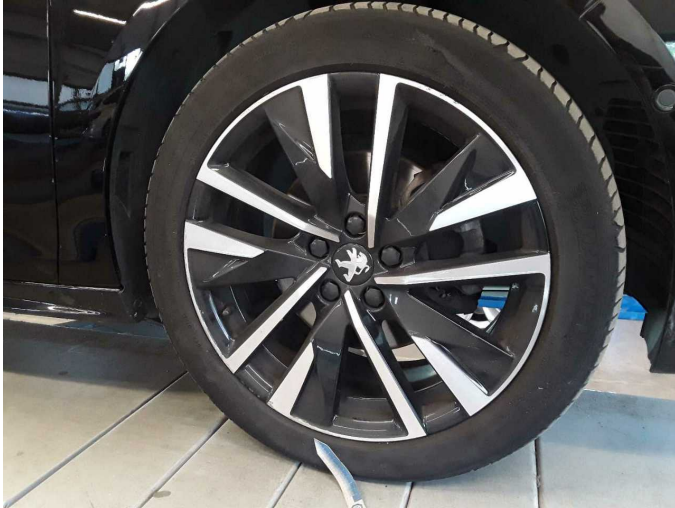
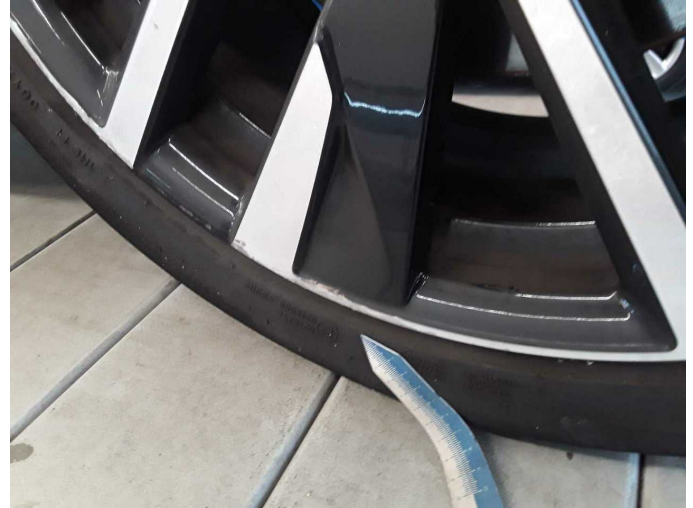
Damage 5: Wheel / tyres: Alloy rim - front right side - Scratched - Loss in value

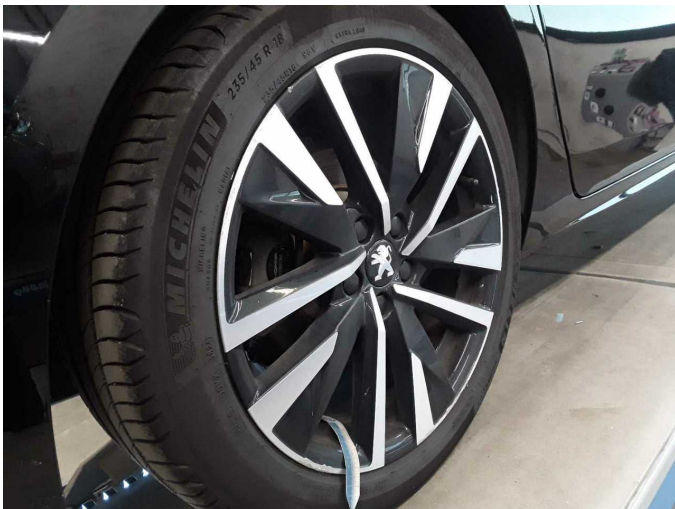
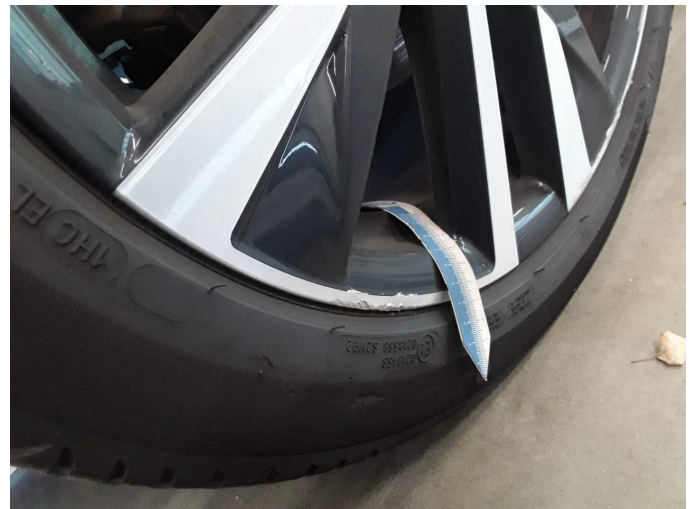
Damage 6: Wheel / tyres: Alloy rim - rear right side - Scratched - Loss in value

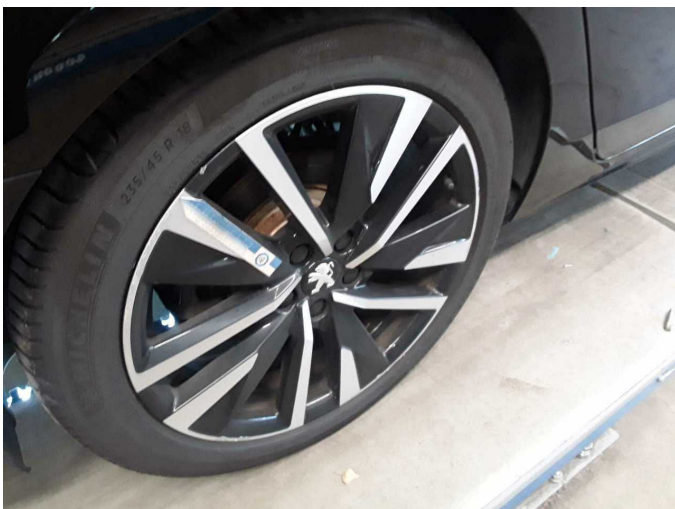
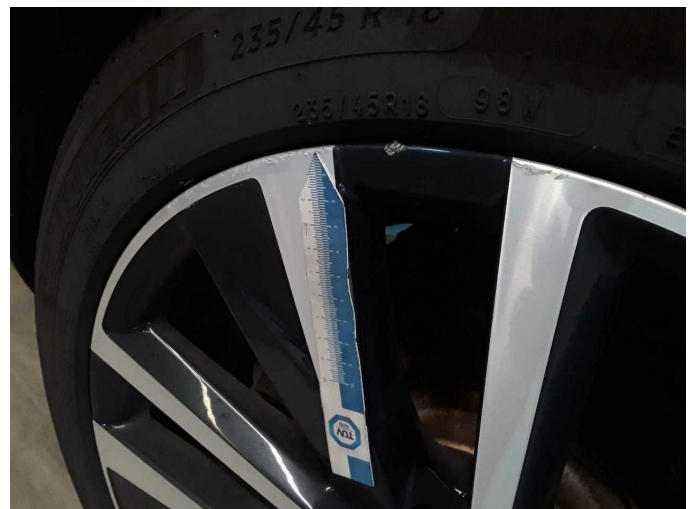
Damage 7: Wheel / tyres: Alloy rim - rear right side - Scratched - Loss in value

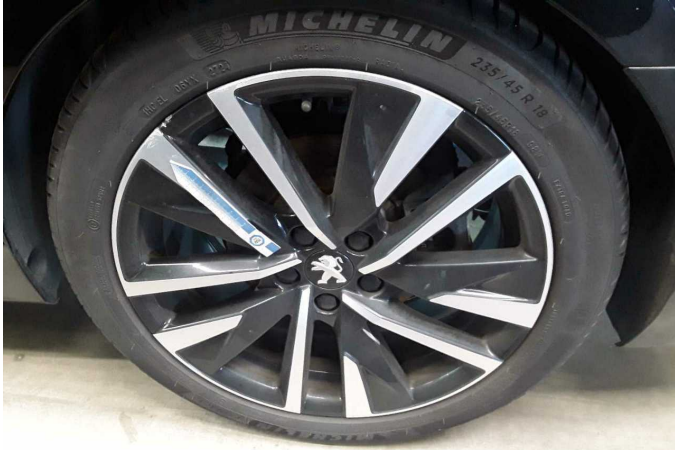
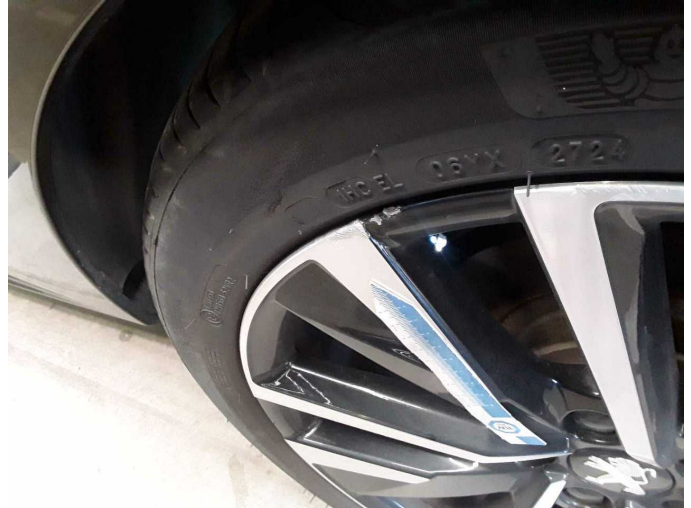
Damage 8: Wheel / tyres: Alloy rim - rear left side - Scratched - Loss in value

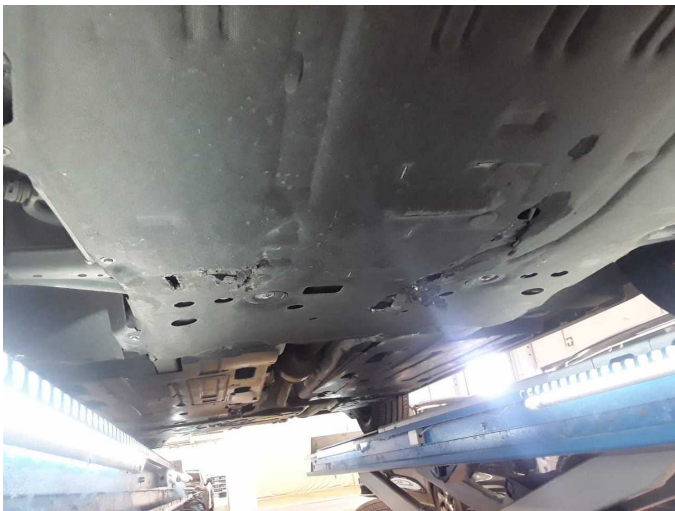
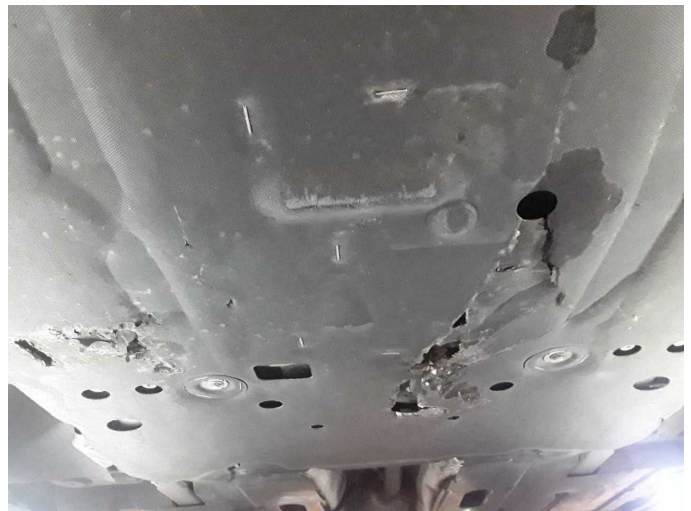
Damage 9: Body: Underbody panelling - Damaged - Replace

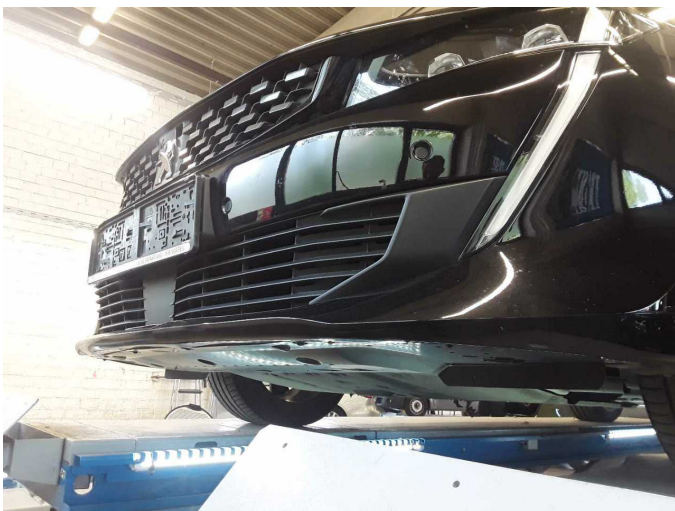
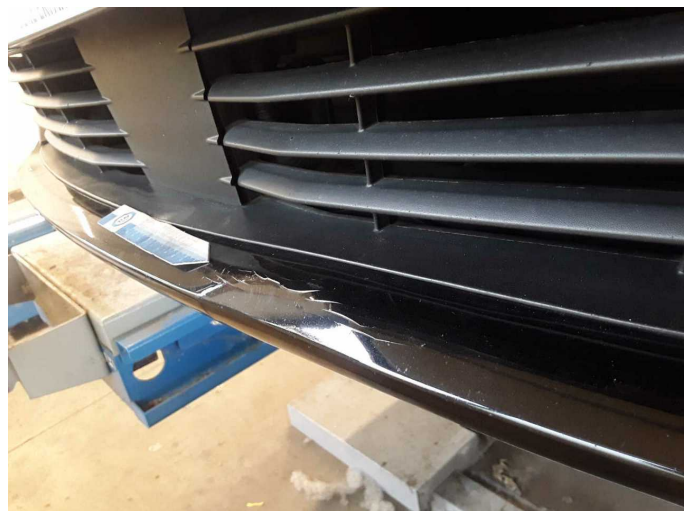
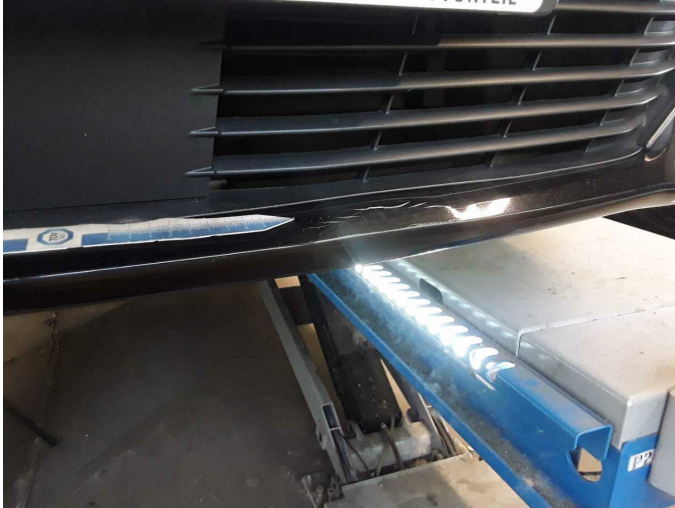
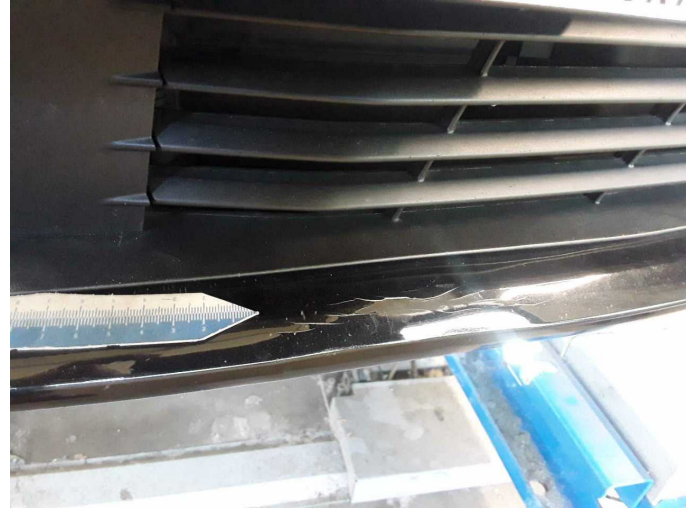
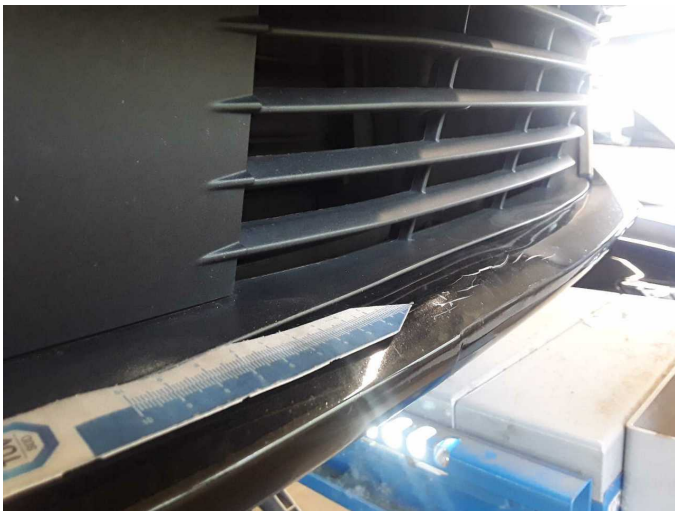
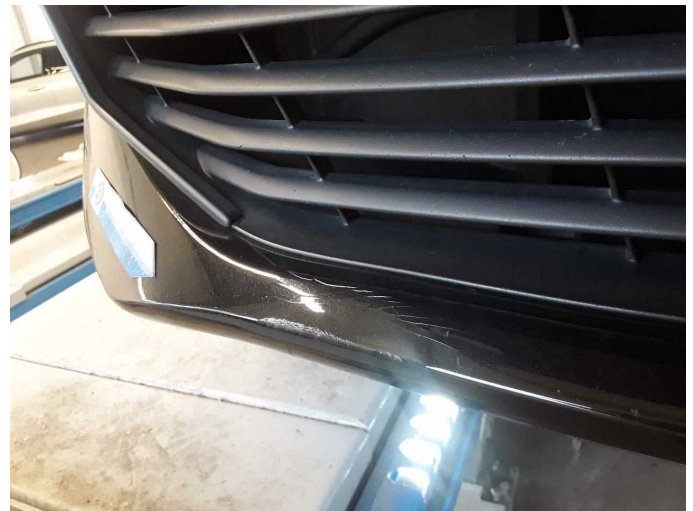
Damage 10: Front bumper: Front bumper - Damaged - Replace

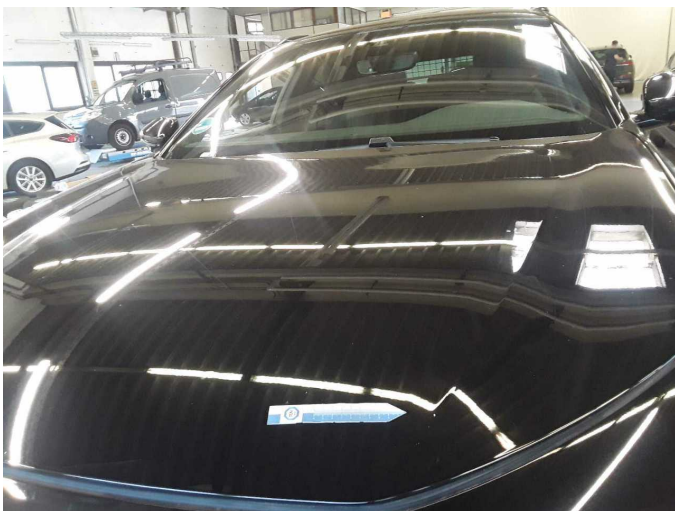
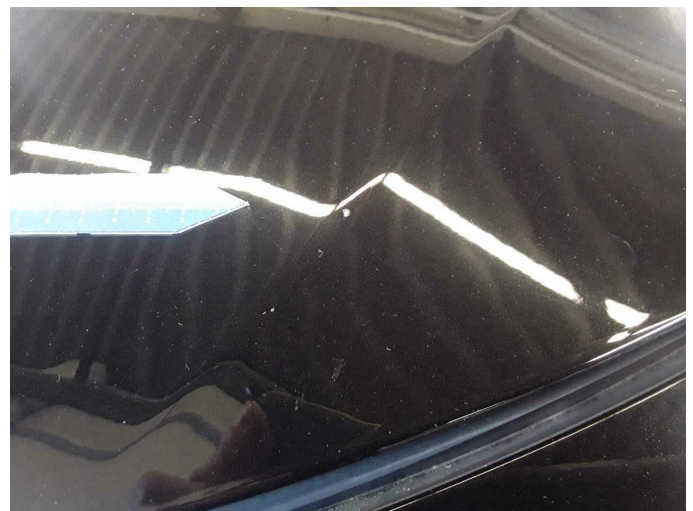
Wear and tear 1: Bonnet: Bonnet - Stone chips - No deduction

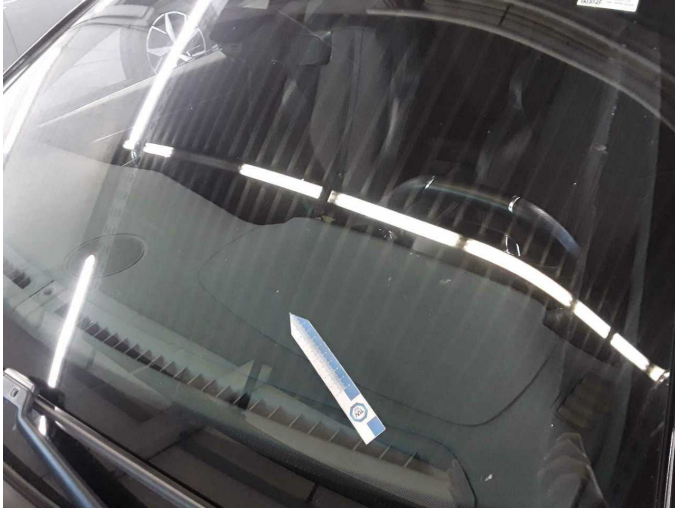
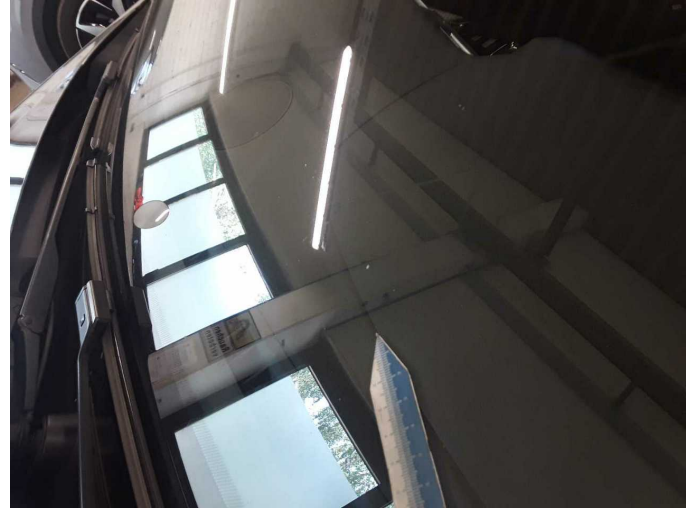
Wear and tear 2: Vehicle glazing: Windscreen - Stone chips - No deduction
