Expertise

Protocol number: 46262401
Order No. / Reference: 26528535
Inspection date: 29 Jun 2026

Model: S-Max 2.0 EcoBlue Aut. TITANIUM

VIN: WF0JXXWPCJNM13585

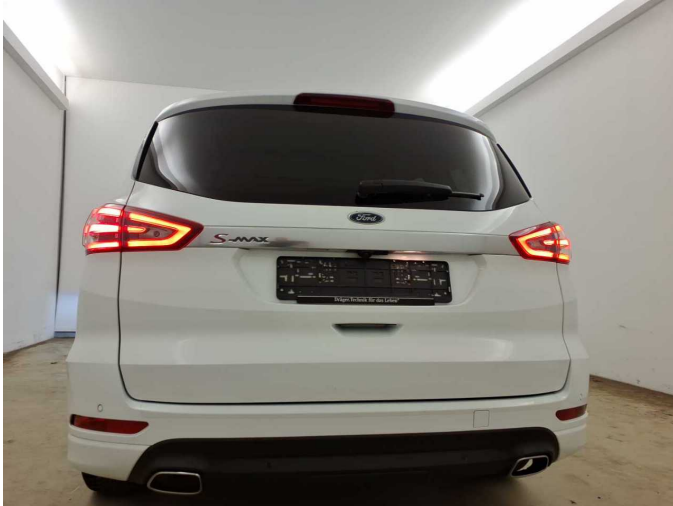
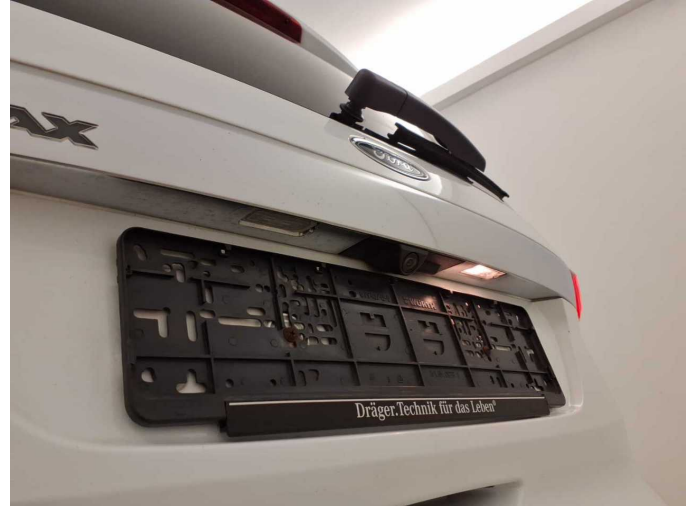
Damage 1: Tail light: License plate lamp - left side - Non-operational - Replace

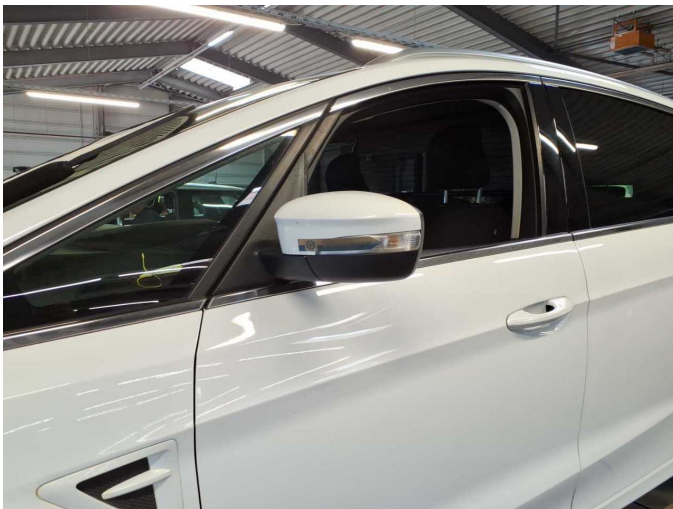
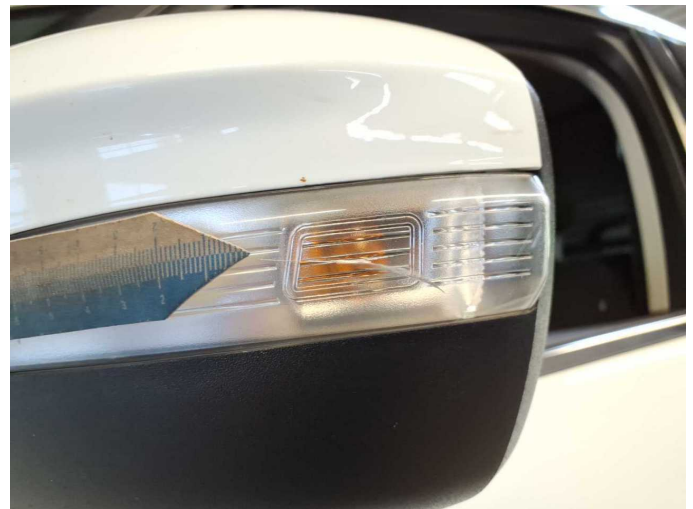
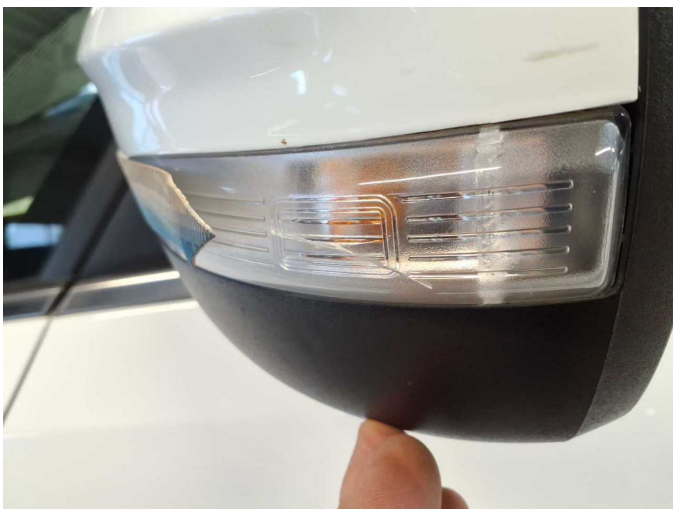
Damage 2: Indicator - front: Mirror - left side - Broken / torn - Replace

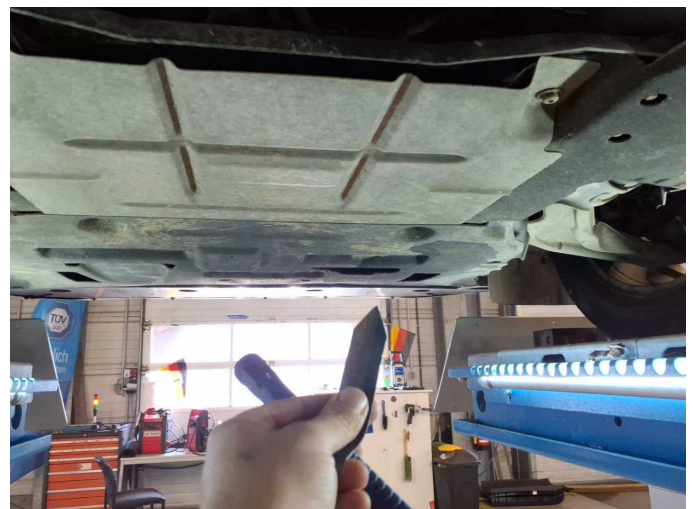
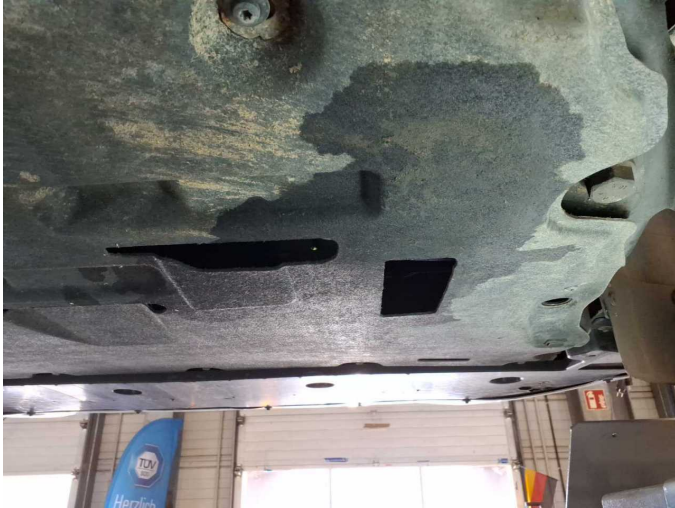
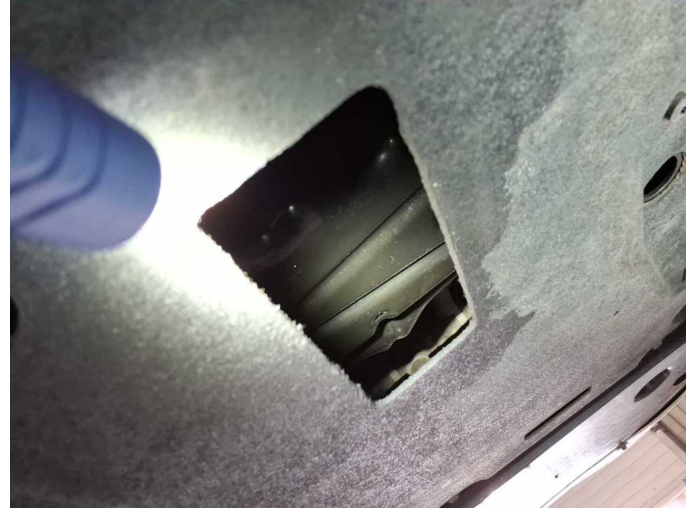
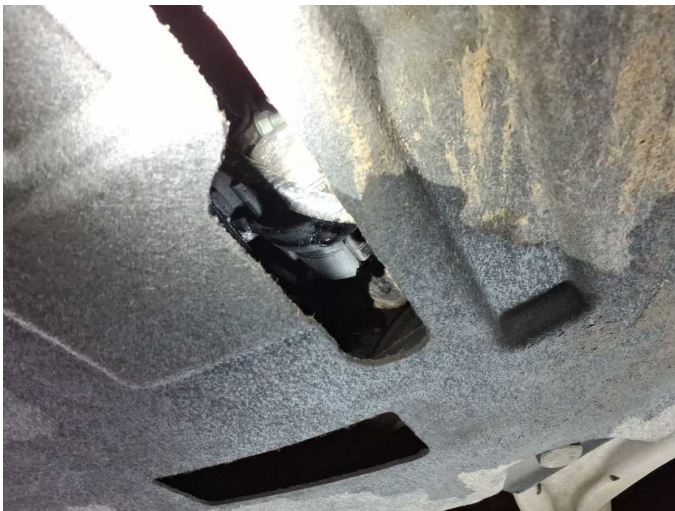
Damage 3: Engine: Engine (Tröpfchenbildung, Umweltbelastung) - Leaking - Perform diagnosis

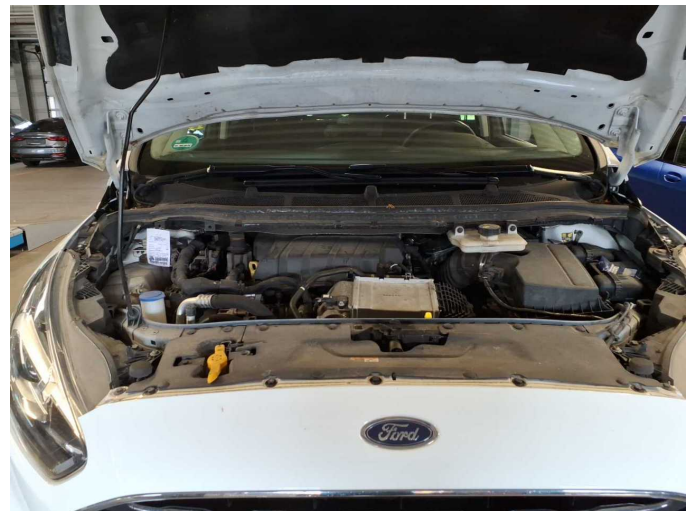
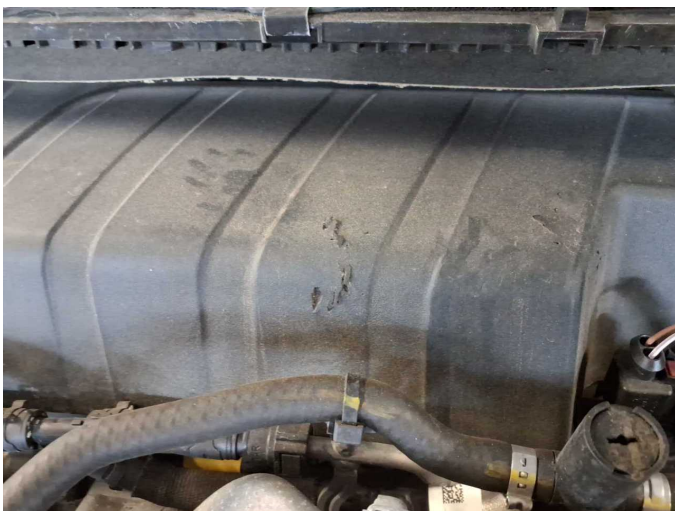
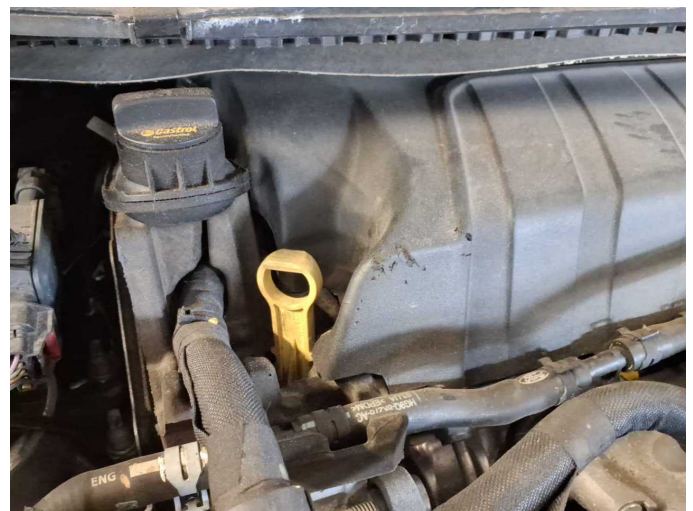
Damage 4: Engine: Engine cover - Damage caused by marten / rodent - Replace

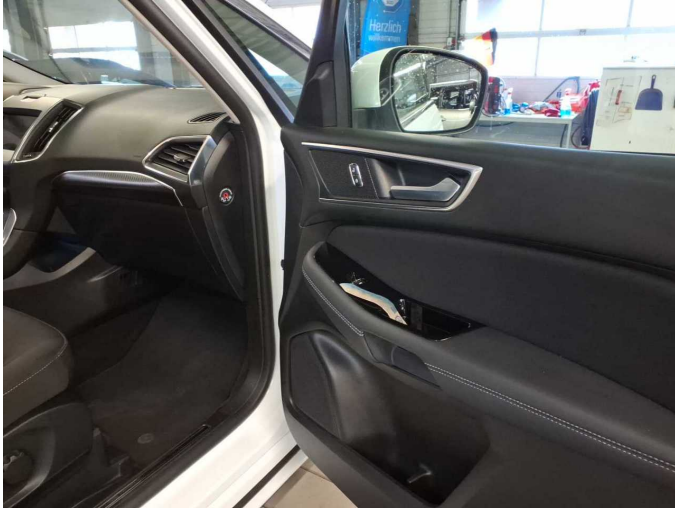
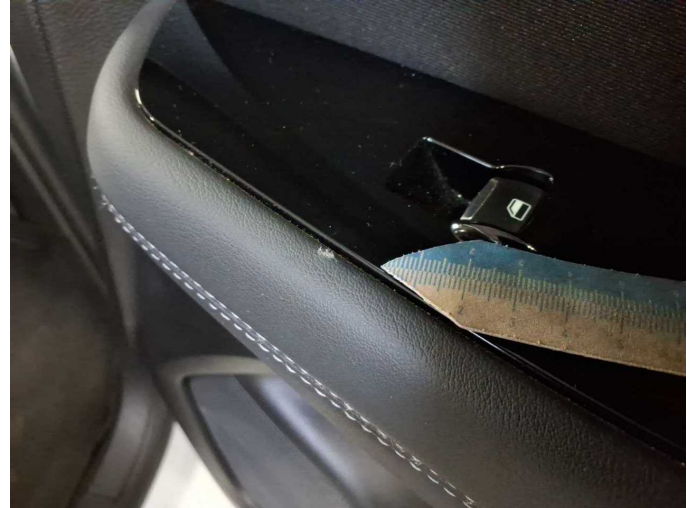
Damage 5: Trim / covers: Door trim - front right side - Broken / torn - Smart repair

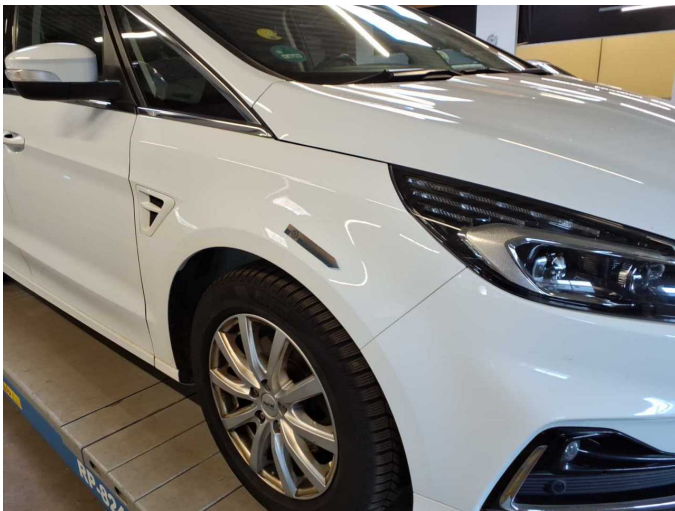
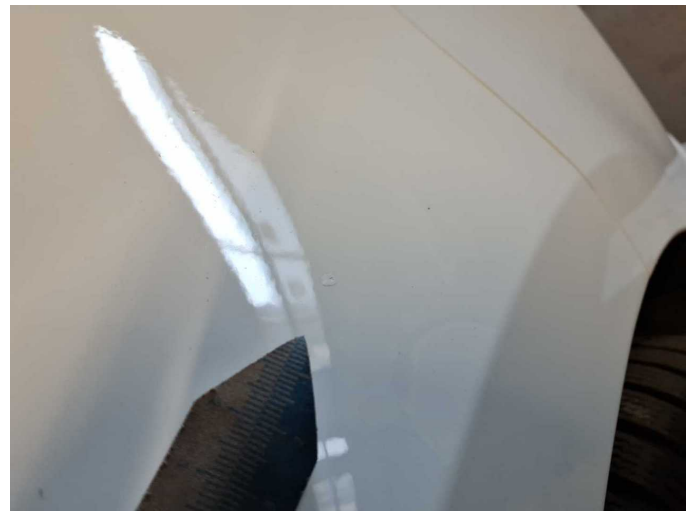
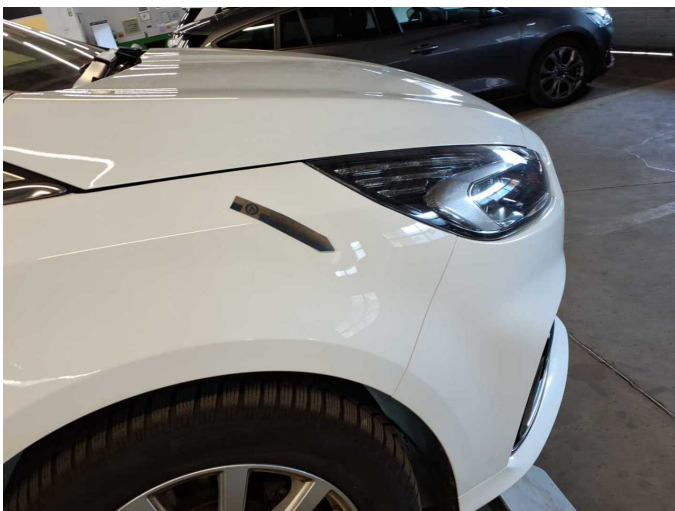
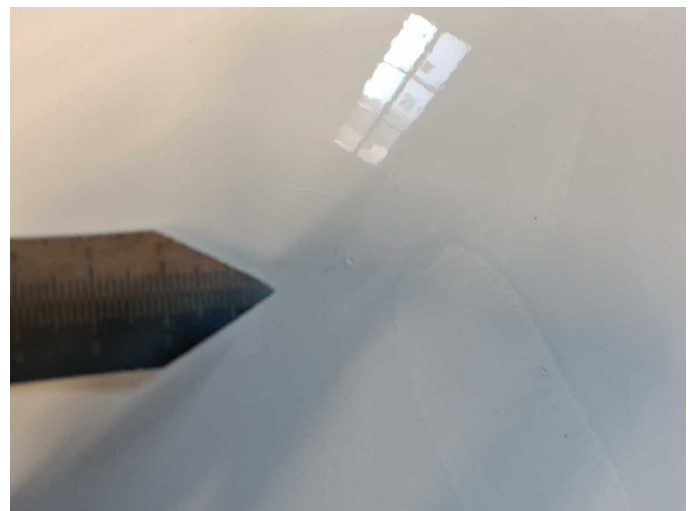
Damage 6: Mudguard - right side: Mudguard - right side - Stone chips - Repair and paint

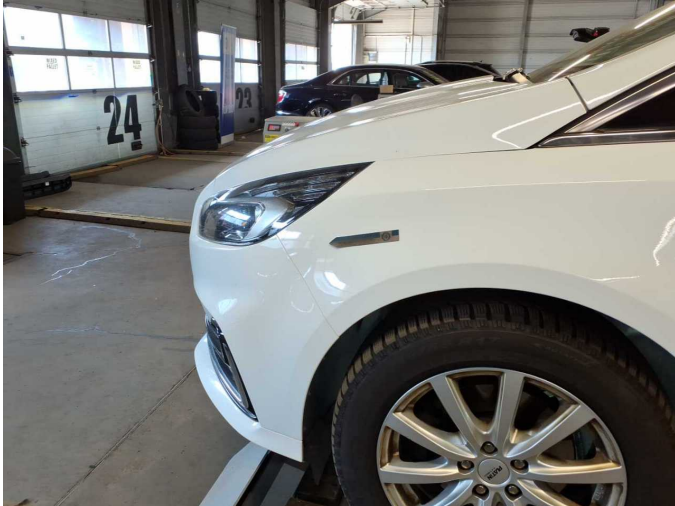
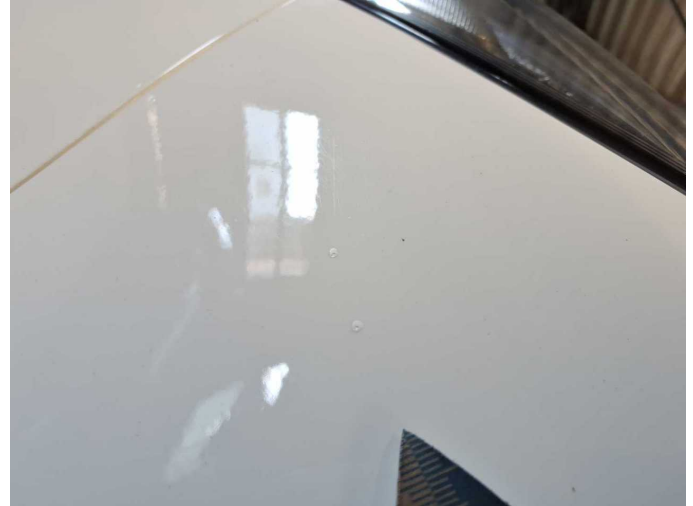
Damage 7: Mudguard - left side: Mudguard - left side - Stone chips - Repair and paint

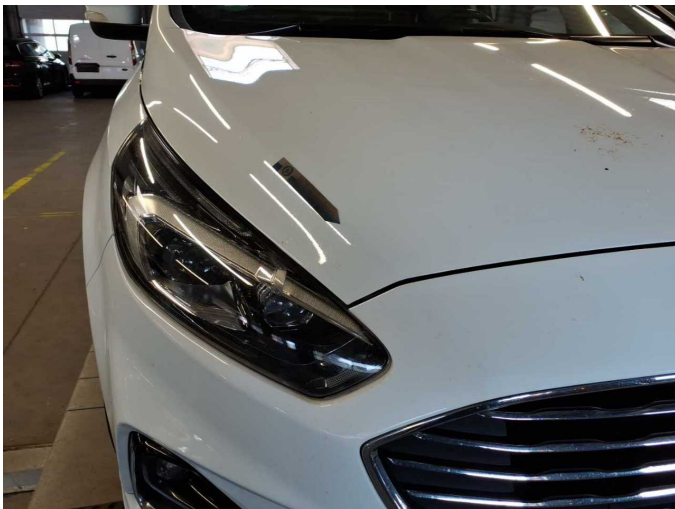
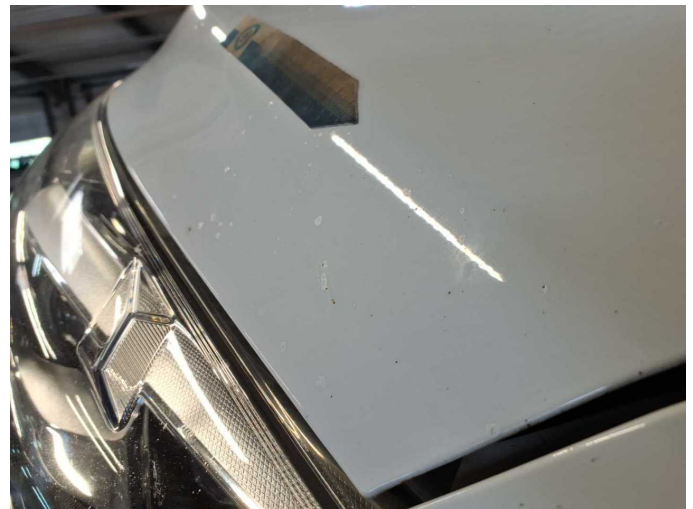
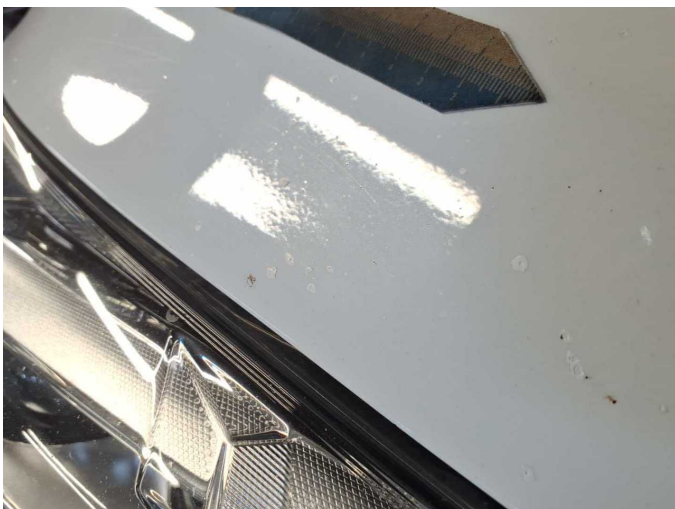
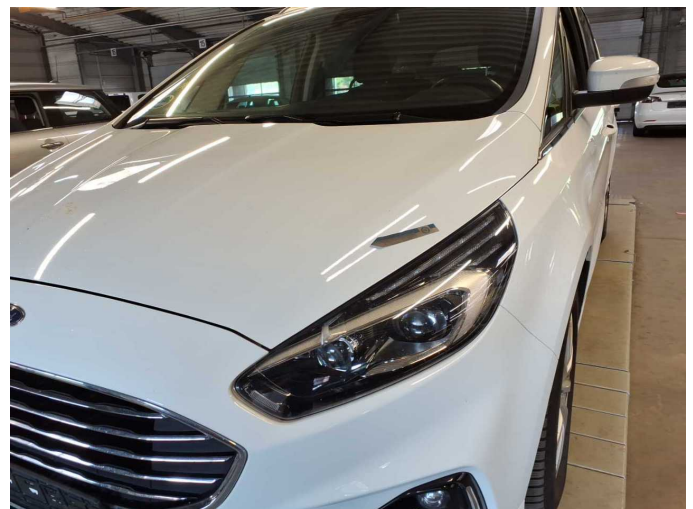
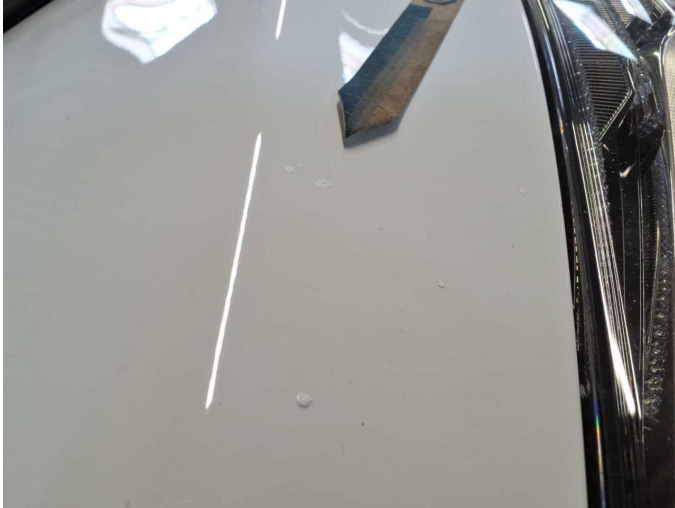
Damage 8: Bonnet: Bonnet (Sandstrahleffekt) - Stone chips - Repair and paint

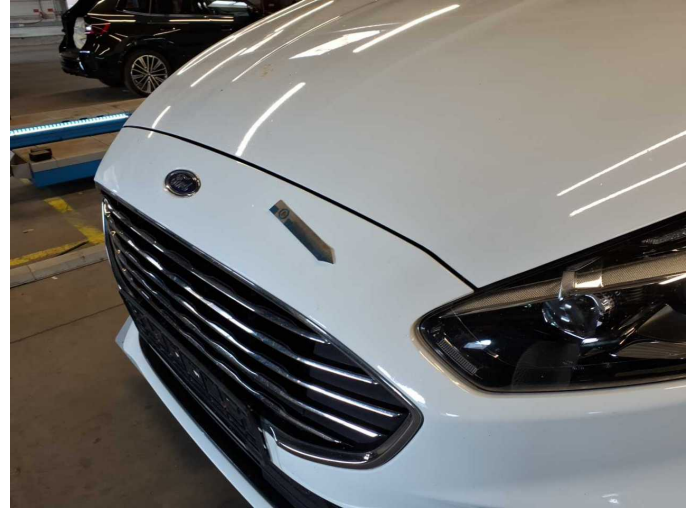
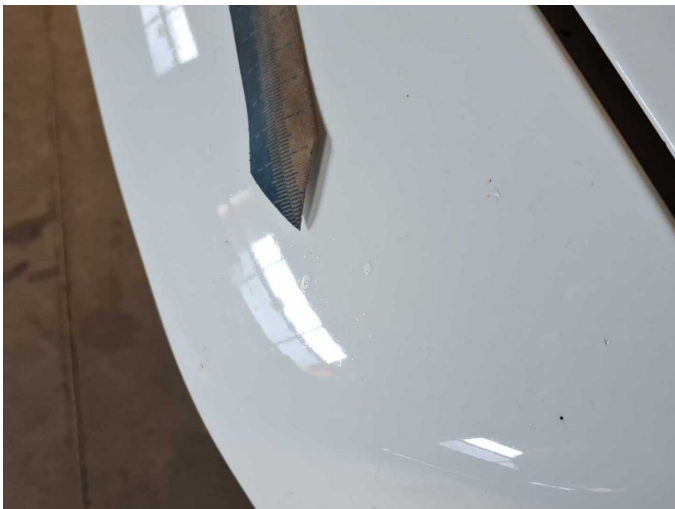
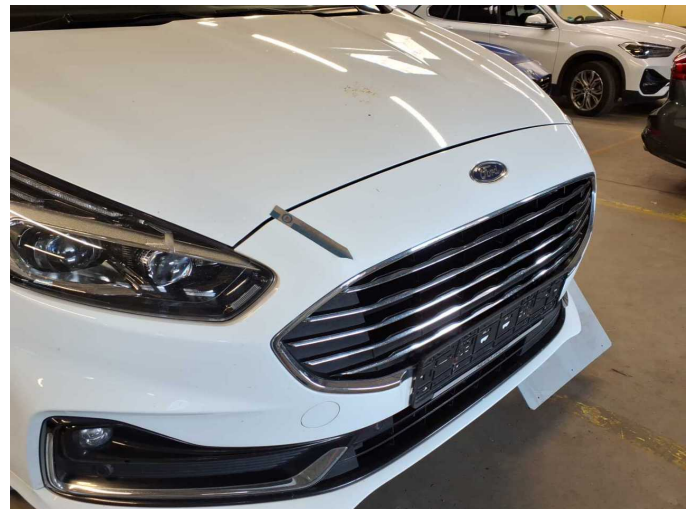
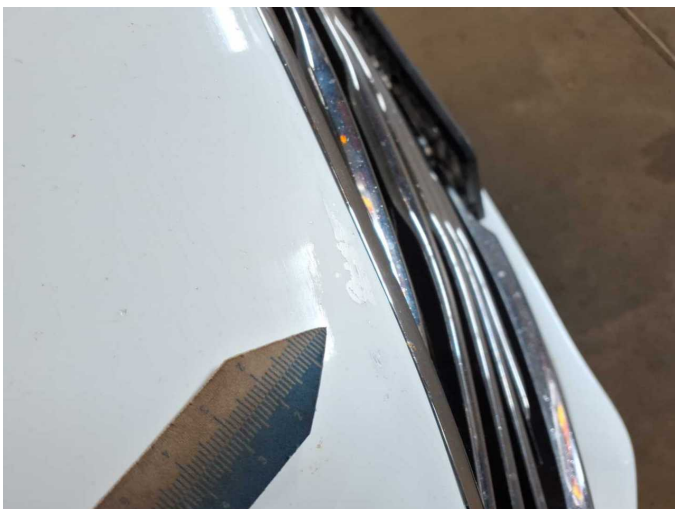
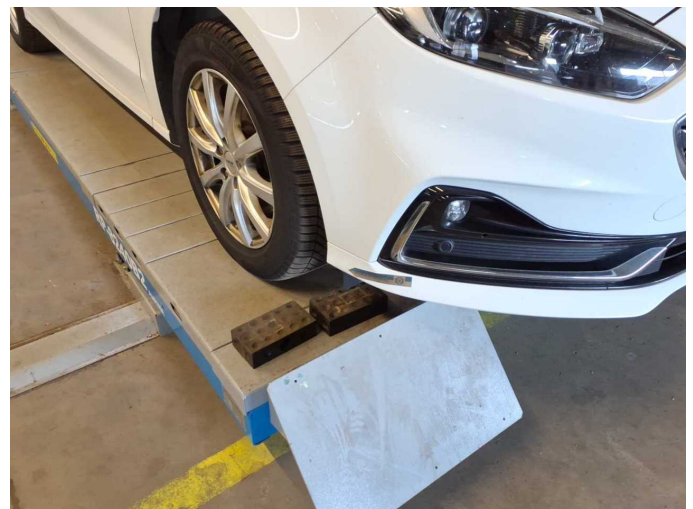
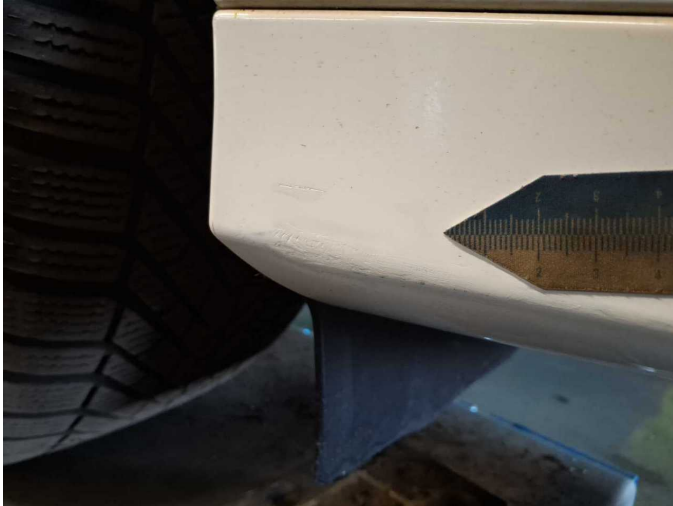
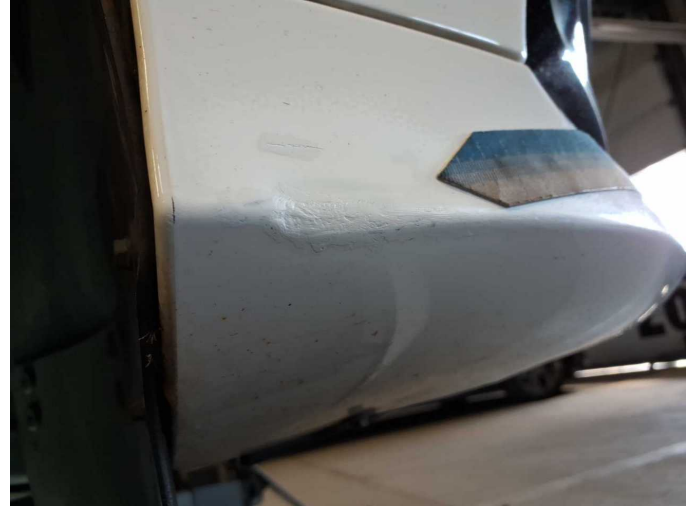
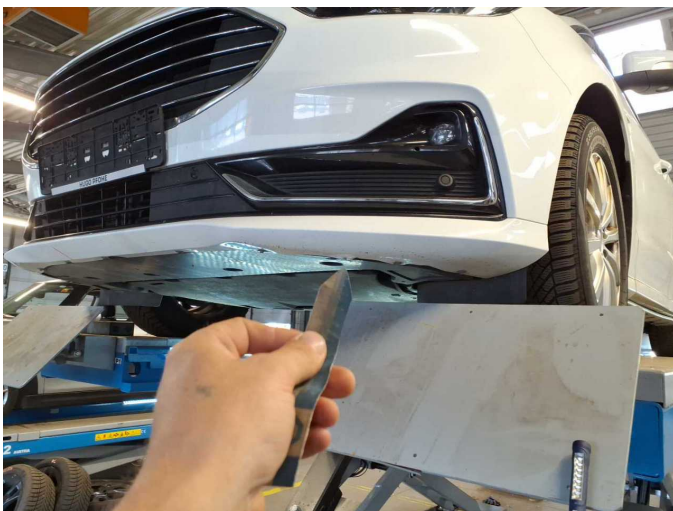
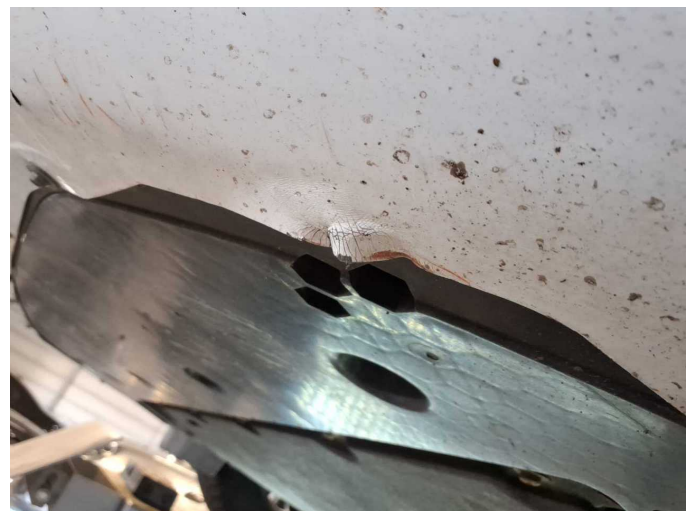
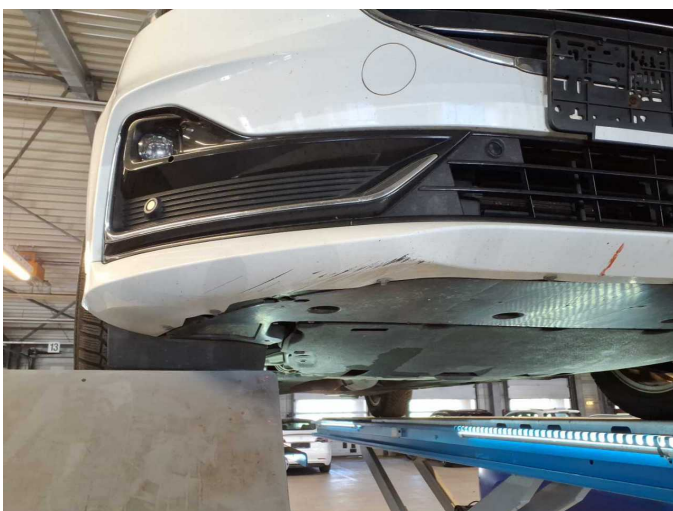
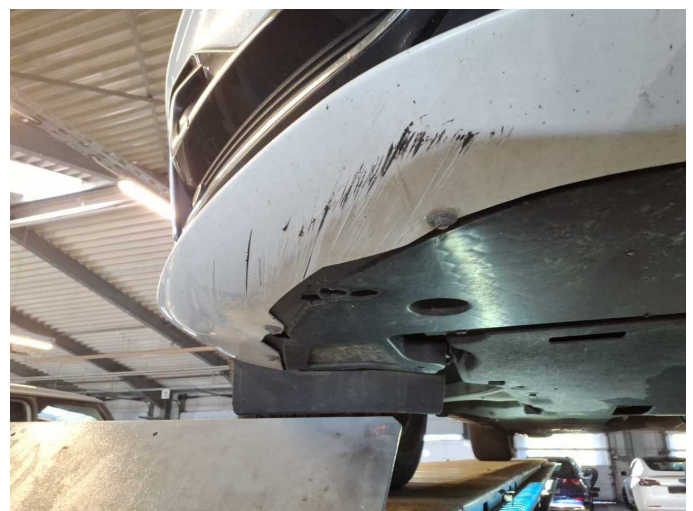
Damage 9: Front bumper: Front bumper (+ Spoiler) - Stone chips - Repair and paint

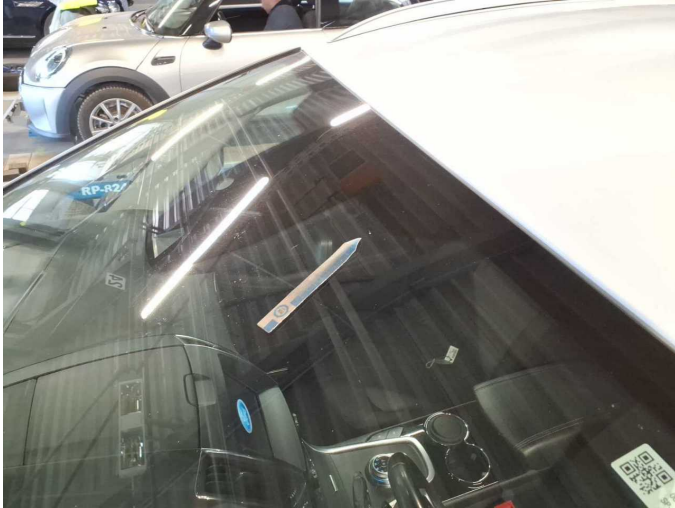
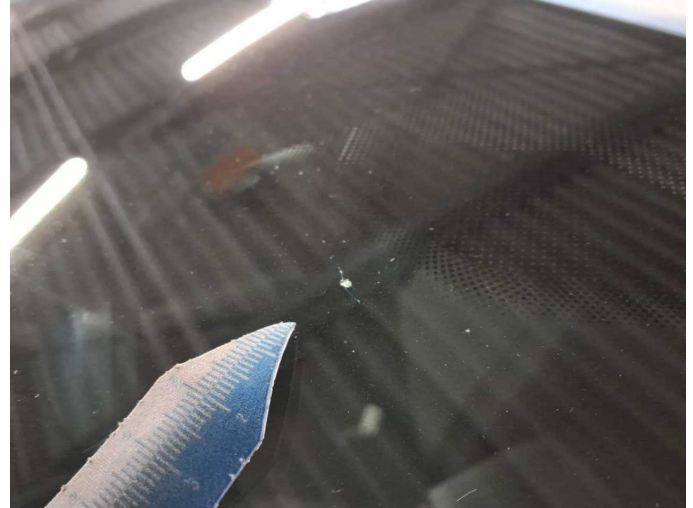
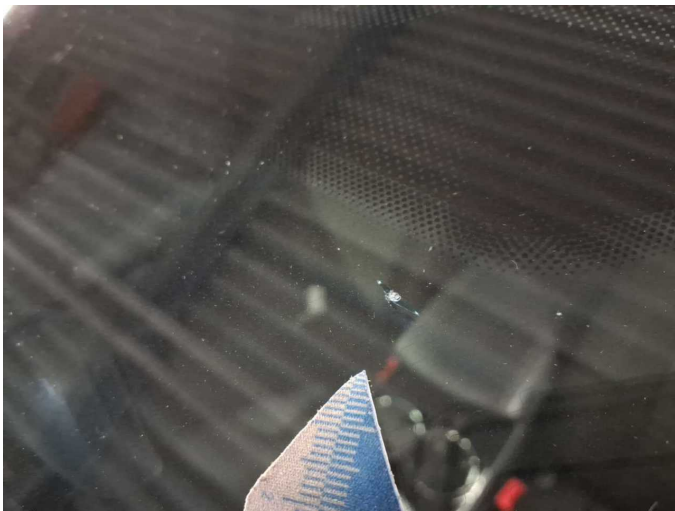
Damage 10: Vehicle glazing: Windscreen - Stone chips - Replace
