Expertise

Protocol number: 46609143  
Order No. / Reference: 26673621  
Inspection date: 21 Jul 2026

Manufacturer: MAN  
VIN: WMA03VUY2P9019775

Model: TGE 3.140 4X2F SB

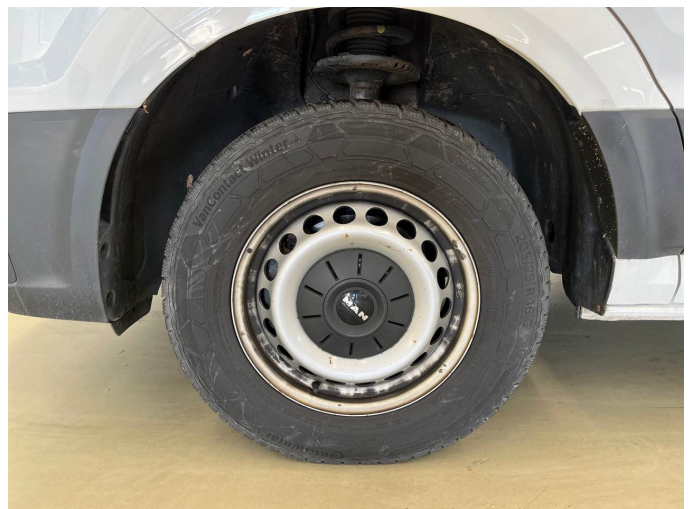
Figure 12: Mounted tyres

| # | Tyre size | Type of tyre | Manufacturer | Tread depth |
|---|---|---|---|---|
| 1) | 205/75 R16 113R | Winter tyres on Steel rim with wheel cover | Continental | 3mm / 3mm |

| No. | Component group | Description |
|---|---|---|
| 3 | Wheel / tyres | Tyre - front - Differs from the original configuration - Replace |

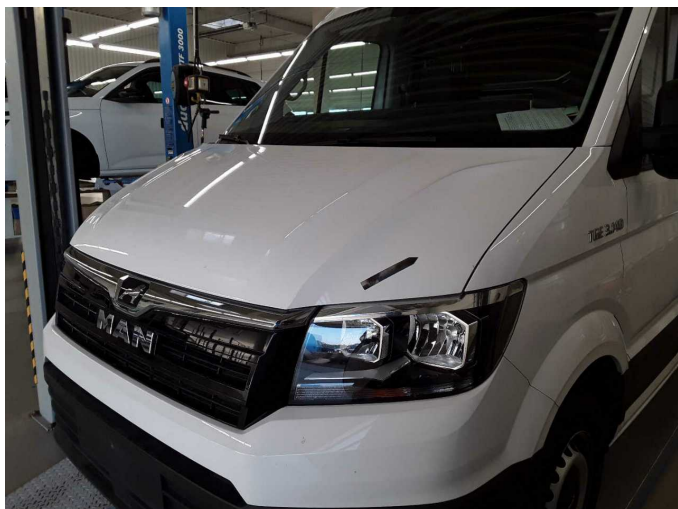
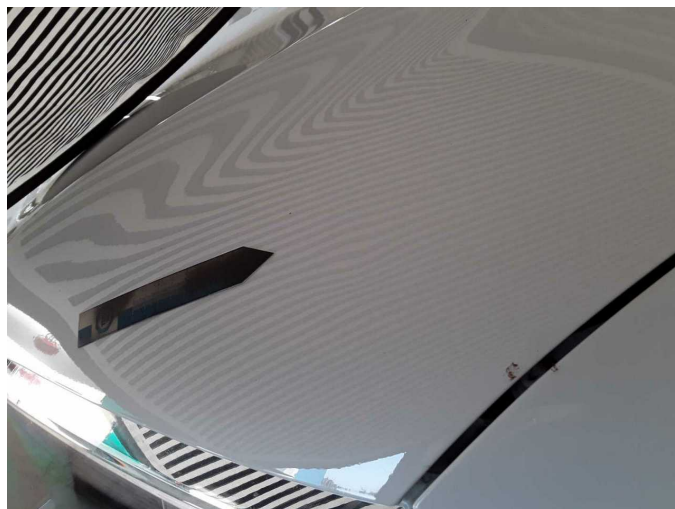
| No. | Component group | Description |
|---|---|---|
| 1 | Bonnet | Bonnet - dent(s) - Smart repair |

**Damage 1:** Bonnet: Bonnet - dent(s) - Smart repair

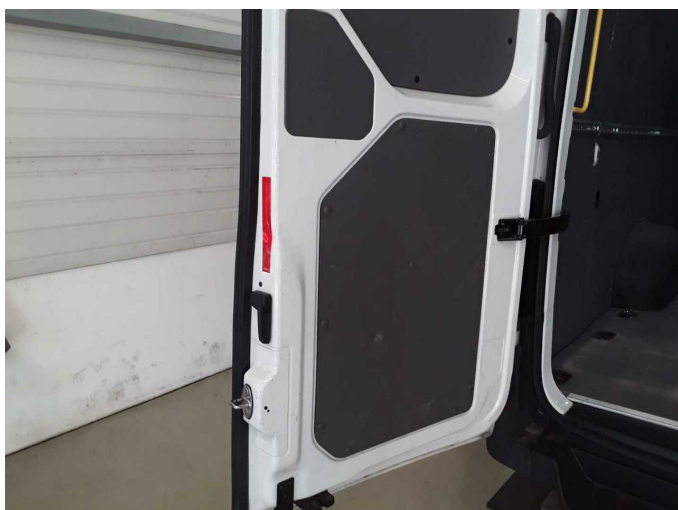
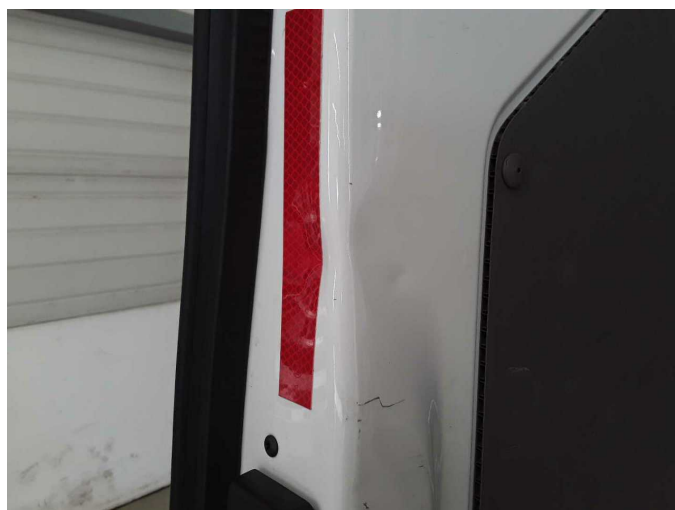
| No. | Component group | Description |
|---|---|---|
| 2 | Boot lid / rear door | Rear door - left side (innen) - dent(s) - Loss in value |

**Damage 2:** Boot lid / rear door: Rear door - left side (innen) - dent(s) - Loss in value

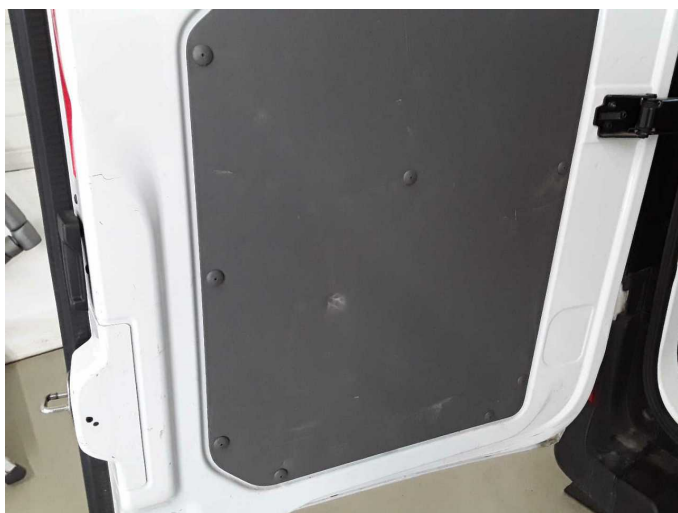
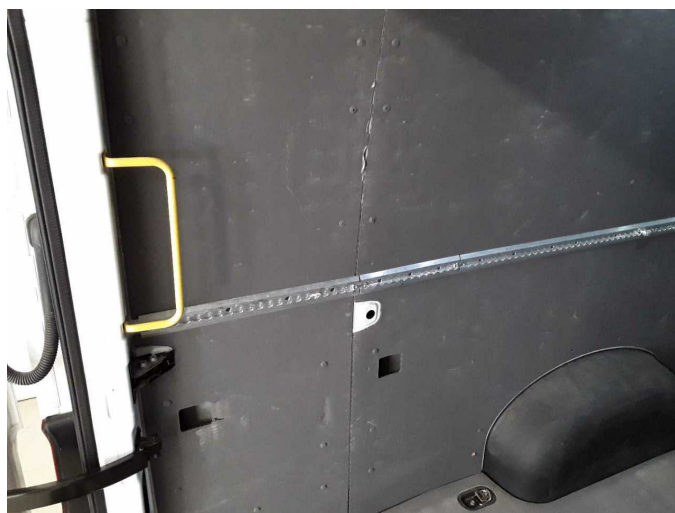
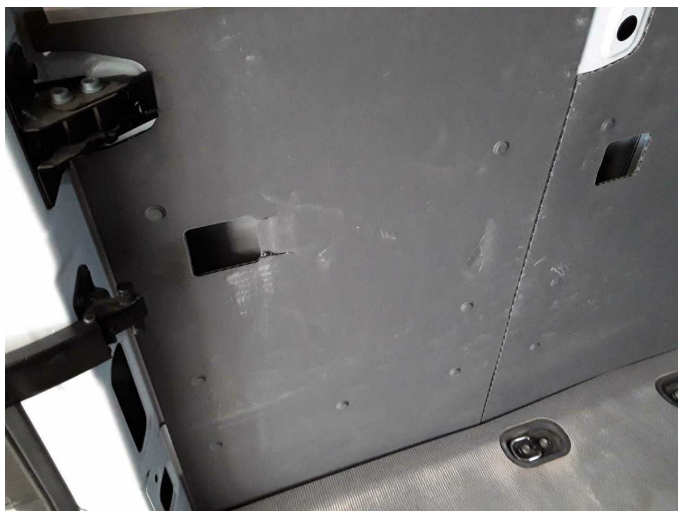
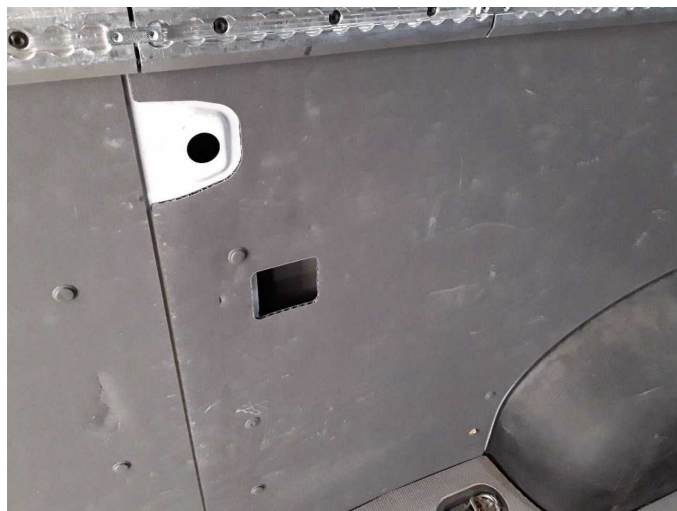
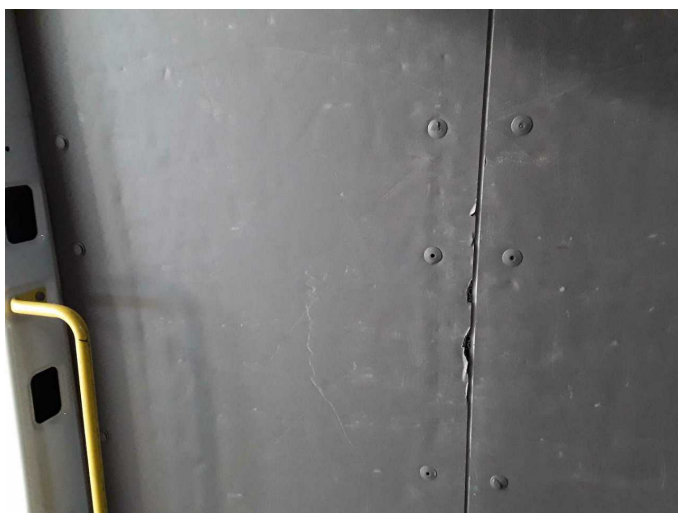
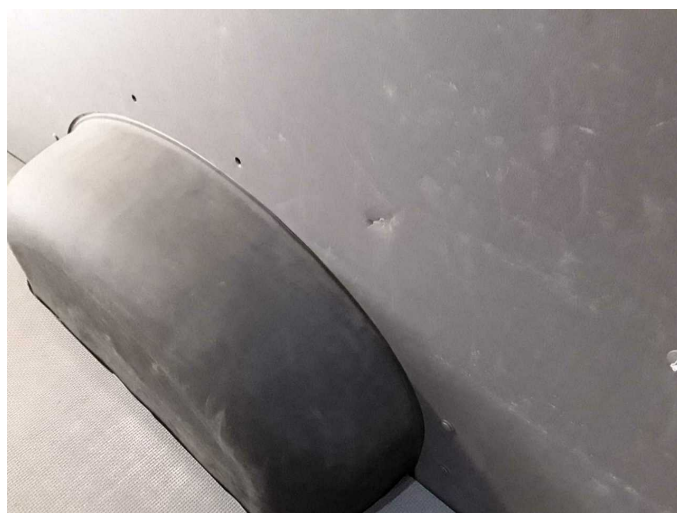
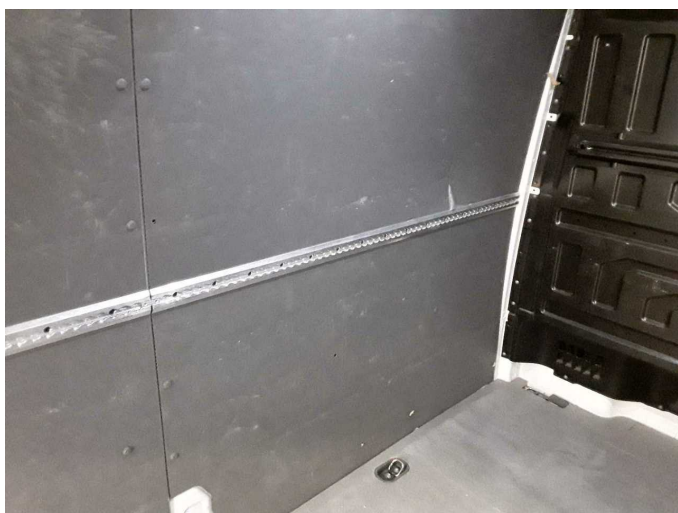
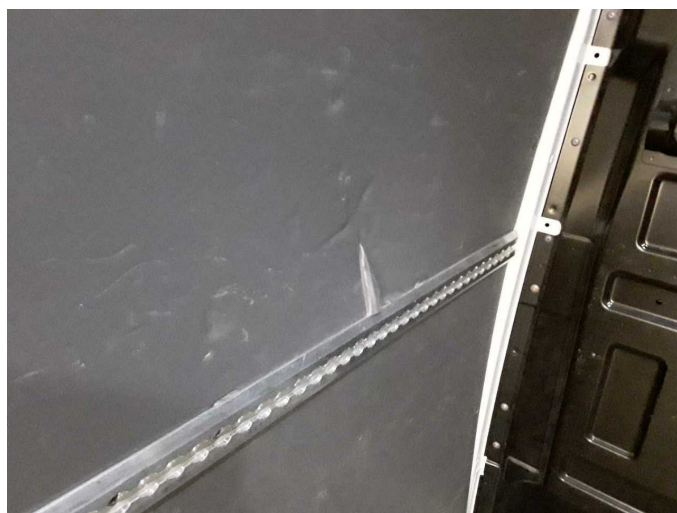
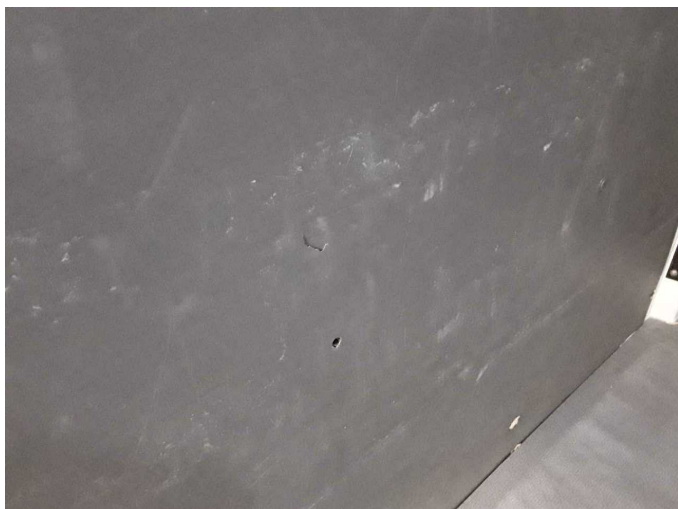
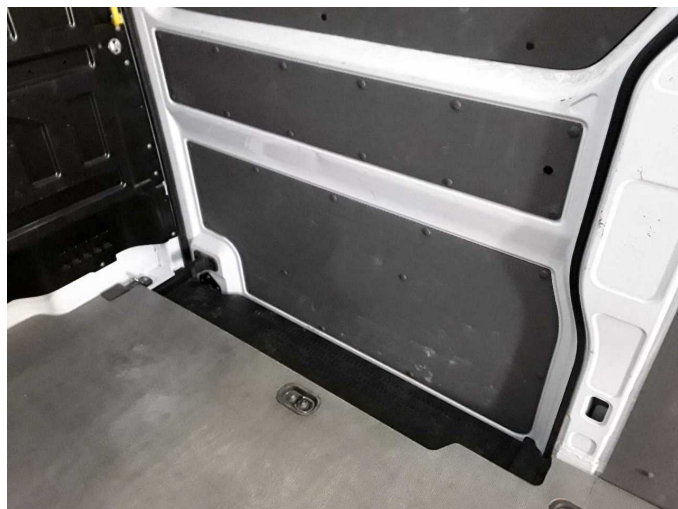
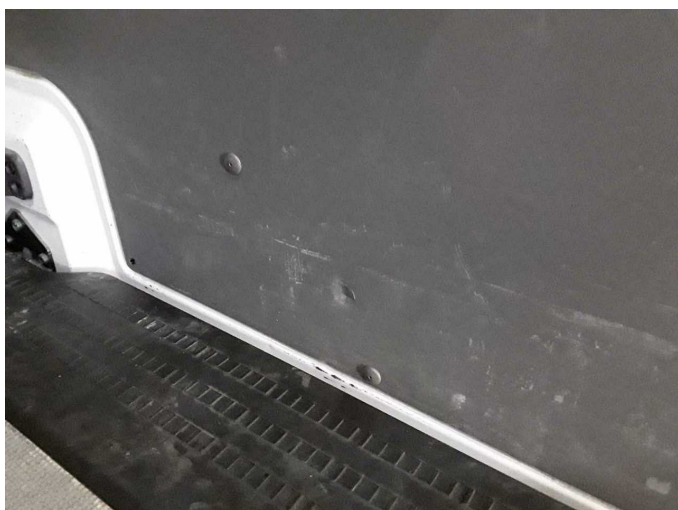
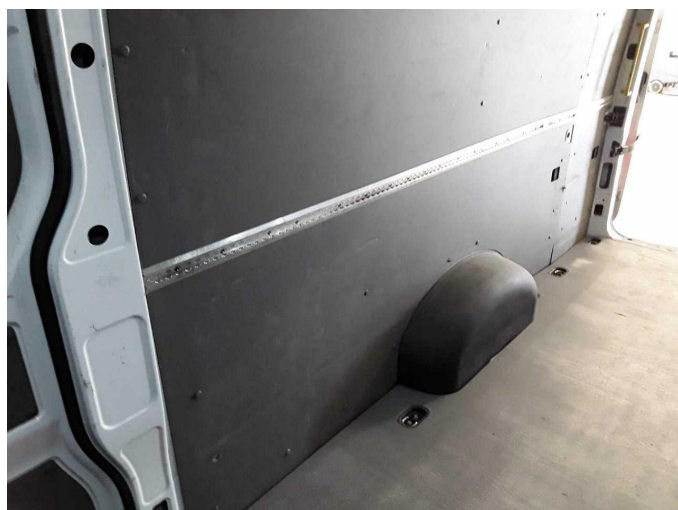
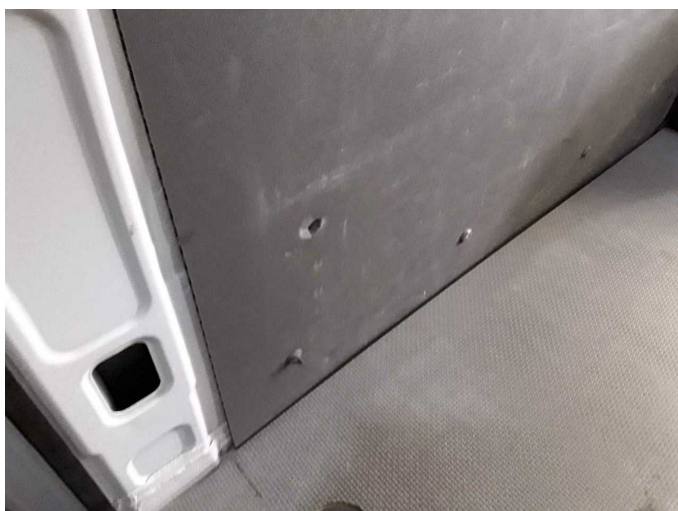
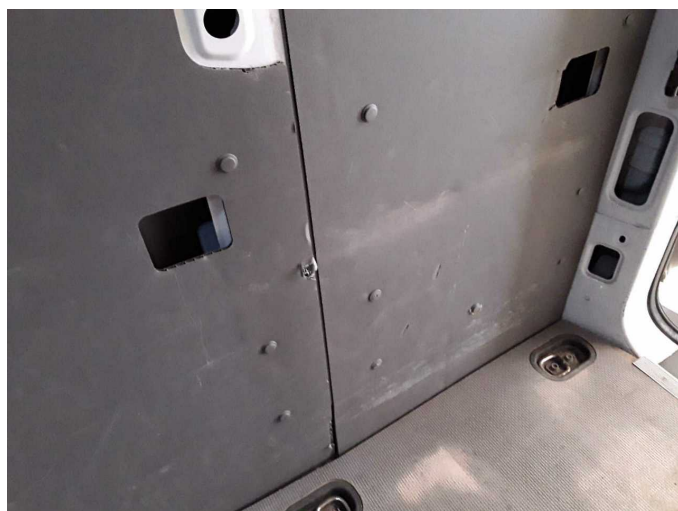
| No. | Component group | Description |
|---|---|---|
| 4 | Interior | Interior (Laderaumverkleidungen) - Broken / torn - Loss in value |

**Damage 4:** Interior: Interior (Laderaumverkleidungen) - Broken / torn - Loss in value

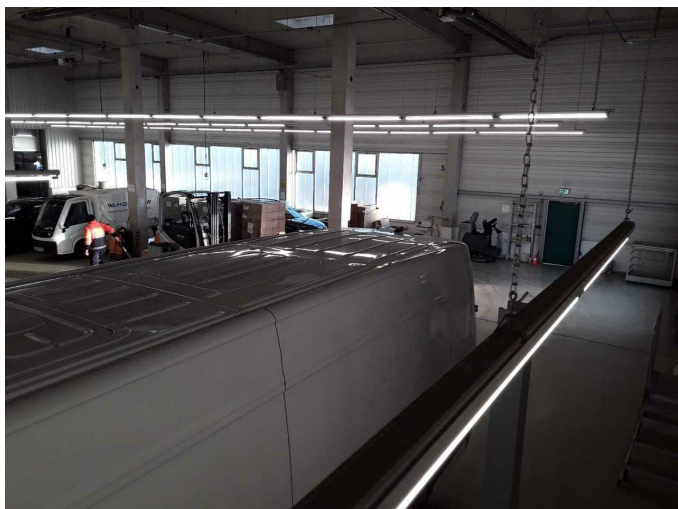
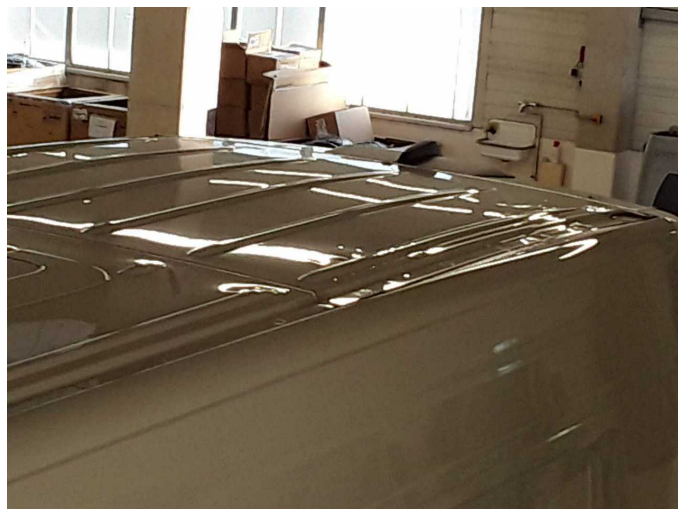
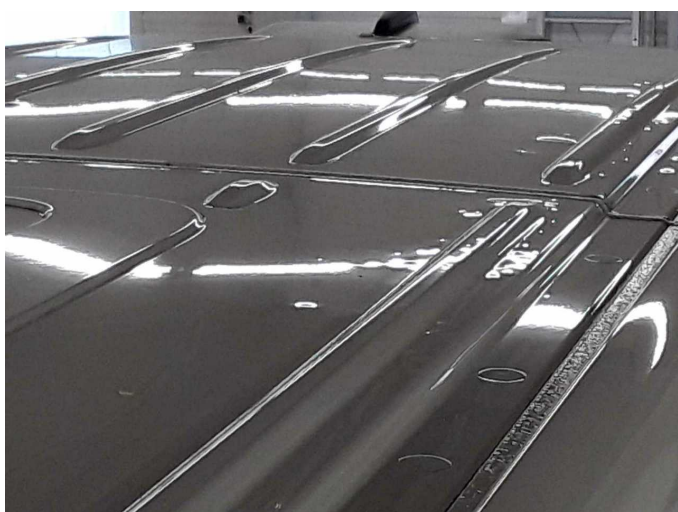
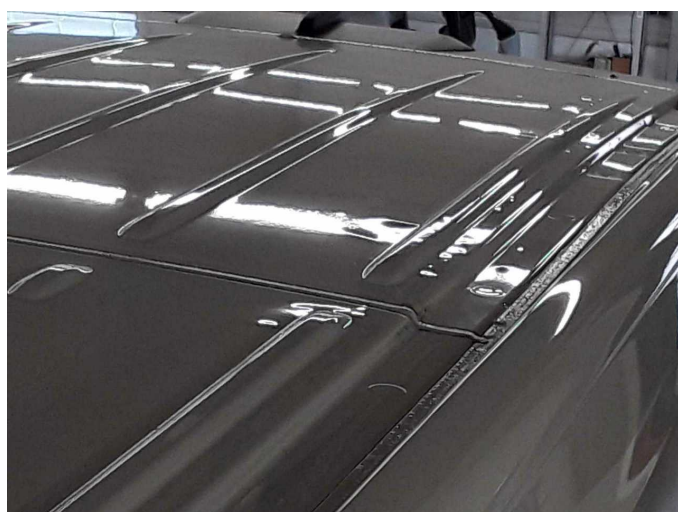
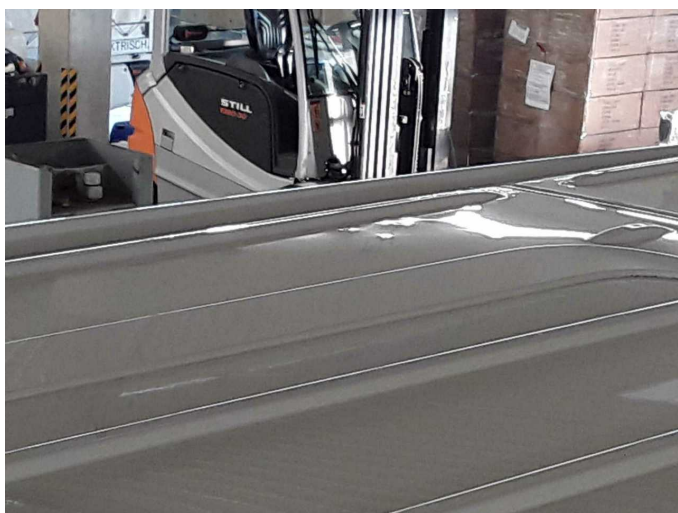
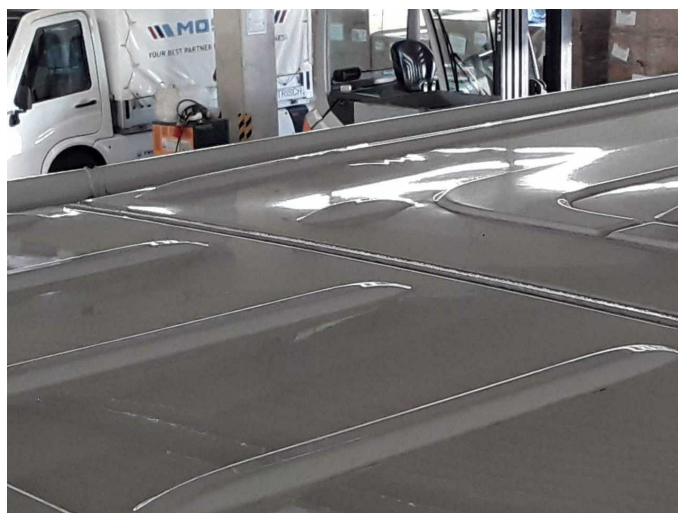
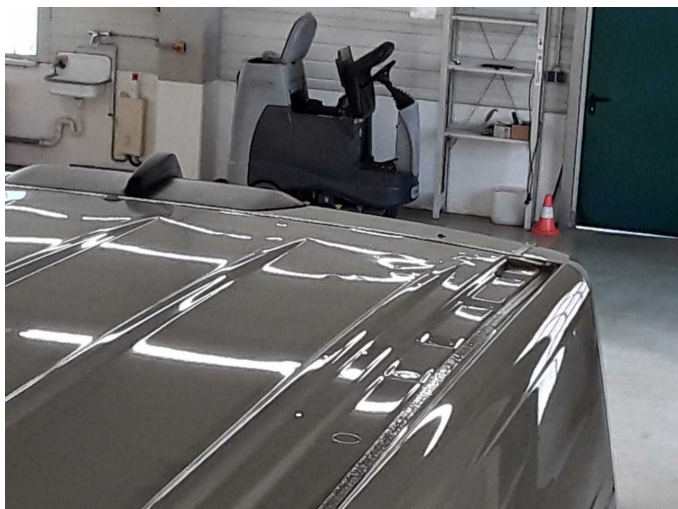
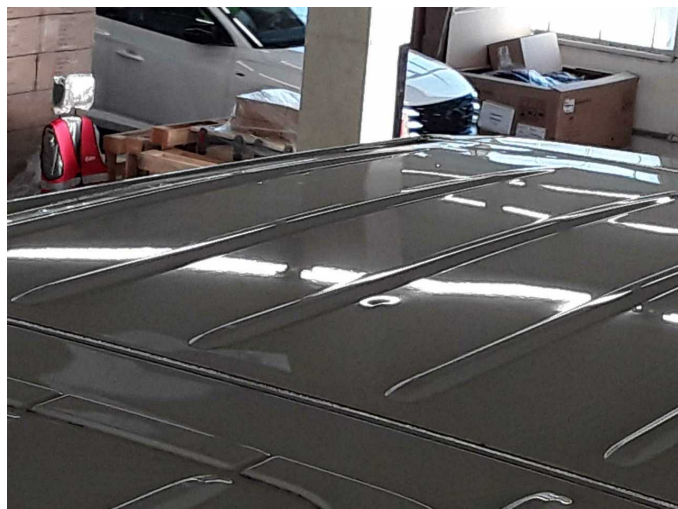
| No. | Component group | Description |
|---|---|---|
| 5 | Roof | Roof - dent(s) - Repair and paint |

**Damage 5:** Roof: Roof - dent(s) - Repair and paint

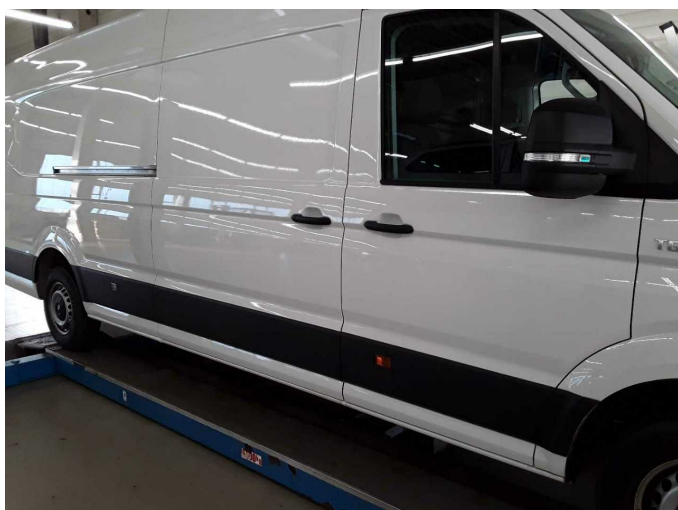
| No. | Previous damage | Extent of damage (Net) |
|---|---|---|
| 1 | Side right, Professionally repaired | |

**Previous damage 1:** Side right

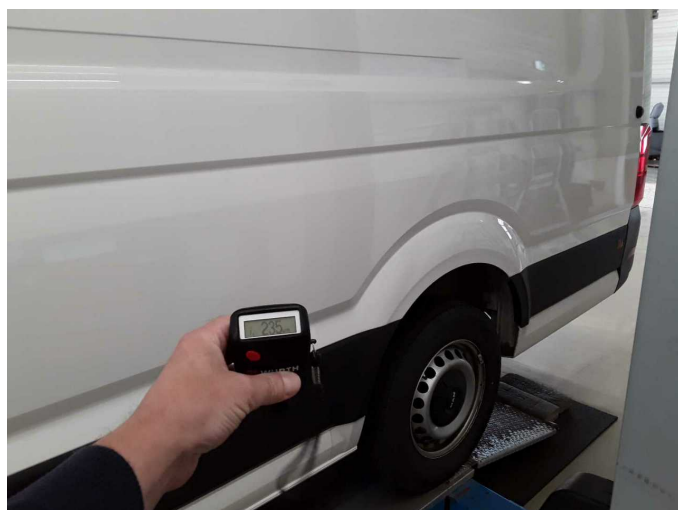
**Side panel - rear left side:** 235 µm

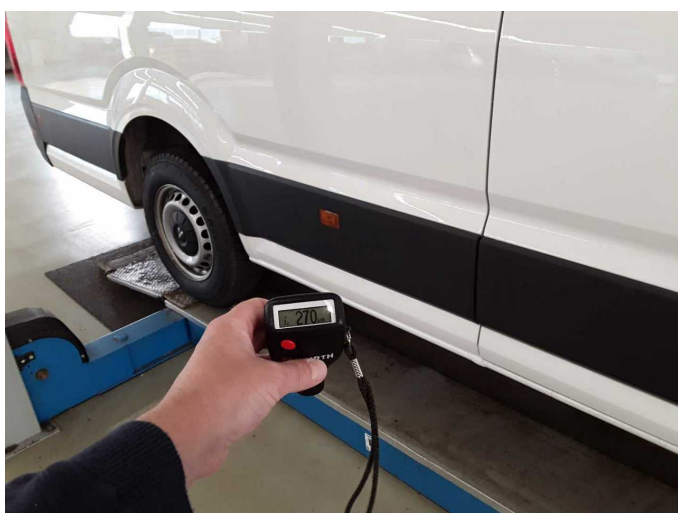
**Side panel - rear right side:** 270 µm

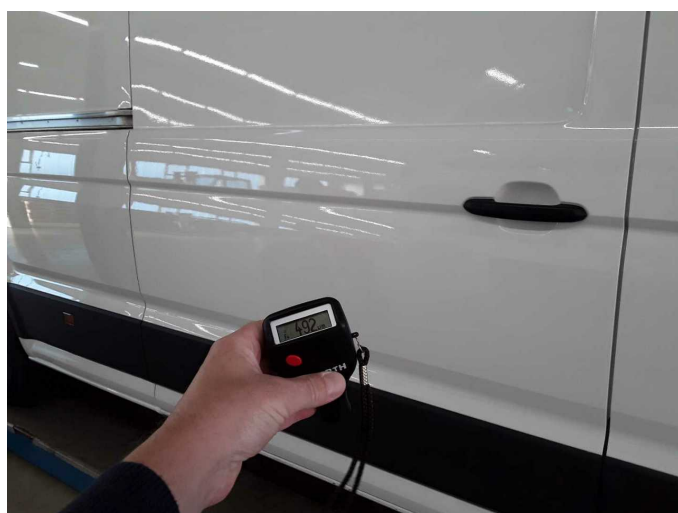
**Door - rear right side:** 492 µm

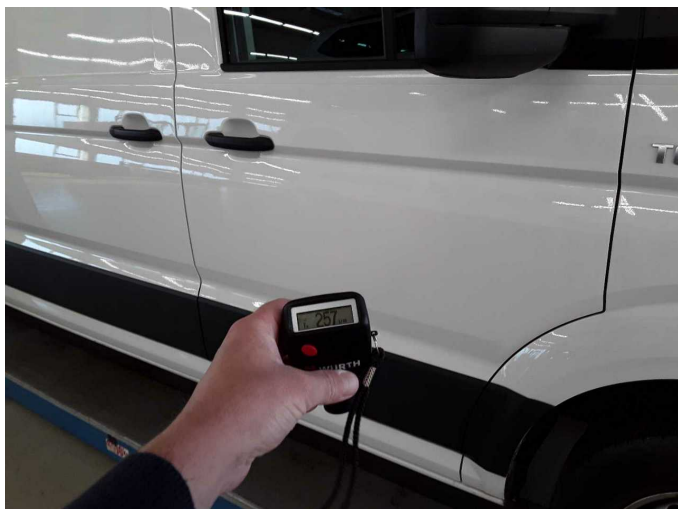
**Door - front right side: 257  $\mu$ m**
