# Damage Review

| Jobnr | 156692 |

| Make | MINI |
| Model | COOPER SE |

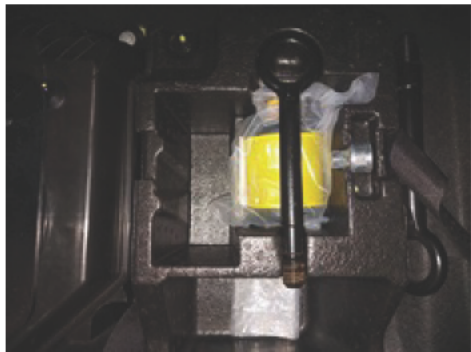
Pomp

| interior | 30 Missing | TYRE KIT | NA missing | Replace | € 0 |

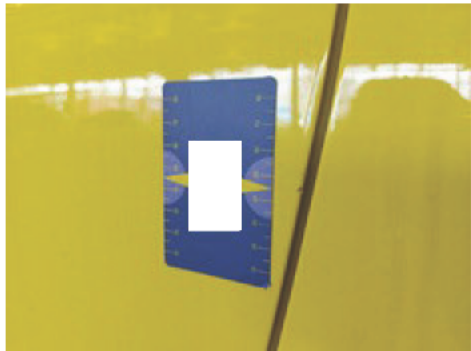
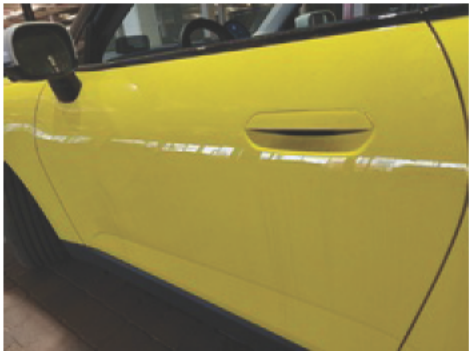
1a

| exterior | 8 DoorFL | DOOR FL | A scratch | SR - Touch up | € 0 |
