Expertise

Protocol number: 45580028
Order No. / Reference: 26348595
Inspection date: 19 May 2026

Model: Kodiaq 2.0 TDI 4x4 DSG Style

VIN: TMBLJ9NSXP8036380

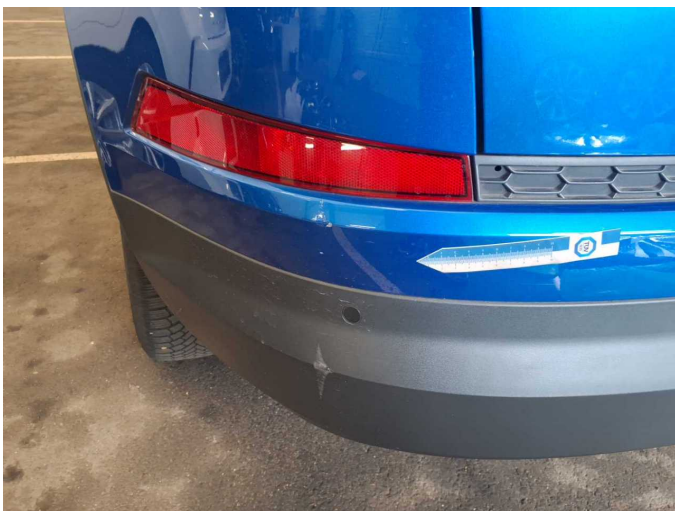
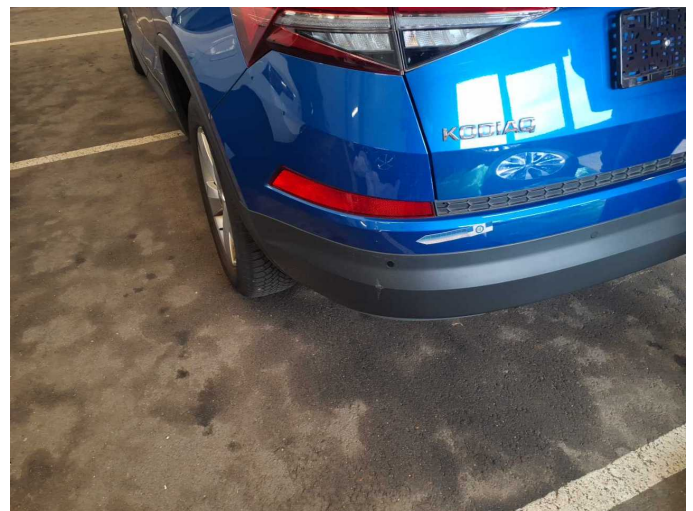
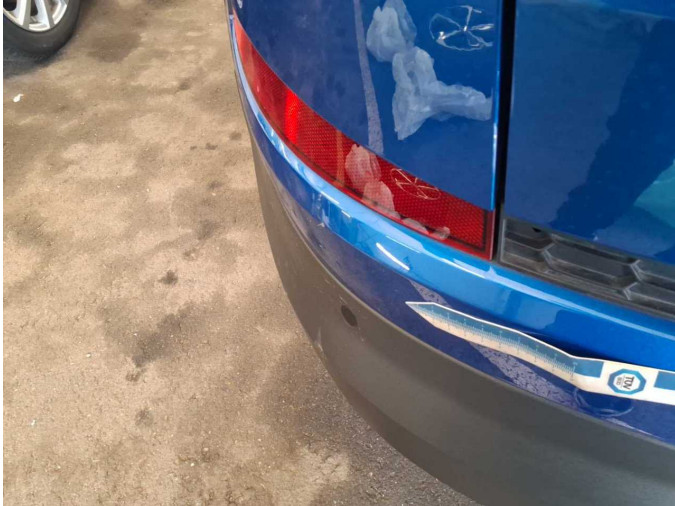
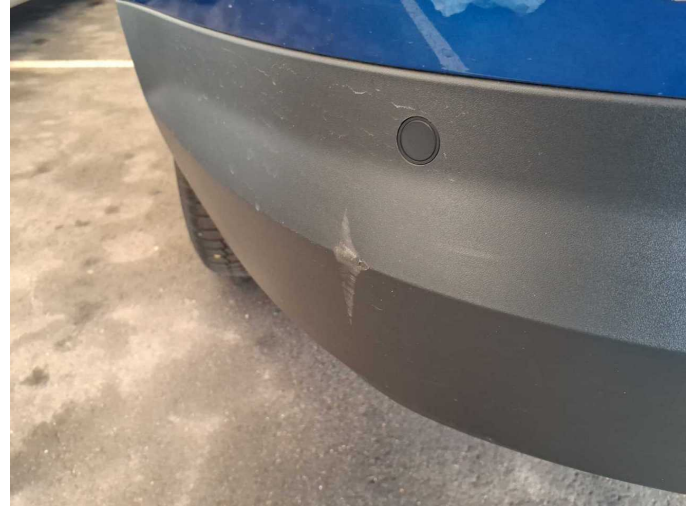
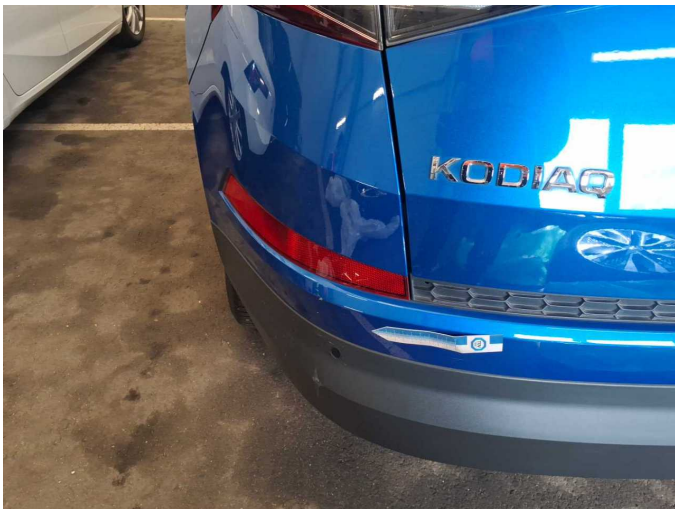
Damage 2: Rear bumper: Rear bumper - Scratched - repair according to calculation

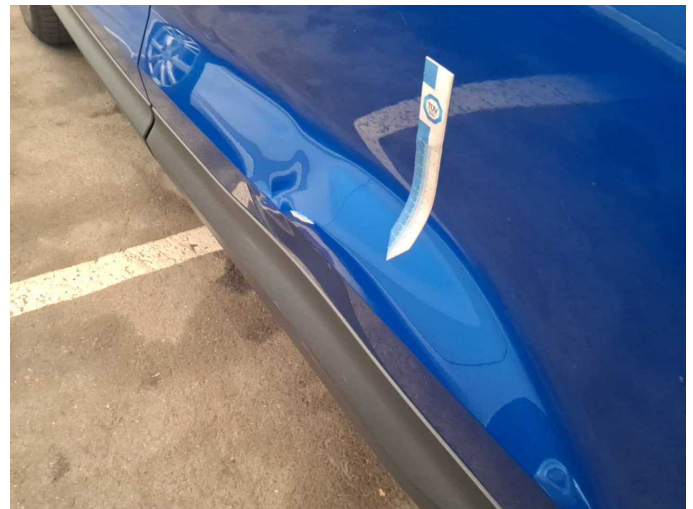
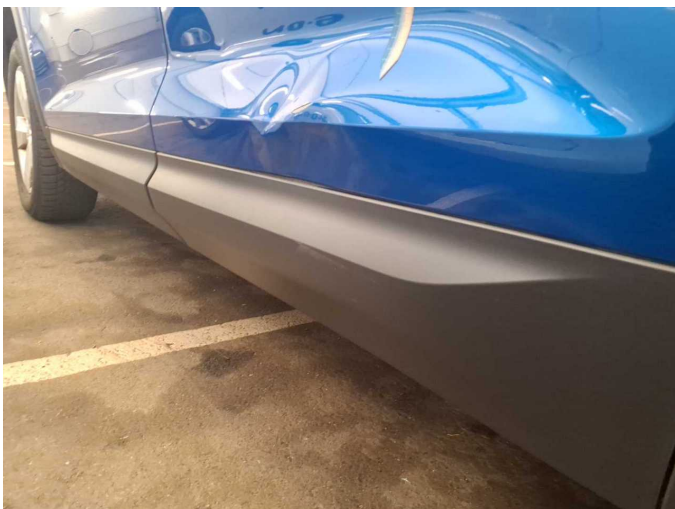
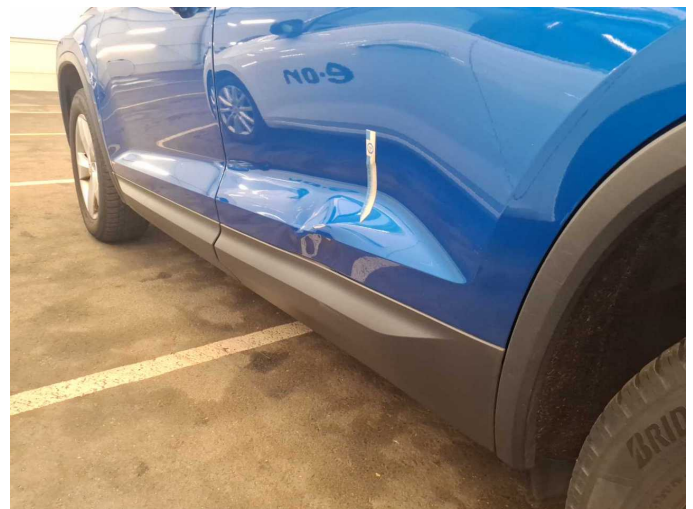
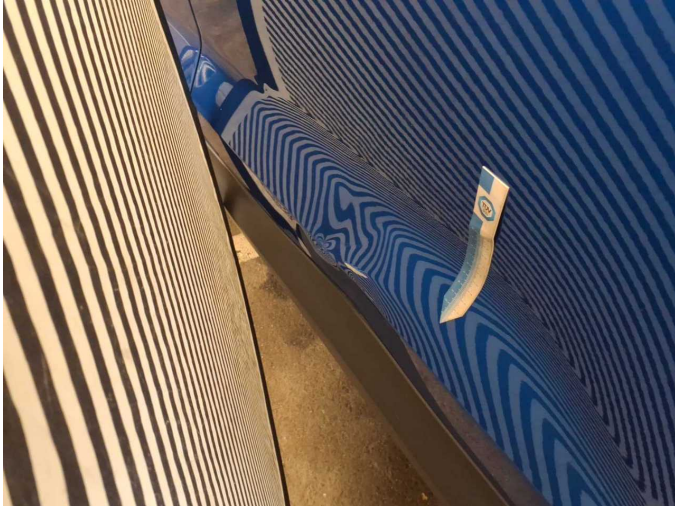
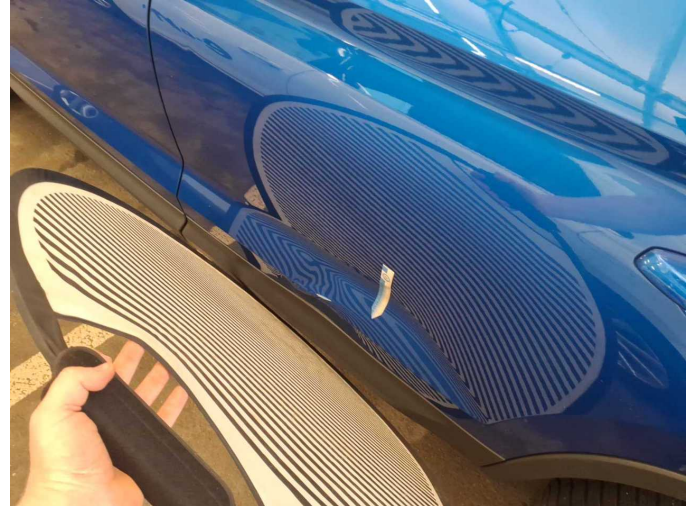
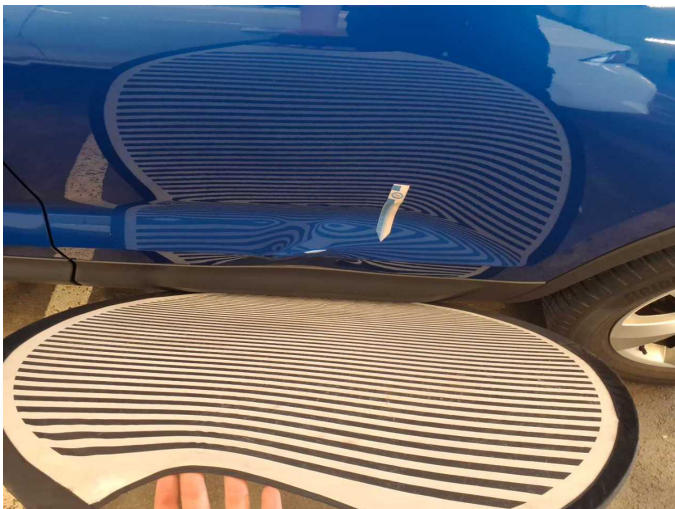
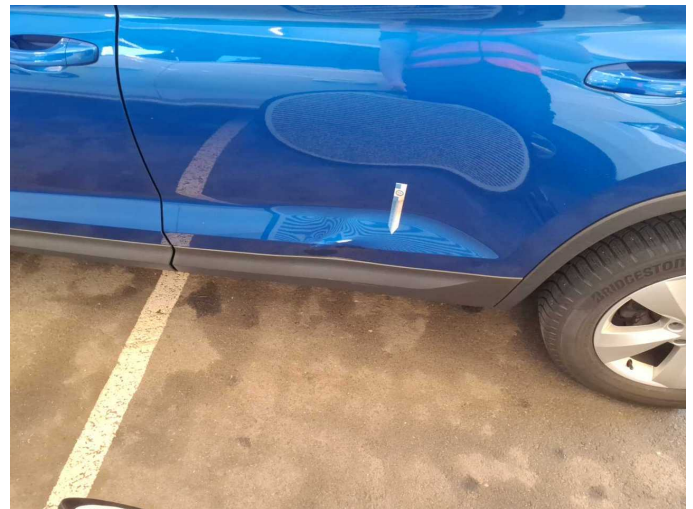
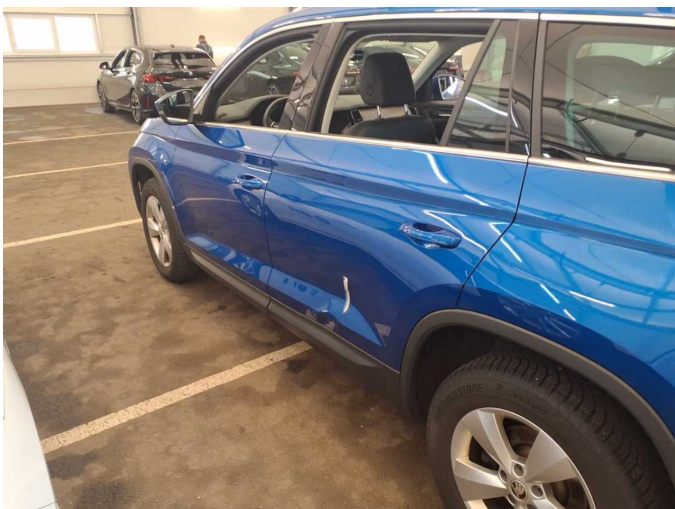
Damage 3: Door - rear left side: Door - Deformed - Replace

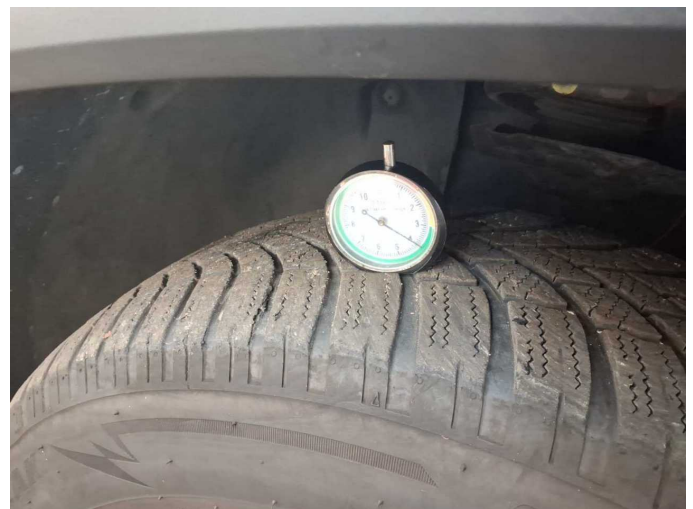
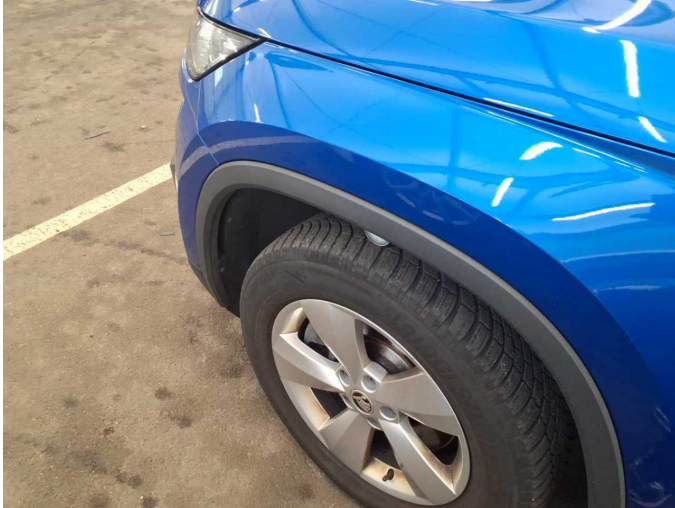
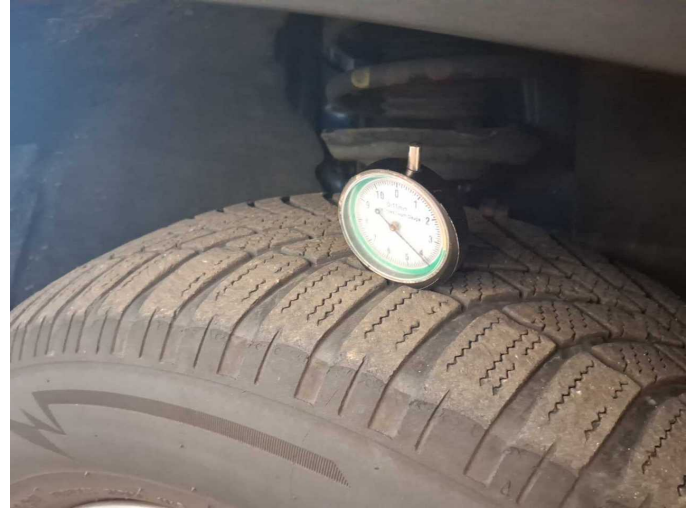
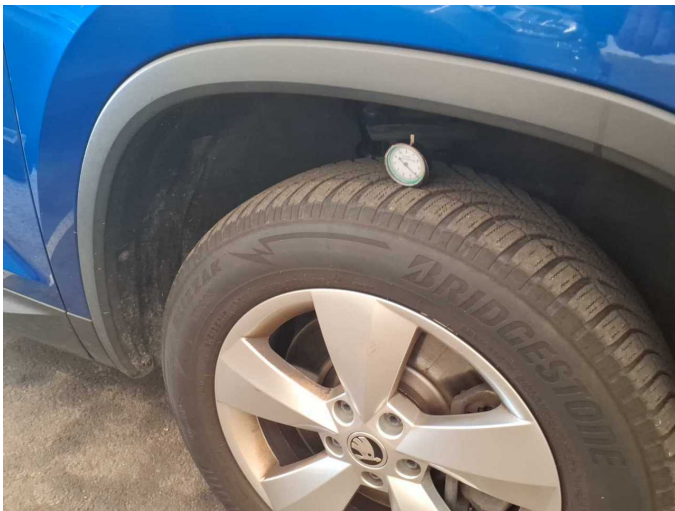
Wear and tear 1: Wheel / tyres: Tyre - front (Nicht Bestandteil der Ausstattung) - Does not meet the leasing specifications - No deduction

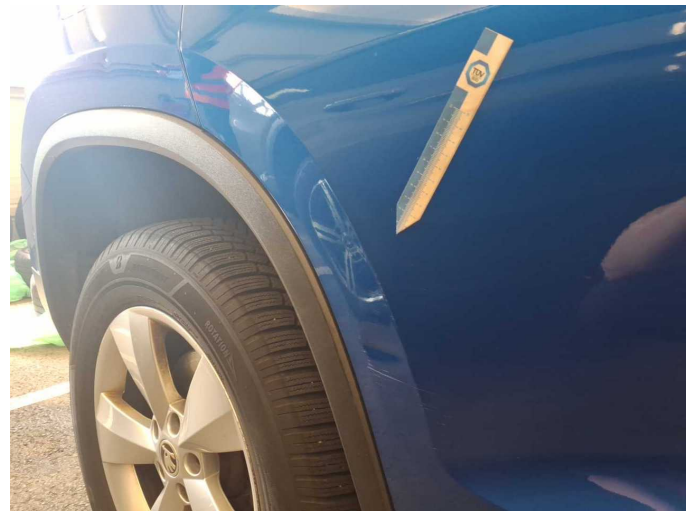
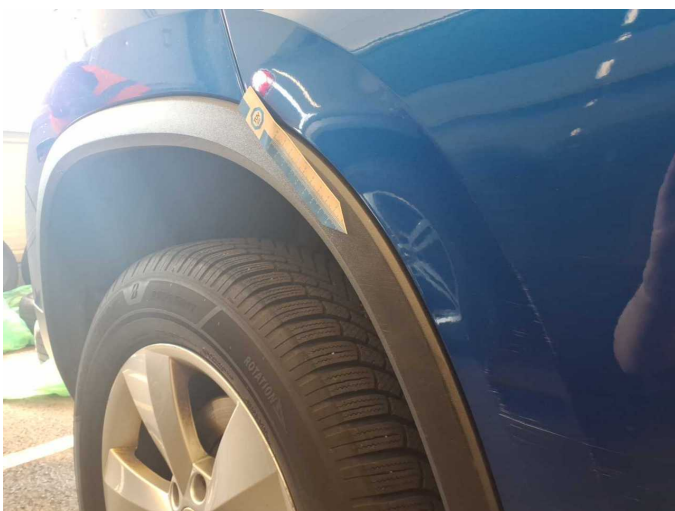
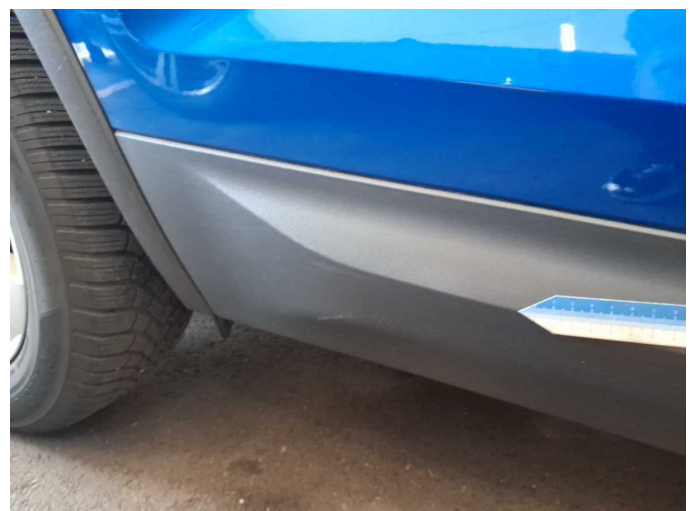
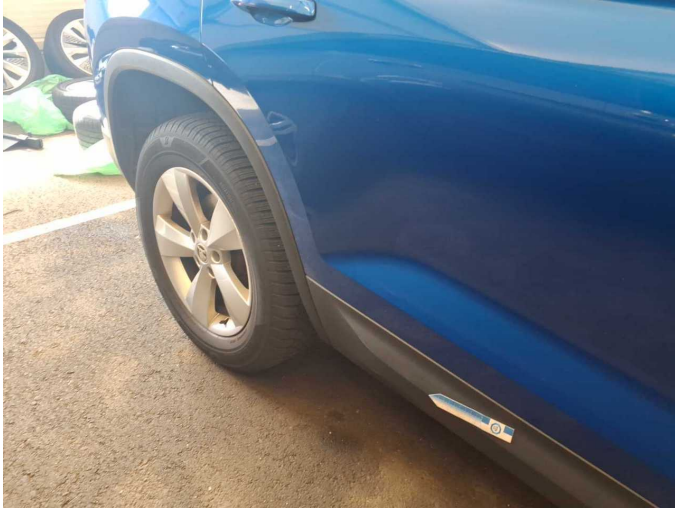
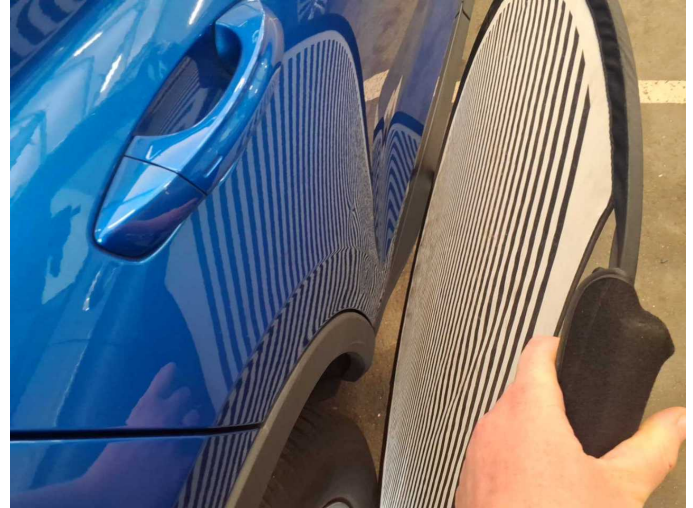
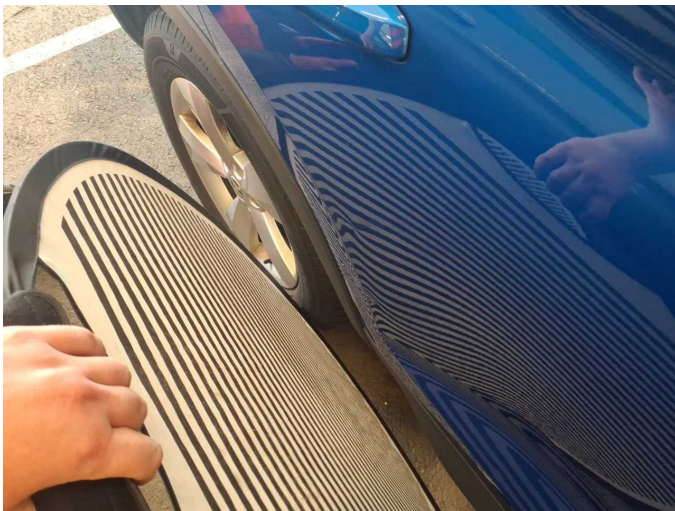
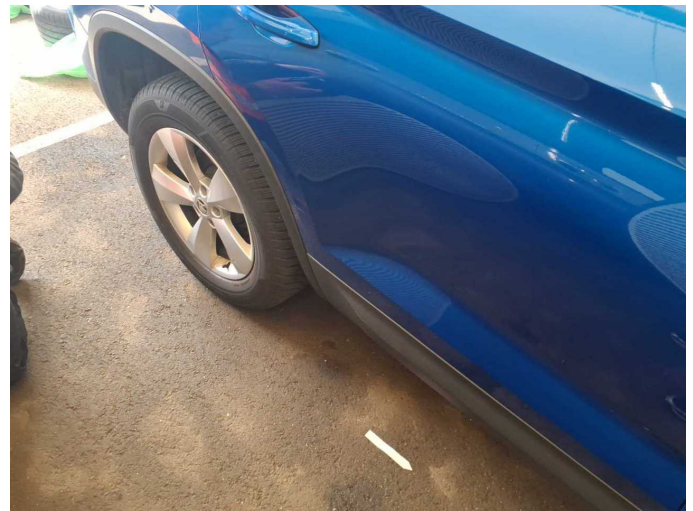
Accident 1: Side right
